WATER SUPPLY ASSESSMENT FOR TWO TAILS WINERY, 963 ORARA WAY NANA GLEN (0160/19DA)

This letter reports on a water supply assessment for the proposed Two Tails Winery development at the above address.

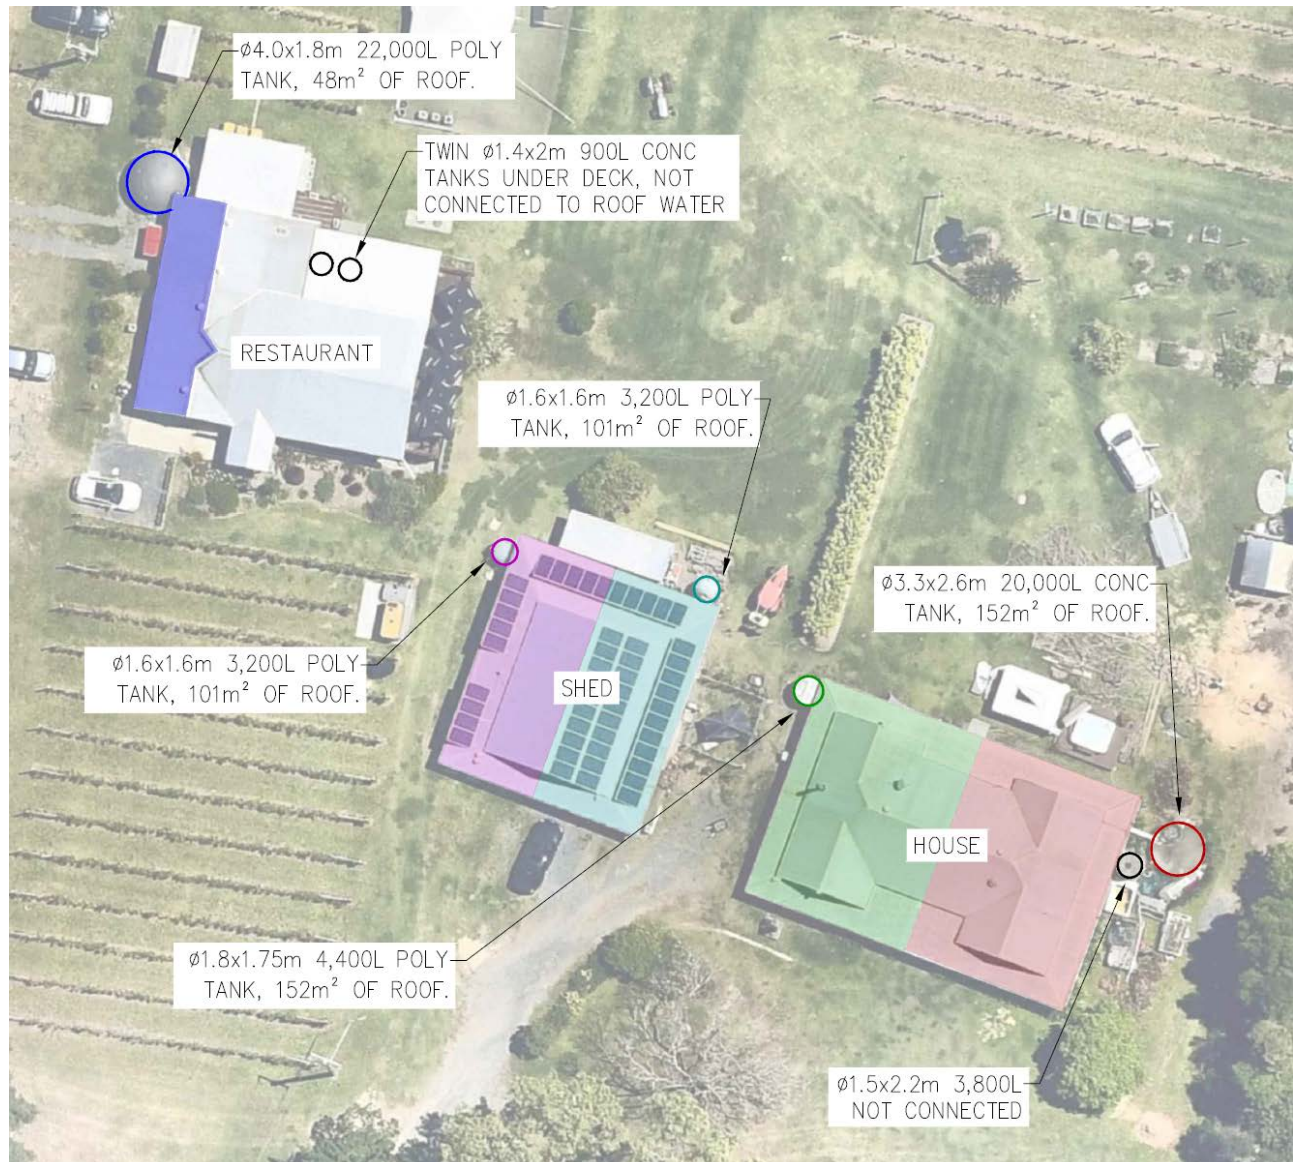
Figure 1 – Arrangement of Roof Water Tanks

There are three permanent buildings on the property from which roof water is harvested into several tanks as shown in Figure 1. The figure shows the location of the tanks which are colour coded to their approximate roof catchment. Note, stated capacities and roof areas are only approximate, likely to $\pm 10\%$

The restaurant's primary tank is a 22,000 L above ground poly tank. However, it only currently captures 48 sq.m of the restaurant's 265 sq.m of roof. The remaining roof is plumbed towards, but not currently connected to, twin 900 L concrete tanks under the restaurant's deck. The supply from the primary tank is treated through canister filters and UV disinfection before plumbed to all fixtures in the restaurant.

The shed has two 3,200 L poly tanks, both with 101 sq.m of roof. This water is mostly used for general agricultural uses. Note, there is no installed irrigation on the property.

The house has three tanks. The smallest is not connected. The remaining two, a 4,400L poly and 20,000 L concrete which is partly in the ground, share the 304 sq.m roof.

The roof gutters, down pipes and roof water plumbing are in fair to poor condition. The number of down pipes is also insufficient by current plumbing standards. Significant gutter overflows in heavy rain is likely, although this would still be only a small percentage of runoff volume.

The tank overflows are not interconnected. Overflow from any tank is lost. There is also no permeant connection of supply from building to building. It is understood that temporary connection, by means of

hoses and pumps can be arranged if needed to transfer water from tank to tank, but this generally hasn't been done.
