## ARBORICULTURAL ADDENDUM

Prepared For: Minter Ellison

Site Address: 1 Gatacre Avenue & 5 Allison Avenue  
LANE COVE, NSW, 2066

Report Date: 19<sup>th</sup> September 2022

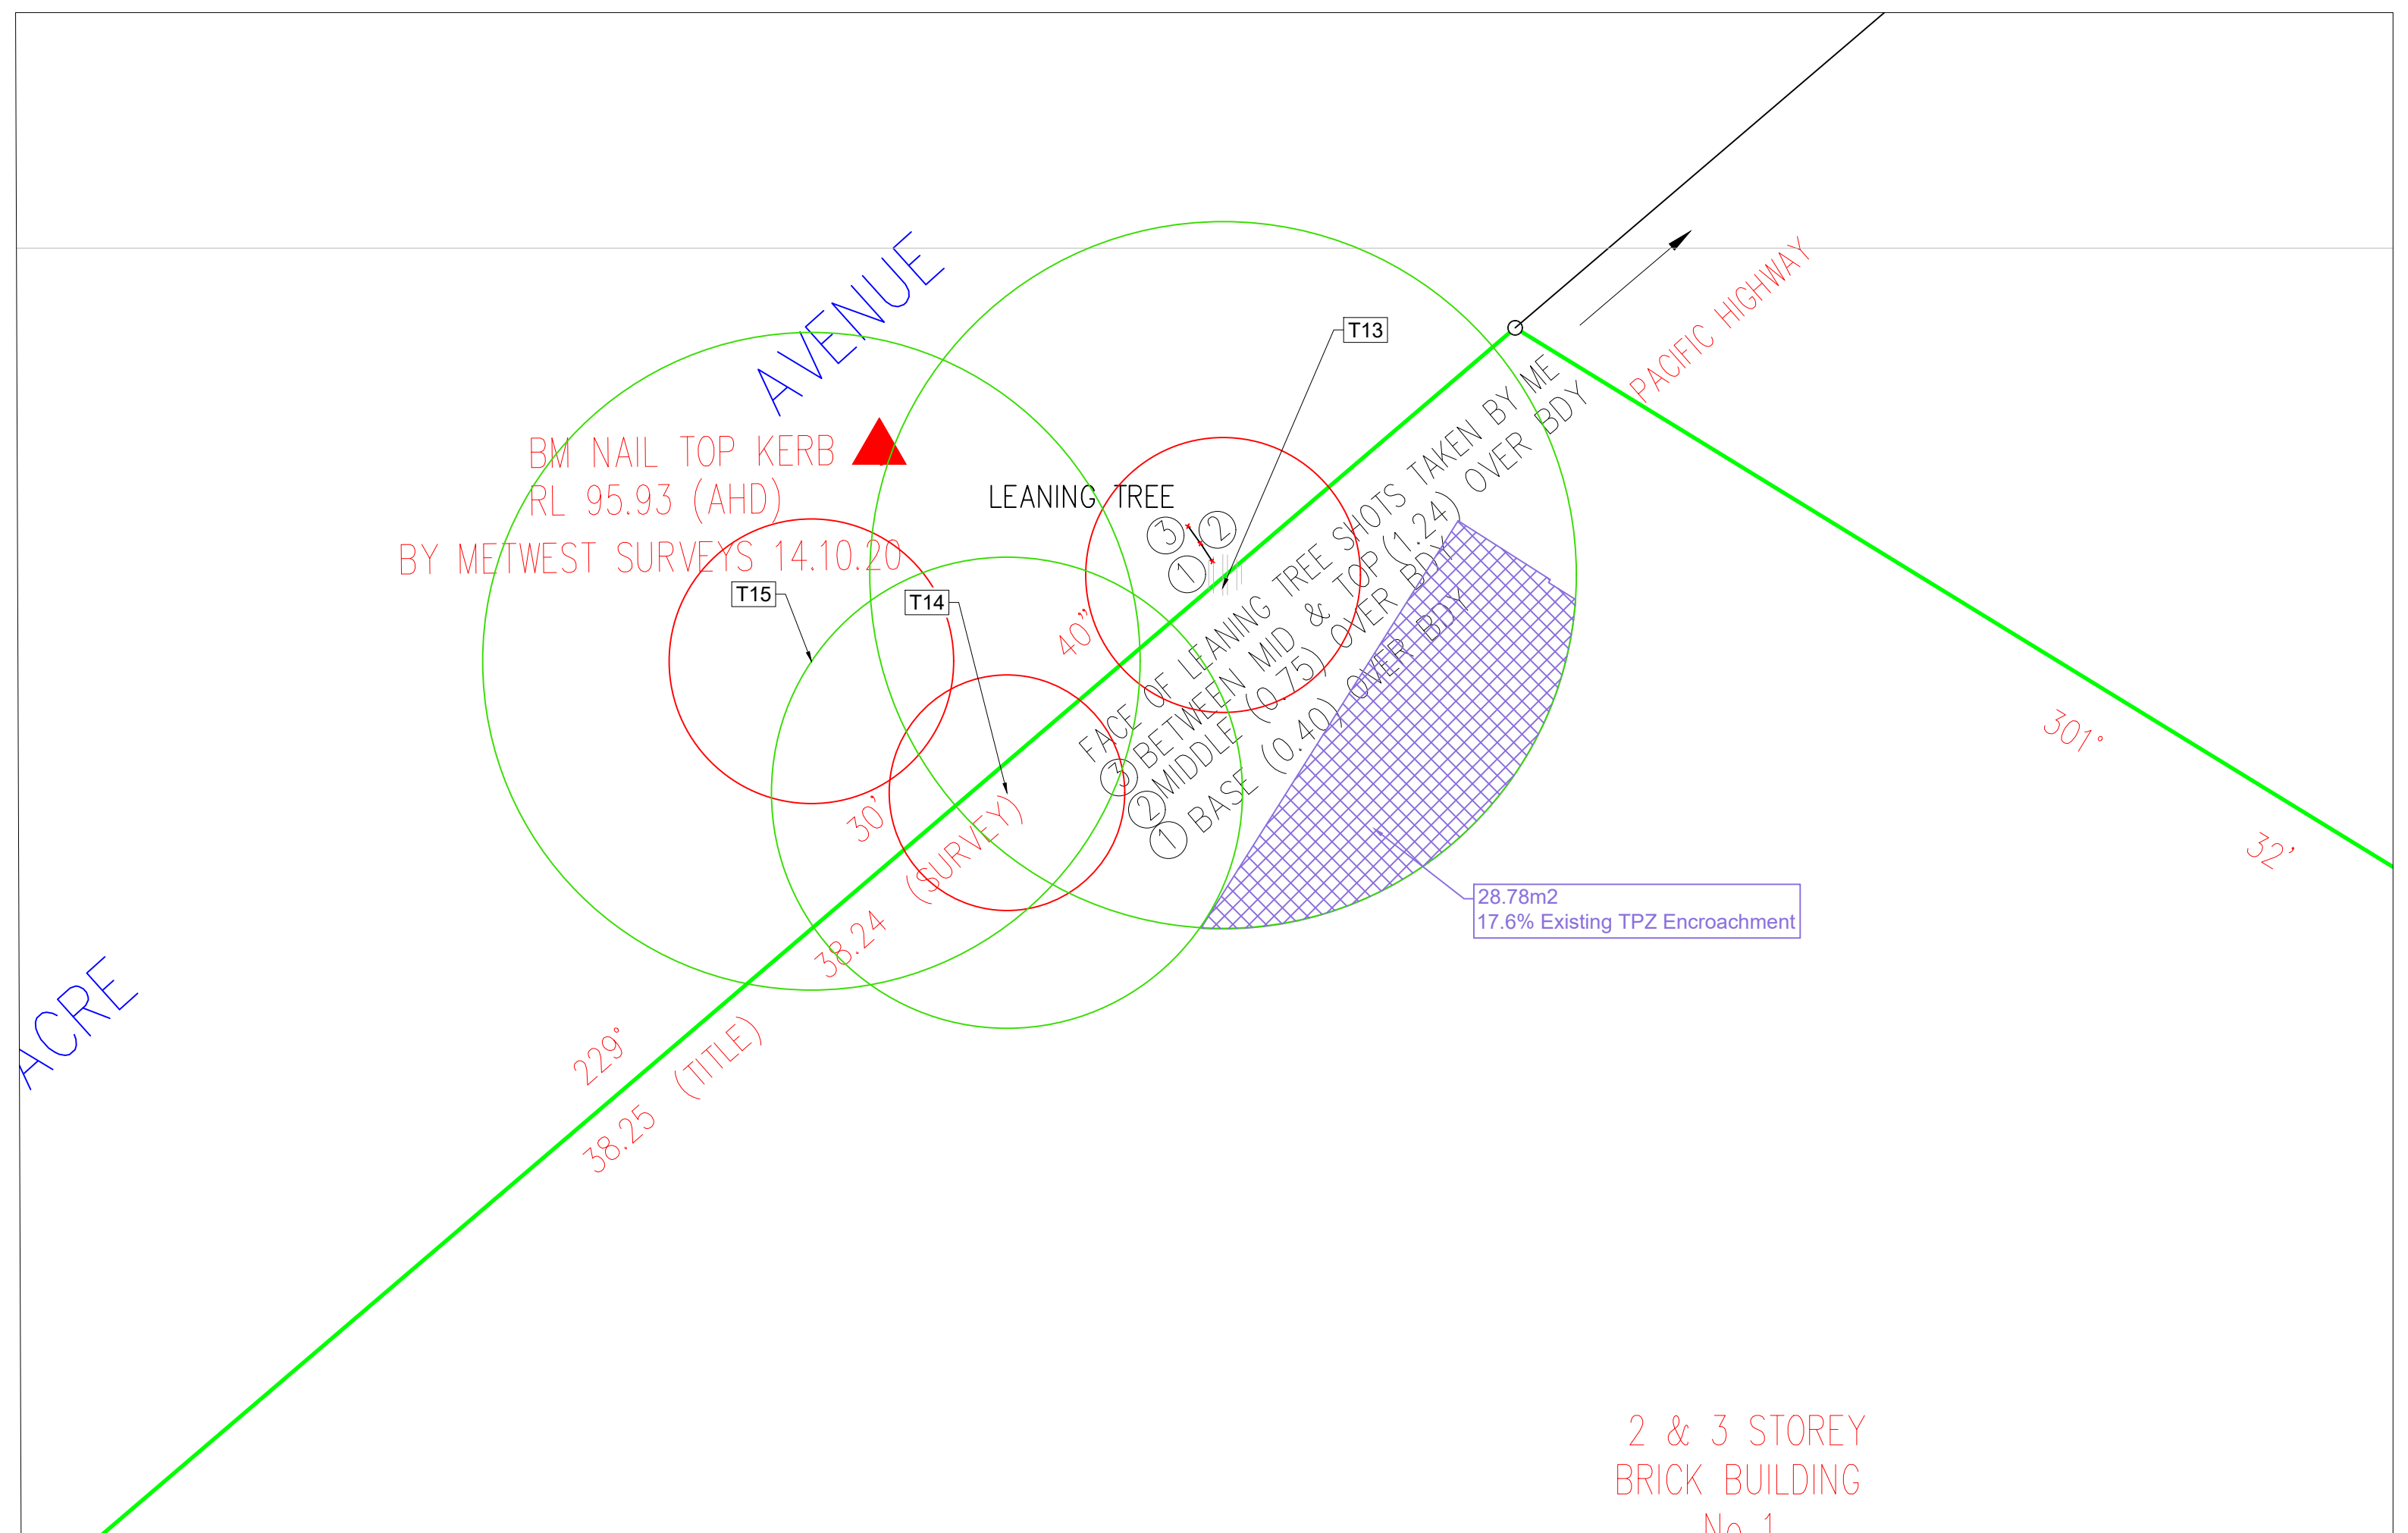
## 7 Appendix 2 – Existing Encroachment Potentials

- 5.1.6 The existing building is located well within the TPZ area of the tree, such that the existing building accounts for approximately 17.6% of the TPZ area - A *Major* encroachment per *the standard*. This value is more than permitted to be redistributed around the remaining TPZ area.

- 5.1.7 From the root mapping study, Structural roots exist against footings of the existing building. Impacts associated with demolition is likely to cause damage or severance to these roots which exist parallel or beneath existing footings. This could include a combination of:

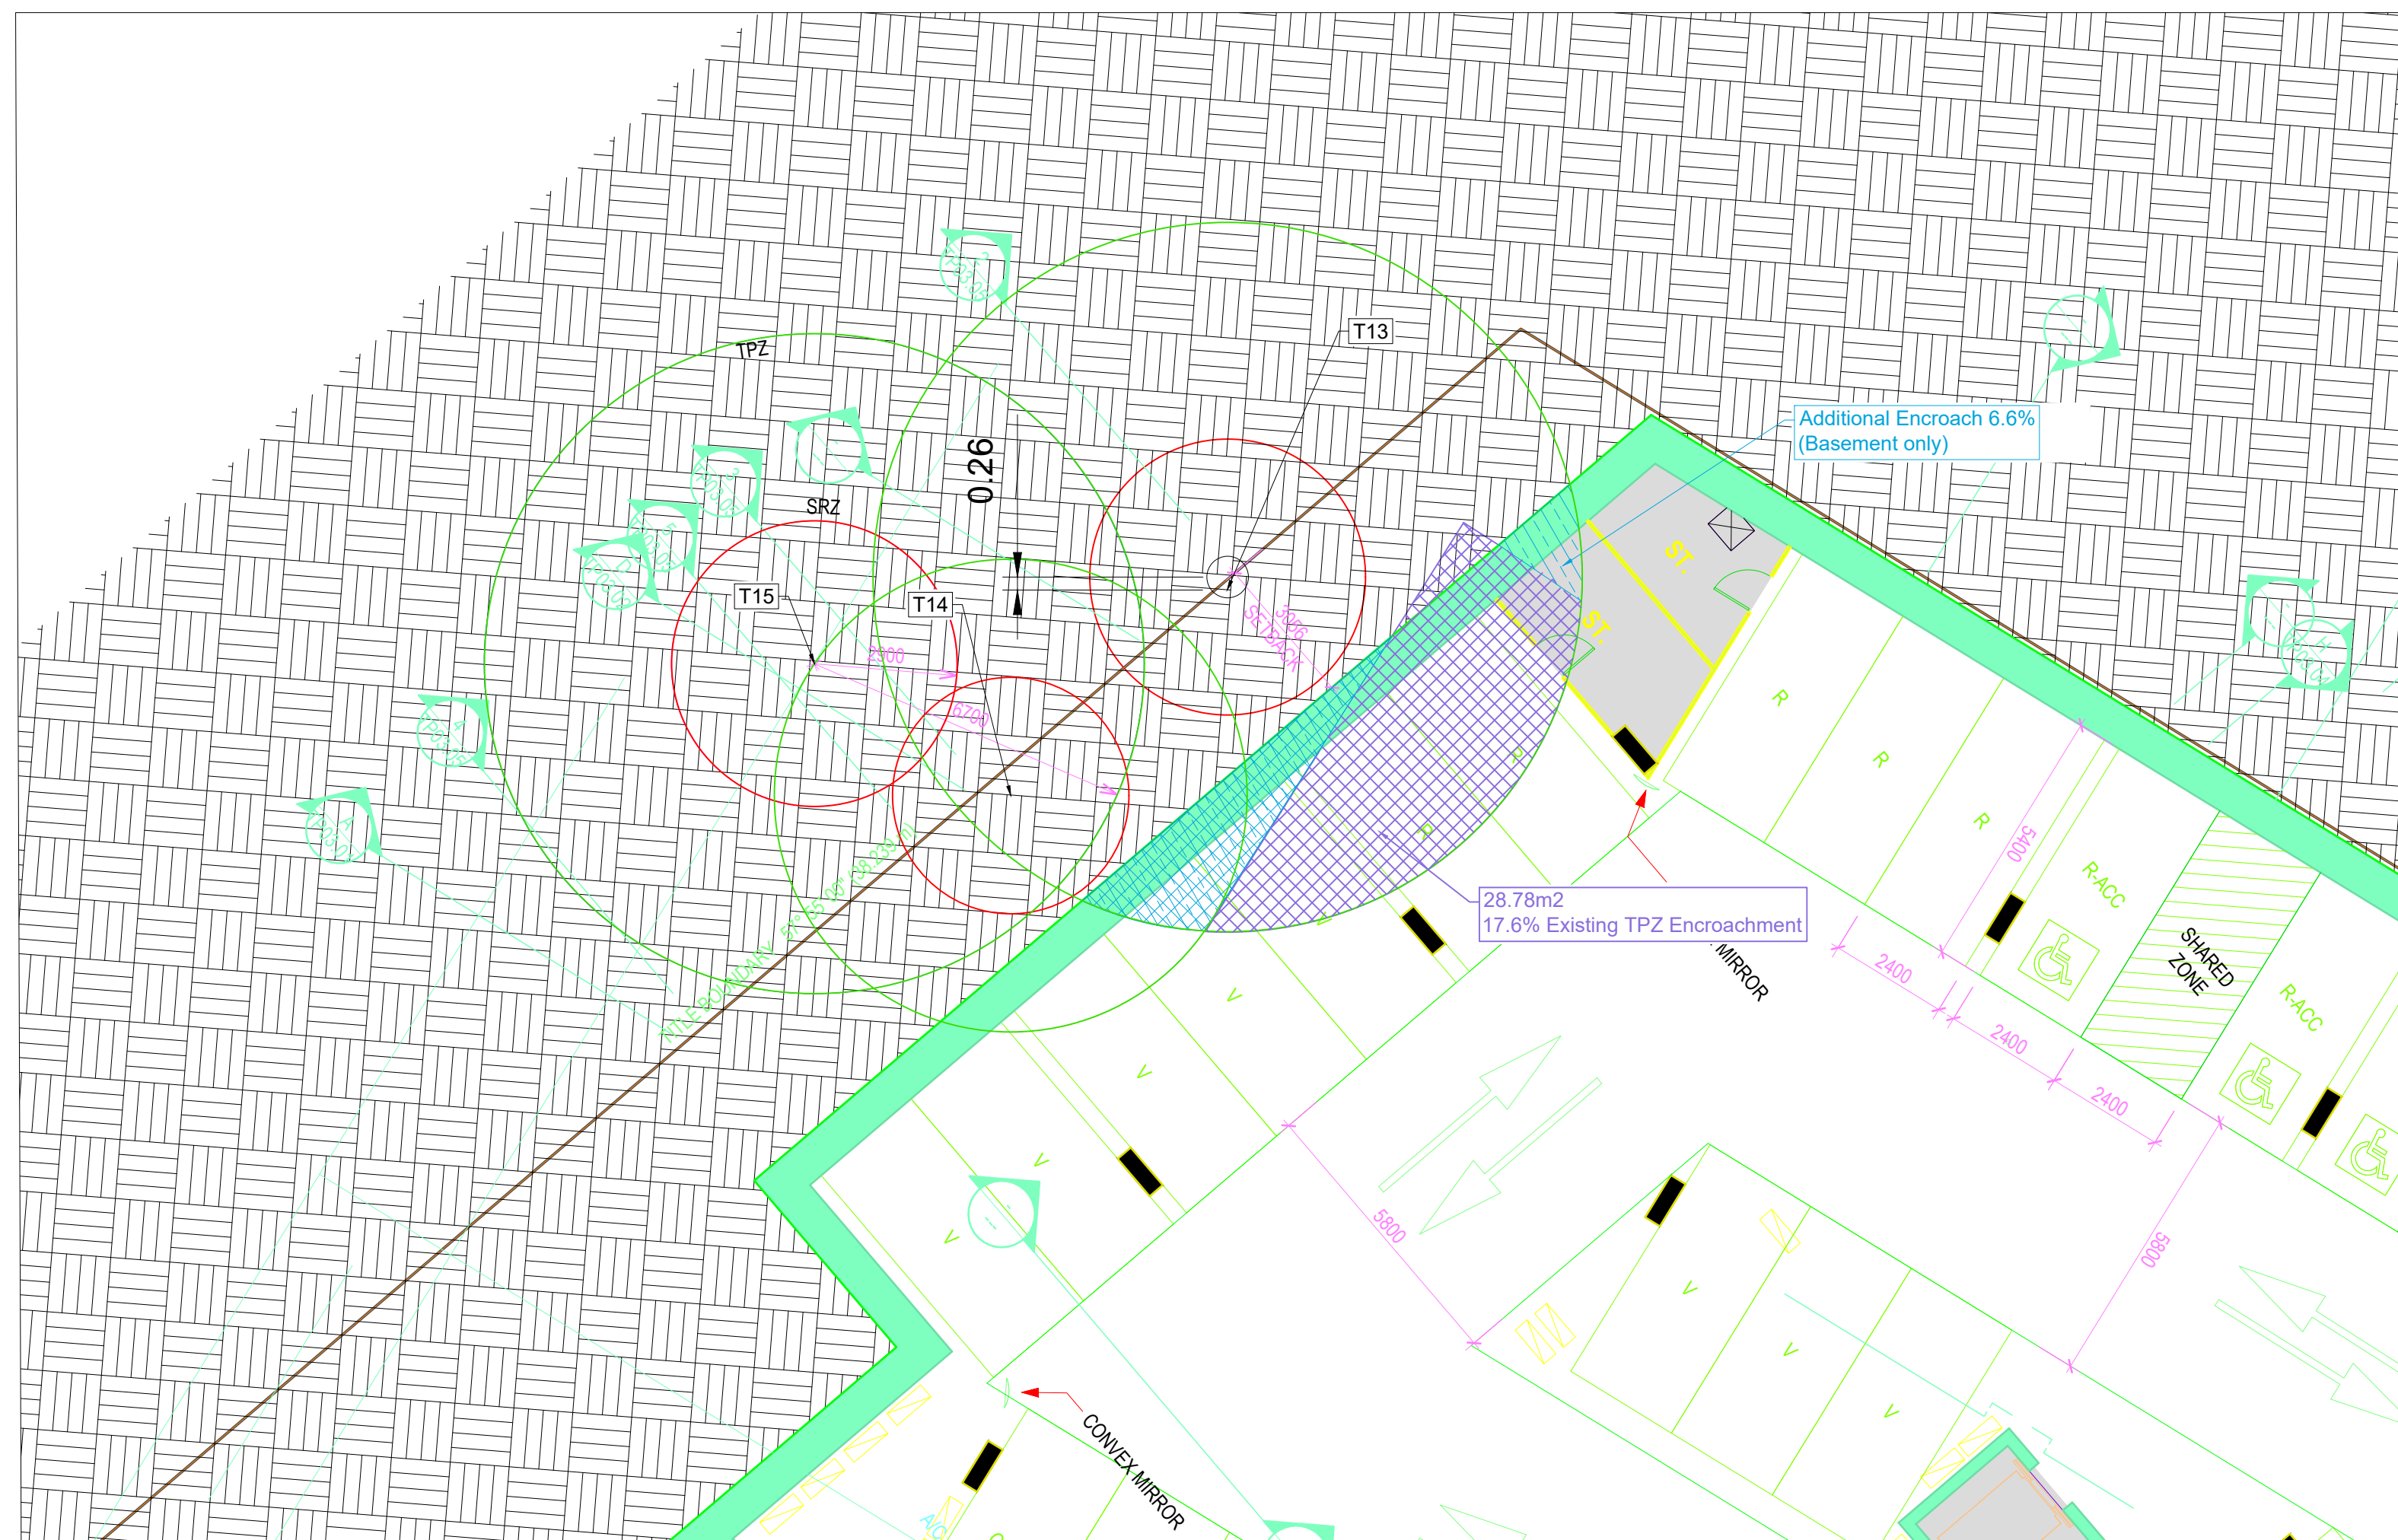
## 8 Appendix 3 – Proposed Encroachment Potentials

- 5.2.2 Plans propose an additional 26.4% encroachment of the TPZ area in total (6.6% for the basement, 19.8% for the ground floor).
- 5.2.3 The outside edge of basement excavation is proposed approximately 10cm outside of the SRZ area. Excavation of soils on the ground floor will occupy approximately 35% of the tree's SRZ.

- 5.2.4 The proposed encroachment is significantly *Major* per AS4970:2009 – *Protection of trees on development sites*.
- 5.2.5 Root severance is *guaranteed* to occur during the excavation of footings to accommodate the proposed development.

- 5.2.6 The tree is susceptible to high lever-arch loading due to the height of the tree and observed exposures during site attendance. With the loss of roots, it is unlikely that the tree could remain stable during a modest wind event.

- 5.2.7 It is my opinion the tree cannot be safely retained with the current proposed development.
- 5.2.8 Excavation of soils to accommodate the retaining wall is within the SRZ area and is likely to destabilise the tree. AS4970:2009 – *Protection of trees on development sites* states the "SRZ is the area required for tree stability. A larger area is required to maintain a viable tree".

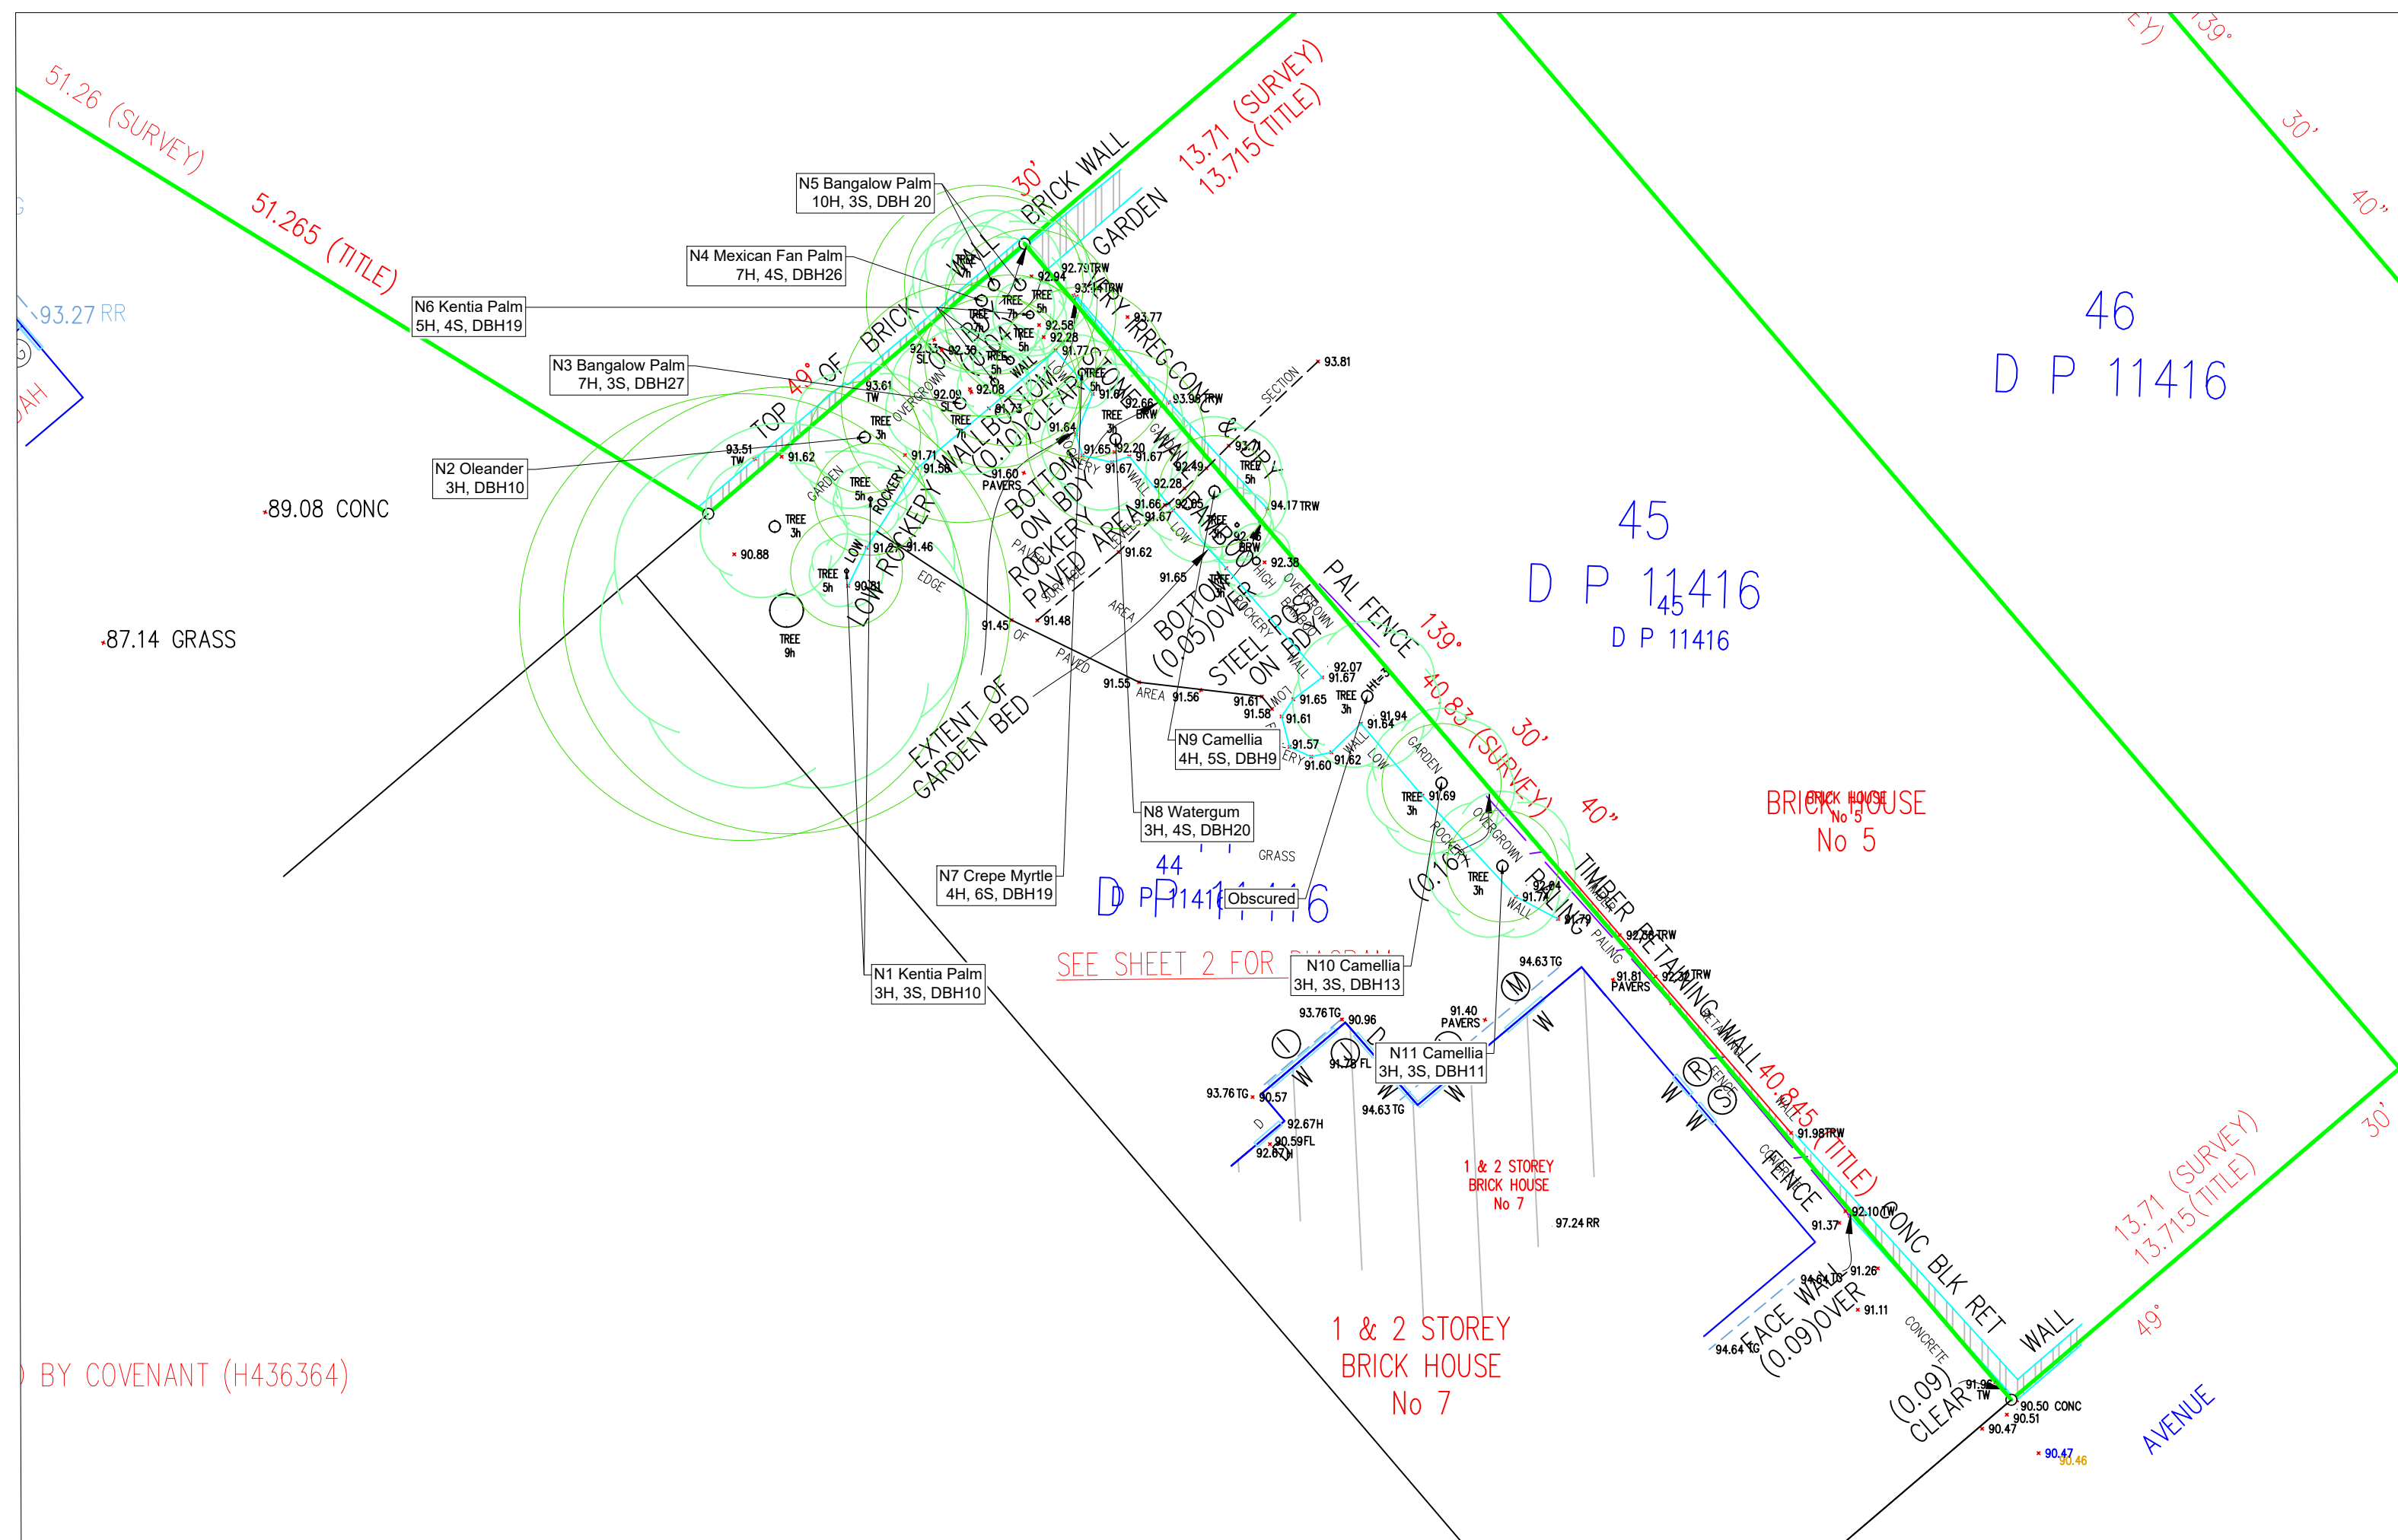
## 9 Appendix 4 – Neighbouring Tree Identification & Encroachment

5.3.2 DBH values for neighbouring trees shown on the recently supplied detail survey & boundary identification correlate with minimal levels of TPZ encroachment is likely to occur with the proposed development.

5.3.3 These trees, shown on supplied plans with an N\* prefix were mostly palms and smaller shrubs of low landscape significance. A thorough assessment was not undertaken for these trees due to limited access.

Despite this, the small sizes of the trees mean it is unlikely that the proposed retaining wall with increased boundary offset will cause any permanent damage to these trees.

5.3.6 Long term survival of these trees is likely & can be supported with additional watering or treatment with a product such as SeaSol® per directions during construction.

5.3.7 Retention of the loose packed dry stone / rubble wall & concrete retaining wall on the boundary of the site & the construction of a new retaining wall with greater construction offset is supported.

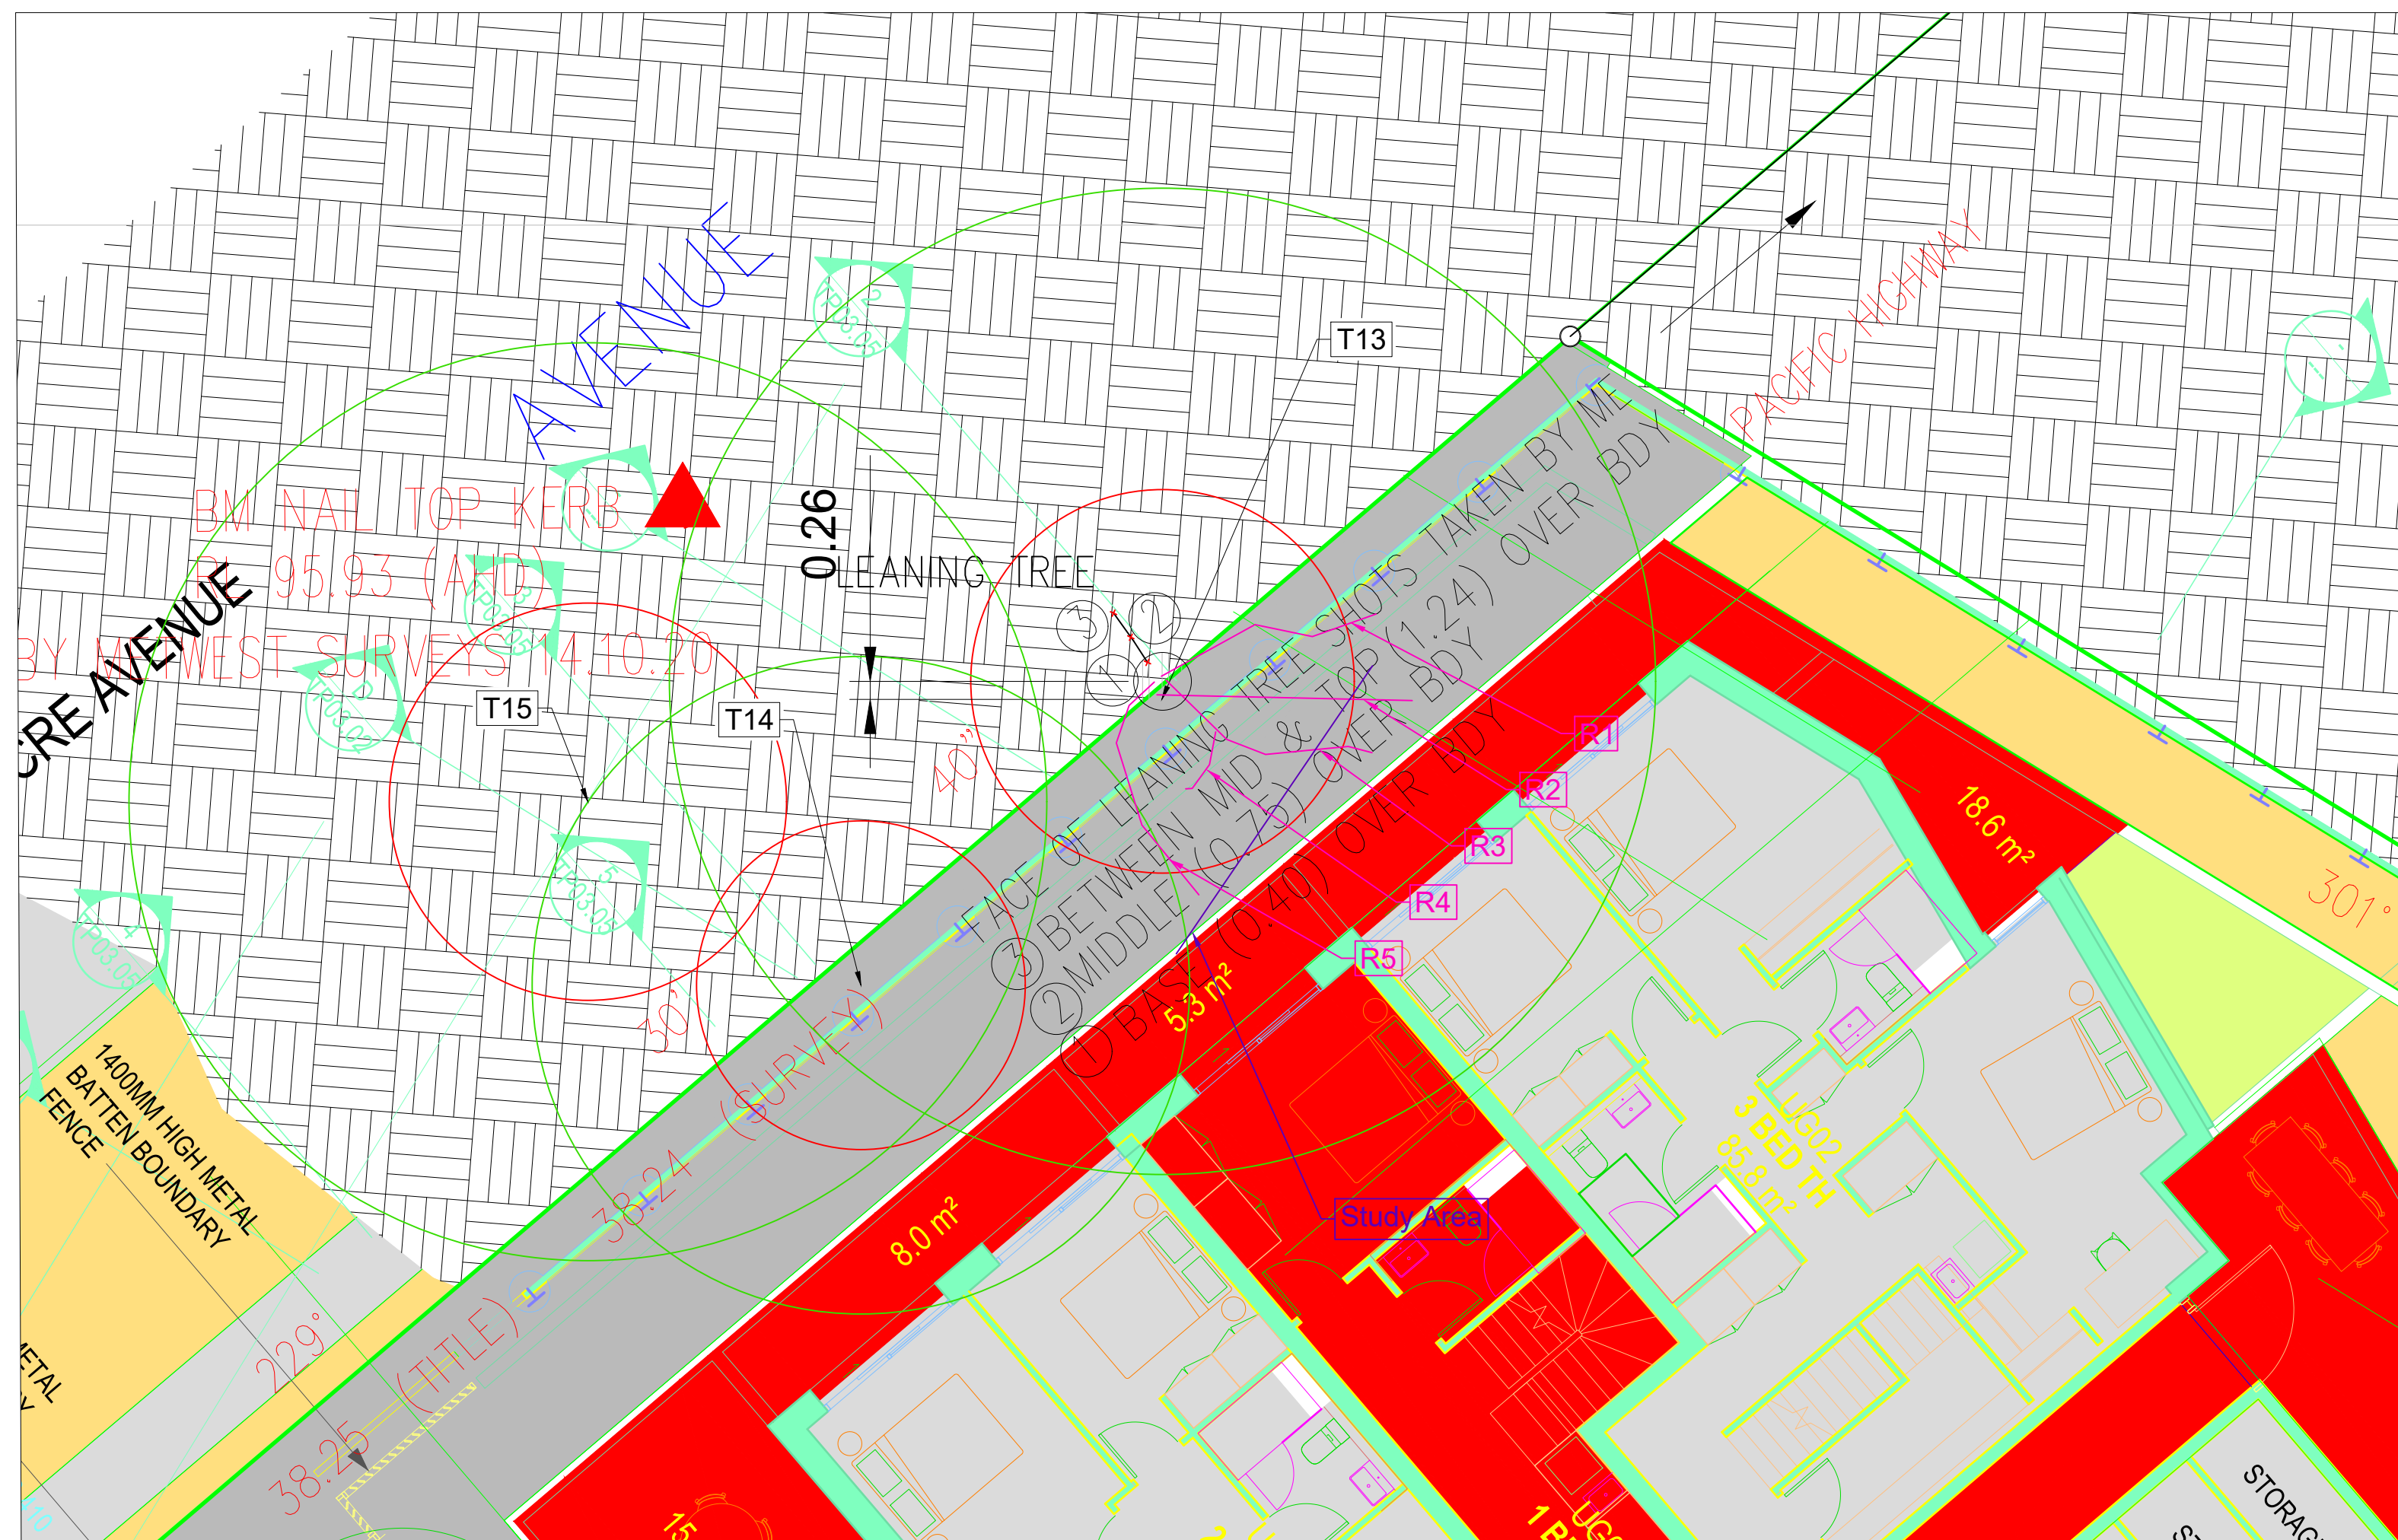
## 10 Appendix 5 – Root Mapping Diagram

3.1.2 Clearing of existing vegetation and minor excavation revealed five significant roots within the vicinity. Roots are numbered in ascending order based on their distance from the existing driveway

Root ID	Diameter	Depth (Top of Root)	Alive?
1	145mm	0-3cm	Yes
2	165mm	0-5cm	Yes
3	85mm	0-4cm	Yes
4	80mm	3-6cm	Yes
5	70mm	0-18cm	Yes

3.1.3 The five roots detected were all seen to be heading towards the existing building.

3.1.4 Roots were all located on the surface, or if not, very close to it. This is likely due to heavy soil compaction beneath or the presence of building waste beneath.

3.1.5 The existing building showed minor sign of damage. Based on this, it is highly likely that tree roots have deflected on contact with the building's footings.

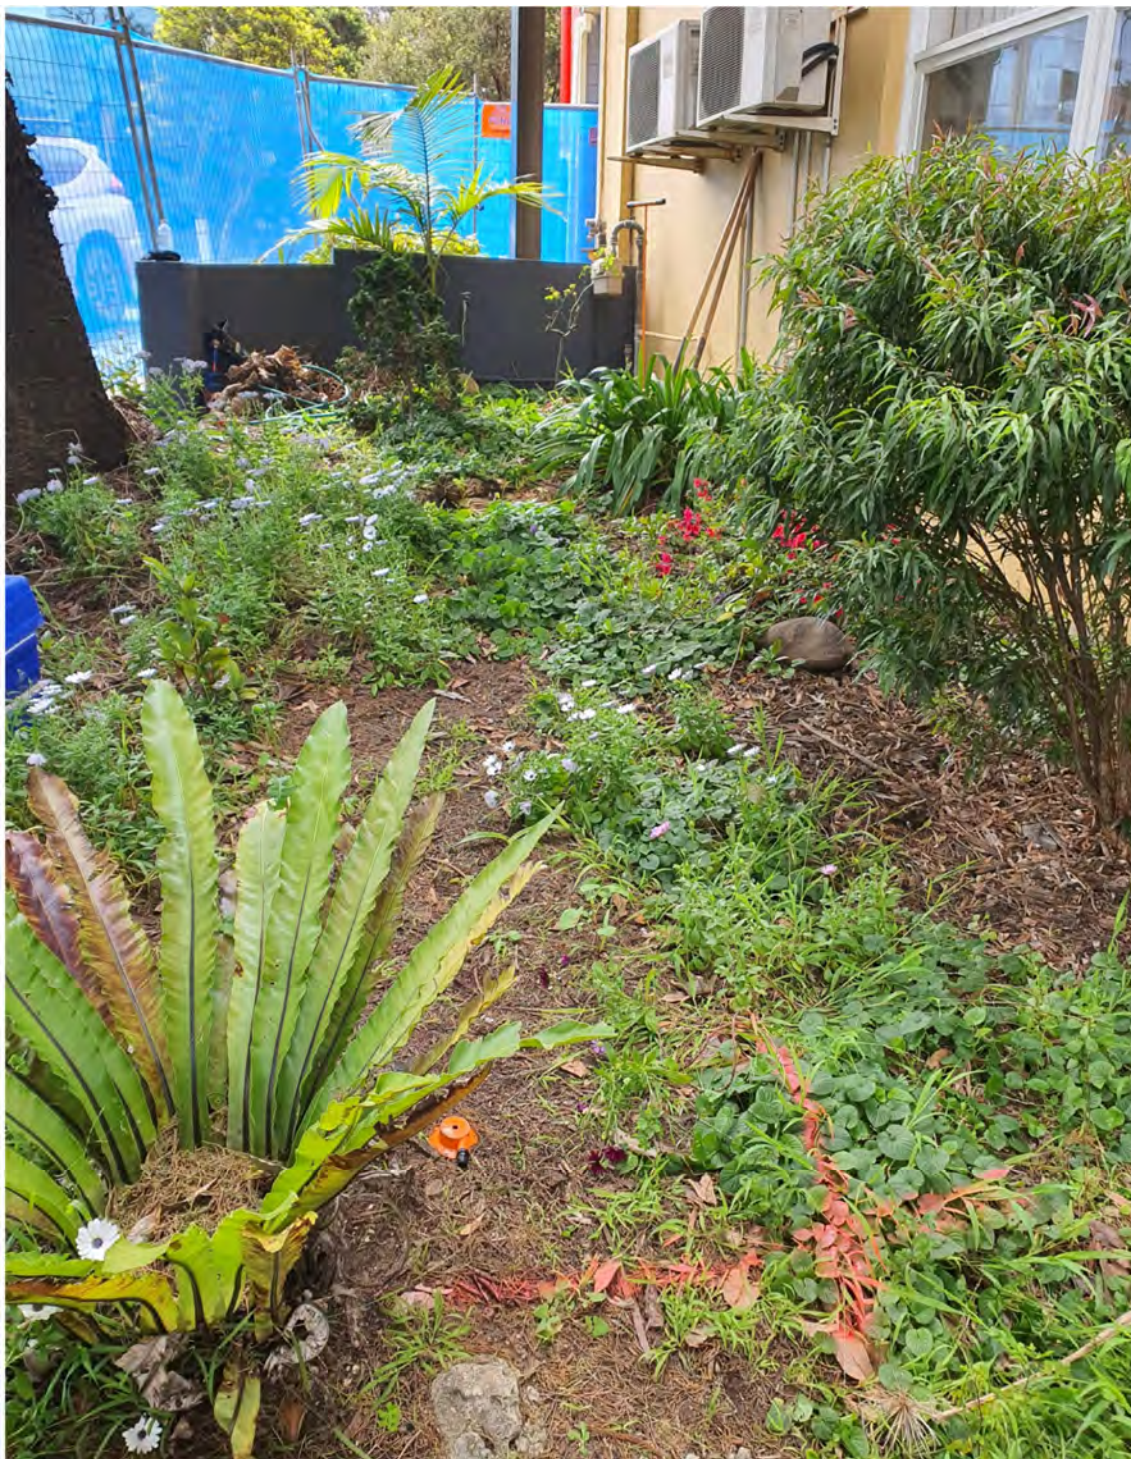
*Image 1: The root mapping study area prior to excavation.*

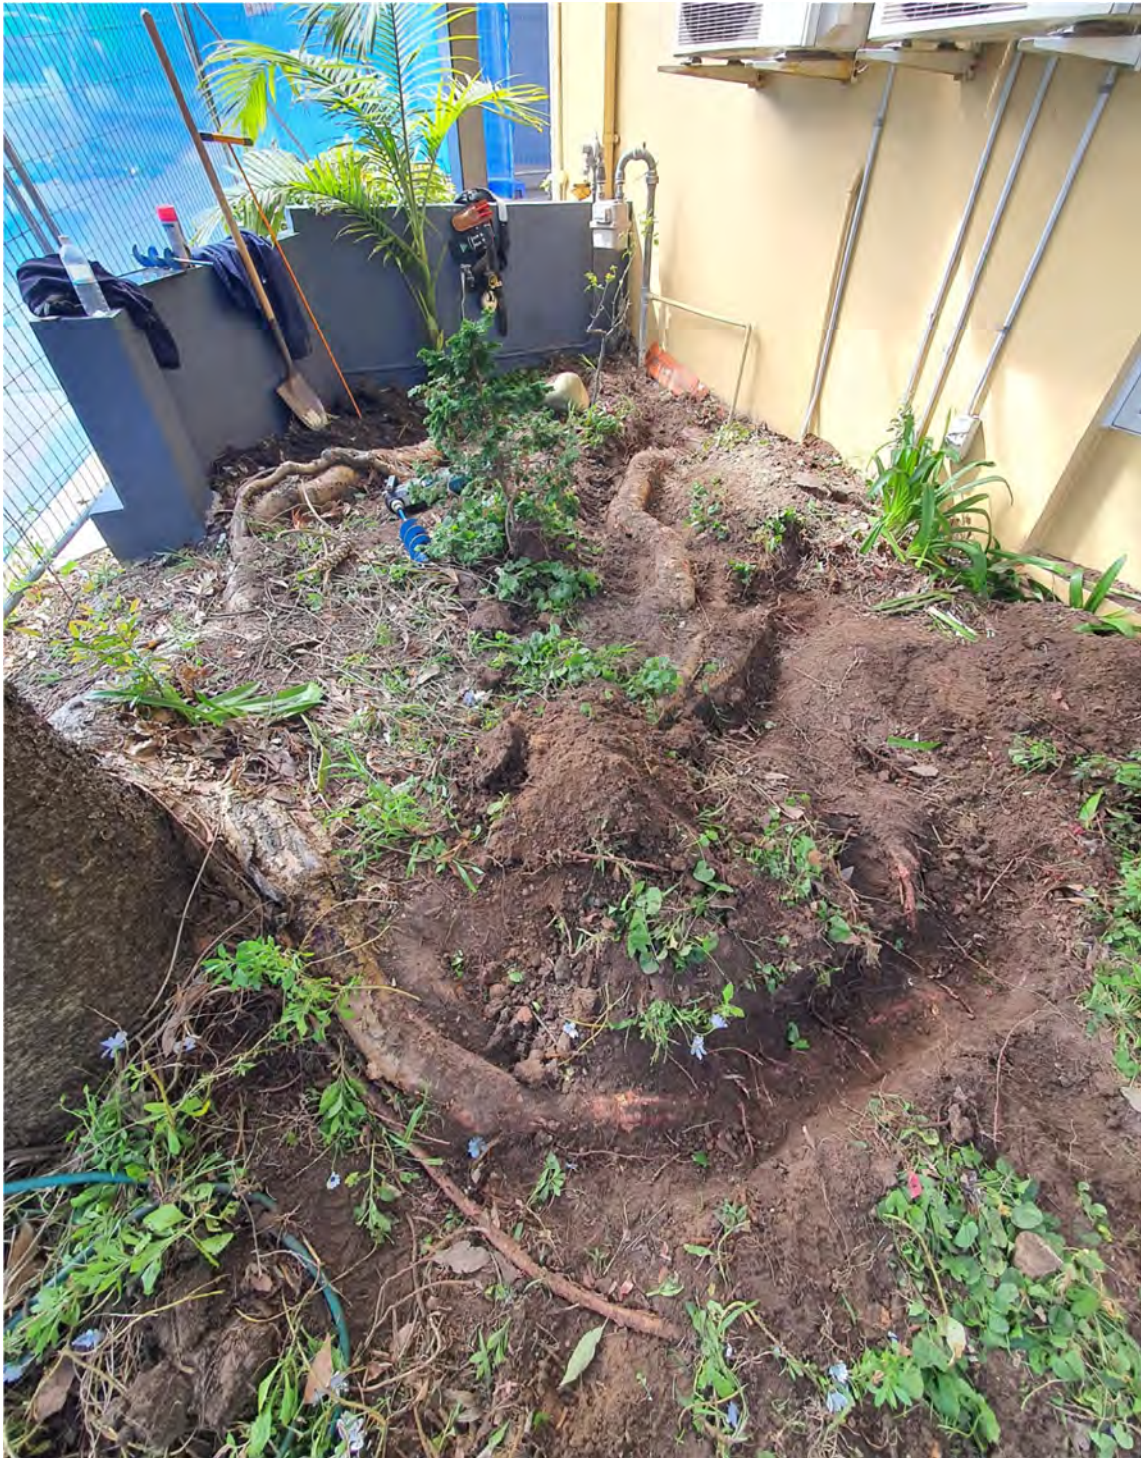
*Image 2: The study area mid-excitation.*

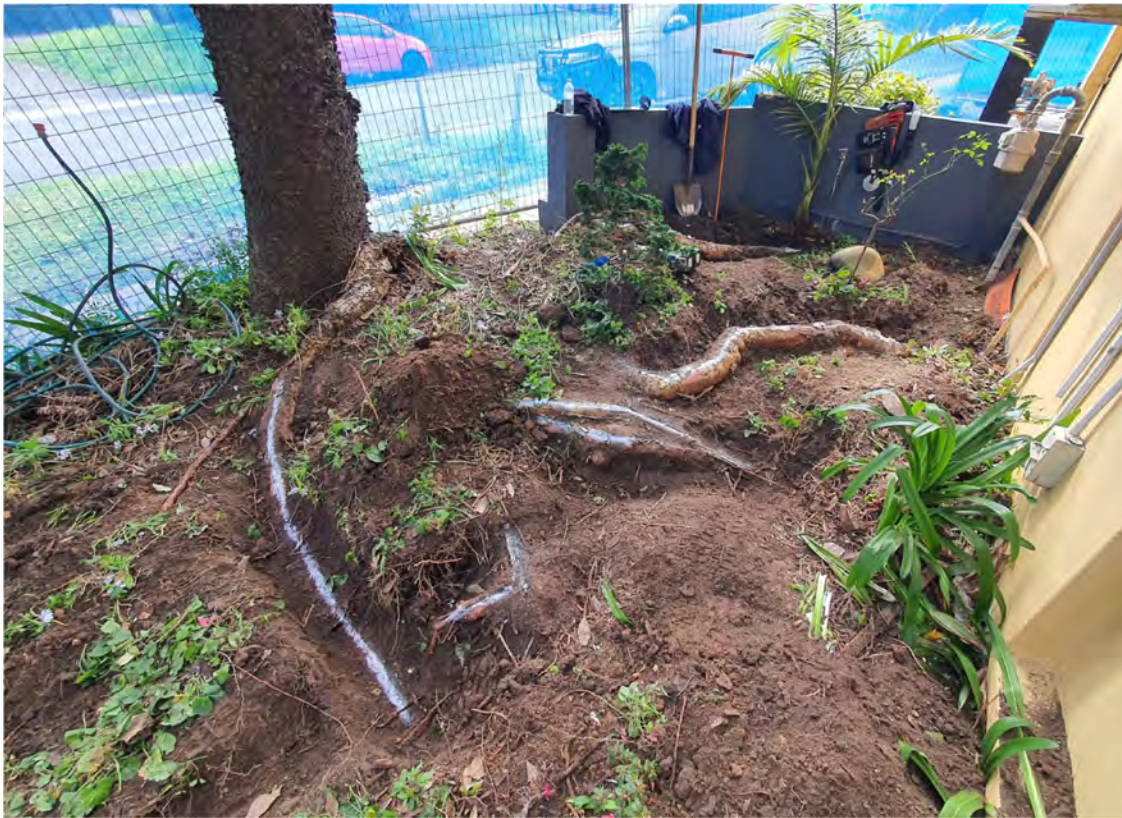
*Image 3: Tree roots as discovered. Roots were marked with white line marking paint for contrast in photos.*

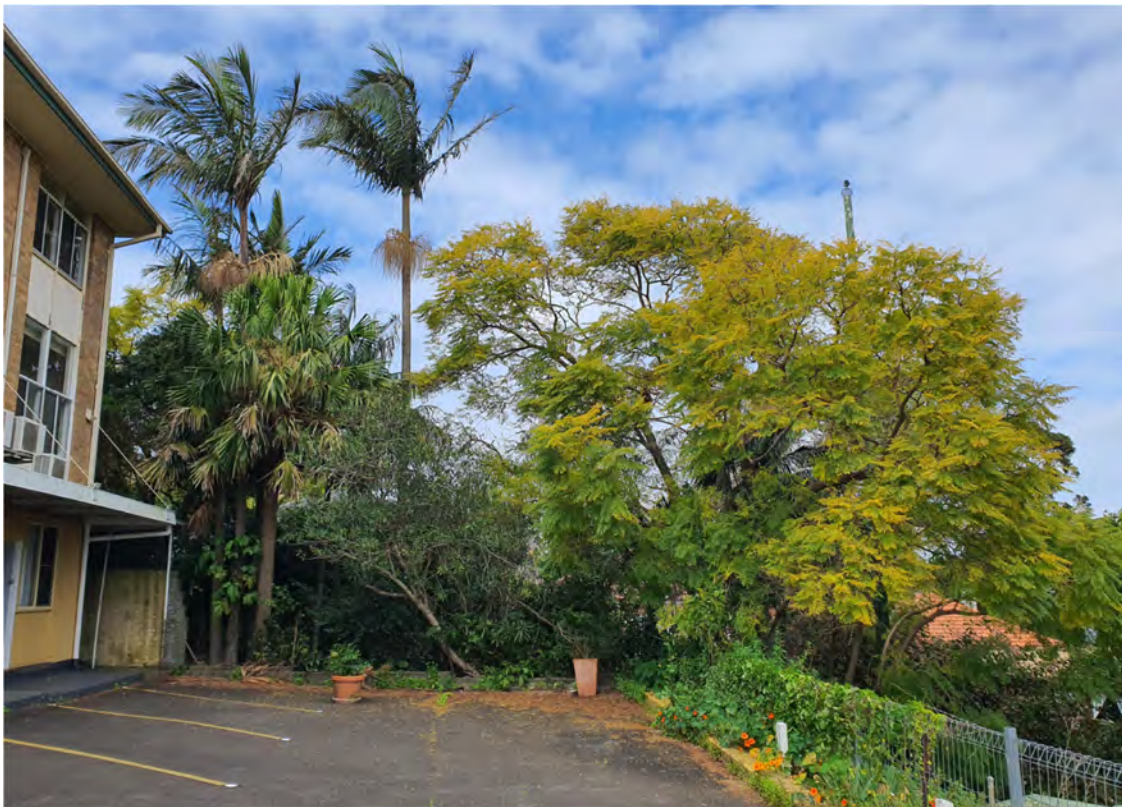
*Image 4: Vegetation on neighbouring property as seen.*

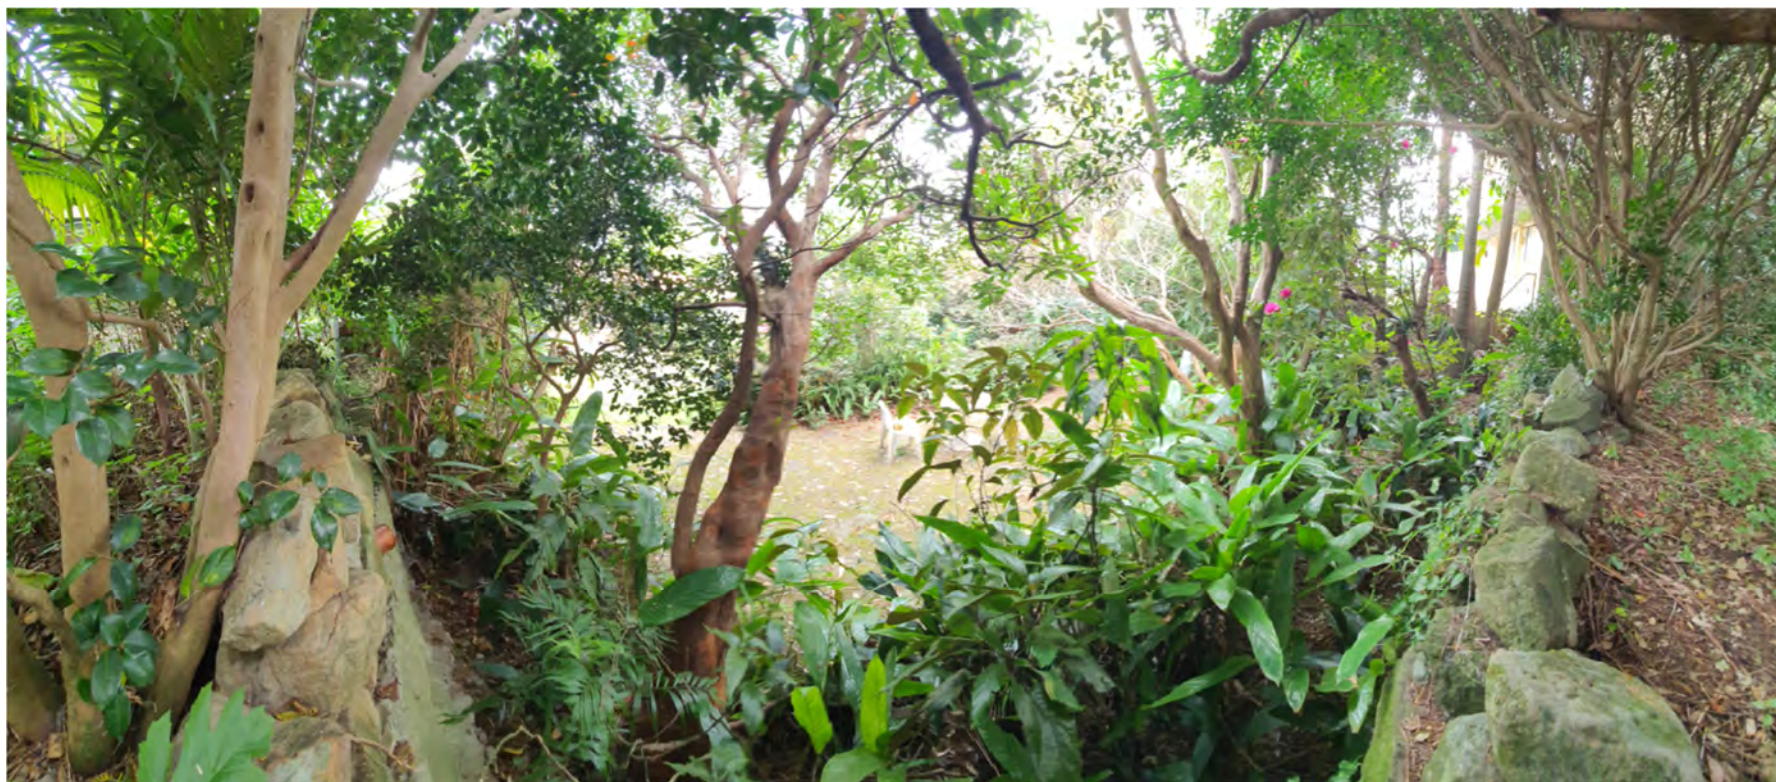
*Image 5: A panorama of vegetation as seen from within the site.*
