22 February 2022

Ref: E052

## RE: Interim Audit Advice – 71-75 Victoria Road, Drummoyne NSW

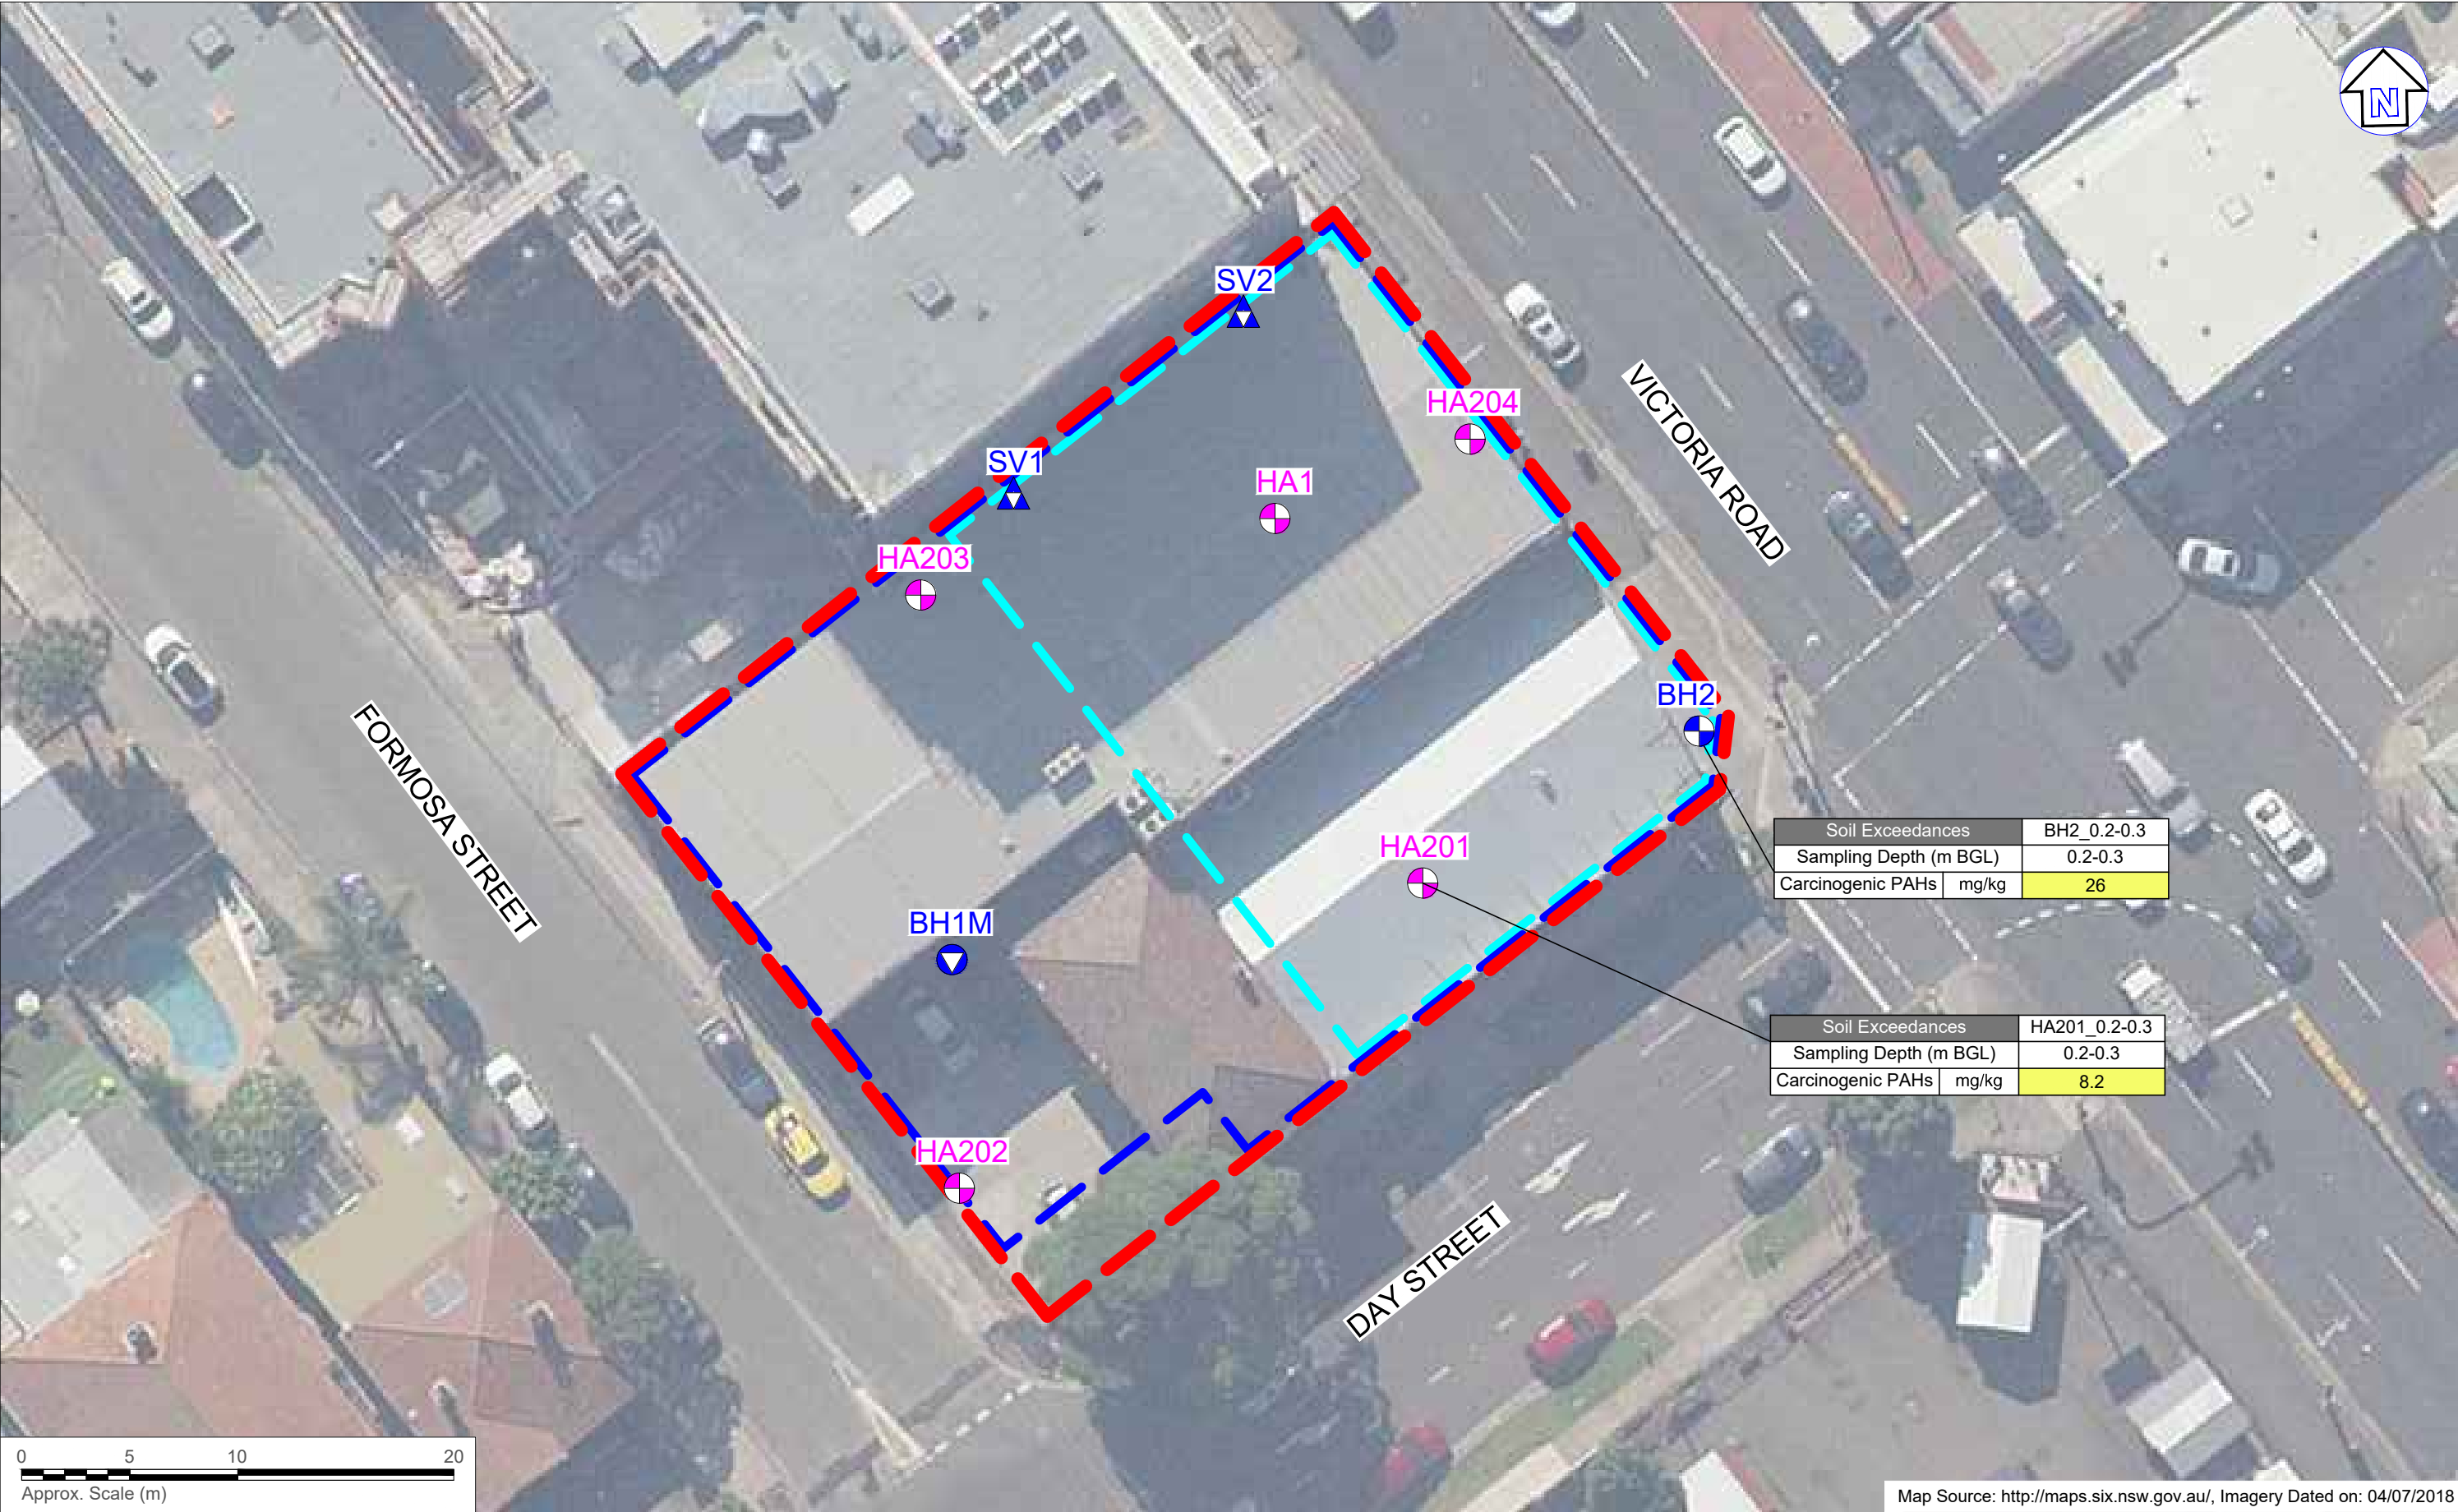
Attachment 1: Site Locality & Investigation Locations

Investigation locations were constrained by existing buildings and sampling locations were located in accessible areas of the site. Sampling locations are shown on Attachment 1.
