WHITE BAY POWER STATION

CONSERVATION MANAGEMENT PLAN VOLUME III BUILDING FABRIC SURVEY (& Condition Report)

FINAL REPORT
SECOND EDITION JULY 2011
(Revised March 2013)

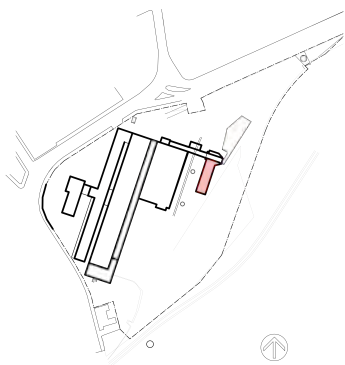
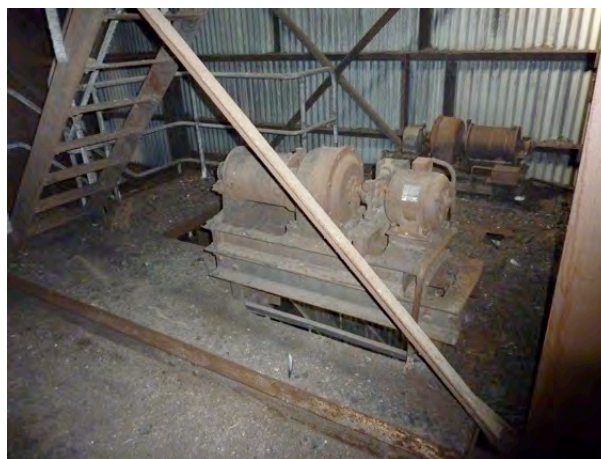
- Floor:** OK, some steel sheets badly corroded
- Skirting:**
- Walls:** N: poor condition at lower level.
S wall E side: good condition- corro steel appears recent.
- Cornice:**
- Ceiling:** Appears to have recent corro steel approx. same age as E wall high section
Trusses seem good but rusted
- Doors:**
- Windows:**
- Other:** Machinery OK - rusted

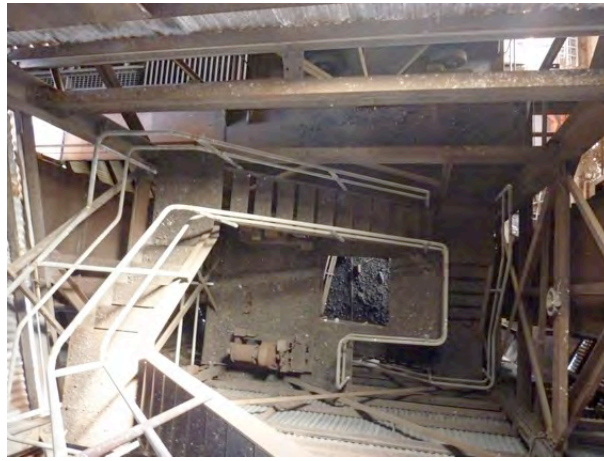
| Condition: | <p>Floor: Seems to be in good condition. Rust but no structural implications. Floor dirty with coal</p> <p>Skirting:</p> <p>Walls: Good N & S corro steel in good condition. Structural elements rusted. Warning signs painted on, flaking off</p> <p>Cornice:</p> <p>Ceiling:</p> <p>Doors:</p> <p>Windows: Bottom panes of both windows missing, Infilled with chicken wire on N window only</p> <p>Other: Birds seem to enter in by window or other means: lots of pigeon shit</p> |

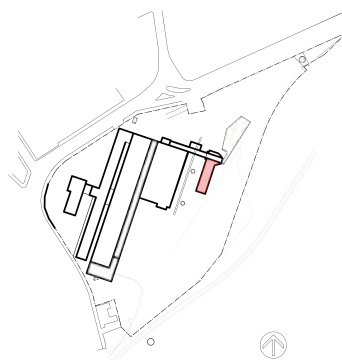
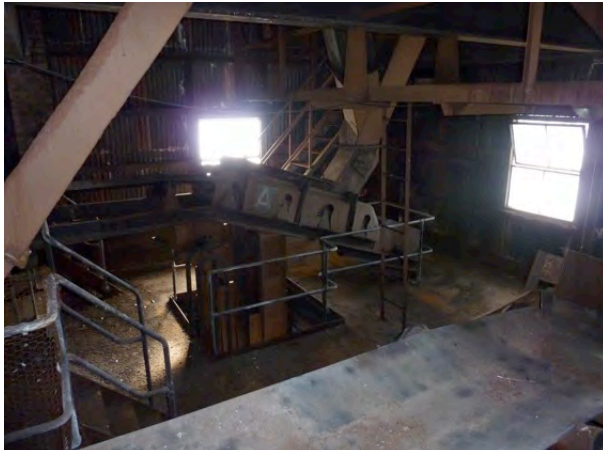
| Condition: | <p>Floor: Appears to be in reasonable condition (not walked upon)</p> <p>Skirting: N: missing sections</p> <p>Walls: Seem to be in good condition – no obvious signs of damage, holes. Appears to be watertight.</p> <p>Cornice:</p> <p>Ceiling: Coal conveyor. Space CH 4.3 above.</p> <p>Doors:</p> <p>Windows: Appear to be in good condition. Most panes of glass cracked. Window still in place.</p> <p>Other:</p> |

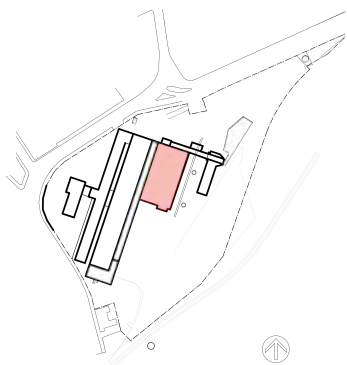
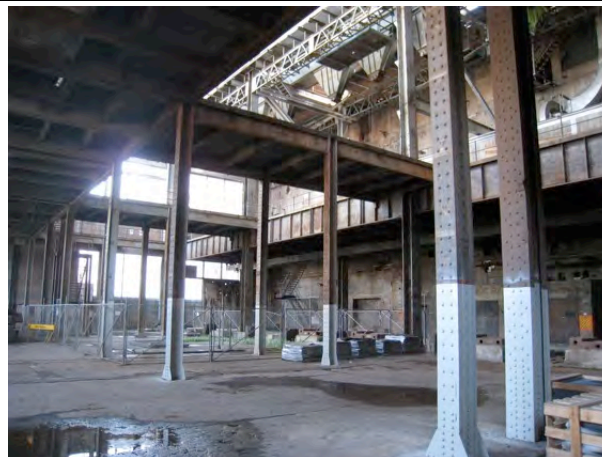
Other issues: Water on floor – evidence of leaking roof.
