POST CONSTRUCTION CONDITION SURVEY - GPS

Nepean Business Park - Penrith NSW

Council Assets
Lugard Street, Leland Street and Old Castlereagh Road
PENRITH NSW 2750

27 July 2022

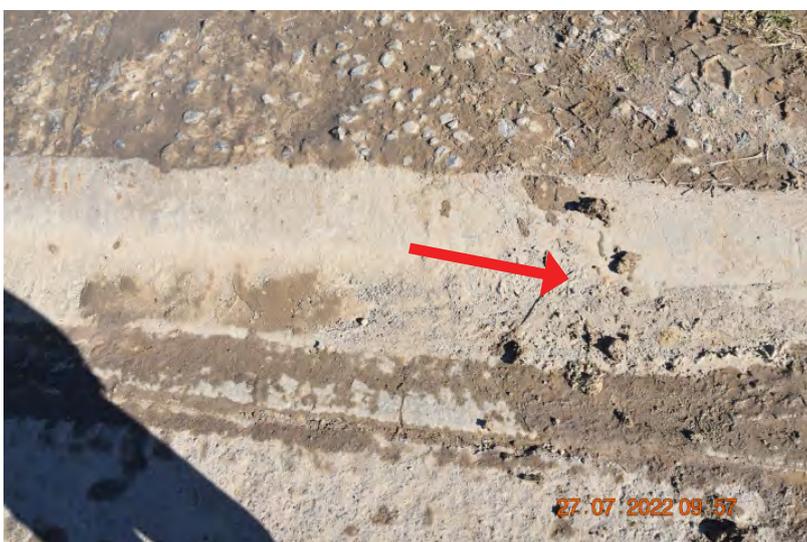
Figure: 0006 Fine cracking in the kerb and gutter, looking to the west. | **CHANGE:** None

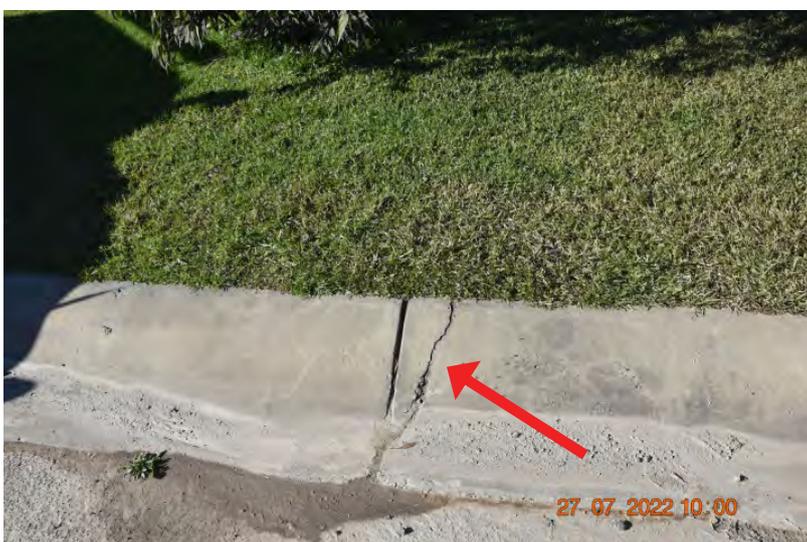
Figure: 0012 Slight cracking in the kerb and gutter. | **CHANGE:** None

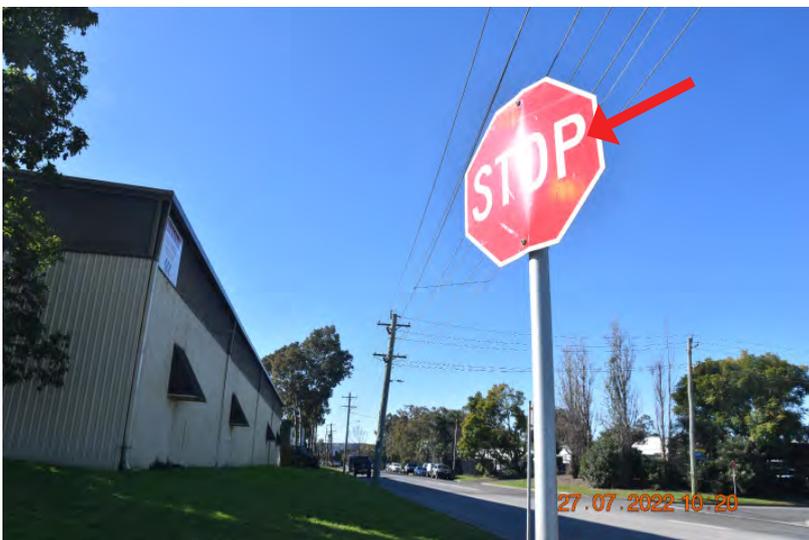
Figure: 0062 Bent street sign. | **CHANGE:** None

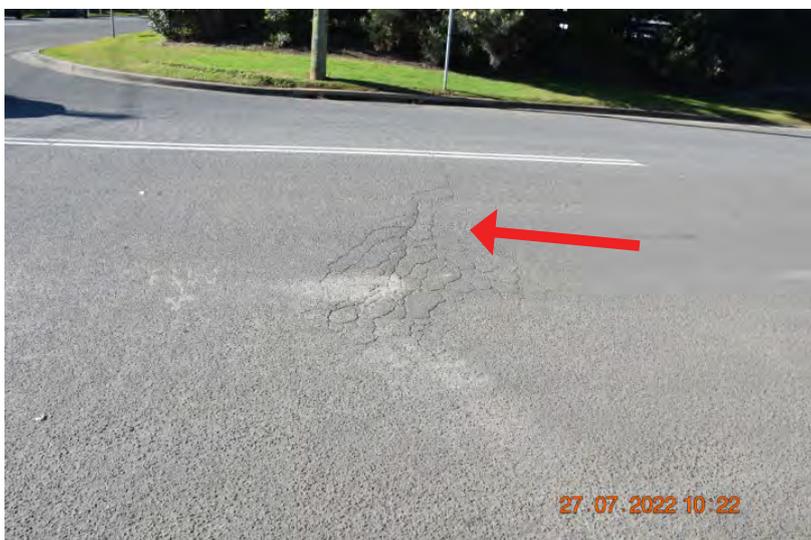
Figure: 0074 Fine alligator cracking in the paving. | **CHANGE:** None

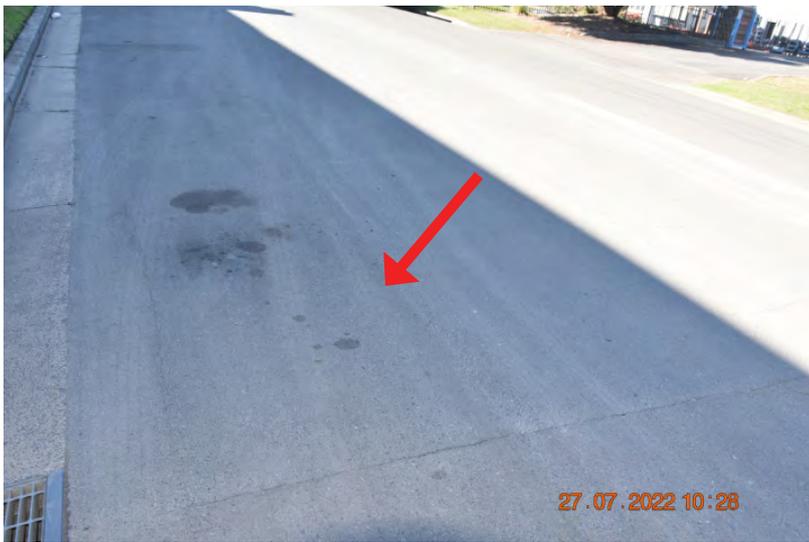
Figure: 0097 Fine alligator cracking in the paving. (RPT FOR FIGURES 97-99) | **CHANGE:** None

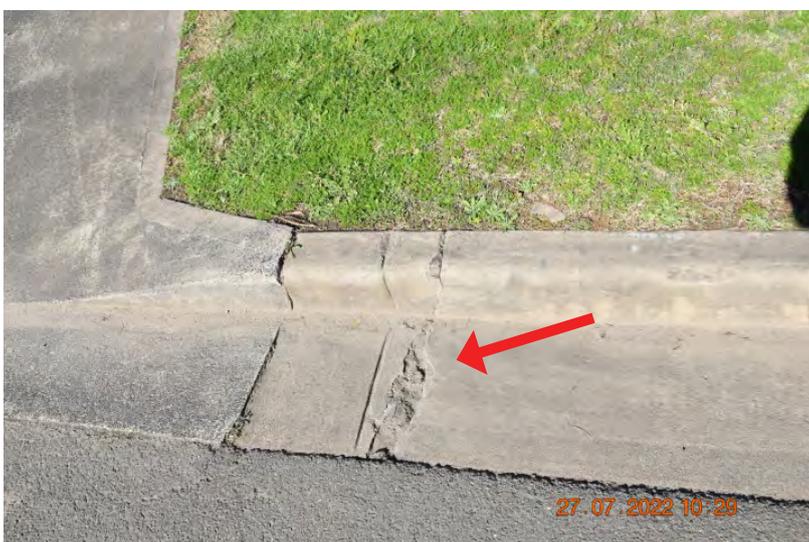
Figure: 0102 Slight cracking and chipping in the kerb and gutter. | **CHANGE:** None

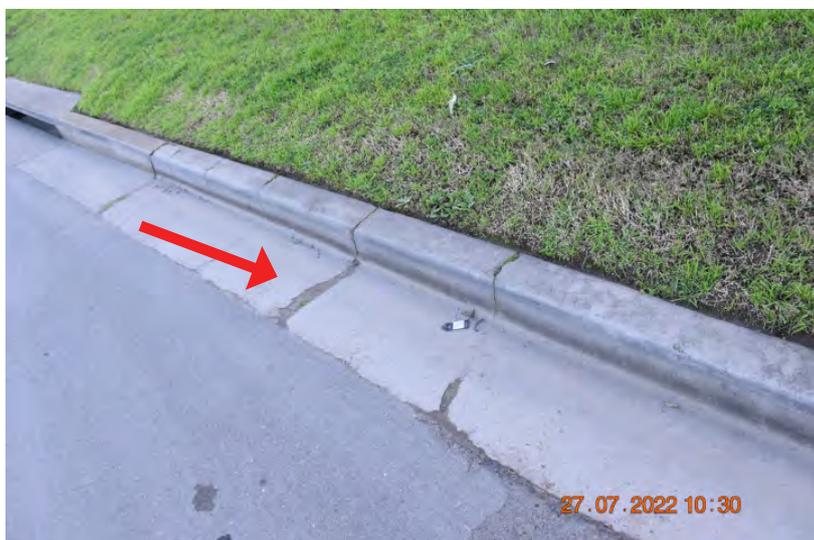
Figure: 0104 Cracking and chipping in the kerb and gutter, looking to the north. | **CHANGE:** None

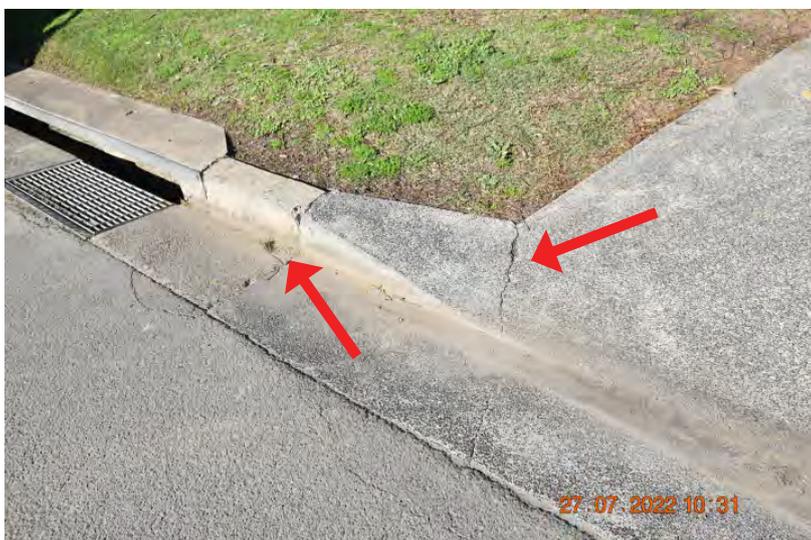
Figure: 0110 Slight cracking in the crossover, looking to the south. | **CHANGE:** None

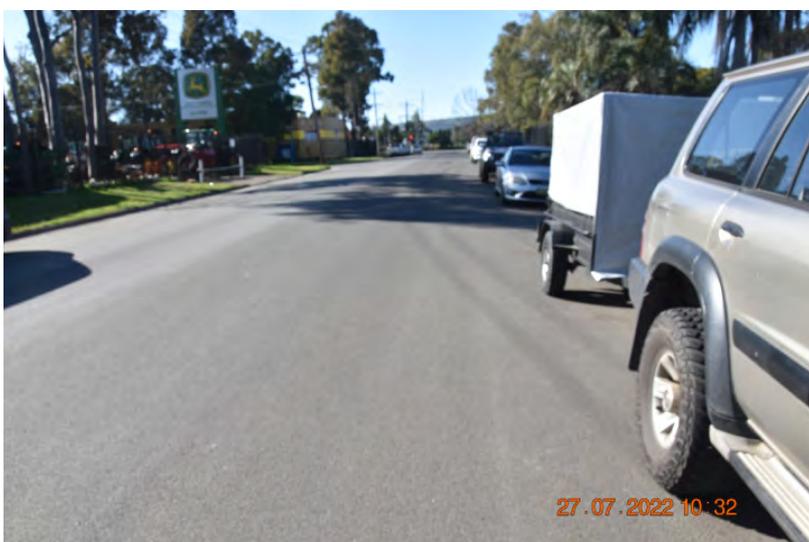
Figure: 0118 Fine cracking in the paving, looking west. | **CHANGE:** None

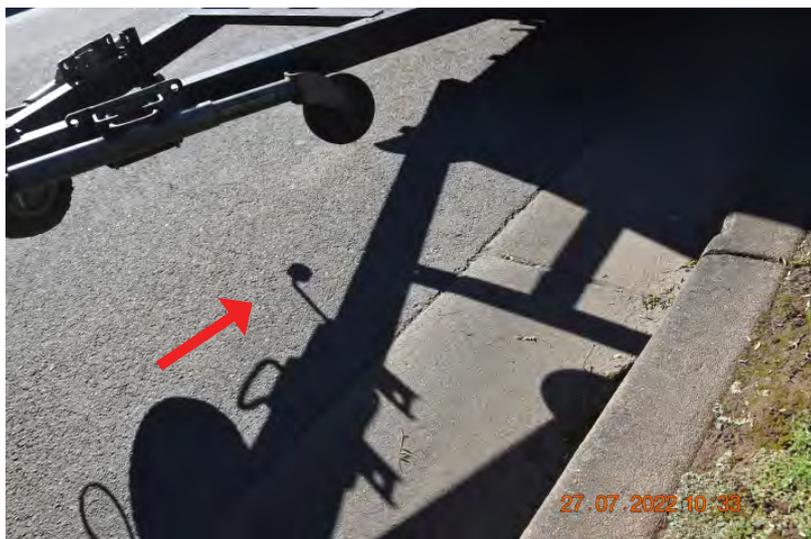
Figure: 0119 Fine cracking in the paving, looking south. (RPT FOR FIGURES 119-120) | **CHANGE:** None

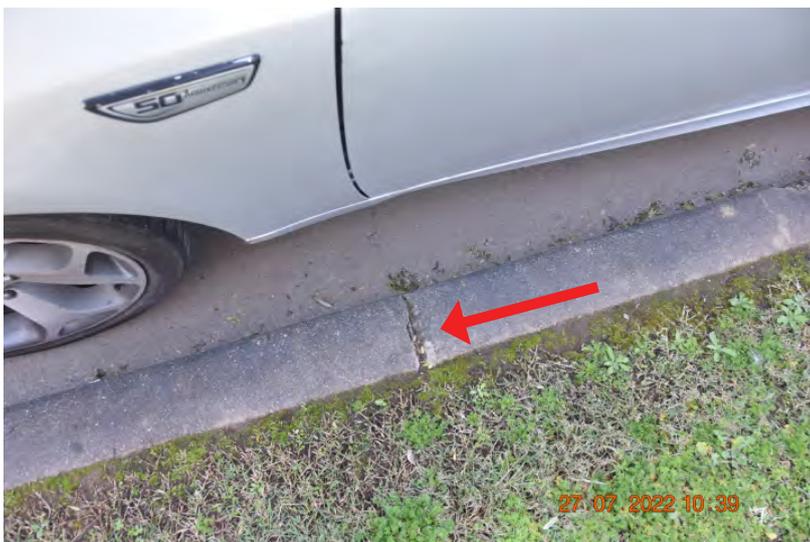
Figure: 0137 Slight cracking and chipping in the kerb and gutter, looking to the south. | **CHANGE:** None

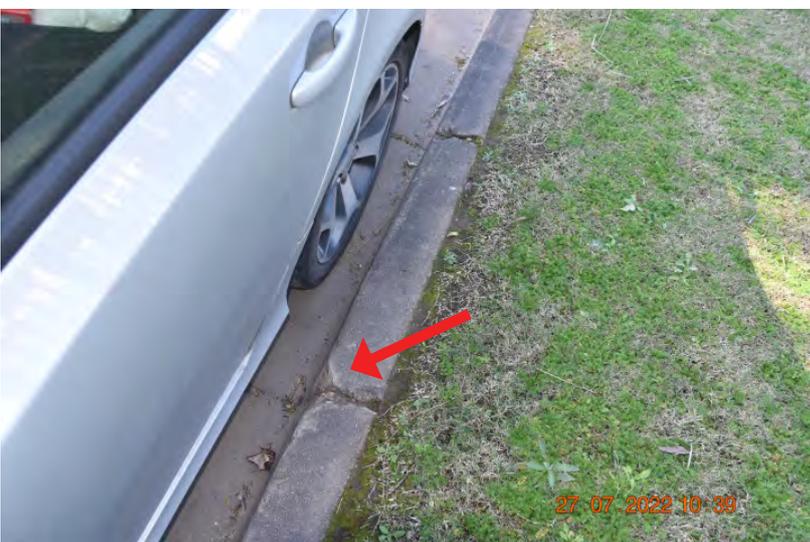
Figure: 0138 Slight cracking in the kerb and gutter, looking to the south. | **CHANGE:** None

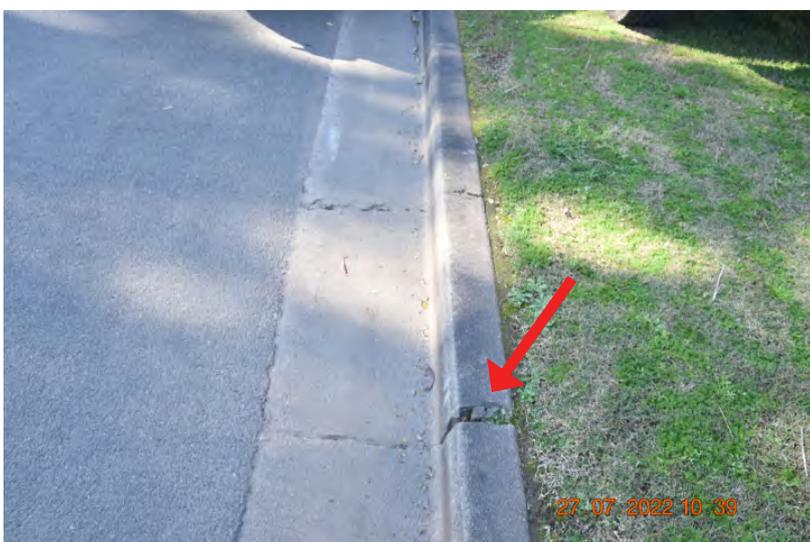
Figure: 0139 Fine cracking in the paving, looking to the north. | **CHANGE:** None

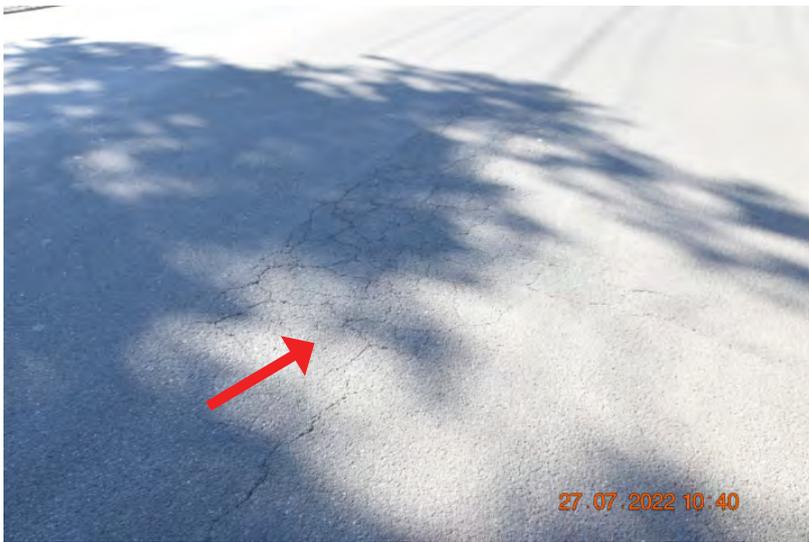
Figure: 0140 Cracking and scoring in the crossover. | **CHANGE:** None

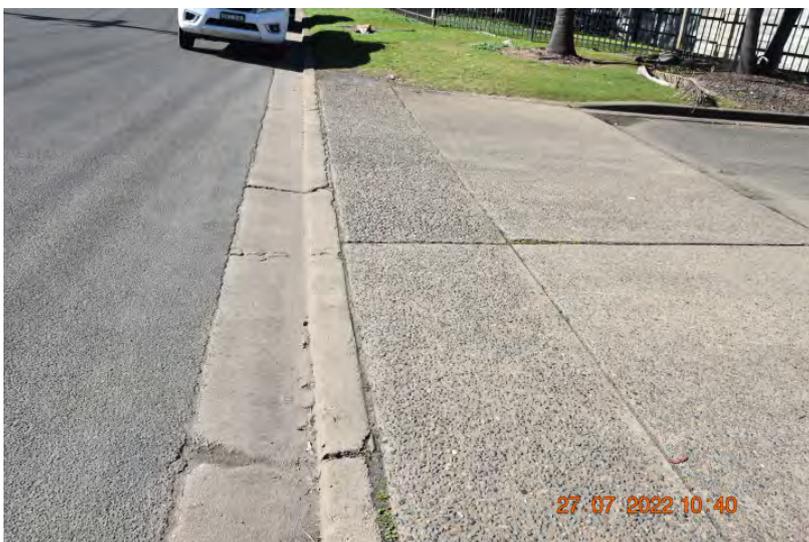
Figure: 0142 Slight cracking and chipping in the crossover. | **CHANGE:** None

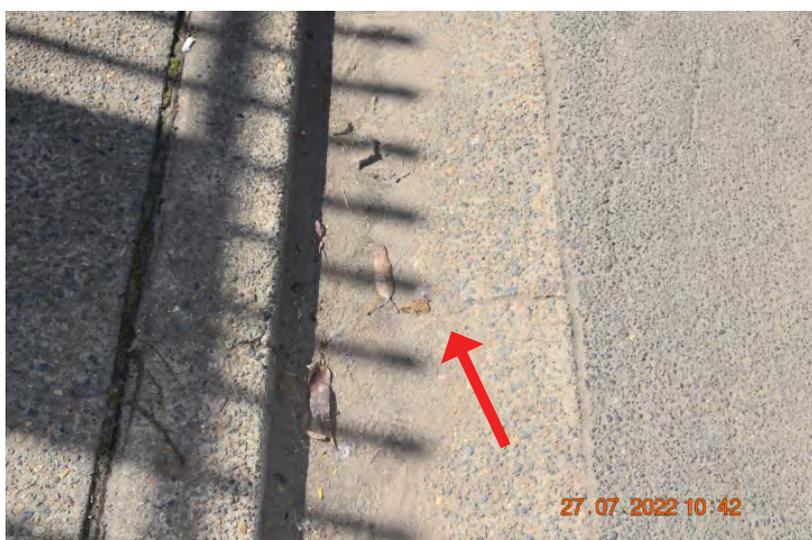
Figure: 0146 Slight cracking in the crossover. (RPT FOR FIGURES 146-148) | **CHANGE:** None

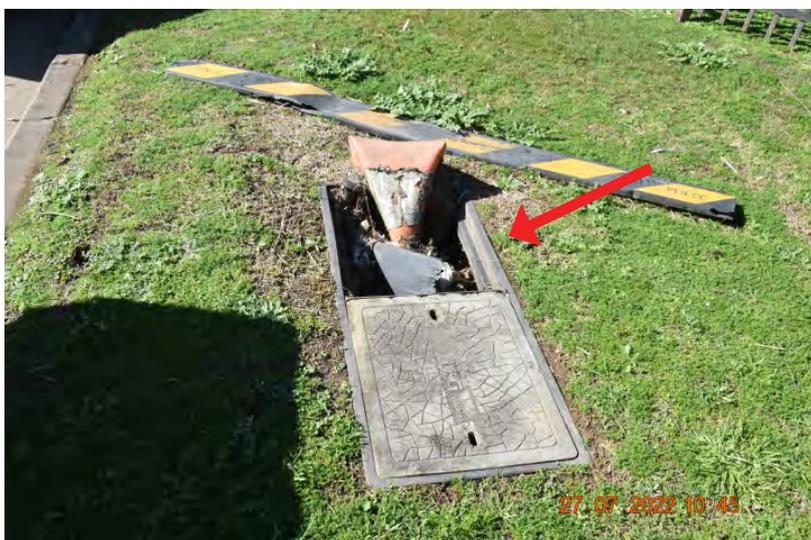
Figure: 0155 Missing pit lid. | **CHANGE:** None

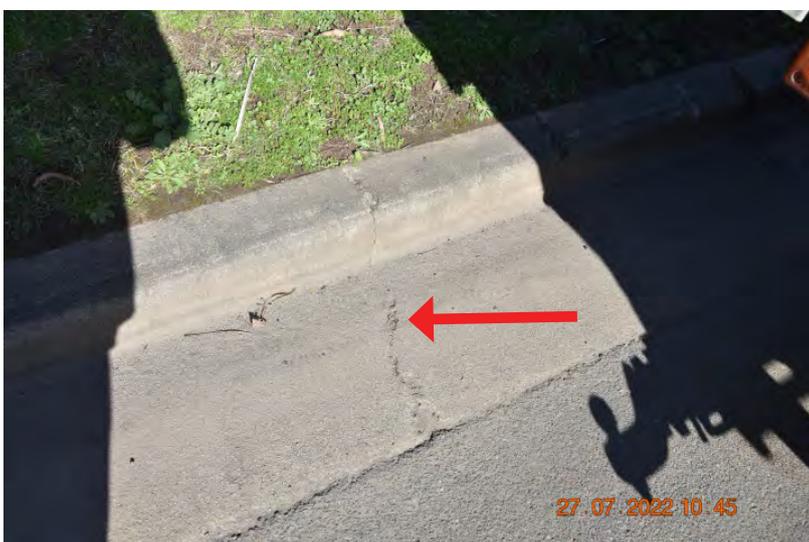
Figure: 0156 Substantial cracking in the kerb and gutter. | **CHANGE:** None

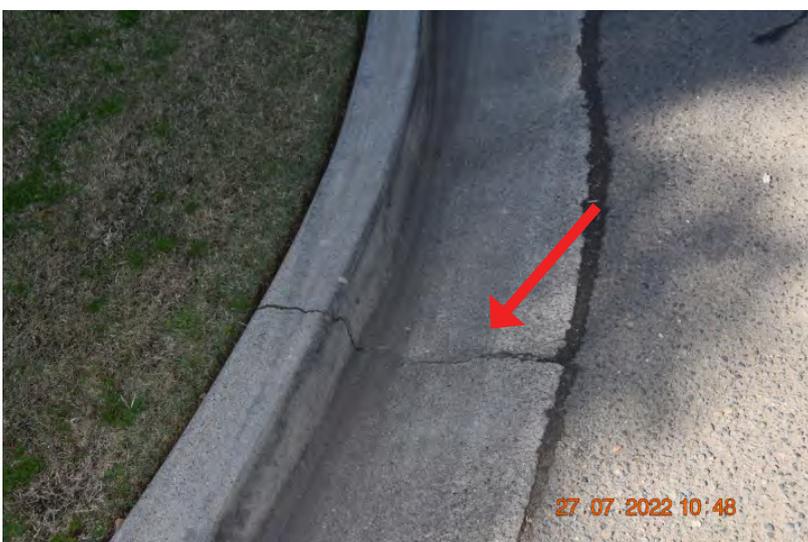
Figure: 0168 Fine cracking in the kerb and gutter. | **CHANGE:** Showing exacerbated cracking. | **CHANGE:** None

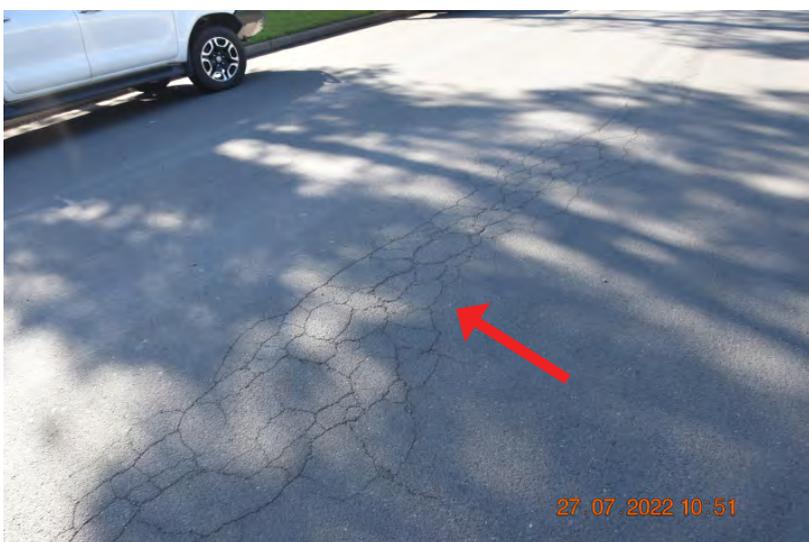
Figure: 0183 Fine cracking in the paving, looking to the north. (RPT FOR FIGURES 183-185) | **CHANGE:** None

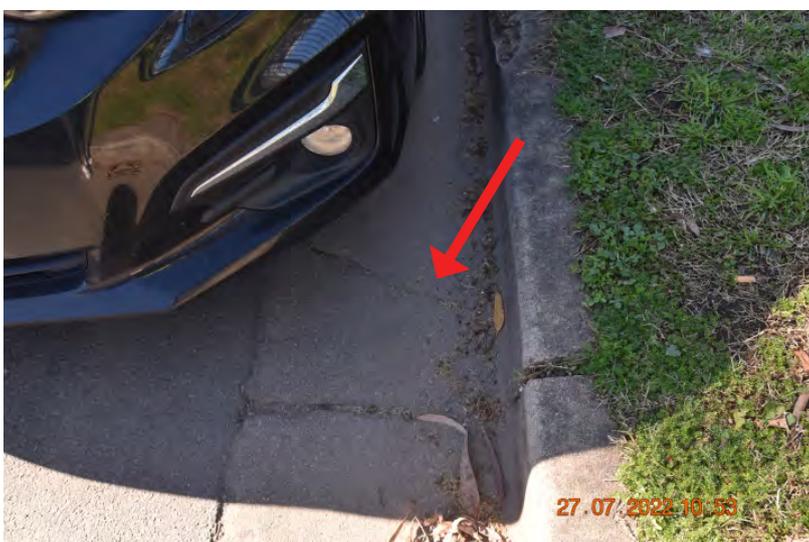
Figure: 0189 Chipping in the kerb. | **CHANGE:** None

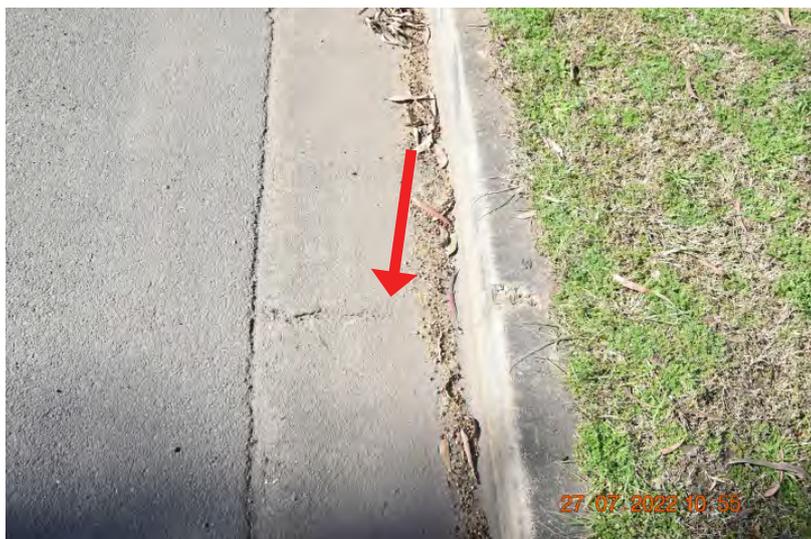
Figure: 0190 Fine cracking in the gutter. | **CHANGE:** None

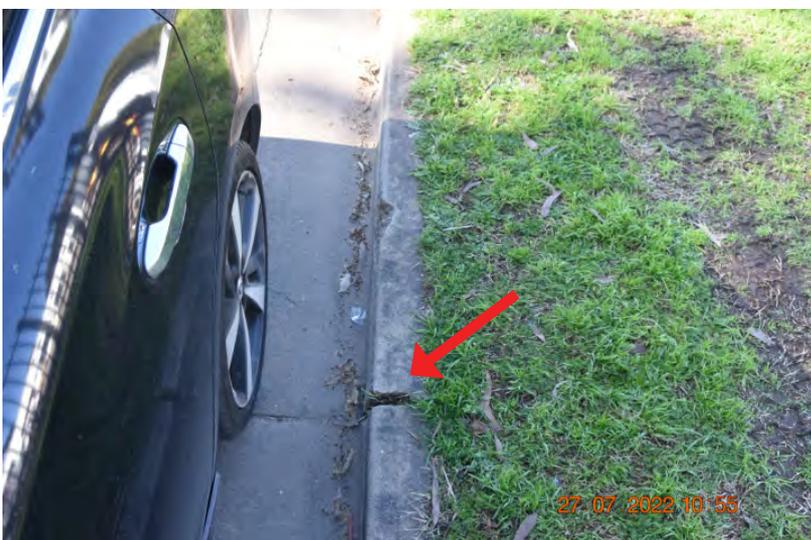
Figure: 0191 Chipping and fine cracking in the kerb and gutter. | **CHANGE:** None

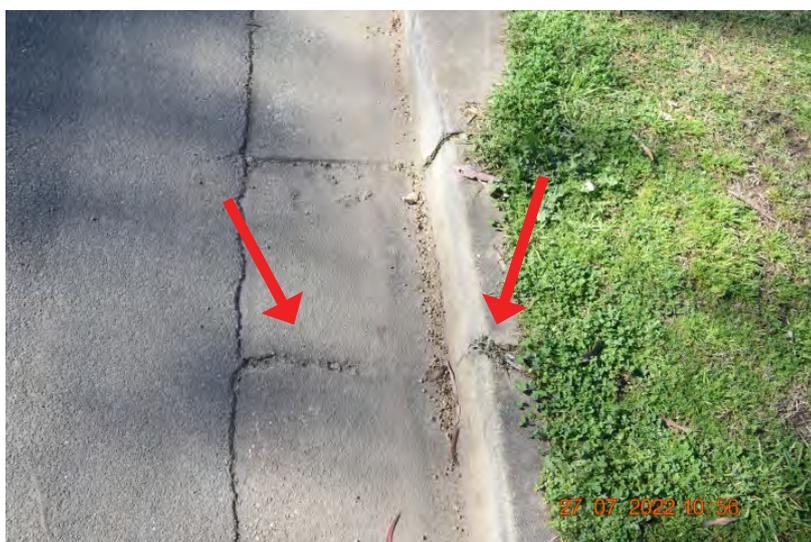
Figure: 0192 Slight cracking in the kerb and gutter. | **CHANGE:** None

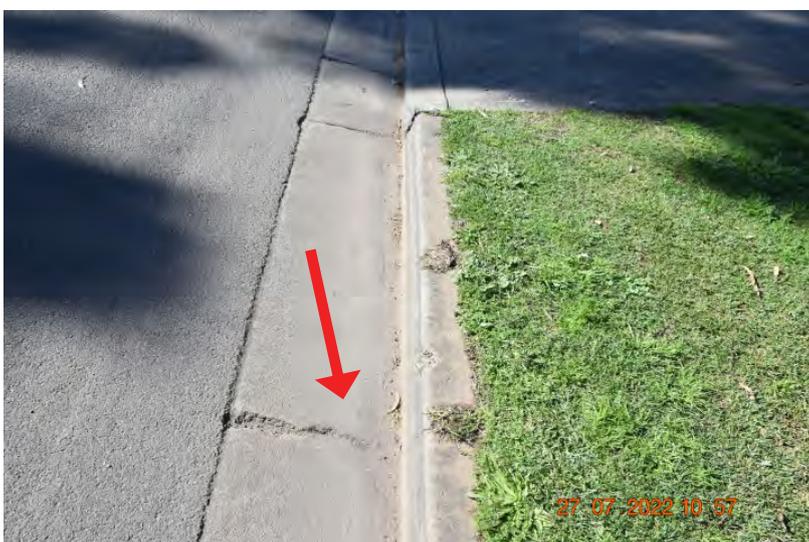
Figure: 0197 Slight cracking in the kerb and gutter. | **CHANGE:** None

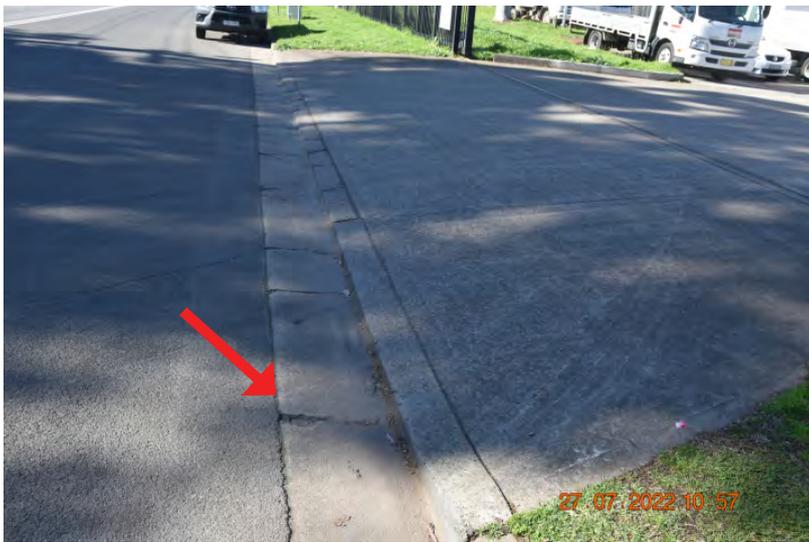
Figure: 0198 Slight cracking in the crossover. (RPT FOR FIGURES 199-203) | **CHANGE:** None

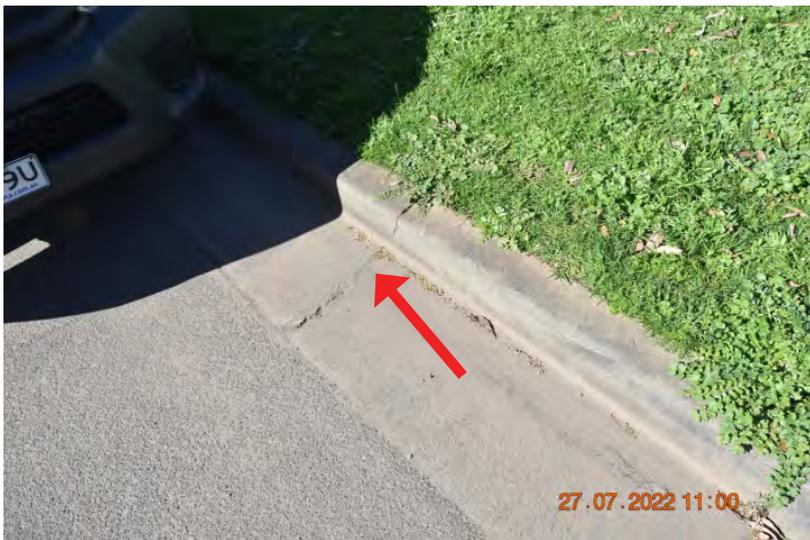
Figure: 0207 Fine cracking in the kerb and gutter. | **CHANGE:** None

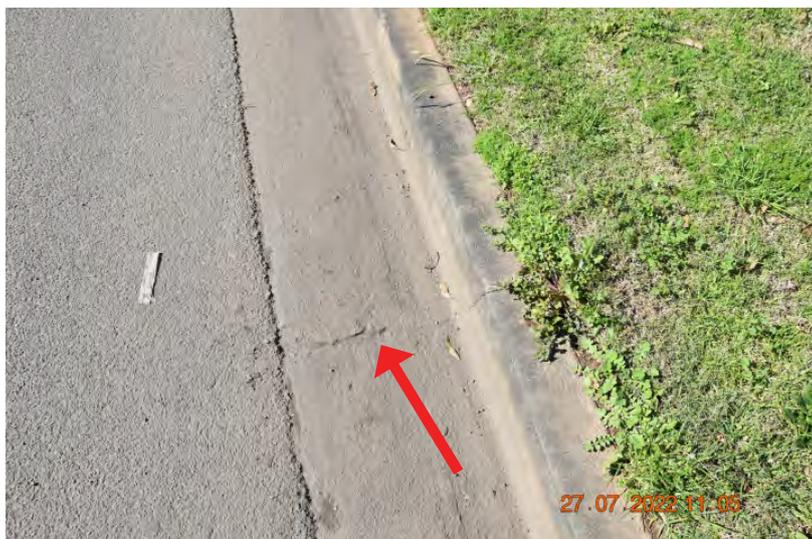
Figure: 0225 Fine cracking in the kerb and gutter. | **CHANGE:** None

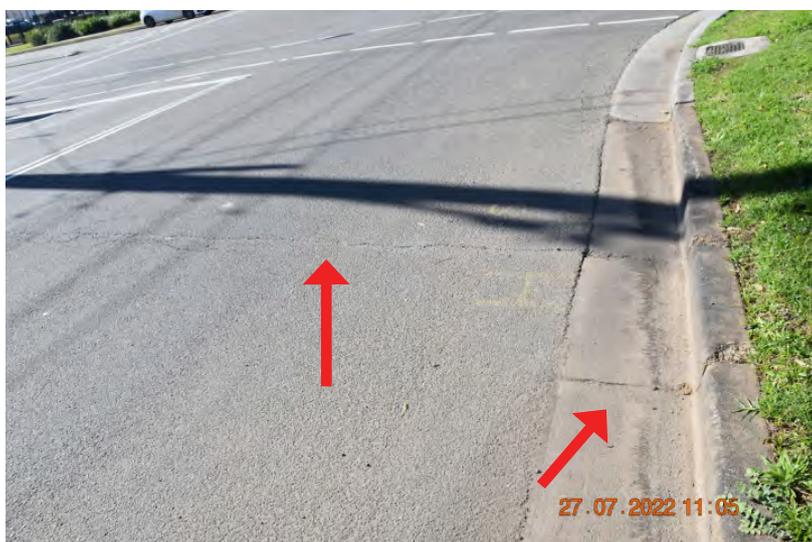
Figure: 0227 Slight cracking to the paving and the kerb and gutter. | **CHANGE:** None

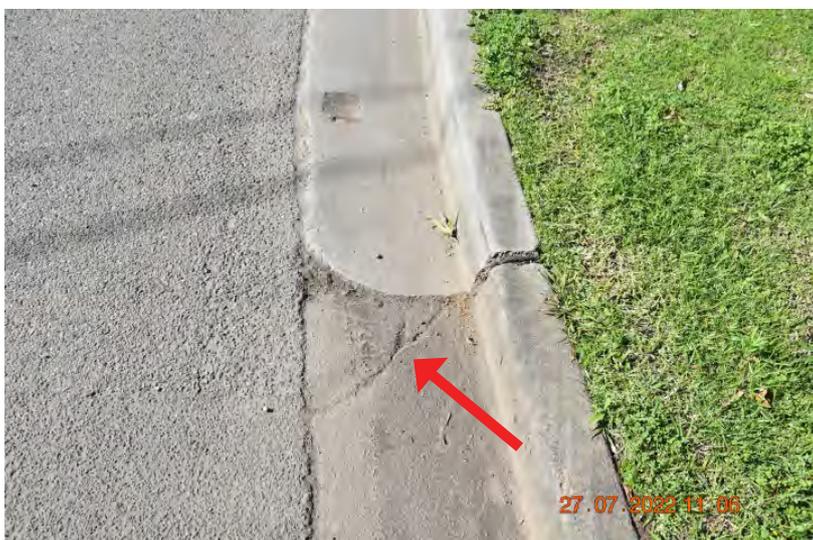
Figure: 0229 Cracking in the kerb and gutter. | **CHANGE:** None

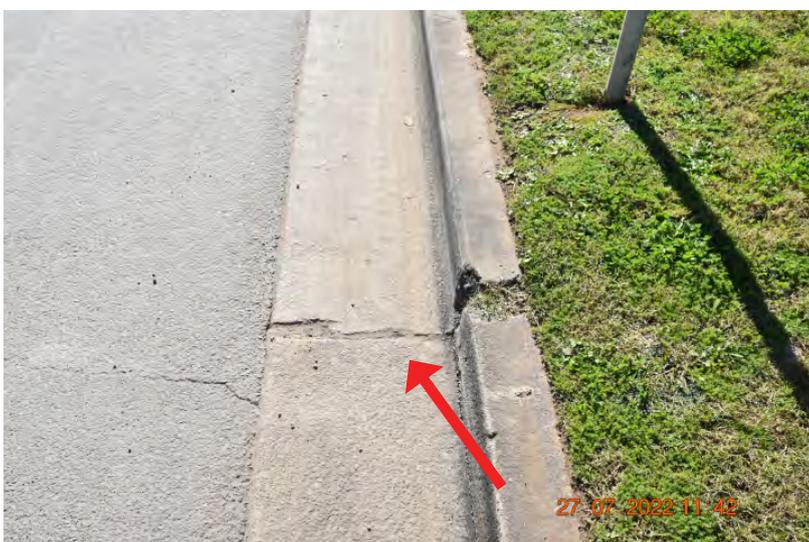
Figure: 0242 Slight cracking in the kerb and gutter. (RPT FOR FIGURES 243-245) | **CHANGE:** None

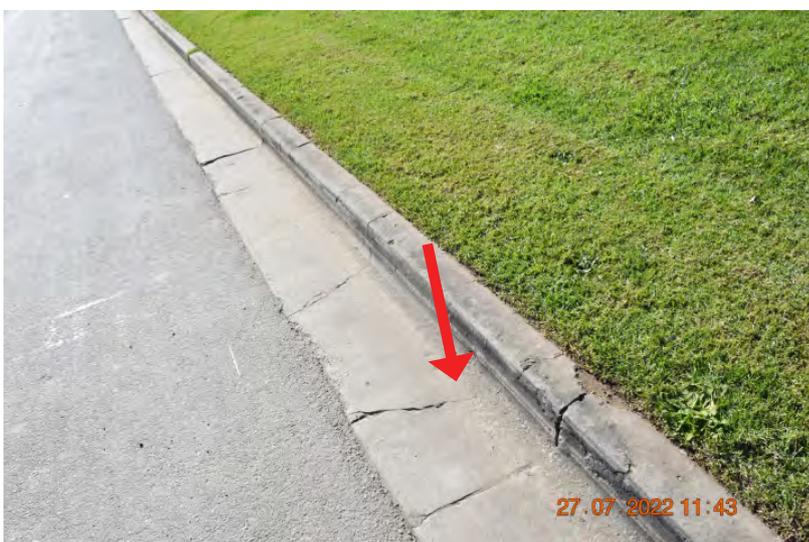
Figure: 0245 Chipping and cracking to the kerb and gutter. | **CHANGE:** None

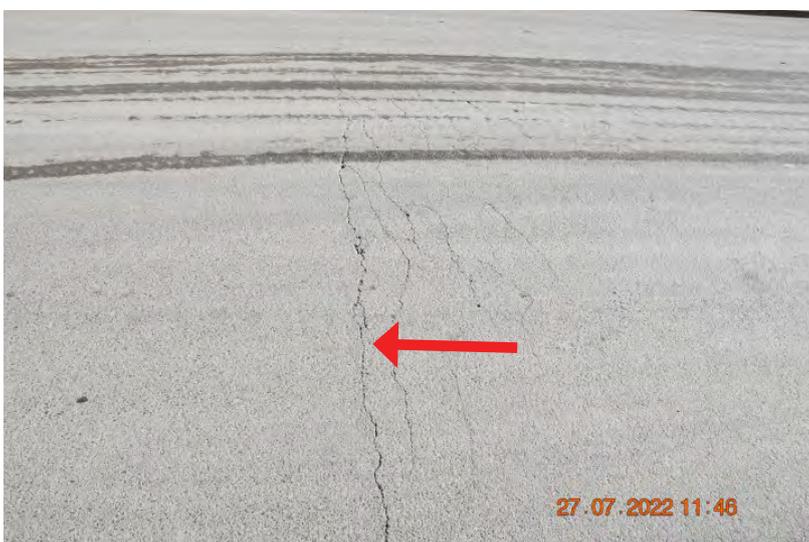
Figure: 0251 Fine cracking in the paving. | **CHANGE:** None

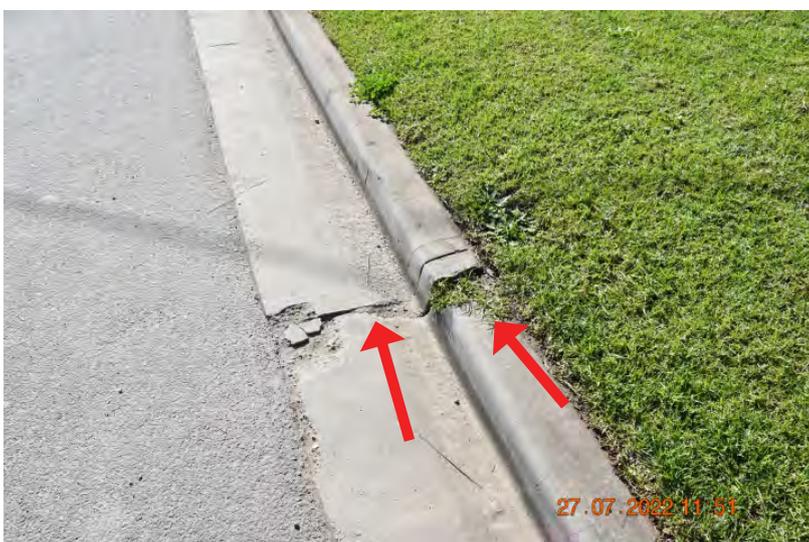
Figure: 0254 Chipping in the kerb and gutter. | **CHANGE:** None

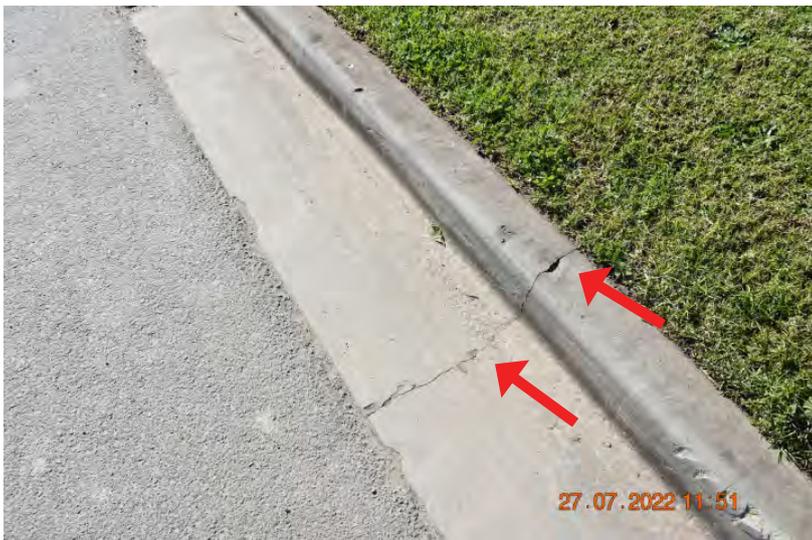
Figure: 0255 Fine cracking in the kerb and gutter, looking to the east. (RPT FOR FIGURES 256-257) | **CHANGE:** None

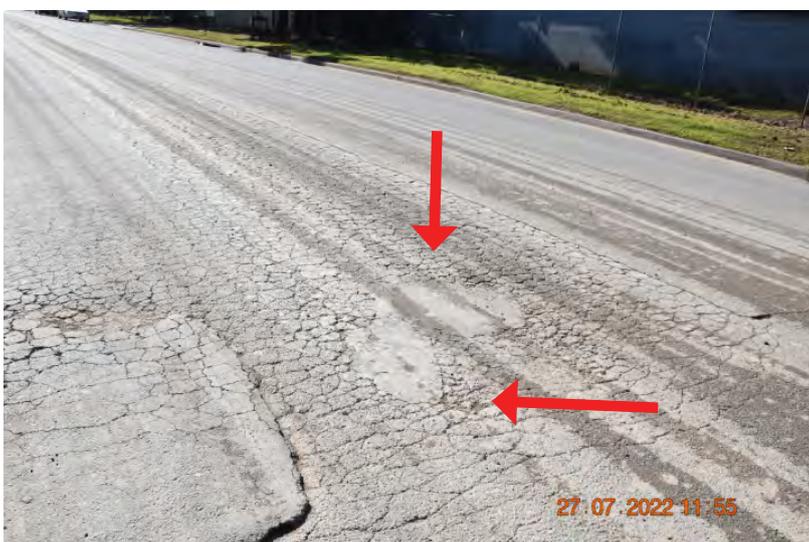
Figure: 0275 Slight alligator cracking in the paving. Also showing subsidence. | **CHANGE:** None

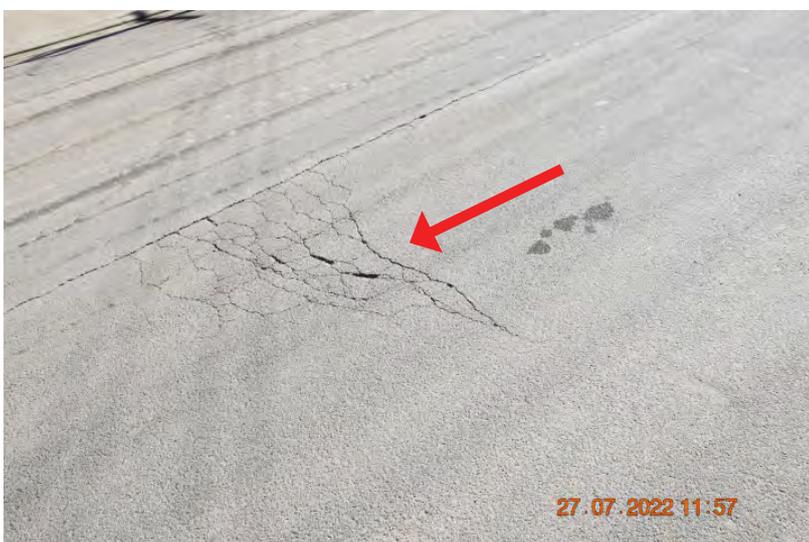
Figure: 0284 Slight cracking in the paving. (RPT FOR FIGURES 285-288) | **CHANGE:** None

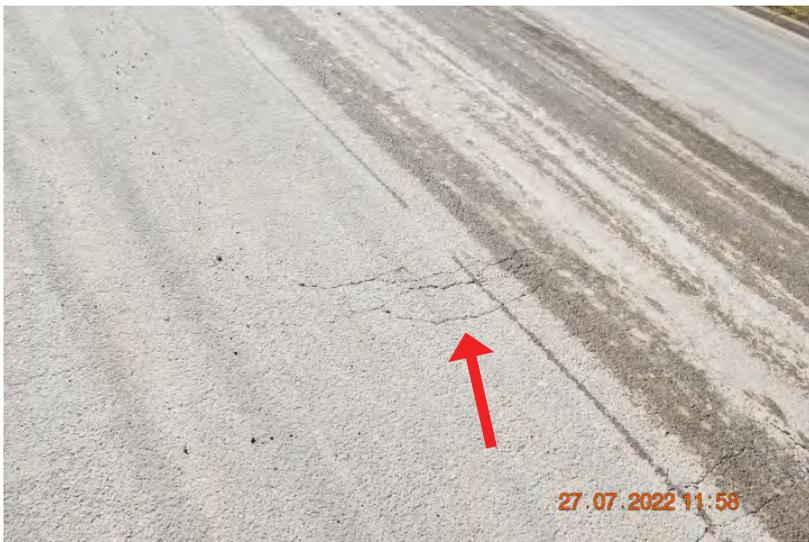
Figure: 0288 Fine alligator cracking. | **CHANGE:** None

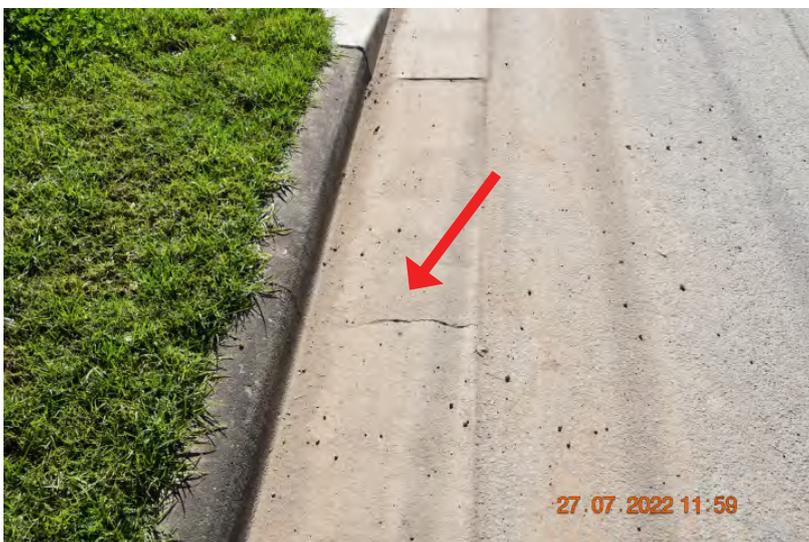
Figure: 0290 Fine cracking in the kerb and gutter. | **CHANGE:** None

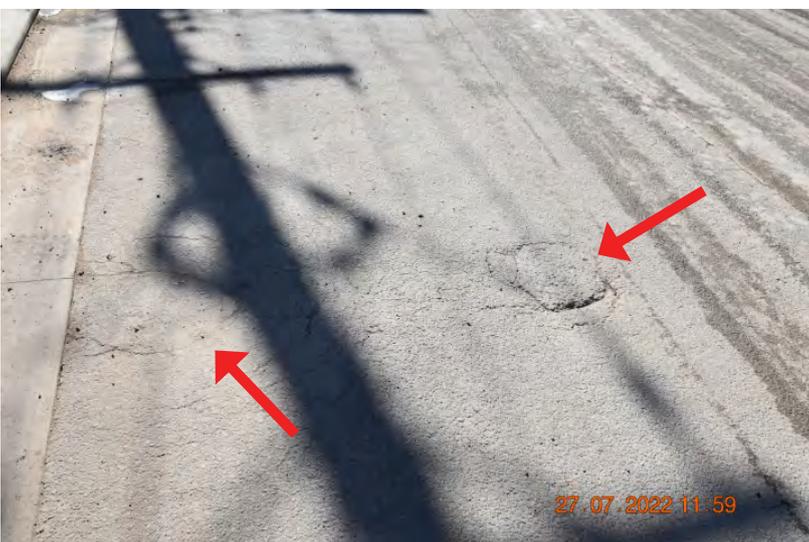
Figure: 0292 Subsidence in the paving. | **CHANGE:** None

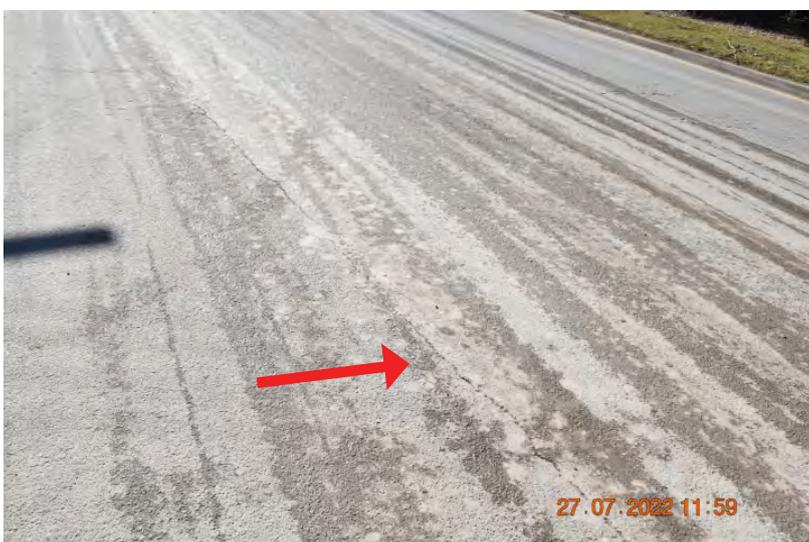
Figure: 0293 Slight cracking in the paving. (RPT FOR FIGURES 294-296) | **CHANGE:** None

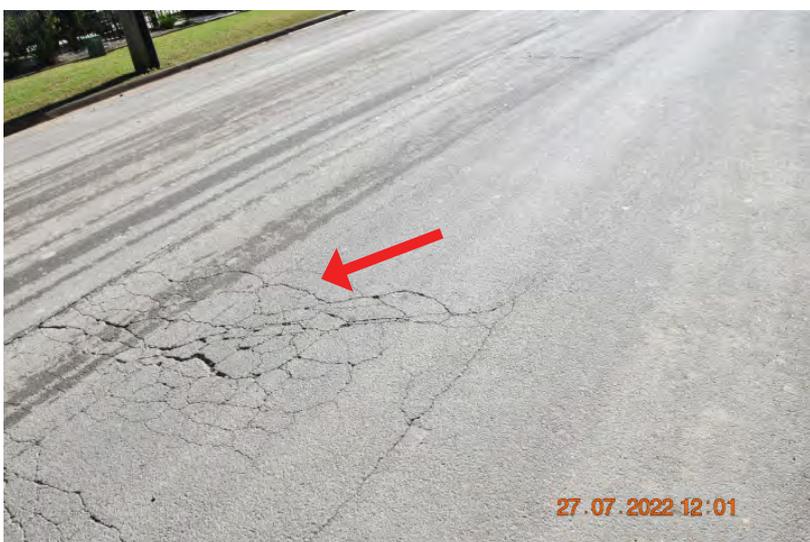
Figure: 0299 Slight cracking in the paving. (RPT FOR FIGURES 300-301) | **CHANGE:** None

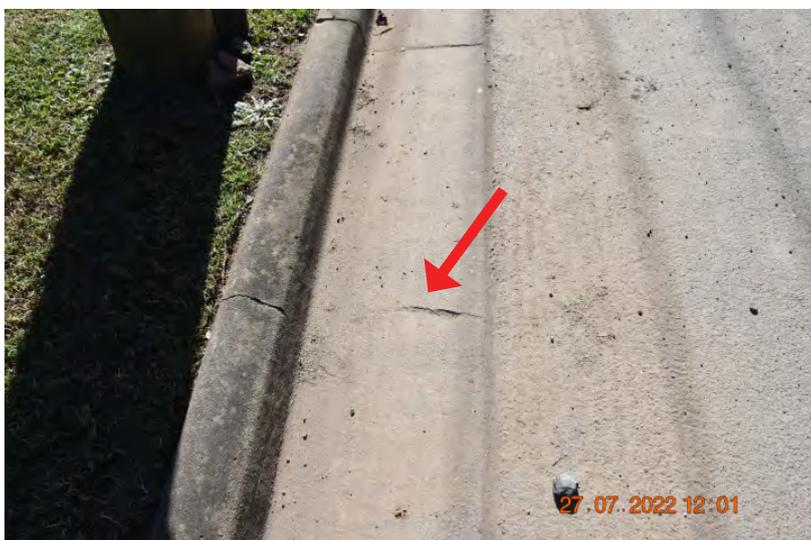
Figure: 0304 Slight cracking in the kerb and gutter. (RPT FOR FIGURES 305-306) | **CHANGE:** None

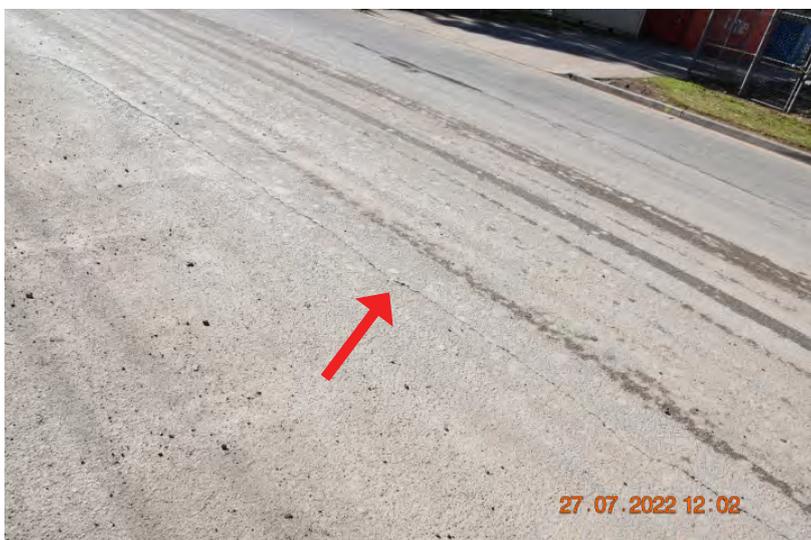
Figure: 0307 Slight cracking in the paving. (RPT FOR FIGURES 308-311) | **CHANGE:** None

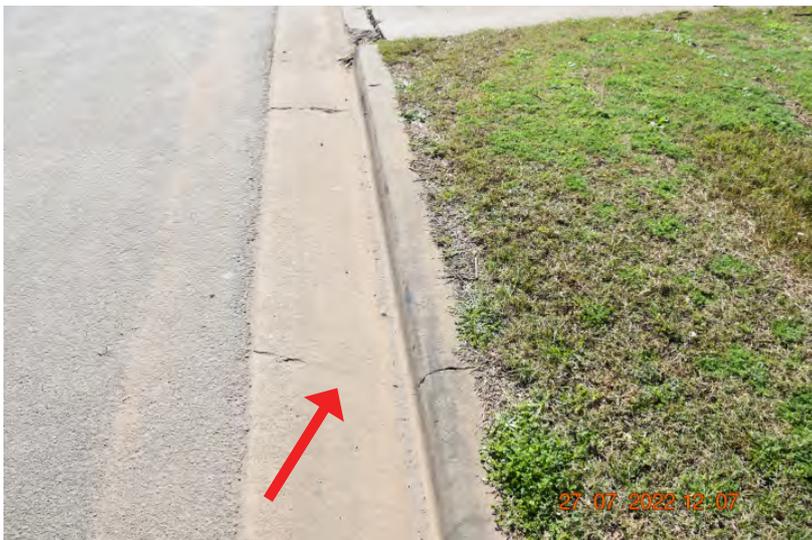
Figure: 0333 Fine cracking in the kerb and gutter. | **CHANGE:** None

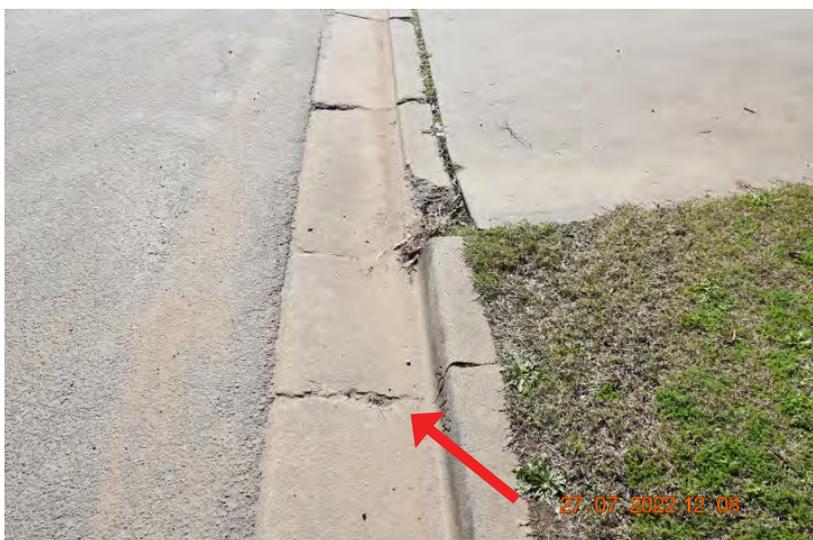
Figure: 0334 Slight cracking in the kerb and gutter. | **CHANGE:** None

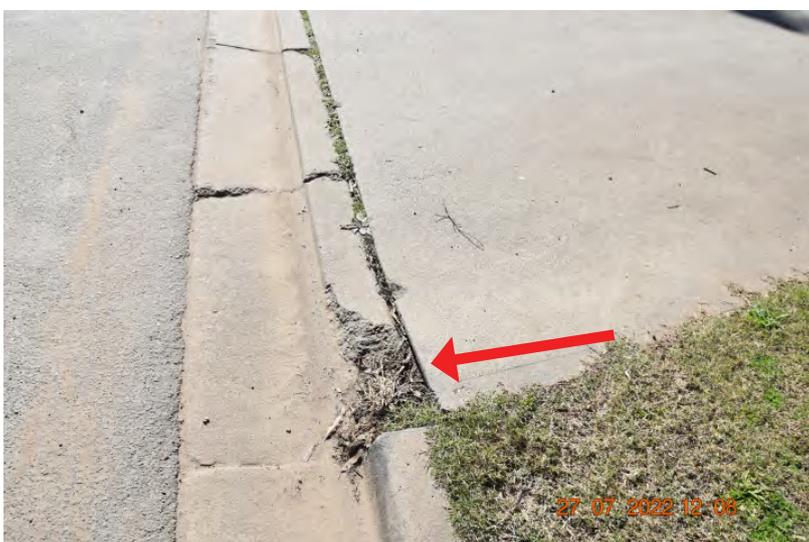
Figure: 0335 Chipping and slight cracking in the crossover. | **CHANGE:** None

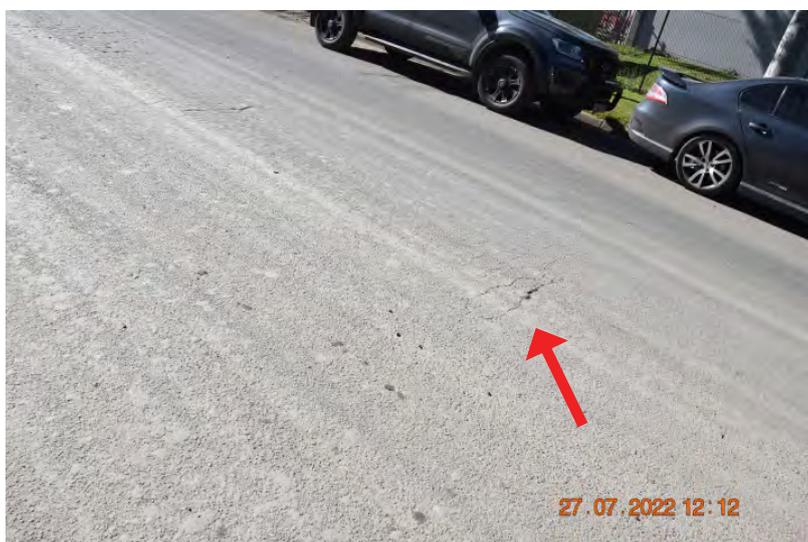
Figure: 0353 Fine cracking in the paving. (RPT FOR FIGURES 354-356) | **CHANGE:** None

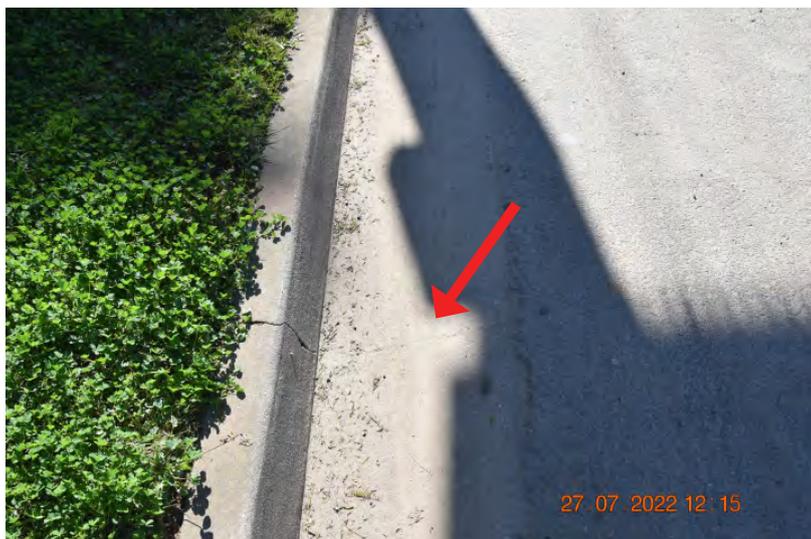
Figure: 0369 Fine cracking in the kerb and gutter. | **CHANGE:** None

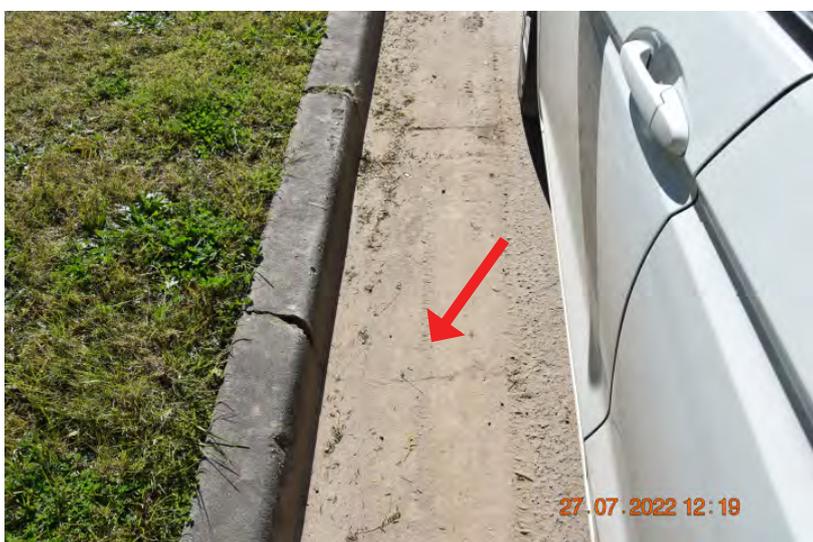
Figure: 0388 Fine cracking in the kerb. | **CHANGE:** None
