POST CONSTRUCTION CONDITION SURVEY - GPS

Nepean Business Park - Penrith NSW

Council Assets
Lugard Street, Leland Street and Old Castlereagh Road
PENRITH NSW 2750

27 July 2022

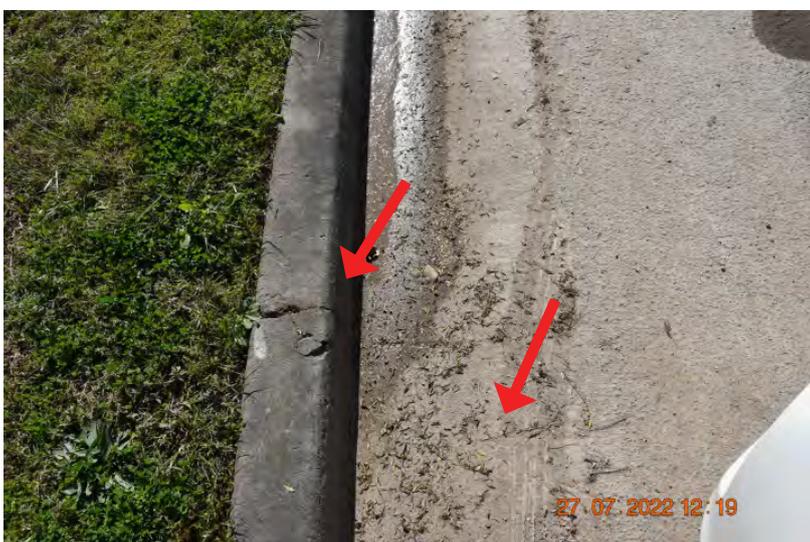
Figure: 0389 Fine cracking in the kerb and gutter. | **CHANGE:** None

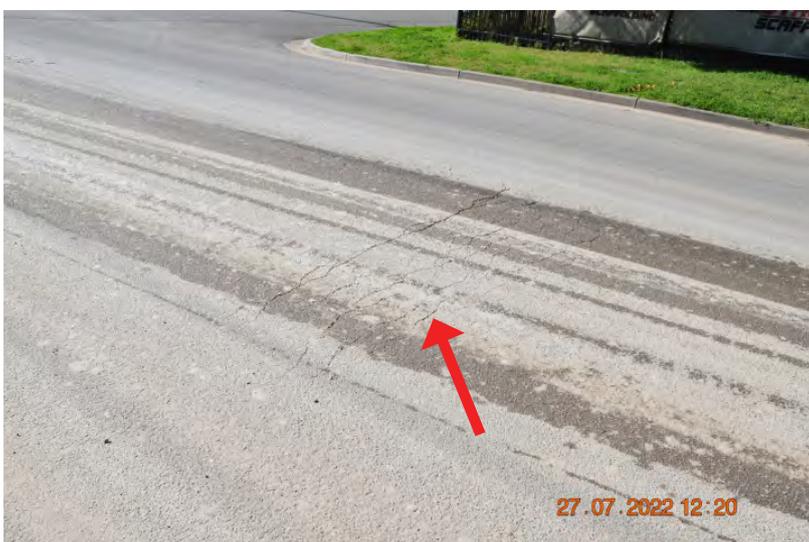
Figure: 0392 Alligator cracking in the paving. | **CHANGE:** None
