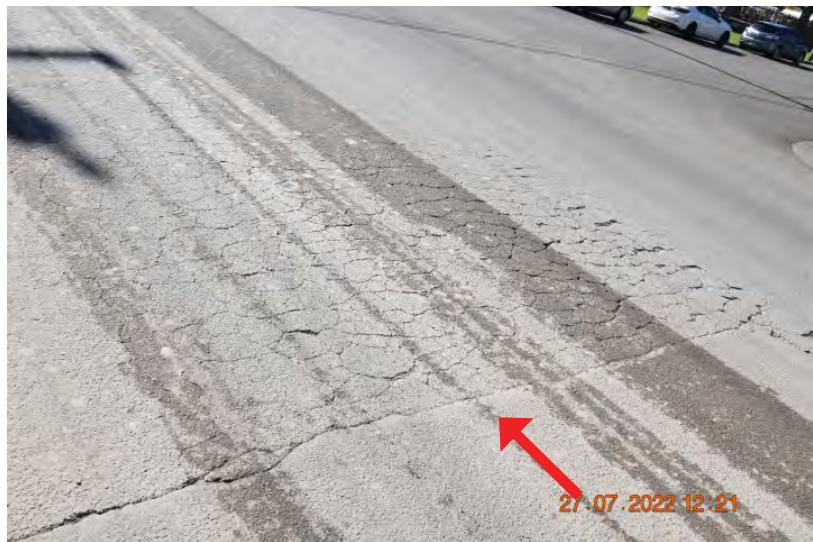
Figure: 0402 Alligator cracking in the paving. | **CHANGE:** None

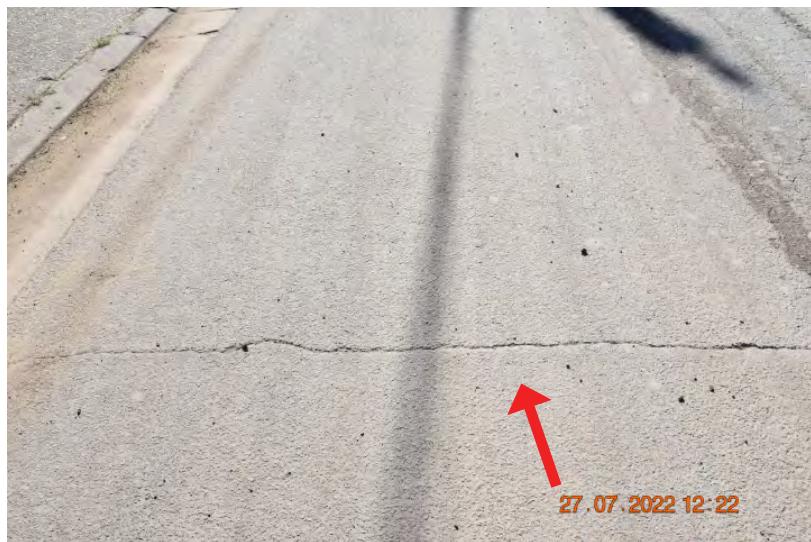
Figure: 0403 Slight cracking in the paving. | **CHANGE:** None

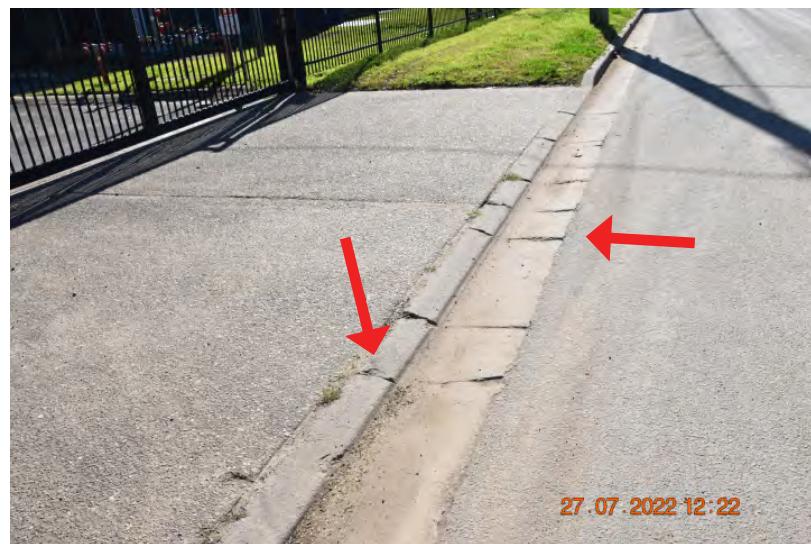
Figure: 0404 Chipping and slight cracking in the crossover. (RPT FOR FIGURES 405-406) | **CHANGE:** None

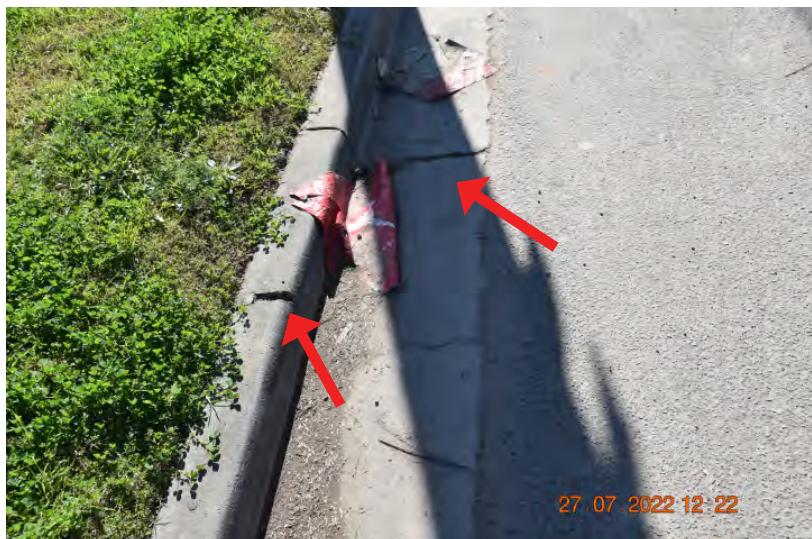
Figure: 0406 Fine cracking in the kerb and gutter. | **CHANGE:** None

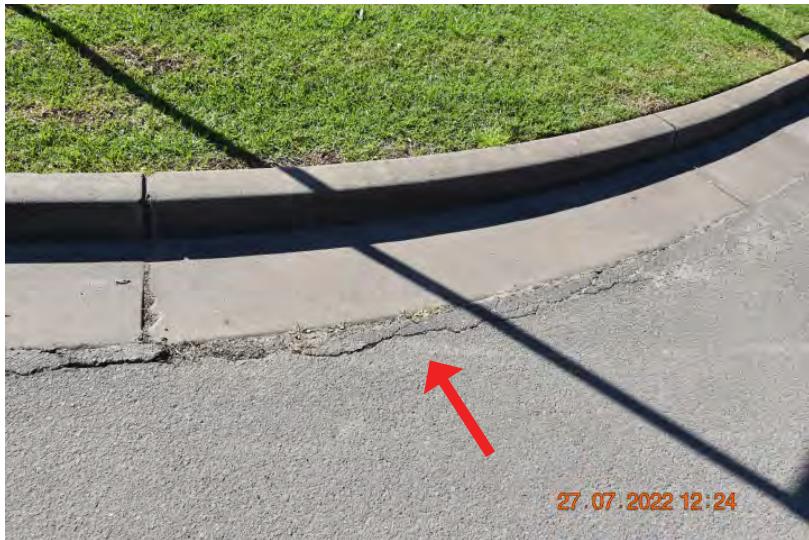
Figure: 0414 Fine cracking in the roadway. (RPT FOR FIGURES 415-416) | **CHANGE:** None

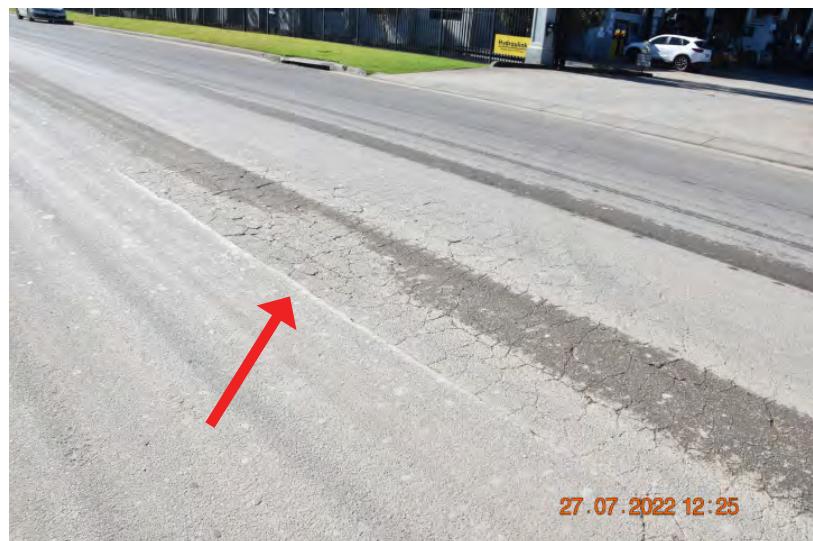
Figure: 0425 Fine alligator cracking in the paving. | **CHANGE:** None

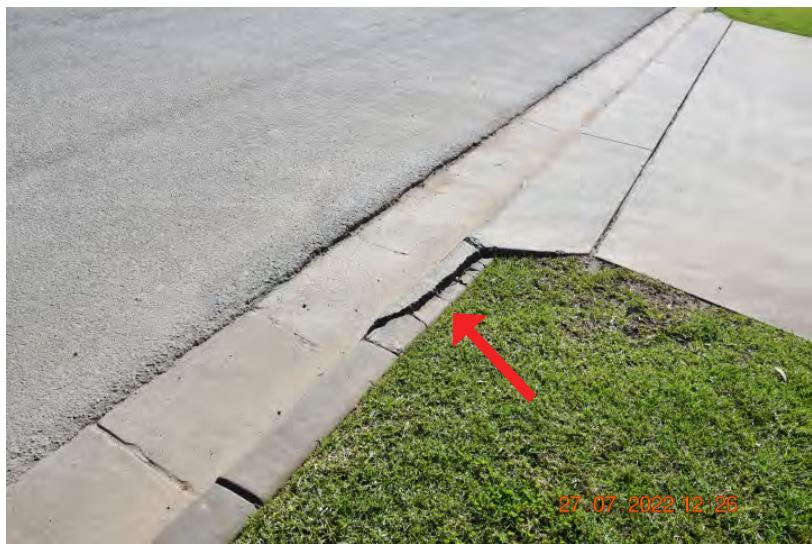
Figure: 0427 Substantial cracking in the kerb. | **CHANGE:** None

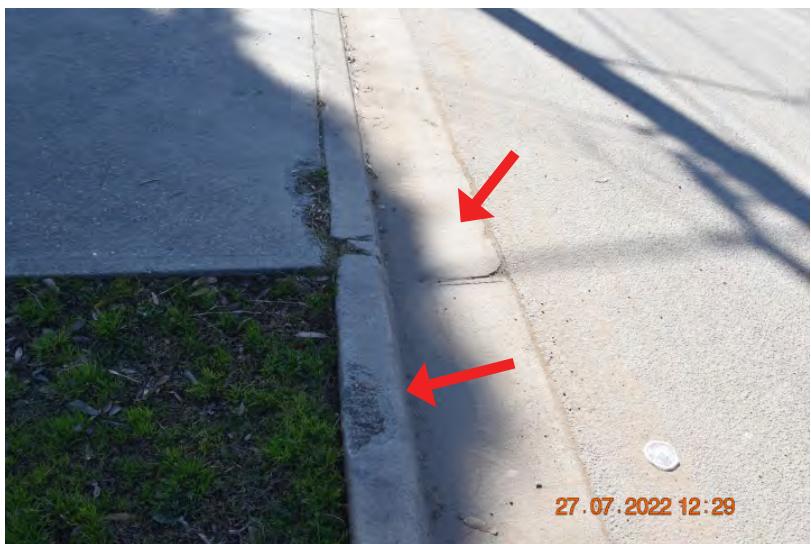
Figure: 0440 Chipping and slight cracking in the crossover. | **CHANGE:** None

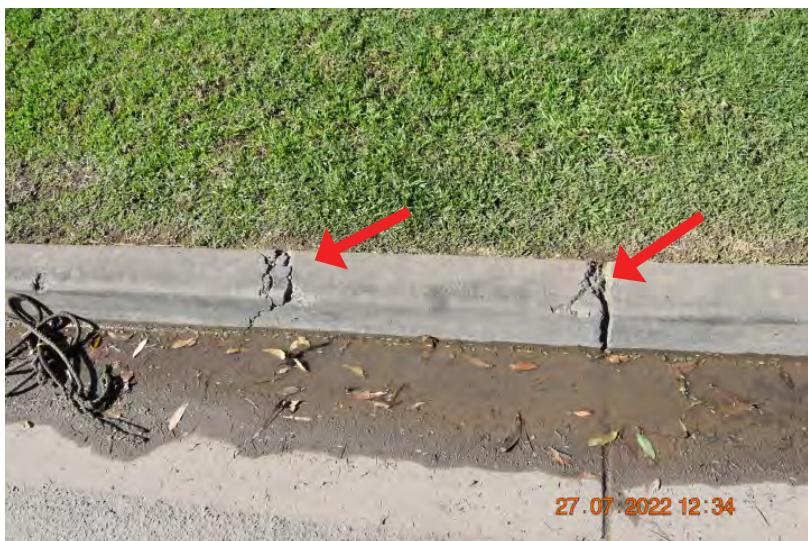
Figure: 0449 Slight cracking in the kerb and gutter. | **CHANGE:** None

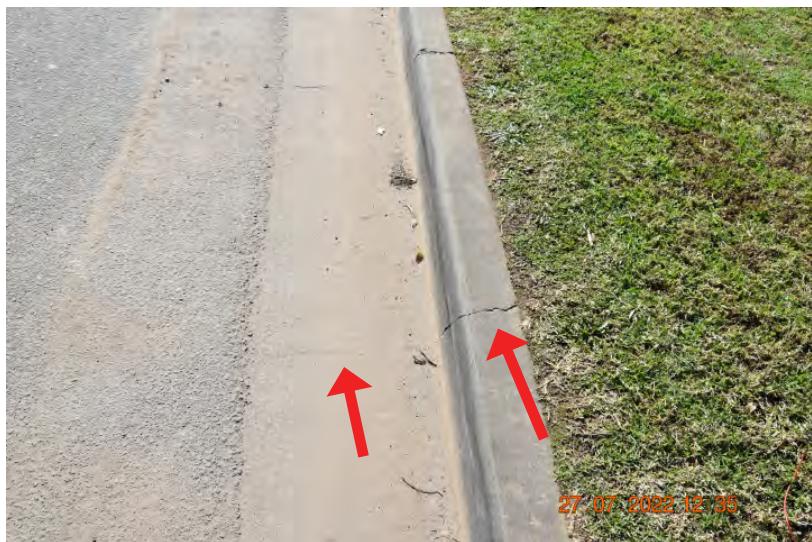
Figure: 0454 Fine cracking in the kerb and gutter. (RPT FOR FIGURES 455-456) | CHANGE: None

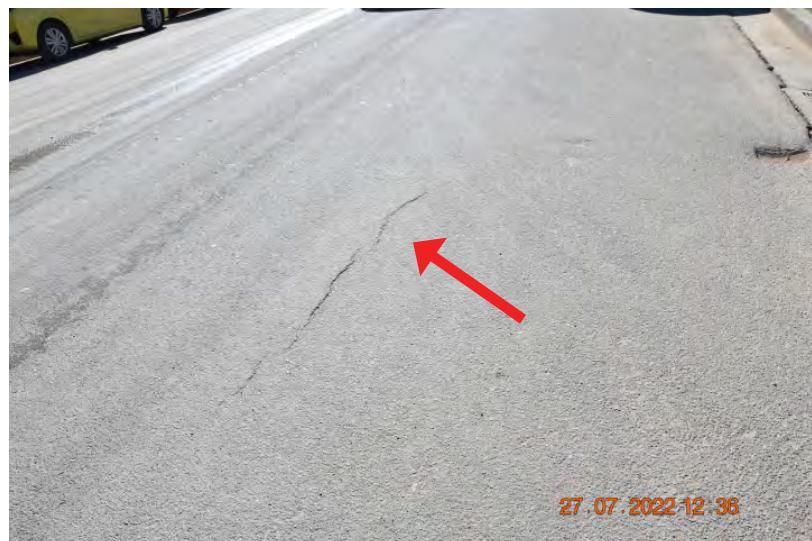
Figure: 0458 Fine cracking in the paving. | **CHANGE:** None

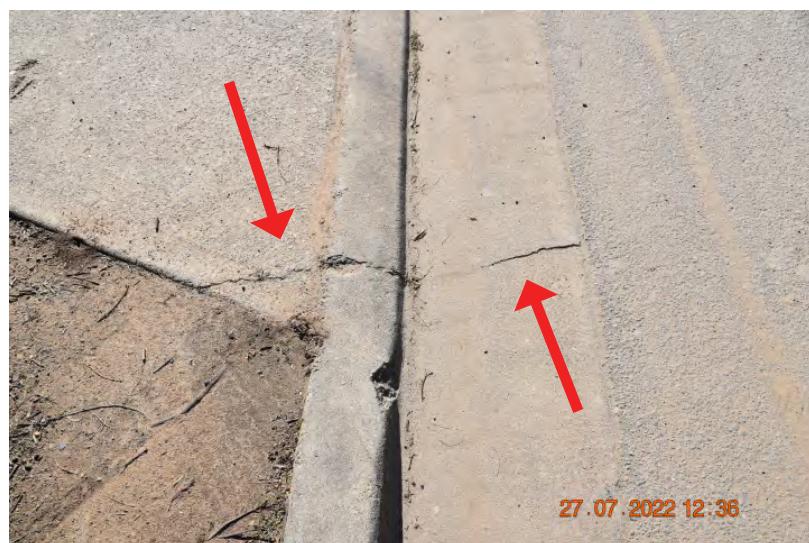
Figure: 0461 Fine cracking in the crossover. (462-463) | **CHANGE:** None

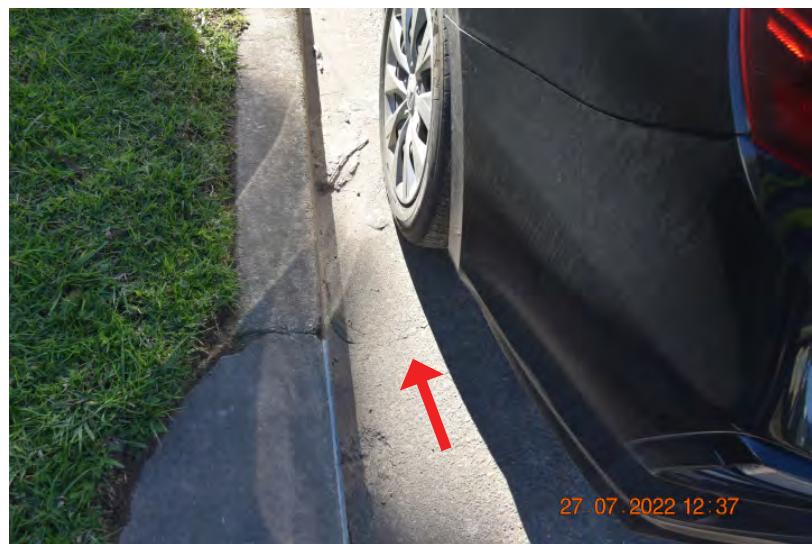
Figure: 0464 Fine cracking in the gutter. | **CHANGE:** None

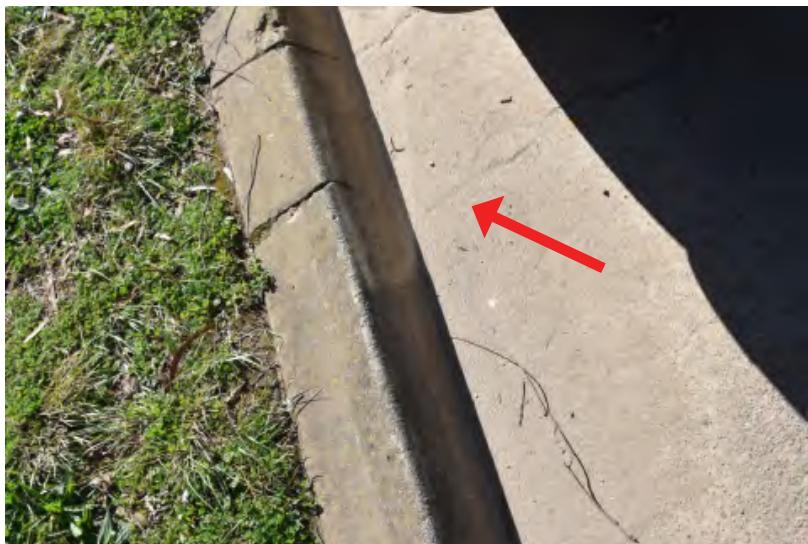
Figure: 0471 Slight cracking and chipping in the kerb and gutter. | **CHANGE:** None

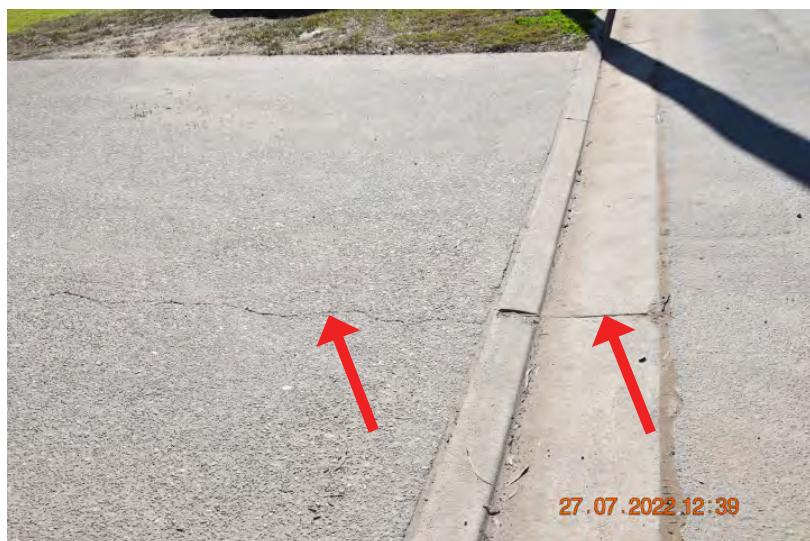
Figure: 0475 Slight cracking in the paving and the crossover. | **CHANGE:** None

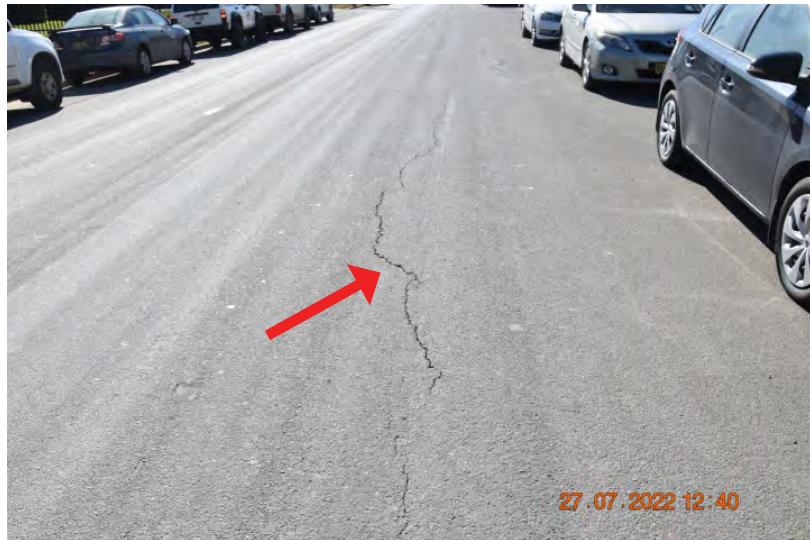
Figure: 0480 Slight cracking in the paving. | **CHANGE:** None

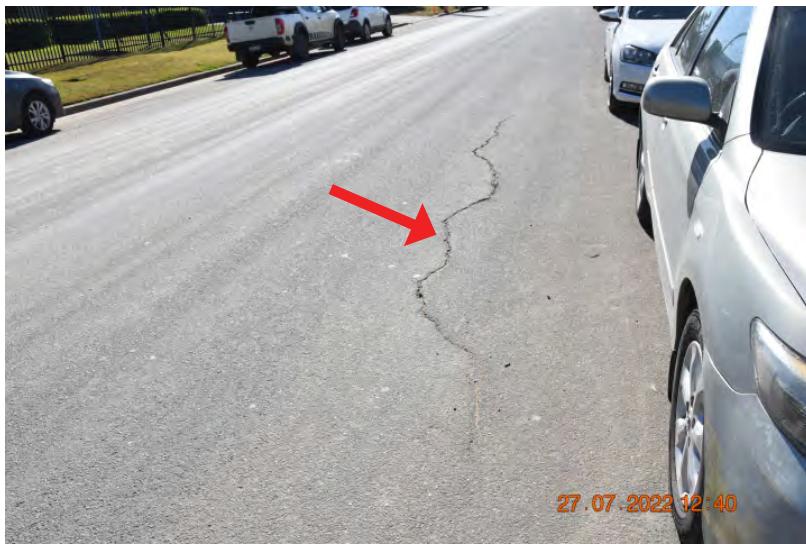
Figure: 0483 Slight cracking in the roadway. (RPT FOR FIGURES 484-485) | CHANGE: None

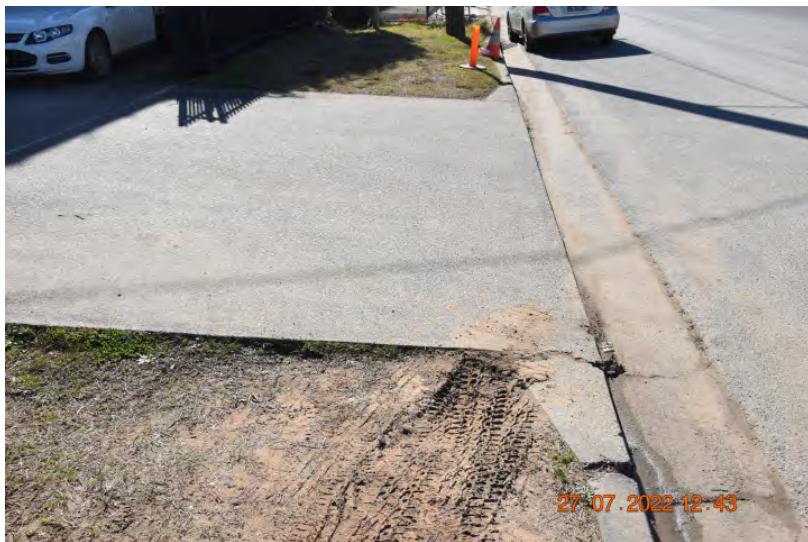
Figure: 0496 Slight cracking and chipping in the kerb and gutter. | **CHANGE:** None

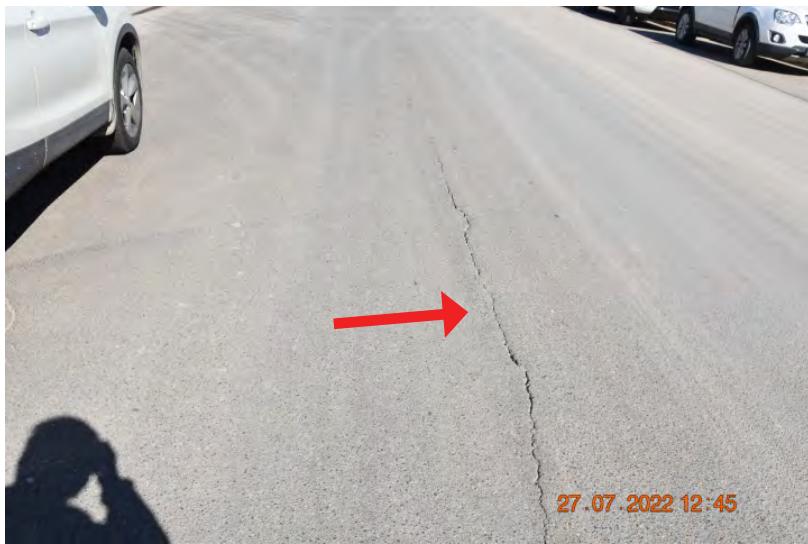
Figure: 0498 Slight cracking in the roadway. (RPT FOR FIGURES 499-500) | CHANGE: None

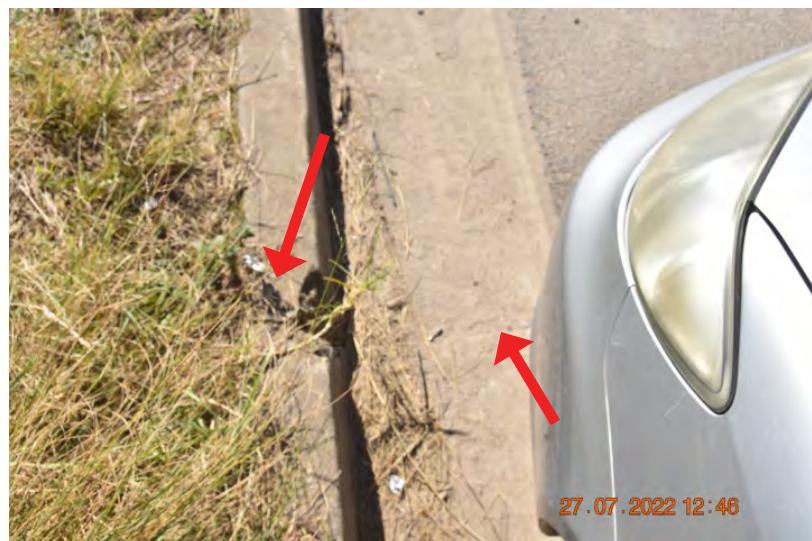
Figure: 0506 Chipping in the kerb. Also showing fine cracking in the gutter. | **CHANGE:** None

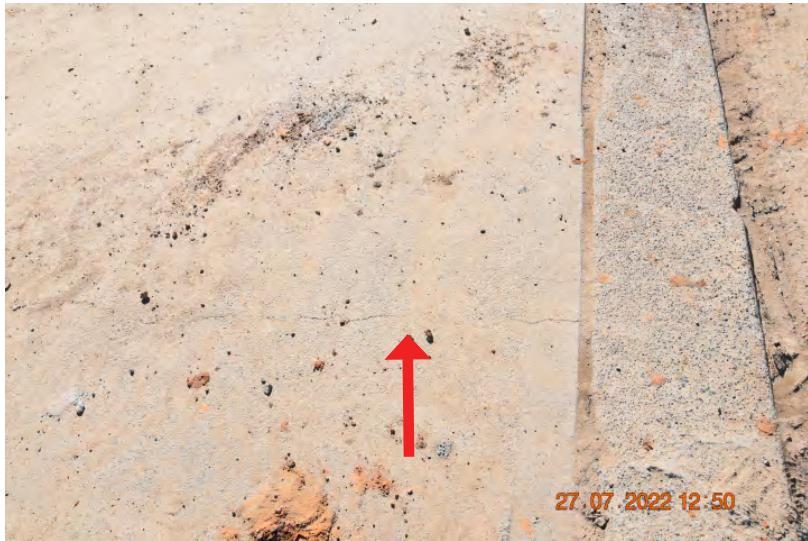
Figure: 0515 Fine cracking in the crossover, looking to the west. | **CHANGE:** None

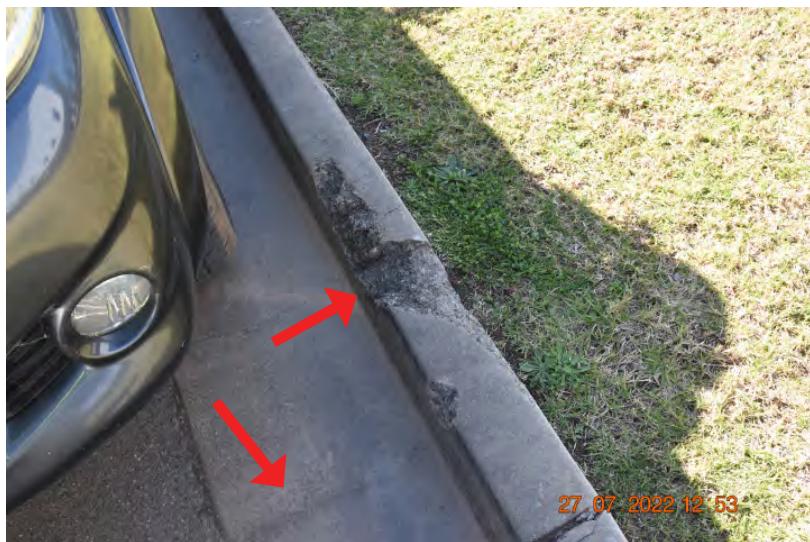
Figure: 0520 Chipping and fine cracking in the kerb and gutter. | **CHANGE:** None

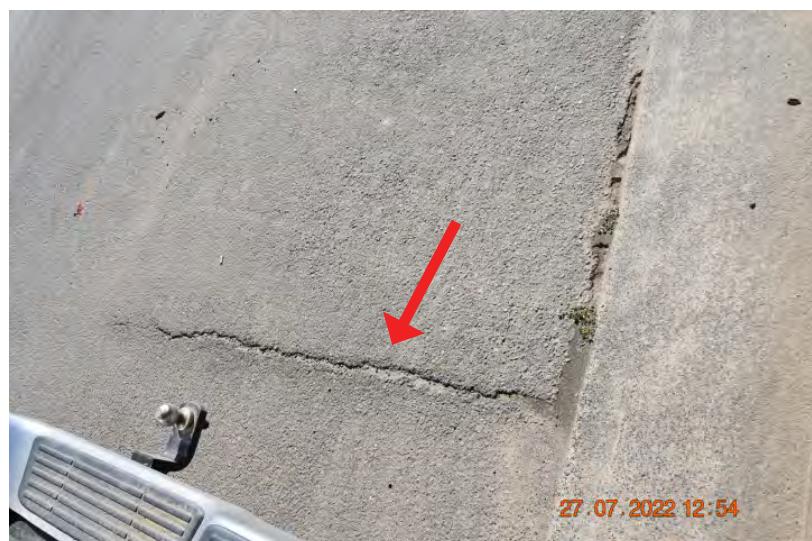
Figure: 0524 Slight cracking in the paving. | **CHANGE:** None

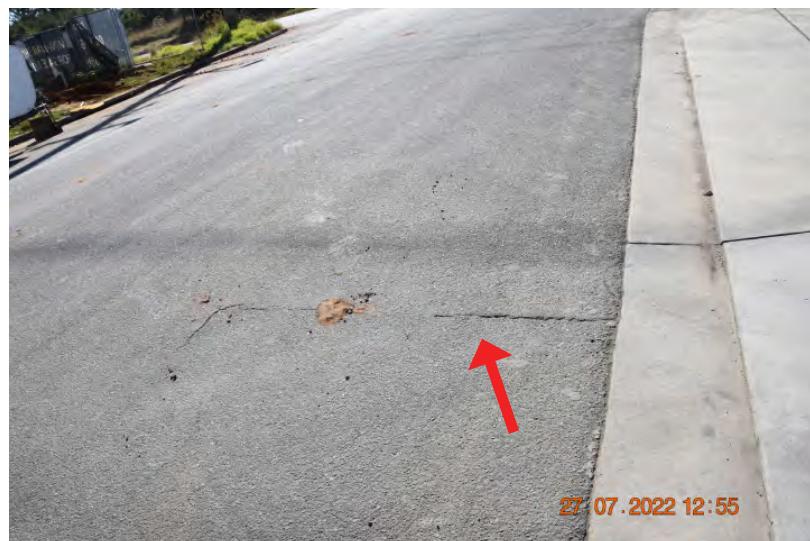
Figure: 0527 Slight cracking in the roadway. | **CHANGE:** None

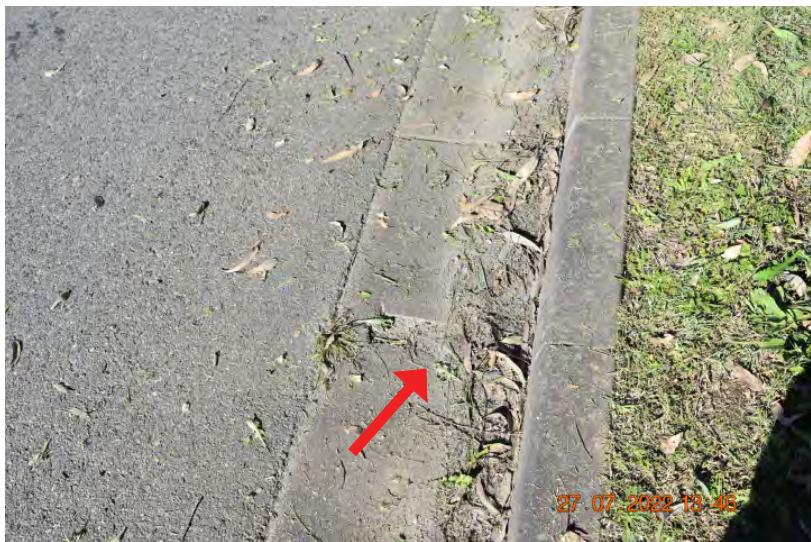
Figure: 0540 Slight cracking in the kerb and gutter. | **CHANGE:** None

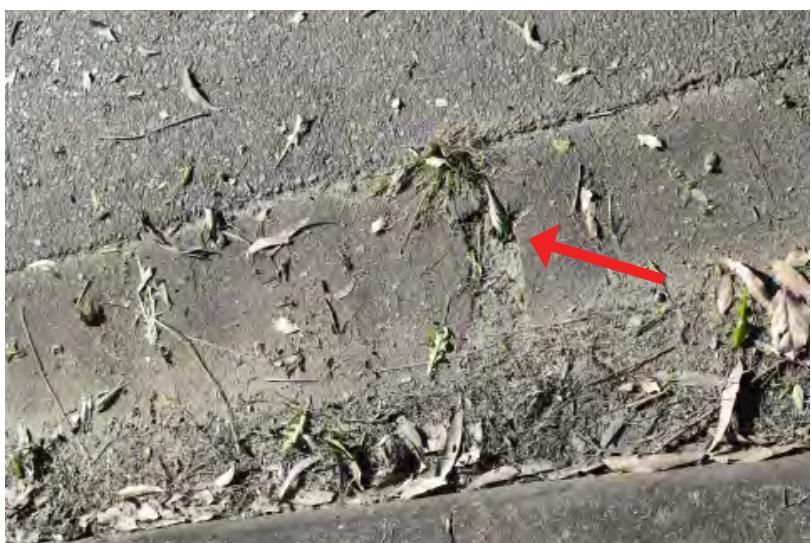
Figure: 0548 Slight cracking in the kerb and gutter. | **CHANGE:** None

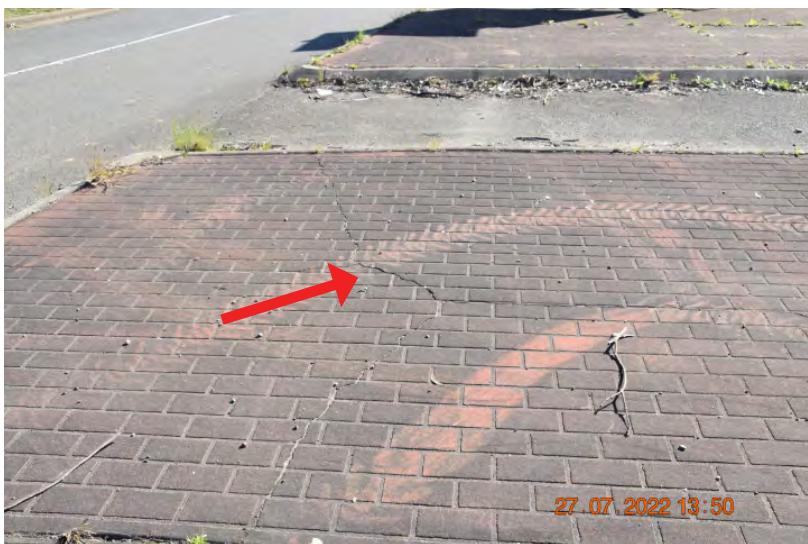
Figure: 0554 Slight cracking in the median strip. | **CHANGE:** None

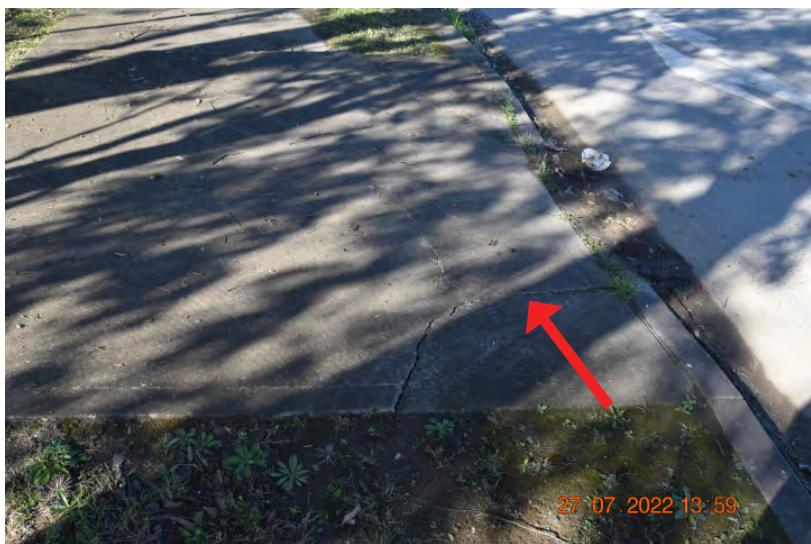
Figure: 0567 Slight cracking and chipping in the kerb and gutter. | **CHANGE:** None

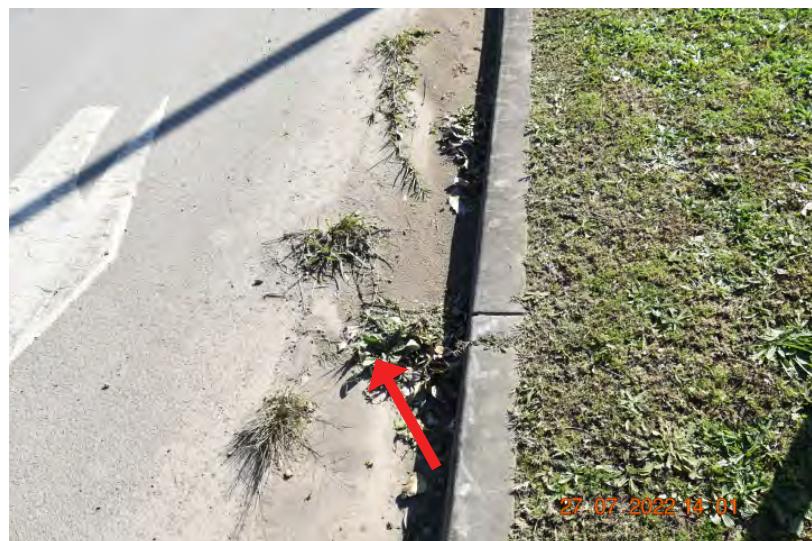
Figure: 0590 Slight cracking and chipping in the kerb and gutter. | **CHANGE:** None

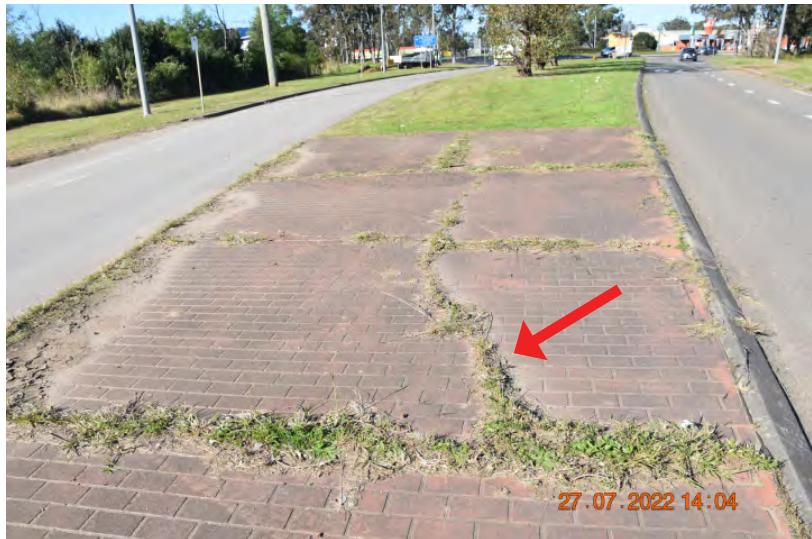
Figure: 0607 Fine cracking in the median strip. | CHANGE: None

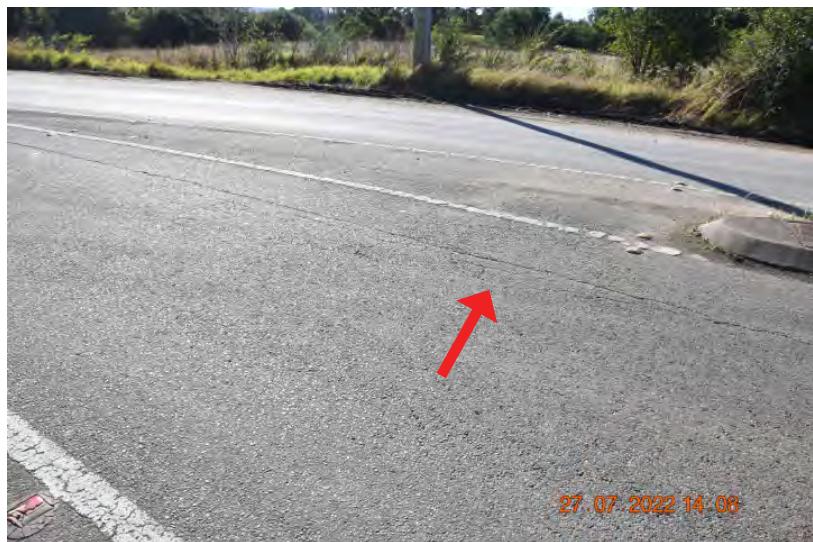
Figure: 0625 Slight cracking in the paving. | **CHANGE:** None

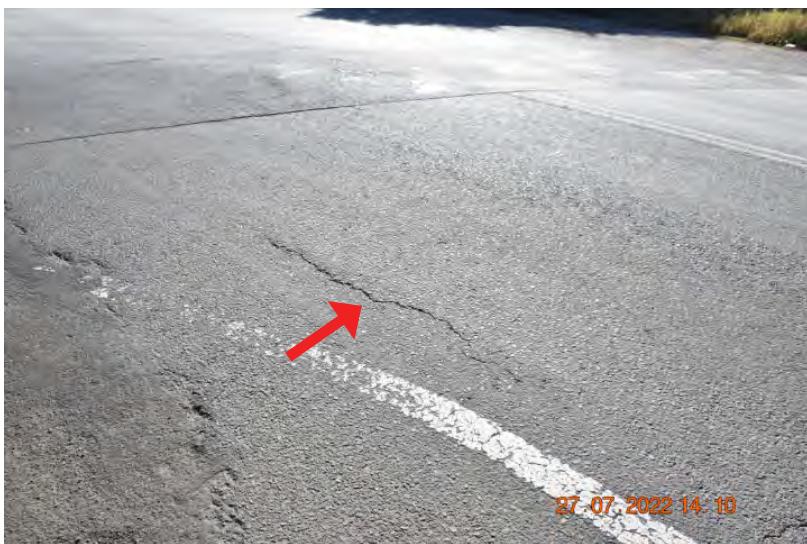
Figure: 0633 Slight cracking in the paving. | **CHANGE:** None

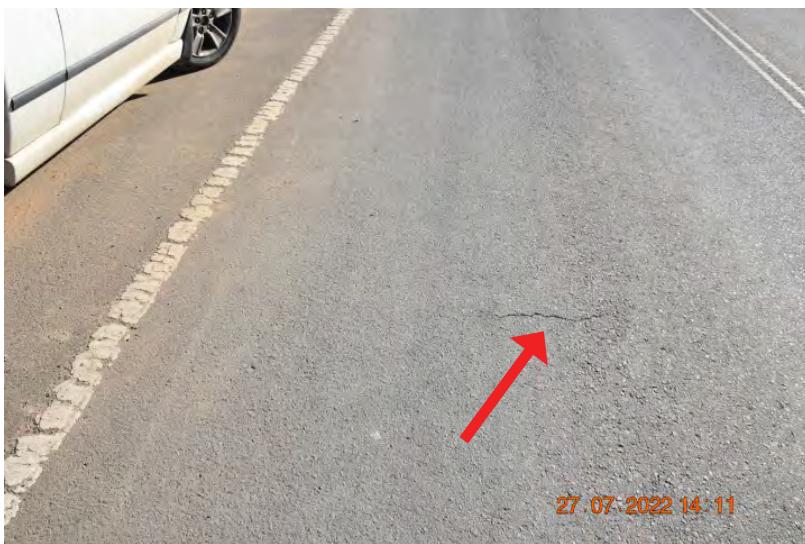
Figure: 0636 Slight cracking in the paving. | **CHANGE:** None

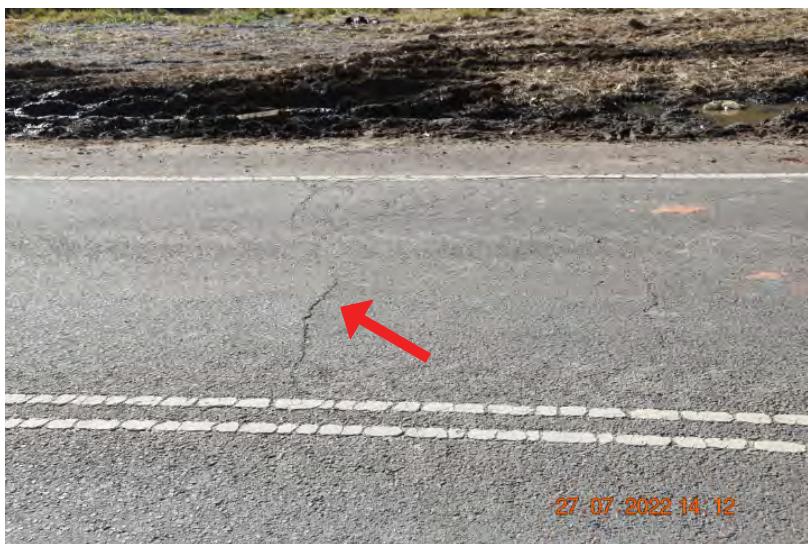
Figure: 0641 Slight cracking in the paving. (RPT FOR FIGURES 642-643) | **CHANGE:** None

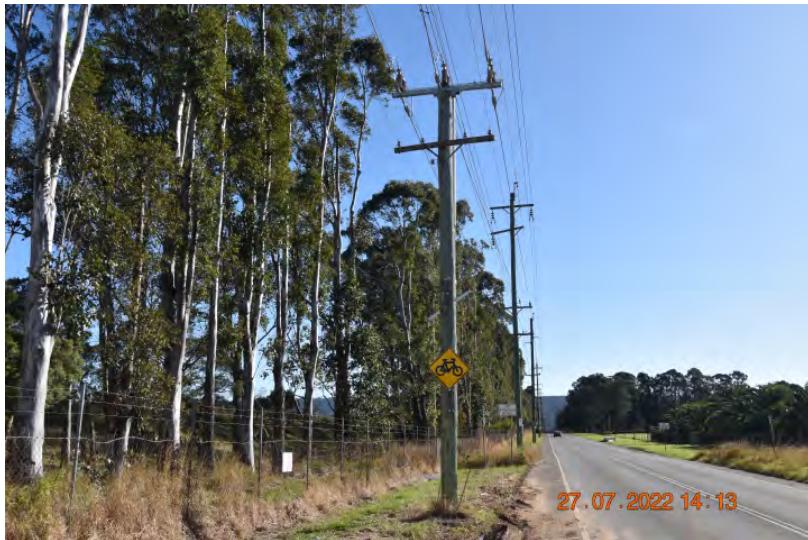
Figure: 0646 Slight cracking in the paving. | **CHANGE:** None

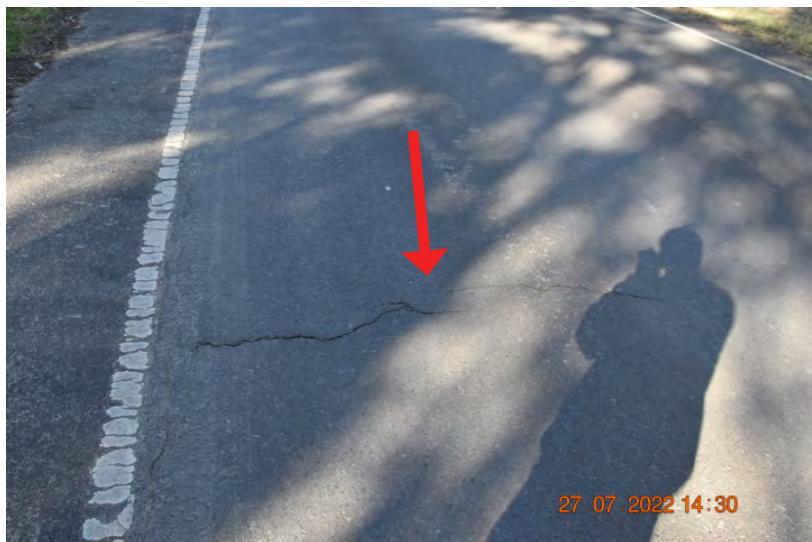
Figure: 0715 Fine cracking in the paving. | CHANGE: None

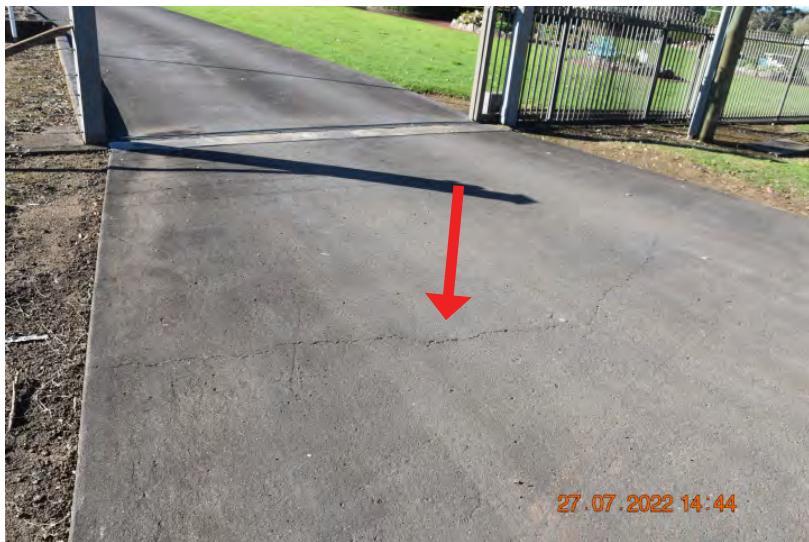
Figure: 0747 Fine cracking in the crossover. (RPT FOR FIGURES 748-749) | CHANGE: None
