**Sydney Trains
Level 20, 477 Pitt Street
Sydney NSW 2000**

Project 99739.00
18 July 2020
R.002.Rev0
HDS

**Preliminary Geotechnical Assessment
Proposed Billboard Sign Monopole
Western Distributor North, Pyrmont**

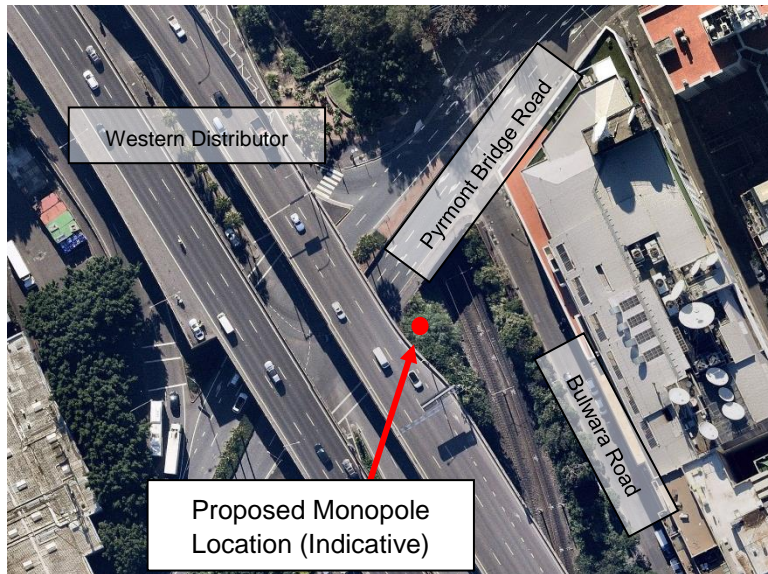
Figure 1: Proposed Monopole Location

The proposed position of the monopole is within the rail corridor to the east of the Western Distributor and on the southern side of Pyrmont Bridge Road, at the crest of a rail cutting and within a flat, vegetated, relatively narrow area (about 3-4 m wide: between the cutting crest and the rail corridor boundary fence). A few small trees and shrubs were also present in this area. An aerial photograph showing the indicative monopole location is given in Figure 1.

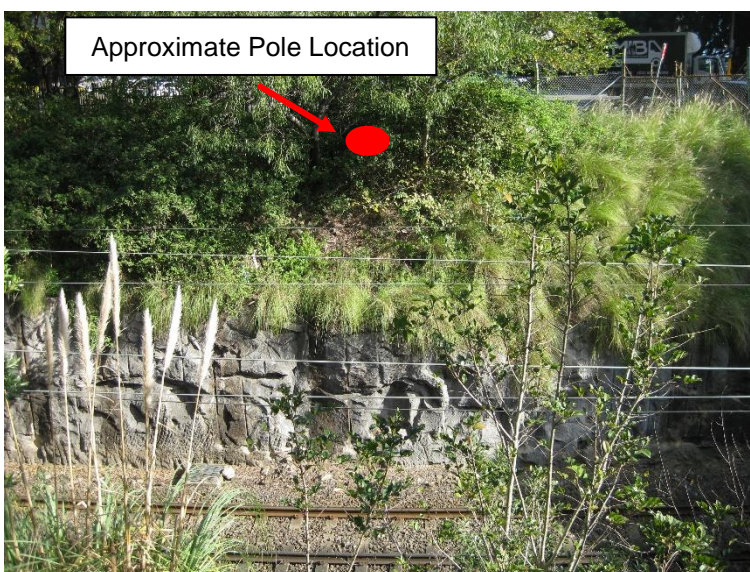
Figure 2: Site photograph at the proposed monopole location

The rail cutting is about 5 m high. The lower 2-3 m is sub-vertical with exposed sandstone bedrock which appears to be medium to high strength as there are closely-spaced pre-split blast holes visible on the face. The upper part of the cutting is covered with soil and vegetation and has an average slope of about 1.5H:1V. DP predicts that this section probably comprises about 1 m of stepped and benched low strength rock overlain by about 1 m of soil.

A pedestrian footpath and asphalt-surfaced access laneway (with gated entry) are present on the western side of the corridor boundary fence. Columns supporting the Western Distributor viaduct are present nearby. A site photograph is presented as Figure 2.
