**STANNARDS MARINE PTY LTD V NORTH SYDNEY
COUNCIL L&E 63136/2021**

MARINE ECOLOGY IMPACT ASSESSMENT

**Paul Anink
Principal Scientist
Marine Pollution Research Pty Ltd**

03 December 2021

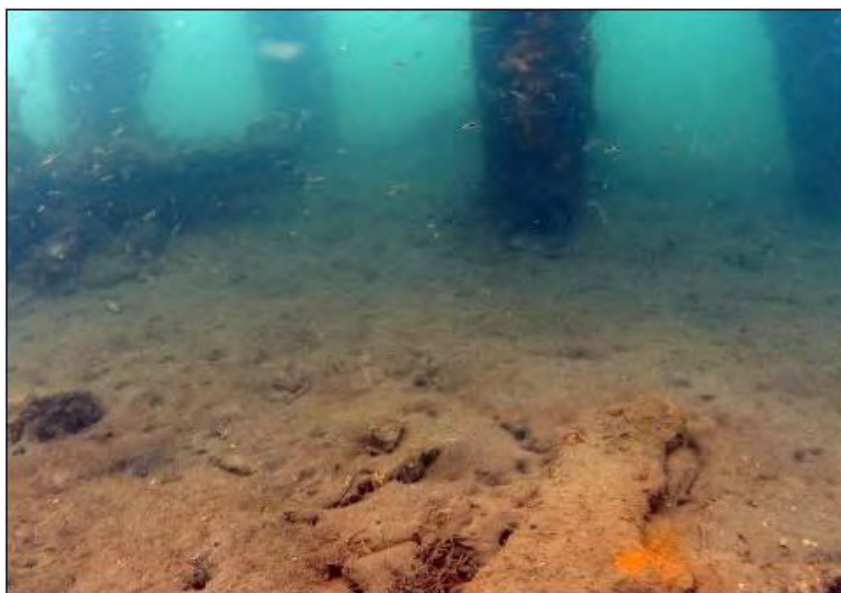
Plate 6.9 An example of the seabed within the project footprint. (Source: Comber Consultants, 2021).
