Blackwattle Bay
State Significant Precinct

Urban Forestry Strategy

URBAN FORESTRY STRATEGY

Blackwattle Bay State Significant Precinct Study

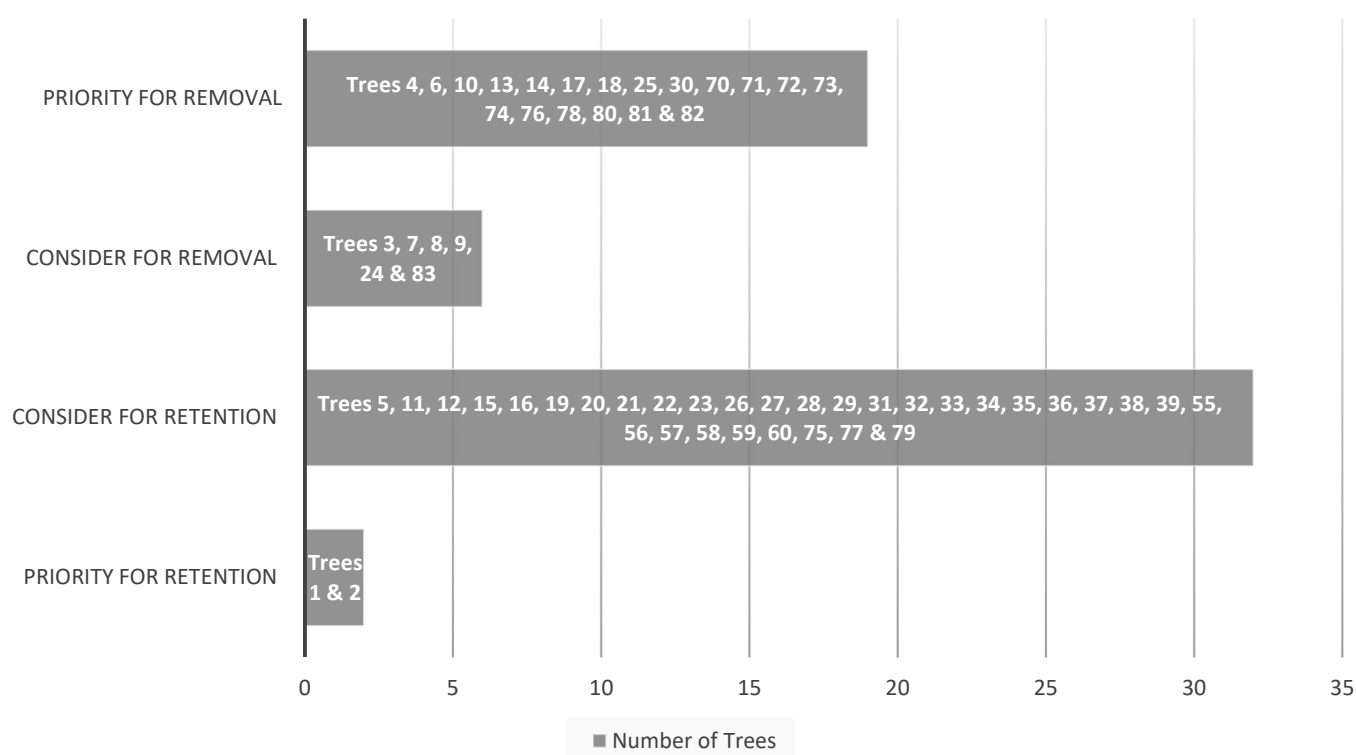
Chart 1: Retention Values

2.1.6 In general, the trees within the Study Area are of low to moderate value with 54% of the population being allocated a Retention Value of *Consider for Retention*. Trees with a Retention Value of *Priority for Removal* represent the second largest percentage at 32%. These trees have a Useful Life Expectancy (ULE) of less than 5 years and should be removed regardless of future development works. Trees with a Retention Value of *Consider for Removal* represent 10% of the population and are generally of low Landscape Significance with a short (5-15) ULE. The removal of these trees would provide space for the planting of better-quality specimens which should provide a positive contribution to the Study Area in the medium to long term. Trees with a Retention Value of *Priority for Retention* represent the lowest percentage of trees within the Study Area at 3%. Ideally, these trees should be accommodated within future development works. The Retention Value of the existing trees are identified in Chart 1.
