# Bays West Stage 1 Rezoning Proposal – Aboriginal Due Diligence

**Department of Planning and Environment**

<b>Project Name</b>	Bays West Stage 1 Rezoning Proposal – Aboriginal Due Diligence
<b>Project Number</b>	22SYD-2535
<b>Project Manager</b>	Dr. Meredith Henderson
<b>Prepared by</b>	Charlotte Bradshaw
<b>Reviewed by</b>	Karyn McLeod
<b>Approved by</b>	Karyn McLeod
<b>Status</b>	Final
<b>Version Number</b>	V2
<b>Last saved on</b>	5 August 2022

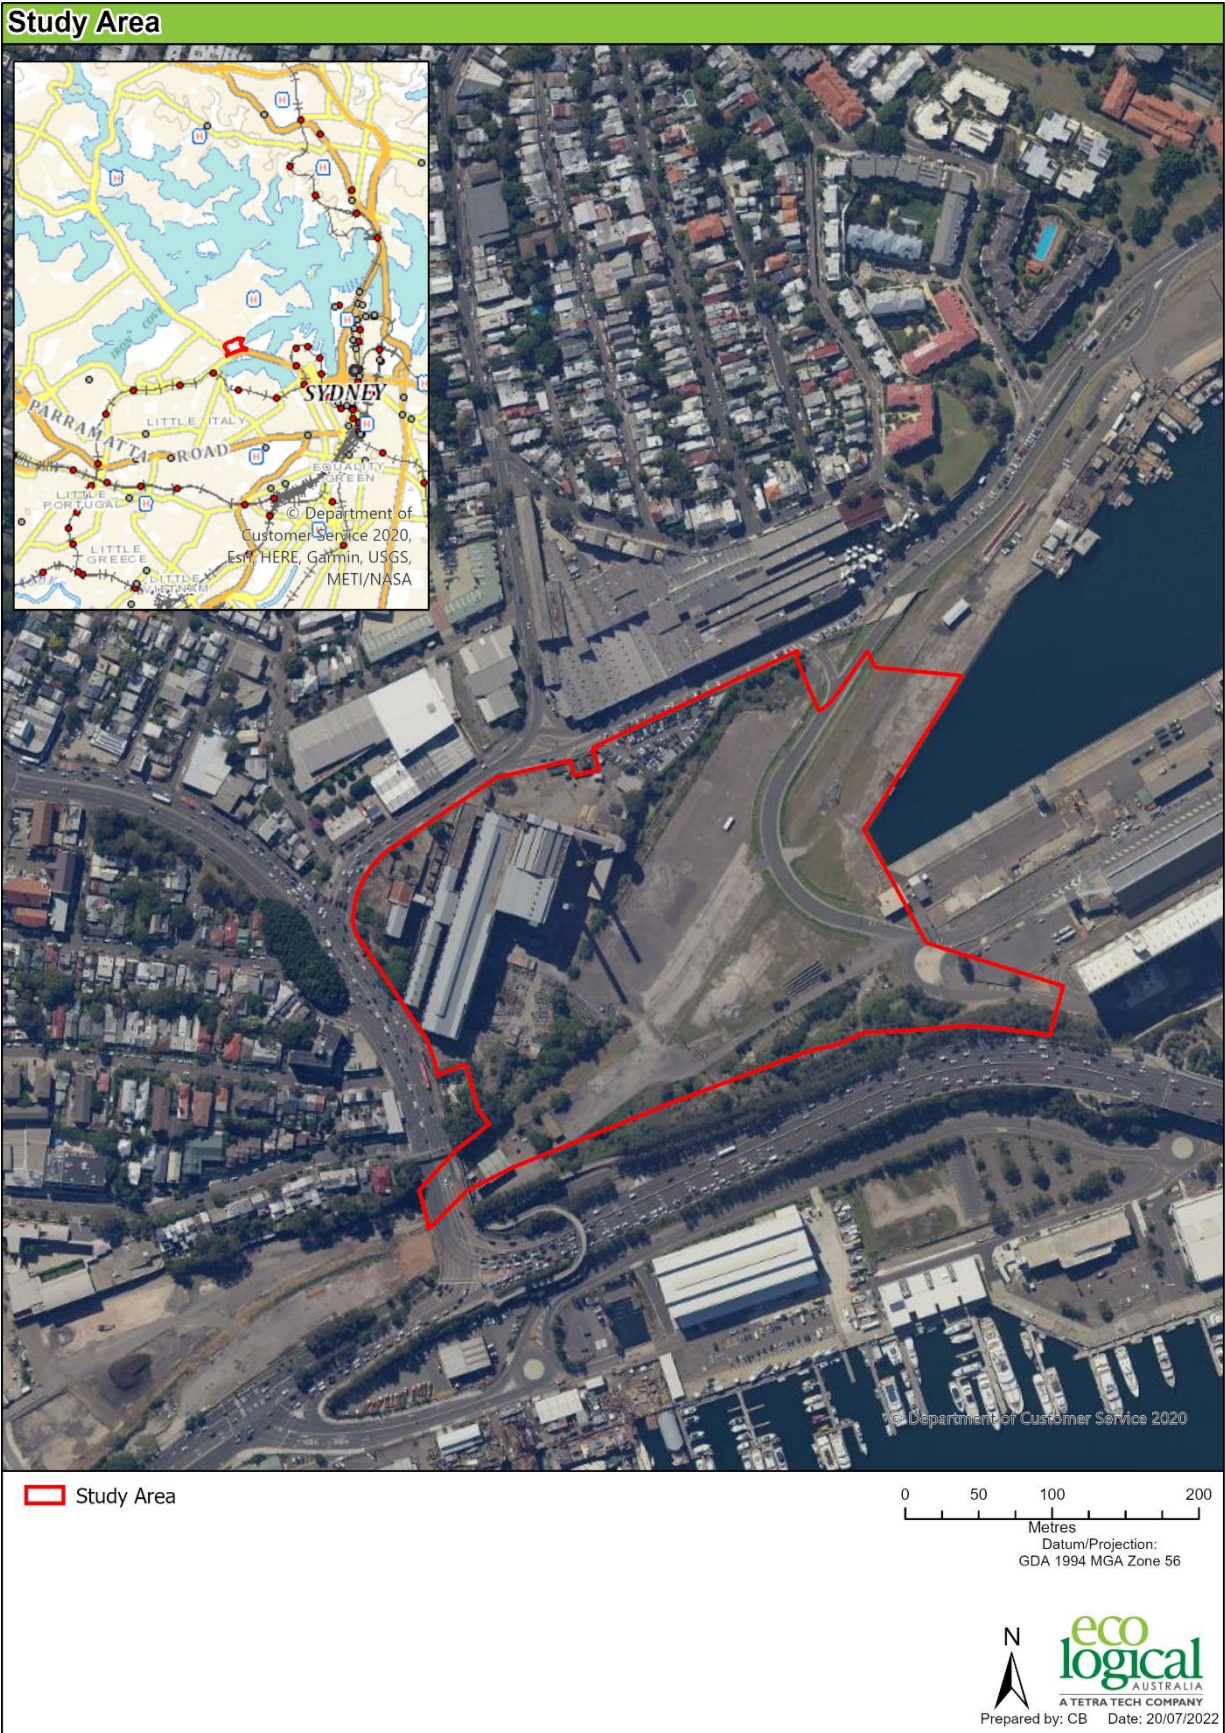
Figure 1: The study area

There are ten sub-precincts that form the Bays West Precinct. However, only the portion of land pertaining to the Stage 1 works will be the subject of this assessment (hereafter referred to as ‘the study area’; Figure 1). This is the White Bay Power Station and Metro sub-precinct located on the south-eastern edge of the Balmain peninsula, and to the west of Glebe Island, with a foreshore along White Bay. Located within the Inner West Local Government Area within the suburb of Rozelle. Currently the area is closed to the public. The land is bound by Robert Street to the north, Victoria Road to the west, Anzac Bridge Access Road to the south and Glebe Island or the waters of White Bay to the east.

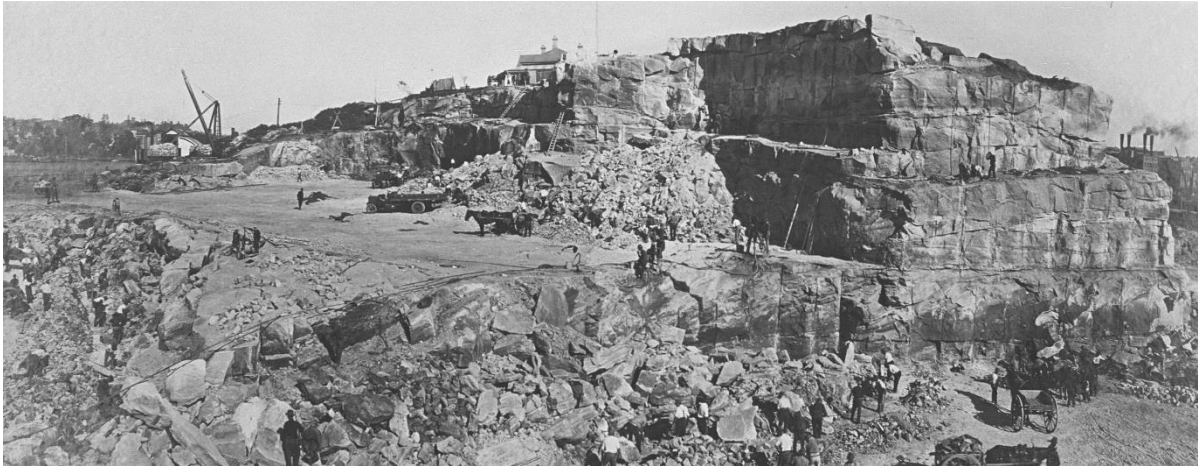
**Figure 7: View east, showing the sandstone quarrying within Glebe Island at the approximate location of the existing grain silos with White Bay Power Station on right, c. 1919 (State Library of NSW)**

Through quarrying and levelling, the entirety of Glebe Island was flattened (Figure 7). Reclamation works occurred along the shoreline of White Bay and Glebe Island from 1895 into the mid-20<sup>th</sup> century (Reynolds, 2008). The original and unmodified shoreline has been approximately mapped using early parish and survey maps (Figure 11). The land along White Bay was utilised for a variety of industries, including the John Booth Steam Saw Mill (1854-1902), Lever Brothers soap manufacturing (1895-1988), the White Bay Power Station (1912-1984) and as the first port in New South Wales to handle containerised shipping (1969-2004).

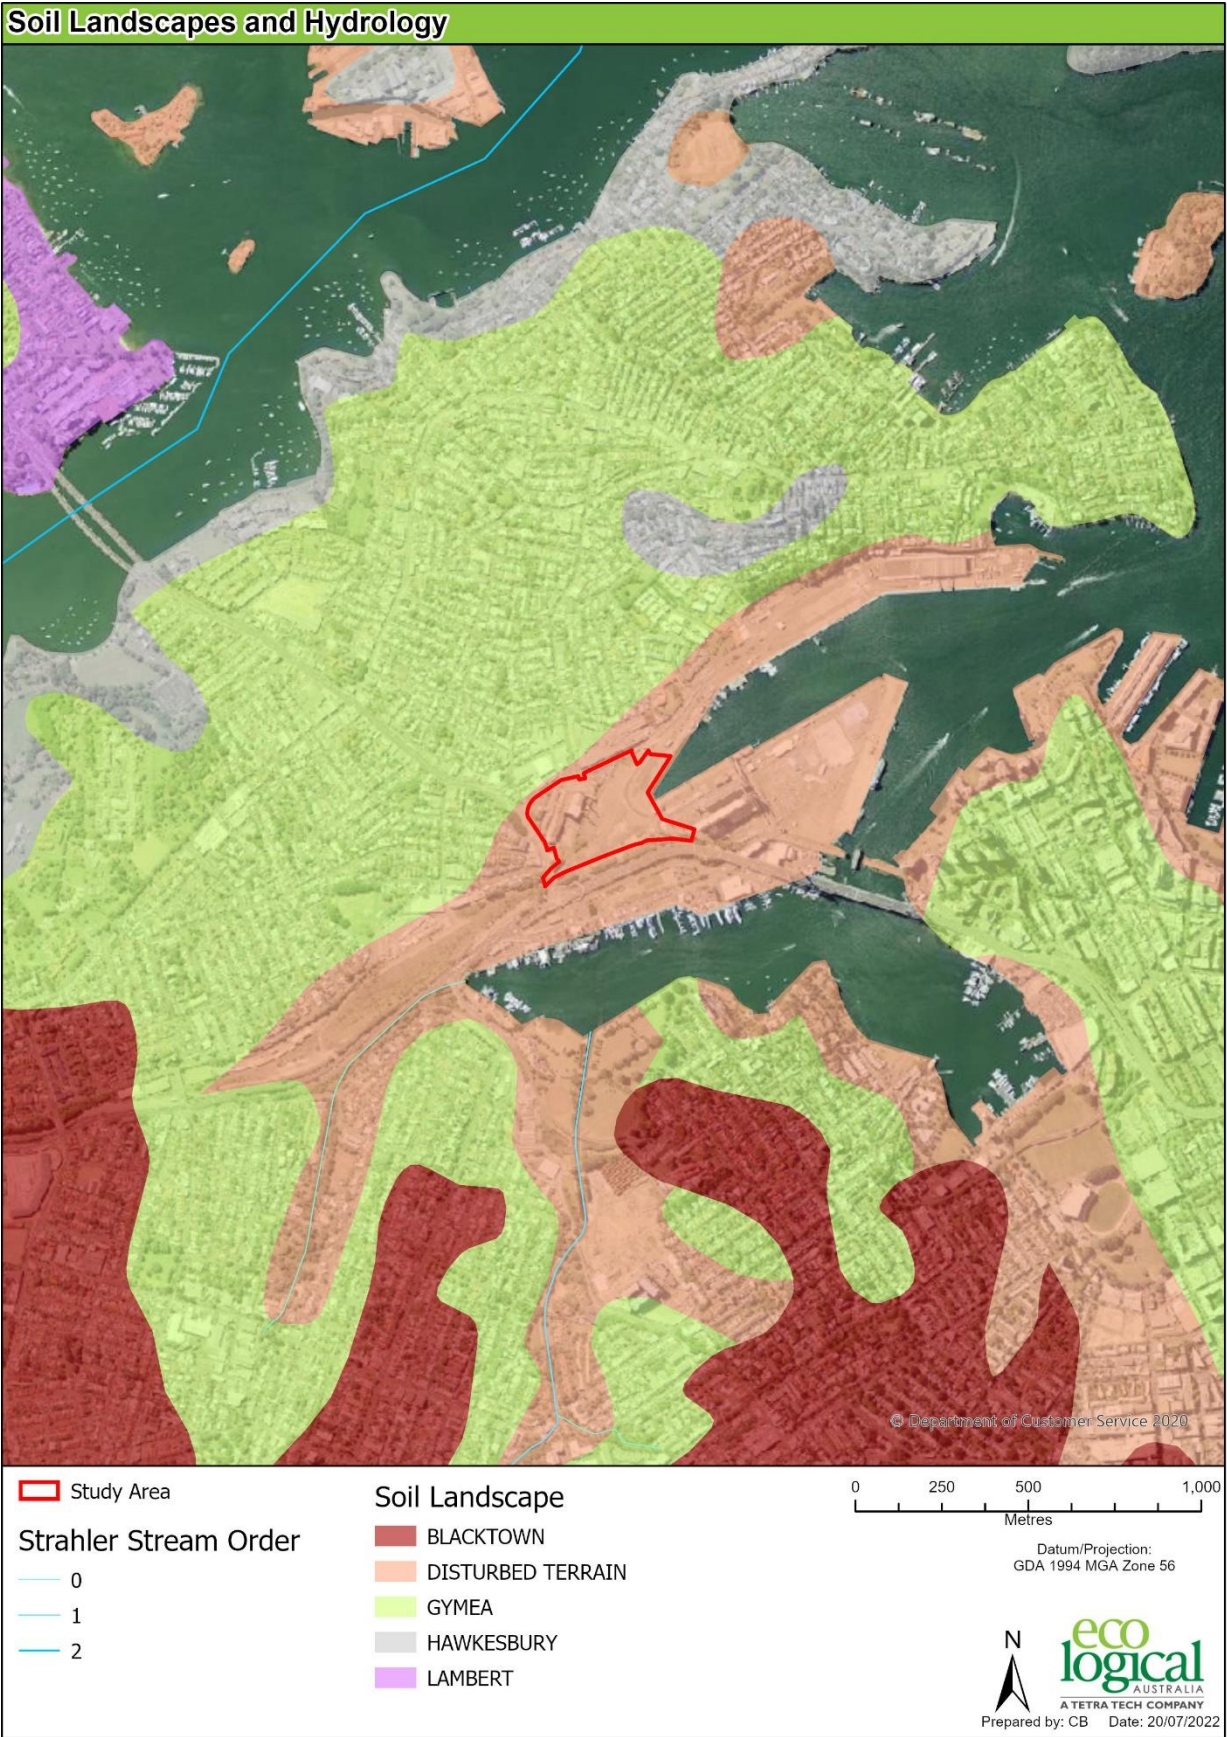
Figure 8: Soil landscapes and hydrology of the study area

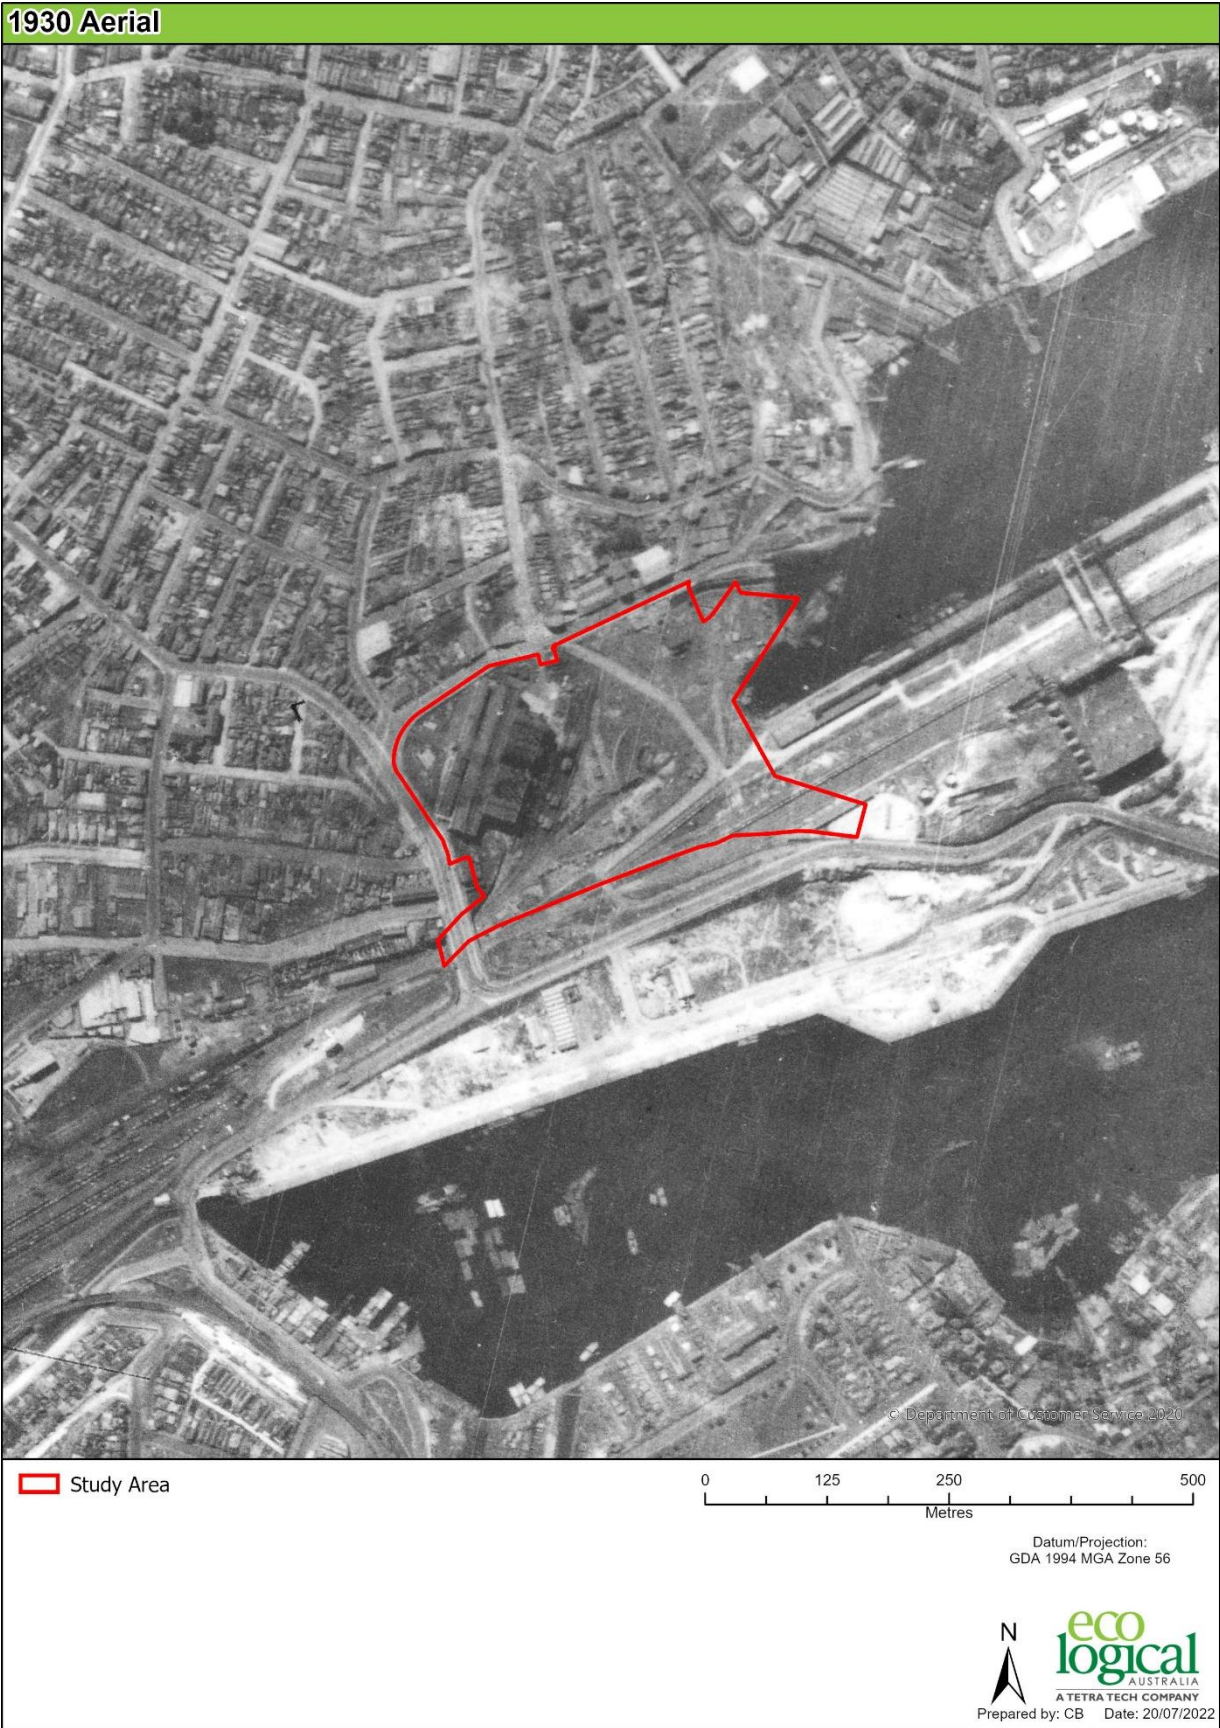
Figure 9: Aerial imagery showing the study area in 1930 (source: NSW Historical Image Viewer)

The earliest available aerial imagery from 1930 shows the study area not dissimilar to the current site today (Figure 9). The White Bay Power Station is the primary use of the study area taking up a larger footprint than current day. The reclaimed shoreline was also slightly different from current day. At the southern end of the study area, the railway line of the Sydney Metropolitan Goods Line is visible. In 1961, further rail lines have been constructed from the south-west up towards the northern shore of White Bay (Figure 10). The footprint of White Bay has expanded with numerous associated buildings in the north-west of the study area.

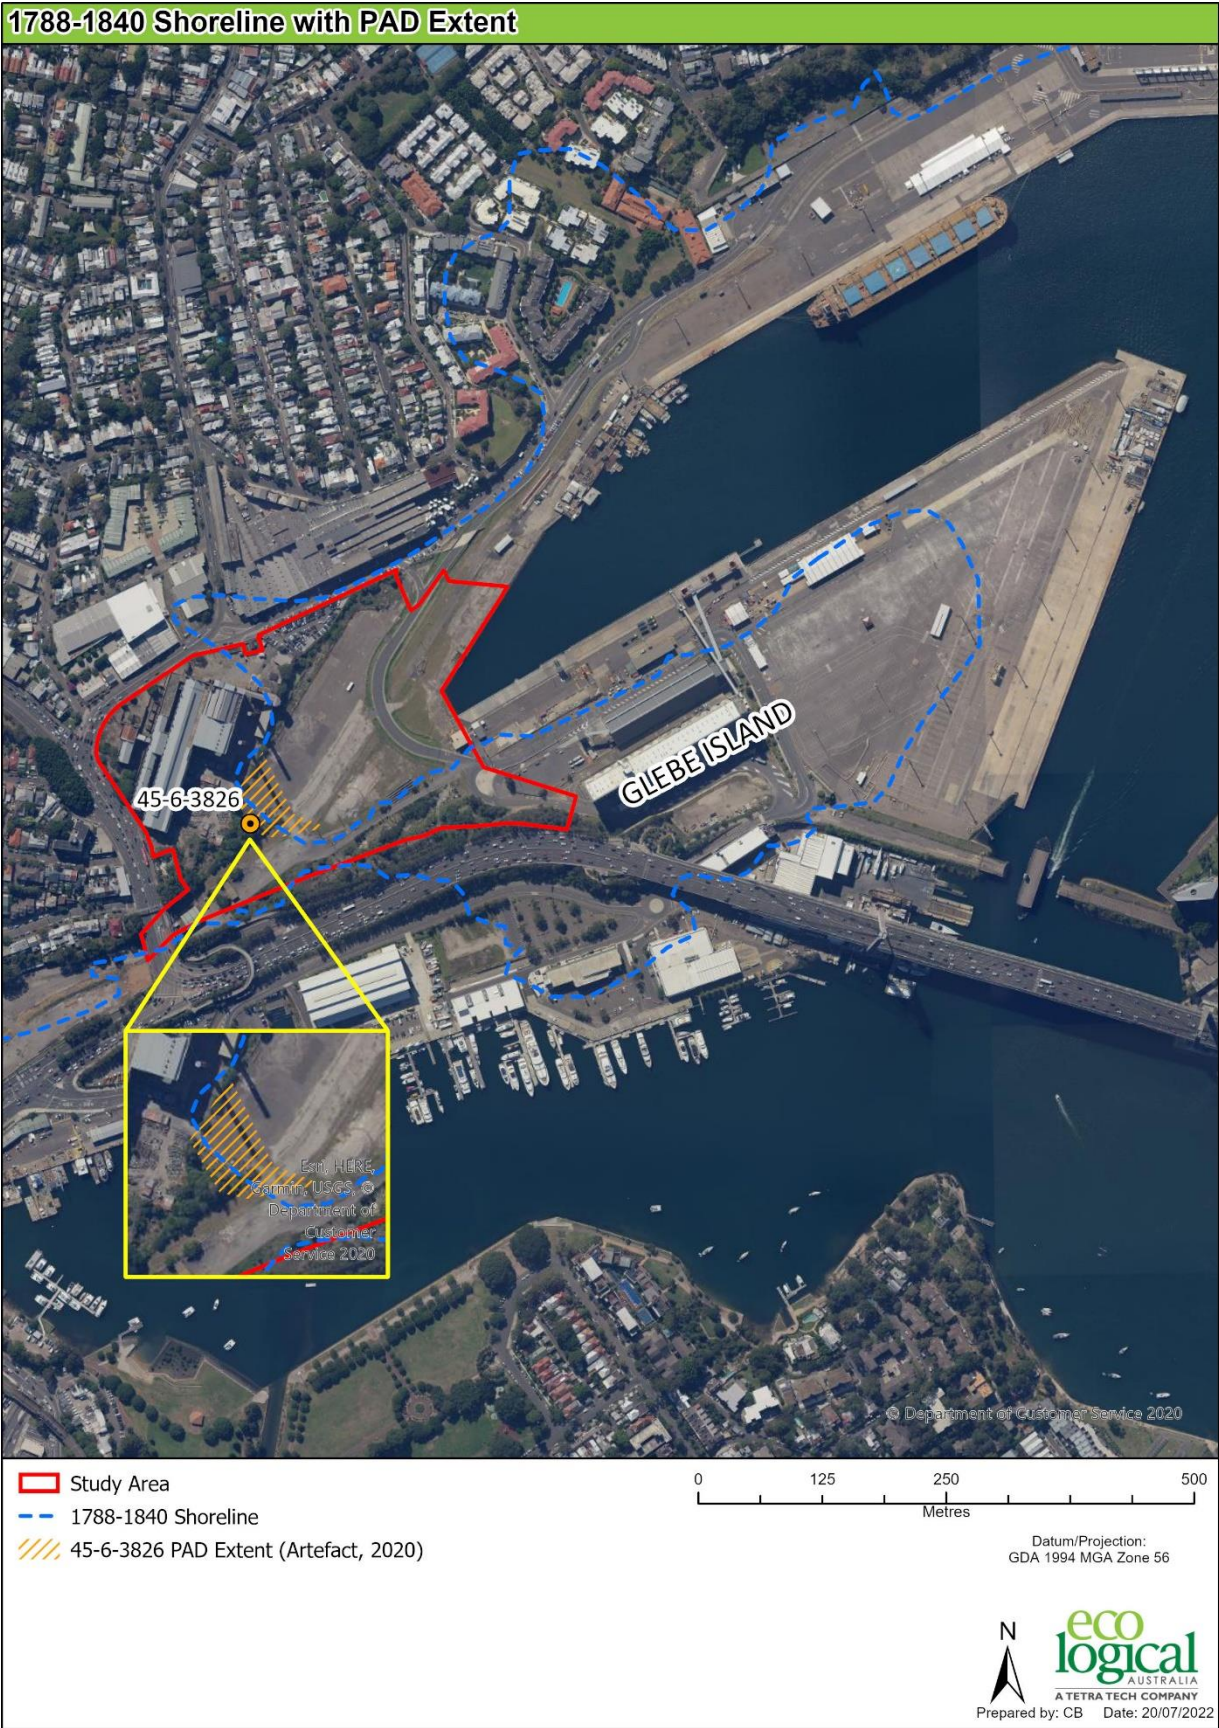
Figure 11: Approximate shoreline from 1788 to 1840 with the mapped PAD Extent of AHIMS ID 45-6-3826

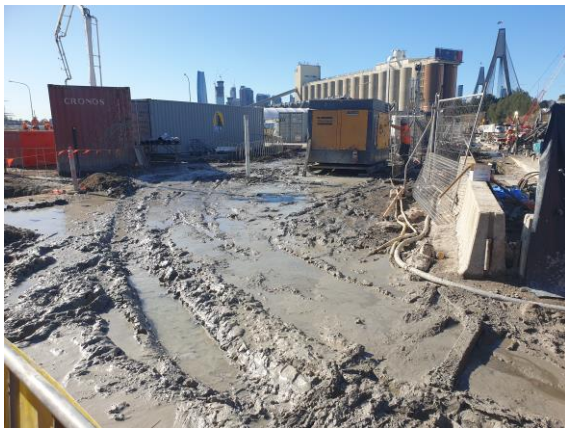
**Figure 12: View south-east, showing the ongoing construction across and the study area and surrounding AHIMS ID 45-6-3826**

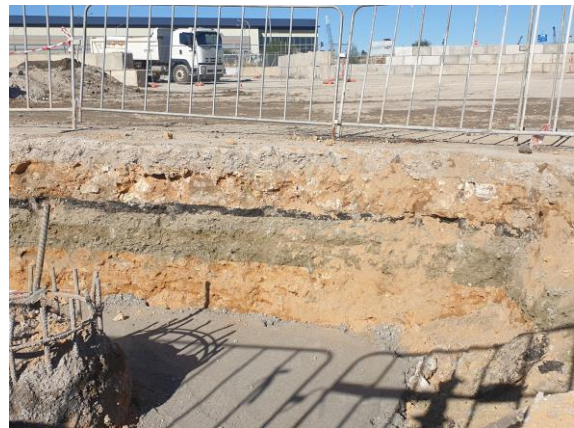
The area previously identified as containing “very old oyster and cockle shells” (Bangawarra, 2021) south of the silos was briefly inspected. The land was not accessible and could only be viewed from the road. Confirming the findings of the desktop assessment, it is clear that the landscape has been excavated into bedrock and any deposit present is fill material.

**Figure 13: Excavated pit showing layers of fill**

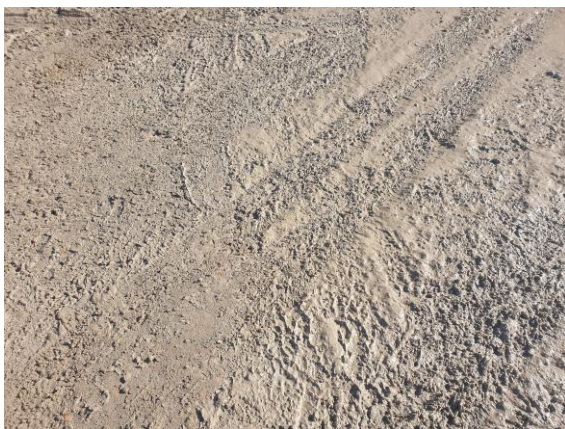
Due to the limitations in site access as an active construction site, the visual inspection focused on the area which was mapped as a Potential Archaeological Deposit (Artefact, 2020; AHIMS ID 45-6-3826). The visual inspection that the area has been highly disturbed by past and ongoing activities. There was moderate surface visibility though was partially impeded by the flooding within the site. The areas surface visibility showed grey sandy infill soils covering a majority of the PAD area (Figure 14). There was moderate soil exposure within excavated pits, showing the stratigraphic phases of infill material (Figure 13). No Aboriginal objects were identified as a result of the visual inspection and no areas with a likelihood for subsurface archaeological material was identified.

**Figure 14: Surface visibility within boundaries of AHIMS ID 45-6-3826**

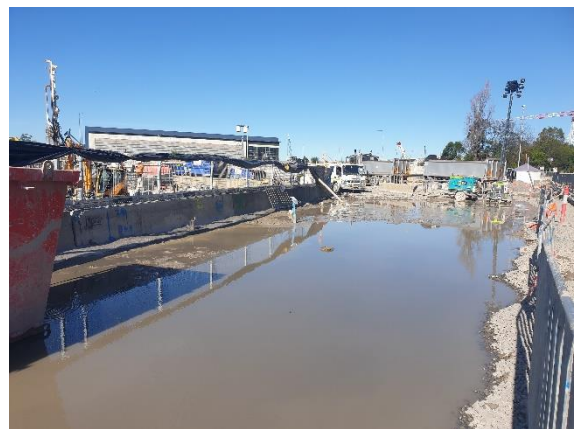
**Figure 15: View east, showing limitations in surface visibility due to flooding**
