Site Audit Report

**Southern Wetlands Dedication Area
Penrith Lakes Scheme
Castlereagh NSW**

Penrith Lakes Development Corporation (PLDC)

Report Reference: 600033_0301-1319-13

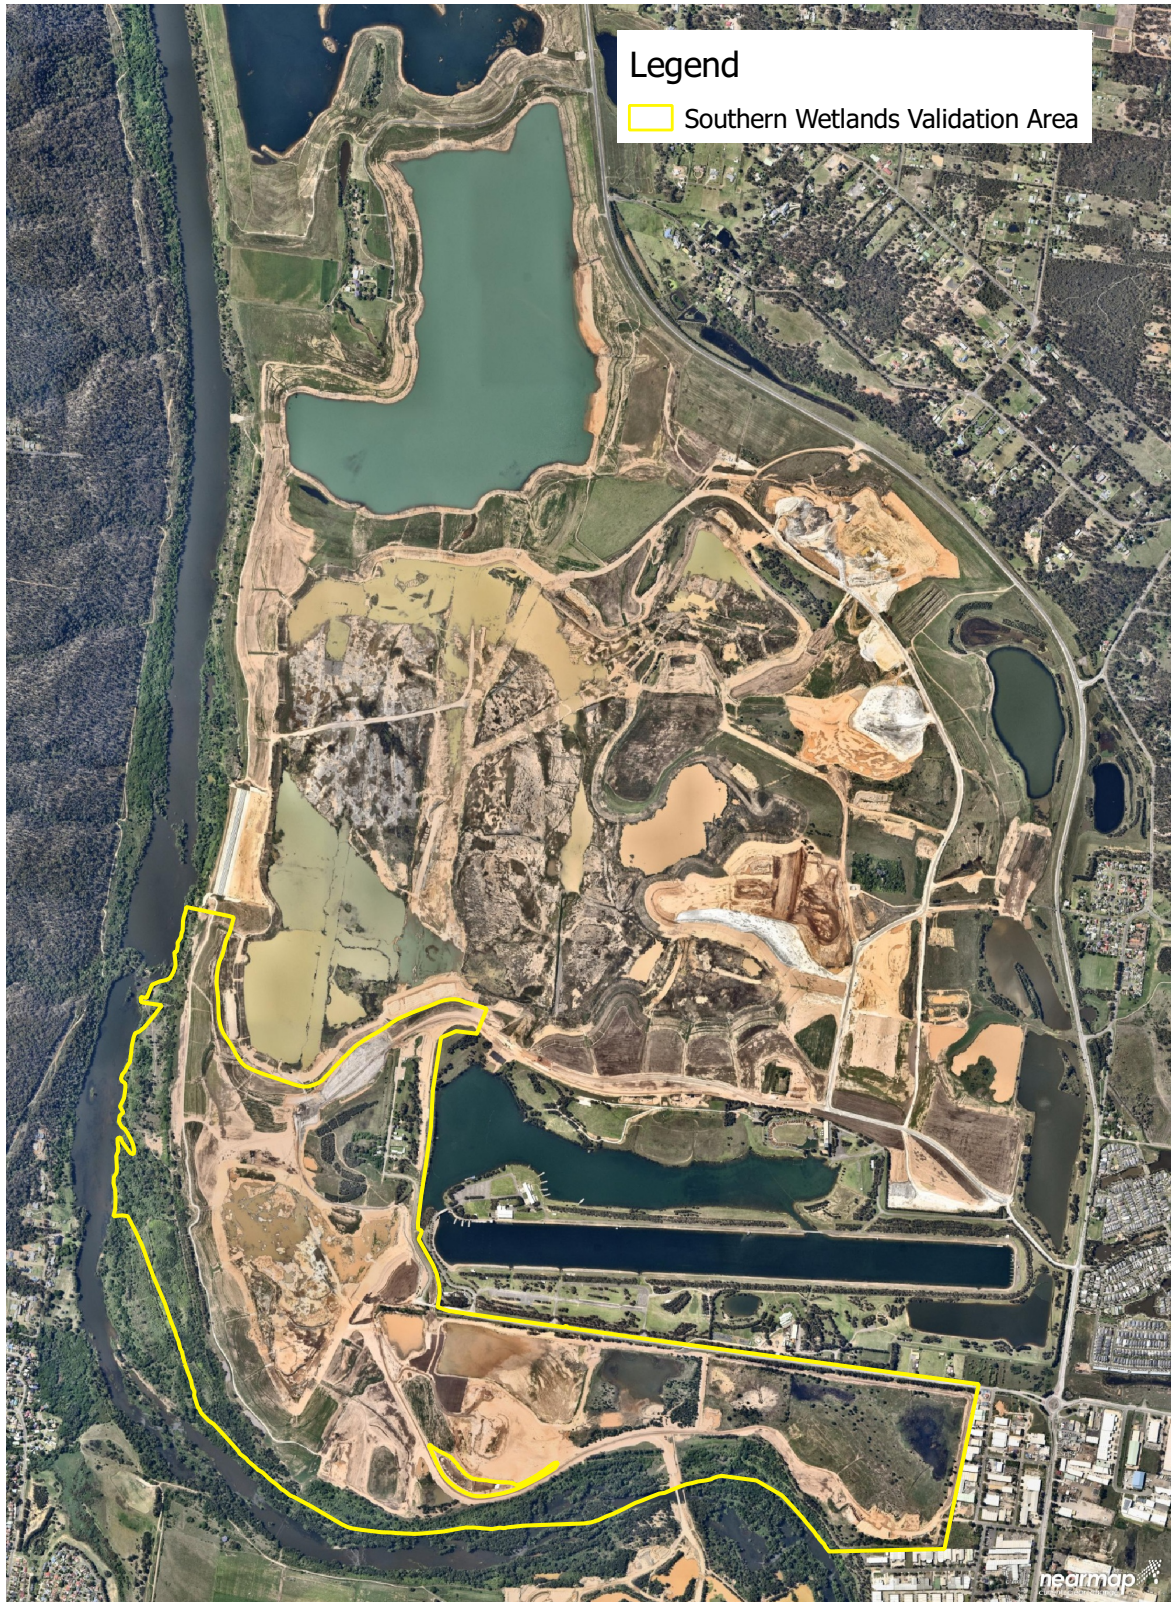
Figure: 1
 Date: 15/07/2015
 Compiled: RJ

Legend
 [Yellow Outline] Southern Wetlands Validation Area

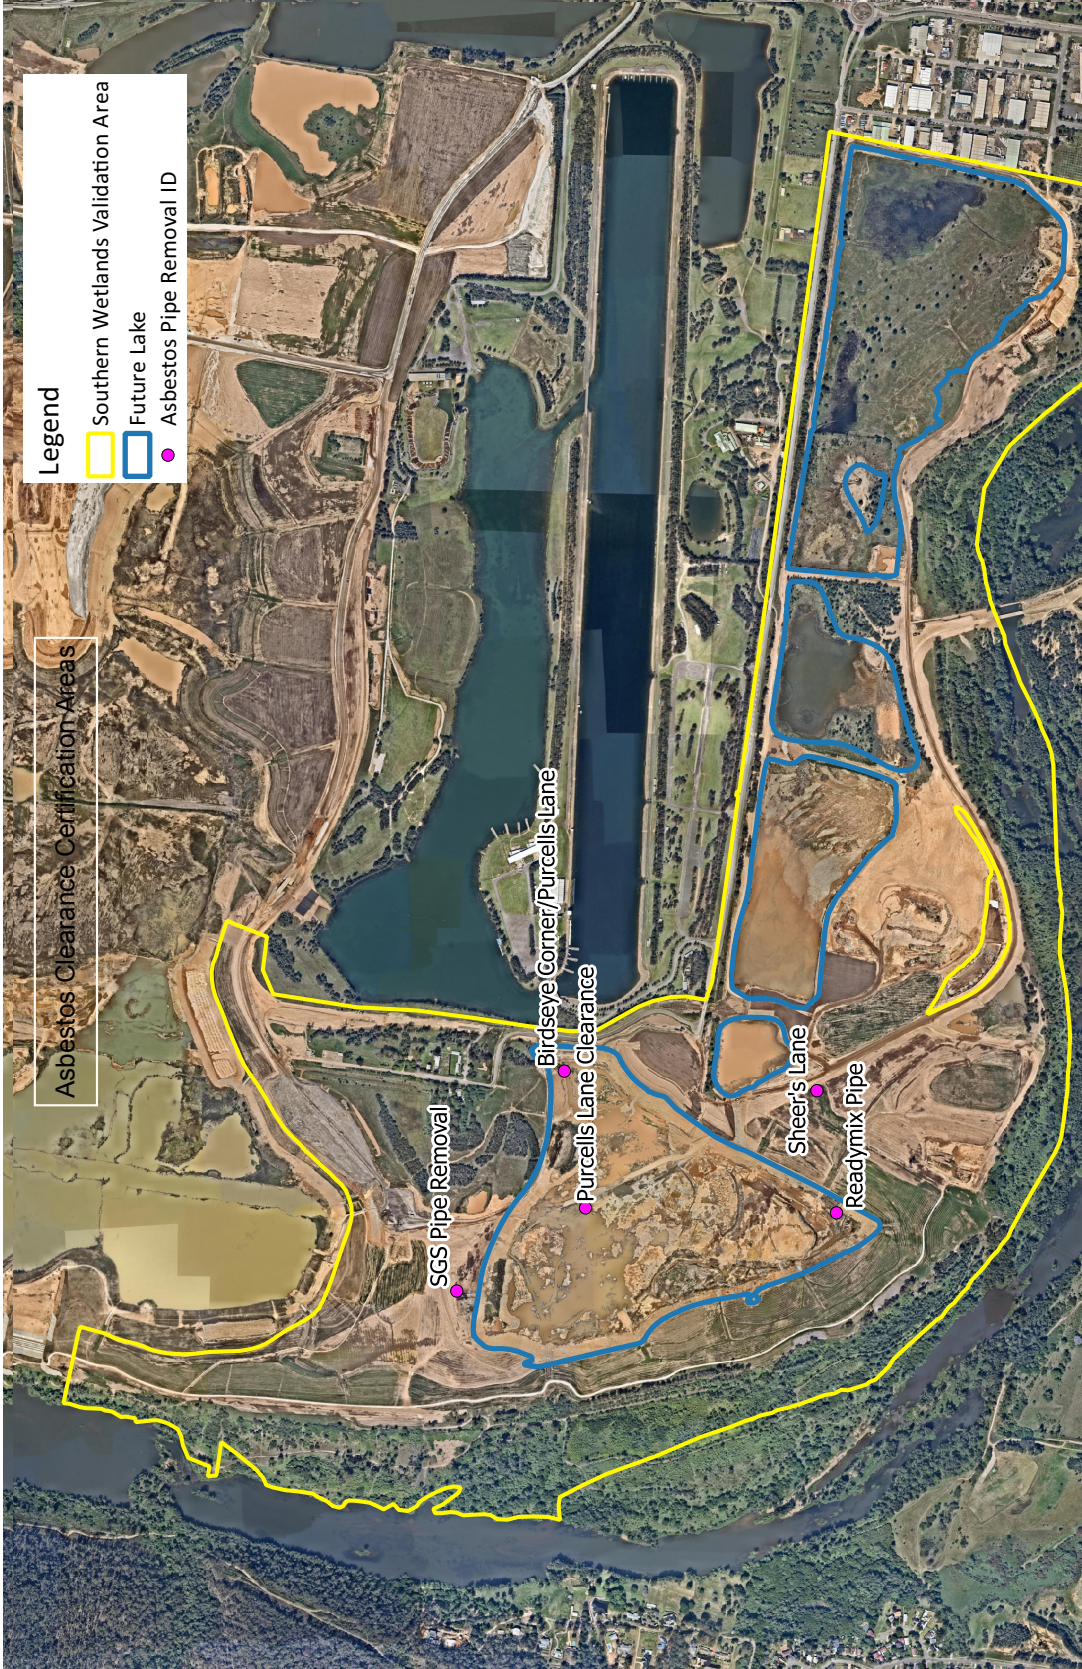
Figure: 4
 Date: 17/11/2015
 Compiled: RJ

Asbestos Clearance Certification Areas

- Legend**
- Southern Wetlands Validation Area
 - Future Lake
 - Asbestos Pipe Removal ID

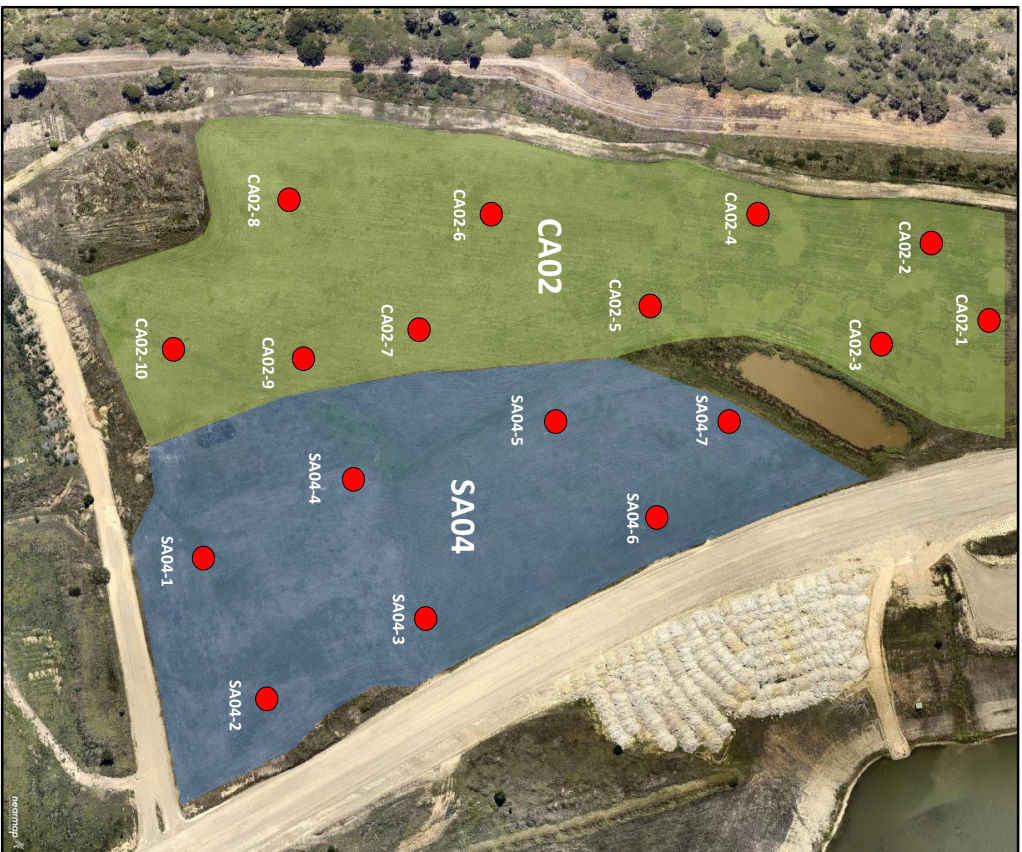
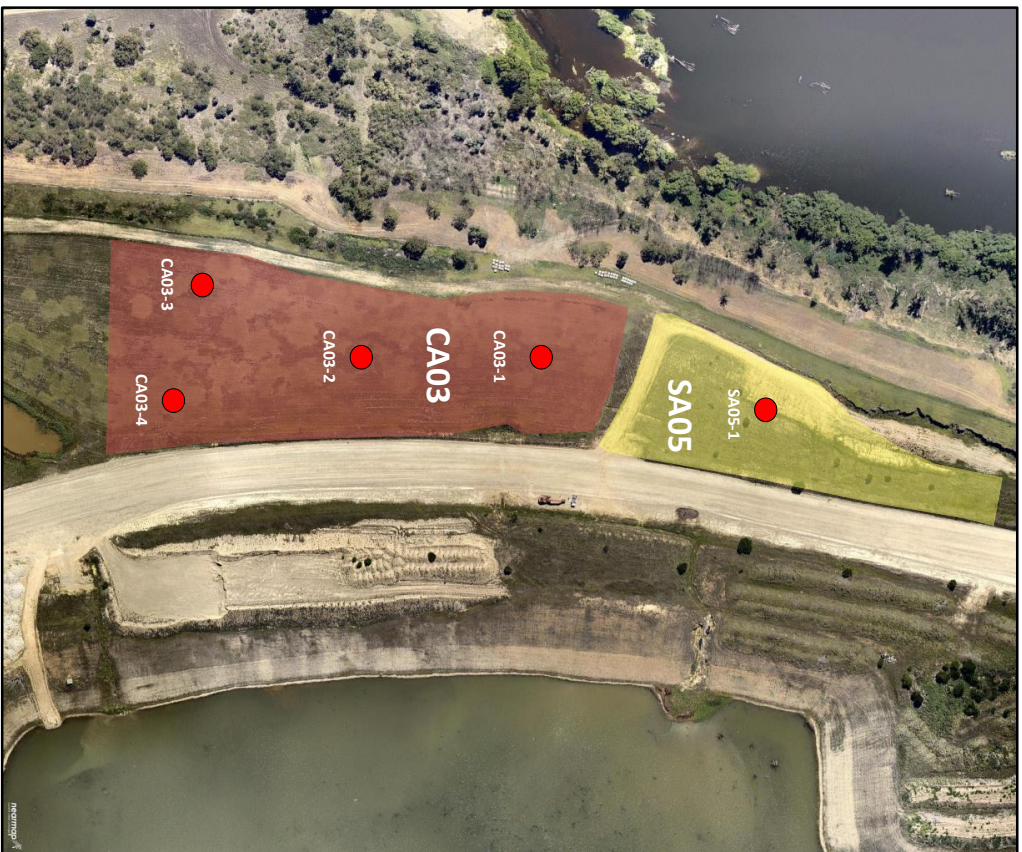
- Legend:**
- CA02 Cultivated Area
 - SA04 Surface Spread Area
 - CA03 Cultivated Area
 - SA05 Surface Spread Area
 - Validation Sampling Location

The vertical extent of organic material in cultivated areas was observed to range between depths of 0m and 0.10 m. The material in these areas generally comprised fine to coarse sized organics cultivated into brown silty/sandy clay with a range of building and household waste including brick, concrete, tile, metal, glass, plastic, crockery, and the target contaminant - ACM. It is noted that the amount of organics and inclusions in these areas was much less (observed to be approximately $\leq 10\%$ of material inspected) than the surface spread areas or stockpiles due to the dilution with soil. In general, cultivated organics area sampling locations were covered with grass prior to scraping.

The vertical extent of organic material in surface spread areas was observed to range between depths of 0 m and 0.06 m. The material in these areas generally comprised fine to coarse sized organics with a range of building and household waste including brick, concrete, metal, tile, glass, plastic, crockery, and the target contaminant - ACM. In general, surface spread area sampling locations were covered with grass prior to scraping.

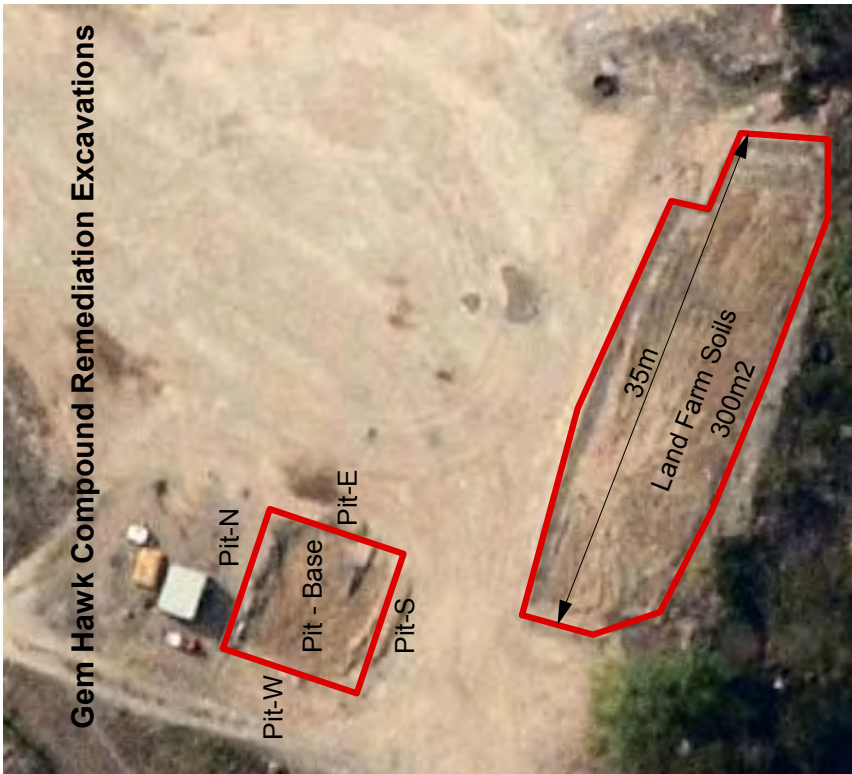
Title: Site Layout and Sampling Locations		
	Client: Penrith Lakes (PLDC)	Figure No: 2	Date: Nov. 11
Newcastle Office Phone (02) 4945 3800 Fax (02) 4945 3811	Scale	Sheet 1 of 1	Revision 1
Sydney Office Phone (02) 9476 1765 Fax (02) 9476 1557

Gem Hawk Compound Remediation Excavations

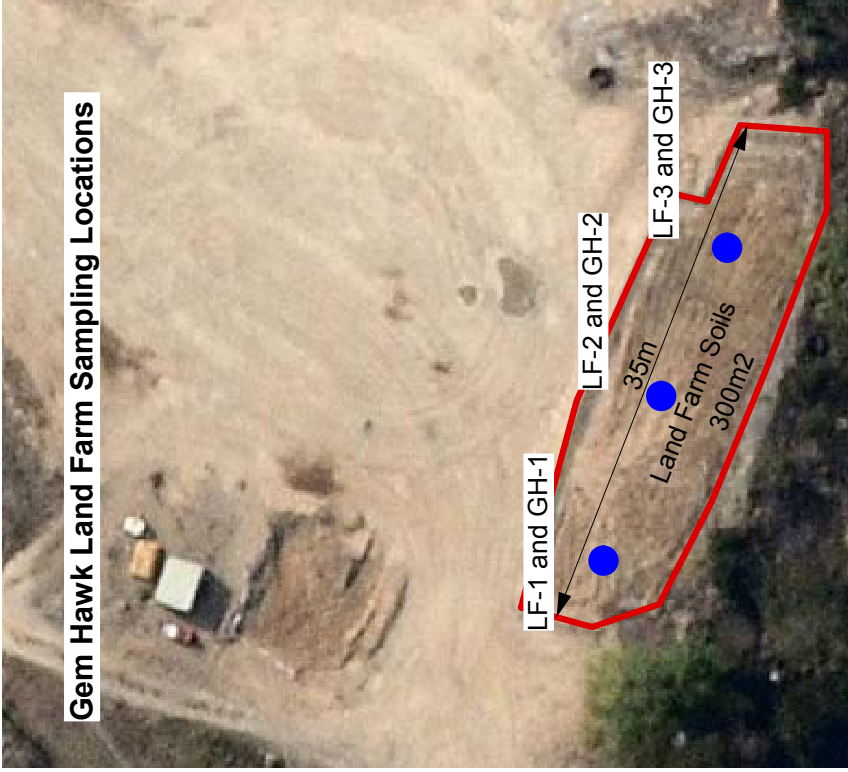
Title: Site Layout and Sampling Locations		
	Client: Penrith Lakes (PLDC)	Figure No: 1	Date: Feb. 13
Newcastle Office Phone (02) 4948 3800 Fax (02) 4948 3811	Scale	Sheet 1 of 1	Revision 1
Sydney Office Phone (02) 9476 1765 Fax (02) 9476 1557

Gem Hawk Land Farm Sampling Locations

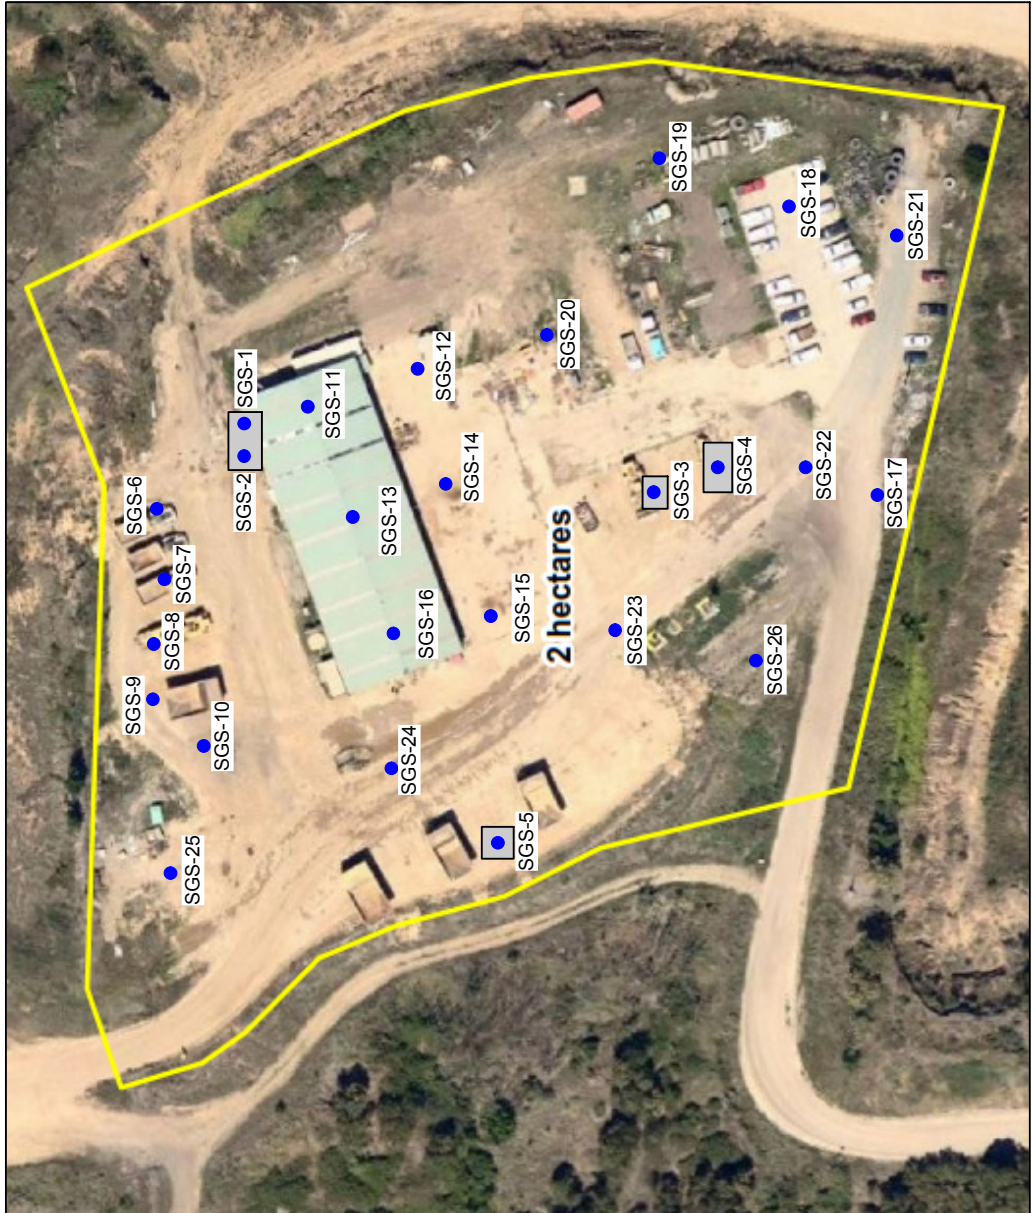
Client:	Shepherd Group Services	Figure No:	1	Date:	May 13
Newcastle Office	Sydney Office	Scale	As shown	Sheet	1 of 1
Phone (02) 4949 3800	Phone (02) 9476 1765	Revision			1.0
Fax (02) 4949 3811	Fax (02) 9476 1557

Title: SGS Compound Sample Locations

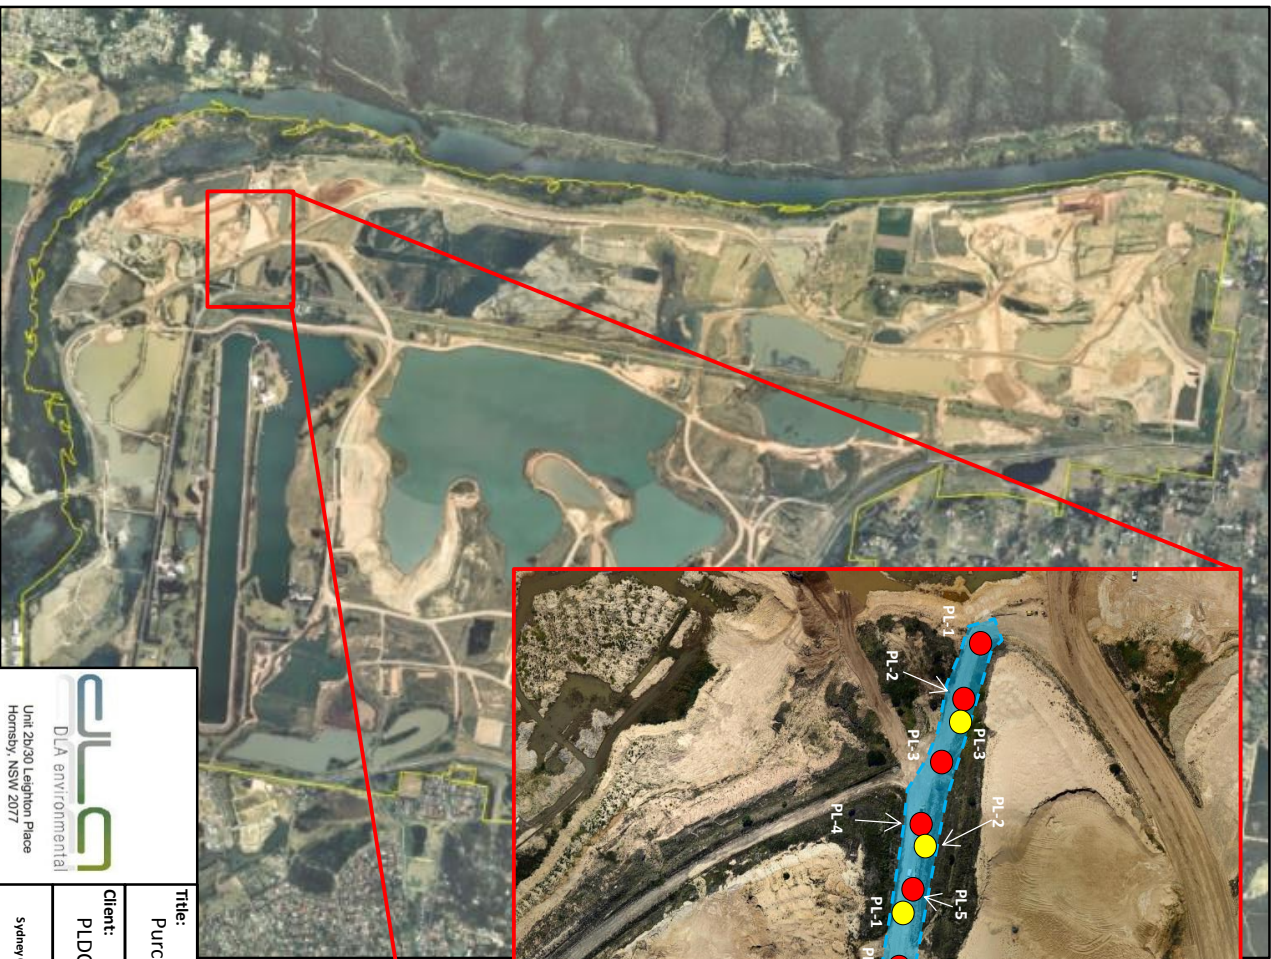
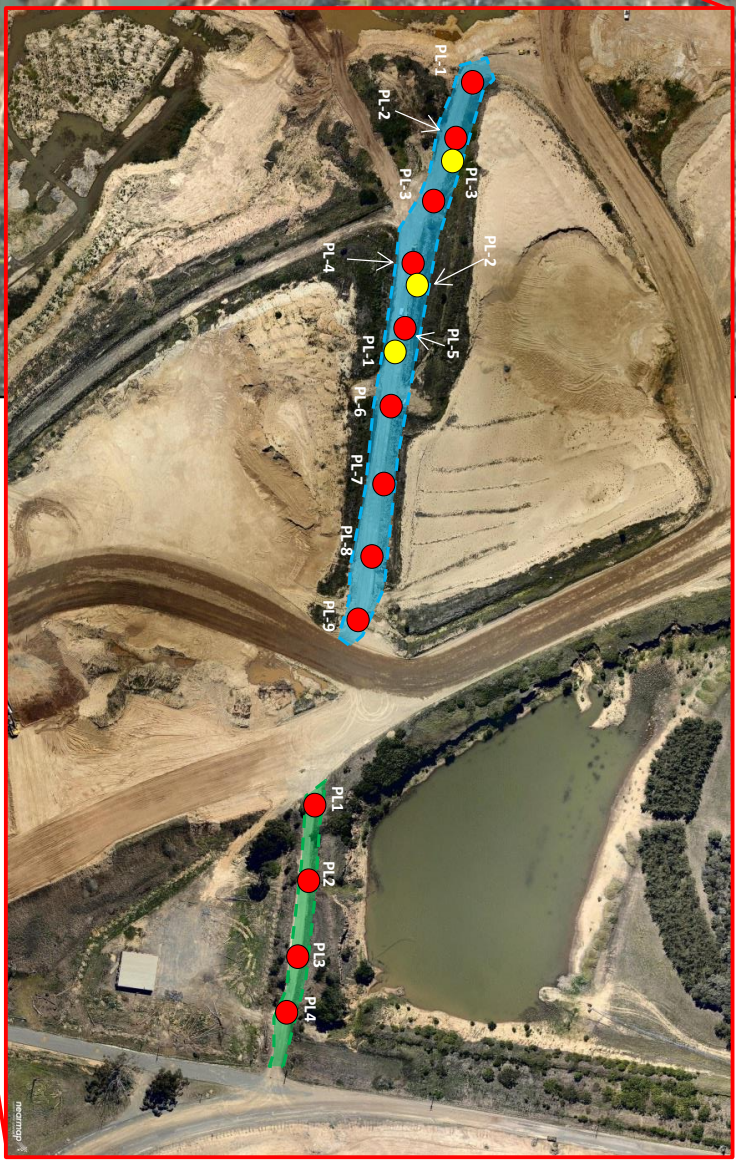
- Legend:**
- Asphalt Sampling Location
 - Purcell's Lane West
 - Purcell's Lane East
 - Asphalt Sampling Location after Rescrape
 - Penrith Lakes Scheme Boundary

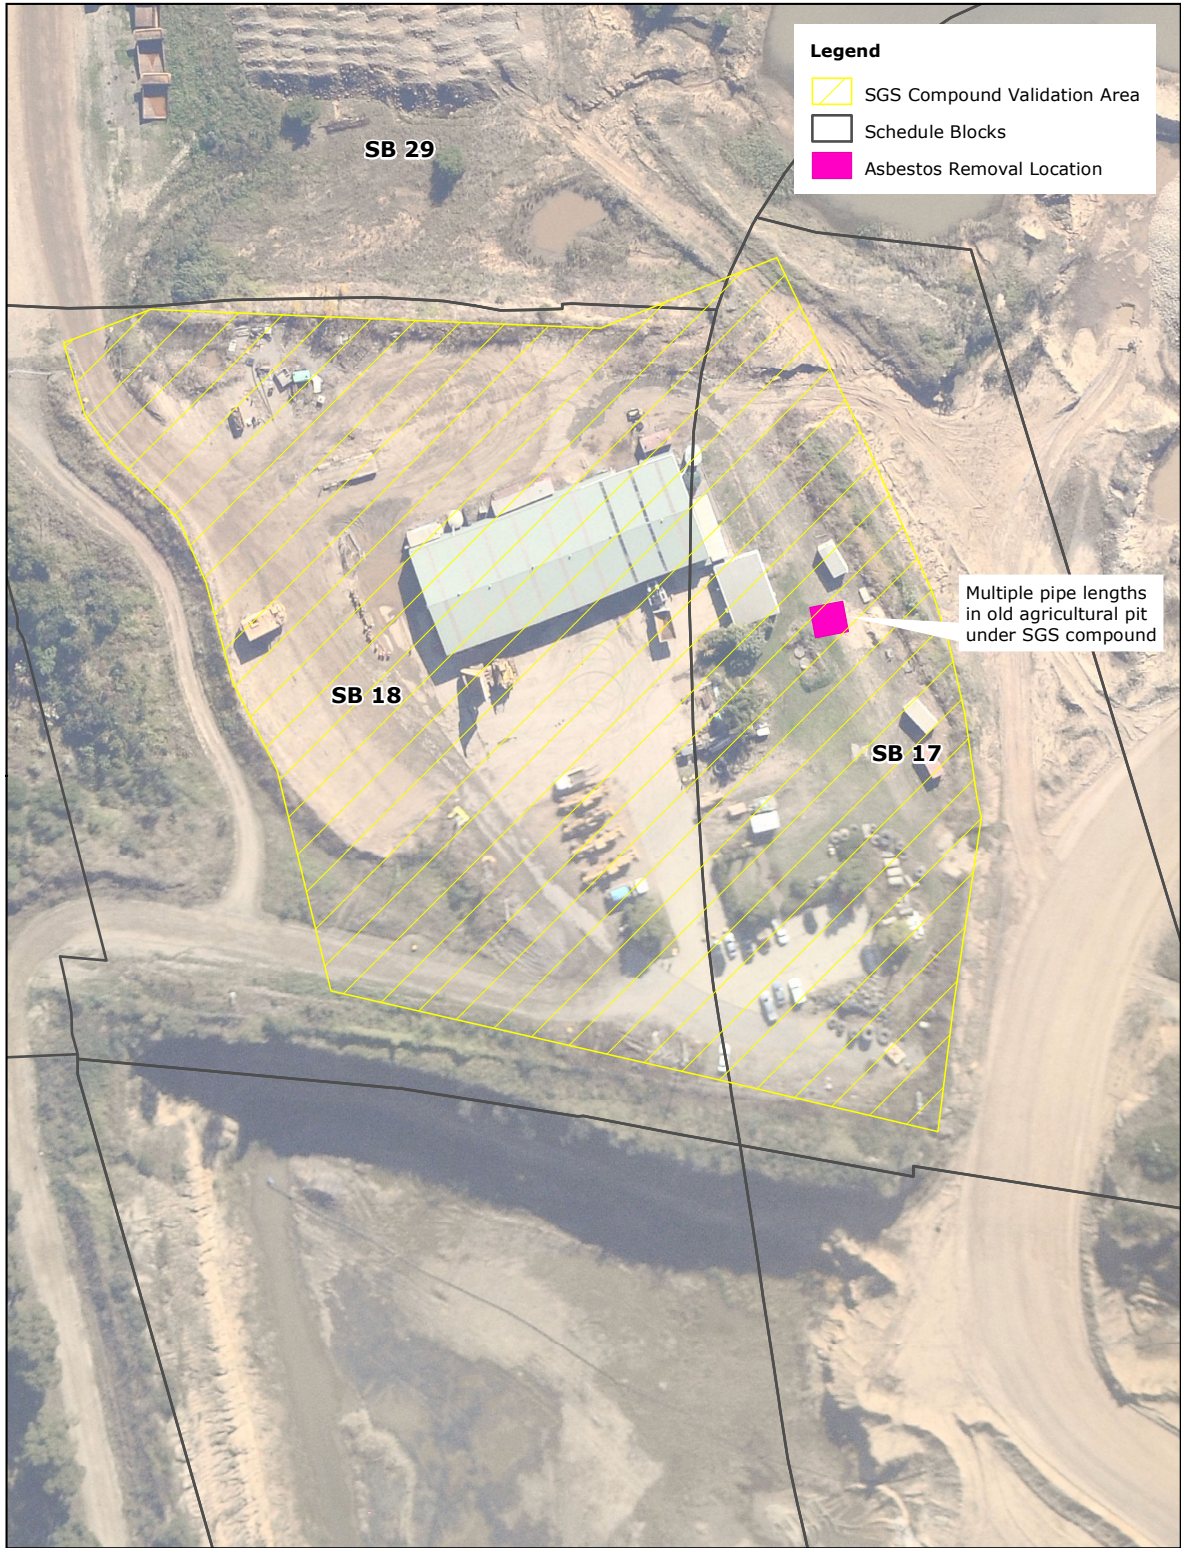
Title: Inspection Locations	
	Client: Penrith Lakes (PLDC)	Figure No: 1
Newcastle Office Phone (02) 4945 3800 Fax (02) 4945 3811	Sydney Office Phone (02) 9476 1765 Fax (02) 9476 1557	Date: March 12
Scale		Sheet: 1 of 1
		Revision: 1

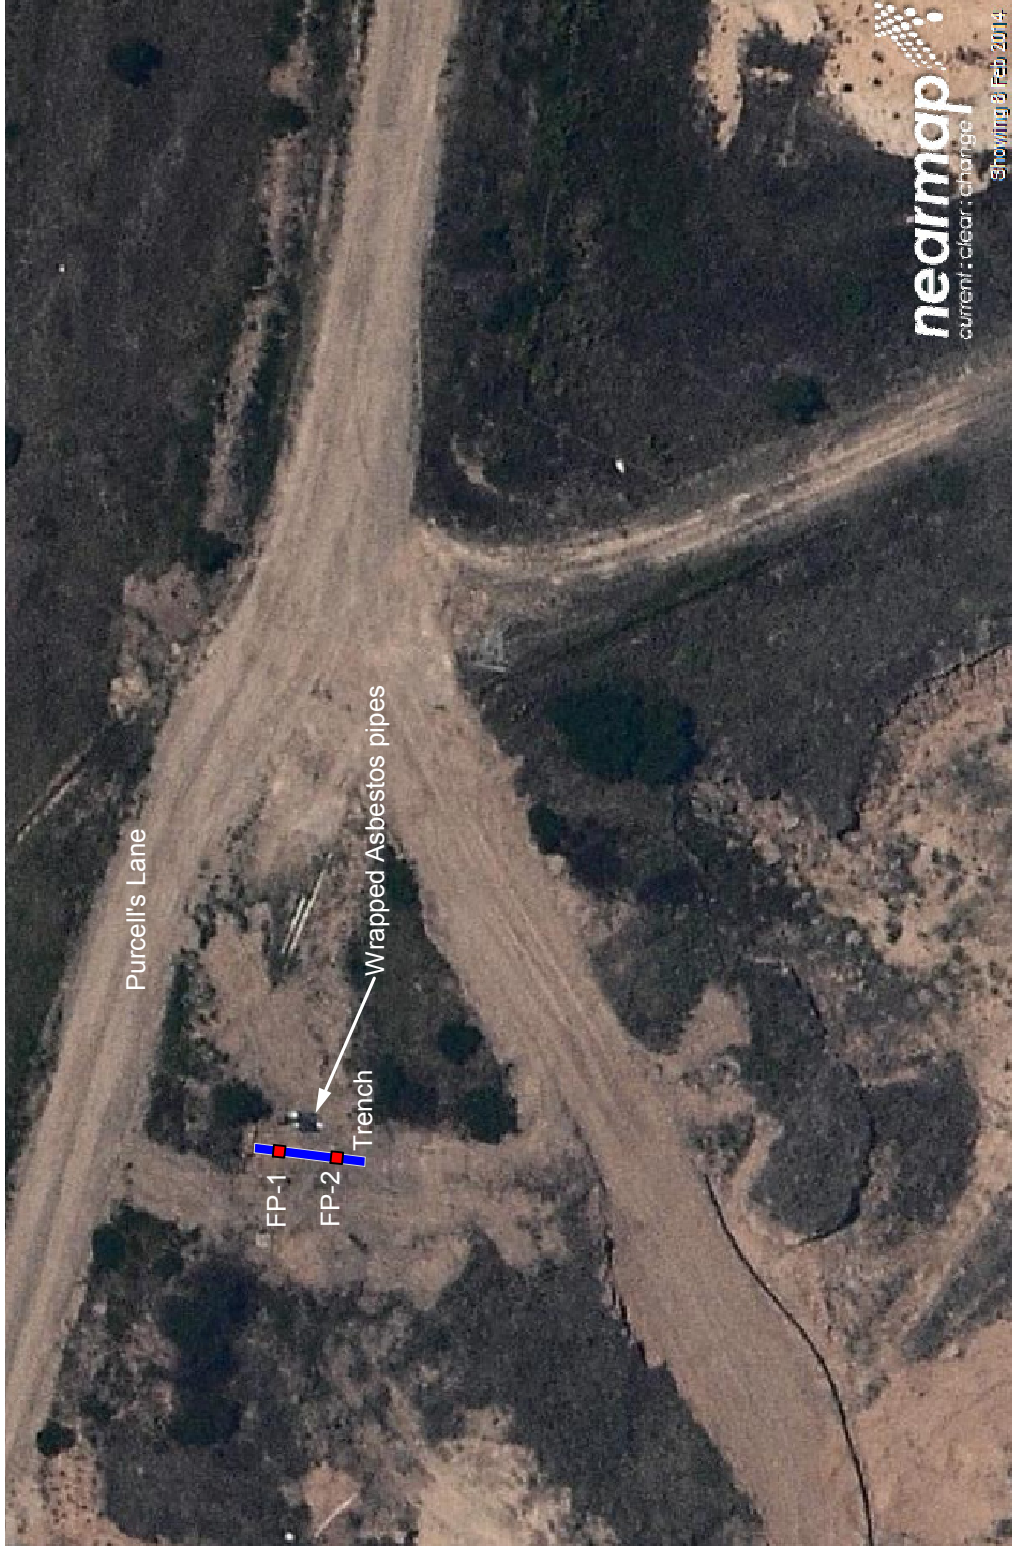
- Asbestos Detected
- Asbestos trench sample

DLA environmental	Title: Site Layout and Sampling Locations		
	Client: Penrith Lakes (PLDC)	Figure No: 1	Date: Feb 14
Newcastle Office Phone (02) 4949 3800 Fax (02) 4949 3811	Sydney Office Phone (02) 9476 1765 Fax (02) 9476 1557	Scale: AS SHOWN	Revision: 1 of 1
