RE: Digital advertising sign, Eastern Distributor, Woolloomooloo

I refer to your instruction for us to prepare a response to the Department of Planning, Industry and Environment (DPIE) letter issued in respect of the above in relation to visual impact matters.

Appendix 1: visual evidence – 2-4 Sir John Young Crescent

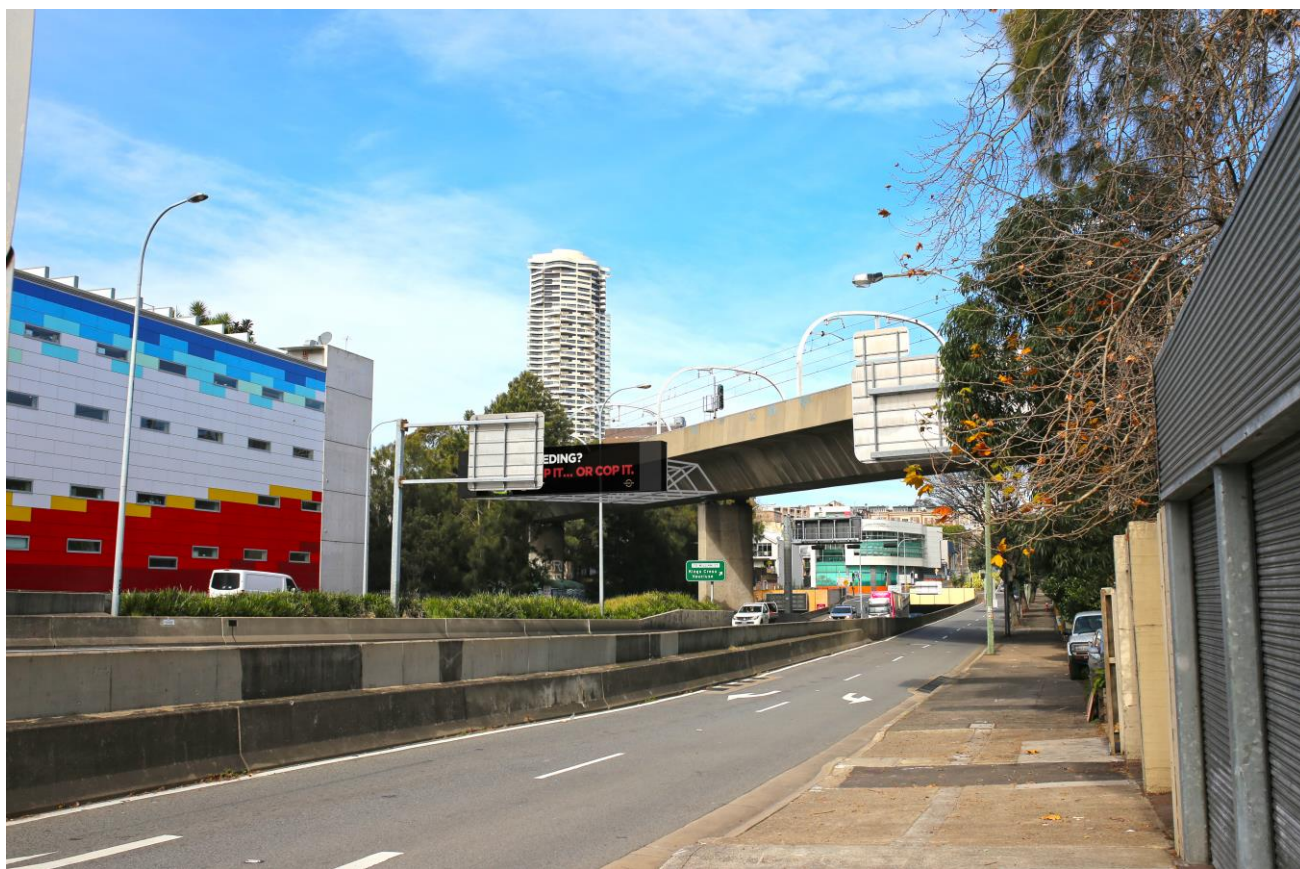
Figure 2 Photomontage

Figure 1 shows the viewpoint selected to represent this location. **Figure 2** provides a photomontage from this viewpoint.

It shows that the nature of visual impact is similar to, or less than (due to the obstruction from the north-bound directional signage) that of viewpoint 3 (Palmer Street park) in the original VIA. While obstruction from the north-bound directional signage may be removed from levels higher up in 2-4 Sir John Young Crescent, the overall visual impact is likely to be similar.

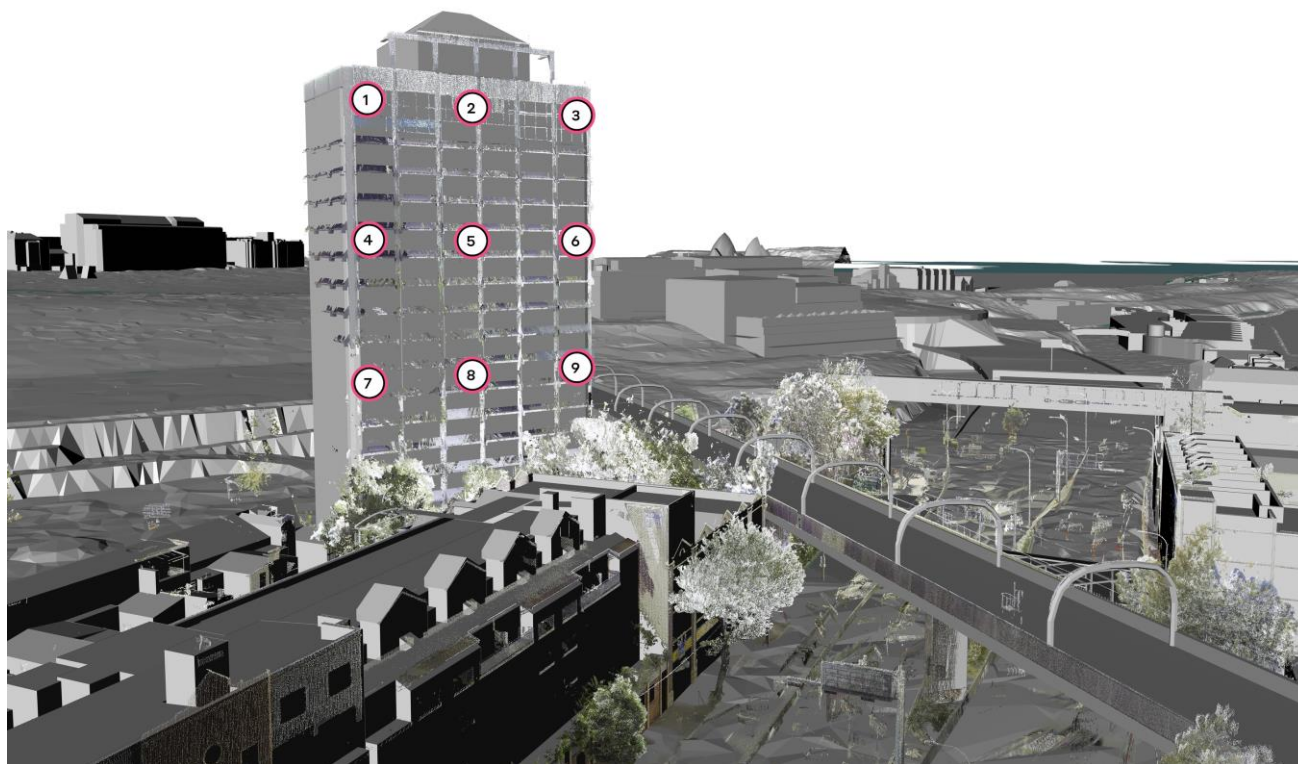
Figure 3 Viewpoint locations

Figure 3 shows the viewpoints selected to represent this location. The south-east facing elevation was selected as it is considered the most exposed to views of the site and proposal. These viewpoints are located at the lower, middle and upper floors and at northern, central and southern positions **Figure 4** to **Figure 14** provides photomontages from these viewpoints.

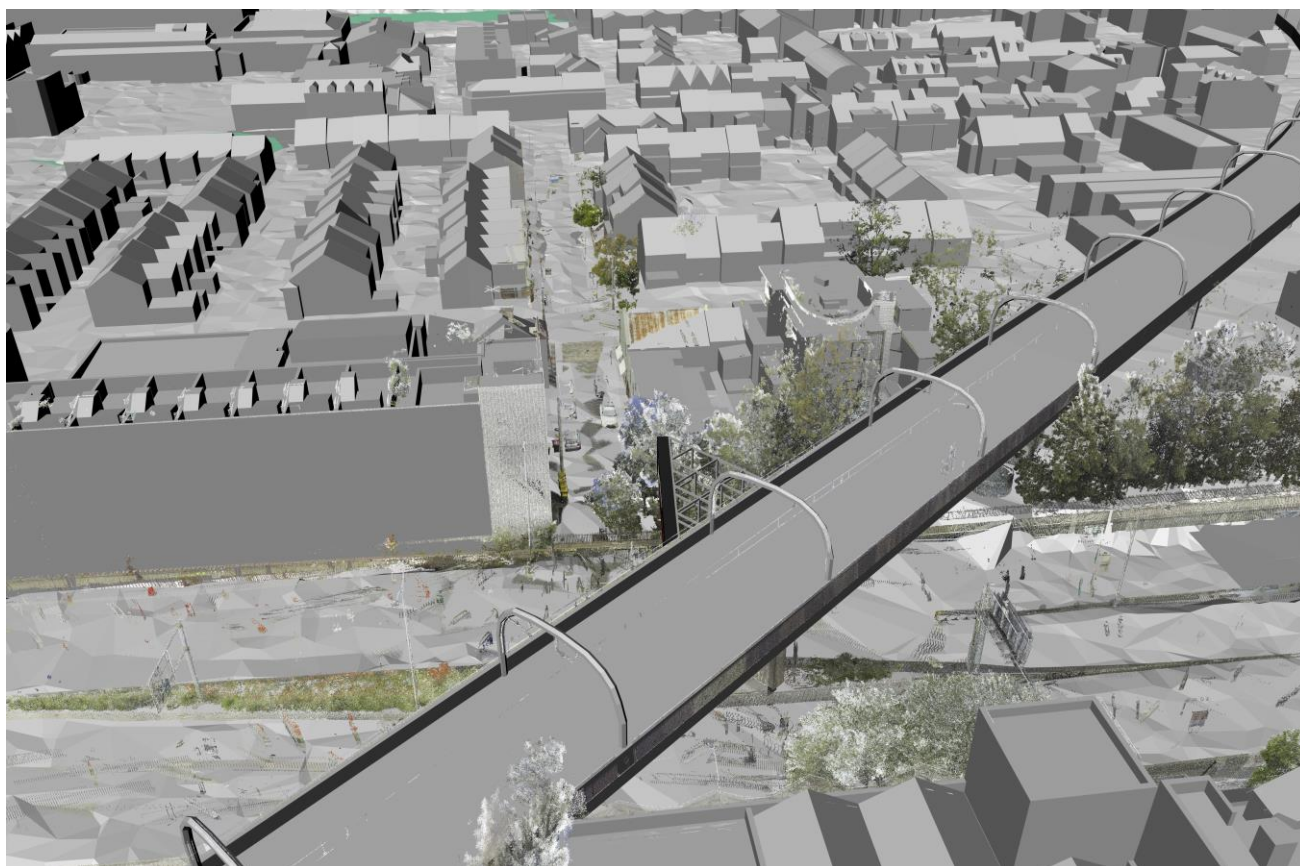
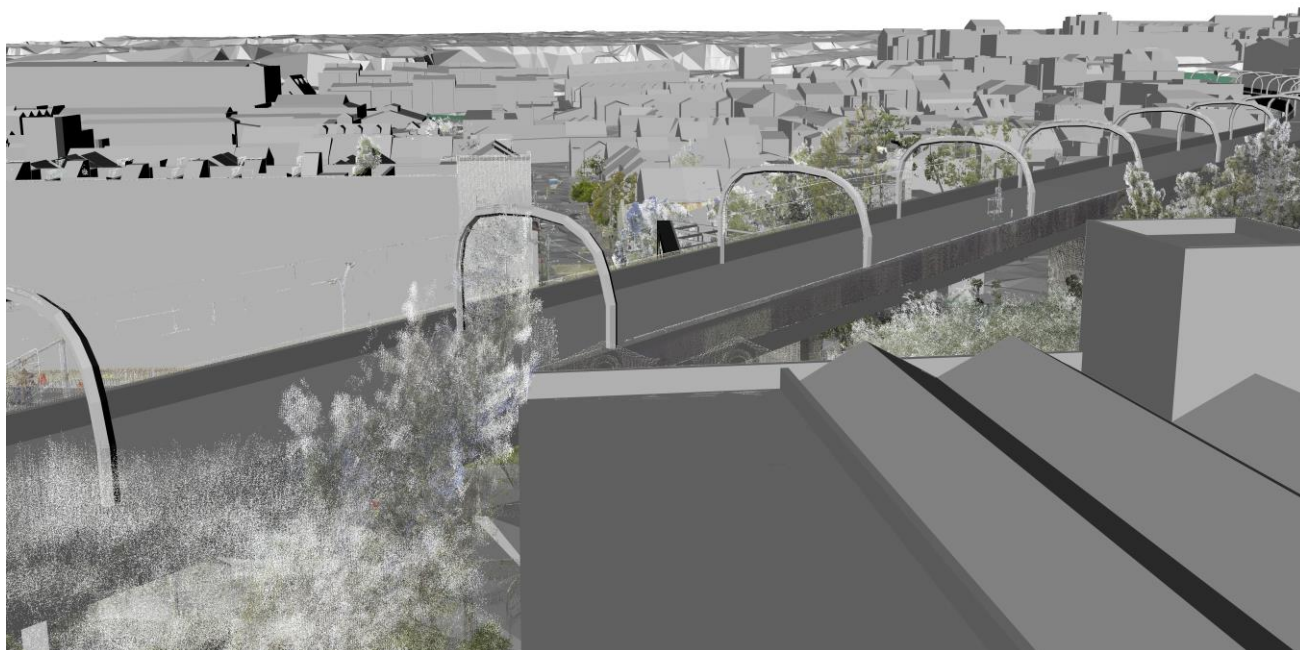
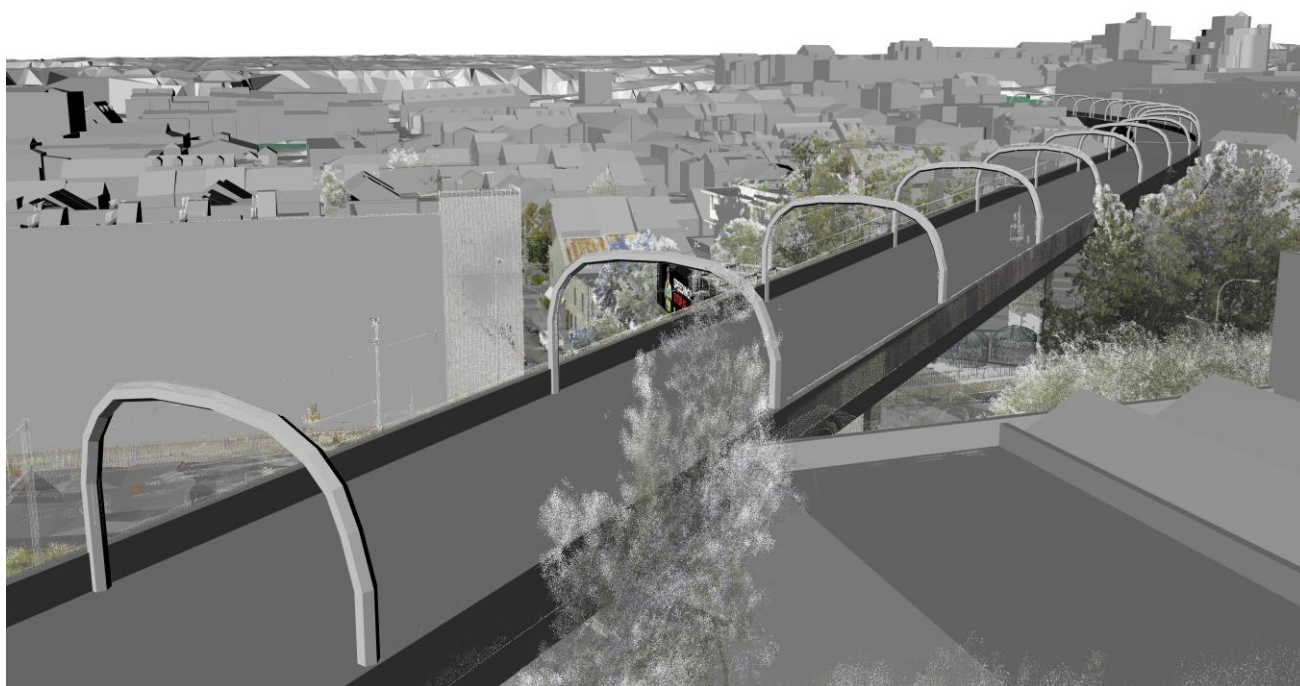
This shows that the most affected viewpoints are at the northern end of the building on upper and middle floors. However, given the complexity of the visual environment and the bulk and scale of the railway viaduct,

the proposal is not considered to be a prominent element in the visual landscape. From these levels the proposal will be visible together with existing signage and street lighting, further reducing its visual impact.

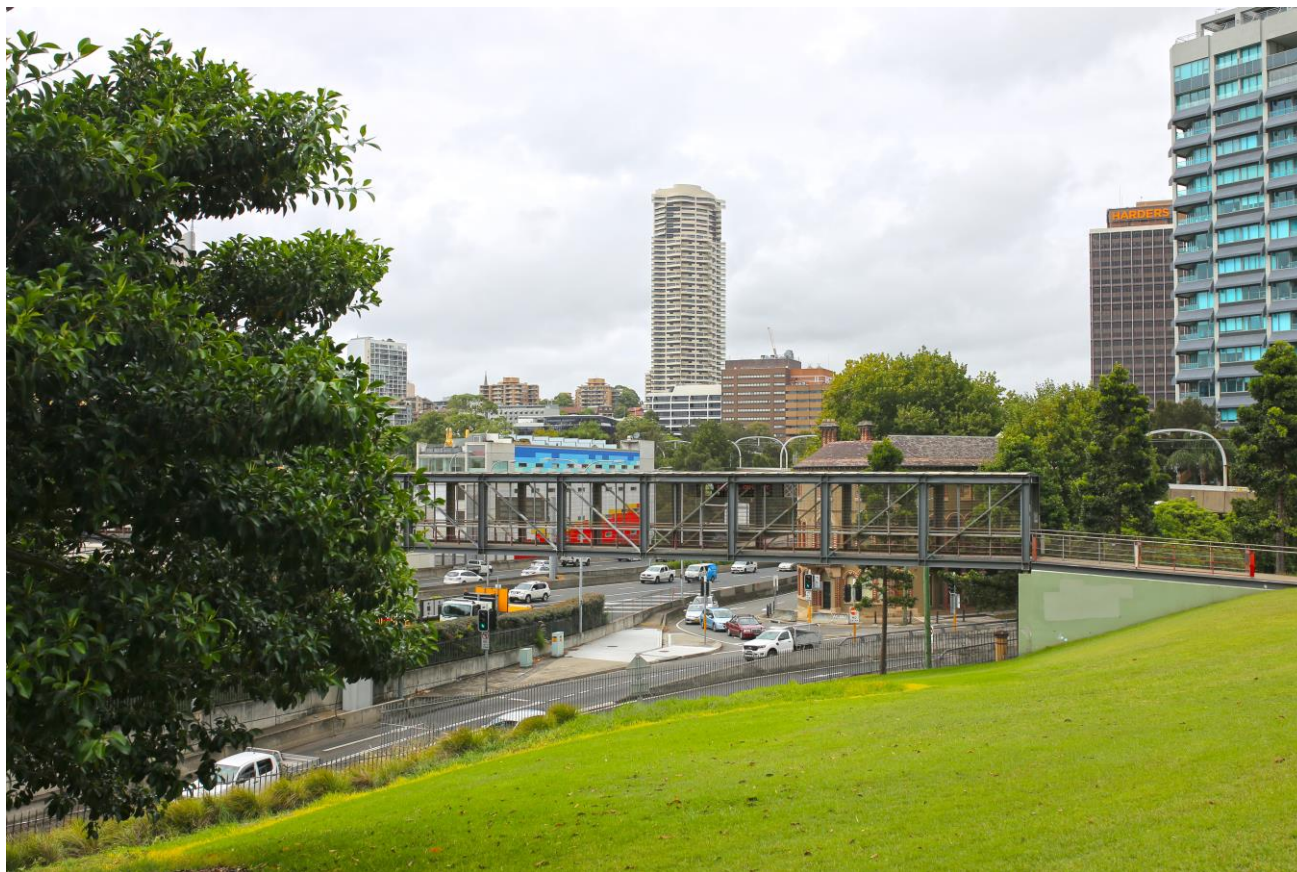
Figure 13 Rear of Art Gallery photo

View 1 – Rear of Art Gallery

This is considered part of the most exposed area of The Domain (the Crescent Precinct) to views of the proposal.

However, due to its characteristics, including location to the rear of the Art Gallery, relatively steep slope and proximity to a major source of noise in the form of the Eastern Distributor, it is not highly used.

The specific viewpoints was selected as it is on the main north-south pedestrian path.

As can be seen in **Figure 15**, the nature of The Domain – Woolloomooloo footbridge (including its placement and dimensions) results in the site (and therefore the proposal) not being readily visible from this location. Moving further to the right results in the view being blocked by the building located at 2-4 Sir John Young Crescent. Moving further to the left results in the view either being blocked or occluded by a tree.

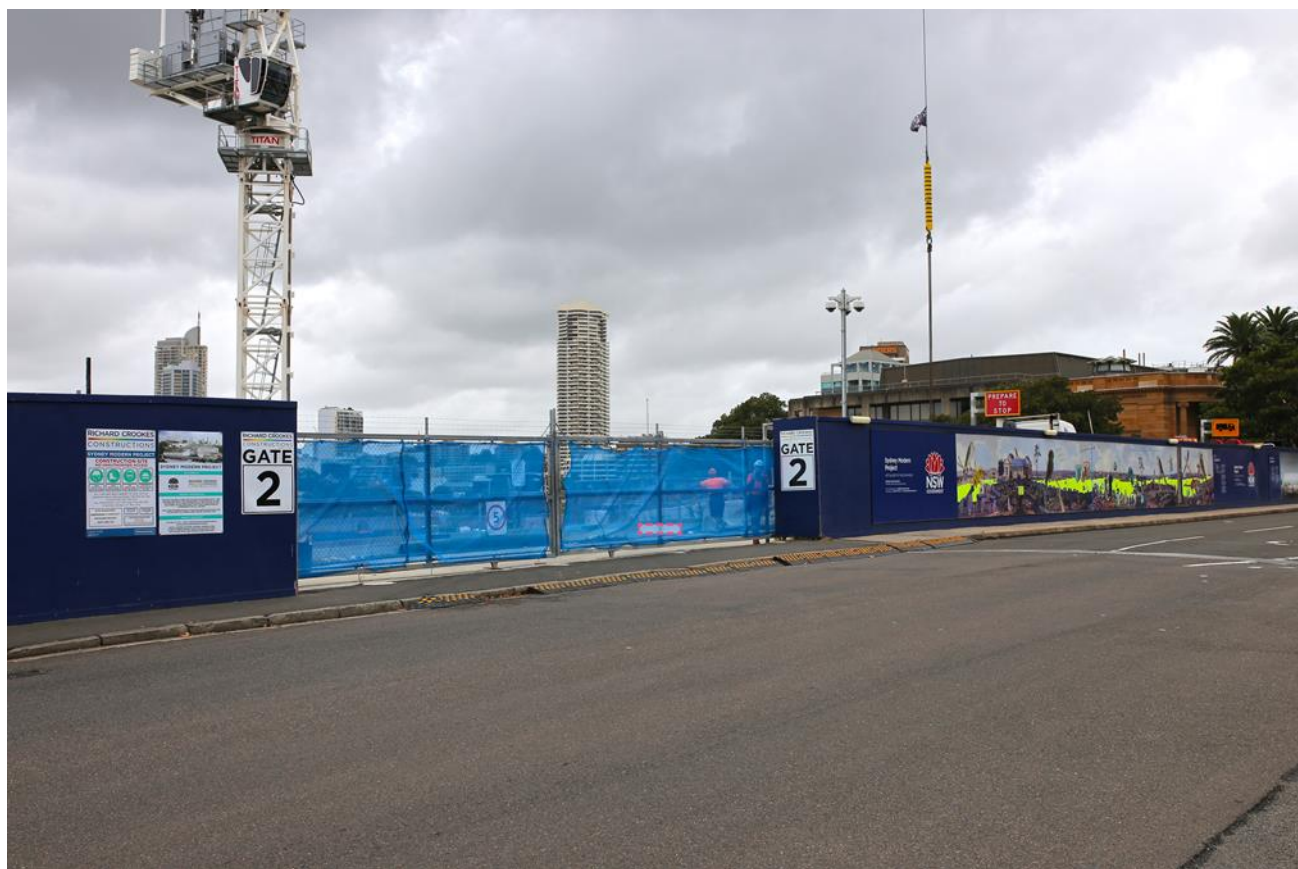
Figure 15 Art Gallery Road photo

View 3 – Art Gallery Road

This is a heavily used pedestrian connection across the Eastern Distributor between both sides of The Domain.

Due to construction activity, an unobstructed photograph from this viewpoint was not able to be captured (refer **Figure 17**). However, due to its angle relative to the site, it is unlikely that the proposal will be readily visible from this viewpoint. It is likely that built form (eg, the Art Gallery) and vegetation will appear between the viewpoint and site. Furthermore, the viewpoint is located some distance (approximately 280m) from the site.

It is understood that the eastern edge of the land-bridge may be repurposed as part of the Sydney Modern project. While this point is located at a less acute angle and is closer to the site, views are again it is likely to be obstructed by intervening built form, in particular The Domain – Woolloomooloo footbridge.
