Author:	Elanor Pitt, Anita Yousif, Michael Lever
Project manager:	Sandra Wallace
Name of organisation:	Artefact Heritage Services Pty Ltd
Name of project:	Central Station Precinct Renewal
Name of document:	Non-Aboriginal Archaeological Site Plan
Document version:	Official

EXECUTIVE SUMMARY

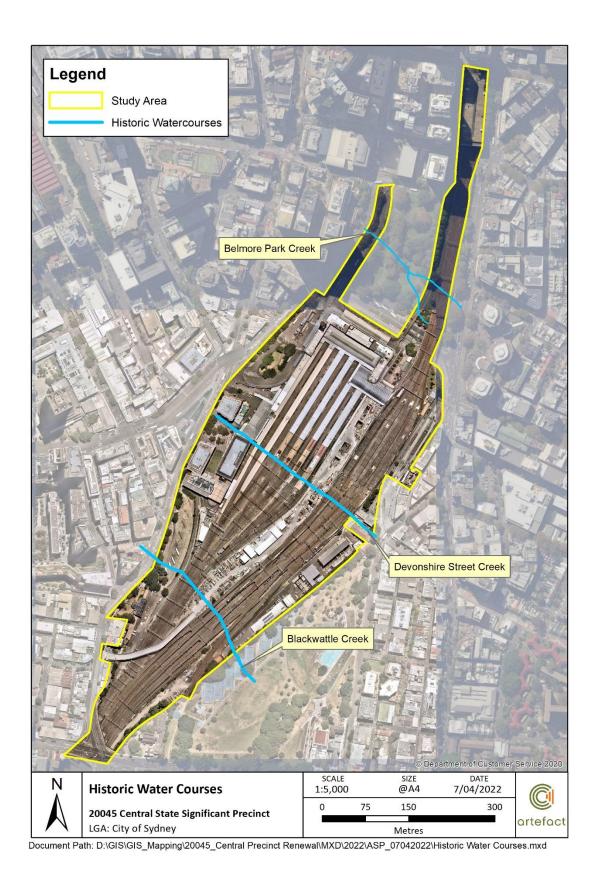
Figure 3. Approximate historical location of watercourses within the study area.

Early historic plans additionally show the Belmore Creek, which runs south-east from the western side of Belmore Park to the centre, where it splits into two additional tributaries running south-east and SSE. It is unclear as to the source of the creek, as the available maps do not show the source. However, it is likely to have been a tributary of Blackwattle Creek/Blackwattle Swamp Creek.

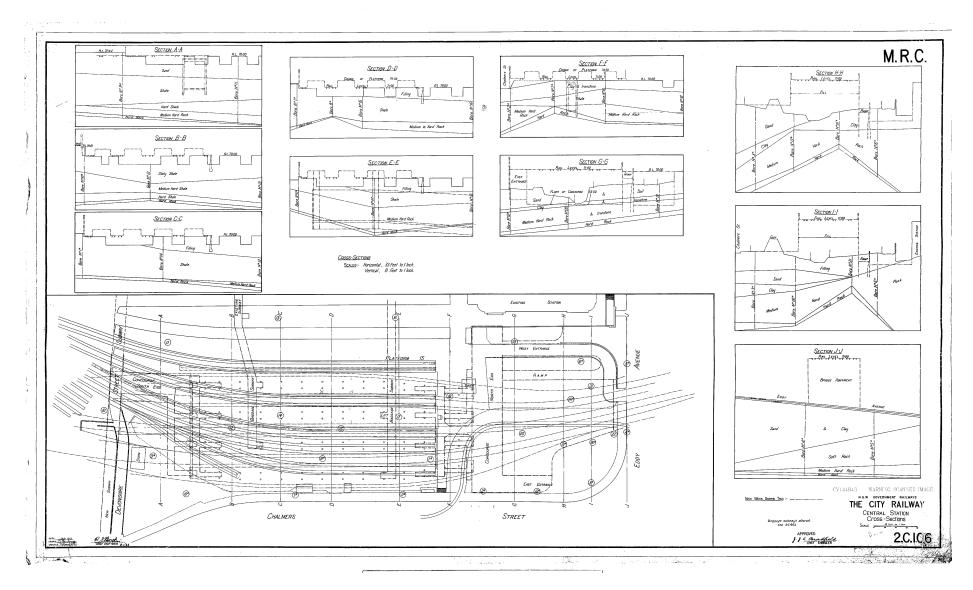
Figure 4: NSWGR Plan of Central Station Suburban Platform design 1922

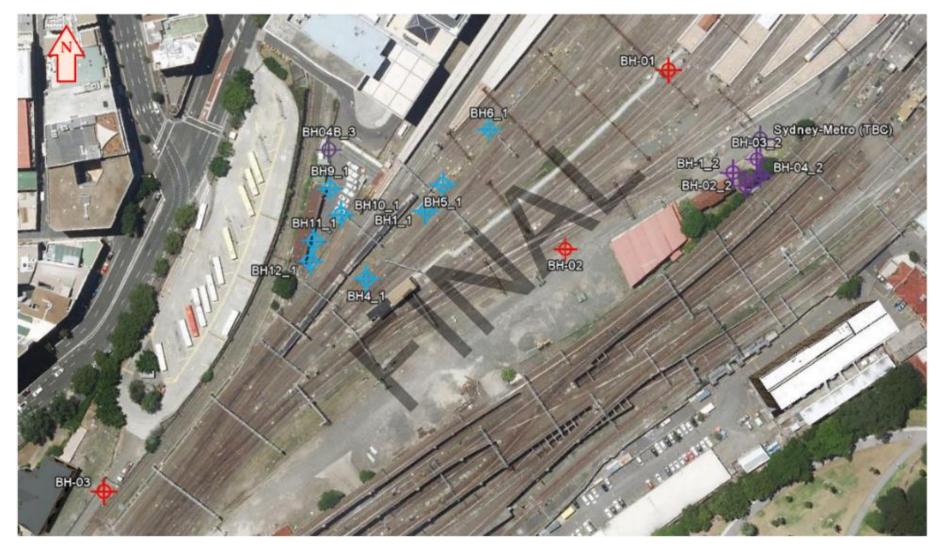
Figure 7: Location of Geotechnical investigation including AECOM (red) and GHD (blue) investigations

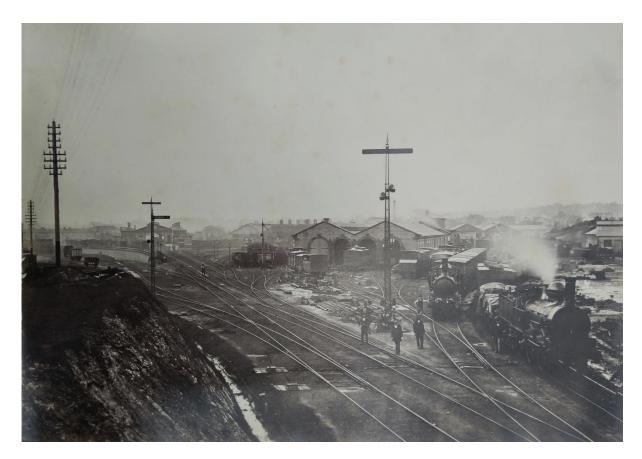
Figure 21. This 1877 photograph indicates the complexity of operations and the range of structures and features in place in Sydney Yard during the second phase of the station's development (Source: State Library of NSW, PXD 1175)

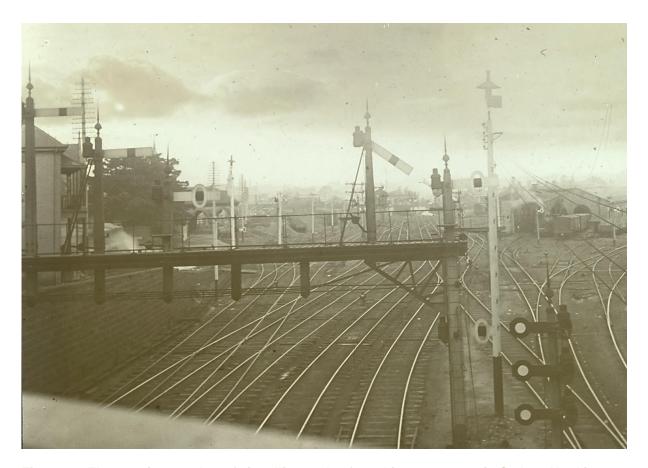
Figure 22. The growing number of signalling and safeworking structures in Sydney Yard is illustrated in this 1880s photograph by John Henry Harvey, with Mortuary Station on the left (Source: State Library of Victoria, H91.300/43)

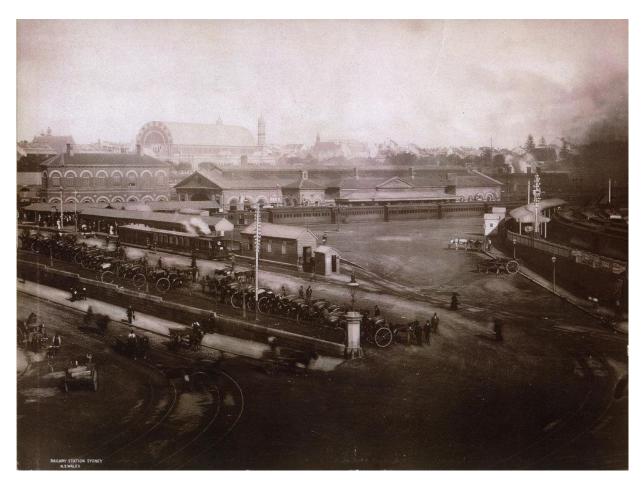
Figure 23. Emphasising the full reach of the second stage of Sydney Terminus, this 1890 photograph includes many of the ancillary structures that serviced the city's main railway station (Source: City of Sydney Archives, A-00033151)

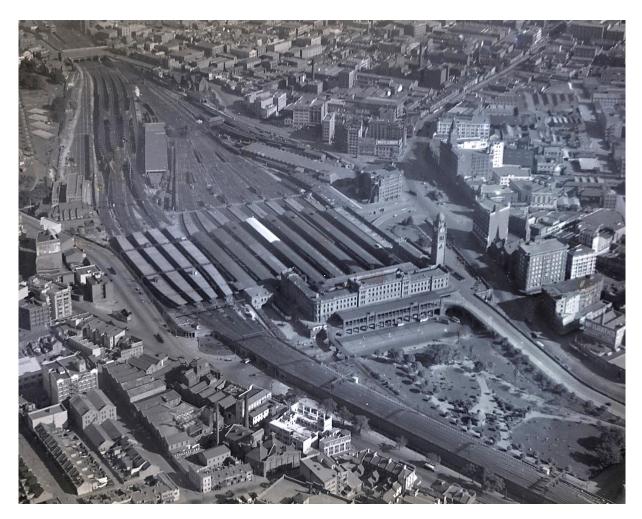
Figure 25. This Hall & Co. aerial photograph from the 1930s illustrates the complexity of the structures associated with the eastern and western carriage sheds, including the clustering of buildings along the edges of the Darling Harbour diversion (Source: Chau Chak Wing Museum, HP83.66.106)

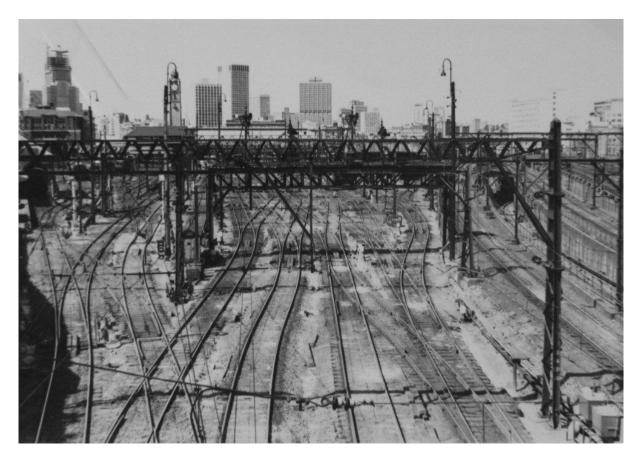
Figure 26. By 1980 the overhead wiring and signalling systems in Sydney Yard had been fully adapted for the end of steam train services (Source: City of Sydney Archives, A-000197)

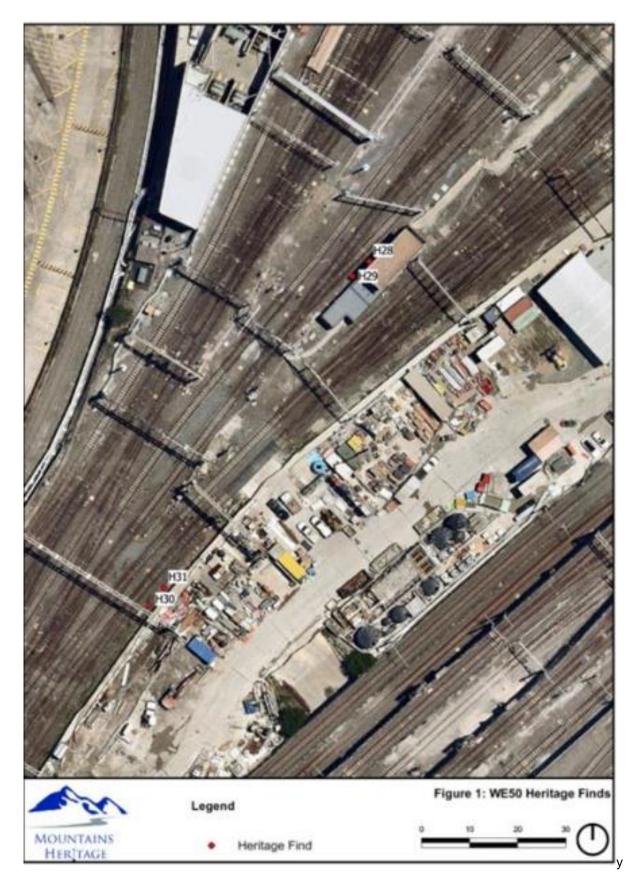
Figure 28: Location of heritage finds during the MTMS 1 archaeological program (2020 – 2021) (Source: Mountains Heritage, 2021)

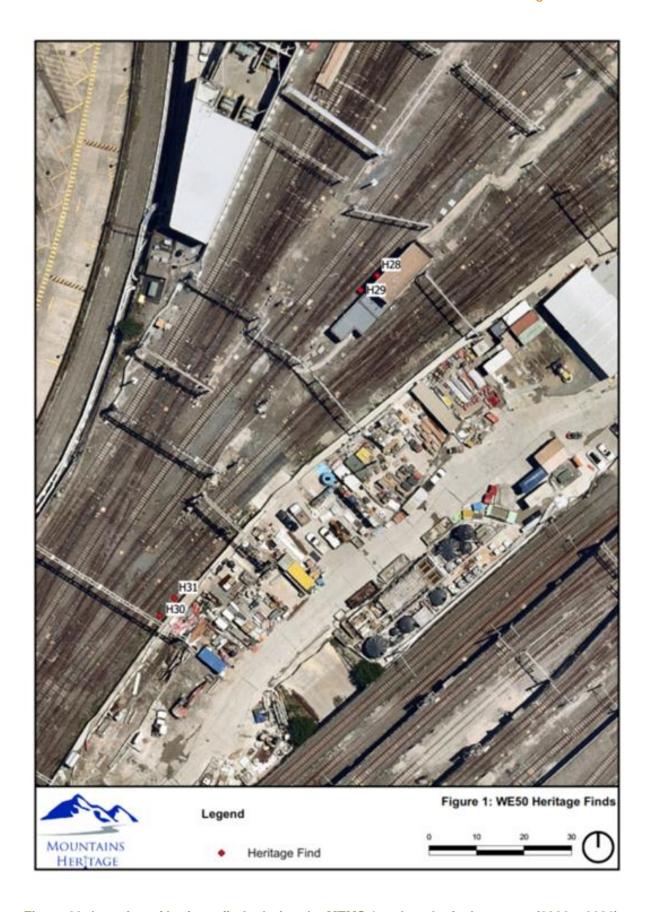
Figure 29: Location of heritage finds during the MTMS 1 archaeological program (2020 – 2021) (Source: Mountains Heritage, 2021)

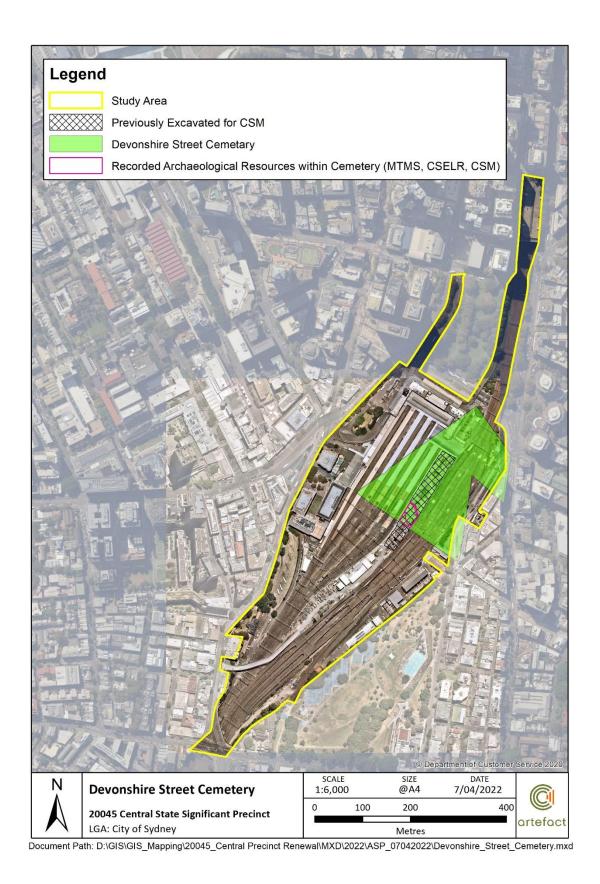
Figure 32. Extent of former Devonshire Street Cemetery overlaid on the Central State Significant Precinct study area (Source: Artefact, 2022)

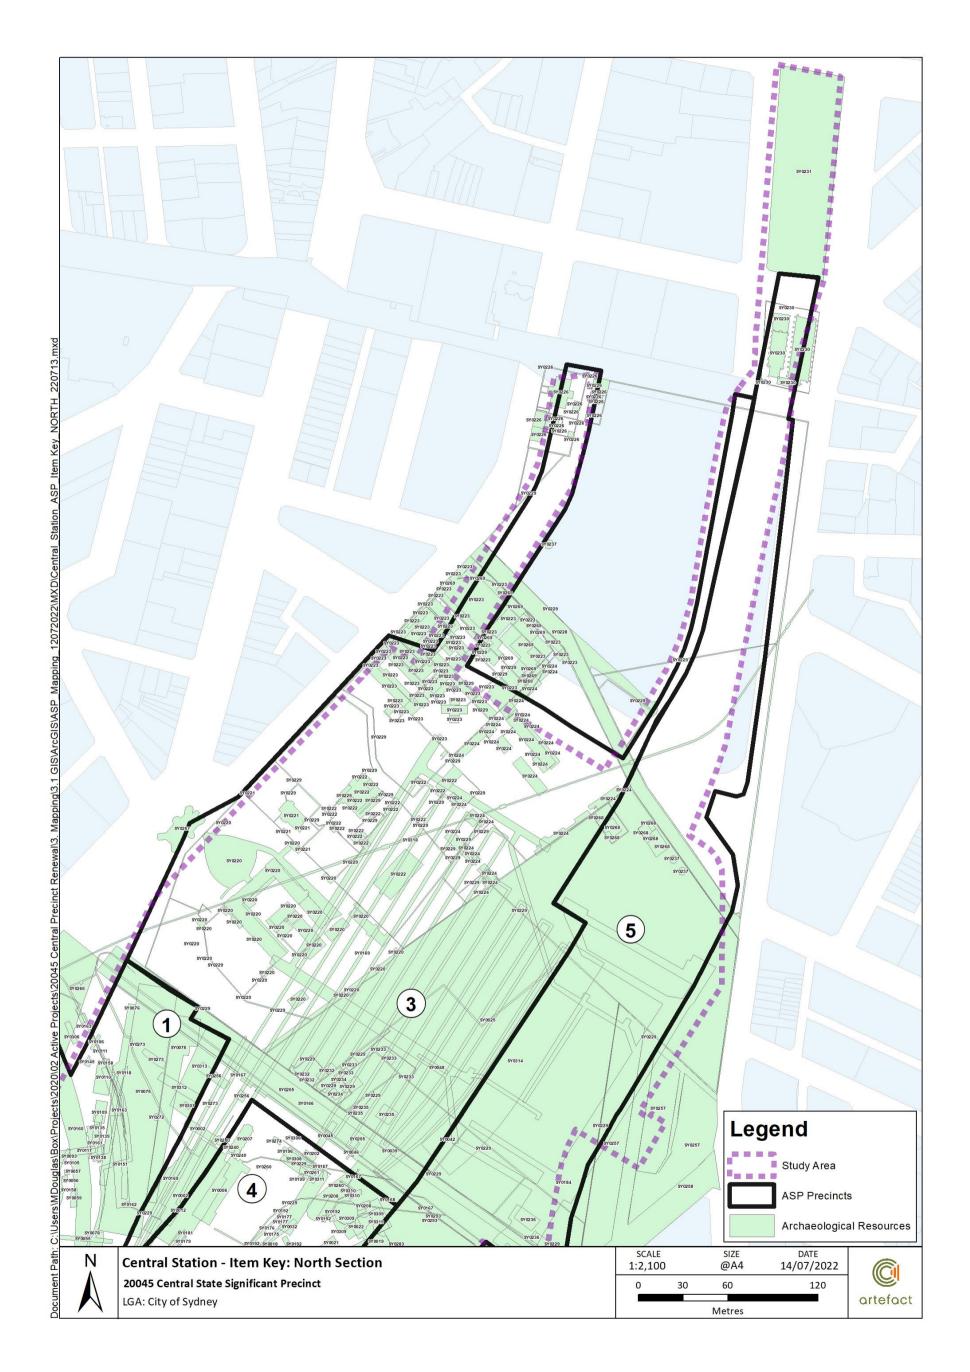
Figure 33. Comprehensive plan of archaeological resources within and adjacent to the study area in the northern section of the study area.

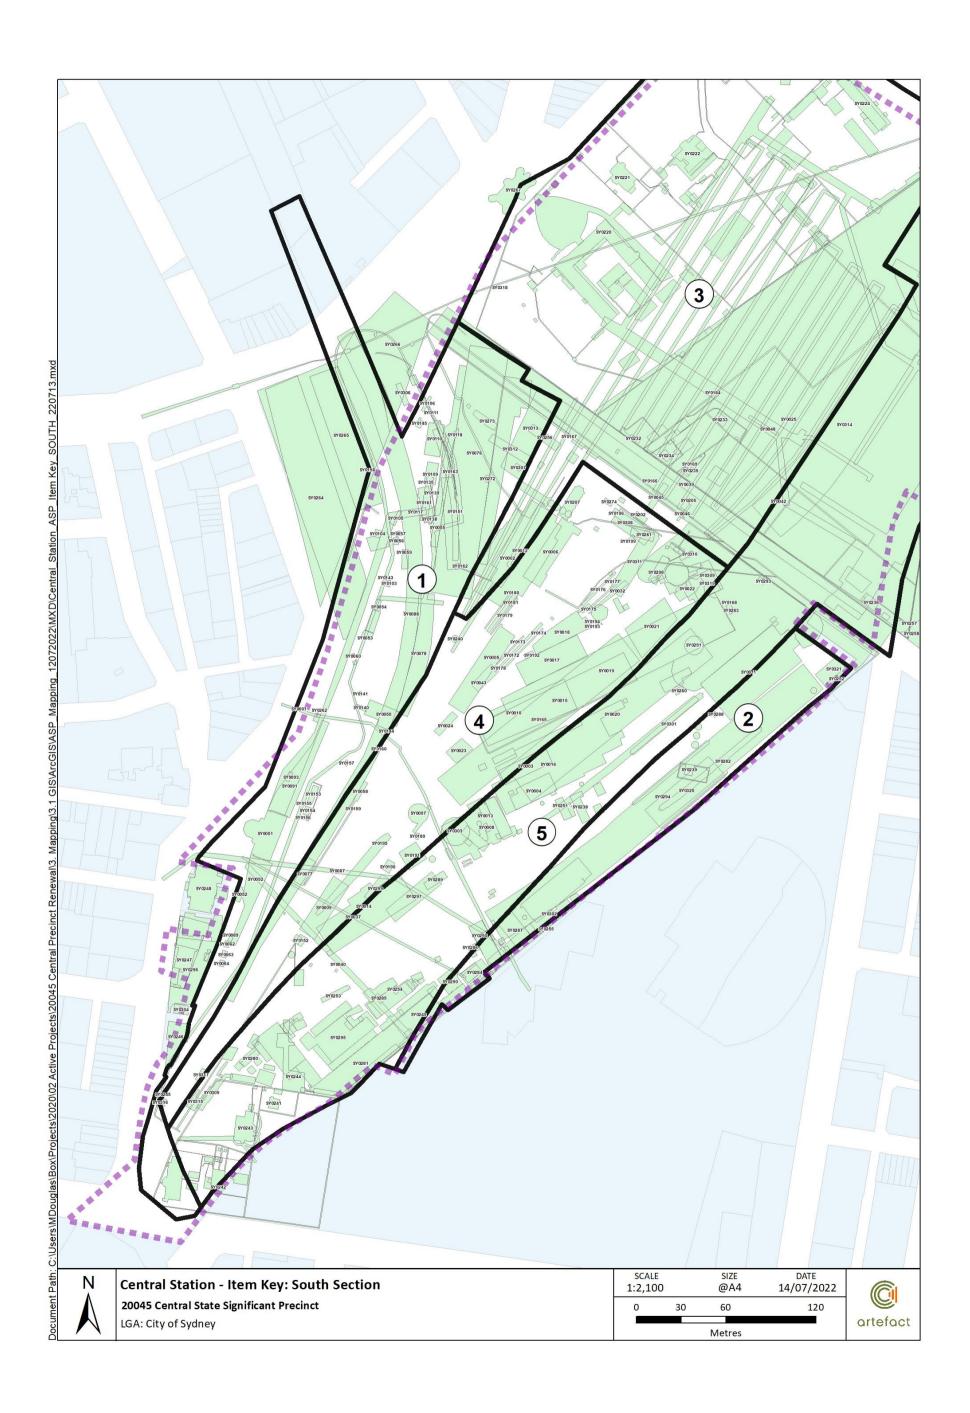
Figure 34. Comprehensive plan of archaeological resources within and adjacent to the study area in the southern section of the study area.

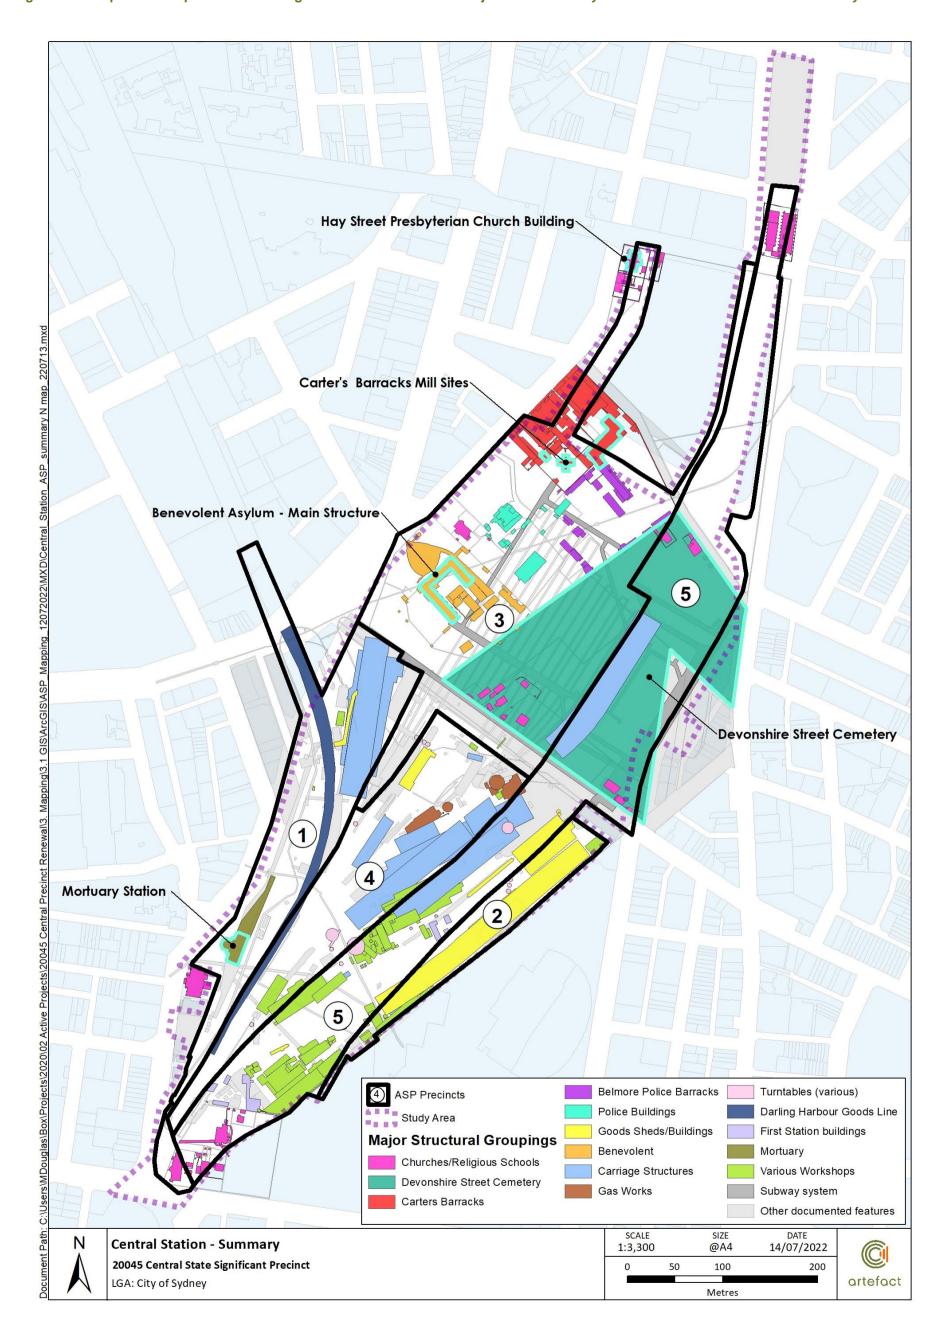
Figure 35. Thematic plan of the archaeological resources within and adjacent to the study area.

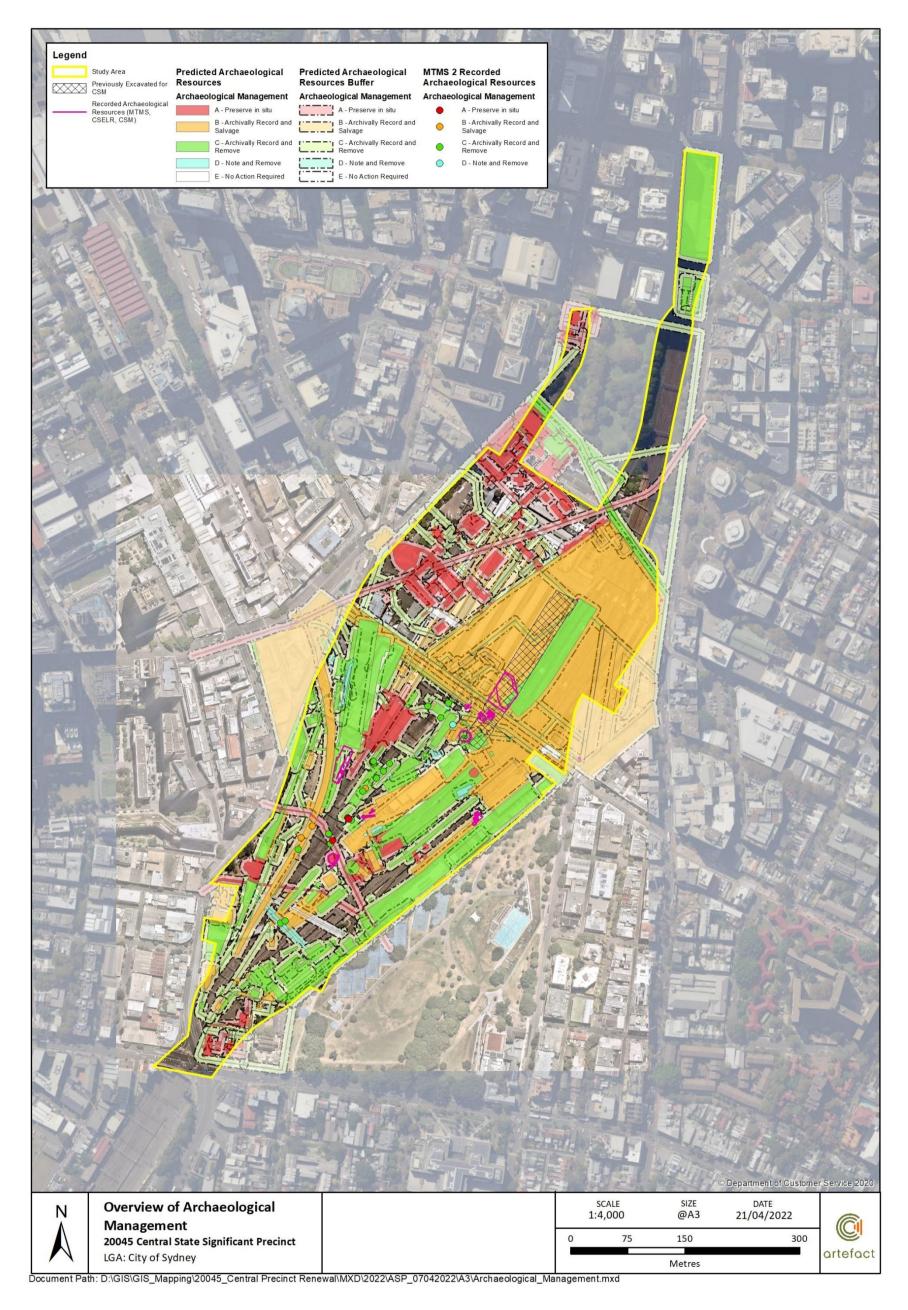
Figure 54. Archaeological management for items within and adjacent to the study area (Source: Artefact Heritage, 2022)

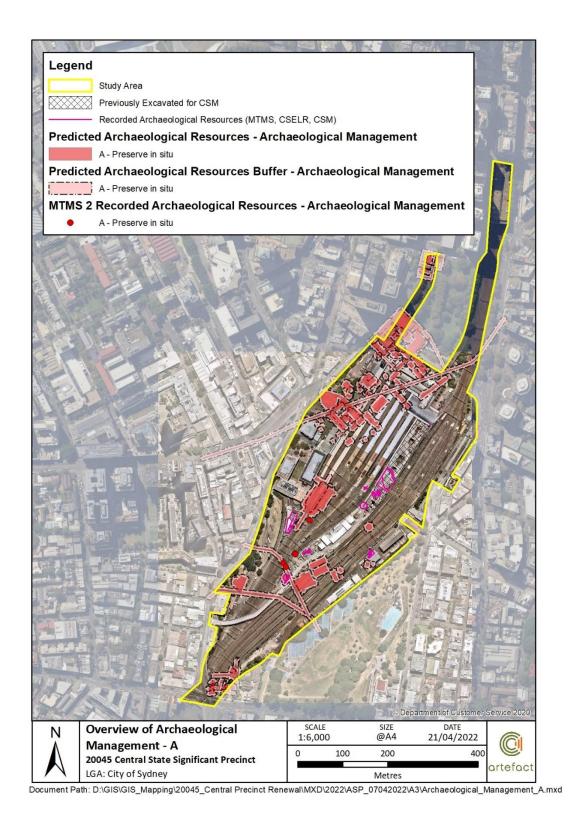
Figure 55. Items requiring Archaeological Management Level A (Preserve in situ) (Source: Artefact Heritage, 2022)

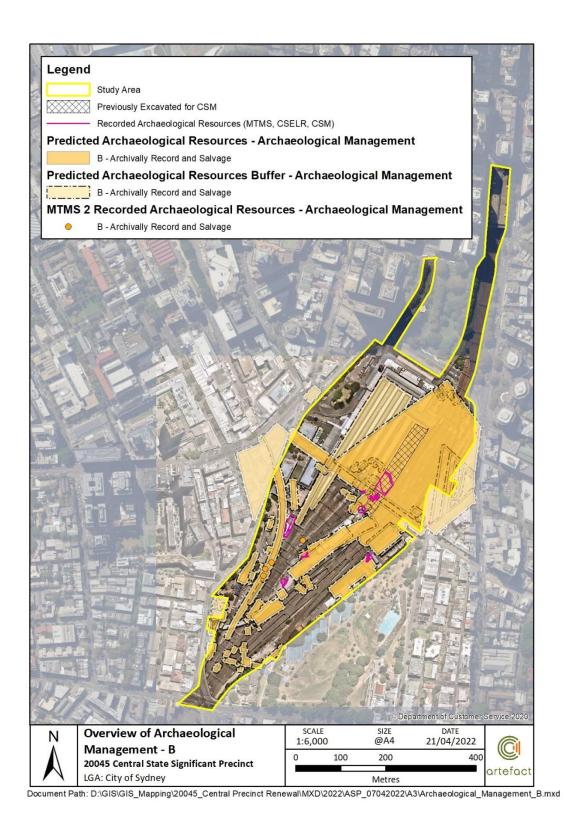
Figure 56. Items requiring Archaeological Management Level B (Archivally Record and Salvage) (Source: Artefact Heritage, 2022)

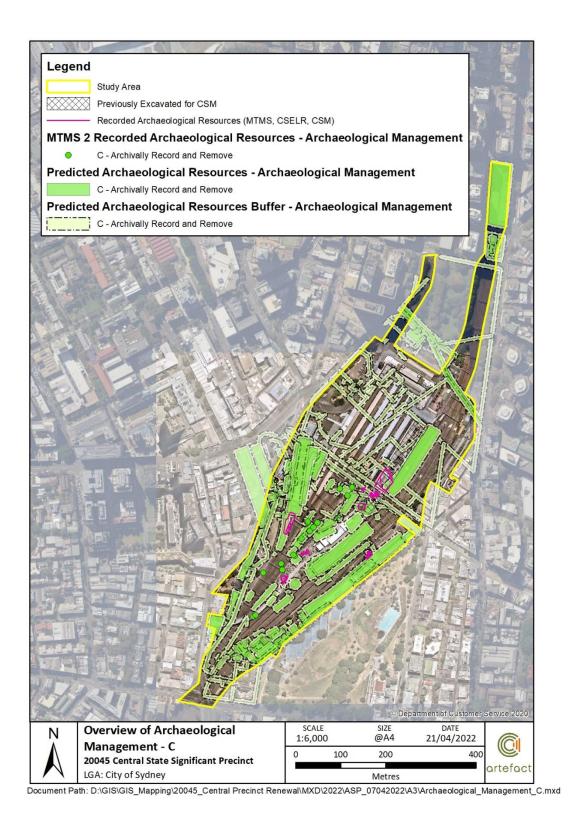
Figure 57. Items requiring Archaeological Management Level C (Archivally Record and Remove) (Source: Artefact Heritage, 2022)

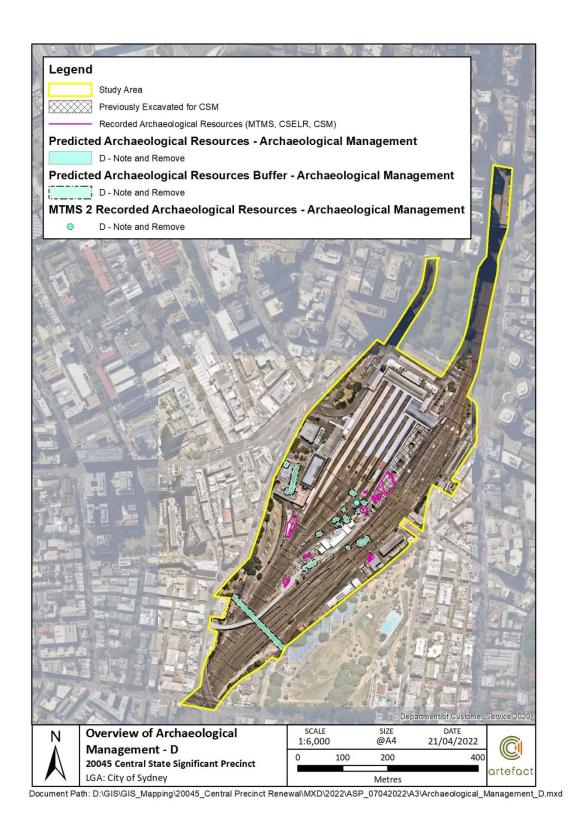
Figure 58. Items requiring Archaeological Management Level D (Note and Remove) (Source: Artefact Heritage, 2022)

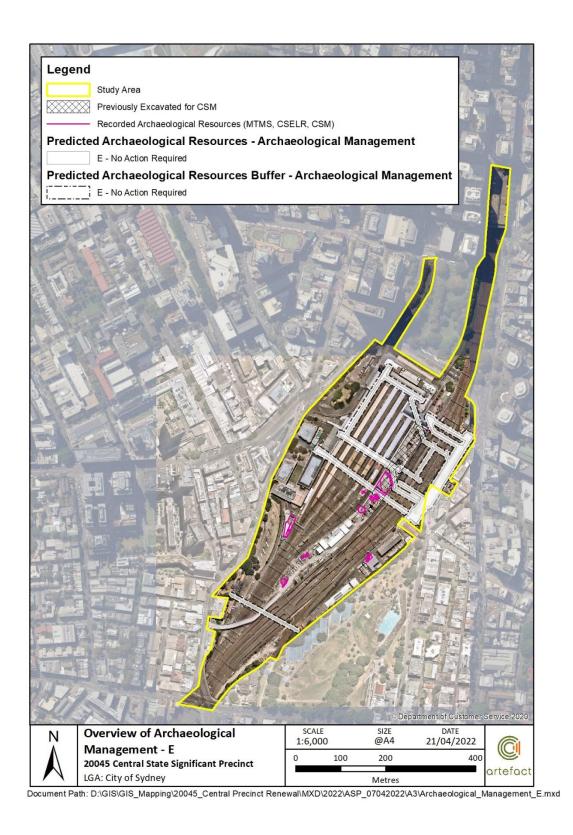
Figure 59. Items requiring Archaeological Management Level E (No Action Required) (Source: Artefact Heritage, 2022)

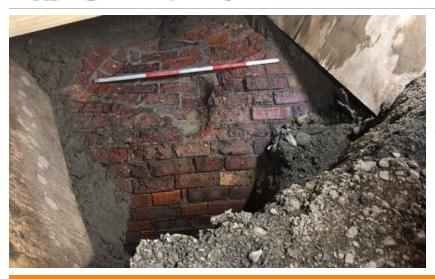
Figure 9. Brick drain uncovered in Sydney Yard on 10 April 2021 during works for MTMS 2. Source: Artefact Heritage

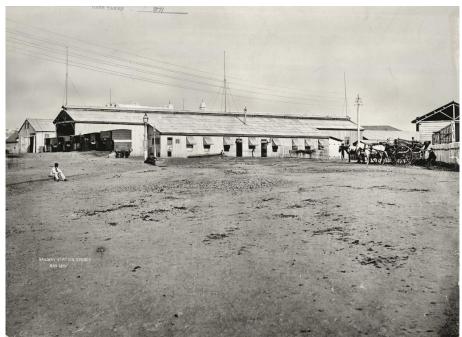
Figure 13. First Sydney Railway Station, 1871. This is the first Sydney Railway Station, showing the remains of the old tramway tracks where man is sitting. The Goods Shed is on the far left and the platform on the right side became the George St Platform. Source: State Records, Digital ID 17420_a014_a0140000245

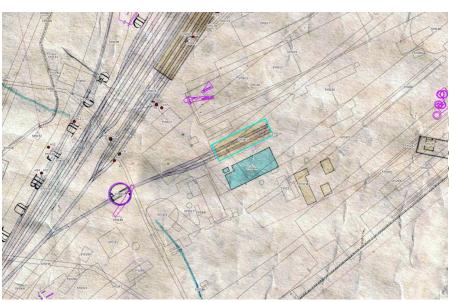
Figure 18. 1857 City of Sydney Detail Plan (annotated) showing the location of the First Engine Shed. Source: City of Sydney Archives & History Resources, A-00880168.

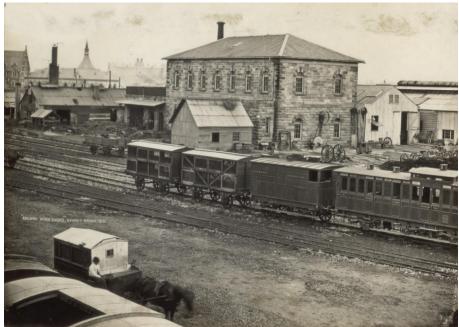
Figure 21. 'Redfern Railway Workshops, Sydney, March 1871' Note: Two-storeyed workshop building with first Blacksmith's at rear (before demolition) and showing c.1860s expansion of workshops to the west (in less robust materials). Source: Redfern Railway Workshops, Redfern Nsw 1871." State Records NRS 17420 State Rail Authority **Archives Photographic Reference Print Collection,** 1871.

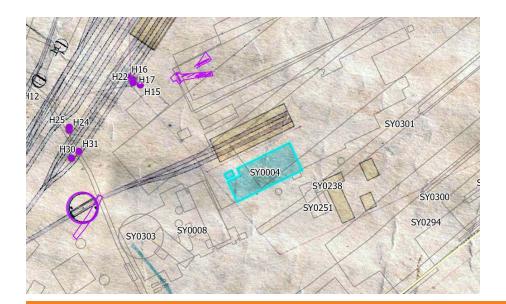
Figure 22. 1857 City of Sydney Detail Plan (annotated) showing the location of the First Engine Shed. Source: Source: City of Sydney Archives & History Resources, A-00880168.

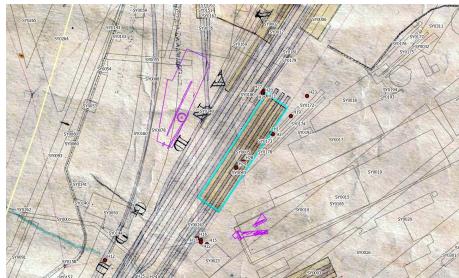
Figure 24. 1855 plan from the Historical Atlas of Sydney, showing a timber carriage shed. Source: City of Sydney Archives. Detail Plans, 1855: Sheet 23. City of Sydney Archives, A-00880168

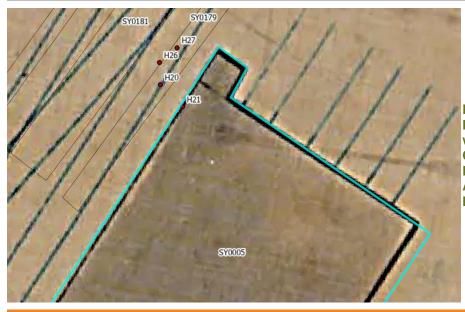
Figure 25. 1857 plan from the Historical Atlas of Sydney, overlaid with the MTMS find [H21]. Source: City of Sydney Archives. Detail Plans, 1855: Sheet 23. City of Sydney Archives. A-00880168. Location of H21 by Mountains Heritage 2021.

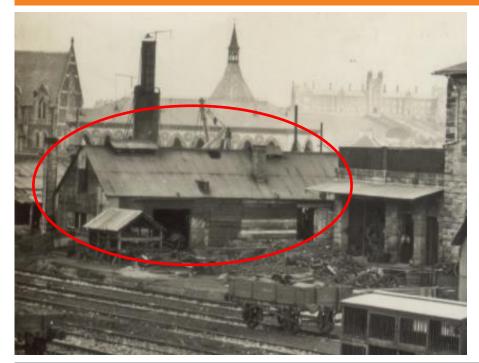
Figure 34. Close-up excerpt of 'Redfern Railway Workshops, Sydney, March 1871', showing the eastern elevation of the eastern blacksmith's workshop. Note: appears to depict blacksmith's shortly before their demolition, based on alignment and layout of the buildings. **Mortuary Station at rear. The** chimney with the cap is likely to be for the steam hammer Source: "Redfern Railway Workshops, Redfern Nsw 1871." State Records NRS 17420 State **Rail Authority Archives Photographic Reference Print** Collection, 1871.

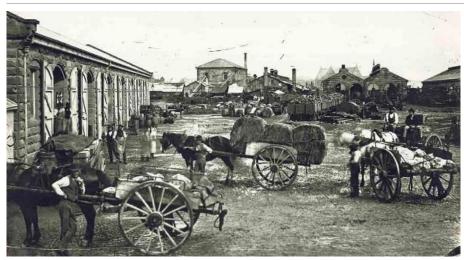
Figure 42. c.1875. Well known image of the Goods Shed with the workshops facilities in the rear (Colonial Office). Source: SLNSW, Call number: PXD 1175

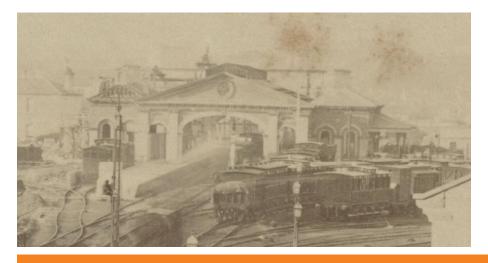
Figure 49. c.1873 – 1880. photograph showing the construction of the Second Redfern Station from the southwest. Source: Trove, PIC/12254/914 LOC Album 1136.

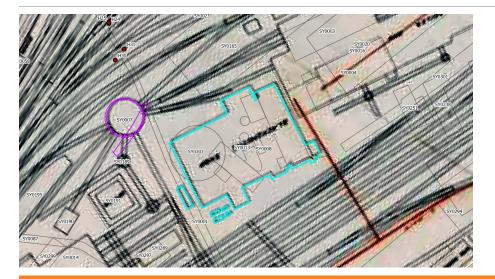
Figure 51. c.1872 Redfern Station map. Source: c.1872 G.S.R. Redfern Station map. Source: Antique Print & Map Room, NSW-GSR-234118.

The repairing shops and office building were first indicated in the c.1872 Redfern Station plan and the 1884 Sydney Water Board Plan (being the first comprehensive plans depicting the Second Sydney Station). Four lines or sidings were shown to enter the shops. They were still extant in the 1896 City of Sydney Detail Plan. By the c.1903 plan of the proposed new (third) Sydney Station and subsequent plans, they had been removed. The new engine servicing facilities appear to take a similar location to the former repairing shops however on a different alignment. The removal of this workshop building around the 1880s/1890s is consistent with the general shift of railway workshop facilities from Central to Eveleigh from the 1880s.

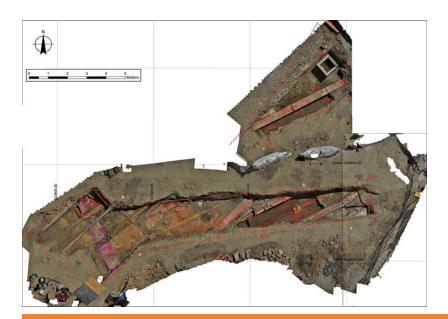
Figure 59. Orthophoto recording of the remains of the Loco Shed. Source: Artefact, Sydney Metro, 2020.

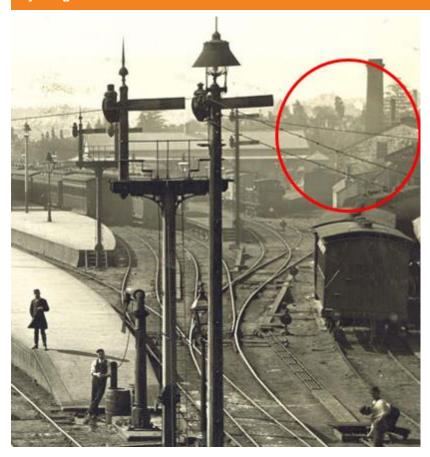
Figure 65. Close-up excerpt of 1884 image. Source: SLNSW.
Photographs - New South Wales, 1879 - ca. 1892 / N.S.W. Government Printer. FL1057569. Note: carriage shop and gas works to right of image near chimney. Only image available. Chimney and stone building associated with Gas Works?

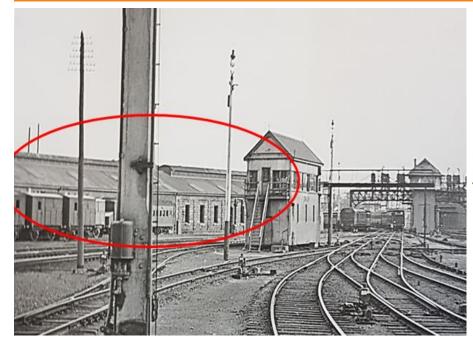
Figure 68: Photograph of the First Eastern Carriage Shed. Source: Taaffe 2019, p. 174.

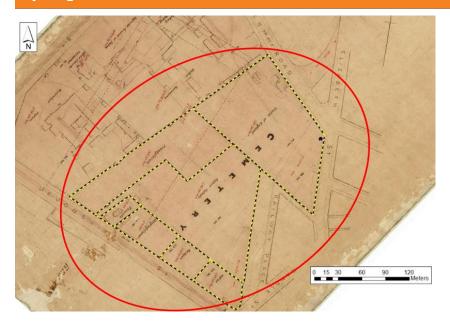
Figure 103. Devonshire Cemetery Layout, 1901. Source: Parish of St Lawrence, County of Cumberland Plan", MS 2166-3000'. 1901 (annotated by Artefact)

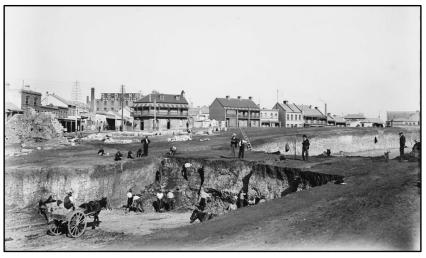
Figure 106. Second phase of trenching looking towards the corner of Elizabeth Street and Railway Place, 1901. Source: SLNSW. 470. [Excavations for Central Railway Station with Elizabeth Street behind]. Box 15: Royal Australian Historical Society: photonegatives, ca. 1900-1910. FL8960895

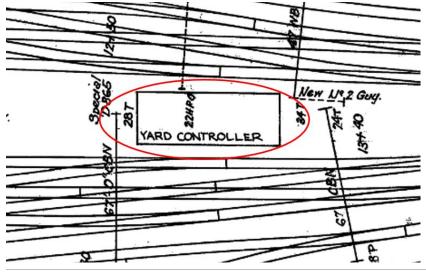
Figure 120. Excerpt of Sydney Yard electrification, complete layout plan of OHW Masts and structures. Dated 1948, e.d. 1956. Source: Sydney Trains VPR

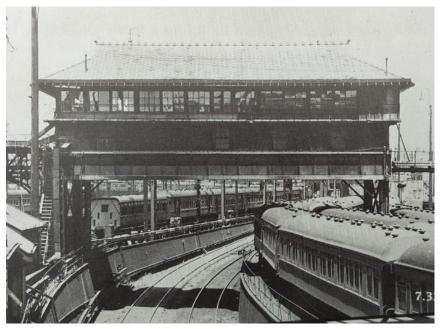
Figure 134. Photo of the station west signal box. Source: Source: Taaffe, Robert T. Signal boxes of New South Wales, Volume 2

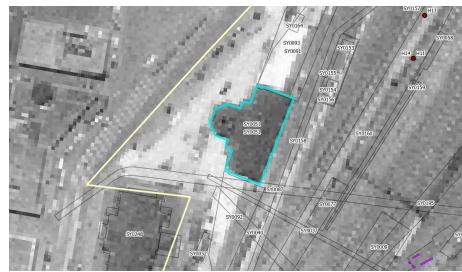
Figure 137. 1949 aerial image. Source: City of Sydney, A-00879995.

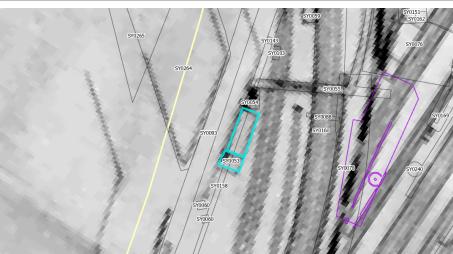
Figure 145. 1900 plan, showing the additions to the structure. Source: SLNSW.

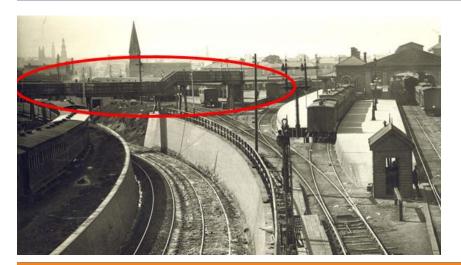
Figure 152. 1884 photograph taken from the Sydney Station Signal Box, showing footbridge. Source: SLNSW. Photographs - New South Wales, 1879 - ca. 1892 / N.S.W. Government Printer. FL1057569.

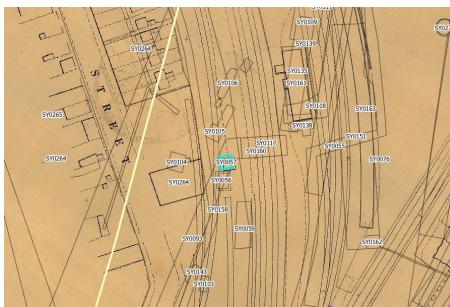
Figure 154. 1884 Water Board detail map. Source: State Archives NSW. Metropolitan Water Sewerage & Drainage Board. Sheet I2

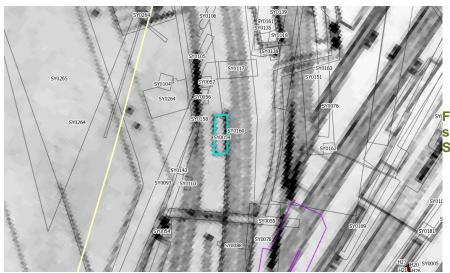
Figure 162. 1900 of the Station yards, showing additions to the structure. Source: Sydney Trains VPR.

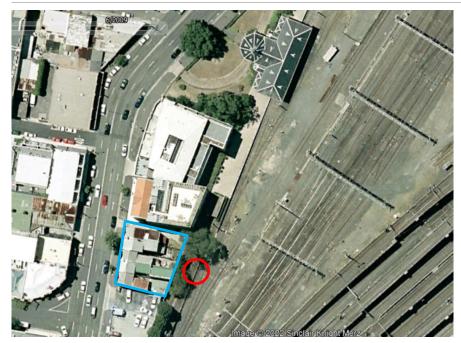
Figure 169. Study area (red) prior to construction of the access bridge. Blue outline highlights structures demolished to construct/ location of the access bridge entry to the Sydney Yard. Source: Google Earth, 2009.

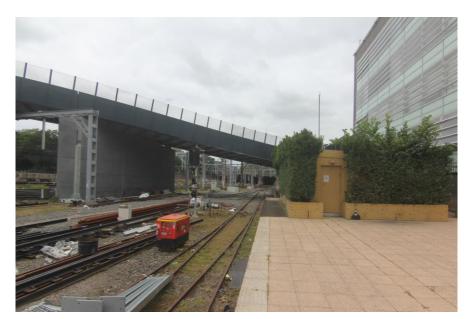
Figure 170. Looking south-west from the Mortuary Station platform, towards the new concrete access bridge. Source: Artefact Heritage, 2021.

In the late 2010s, the Sydney Yards Access Bridge was erected to facilitate the construction of the new Sydney Metro connection to Central Station. The concrete structure connects Regent Street to the centre of the Sydney Yards. Its entrance is located to the south of Mortuary Station. It is possible that the foundations of the bridge were constructed above the study area, but this is difficult to determine through photographs and aerial images.

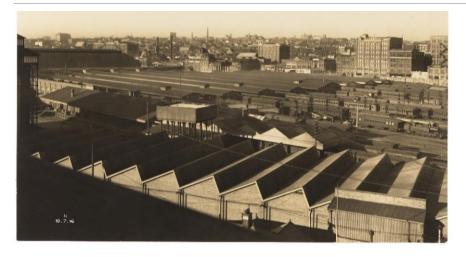
Figure 173. 1916 view of Central Station and Yard, looking east. Western Carriage Shed visible in the foreground. Source: State Library NSW, ID: YezdpQb9.

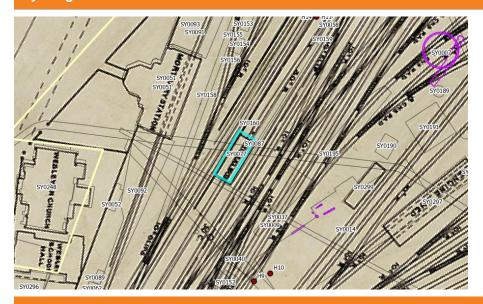
Figure 183. Plan of Central, dated 17 February 1903, showing the proposed location of the signal box. Source: SLNSW, Sydney Central Station arrangements. FL9189417

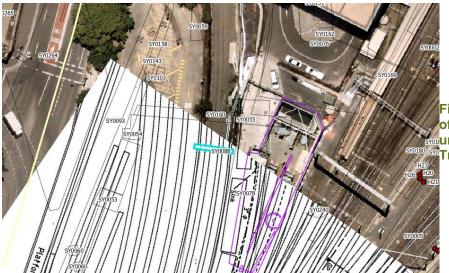
Figure 192. 1992 tracing of a 1954 plan of Sydney Yard, showing the underground services. Source: Sydney Trains VPR.

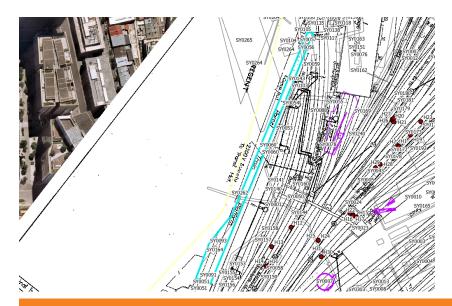
Figure 200. 1953 lighting plan of Sydney Yard, showing the platform. Source: Sydney Trains VPR.

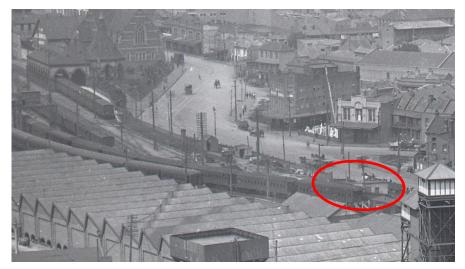
Figure 205. c.1910 photograph, looking south-west towards the structure. Entry gates and small structure, possibly the Distributing Chamber, shown in red. Source: UON Living Histories, ID: ARHSBox004_0074.

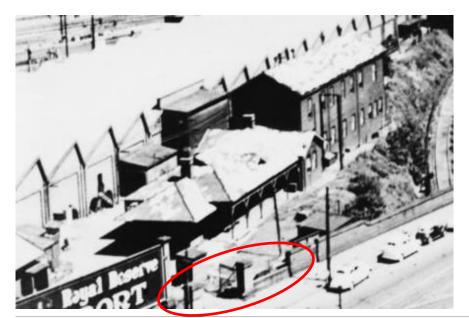
Figure 218. c.1939 photograph looking south towards the Darling Harbour Goods Line. Note the entrance gate outlined in red. Source: City of Sydney Archives, A-00057892.

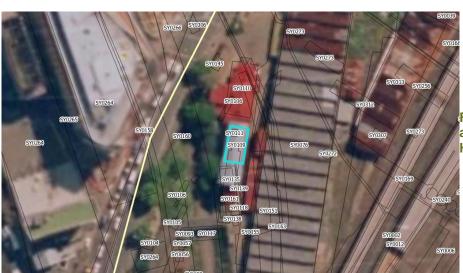
Figure 227. 1998 aerial of the study area. Source: NSW Government, Historical Imagery viewer

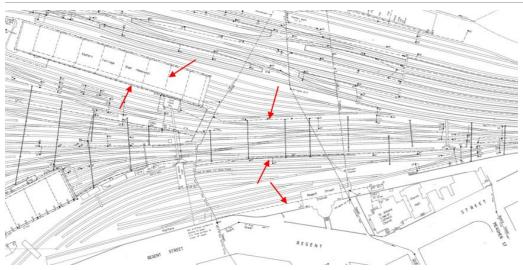
Figure 246. 1992 tracing of a 1954 plan of Sydney Yard, showing the underground track drains and grated pits. Source: Sydney Trains VPR

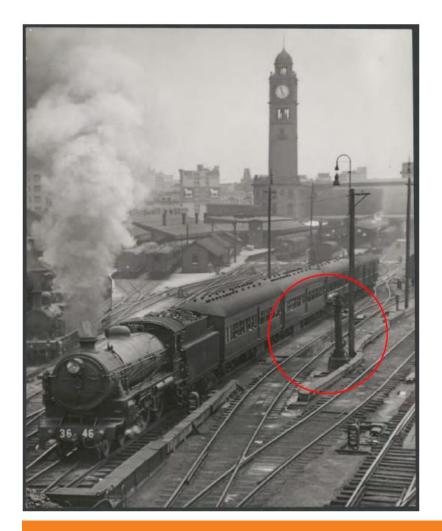
Figure 249. Photograph of a train leaving Central c.1940s. Example of a water column next to an ash pit is circled red. Source: Mountains Heritage 2021 Plate 2:10; Flickr – Central Station collection

Some level of water distribution system or main was likely established with the first Sydney Station in the 1850s, to provide water to the station buildings and infrastructure like water columns for steam locomotives. Evidence of early water mains related to the first and second Sydney Stations is scarce, but it is likely that extant water mains relate to the third Sydney Station development as came to fruition chiefly over 1900-1906 and during the 1920s, in totality encompassing the whole yards area. Drainage pits were a basic requirement to prevent the degrading of yard surfaces or flooding of the yards.

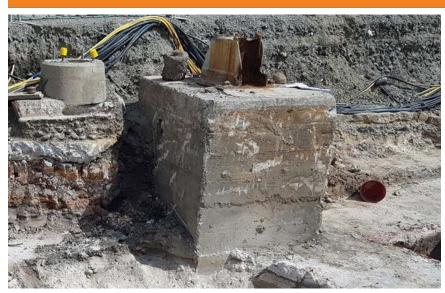
Figure 251. Typical stanchion base and hold down structure, Test Trench 1 CSM. Source: Artefact, 2018.

The archaeological evidence of Overhead Sanctions are concrete footings with evidence of hold down structures and masts. One of these was excavated in the Central Station Metro project. Another was observed to be in situ and had a date – 1954 – scratched into it.

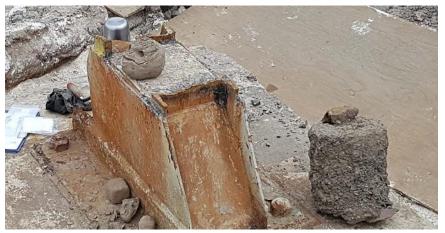
Figure 252. Detail of stanchion base pedestal and hold down structure for the mast. In this case the mast has been cut off and the whole structure was buried "in situ" only to be excavated as part of the Test Trench 1 excavations for Central Station Metro. Source: Artefact, 2018.

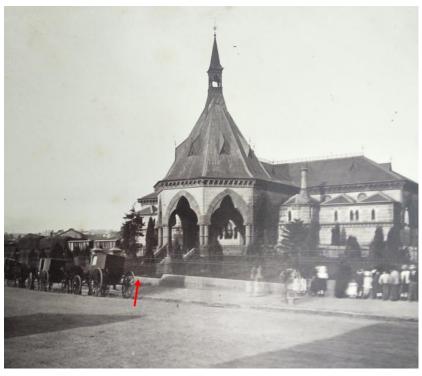
Figure 289. 1877 photograph of Mortuary Station, showing the stone and iron railing fencing and the timber railing fencing in the background. Source:-SLNSW. 16. Mortuary, Sydney, looking east.

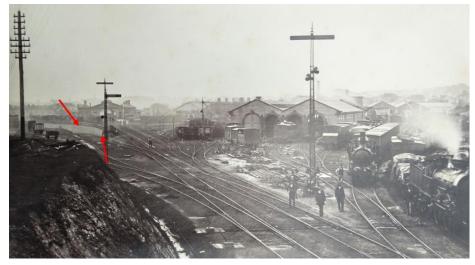
Figure 297. 1877 photograph, showing the retaining wall of the Darling Harbour dive. Source: SLNSW. Photographic views: The Railways of New South Wales / compiled from reports by Rae [John], commissioner, and Whitton [John], Engineer-in-Chief for Railways. PXD 1175.

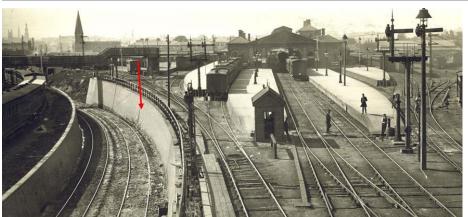
Figure 298. 1884 photograph taken from the Sydney Station Signal Box, showing the retaining wall of the Darling Harbour dive. Source: SLNSW. Photographs - New South Wales, 1879 - ca. 1892 / N.S.W. Government Printer, FL1057569.

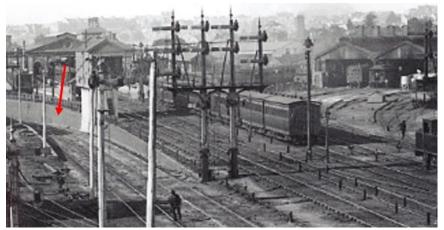
Figure 300. Photograph taken prior to 1904 of the 1884 Sydney Station Signal Box, showing the Darling Harbour branch dive retaining wall at the base of the signal box. Source: ARHS NSW in Taaffe 2019, p. 173.

Archaeological evidence of the retaining wall for the Darling Harbour branch line includes a section of c.1926 brick retaining wall (identified as H11) found during MTMS 2 monitoring excavation for a new OHW footing at B0+470 and B0+505 (west). A pebble rich deposit associated with the c.1926 brick footing (identified as H12) was also identified during this monitoring excavation. Two sandstone features (identified as H13), which may represent a continuous footing associated with the Goods Line infrastructure, were also identified during the MTMS 2 monitoring works.

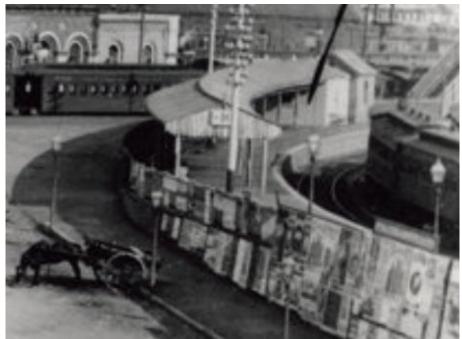
Figure 318. c.1900 photograph of the second Sydney Station. Detail of the platform structure is evident. Source: City of Sydney Archives, A-00024357.

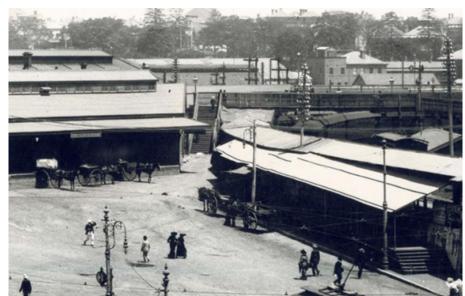
Figure 320. C.1900-1906 photograph of the second Sydney Station. Later photo as the addition of an awning structure to the north of the platform retaining wall is visible. Source: Sydney Living Museums, Digital ID: 17420_a014_a01400025.

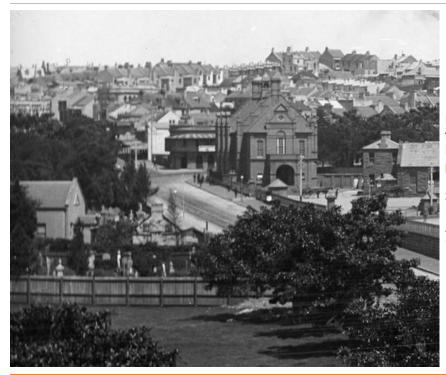
Figure 336. Photograph showing the fence along the south-east end of Devonshire Street, on the right of the photograph. Source: King, Henry. "Railway Station, Redfern Sydney." 39/71 Tyrrell Inventory Number, 1243 King Studio Number, Museum of Applied Arts and Sciences. Sydney, 1891-1901.

Remains of the stone wall were found in situ during previous Central Station Metro excavations in 2018-2020. Therefore, it is likely that more of the base of the stone wall and pillar bases along the south side of Devonshire Street has remained in situ, although the iron railings and pillars are likely to have been removed, relocated or redeposited ex situ.

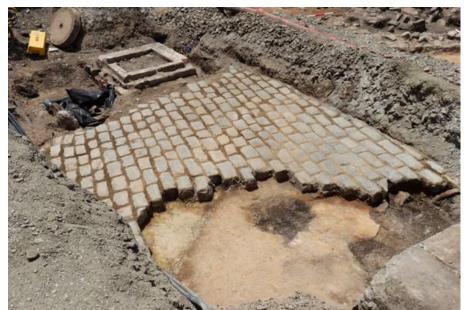
Figure 337 Section of cobbled paving from the Goods Yard.
Source: Hazell, Guy. "Turntable CSM", Orthophoto and Plan Guy Hazell for Artefact, Sydney Metro, 2019.

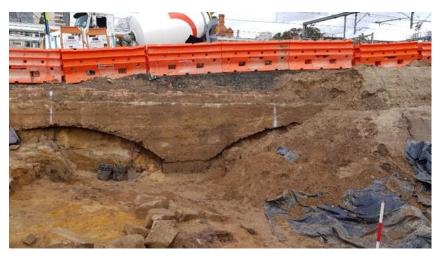
Figure 339. Construction detail of Platform 15 exposed in the Central Station Metro Station Box Excavations, 2019. Source: Hazell, Guy. "Turntable CSM", Orthophoto and Plan Guy Hazell for Artefact, Sydney Metro, 2019.
