Author:	Elanor Pitt, Anita Yousif, Michael Lever
Project manager:	Sandra Wallace
Name of organisation:	Artefact Heritage Services Pty Ltd
Name of project:	Central Station Precinct Renewal
Name of document:	Non-Aboriginal Archaeological Site Plan
Document version:	Official

EXECUTIVE SUMMARY

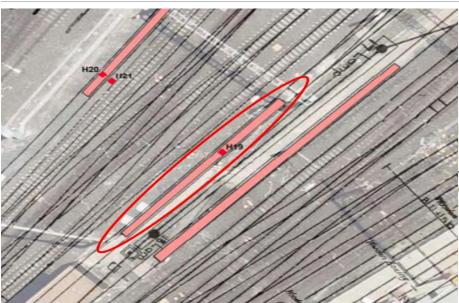
Figure 344. An overlay of the 1928 plan of Sydney Yard showing the location of the ash pit to the south of Platform 8 and the identified remains found during MTMS 2 excavations (H19). Source: Overlay of Mountains Heritage 2021 Sydney Trains VPR.

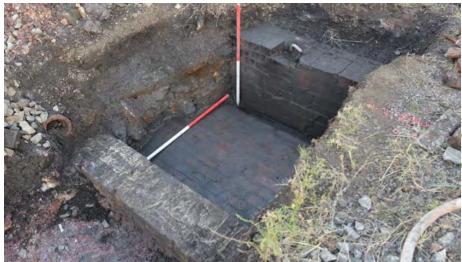
Figure 345. A photograph of a section of the ash pit identified during excavation for MTMS 2 (H19). Source: Mountains Heritage, 2021, p. 67.

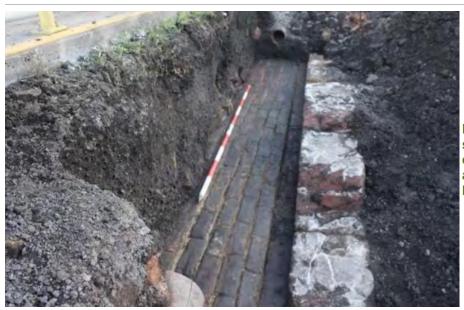
Figure 346. A photograph of a section of the ash pit identified during excavation for MTMS 2 (H1 and H2). Source: Mountains Heritage, 2021, p. 62

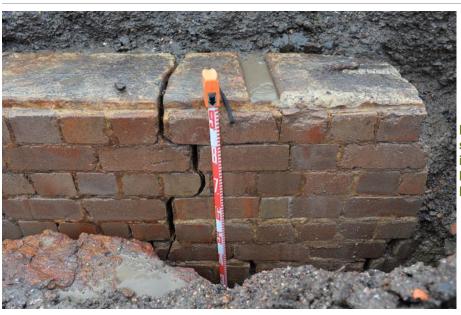
Figure 347. A photograph of a section of the wall of the ash pit identified during excavation for MTMS 2 (H1). Source: Mountains Heritage, 2020

Mountains Heritage, 2020. More Trains More Services, Sydney Terminal Area Reconfiguration (STAR): Discovery of a Brick Footing (H1) during archaeological monitoring at Central Station. Report prepared for John Holland.

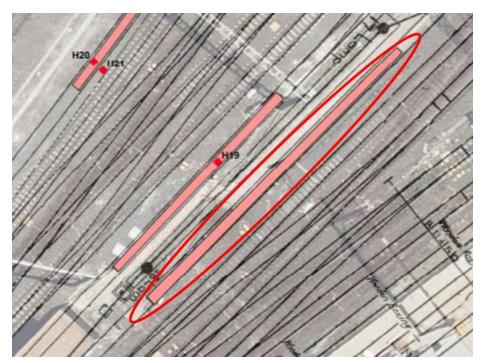
Figure 350. An overlay of the 1928 plan of Sydney Yard showing the location of the ash pit to the south of Platform 8 and the identified remains found during MTMS 2 excavations (H19). Source:

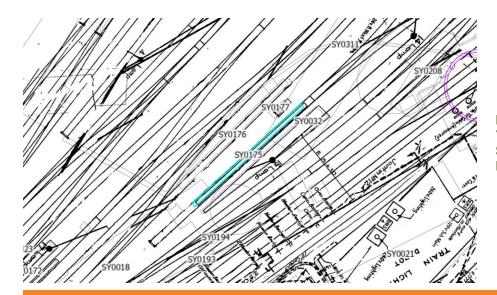
Figure 352. A 1928 plan of Sydney Yard showing the ash pit. Sydney: Sydney Trains VPR, EDMS EL0045988.

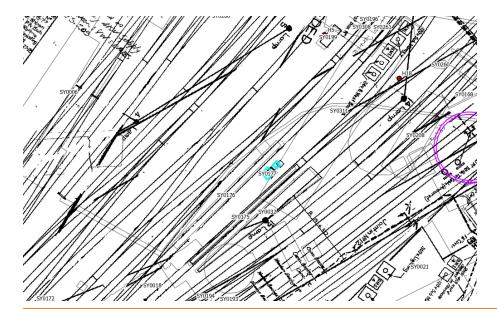
Figure 353. A 1928 plan of Sydney Yard showing the water crane. Source: Sydney Trains VPR, EDMS EL0045988.

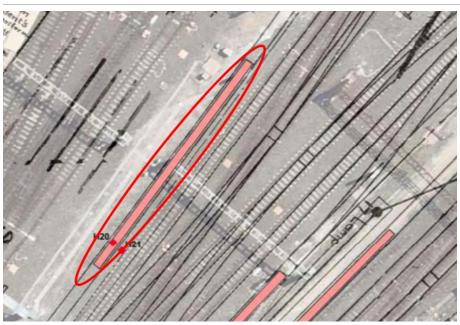
Figure 358. An overlay of the 1928 plan of Sydney Yard showing the location of the ash pit to the south of Platform 8 and the identified remains found during MTMS 2 excavations (H20). Source: Overlay of Mountains Heritage 2021 using Sydney Trains VPR, EDMS EL0045988.

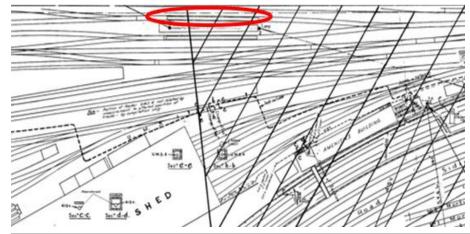
Figure 359. A c.1925 N.S.W.G.R. Chief Electrical Engineer's Office plan of the Western Carriage Shed and the surrounding railway tracks, showing the location of the ash pit. Source: Sydney Trains VPR, B/27846, 0045989_TOC.

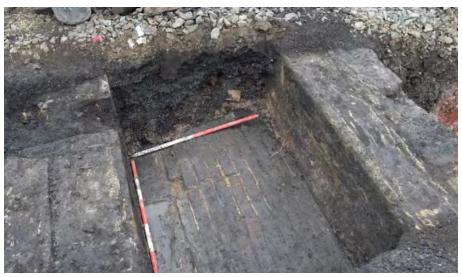
Figure 360. A photograph of a section of the ash pit identified during excavation for MTMS 2 (H20). Source: Mountains Heritage, 2021, p. 19.

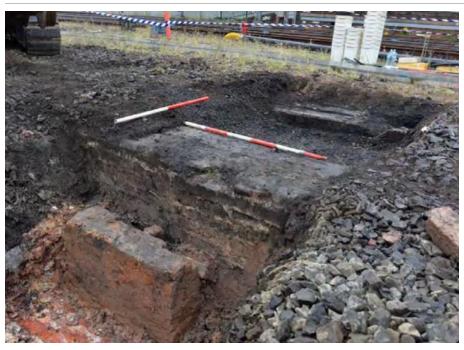
Figure 361. A photograph of the disturbed brick footing cut by the section of the ash pit identified during excavation for MTMS 2 (H20). Source: Mountains Heritage, 2021, p. 73.

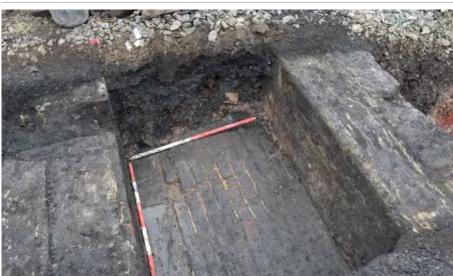
Figure 364. A photograph of a section of the nearby ash pit to the south of Platform 6 (SY0179) identified during excavation for MTMS 2 (H20) [Source: Mountains Heritage, 2021, p. 19]

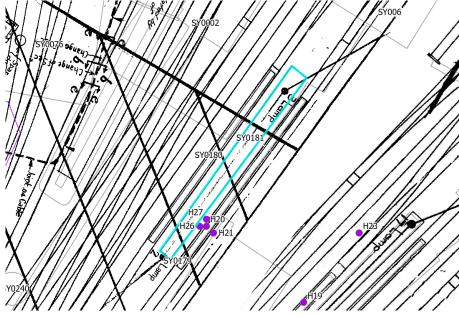
Figure 365. A c.1925 N.S.W.G.R. Chief Electrical Engineer's Office plan of the Western Carriage Shed and the surrounding railway tracks, showing the location of the ash pit. Source: Sydney Trains, B/27846, 0045989_T0C.

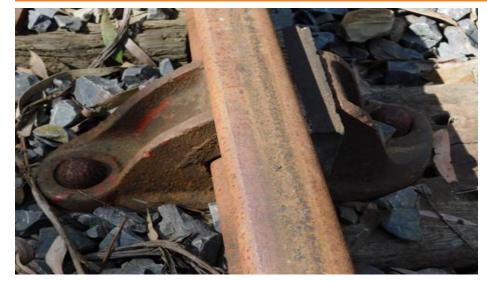
Figure 367 An example of Double Headed rail, Ravenswood Victoria. Source: Victorian Collections

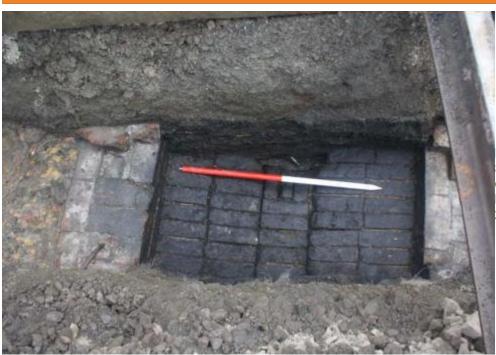
Figure 389. View of SY0197/H22 inspection pit with central drain. Source: Mountains Heritage 2021 Plate 2:6.

The 'Locomotive Shops' are shown in several historical photographs, including one from 1875 which shows a large sandstone building. Based on the typical layout of locomotive workshops it can be assumed that it contained several mechanical service bays, each with a below-ground inspection pit to repair locomotives and their components.¹⁹¹

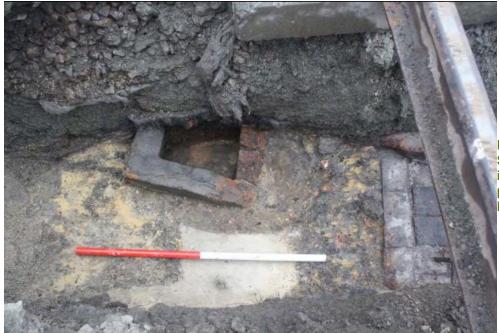
Figure 390. View of SY0197/H22 brick sump immediately east of inspection pit. Source: Mountains Heritage 2021 Pg. 77.

H22: Brick sump identified directly east of the brick service pit (Source: MTS Heritage, 2021).

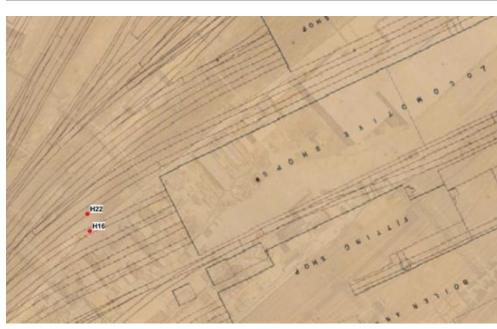
Figure 391. Location
SY0197/H22 in relation to the
1884 City of Sydney Plan. Note
discrepancy in location of
Locomotive Shops and
archaeological remains.
Source: Mountains Heritage
2021 Figure 2.6.

It is noted though that the location of the footing and surface H22 does not correspond with the location of the Locomotive Workshops as they appear on the 1884 City of Sydney Plan. This suggests the 1884 plan is inaccurate or that an undocumented south-western extension of the Locomotive Shops was constructed.¹⁹⁰

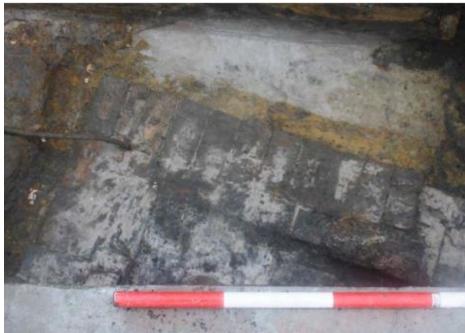
Figure 393. View of brick footing in section below modern concrete. Source: Mountains Heritage 2021 Plate 2:2.

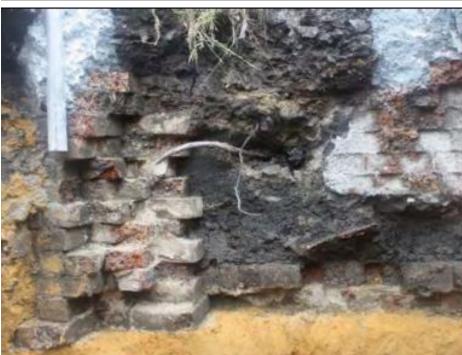
Figure 394. View of possible brick floor in section below ash fill. Source: Mountains Heritage 2021 Pg. 64.

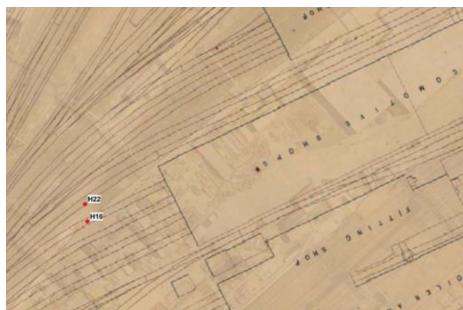
Figure 395. Location SY0198/H16 in relation to the 1884 City of Sydney Plan. Note discrepancy in location of Locomotive Shops and archaeological remains. Source: Mountains Heritage 2021 Figure 2.6.

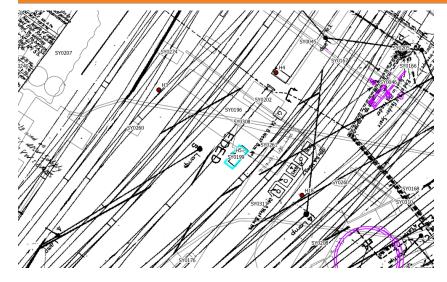
Figure 396. 1925 plan of Sydney Yard, showing a structure in approximate location of H5. Source: Sydney Trains VPR.

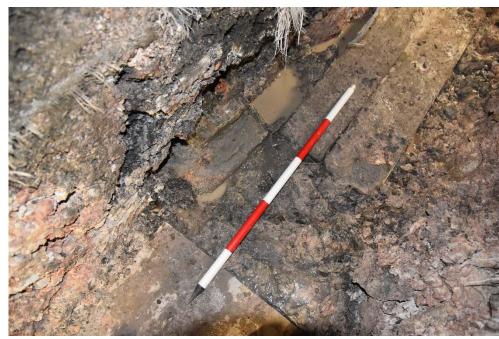
Figure 401. Small brick footing exposed at the base of the drainage trench, facing south east. Source:
Mountains Heritage 2021

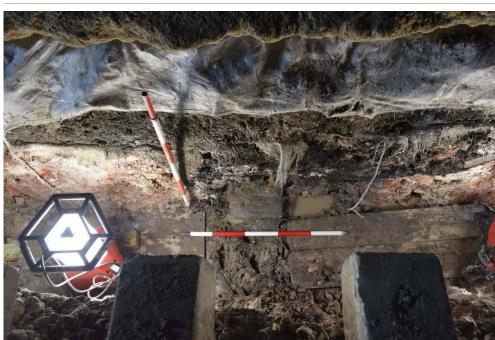
Figure 402. Small brick footing exposed in the east section of the drainage trench. Source: Mountains Heritage 2021

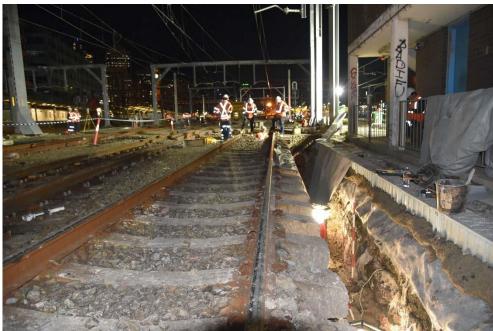
Figure 403. Small brick footing exposed in drainage trench, facing north. Source: Mountains Heritage 2021

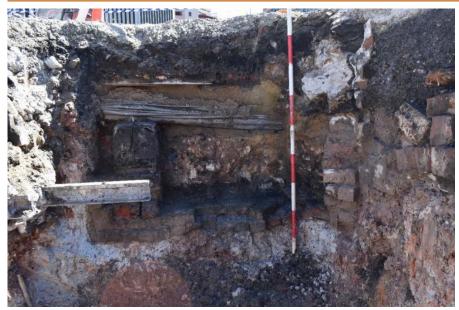
Figure 404. West section of ULX3 West Pit, showing the brick ash pit in section. Source: Mountains Heritage, 2021)

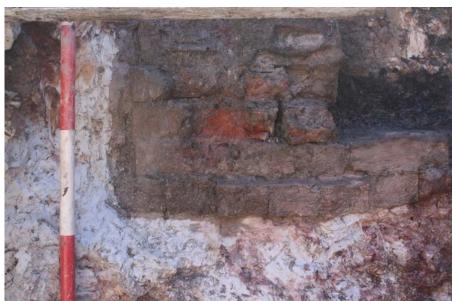
Figure 405. Detail view of the west section showing the brick floor and footing cut into natural B horizon clay. Source: Mountains Heritage, 2021

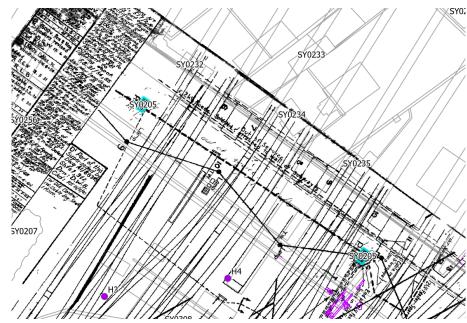
Figure 406. c.1925 N.S.W.G.R. Chief Electrical Engineer's Office plan of the Western Carriage Shed and the surrounding railway tracks, showing the location of the electrical pits. Source: Sydney Trains VPR.

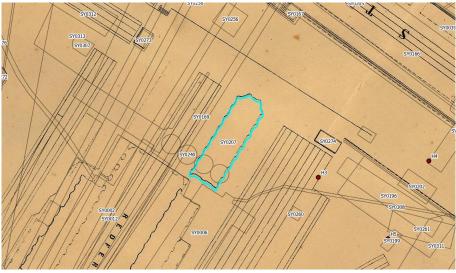
Figure 411. 1884 plan of the Second Sydney Station. Source: State Archives NSW. Metropolitan Water Sewerage & Drainage Board. Sheet 12.

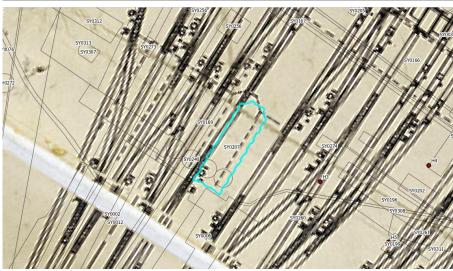
Figure 418. 1903 Central Station.
Source: SLNSW, Z/M3
811.1746/1903/1. N.S.W. Railways,
Sydney Central Station: Station
Arrangements. 1903.

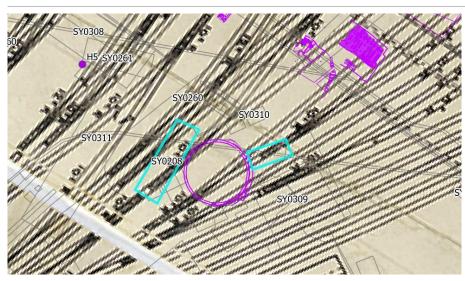
Figure 423. 1903 Central Station plan. Source: SLNSW, Z/M3 811.1746/1903/1. N.S.W. Railways, Sydney Central Station: Station Arrangements. 1903.

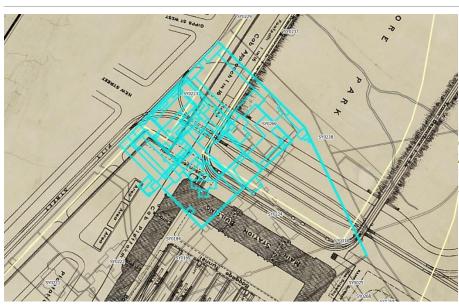
Figure 40. 1903 NS.W.R. Sydney Central Station. Source: SLNSW, Z/M3 811.1746/1903/1. N.S.W. Railways, Sydney Central Station: Station Arrangements. 1903.

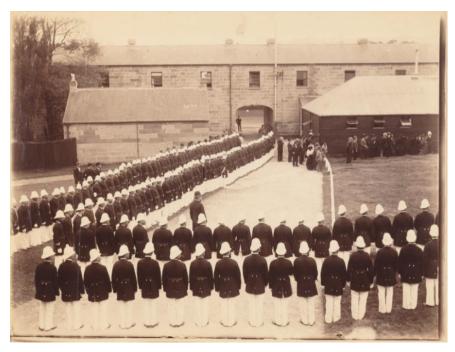
Figure 47. Police parade at Belmore Barracks 12 February 1896. Source: SLNSW. *Sydney Suburbs*, item 36 ca.1855-1924, DL PX 165.

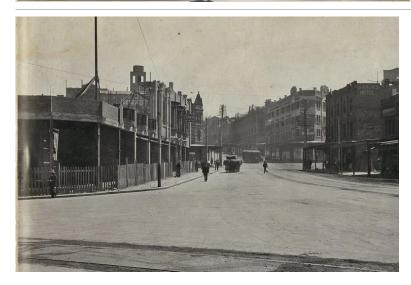
Figure 94. c.1913. Looking north up Elizabeth Street. Rickards Building under construction to the left. Source: City of Sydney Archives & History Resources, A-00024591

Construction of the Rickards Building was underway in 1913 and it was completed by 1914 (Figure 95, Figure 96). However, it was demolished a few years later due to the construction of the City Loop Railway Line, making it one of the shortest-lived buildings in Sydney's CBD (Figure 97, Figure 98).

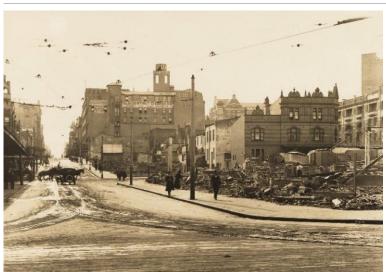
Figure 97. July 1916. Looking north up Castlereagh Street from Belmore Park. Note the Rickards Building under demolition to the right. Source: State Library NSW, YezdpQb9, p. 40.

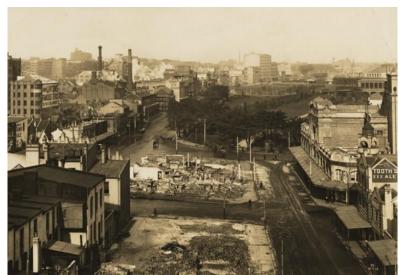
Figure 98. July 1916. Looking south from Oddfellows Hall towards Belmore Park. Note the former St Francis Church plot has been completely flattened. Source: State Library NSW, YezdpQb9, p. 43.

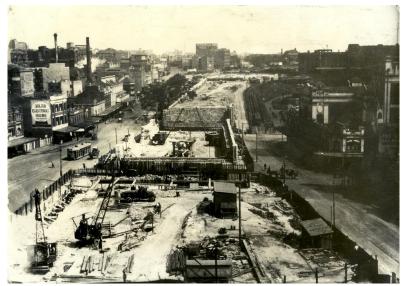
Figure 99. c.1925. Looking south from Goulburn Street. Electric railway lines between Central Station and Town Hall under construction. Note the extensive excavation work required to construct the lines, which are located beneath street level.

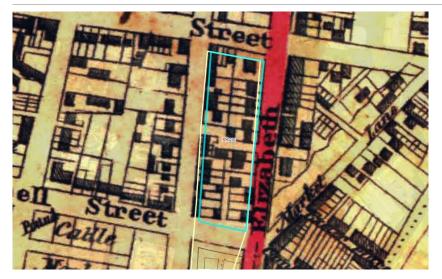
Figure 103. 1845 Sheilds Map. Source: City of Sydney Archives & History, A-00880420.

Historical maps from 1854 to 1903 (Figure 104, Figure 105, Figure 106) indicate that a number of structures were built on the parcel of land between Campbell and Goulburn Streets. Consistent with the accounts above, the sale of the structures suggests they were likely terrace houses, workers cottages or shops.

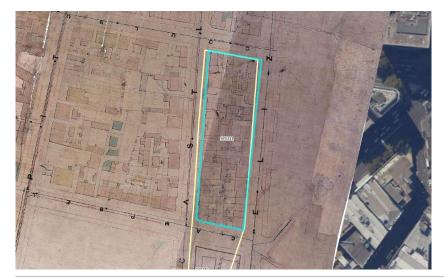
Figure 104. 1854 City of Sydney map. Source: City of Sydney Archives & History Resources, A-00880471.

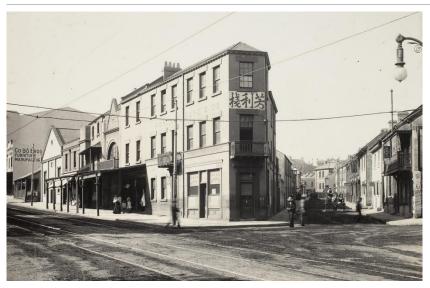
Figure 109. Eastern side of Elizabeth Street in the early 1900s. The images indicate that Elizabeth Street was predominantly lined by shops. Source: City of Sydney Archives & History Resources, A-00038796.

Archival recordings of the area were taken prior to its demolition. While views of the western side of Elizabeth Street, which forms the eastern boundary of the plot between Campbell and Goulburn Streets, were not captured, images of the eastern side of Elizabeth Street were recorded. These reveal the character of Elizabeth Street and its surrounds during the early 1900s (Figure 109, Figure 110, Figure 111, Figure 112).

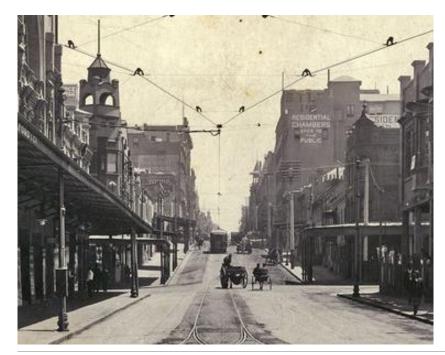
Figure 110. c.1906. Eastern side of Elizabeth Street in the early 1900s. Wexford Street visible to the right. Note the Fong Lee Jang & Co on the corner of Elizabeth and Wexford Streets. Source: City of Sydney Archives & History Resources, A-00040076.

The railway end of Castlereagh Street in the mid-1910s was described as featuring "Chinese shops and dwellings" as well as "nondescript" cheap lodging houses and social clubs. ⁵⁸ This account is consistent with historic photographs which show a Lodging House located on the block between Campbell and Goulburn Streets. Also shown is the Fong Lee Jang & Co building on the corner of Castlereagh and Campbell Streets. Fong Lee Jang & Co was located at 196 Elizabeth Street Sydney, however, relocated to 346- 352 Castlereagh Street following the resumption of Wexford Street (Figure 110 and Figure 111).

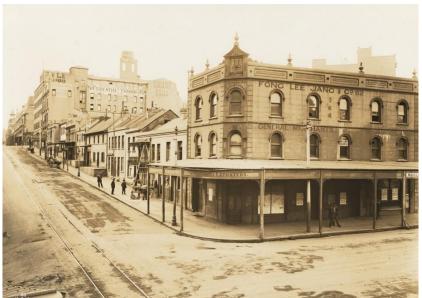
Figure 111. c.1914. View up Castlereagh Street from Hay Street, looking towards Campbell Street. Note the boarding house and Fong Lee Jang & Co (right). Source: Source: City of Sydney Archives & History Resources, A-00024592.

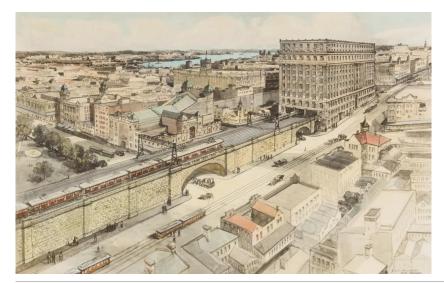
Figure 112. C.1915. Plot prior to demolition. Looking north up Castlereagh Street.

Note Fong Lee Jang & Co building to the right. This was relocated to the corner of Castlereagh and Campbell Streets following the Wexford Street resumption.

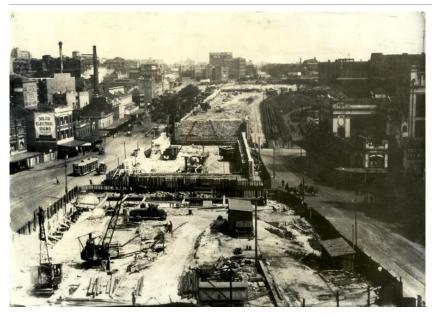
Figure 114. c.1917. Demolition of the structures on the block between Campbell and Goulburn Streets. Looking north. Note the variety of scale and form between the remaining buildings.

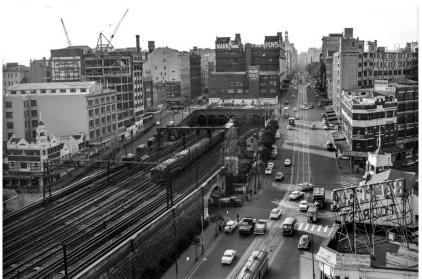
Figure 116. c.1956. Looking north towards the six underground railway tunnel entrances located beneath Goulburn Street. Signal box in the right corner. Note the level of ground disturbance due to the construction of the railway lines and their location beneath street level. This area is now concealed by the Goulburn Street Parking Station.

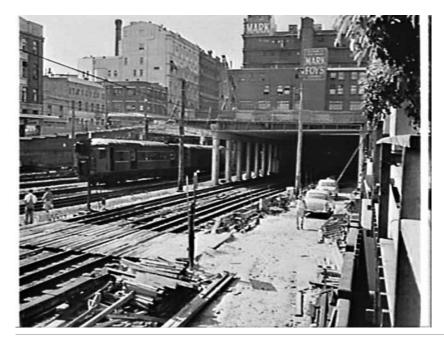
Figure 117. c.1960. Area between Goulburn and Campbell Streets prior to the erection of the Goulburn Street Parking Station. View looking north up Elizabeth Street. Goulburn Street is located above the six railway tunnels and Campbell Street is defined by the railway underpass to the south.

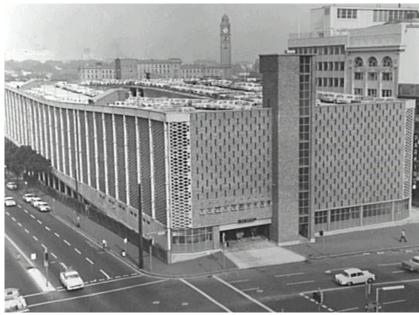
Figure 118 c.1962. Goulburn Street Parking Sta.tion under construction. Note the large structural piers between the railway lines.

Large concrete columns and foundations were required to build the Goulburn Street Car Park. Although these would be deeply ground penetrating, the ground had already been disturbed by previous works.

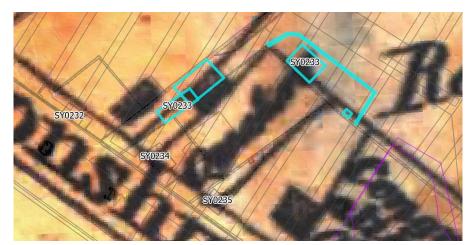
Figure 127. 1854 City of Sydney map. Source: City of Sydney Archives & History Resources, A-00880471.

The Roman Catholic section of Devonshire Street Cemetery was granted in 1825.⁷² The Roman Catholic caretaker's cottage was constructed in the mid-1830s,⁷³ although the earliest mapping showing such a building only dates to 1854 (Figure 127). The 1854 map shows that the Roman Catholic portion of the cemetery was a battle-axe block, accessed from Devonshire Street via an easement that ran alongside the portion of the Quakers. The 1854 map shows an indistinct rectilinear building along the easement; this is thought to be the hipped-roofed cottage which appears in a drawing by Frederick Mackie in 1854 (Figure 133), although the exact position of the building is unlikely to be correct due to the inaccuracy of the 1854 plan. An 1857 map shows a timber structure located along the eastern boundary of the easement; this may be the same structure as that shown on the 1854 map, but this assumption is uncertain (Figure 128). An 1881 plan of the neighbouring Quakers allotment shows a small 'cottage' built back to back with a shed in the Quakers section (Figure 134). The 1888 City of Sydney Plan no longer shows this timber item (Figure 130). These records indicate that the timber cottage, likely a sexton's or keeper's residence, was constructed prior to 1854 and was demolished by 1888.

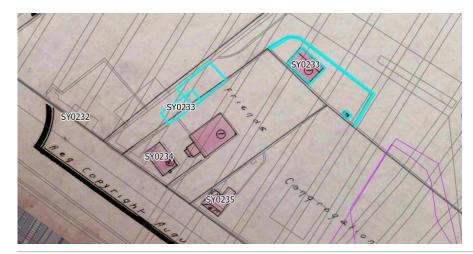
Figure 130. 1888 City of Sydney Rygate & West Plans of Sydney, 1888: Sheet 40. Source: City of Sydney Archives & History Resources, A-00880455.

By the time of 1888 plan, a single storey brick building was located to the north-east of the Quakers portion within the Roman Catholic section, with a small brick structure situated nearby to the south-east (Figure 130). These two brick items are further seen in mapping dated to 1896 and are interpreted as a caretaker's cottage and a privy (Figure 131). A photograph from 1900-1901 shows the caretaker's cottage as a rectilinear brick building with a corrugated iron-clad gabled roof and a sandstone-paved veranda along the north-eastern elevation, with an ad hoc timber extension along the south-eastern elevation (Figure 135). The brick cottage and privy were demolished in 1901 following the resumption of the area for the Third Central Station.

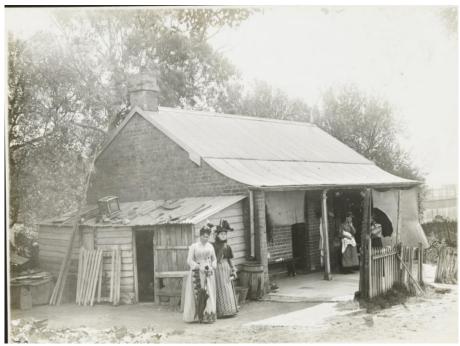
Figure 135. A 1900-1901 photograph of the brick Catholic caretaker's cottage. Source: SLNSW, FL15657655.

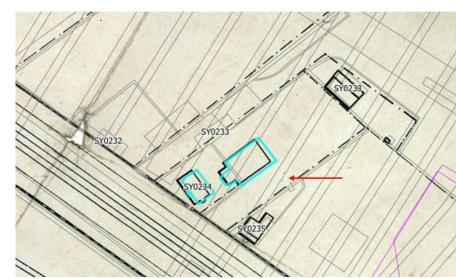
Figure 139. 1888 City of Sydney Rygate & West Plans of Sydney, 1888: Sheet 40. Source: City of Sydney Archives & History Resources, A-00880455.

the north-east of the c.1857 building, the Friends Meeting House, was constructed in 1868⁷⁷ and oriented at a right angle to the earlier structure (Figure 139). The two structures are both evident in the Society of Friends burial grounds in maps dating to 1888 and 1896 (Figure 139 and Figure 140). These maps correspond directly to a map produced for the Society of Friends by D. Clarke in 1888, which exhibits both the Meeting House and cottage/caretaker's residence, as well as the presence of a small shed along the north-western border of the Friends section, presumably used for storing caretaking equipment.⁷⁸ Little is known about the shed other than it was constructed between 1868 and 1881 and was demolished between 1881 and 1901.

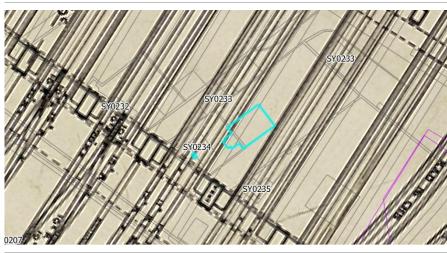
Figure 140. 1896 Redfern Station Yard. Red arrow indicates direction and location from which Figure 143 is taken. Source: SLNSW, FL16812178.

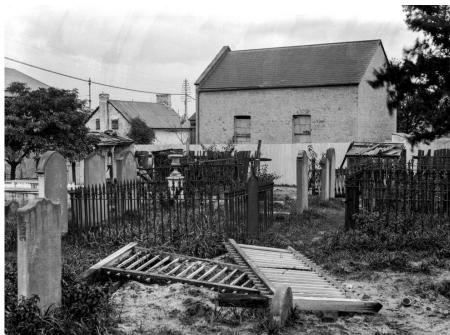
Figure 143. 1901 photograph of the Quakers Meeting House and cottage prior to demolition. Source: City of Sydney Archives & History Resources, A-01000181.

Photographs dating to the resumption of the area for the Third Central Station show the Friends Meeting House and cottage prior to demolition (Figure 143). The Friends Meeting House is shown as a tall rectilinear brick building on an ashlar sandstone foundation with a steeply pitched slate tiled gabled roof and multi-light timber sash windows. A gable-roofed entrance portico (narthex) flanked by cast iron columns with composite capitals surmounted by a timber and cast iron filigree entablature is visible along the south-western elevation (Figure 144). The portico is also shown as having timber lattice infill between the columns, a timber panelled pediment and a slate tiled fabled roof. The cottage is shown as a one-storey rectilinear brick building with a corrugated iron-clad gable roof and two brick chimneys at the north-western and south-eastern ends and two small four-light timber framed windows along the south-eastern elevation (Figure 143).

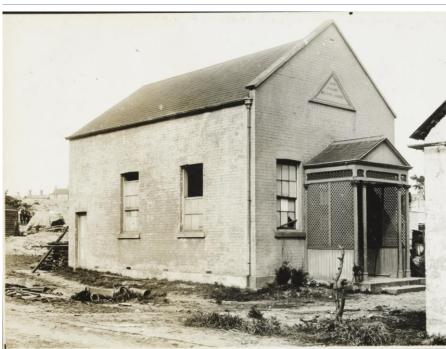
Figure 144. 1900-1901 photograph of the Quakers Meeting House and cottage prior to demolition. Source: SLNSW, FL15657660.

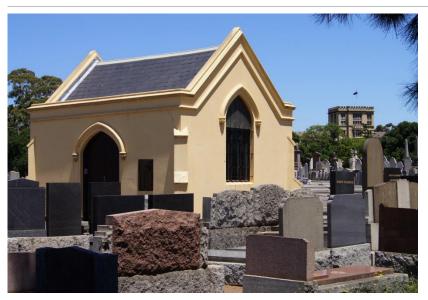
Figure 163. Melbourne General Cemetery Jewish Metahar House, view south west. Source: Melbourne Australia Photos, 2012.

Facilities for carrying out *tahara* are an intrinsic characteristic of Jewish burial infrastructure. The *Metahar* house at the Melbourne General Cemetery was constructed in 1854 and has recently been restored to immaculate condition (Figure 163). The Melbourne *Metahar* house is far smaller but also far more robustly constructed than the timber cottage that once comprised the Burial House and Sexton's Residence at Devonshire Street. An alternative burial location had been available to Jewish people in private land at Rookwood from 1867. In total, the timber Burial House and Sexton's Residence at Devonshire Street Cemetery would only have been in use for 35 years. The timber Burial House and Sexton's Residence may well have fallen into disrepair and ruin once the Devonshire Street Cemetery was closed and the buildings demolished by 1888, well before Jewish graves were removed by 1901.

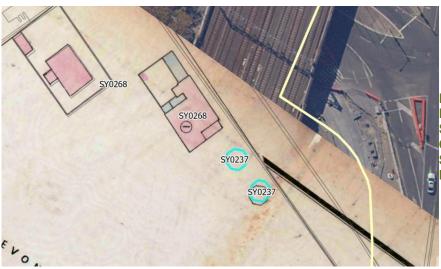
Figure 167. 1888 City of Sydney Rygate & West Plans of Sydney, 1888: Sheet 40, showing only the eastern Cemetery entrance gate to be intact. Source: City of Sydney Archives & History Resources, A-00880455.

In 1818, Governor Macquarie reserved land on Devonshire Street for use as a cemetery, with specific allotments for various religious denominations. The land was originally in a remote location relative to the heart of the city, which was necessary due to the Sydney Burial Ground reaching capacity. In June 1819 tenders had been called to construct a wall 4ft 6in high to enclose the grounds, resulting in the construction of a wall around the perimeter of the burial grounds. In September 1819 the first internment took place. The Devonshire Street Cemetery was officially opened and consecrated in January 1820.⁸⁶ The Devonshire Street Cemetery had a number of access points and gateways. On level ground the cemetery was surrounded by sandstone footings with iron fencing uprights inserted. In areas where a retaining wall was required, sandstone blocks were used. It is difficult to accurately gauge the size of the largest mapped gates – those to the south east of the Church of England chapel and cottage. As shown in the 1888 map of the area, the gate posts are represented as being approximately half the width of the chapel itself (Figure 167). This is unlikely, and it is more probable that the size of the gateposts has been exaggerated on historical mapping to enhance their visibility. By 1888, it appears that the north-western entrance gate next to the Church of England Chapel was relocated to the south-western end of Belmore Park (Figure 167 and Figure 168).

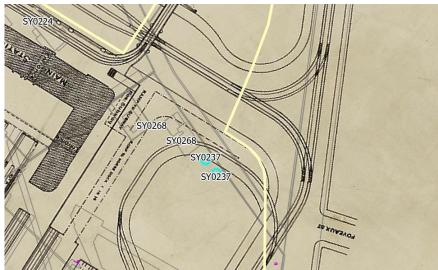
Figure 169. 1903 Central Station, showing the original location of the cemetery gates no longer extant.

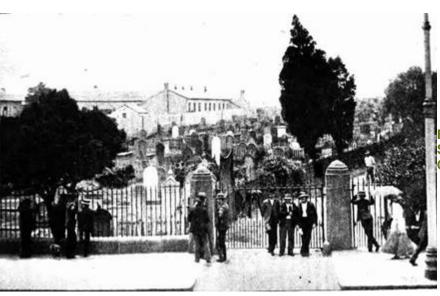
Figure 171. Gates to Devonshire Street Cemetery pre-1901. Source: Cited West, 2022.

Figure 171 shows one set of gates in place at the Devonshire Cemetery, while Figure 173 shows a set of these gates that were relocated to Rookwood Necropolis in 2004. One other set of gateposts had been previously relocated to the Camperdown Cemetery in 1946 as shown in Figure 174 and Figure 175.

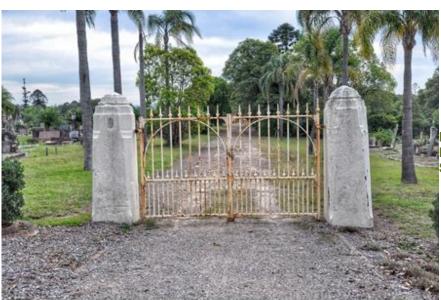
Figure 173. Gates relocated to Rookwood Necropolis in 2018. Source: Flickr, 2018.

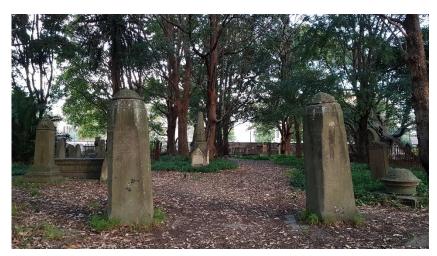
Figure 174. Gate posts relocated to Camperdown Cemetery. Source: Artefact, 2021.

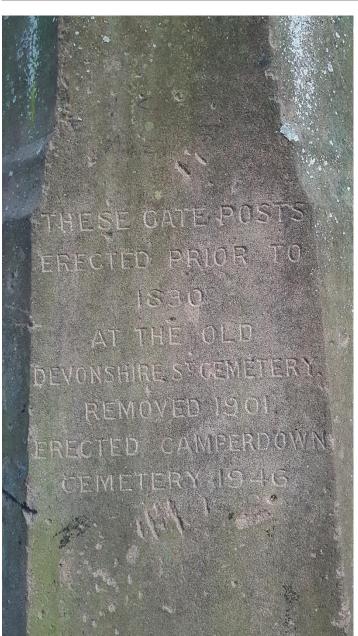
Figure 175. Gate posts relocated to Camperdown Cemetery. Source: Artefact, 2021.

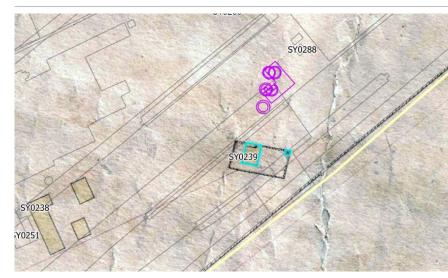
Figure 184. 1857 Chippendale Sheet 23, City of Sydney. Source: City of Sydney Archives & History Resources, A-00880168.

Likely associated with the first Sydney Railway Station constructed in 1855, this item is shown on mapping from 1857 as comprising two structures of different construction materials (Figure 184). The first is a rectangular building oriented approximately north to south, measuring some 6m by 3m. This is represented on in the 1857 map as being constructed from timber. Approximately 11m north east from this feature is a small square item represented as constructed in brick and not measuring substantially more than 1m x 1m; this structure is likely to have been a privy. Neither item is shown on mapping dated to 1855-1865 (Figure 185) or subsequent (Figure 186), indicating that the structures were temporary and demolished prior to 1865. Following demolition, the location of the buildings became a part of Prince Alfred Sidings, which was used for goods platforms and tracks in the late nineteenth century, a Lighting Depot in the twentieth century and an electrical substation in the twenty-first century.

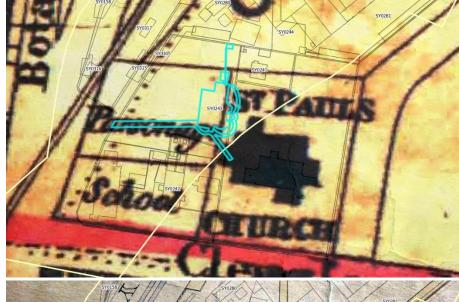
Figure 221. 1854 City of Sydney map. Source: City of Sydney Archives & History Resources, A-00880471.

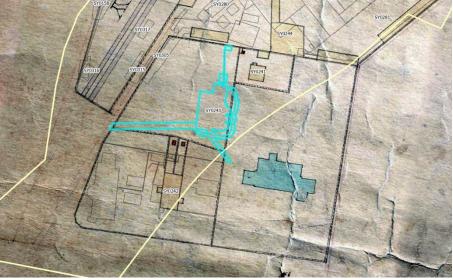
Figure 222. 1857 Chippendale Sheet 23, City of Sydney. Source: City of Sydney Archives & History Resources, A-00880168.

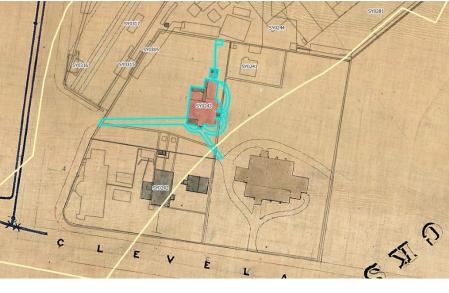
Figure 223. 1855-1865 Trigonometric survey, Block S2. Source: City of Sydney Archives & History Resources, A-00880408.

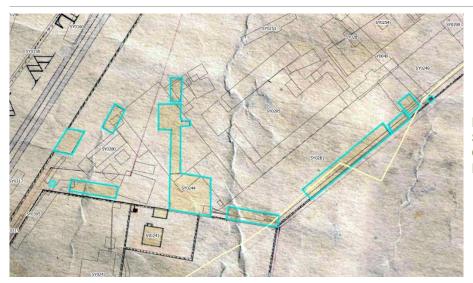
Figure 228. 1857 Chippendale Sheet 23, City of Sydney. Source: City of Sydney Archives & History Resources, A-00880168.

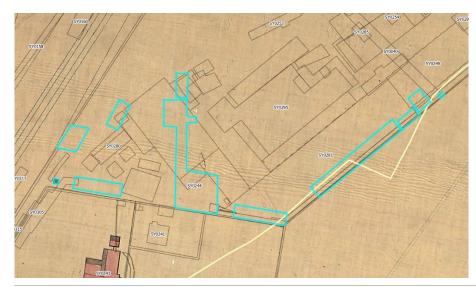
Figure 229. 1855-1865 Trigonometric survey, Block S2. Source: City of Sydney Archives & History Resources, A-00880408.

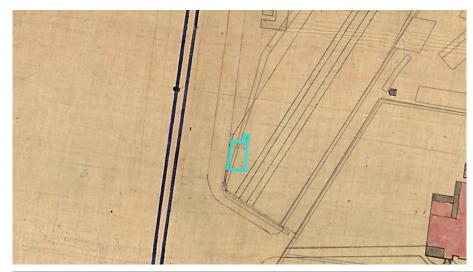
Figure 234. 1855-1865 Trigonometric survey, Block S2. Source: City of Sydney Archives & History Resources, A-00880408.

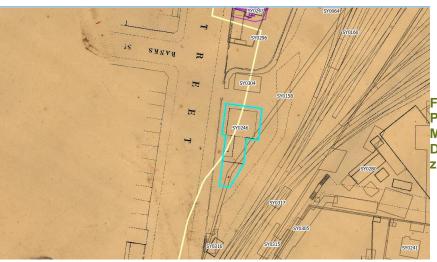
Figure 243. 1884 Sydney Water Board Plan. Source: State Archives NSW. Metropolitan Water Sewerage & Drainage Board. Sheet I2.

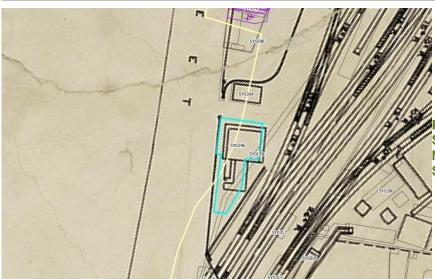
Figure 245. 1903 Central Station map. Source: SLNSW, Z/M3 811.1746/1903/1. N.S.W. Railways, Sydney Central Station: Station Arrangements. 1903.

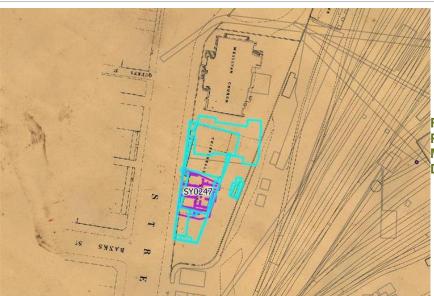
Figure 254. 1884 Sydney Water Board Plan. Source: State Archives NSW. Metropolitan Water Sewerage & Drainage Board. Sheet I2.

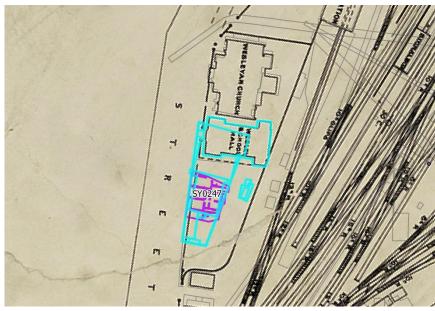
Figure 256. 1903 Central Station map. Source: SLNSW, Z/M3 811.1746/1903/1. N.S.W. Railways, Sydney Central Station: Station Arrangements. 1903.

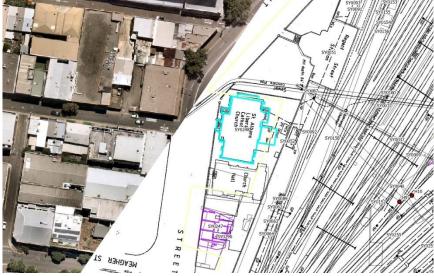
Figure 274. 1992 plan. Source: Sydney Trains VPR.

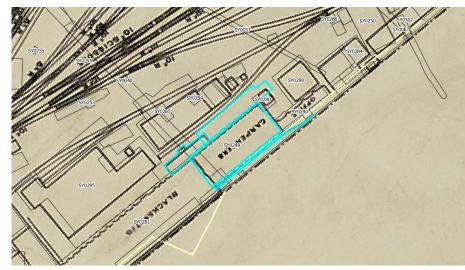
Figure 281. 1903 Central Station. Source: SLNSW, Z/M3 811.1746/1903/1. N.S.W. Railways, Sydney Central Station: Station Arrangements. 1903.

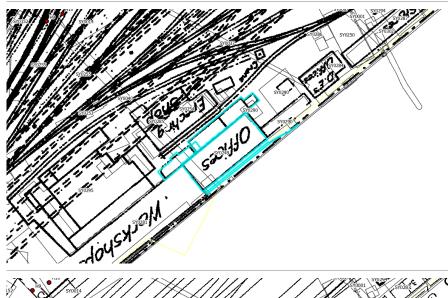
Figure 282. 1916 Sydney Trains Plan. Source: Sydney Trains VPR, 204478 A0C.

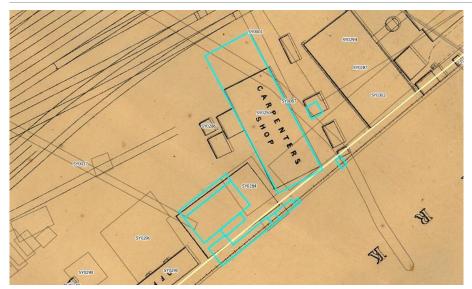
Figure 292. 1884 plan of the Second Sydney Station. Source: State Archives NSW. Metropolitan Water Sewerage & Drainage Board. Sheet I2.

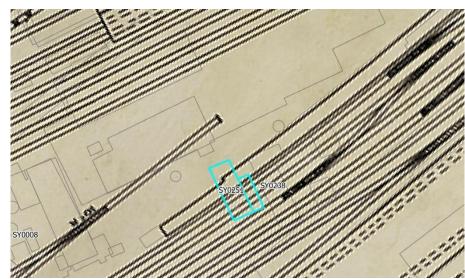
Figure 298. 1903 Central Station. Source: SLNSW, Z/M3 811.1746/1903/1. N.S.W. Railways, Sydney Central Station: Station Arrangements. 1903.

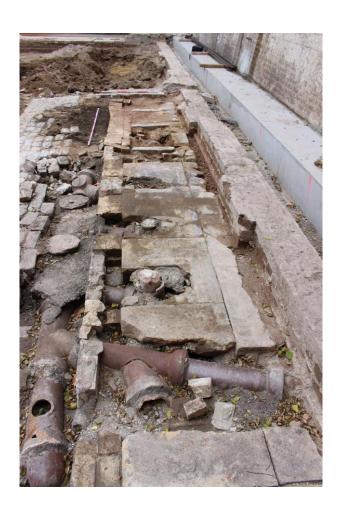
Figure 306. Northeast view of the lower portion of the South Toilets cubicles following the removal of the top concrete and bricks.
Source: Artefact, 2018.

The remains of the urinal building were discovered during monitoring in 2017 and a salvage excavation in 2018 following demolition of the Radio Workshop (SY0321) as part of the CSELR project. The remains of the urinal building were found to include a line of toilet bases within separate cubicles, comprising brick foundations, terracotta piping, sandstone bases and concrete flooring.¹¹⁸ A number of the bricks used in the walls of the urinal building were inscribed with 'SHORTUS'; the bricks therefore can be attributed to William Shortus, a brickmaker based in Marrickville who was active from 1868 to 1875.¹¹⁹

The remains of the cistern and urinals were removed and salvaged during the 2018 salvage excavation. However, the northern end of the urinals or an additional cistern and the tarpaulin shed may remain in situ as the foundations for the Railway Institute Buildings are likely to have truncated, rather than fully removed, the foundations of these structures.

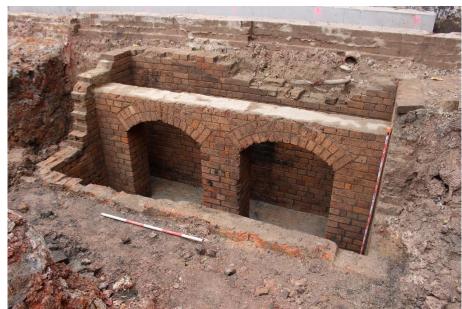
Figure 307. West view of the Brick Cistern. Source: Artefact, 2018.

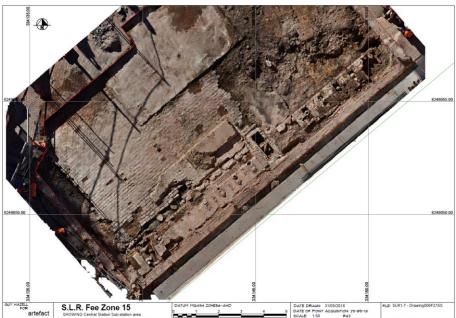
Figure 308. Survey plan (with orthophoto imagery) of the urinal building within the footprint of the Radio Workshop as recorded during the salvage excavation in 2018 as part of the CSELR project. Source: Guy Hazell in Artefact Heritage, 2018.

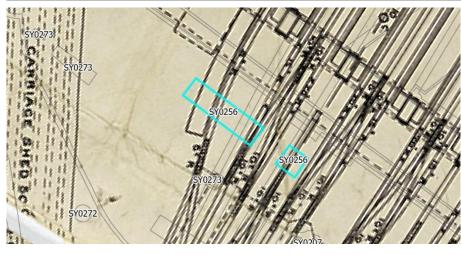
Figure 329. 1903 Central Station map. Source: SLNSW, Z/M3 811.1746/1903/1. N.S.W. Railways, Sydney Central Station: Station Arrangements. 1903.

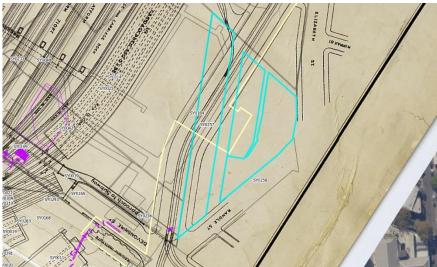
Figure 343. 1903 Central Station map. Source: SLNSW, Z/M3 811.1746/1903/1. N.S.W. Railways, Sydney Central Station: Station Arrangements. 1903.

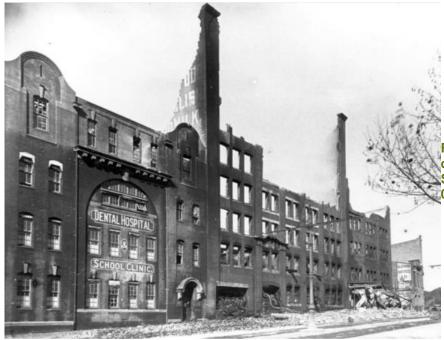
Figure 344. Image of the 1919 fire damage to the Dental Hospital.
Source: City of Sydney Archives, A-00036920

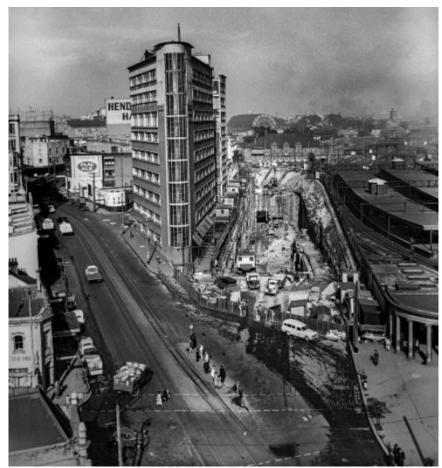
Figure 347. Photograph showing excavation of the ESR, extending across the total width of Chalmers Street. Source: City of Sydney Archives, SRC136.

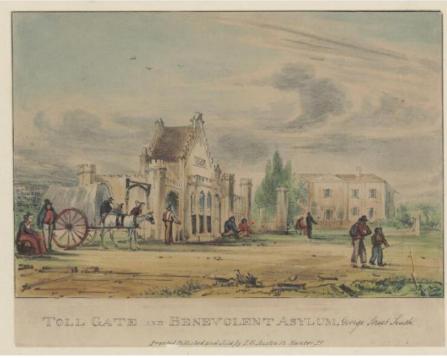
Figure 434. 1836 lithograph of the Toll Gate and Benevolent Asylum. Source: NLA, PIC Drawer 62 #U378 NK707/9.

The earliest cartographic and illustrative representations of a toll gate across the southern end of George Street date to 1821-1822, as shown in Figure 426 and Figure 433. A later representation of a toll gate in the same location dates to 1836, and likely illustrates the item referred to by Governor Bourke and shown in the 1854 map (Figure 435 and Figure 428). This indicates that the toll gate was rebuilt in 1836, likely in response to an increase in traffic.

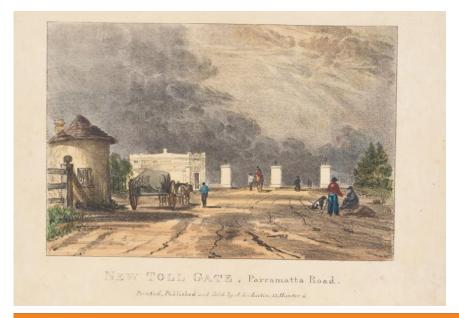
Figure 435. Plate from Austin's 'A series of lithographic drawings of Sydney and its environs', published 1836, showing the "New Toll Gate, Parramatta Road", which is thought to have replaced the earlier Toll Gate. Source: Dixson Library, SLNSW, 1836 DL Pd 6.

The location of the toll house appears to have remained within the road corridor of the intersection of Broadway and Parramatta Road. This may have acted to preferentially preserve remains of the toll houses recorded as having stood here. The first toll gate, likely dated c.1811, shown in Figure 433 and Figure 435, appears as a Gothic Revival toll gate and central gatehouse constructed from sandstone, or plastered brick, with a tiled gabled roof, crenelated decorative sandstone elements and a glazed bay window. The second toll gate, constructed in c.1836, also appears to have been constructed from sandstone or plastered/rendered brickwork. The gate posts are of simpler design that the earlier gate posts, potentially comprising cylindrical or rectilinear posts surmounted by iron lampposts. The gate house itself appears to have been relocated on a right-angle alignment to the gate itself, featuring what appears to be a Classical style of architecture. The site appears to only have been subject to demolition for the purposes of road construction, which may not have entailed the full removal of lower remains and footings of the toll gates or houses. In addition to potential intact remains, a demolition layer may remain intact

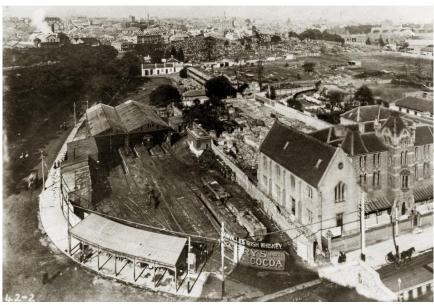
Figure 450. The Belmore Tram Sheds in c.1890. Source: City of Sydney Archives, A-00018780.

The 1888 City of Sydney Rygate & West Plans of Sydney and historical photographs provide information on the fabric, construction and layout of the Tram Sheds structures, indicating that the majority of the multiple structures on site were constructed from iron, likely with timber or steel framing (Figure 447 and Figure 450). The 1888 map and historical photographs additionally demonstrate that one building in the yard, a two-storey rectilinear building along the western boundary of the Tram Sheds yard was constructed from brick (Figure 447 and Figure 450).

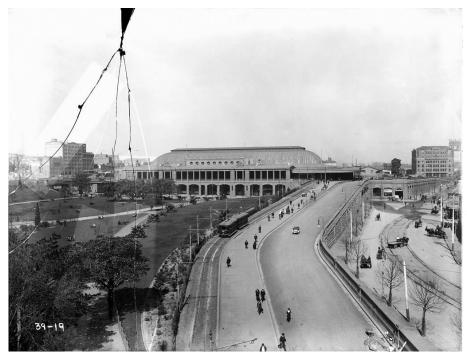
Figure 455. Electrical Tram at Railway Colonnade, Central Station. Source: MAAS Powerhouse Collection, 85/1286-202.

A mix of steam-powered and cable-powered trams were used between 1879 and 1898. However, from 1898 onwards, the lines were progressively electrified until the majority of the Sydney system was electric in 1910.²⁰⁹ The tramlines were gradually closed from the 1930s onwards, with the final service running in 1957, after which, the electrical wires were pulled down and the rails paved over.²¹⁰ An electrical tram is shown drawing into Central Railway Station in Figure 455.

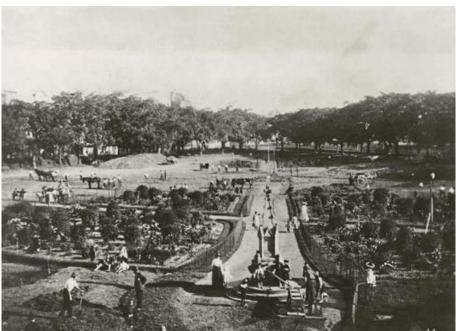
Figure 463. Belmore Park c. 1879, workmen, horses and carts visible excavating the tram line through the park. Pedestrian surfaces appear to be unsealed / gravelled.

The pedestrian paths illustrated in Belmore Park in Figure 1 and Figure 2 were almost certainly earthen or gravelled, as indicated in Figure 463. It is likely that the resumption of Belmore Park for construction of Central Railway Station will have entailed the uprooting of vegetation and trees and levelling of ground surfaces. Little if any sealed pathways are evident in the 1943 aerial image, in which the chief distinguishing feature of Belmore Park is the large number of zig-zag air rad shelters it contains (Figure 462). These are, however, outside of the study area. The asphalt and cement paving within the park appears to be a relatively modern introduction.

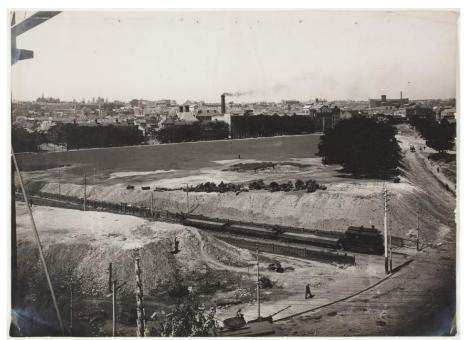
Figure 466. Belmore Park during construction of Central Railway Station. Source: Trove.

During the 1901 resumption of the area for the Third Central Railway Station, the 80,000 cubic yards of earth fill was laid on Belmore Park, burying the earlier layout.²²¹ The extent of this fill can be observed in Figure 466.

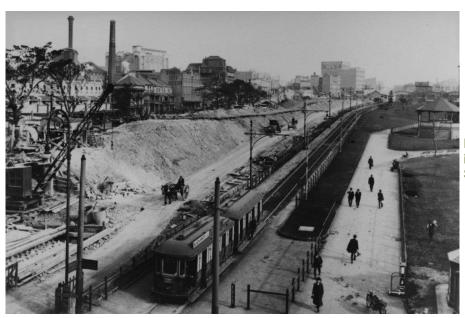
Figure 467. Belmore Park tramline in the 1920s. Source: City of Sydney Archives, A-00057922.

The first steam tram line in Sydney was built in 1879, and steam propelled tram cars were largely replaced by electricity by 1898. 199 The first steam tram line originally travelled from Hunter Street via Elizabeth Street, then across Belmore Park to Pitt Street and up to Devonshire Street where it terminated at the Sydney Railway Station. The Belmore Tram Car Shed yard, otherwise known as the tram depot, was constructed in 1879 to provide sheds for the engines and cars, as well as a siding to connect the station yard and the main line of the tramway. 200 From 1880, the steam tram system rapidly expanded with the existing line serving the Western suburbs and Dulwich Hill. This tramway diagonally bisected Belmore Park and trams were housed in a Tramcar Shed in the south western corner of Belmore Park at the intersection of Pitt Street and Garden Road. 201

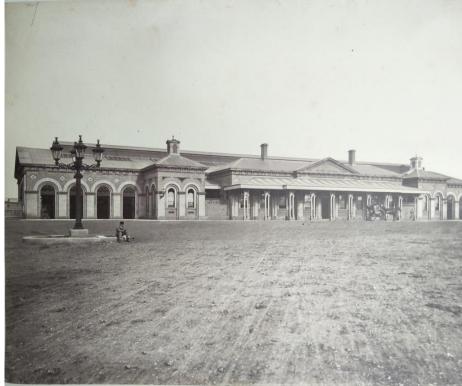
Figure 471. c.1877 photograph of Second Station, looking west, with the lamp post and plinth structure clearly visible on the left hand side of the photograph. Source: SLNSW, PXD 1175, 3.

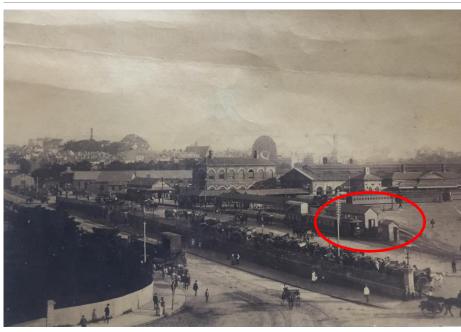
Figure 477. A photograph of Redfern Station dated as c.1867, but more likely c.1887, showing Tramway platform and timber buildings (circled). Source: SLNSW, PXA 2127/Box 11.

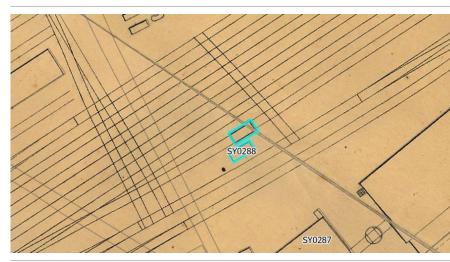
Figure 551. 1884 Sydney Water Board Plan showing the southern group of structures. Source: State Archives NSW. Metropolitan Water Sewerage & Drainage Board. Sheet I2.

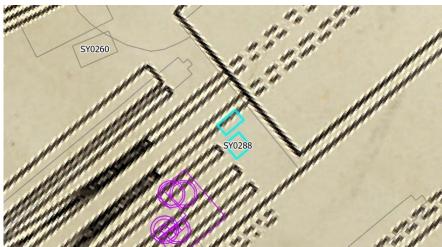
Figure 556. 1903 Central Station map, showing the northern group of structures. Source: SLNSW, Z/M3 811.1746/1903/1. N.S.W. Railways, Sydney Central Station: Station Arrangements. 1903.

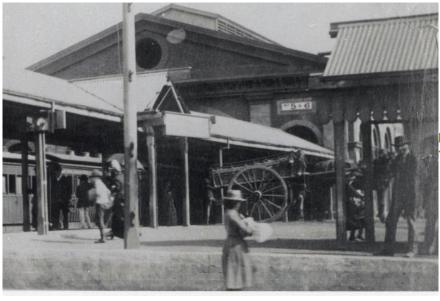
Figure 587. Redfern / Central Station c. 1890. Source: Unknown.

Two small rectangular structures are first shown on mapping dating to c.1872, adjacent to Devonshire Street and staggered relative to each other. Given their proximity to Devonshire Street it is also likely that they fulfilled a function more specific to the street than to the railway station, possibly such as passenger waiting shelters, as seen in the right hand side of Figure 587. These items are last represented on plans dated to 1896 and were most likely

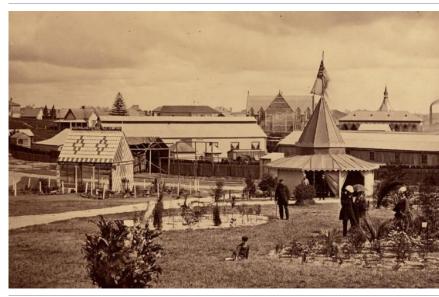
Figure 5: Image of the early Prince Alfred siding buildings (possibly the produce shed and goods shed), c.1870s. (Source: SLNSW)

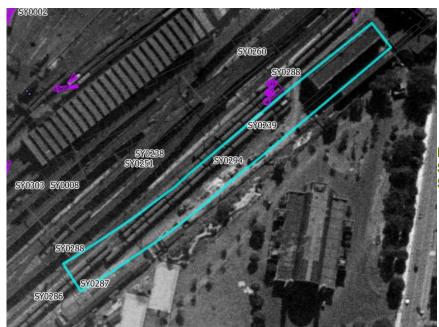
Figure 593. 1925 N.S.W.R. Chief Electrical Engineers Office High Voltage Cables. Source: Sydney Trains Plans Room, 0045989 T0C.
