Author:	Elanor Pitt, Anita Yousif, Michael Lever
Project manager:	Sandra Wallace
Name of organisation:	Artefact Heritage Services Pty Ltd
Name of project:	Central Station Precinct Renewal
Name of document:	Non-Aboriginal Archaeological Site Plan
Document version:	Official

EXECUTIVE SUMMARY

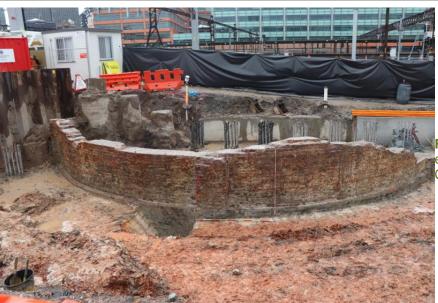
Figure 667. The Gas Holder following excavation in February 2019 during the CMS works. Source: Artefact 2020

As part of the Central Station Main Works (CSMW) project, the eastern section of the Gas Holder was discovered in February 2019.²⁶⁷ The Gas Holder was found to comprise a truncated curved machine-made brick wall measuring approximately length of 21.15m and a maximum height of 2.8 meters, consisting of 34 vertical brick courses, supported by three buttresses. The Gas Holder was found to have been partially demolished and impacted in a number of places by the installation of services. The eastern half of the Gas Holder was removed following completion of recording. The western half of the Gas Holder remains *in situ*. The eastern buildings of the gas works was within the CSMW footprint, but was not identified during excavation works. However, the western building may be intact as it is not located within this footprint.

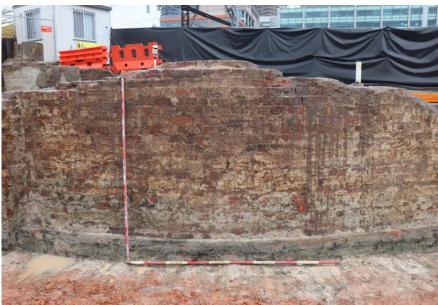
Figure 668. The Gas Holder following excavation in February 2019 during the CMS works. Source: Artefact 2020.

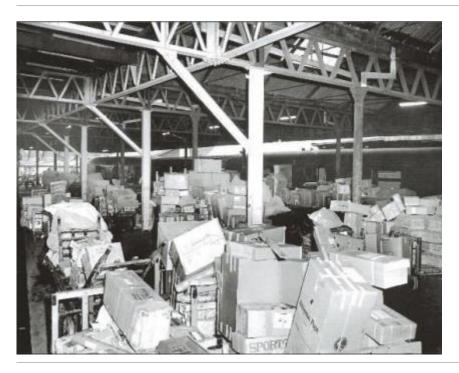
Figure 693. Figure 16: Interior of the Inwards Parcels Shed, circa 1973. Source: McKillop, Ellsmore and Oakes, A Century of Central: Sydney's Central Railway Station 1906 to 2006. Australian Railway Historical Society/NSW Division, NSW

The Inwards Parcels Shed was built in 1906 alongside Platform 1 and was designed by the Government Architect Gorrie Blair, who was also responsible for the design of the Mitchell Library building of the NSW State Library. The purpose of the building was to be a clearing house for parcels arriving from the countryside, forming a complex with the Outwards Parcel Shed which was once on the corner of Pitt Street and Eddy Avenue. The Parcels Post Office (now the Adina Hotel) was constructed in 1910 adjacent to the Inwards Parcels Shed. The Parcels Post Office received parcels from department stores and suppliers and dispatched them to countryside regions on the overnight mail trains which left from Central Station. The building was constructed as a timber structure lined as a corrugated iron shed with a loading dock and yard on the western side. Inside the building, it was configured into three sections, including the Inwards Parcels Office and a Cashier's Office. Fibreglass skylights provided a natural lighting source and rafters support the roof internally and externally. Four rows of columns ran along the building; the two internal rows formed a nave and another row ran along each of the side walls of the building (Figure 693). There are also several internal brick bays with fireplaces which serve to brace the structure of the building. The building included a lift (Figure 694).

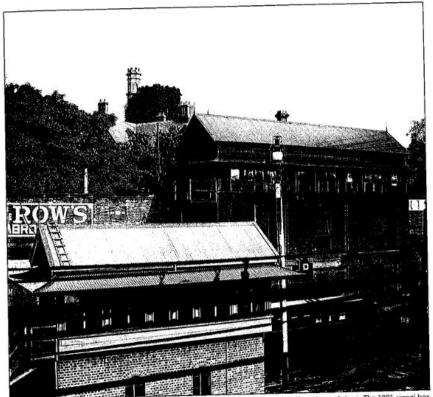
Taken in 1910 as evidenced by the new Tunnel power signal box in the foreground looking nice and clean. The 1891 signal box in the foreground looking nice and clean. The 1891 signal box in the background was still in service.

Figure 711. Image of the Signal Box 1910 (Source: RT Taafee Collection)

The signal provided for the widening of Redfern Tunnel and power operation for Sydney Yard. This signal box was constructed for the use of the new station in 1906, however the reasons unbeknownst the opening of the signal box was delayed until 1910. Plans were found for a temporary base for the signal until a permanent position was found, however, it is unknown whether this permanent relocation occurred. In 1924, the signal box was closed, removed, and replaced by the Sydney Station West and Wells Street signal boxes. There is reason to believe hat the interlocking machine from the 1910 Redfern signal box, was reused at Sydenham Station.

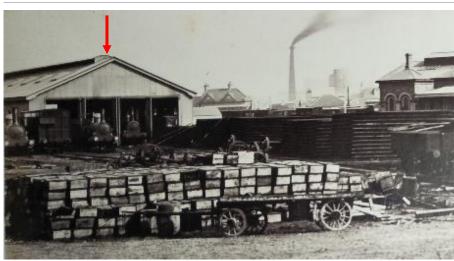
Figure 718. Cropped version of the 1877 photograph of the goods shed of Second Redfern Station looking west, showing the Engine Erecting Shop (left side of frame). Source: SLNSW, PXD 1175.

The Engine Erecting Shop was constructed as part of the rail yard of the Second Station, first appearing on the c.1872 map as rectilinear building oriented on a roughly SW to NE orientation, with four rail tracks leading into the south-western side of the building. An 1877 photograph of the Goods Building shows the Engine Erecting Shop nearby (Figure 718).²⁷⁹ The photograph shows the Engine Erecting Shop to be a timber-framed gable roofed rectilinear building clad in corrugated iron, with an opening along the north-western elevation for the construction and movement of four steam engines at a time. Although the building also appears on an 1884 map, it appears to have been remodelled or replaced by a gas works building by c.1896 (SY0309).

Although the building is shown as an iron clad timber-framed building in the 1877 photograph, it is unknown as to whether or not the foundation of the structure comprised timber postholes or brick footings. Following the c.1896 remodelling of the building associated with the gasworks, the gasworks were removed and the area laid with railway tracks. During the first half of the twentieth century, the area was redeveloped as part of the Sydney Yards, and a Mechanical Plumbers built partly over the location of the Engine Erecting Shop in c.1930. The Mechanical Plumbers building was rebuilt in 1944-46 and demolished in 2018 as part of CMSW (see SY0022). The majority of the footprint of the Engine Erecting Shop is within the CMSW construction area, which is likely to have removed the majority of the remains of the structure. However the eastern section of the footings, if brick, may remain intact.

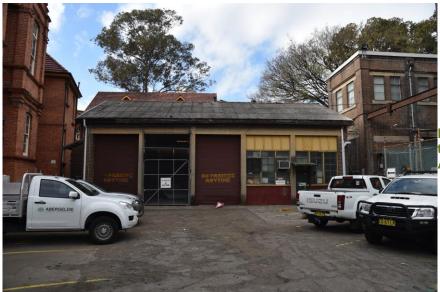
Figure 729. The Radio Workshop prior to its demolition in 2018. Source: Artefact, 2018.

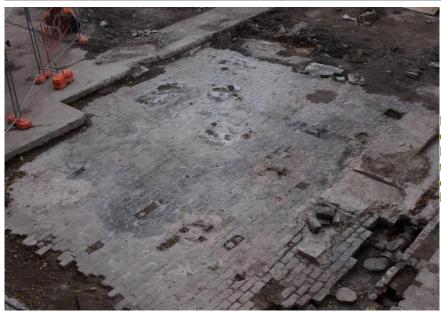
Figure 730. Photograph of the cobblestone flooring surface of the Radio Workshop as recorded during the salvage excavation in 2018 as part of the CSELR project. Source: Artefact Heritage, 2018.

The CSELR salvage excavation is likely to have removed the majority of the archaeological remains, but there may be some evidence of the workshop outside of the areas of the excavation for the substation. These would likely include the brick foundations of the building.

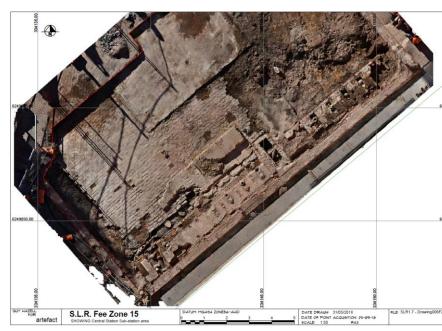
Figure 731. Survey plan (with orthophoto imagery) Photograph of the cobblestone flooring surface of the Radio Workshop as recorded during the salvage excavation in 2018 as part of the CSELR project. Source: Guy, Hazell in Artefact Heritage, 2018.
