Desktop Report on  
Geotechnical Assessment

Proposed Multi-Storey Mixed Use Development  
10 Young St, 61 Central Coast Hwy & 1 Racecourse  
Rd, West Gosford

Prepared for  
Japrico Developments Pty Ltd

Project 75808.03  
August 2022

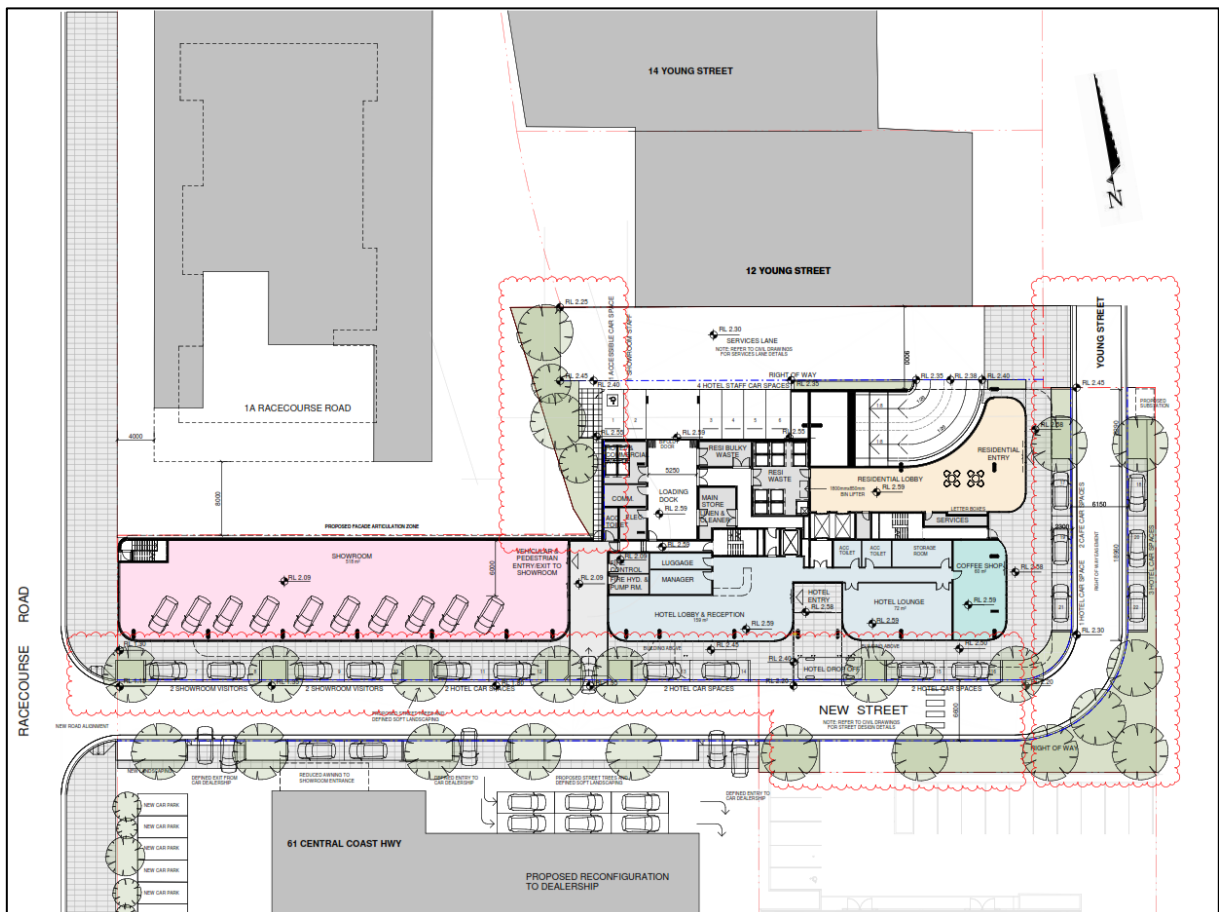
**Figure 1: Ground floor plan for the proposed development**

Figure 1 and Figure 2 show excerpts of the architectural drawings with the pertinent aspects described above.

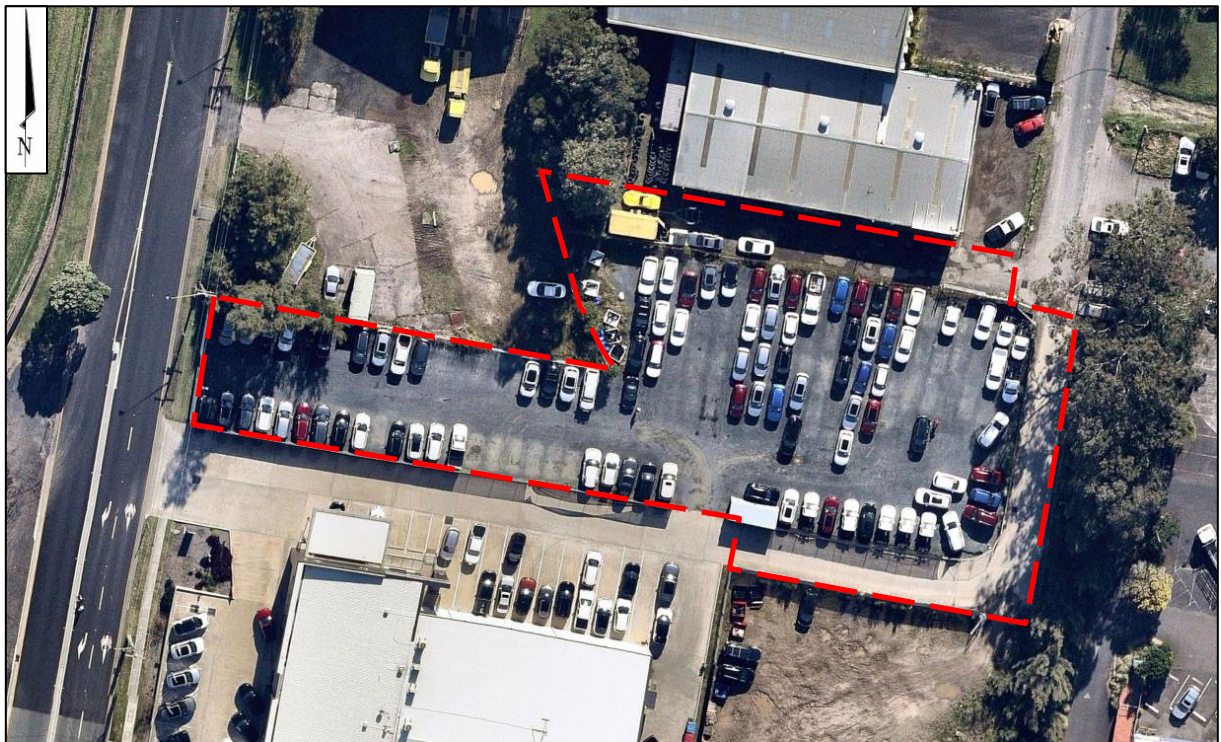
**Figure 3: Aerial view of the site (sourced from NearMap imagery and dated 1 July 2020)**

During the previous field work, several stockpiles were present on the site, and these were associated with excavations to accommodate the new access road. The remainder of the site was covered with grass. Industrial properties were located to the north and east of the site. Figure 3 shows a recent aerial view of the site, and this indicates that, since the time of the investigation (DP, July 2015), it appears that a granular hardstand has been constructed and the site is now used as a vehicle storage compound. The red outline shows the boundary of 10 Young Street.

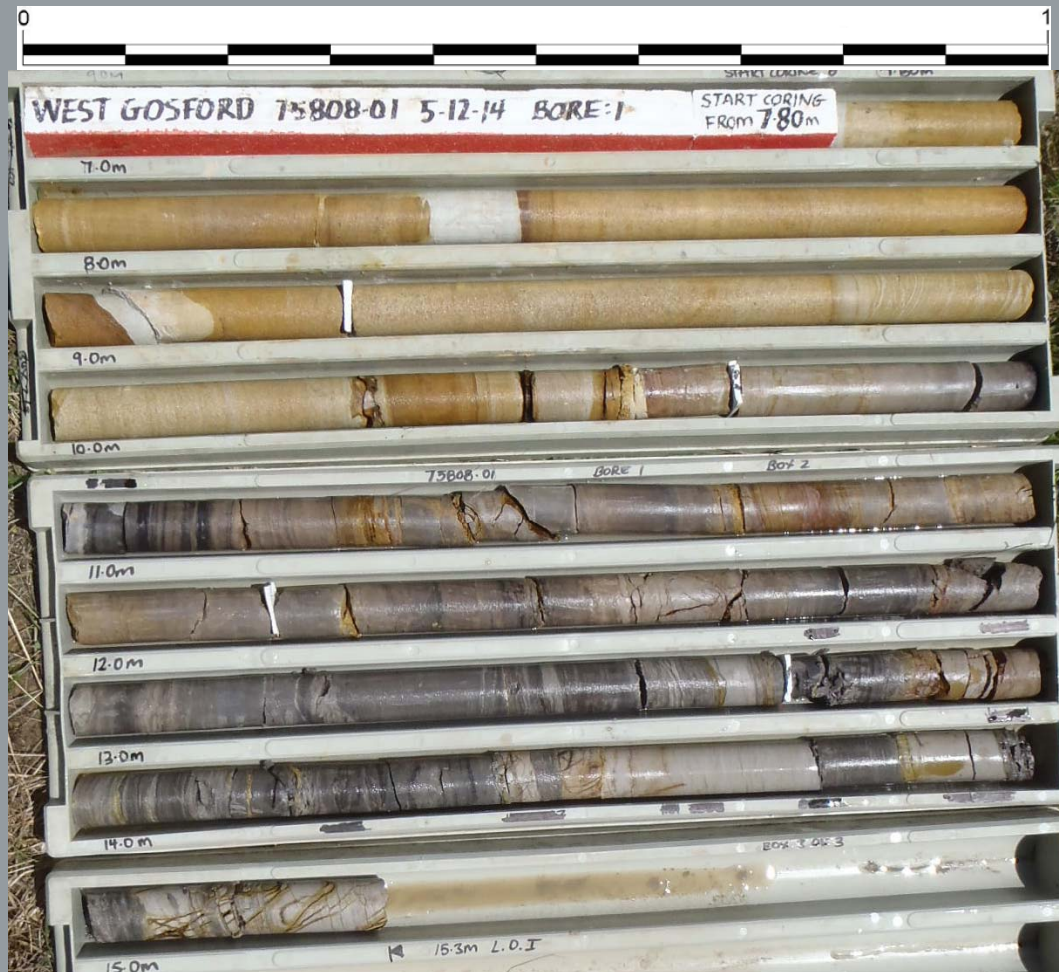
BORE 1

7.8 – 15.3m

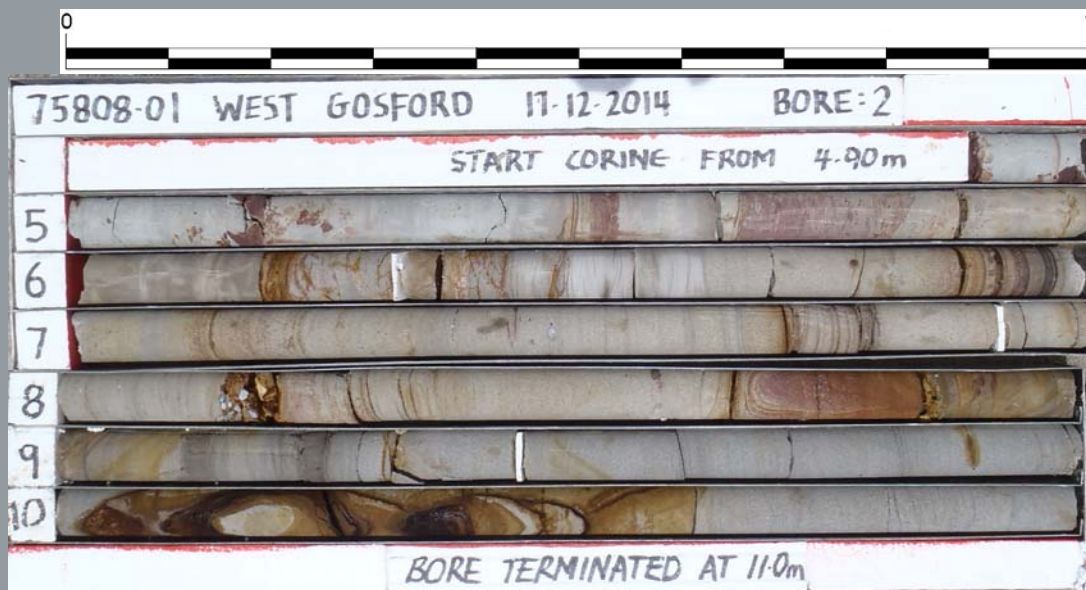
BORE 2

4.9 – 11.0m

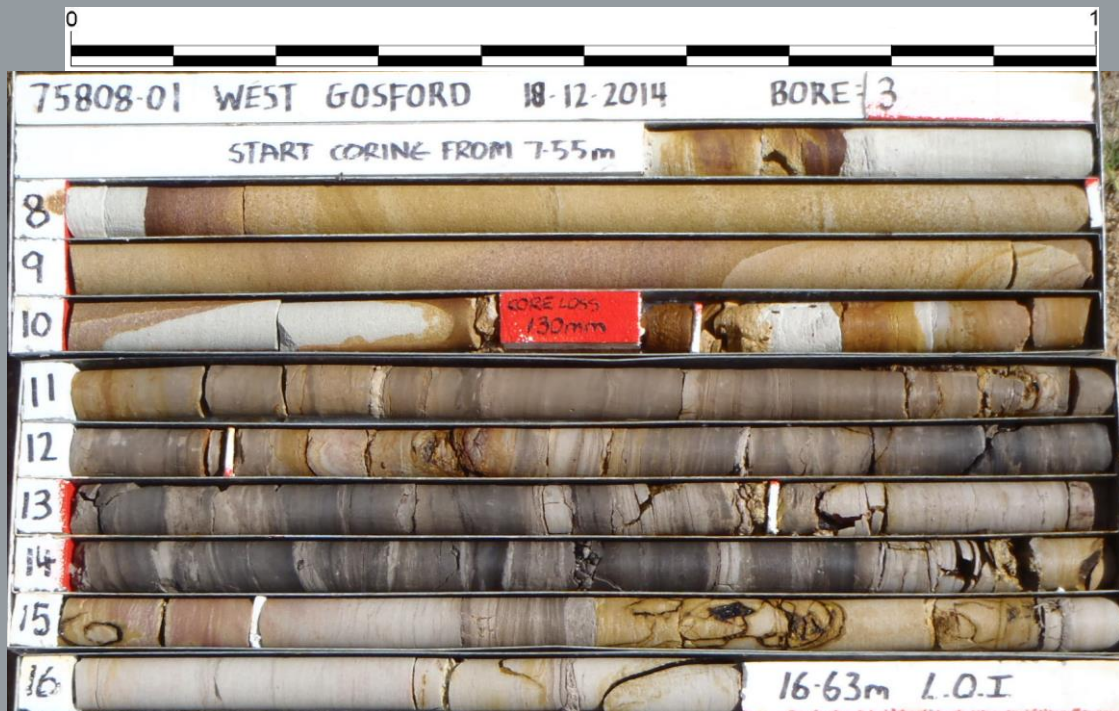
BORE 3

7.55 – 16.63 m

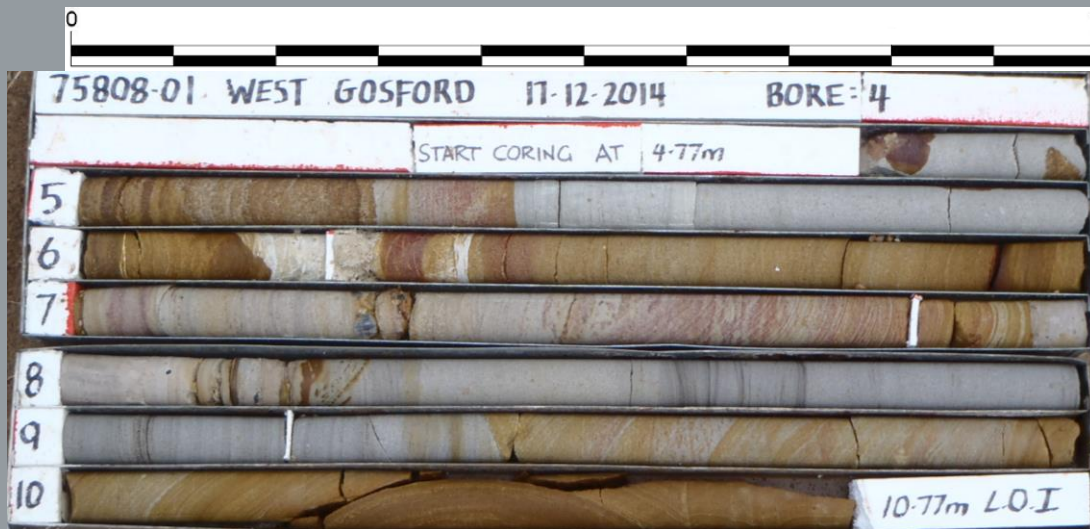
BORE 4

4.77 – 10.77m

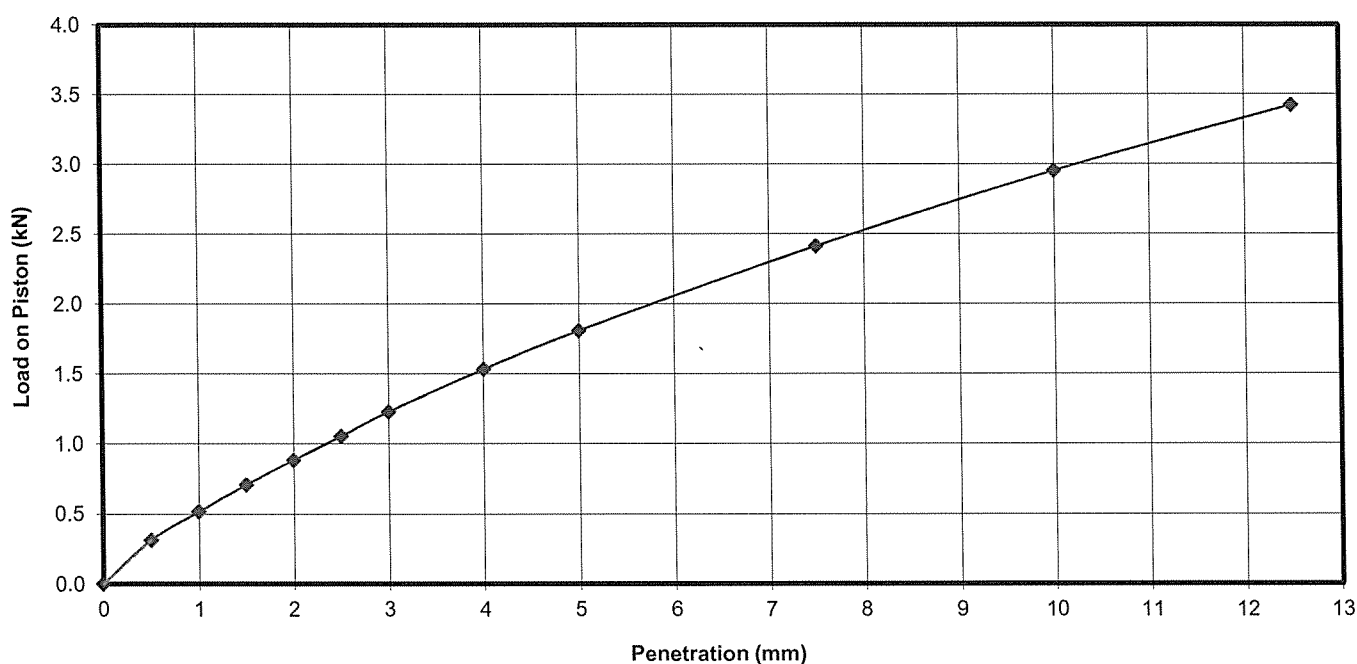
## Result of California Bearing Ratio Test

**Description:** Brown CLAY and SANDY CLAY      **Test Method(s):** AS 1289.6.1.1, AS 1289.2.1.1
