Intrusive Geotechnical Investigation Report

Coffs Harbour Jetty Foreshore Precinct

PSM4842-007R REV6

28 February 2025

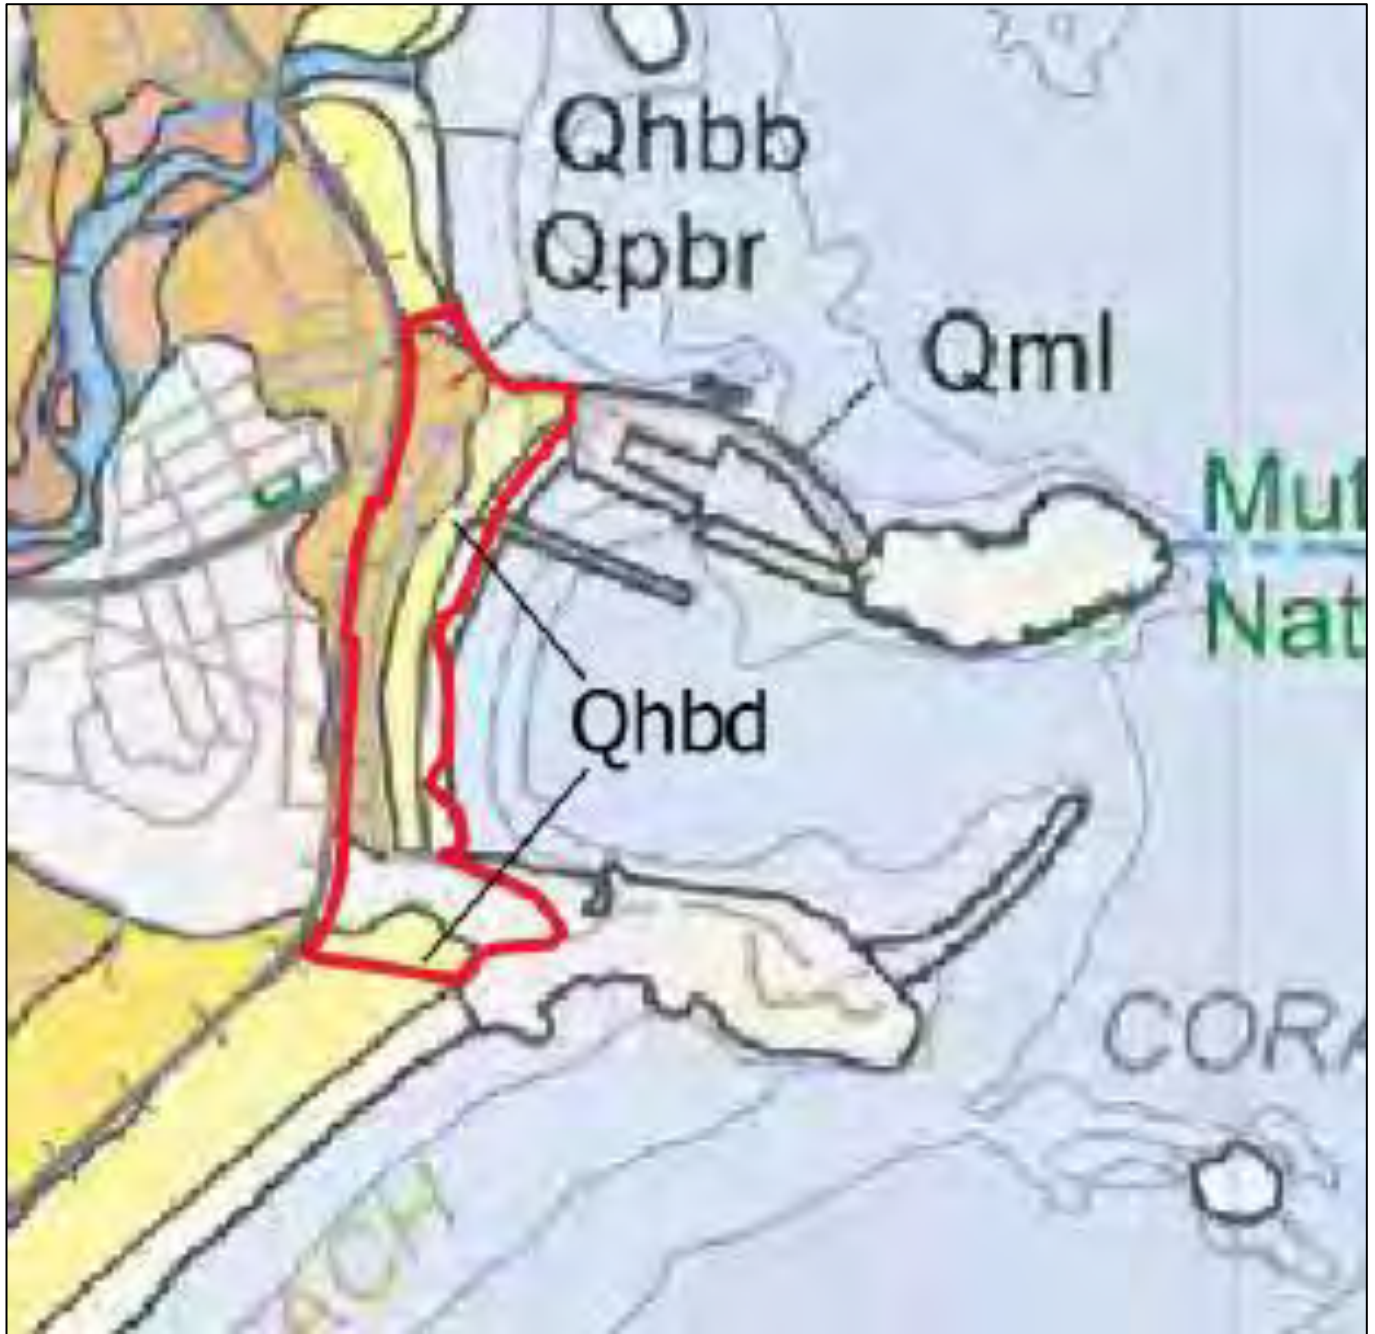
Inset 7: Snippet of the Coffs Harbour Geological Map.
(1:100,000) (approximate site extent in red)

As discussed in the desktop study previously undertaken by PSM and reproduced below, the Coffs Harbour 1:100,000 Coastal Quaternary Geology Map (2007), shown in Inset 7, indicates that the Site is underlain by:

- Pleistocene Sediments (*Qpbr*), comprising of marine sand, indurated sand and gravel, and
- Holocene Sediments (*Qhbb* & *Qhbd*), comprising of marine sand, shells and gravel.

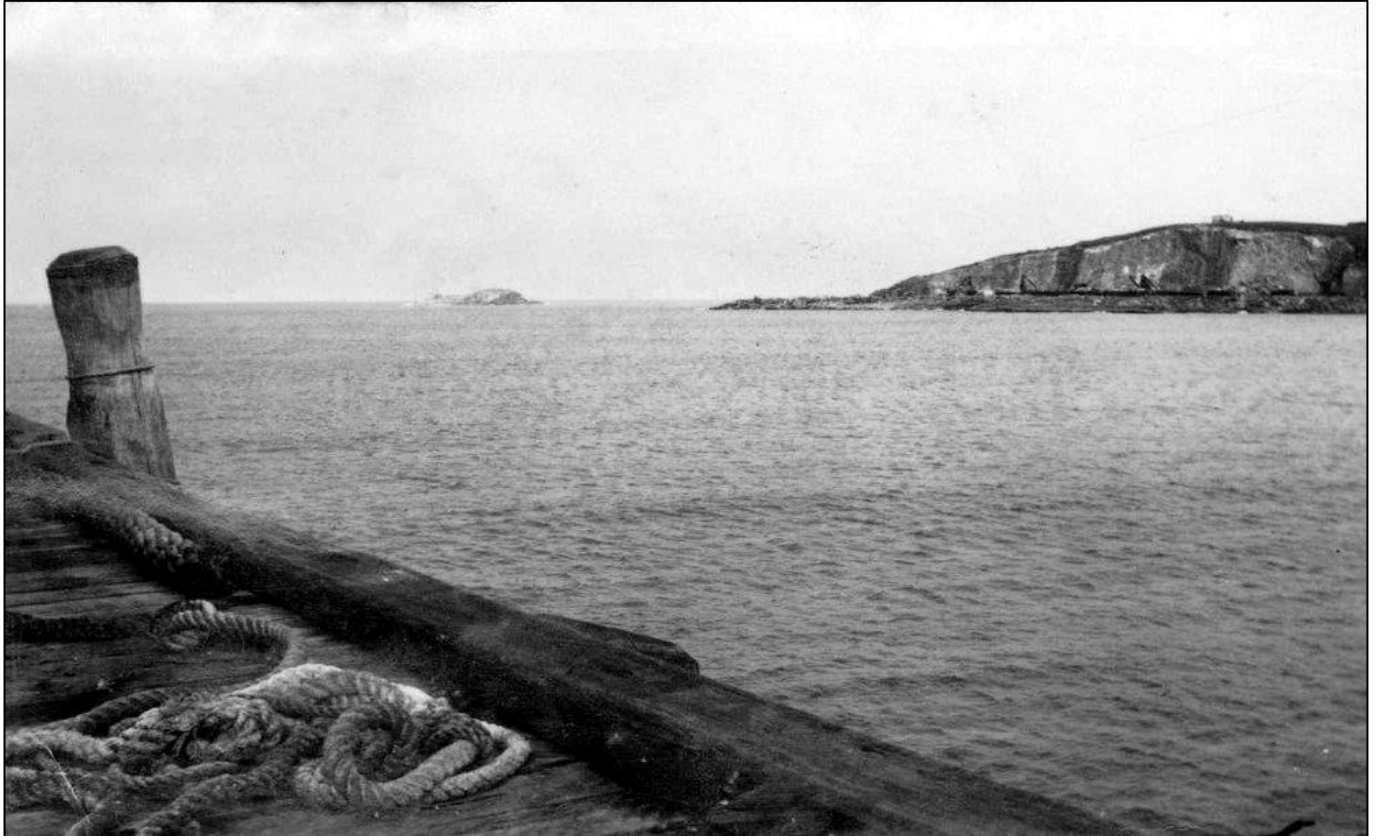
Inset 9: Historic Photograph Taken from the Jetty Towards the Old Quarry.

- The quarry originally began operations on South Coffs Island, now called Corambirra Point, in the early 1900's.
- In 1913 construction began to connect South Coffs Island to the mainland and establish a breakwall to the east of the island.
- The extent of the backfilling operation is not clear, however, it is anticipated that the south-eastern extent of the proposed development area around the existing Deep Sea Fishing Club is likely to comprise a significant volume of backfill material including Argillite and Siltstone boulders, cobbles and gravel.
- The overall development Site has remained largely untouched since the late 1970's.

Inset 9 below shows a photograph of the old quarry taken from the Coffs Harbour jetty, though the date of the photograph is not known.

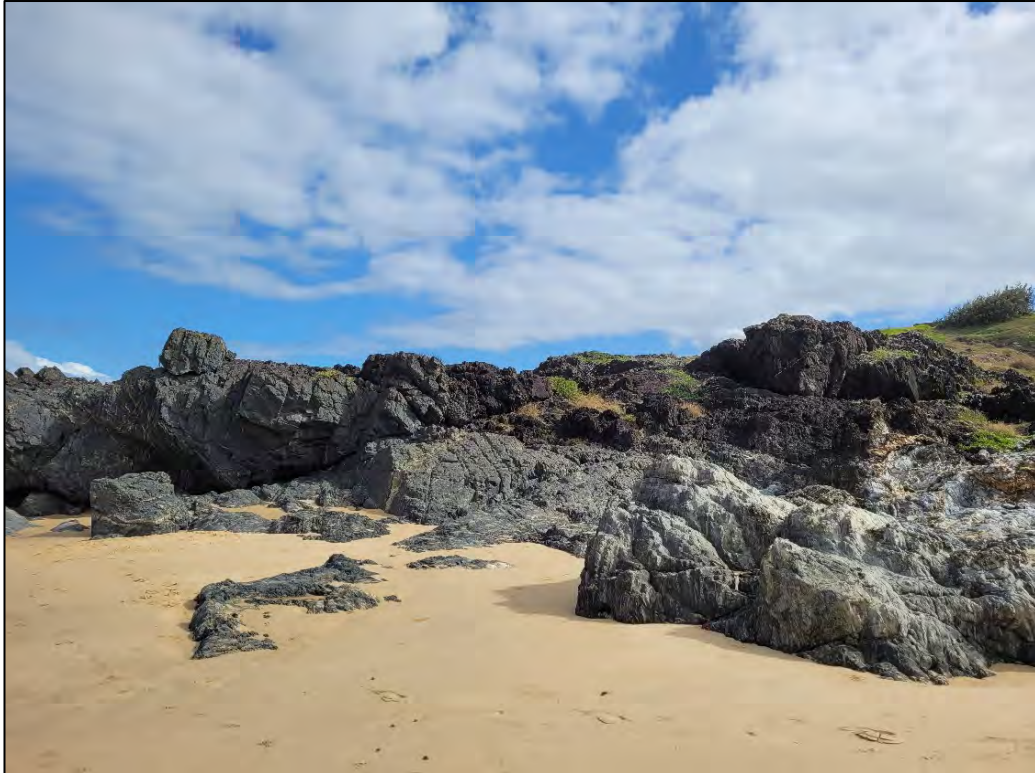
Photo 3: Exposed rock outcrop at southern boundary of the Site

- The southern section of the site is noted to currently be undergoing road works to upgrade thoroughfare within the section of the site. The restaurant, Jetty Beach House, is located at a significantly higher elevation to the surrounding area which consists of an unsealed carpark and a boat ramp. It is noted that there is a rock outcrop present within the area.

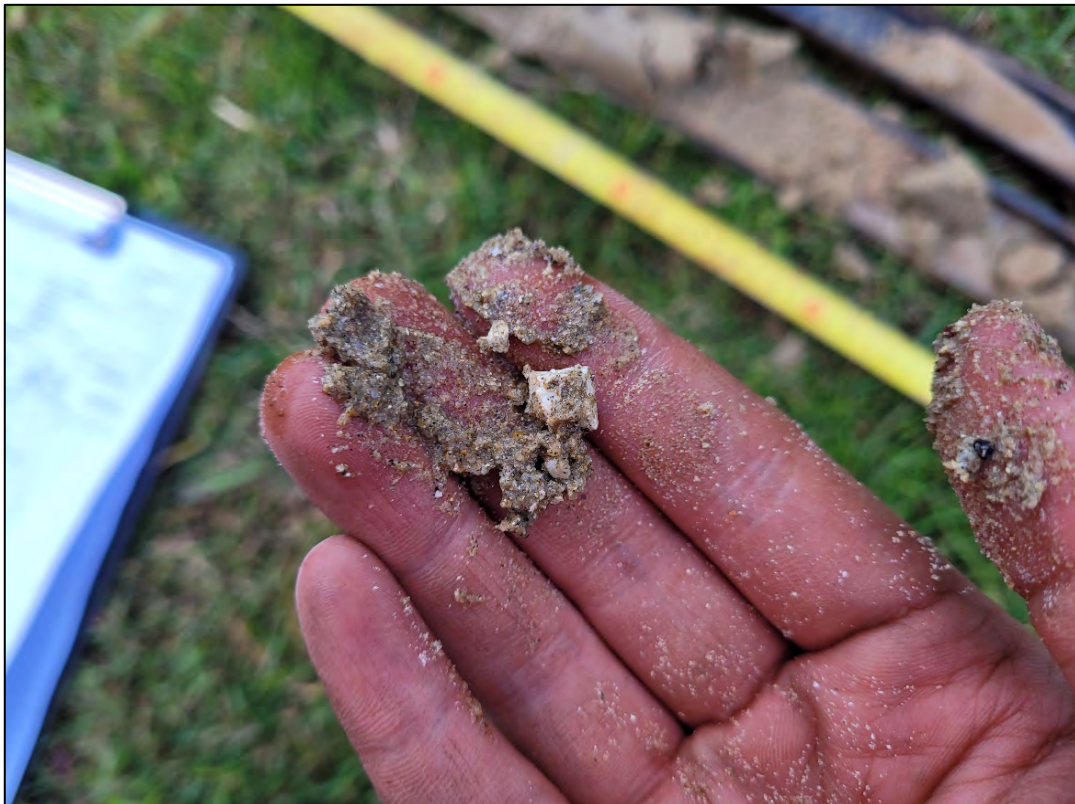
Photo 4: Shell fragment observed within NATURAL unit

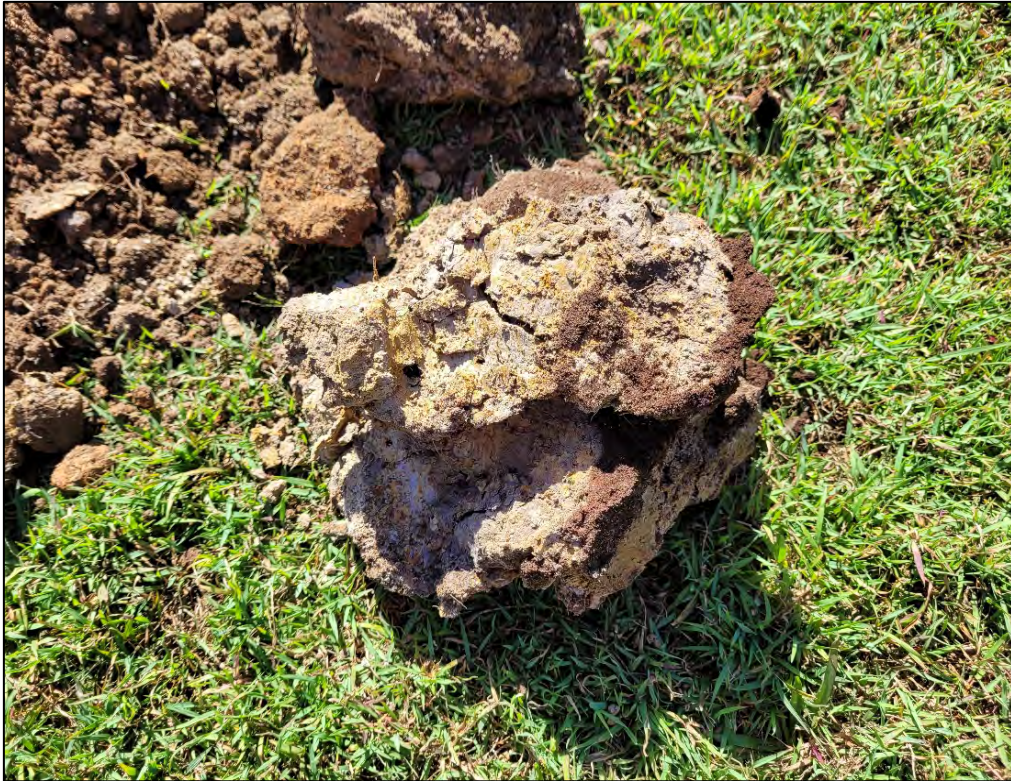
Photo 5: Typical fill unit

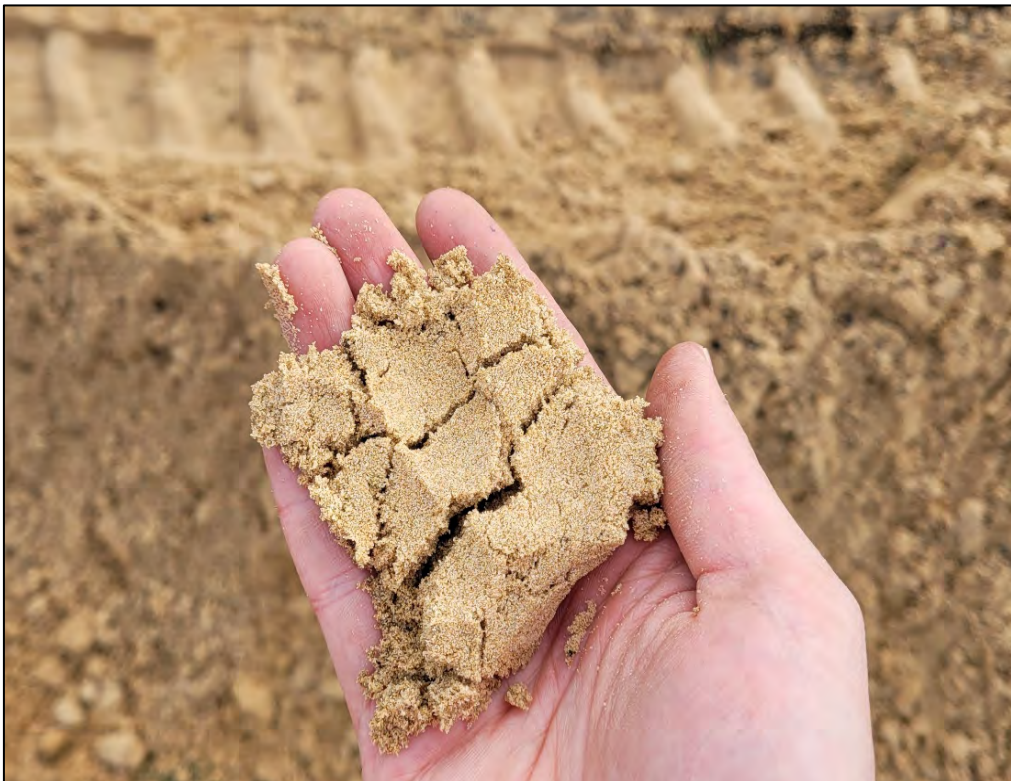
Photo 6: Typical natural unit

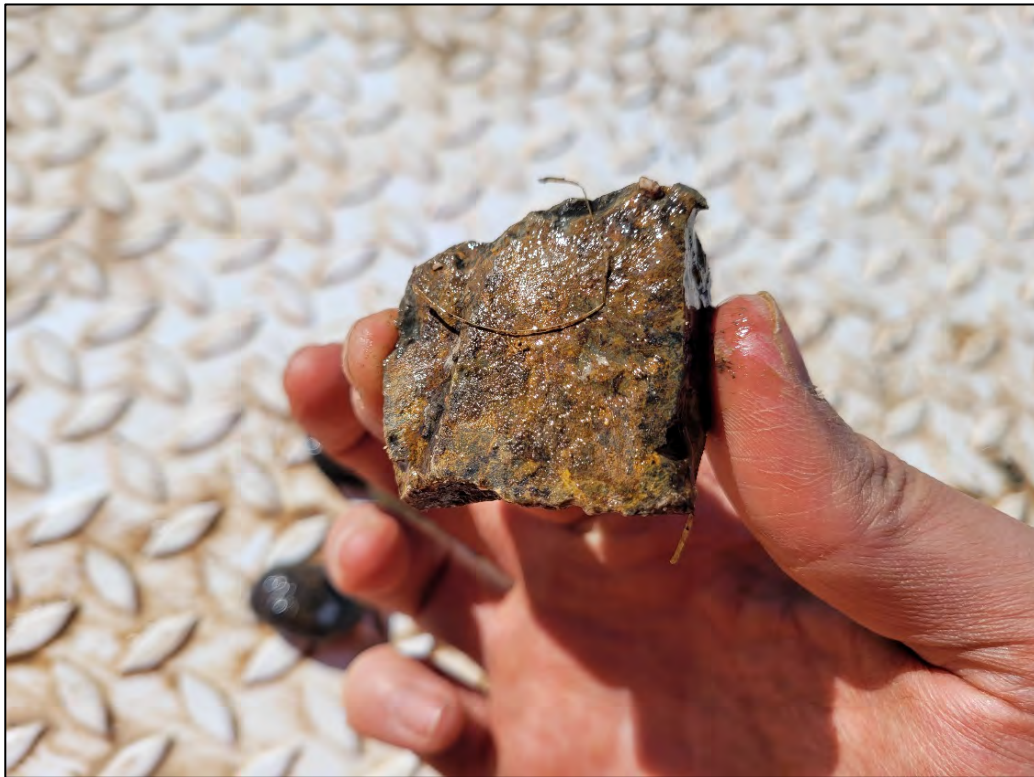
Photo 7: Typical bedrock unit

| Unit Name | Approximate Depth to the Top of Unit (m) | Description |
|---|--|--|
| BEDROCK | 6.3 - 11.9 | <p>ARGILLITE (metamorphous siltstone): grey, red and brown, highly weathered to moderately weathered, medium strength, iron stained, highly fractured</p> <p>SILTSTONE: grey, moderately weathered, medium strength</p> |

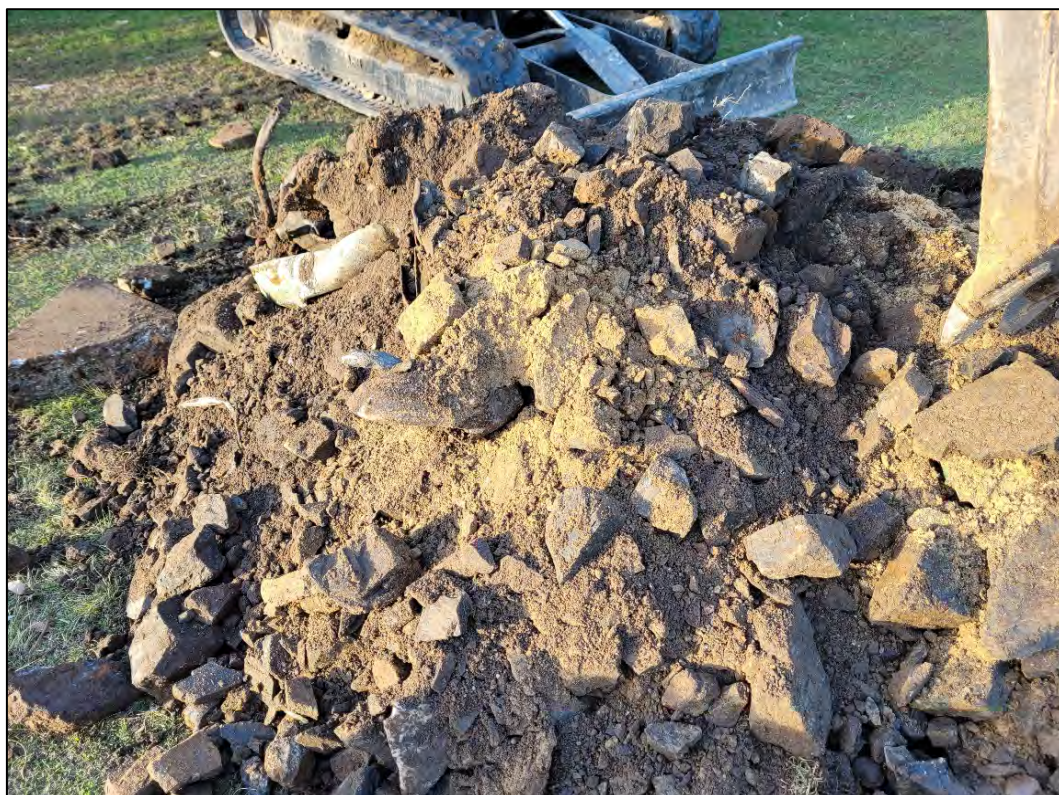
Photo 12: Encountered deleterious materials from TP12

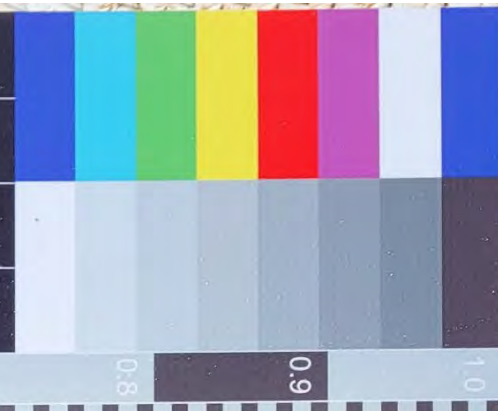
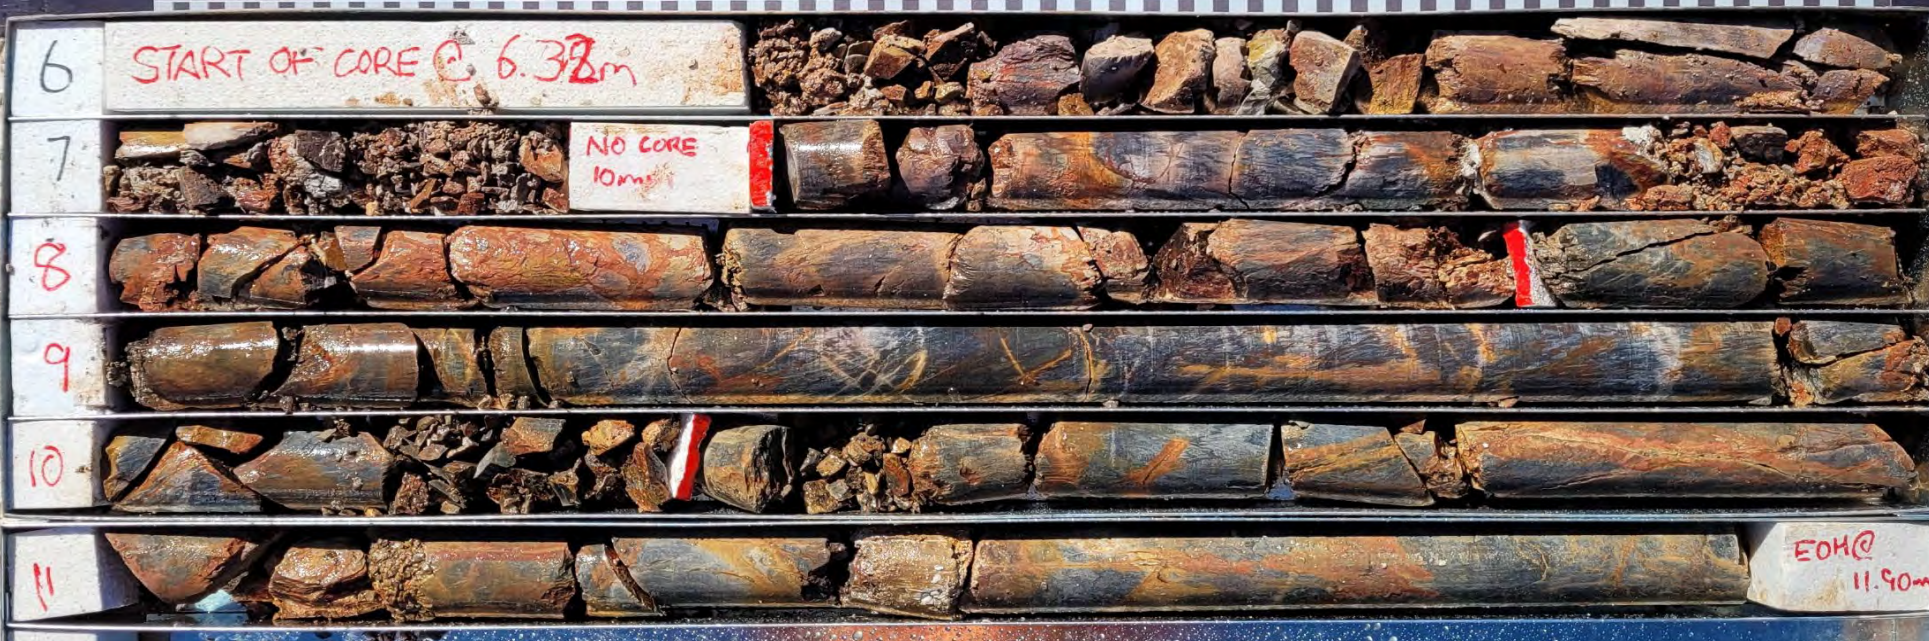
BOREHOLE ID: BH2

DEPTH: 6.32 - 11.90m

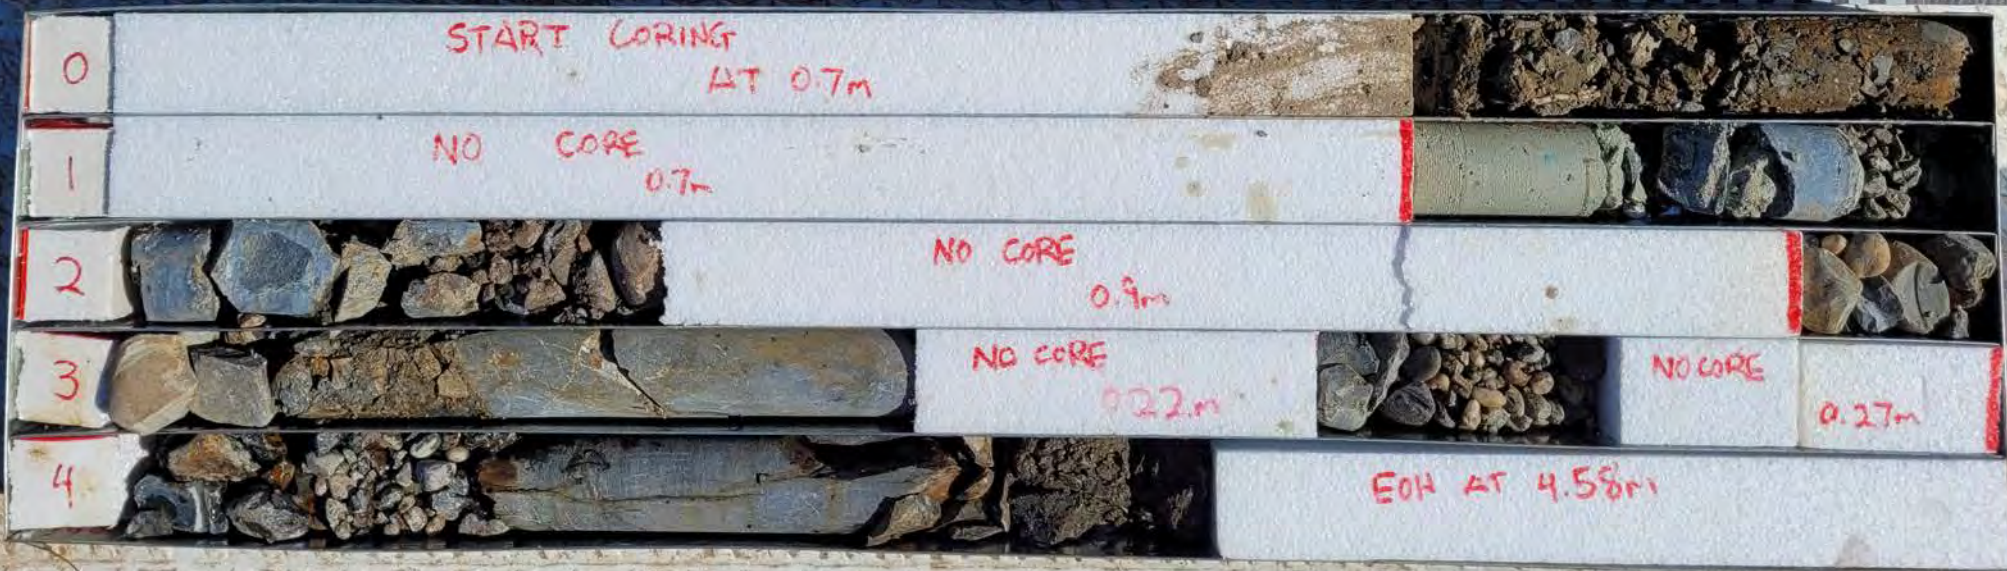
BOREHOLE ID: BH05

DEPTH: 0.7 - 4.58m

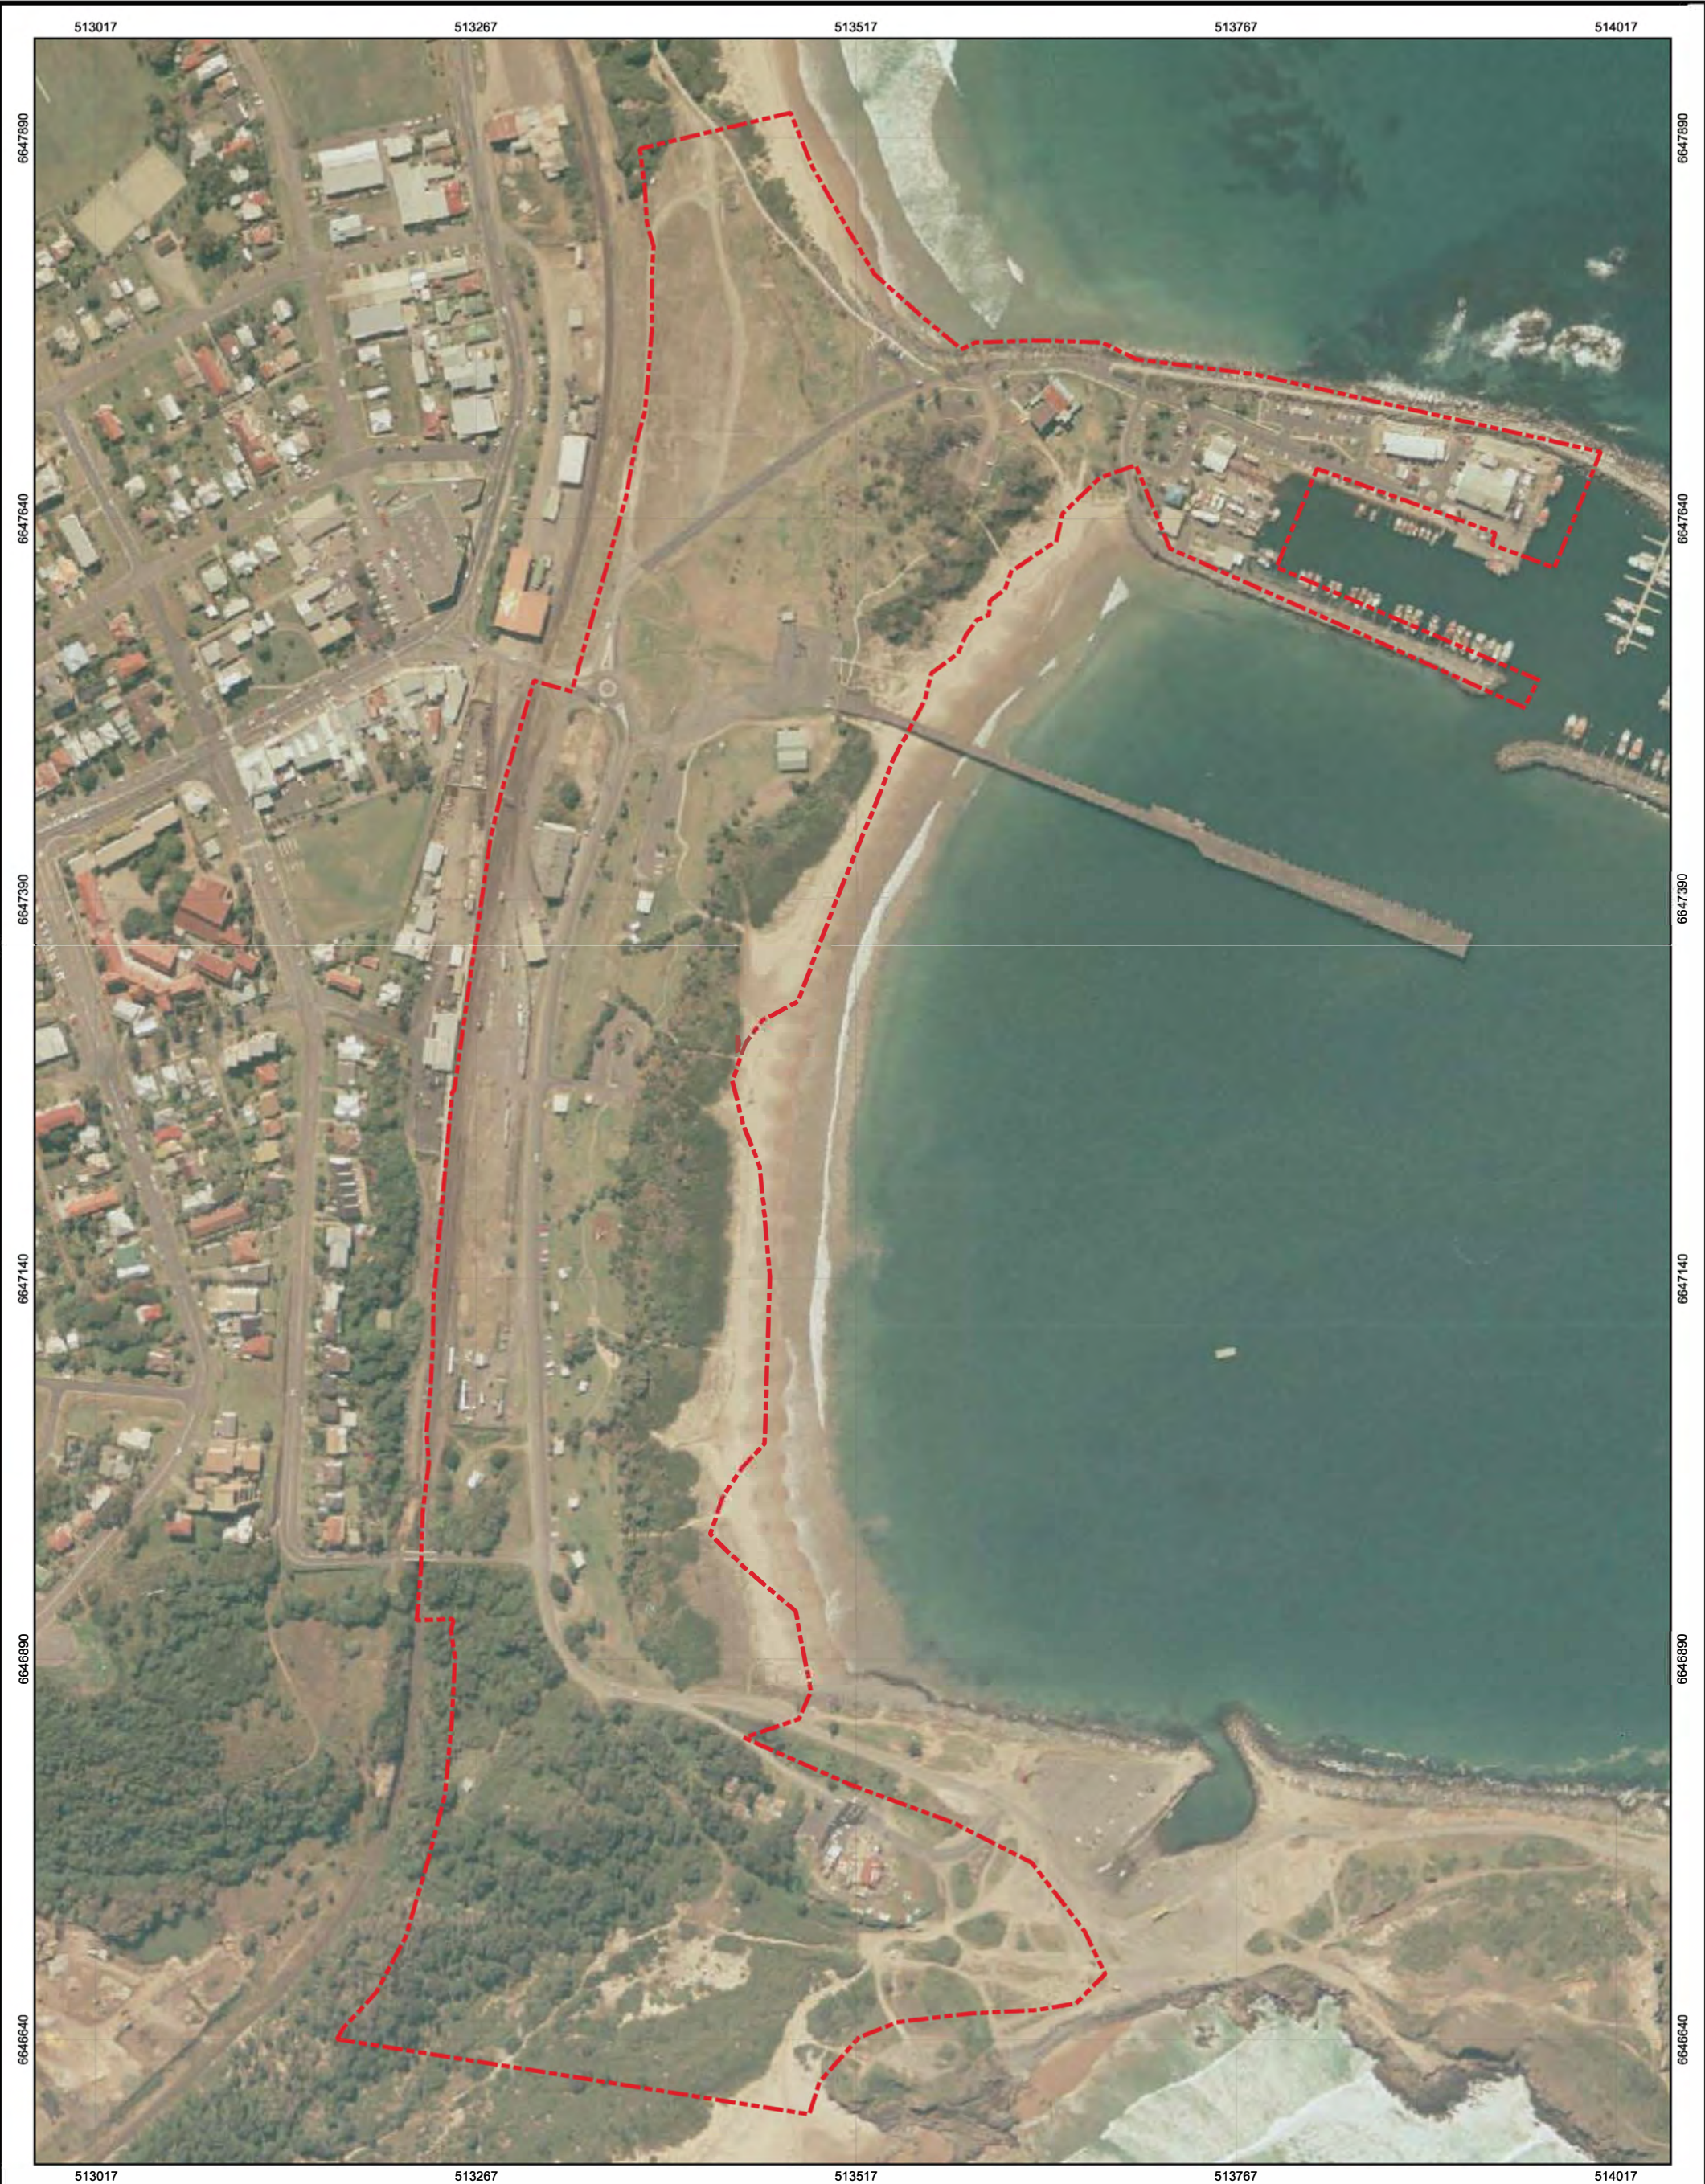
HISTORICAL AERIAL IMAGERY
1994

Notes
1. Aerial imagery sourced from NSW Historical Image Viewer dated 1994.

We have reviewed available aerial photos of the Site, though it is noted that aerial imagery prior to 1979 was not found. Appendix G presents the aerial images.
