Coffs Harbour Jetty Foreshore State Assessed Planning Proposal

Desktop Maritime Archaeological Assessment

Coffs Harbour Jetty Foreshore Precinct,
New South Wales

February 2025

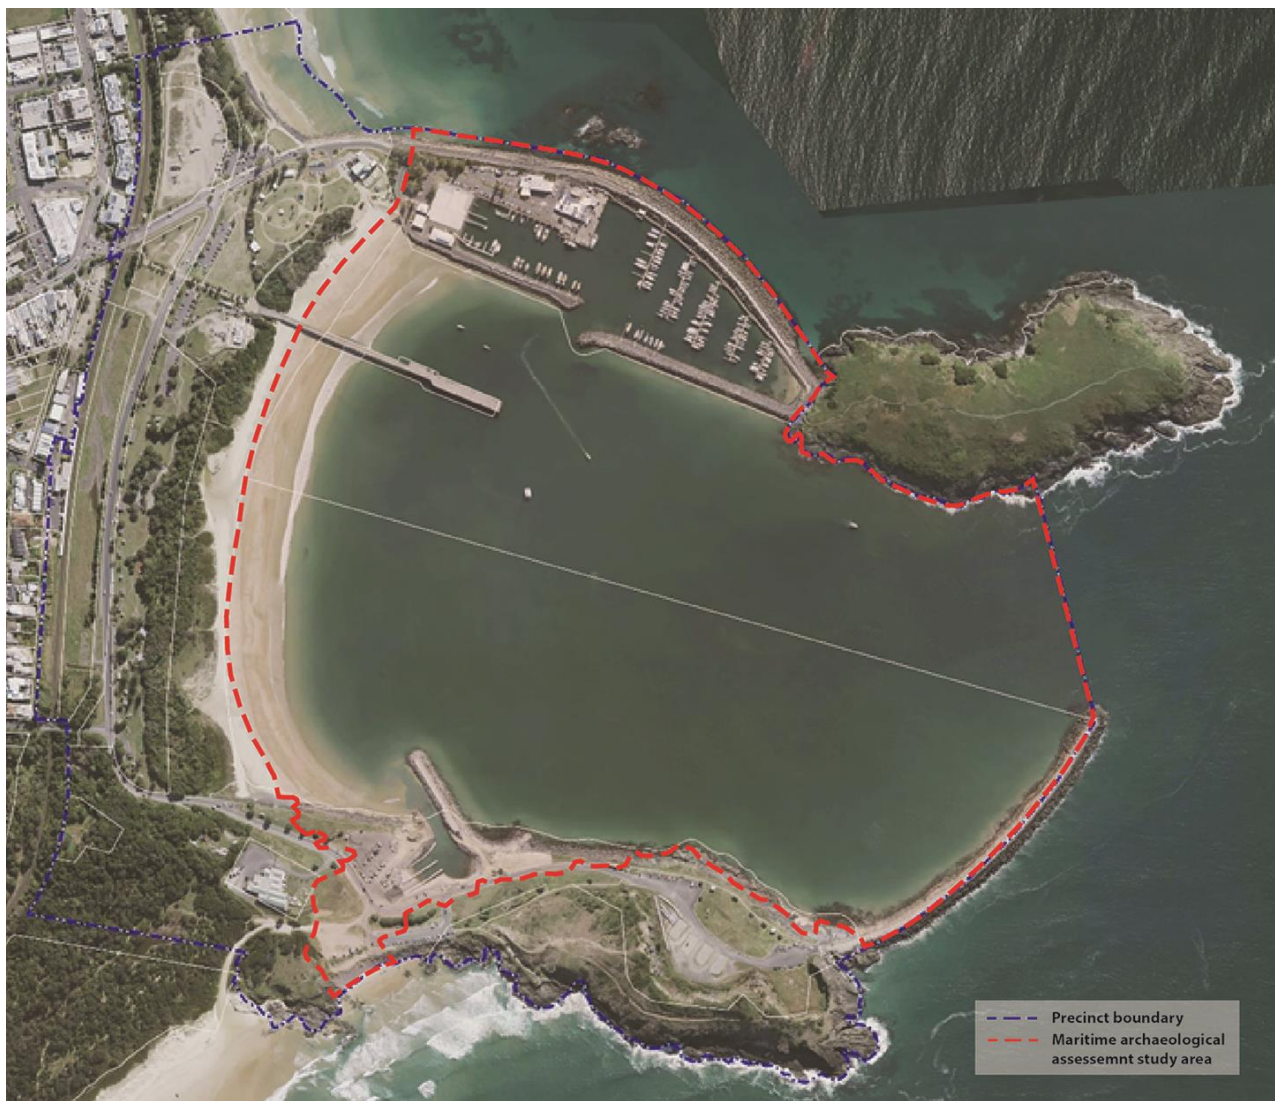
Figure 1.7: Maritime archaeological assessment study area – outlined in red (Base map source: SJB).

The study area for this desktop maritime archaeological assessment covers all areas of the seabed, and former seabed under reclaimed land, within the Precinct up to the historical low water mark – i.e. the 19th century low water mark as at the start of historical colonial occupation.

The boundaries of the maritime archaeological assessment study area are provided in Figure 1.7.

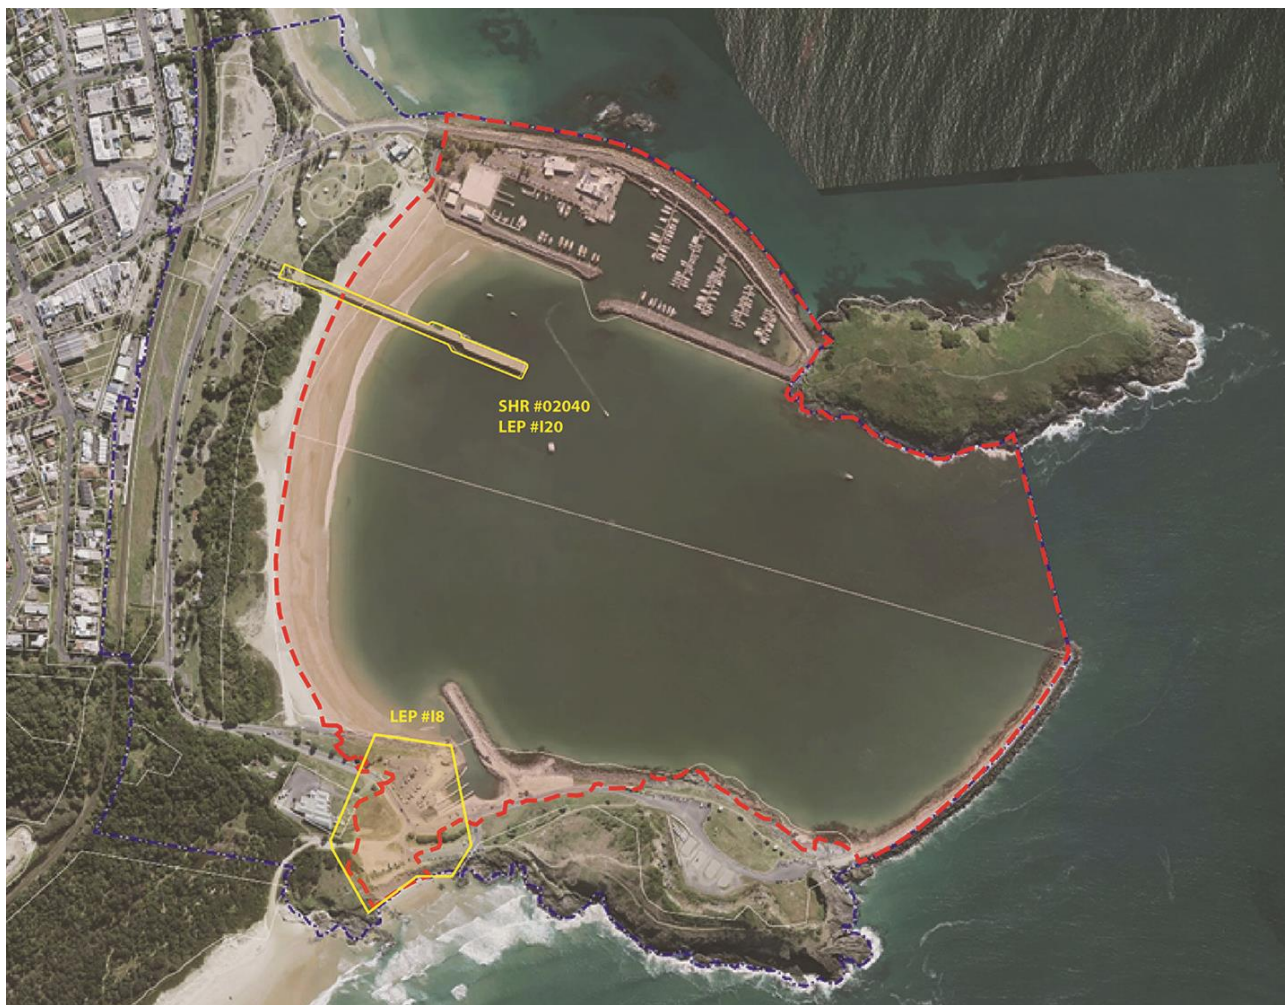
Figure 2.1: Heritage listings within maritime archaeological assessment area (Base map source: SJB).

There are two heritage listed items located either wholly or partially within the maritime archaeological assessment area – see also Table 2.1 and Figure 2.1:

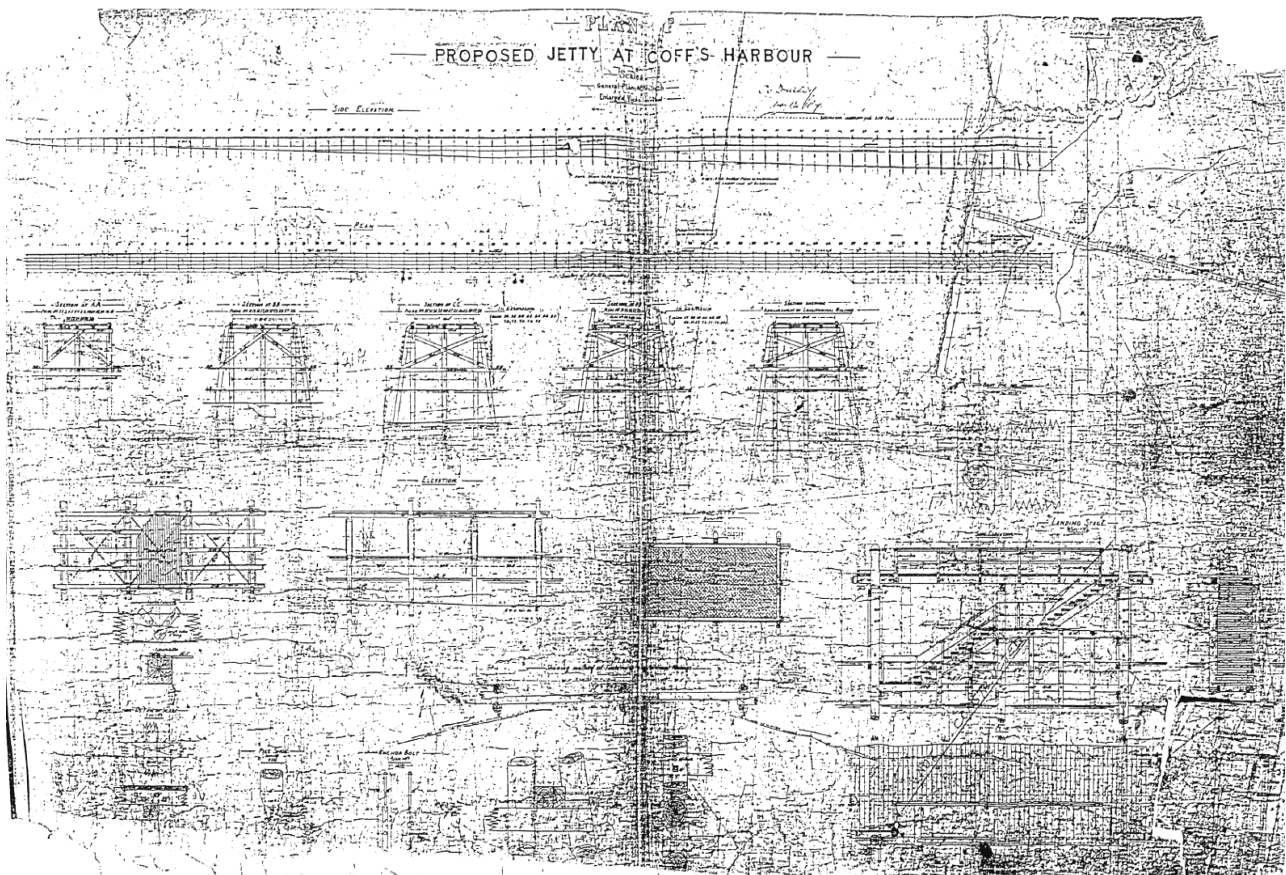
Figure 3.2: NSW Public Works Department 1889 design plan of proposed jetty at Coffs Harbour.¹¹

For about 500 feet the courses of piles will be three abreast, for another interval every alternate course shall consist of five piles, while towards the outer end each course shall be five piles, the outer or raking piles being driven at a slant of one foot in six. The cornices are 20 feet apart each being firmly tied together with turpentine bracing. The piles are to be 20in. in diameter at the head, and 15in. at the small end, and are to be of best turpentine timber. The planking for the greater part of the decking is 9 x 4in., but on 48 feet at the outer end the planks are 9 x 3in., laid diagonally to ensure stability. The decking will be 12ft. above high water, and near the sea end a landing stage is to be erected, with flight of steps to water level.¹⁰

As such, it is highly likely that the basal remains of the majority, if not all, of the timber piles replaced during general maintenance and repair of Coffs Harbour jetty since its construction, and of the timber piles of the seaward extent of the jetty demolished in 1996-1997, remain *in situ*. The majority of these pile remains would be located within the footprint of the extant Coffs Harbour jetty, and the boundaries of the SHR and LEP heritage listings. Pile remains from the 1944-1946 extension of the jetty, however, would extend up to 90-95 m beyond the seaward end of the extant jetty and be located outside the SHR and LEP heritage listings. See Figures 3.2 and 3.3.

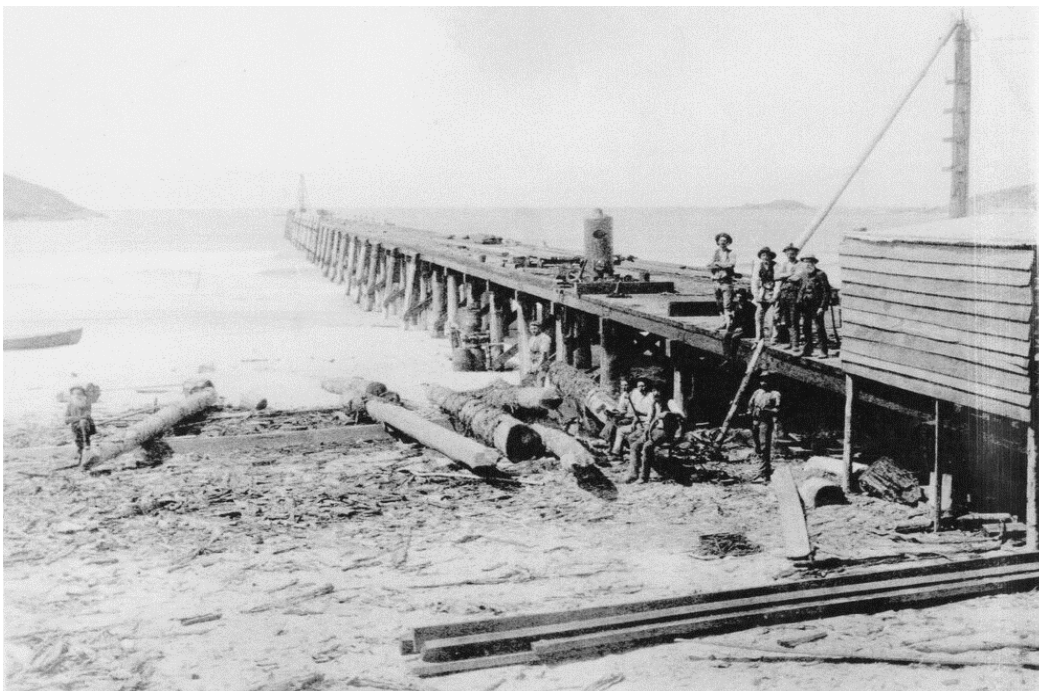
Figure 3.4: Construction of Coffs Harbour jetty, 1892 – pile driver in operation at the seaward end.¹⁵

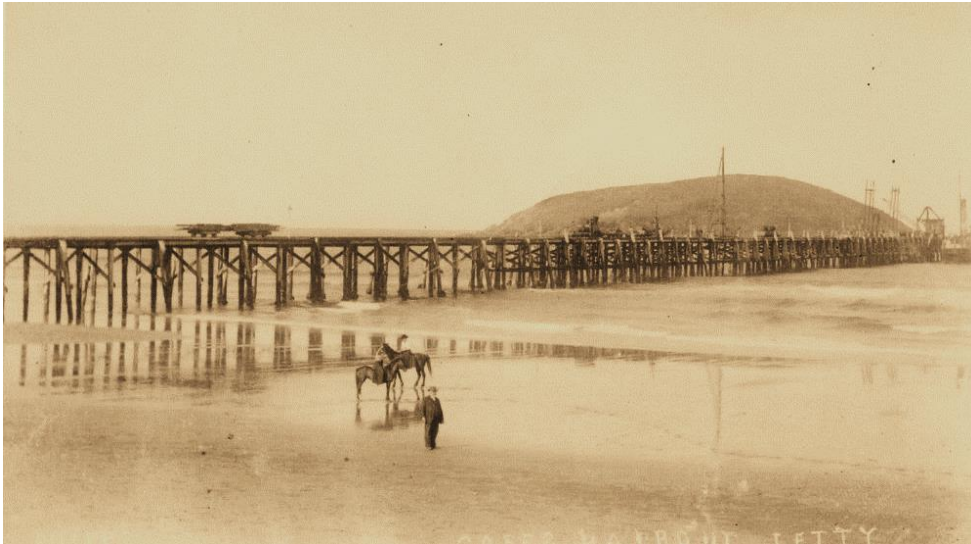
Figure 3.7: 1910 view of Coffs Harbour jetty facing north-west from beach; showing the three-pile trestle piers at landward end and five-pile trestle piers beyond low water mark.²¹

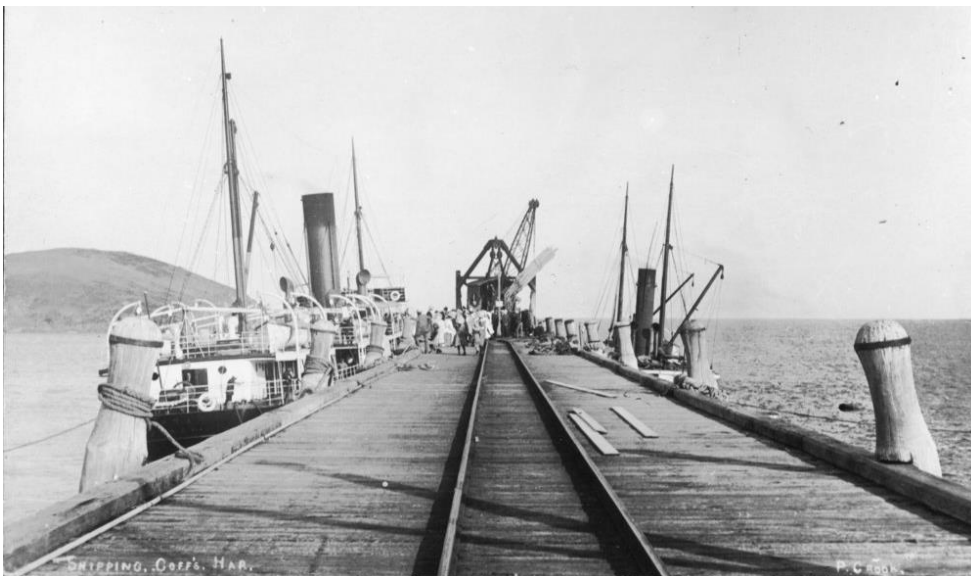
Figure 3.9: 1908 view of seaward end of Coffs Harbour jetty; showing original single tramway and 5 tone steam derrick crane.²³

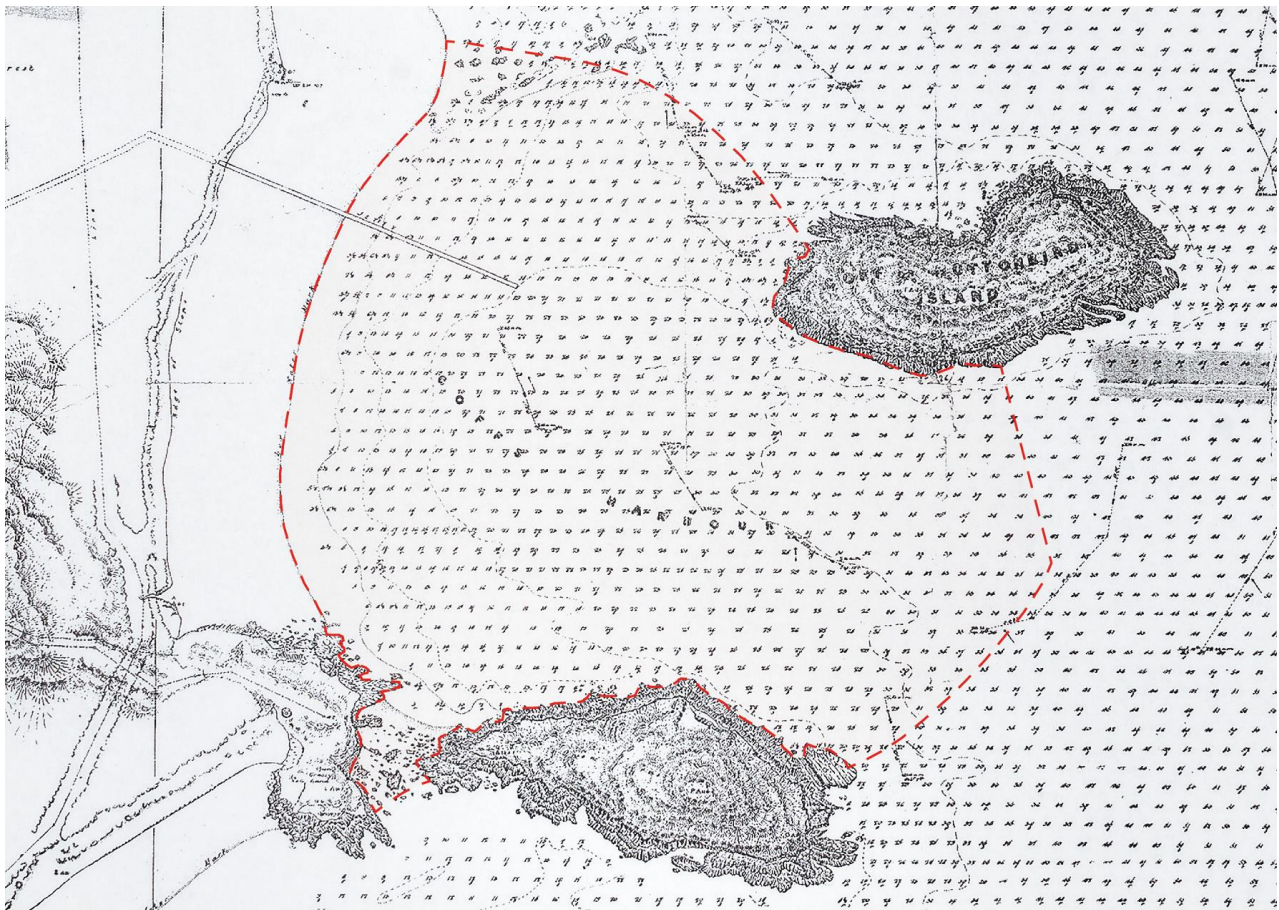
Figure 3.10: 1893 hydrographic chart of Coffs Harbour showing completed jetty²⁴ – maritime archaeological assessment study area outlined in red.

Tenders for construction of a jetty at Coffs Harbour were called in December 1889 by the Office of the Engineer-in-Chief for Harbours and Rivers, Department of Public Works.⁸ In accordance with plans prepared by the Department of Public Works – see Figures 3.2 - 3.3 – the jetty was designed to measure 1640' (499.9 m) long by 21' 6" (8.2 m) wide, and be constructed of timber with metal fastenings. The jetty was to be positioned to commence at the top of a back dune rise and run south-east across the beach, with the first approximately 700' (213.4 m) of the landward end situated above the low water mark, and extending into Coffs Harbour with the seaward end terminating at water depths of approximately 18' (5.5 m) at low water⁹ – see Figure 3.10.

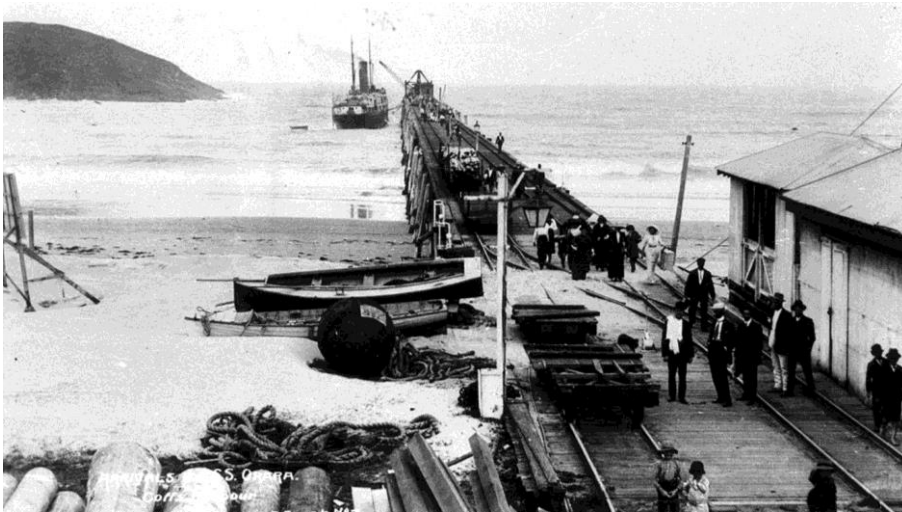
Figure 3.11: Coffs Harbour jetty ca. 1912 – showing duplicated rail lines and SS *Orara* unloading whilst moored off northern side of jetty.²⁸

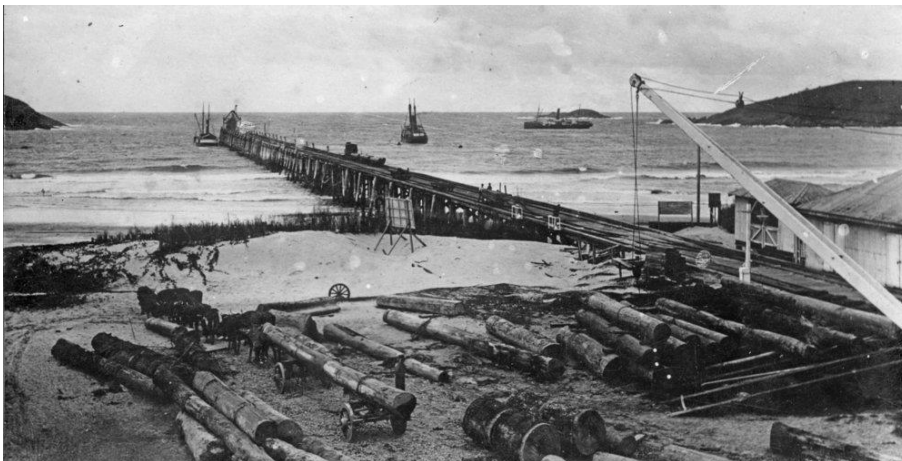
Figure 3.12: Timber logs being loaded onto jetty via landward crane, ca. 1912.²⁹

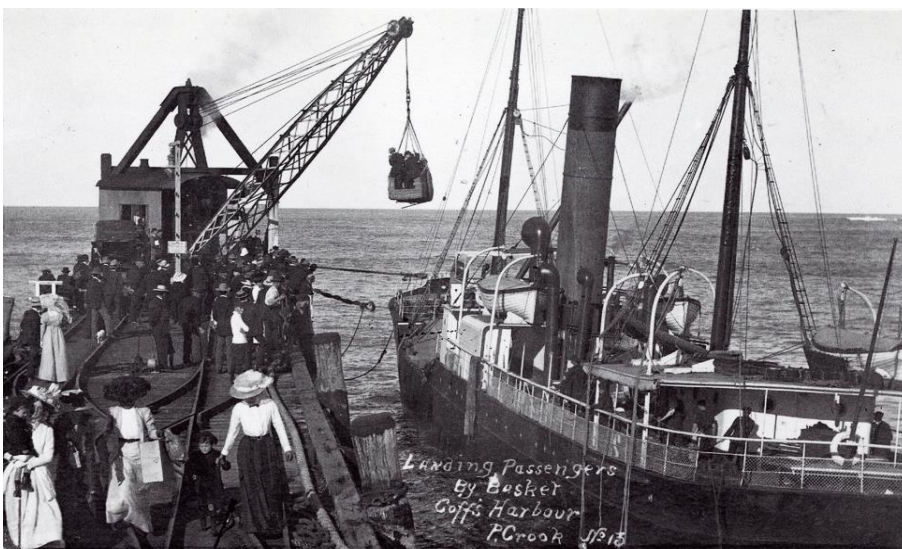
Figure 3.13: Landing passengers by basket from SS *Cavanba* at Coffs Harbour jetty.³⁰

crane (see Figures 3.13 and 3.18). As such, artefact deposits may extend up to and at least 0-15 m and 15-30 m from the jetty. It is important to note that these areas fall outside the SHR / LEP listing boundaries of the Coffs Harbour jetty.

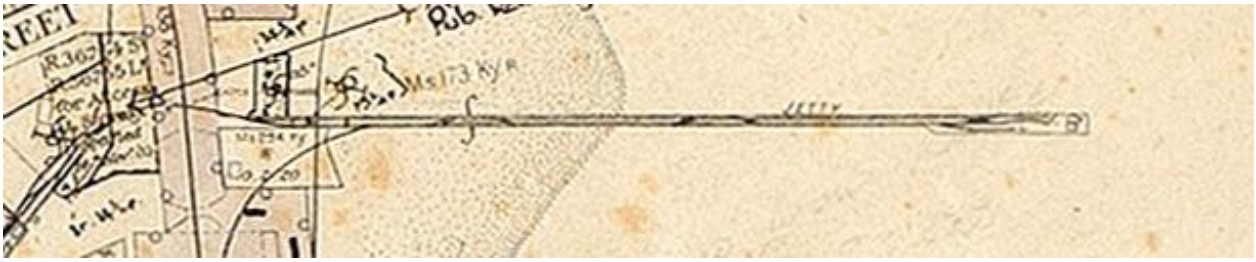
Enlargement of 1922 plan of Coffs Harbour – showing detail of widened jetty.

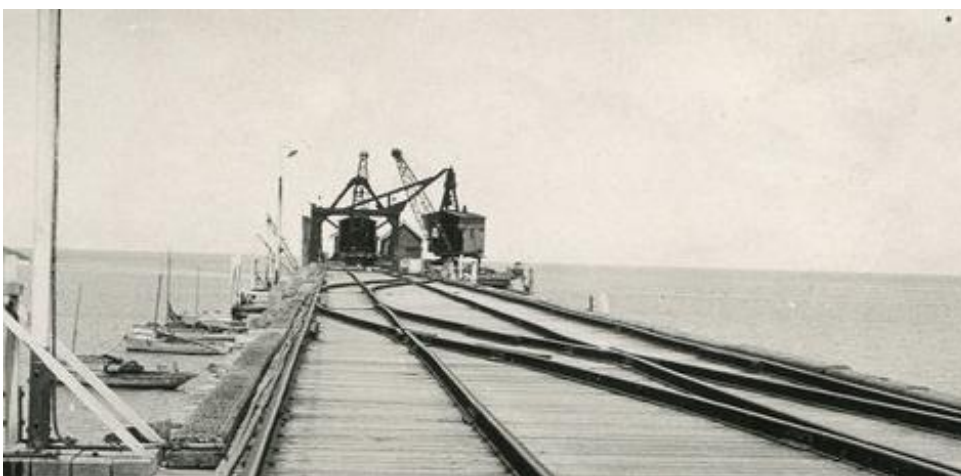
Figure 3.17: ca. 1930 view of Coffs Harbour jetty – showing widening and additional crane on southern side of jetty head.³⁷

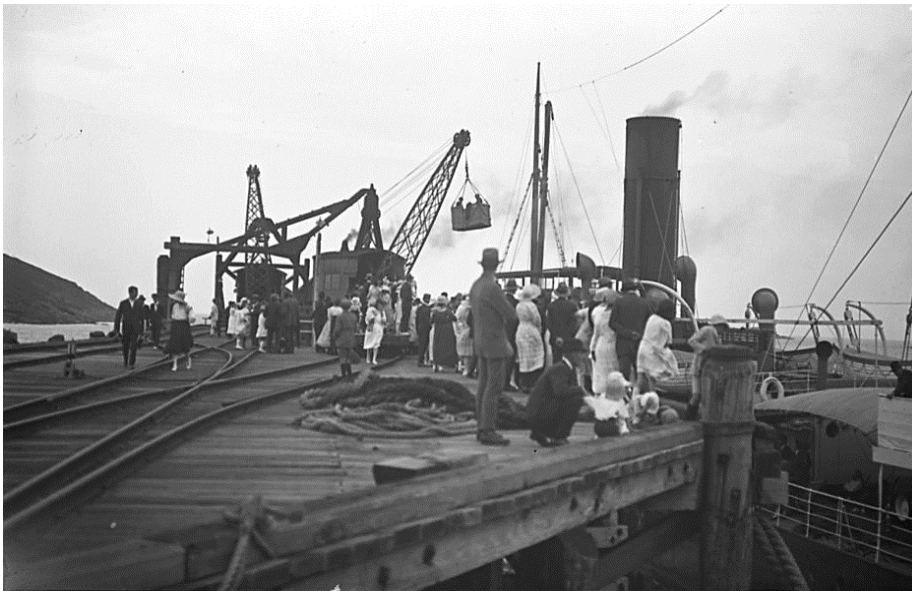
Figure 3.18: ca. 1920 view of passengers disembarking in the basket at Coffs Harbour jetty – showing widening on southern side of jetty head.³⁸

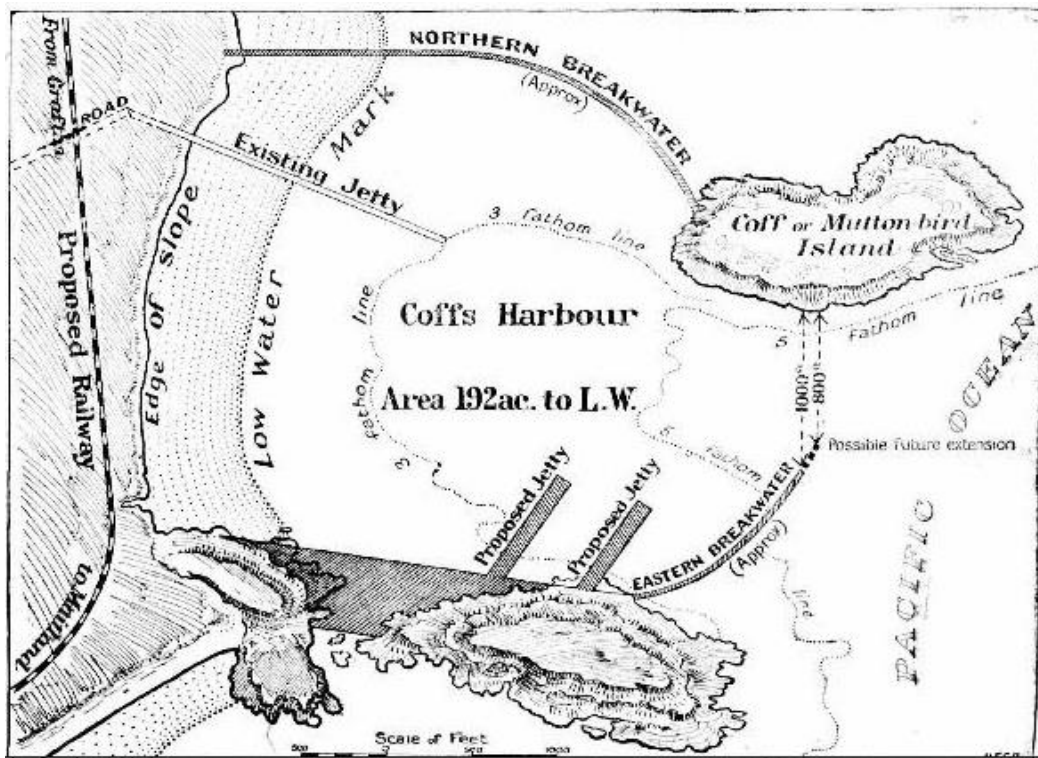
Figure 3.20: 1911 diagram of de Burgh's proposed scheme for Coffs Harbour.⁴⁵

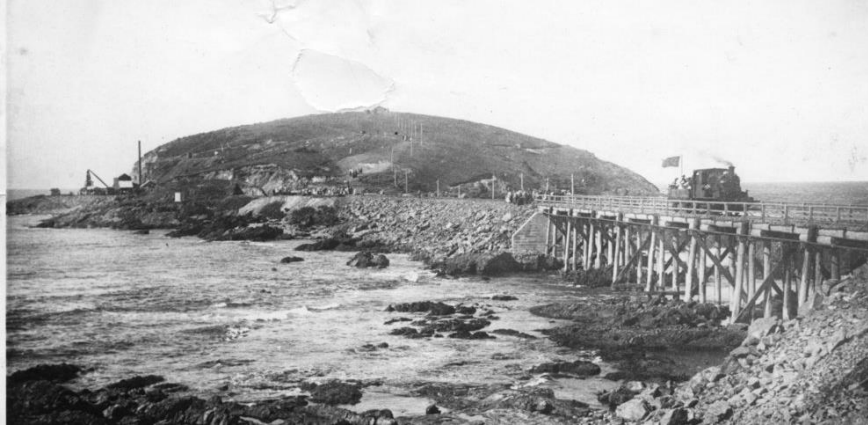
Figure 3.21: Timber trestle railway bridge between South Coffs Island and mainland, facing east with Corambirra Point quarry in background— showing Manning Wardle locomotive crossing the bridge, 1918.⁵⁰

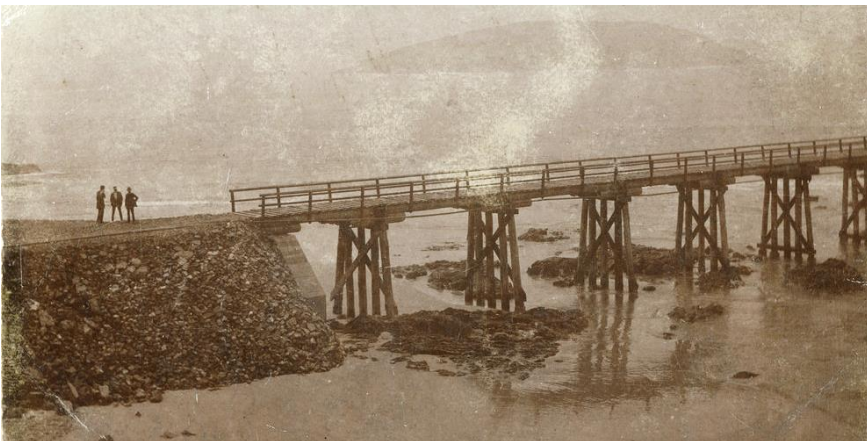
Figure 3.22: View of timber trestle railway bridge between South Coffs Island and mainland, facing north-east, ca. late 1915.⁵¹

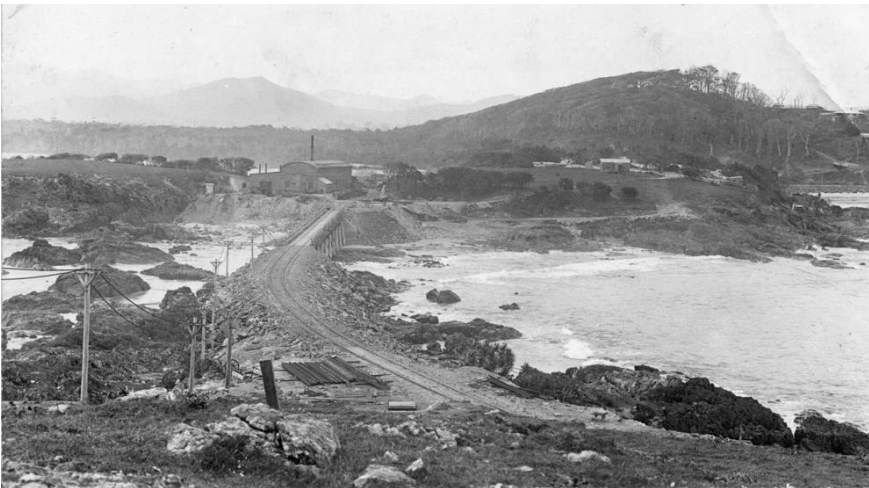
Figure 3.27: View facing west from Corambirra Point, showing the gap between the South Coffs Island and the mainland, prior to the construction of the retaining wall and reclamation, 1917.⁵⁷

As works progressed, rock and fill from the quarry was used to construct a retaining wall along the south-western shore of Coffs Harbour and reclaim an area of the seabed to the south, thus creating a land bridge between South Coffs Island and the mainland. The timber trestle railway bridge was left in place and eventually completely buried within the reclamation. These works were completed in 1928.⁵⁶

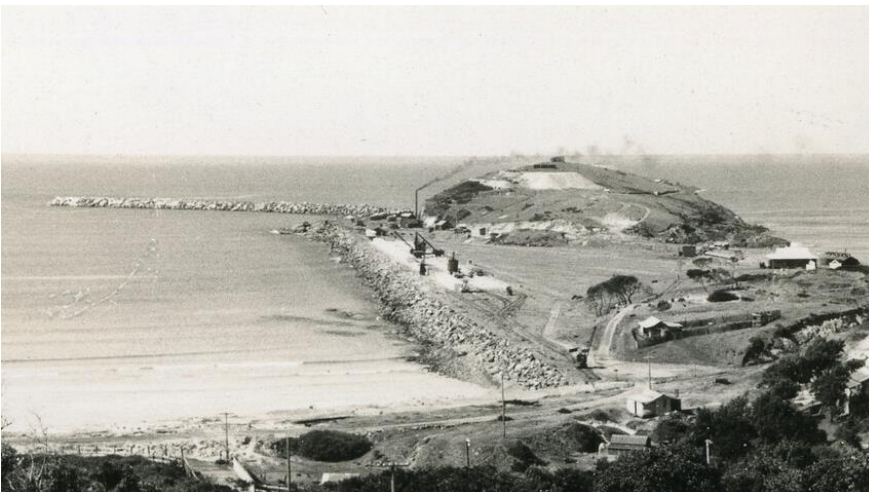
Figure 3.28: View facing east towards Corambirra Point from the mainland, showing completed retaining wall and area of reclamation, 1936.⁵⁸

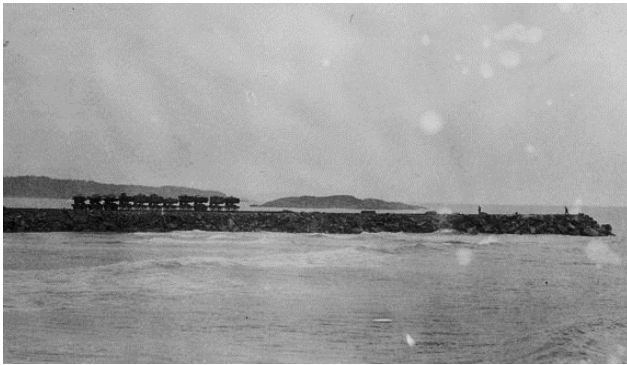
Figure 3.32: Construction of the northern breakwater, showing series of railway wagons loaded with rocks from South Coffs island quarry, ca. 1917.⁶⁵

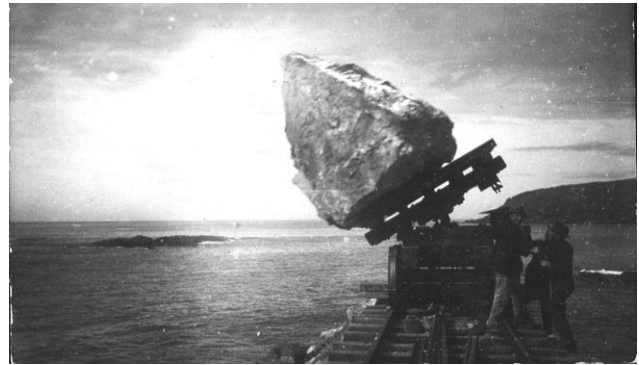
Figure 3.33: Construction of the northern breakwater; tipping rock from railway wagon ca. 1917.⁶⁶

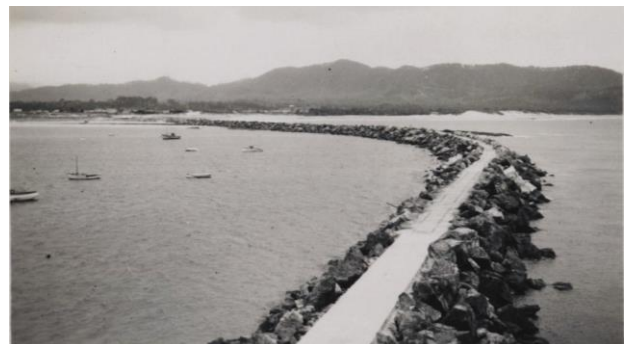
Figure 3.35: Northern breakwater from Muttonbird Island, ca. 1940s – showing concrete capping.⁶⁸

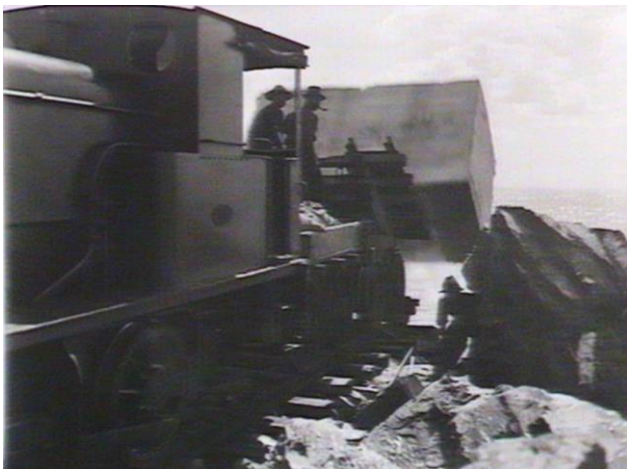
Figure 3.40: 40 tonne concrete block being placed at eastern breakwater, early 1930s.⁷⁶

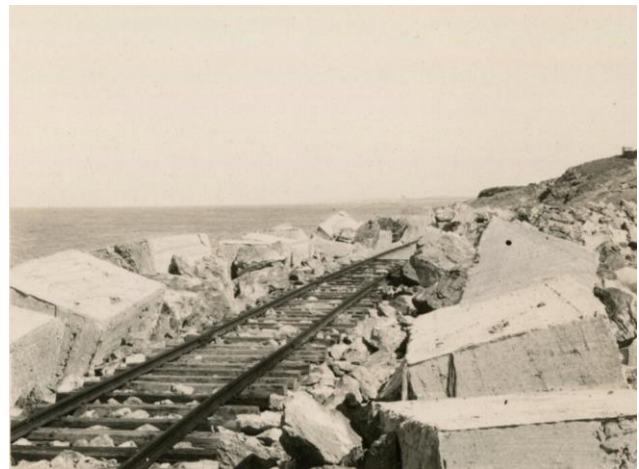
Figure 3.41: View towards end of the eastern breakwater, showing rock and concrete block placement, early 1930s.⁷⁷

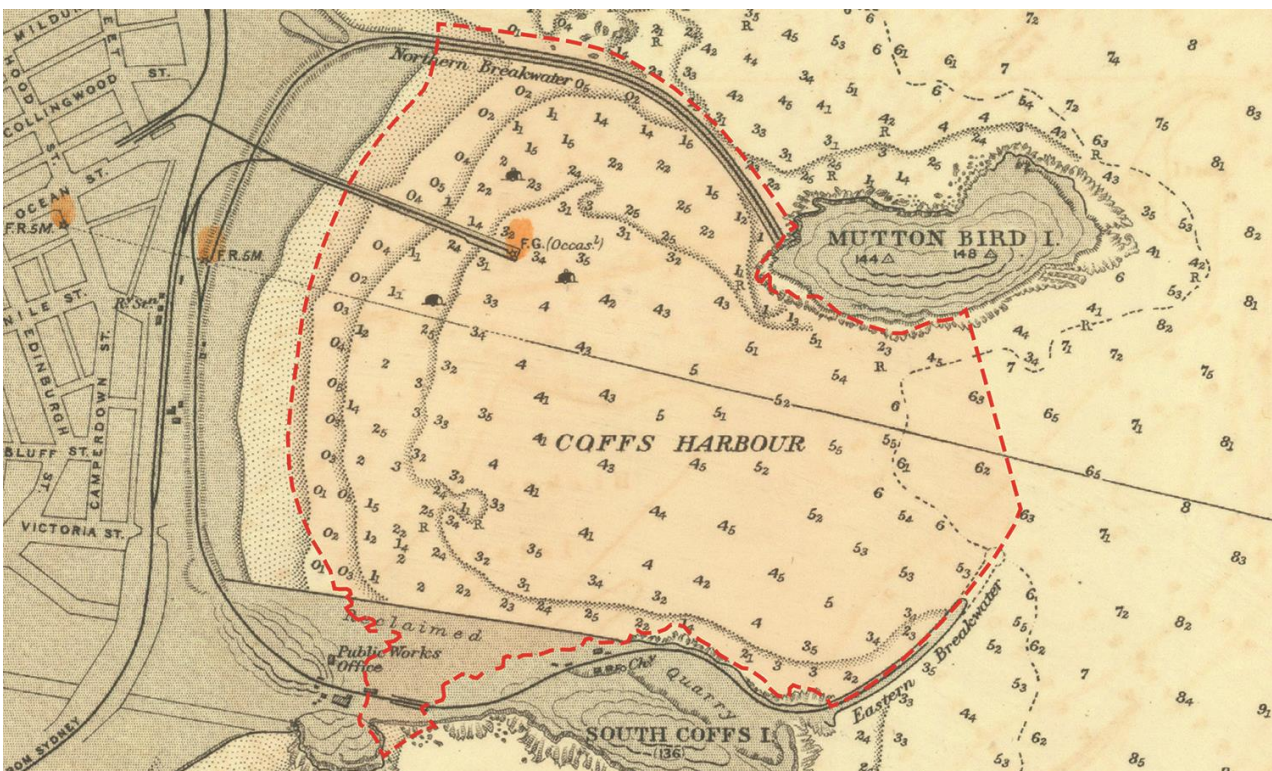
Figure 3.46: 1934 hydrographic chart of Coffs Harbour⁸² – showing completed northern breakwater, partially completed eastern breakwater, quarry on South Coffs Island, and retaining wall and reclamation connecting South Coffs Island to the mainland; also expanded Coffs Harbour jetty and three mooring barrel buoys. Maritime archaeological assessment study area outlined in red.

Construction works commenced in mid 1950 and were finished with the installation of a second Stothert and Pitt crane in mid 1955. Additional works throughout this period included the construction of a new timber storage depot on the northern side of the jetty base, and the relocation and renewal of all jetty moorings – with four vessel moorings installed; two on the north and two on the south of the jetty (see Figure 3.46).⁹⁸

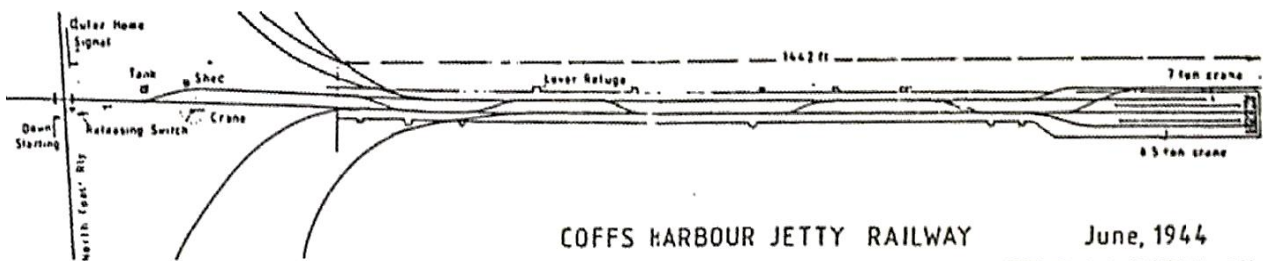
Figure 3.48: 1944 plan of Coffs Harbour jetty – showing jetty structure and railway configuration immediately prior to the 1944-1946 extensions and upgrades.⁸⁹

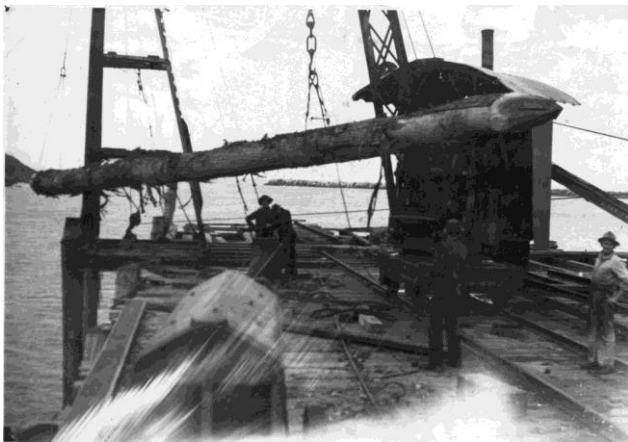
Figure 3.49: Construction of Coffs Harbour jetty extension, 1945 – showing timber pile being hoisted into position in pile driving rig.⁹⁰

Work on the jetty improvements commenced in 1944 with the construction of the seaward extension (see Figures 3.49-3.52) – with the main structure completed in 1946. In 1947-1949, the two steam cranes were removed, sections of the jetty head were strengthened with additional piles and girders, the jetty railway extended to provide three sets of tracks at the seaward end, and the two new travelling diesel electric cranes – that were able to traverse up to 250' (76.2 m) along the length of the jetty – were installed. Other additions to the jetty during these works included the construction of high and low water landing stages for small craft – particularly designed to cater for the Coffs Harbour commercial fishing fleet.⁸⁸

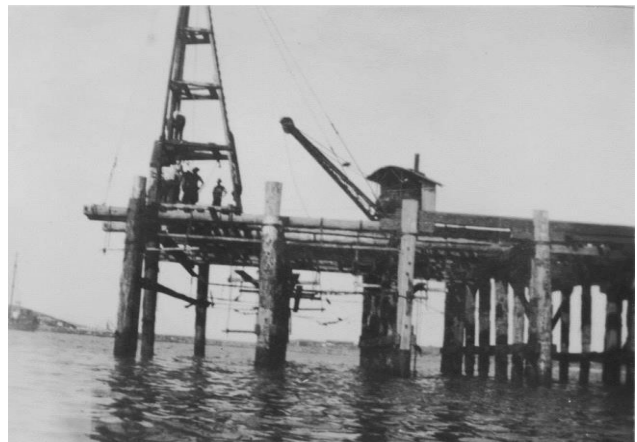
Figure 3.50: Construction of Coffs Harbour jetty extension, 1945 – showing timber pile being driven.⁹¹

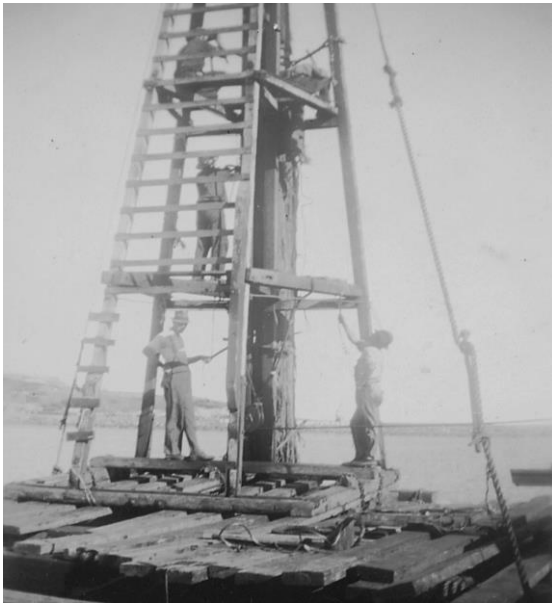
Figure 3.51: Construction of Coffs Harbour jetty extension, 1945 – showing close up of pile rig.⁹²

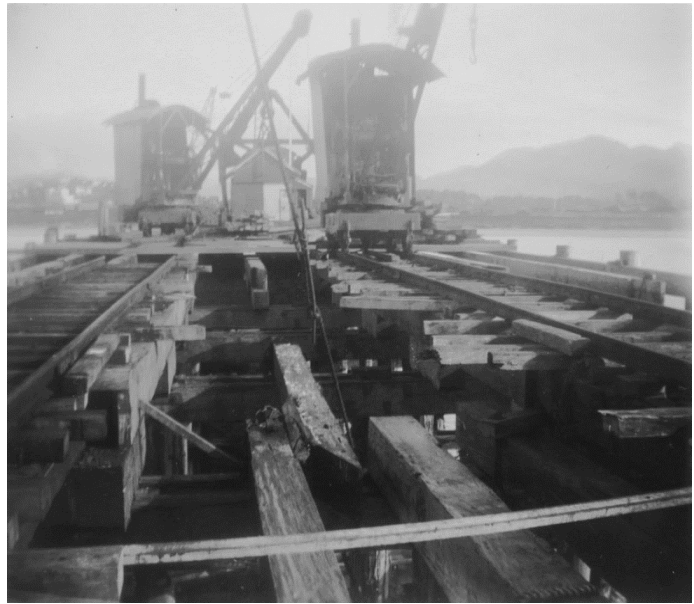
Figure 3.52: Construction of Coffs Harbour jetty extension, 1945 – showing timber girders being positioned.⁹³

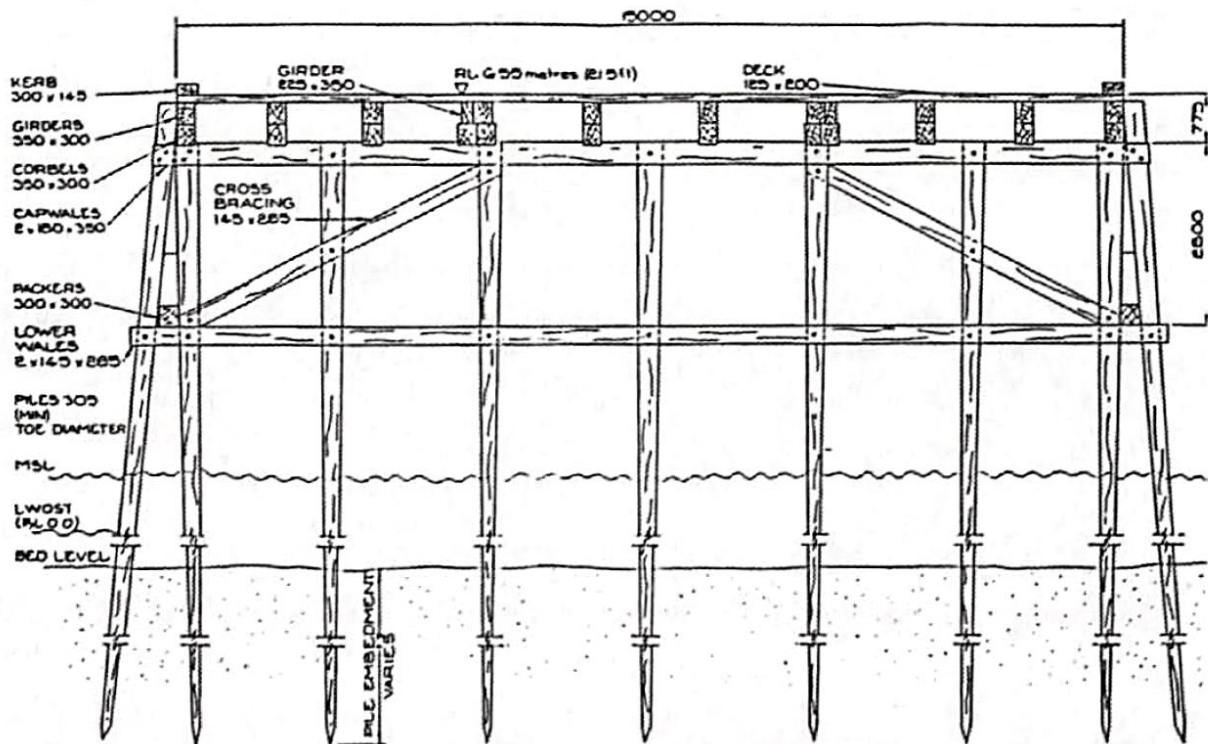
Figure 3.55: Typical cross section of extended and widened seaward section of Coffs Harbour jetty as constructed in 1946 to 1953.⁹⁹

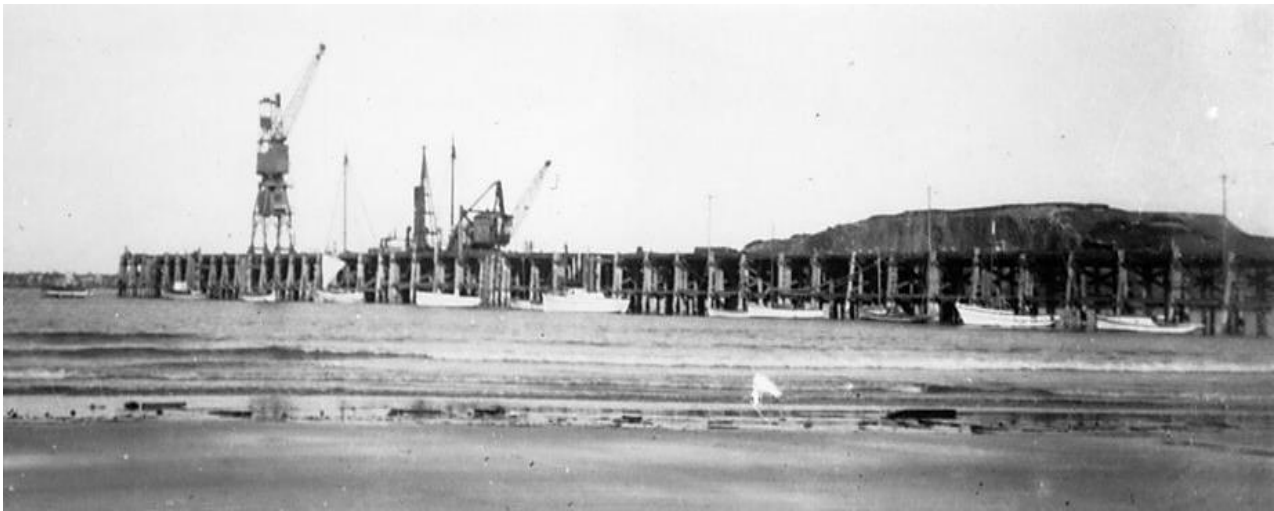
Figure 3.56: View of northern side of Coffs Harbour jetty, ca. 1952 – showing widening works in progress with pile driving rig adjacent to steam crane.¹⁰⁰

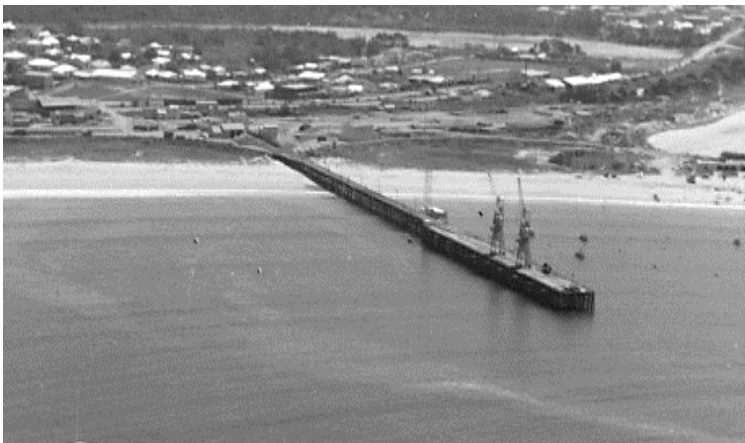
Figure 3.57: 1972 oblique aerial photograph of Coffs Harbour, showing extended and widened jetty with two Stothert & Pitt cranes.¹⁰¹

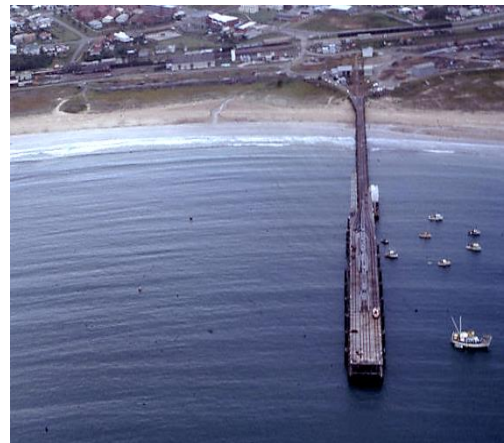
Figure 3.58: 1968 aerial photograph of Coffs Harbour showing widened and extended jetty¹⁰²

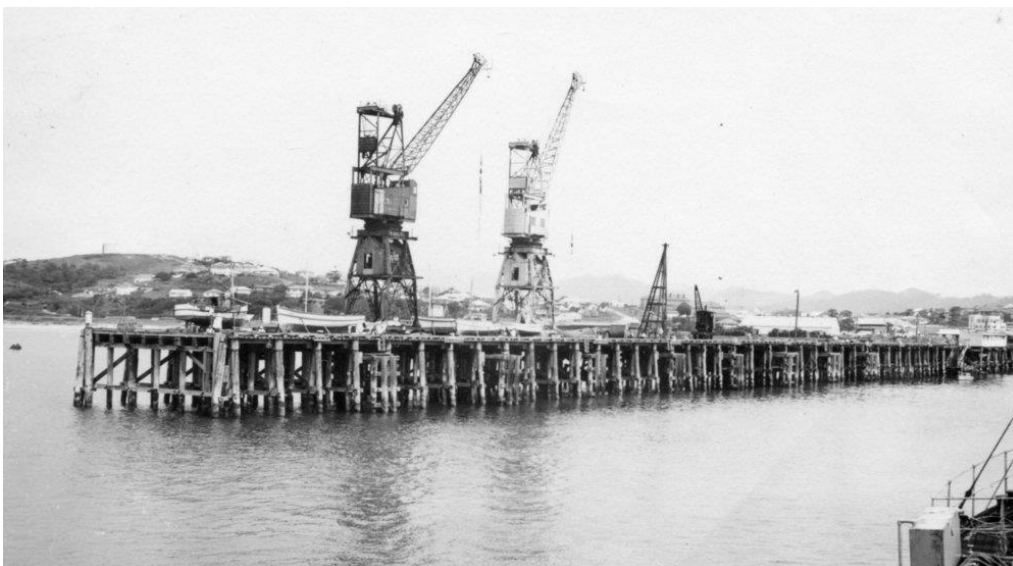
Figure 3.59: 1957 view of Coffs Harbour jetty – showing detail of widened structure at jetty head.¹⁰³

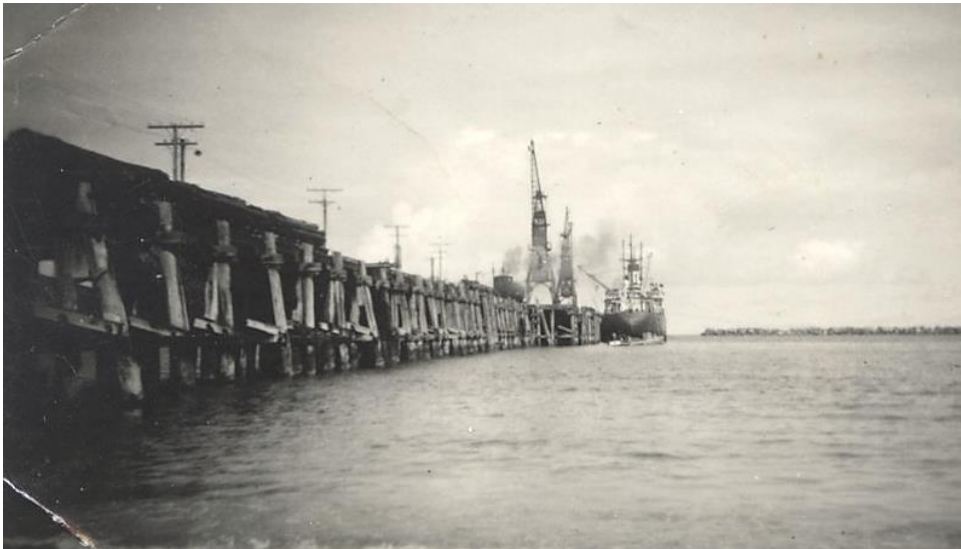
Figure 3.60: ca. late 1950s view of southern side of Coffs Harbour jetty – showing widened seaward end, with cargo vessel being loaded by Stothert & Pitt crane.¹⁰⁴

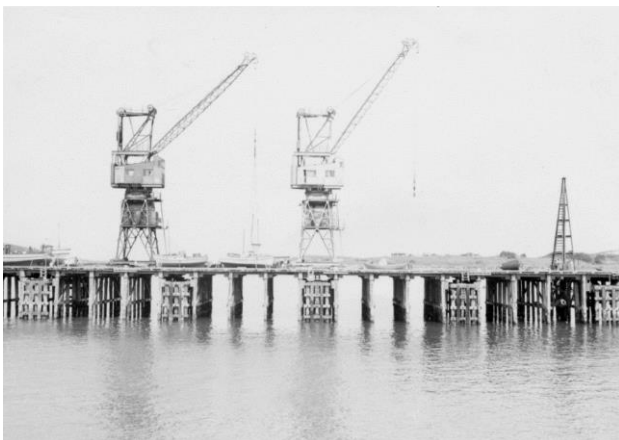
Figure 3.61: 1957 side view of Coffs Harbour jetty – showing strengthened sections for Stothert & Pitt cranes.¹⁰⁵

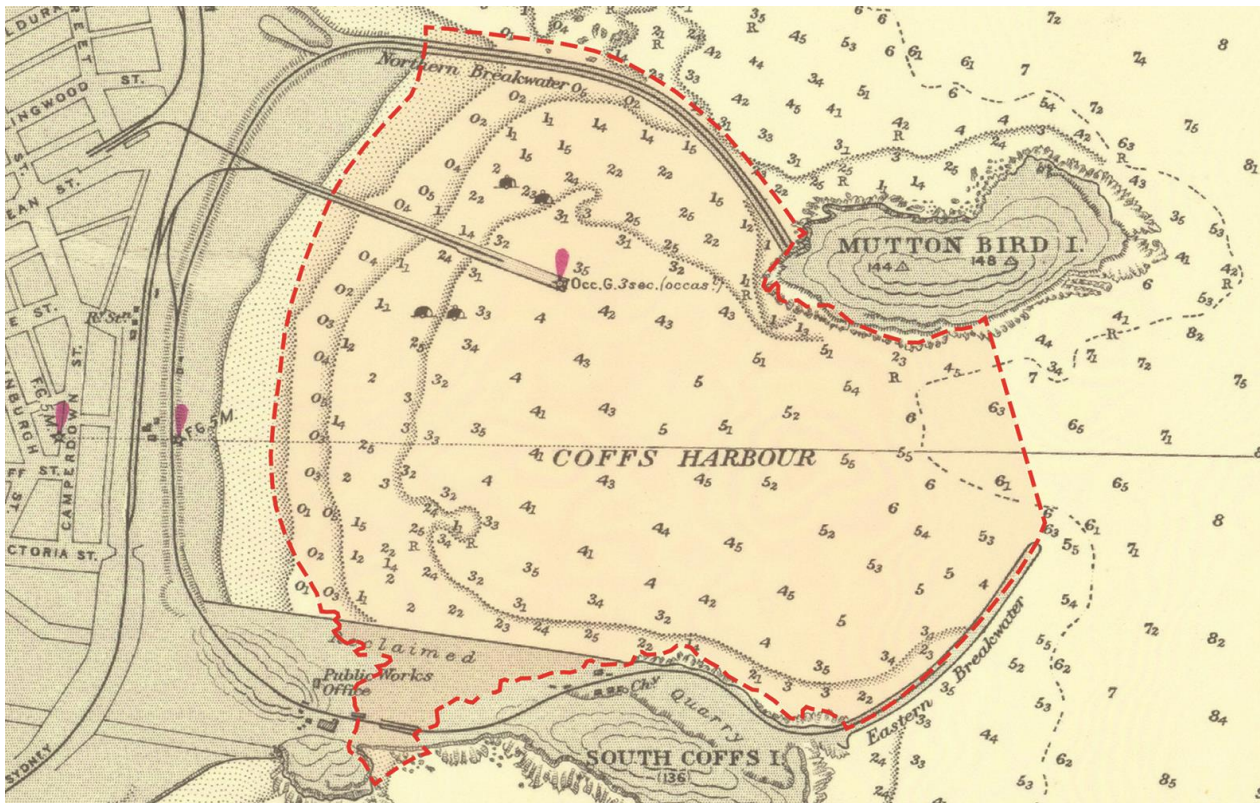
Figure 3.64: 1965 hydrographic chart of Coffs Harbour¹⁰⁸ – showing extended and widened jetty and relocated moorings; marked with mooring barrel buoys. Maritime archaeological assessment study area outlined in red.
