Coffs Harbour Jetty Foreshore State Assessed Planning Proposal

Desktop Maritime Archaeological Assessment

Coffs Harbour Jetty Foreshore Precinct,
New South Wales

February 2025

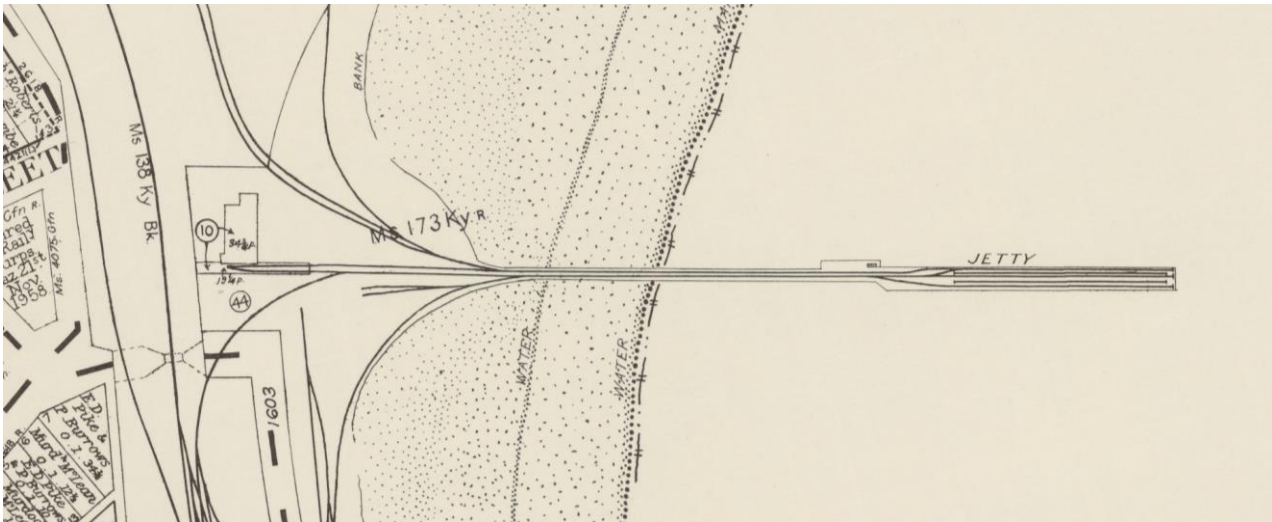
Enlarged of 1968 plan showing detail of Coffs Harbour jetty.

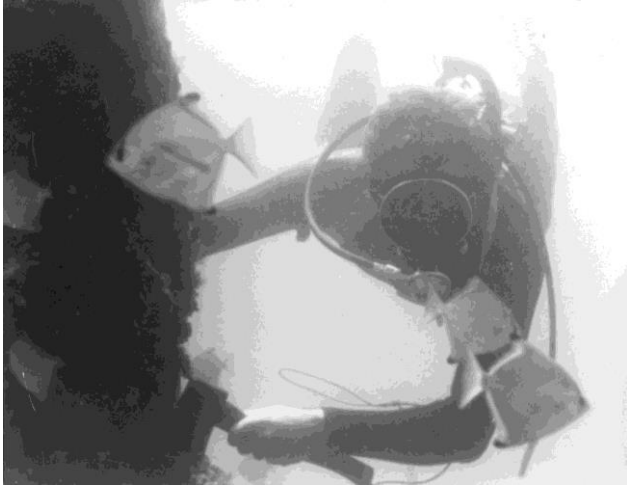
Figure 3.71: Department of Public Works dive inspections of Coffs Harbour jetty piles, 1975 – clearing marine growth to observe pile condition.¹²³

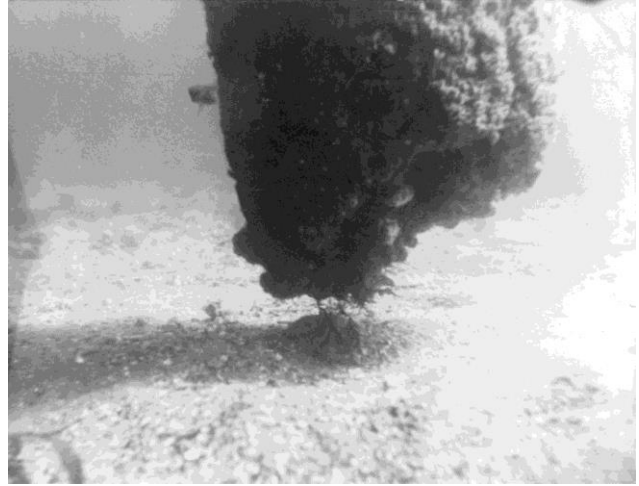
Figure 3.72: Department of Public Works dive inspections of Coffs Harbour jetty piles, 1975 – broken pile suspended above seabed, showing evidence of extreme marine borer damage.¹²⁴

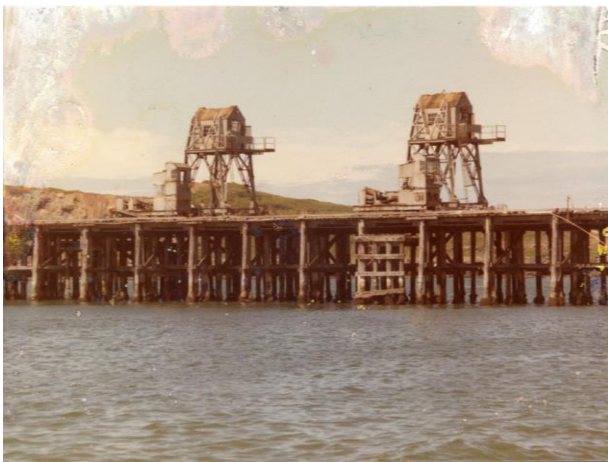
Figure 3.73: Stothert & Pitt cranes on Coffs Harbour jetty being disassembled, 1984.¹²⁵

Public Works and the Marine Services Board from 1975 to 1977 found the condition of the timber structure was too poor to support regular shipping or cargo handling, and the two Stothert and Pitt cranes had become unsafe to operate. Another inspection by the Marine Services Board in 1981 found that the two cranes were unstable and presented a danger to the public. Both cranes, their accompanying railway track, and associated equipment, were subsequently dismantled and removed in 1983-1984.¹²²

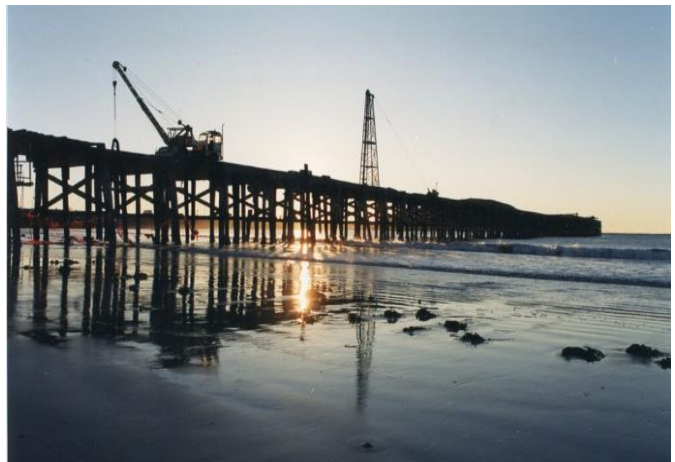
Figure 3.74: Sections of Stothert & Pitt cranes and machinery being removed from Coffs Harbour jetty.¹²⁶

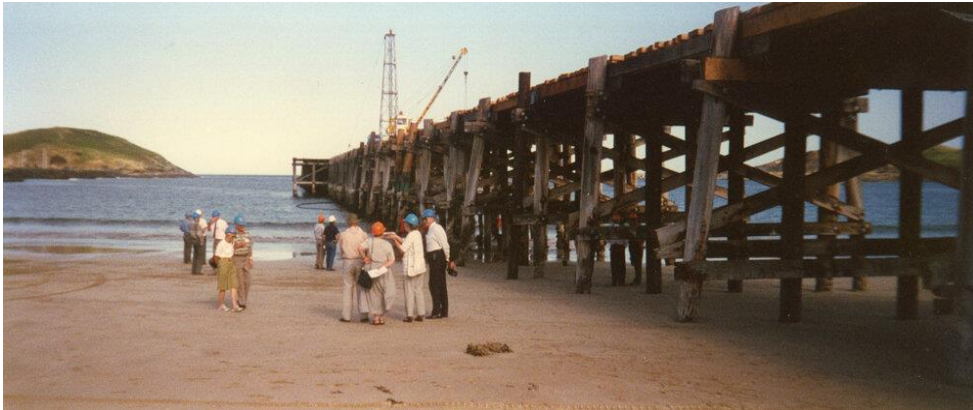
Figure 3.75: Inspection of the Coffs Harbour jetty as part of partial demolition and refurbishment works, 1996.¹²⁷

representing the 91.4 m long extension constructed in 1944-1946, and retain the original 1892 length, complete with the 1912-1914 widening and sections of the 1950-1955 widening.

Demolition and restoration works commenced in March 1996 and were finished with a re-opening ceremony and festivities on 11 October 1997.

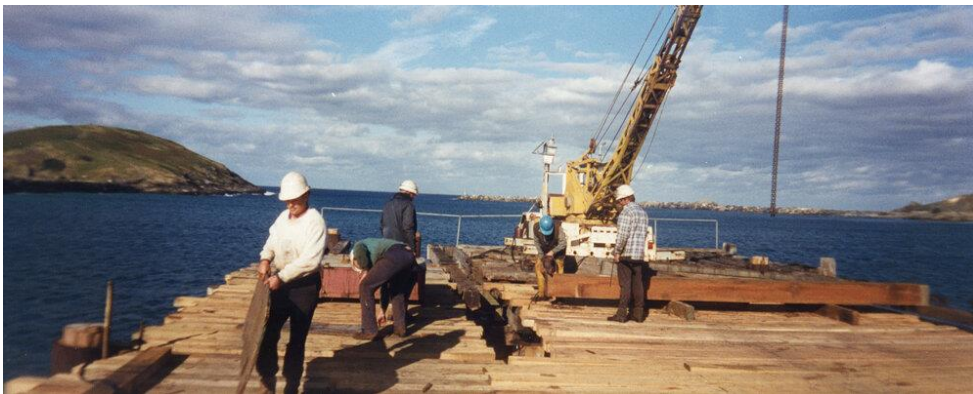
Figure 3.76: Coffs Harbour jetty partial demolition and refurbishment works, 1996.¹²⁸

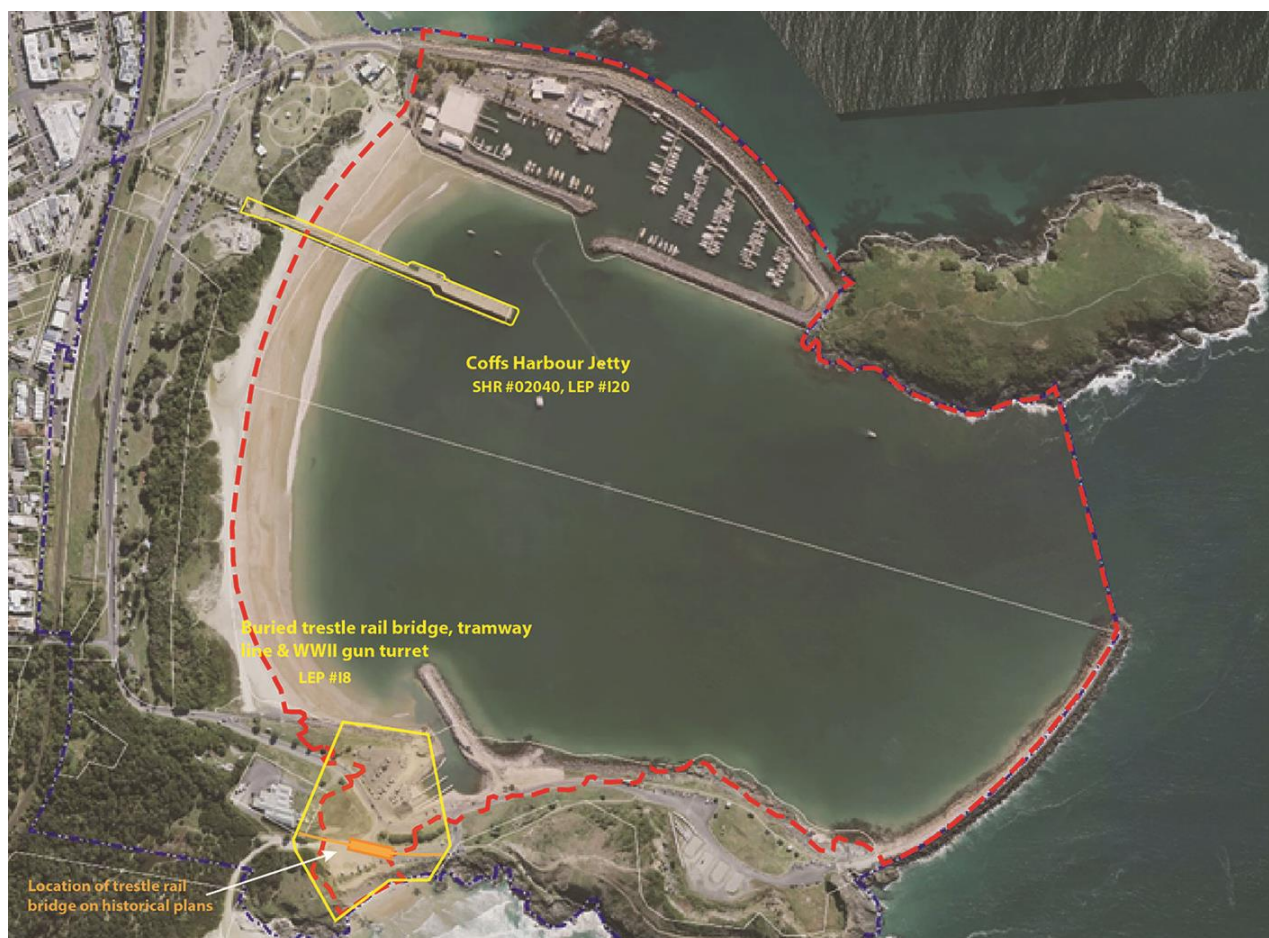
Figure 4.1: Known maritime heritage and archaeological sites within the Coffs Harbour maritime assessment area.

The boundaries of the statutory heritage listings for the Coffs Harbour jetty – both SHR and LEP – commence at the first timber decking board at the shoreward end of the jetty and extend along the full length and width of the extant jetty structure, measuring ca. 360 m long, ca. 6.5 m wide at the landward end, and ca. 15 m wide at the seaward end, and incorporate a 5 m buffer covering land and water on all but the landward end – see Figure 4.1.

Part of the retaining wall and land reclamation between South Coffs Island and the mainland was excavated during the mid 1970s to create the Coffs Harbour boat ramp basin, and both the basin and the entrance channel are regularly maintenance dredged. These works, however, did not extend to the location of the timber trestle rail bridge, as marked on early to mid 19th century plans – see Figure 4.1.

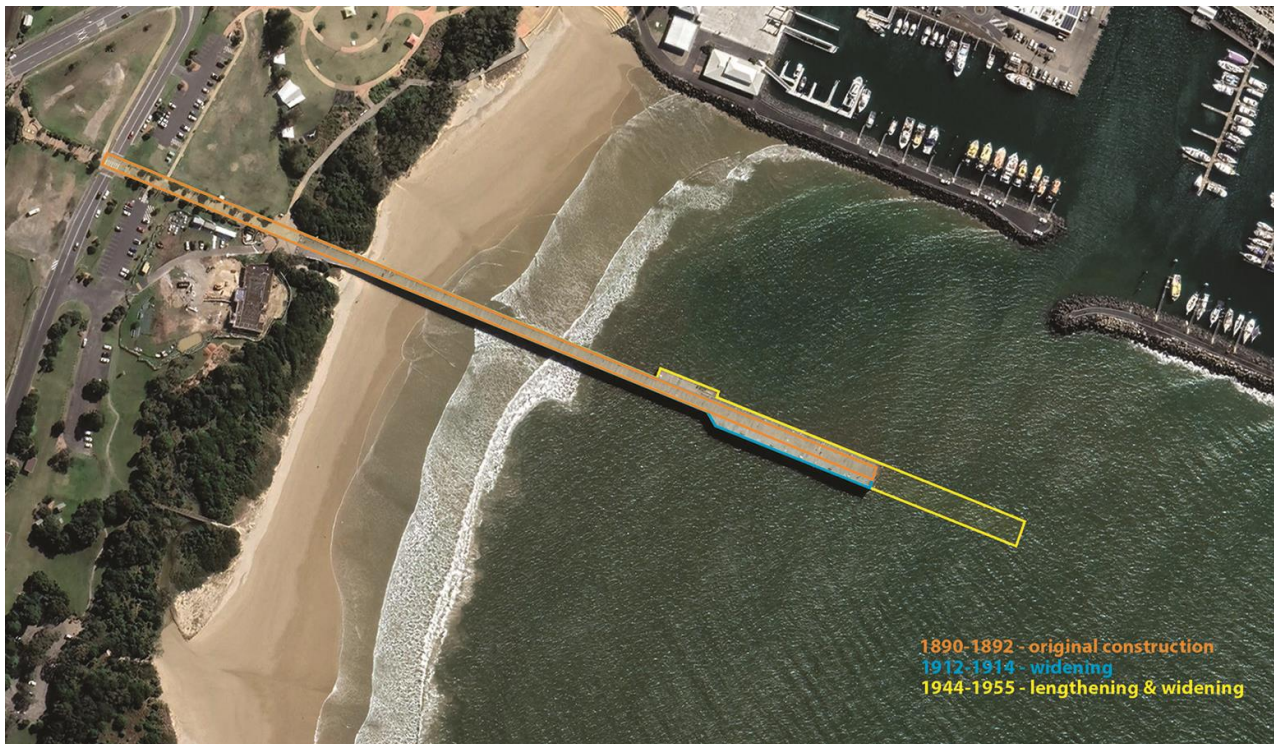
Figure 4.2: Footprint outlines of construction phases of Coffs Harbour jetty overlain on current aerial photograph.

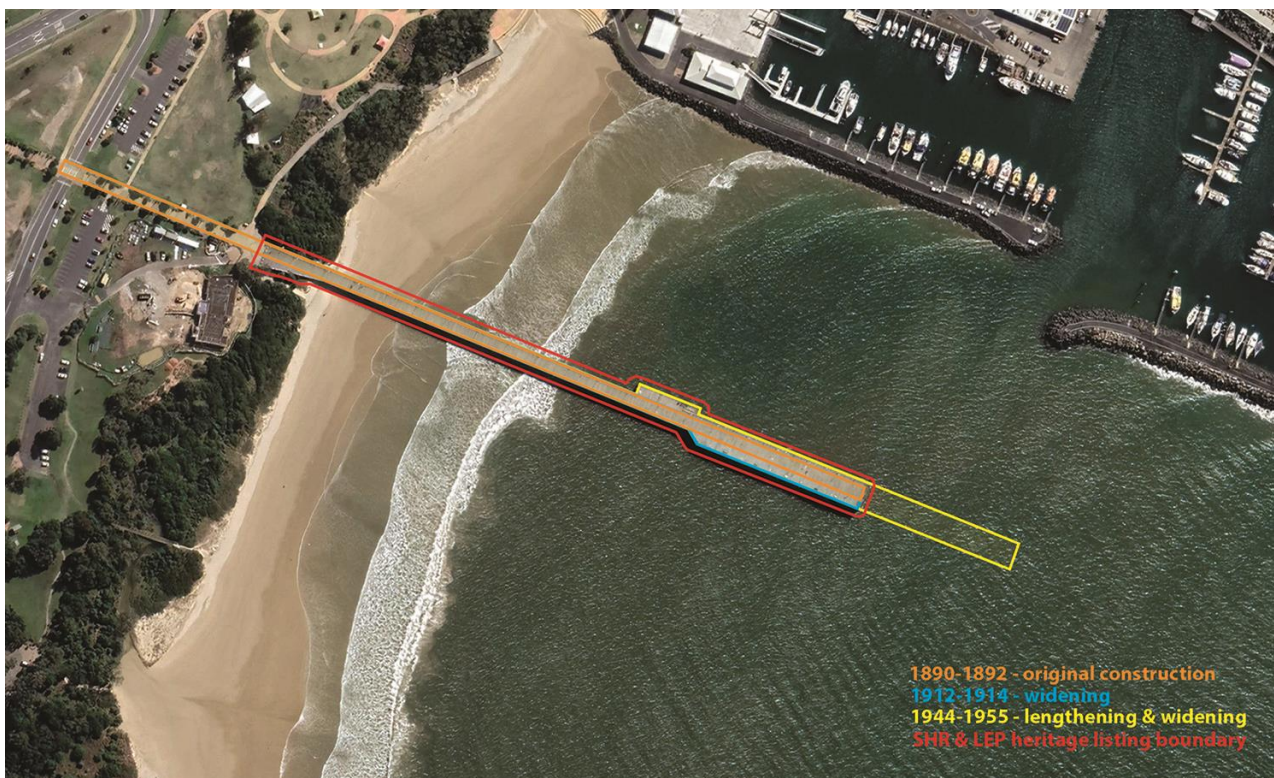
Figure 4.3: Footprint outlines of construction phases of Coffs Harbour jetty overlain on current aerial photograph – SHR and LEP heritage listing boundaries shown in red.

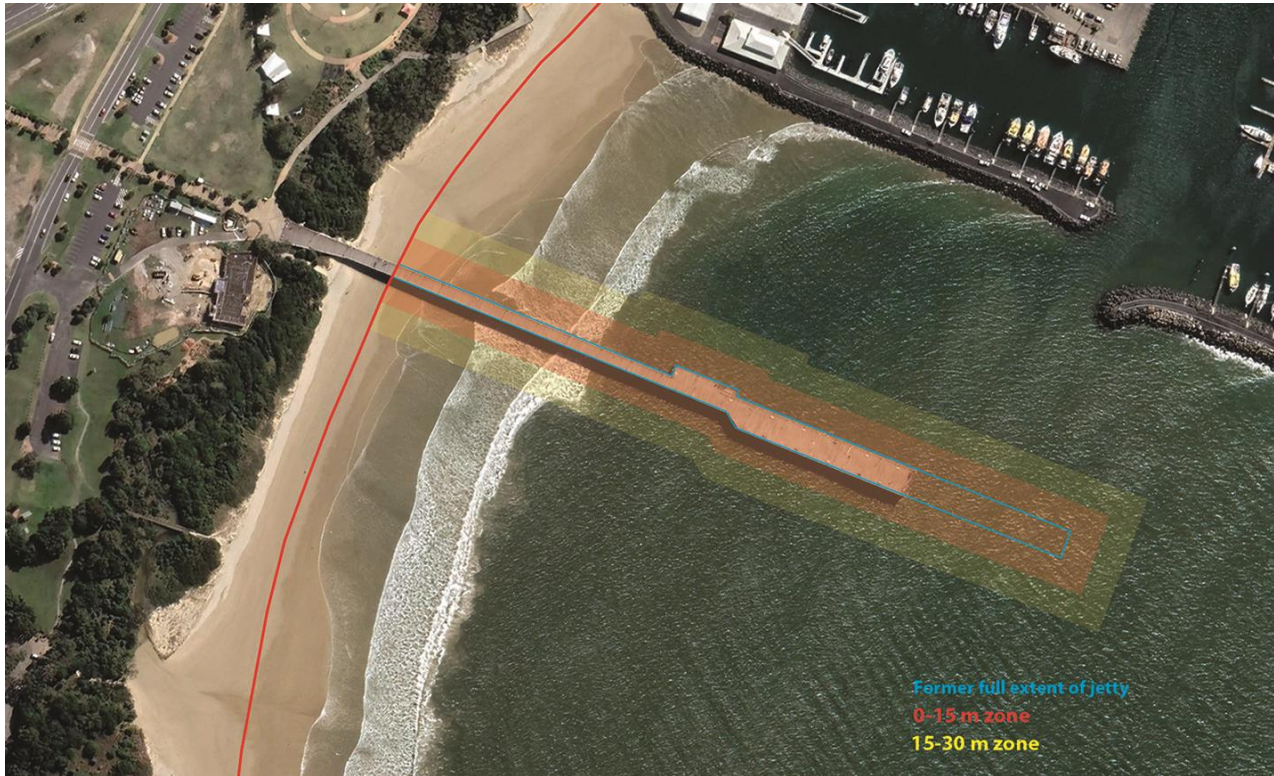
Figure 4.4: Potential extent of artefact deposits on the seabed underneath and adjacent to Coffs Harbour jetty.

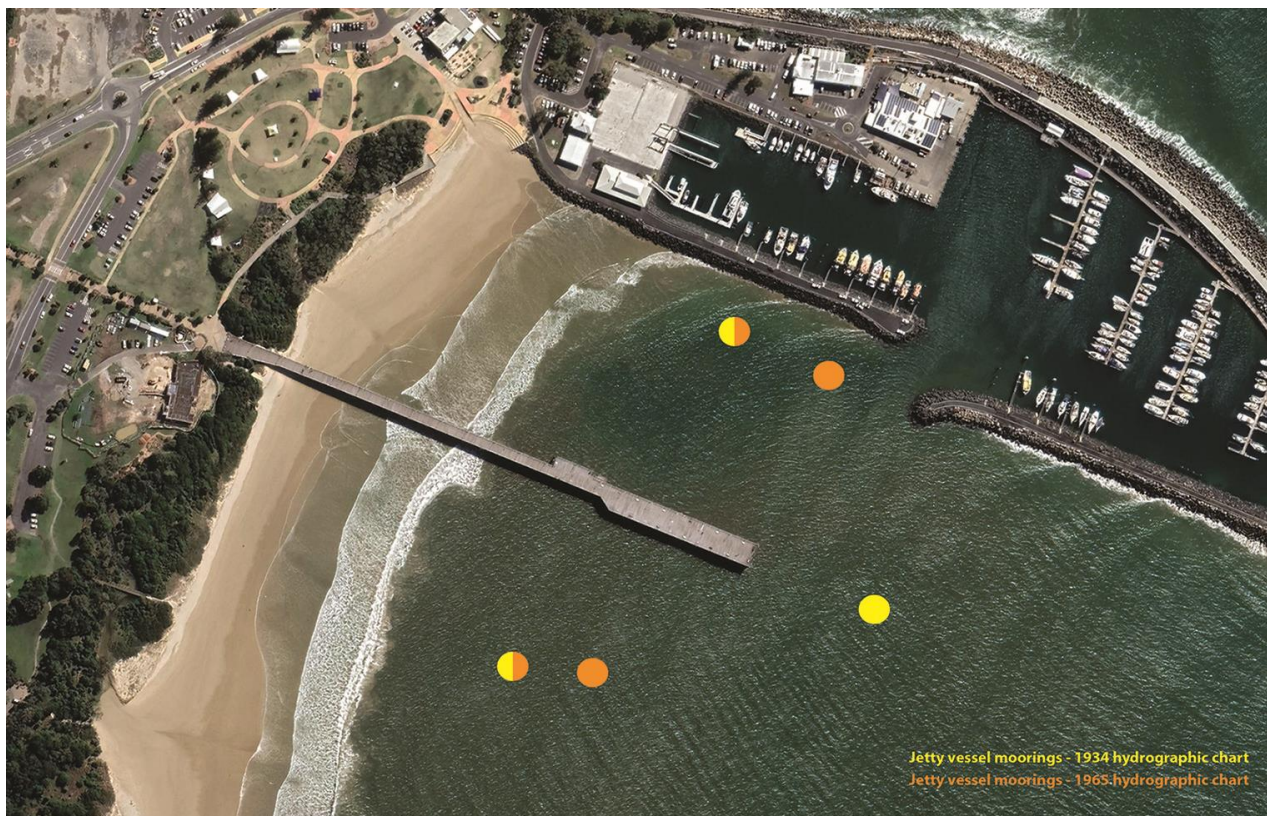
Figure 4.5: Overlay showing locations of vessel moorings as marked on 1934 and 1965 hydrographic charts.

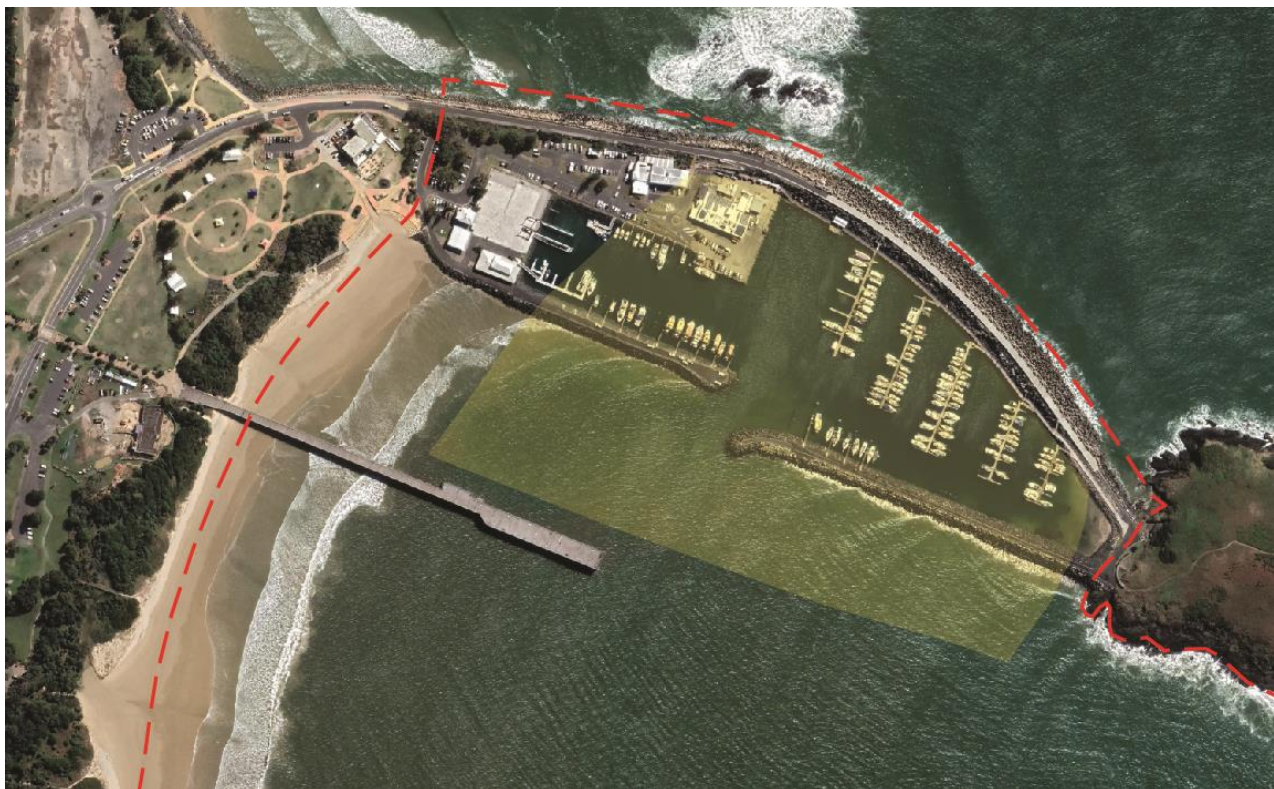
Figure 4.6: General extent of former area of small vessel moorings in Coffs Harbour.

An unknown number of small vessel moorings were also established in Coffs Harbour throughout the early to mid 20th century, catering to smaller vessels and the growing Coffs Harbour commercial fishing fleet, prior to the construction of the boat harbour in the mid 1970s. Based on a range of historical photographs (e.g. Figures 3.35, 3.36, 3.54 and 3.79), these moorings appear to have been located north of Coffs Harbour jetty, scattered throughout the area within the shelter of the northern breakwater and Muttonbird Island – see Figure 4.6.

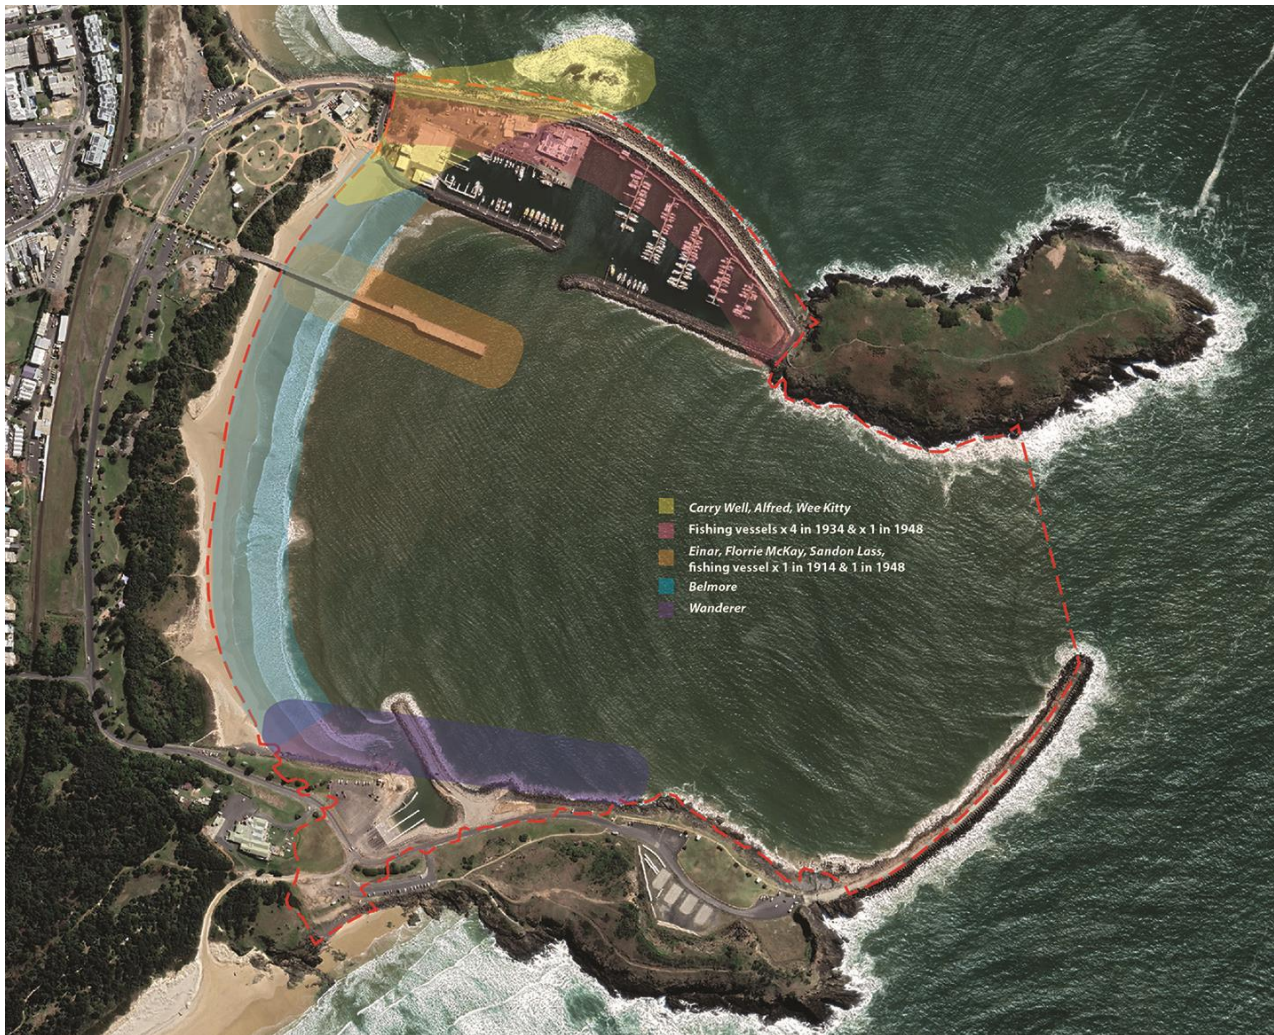
Figure 4.7: General wrecking location of known shipwrecks within Coffs Harbour according to historical accounts.

somewhere along Jetty Beach. Figure 4.7 below shows the general wrecking location of each vessel according to the broad descriptions in historical accounts.

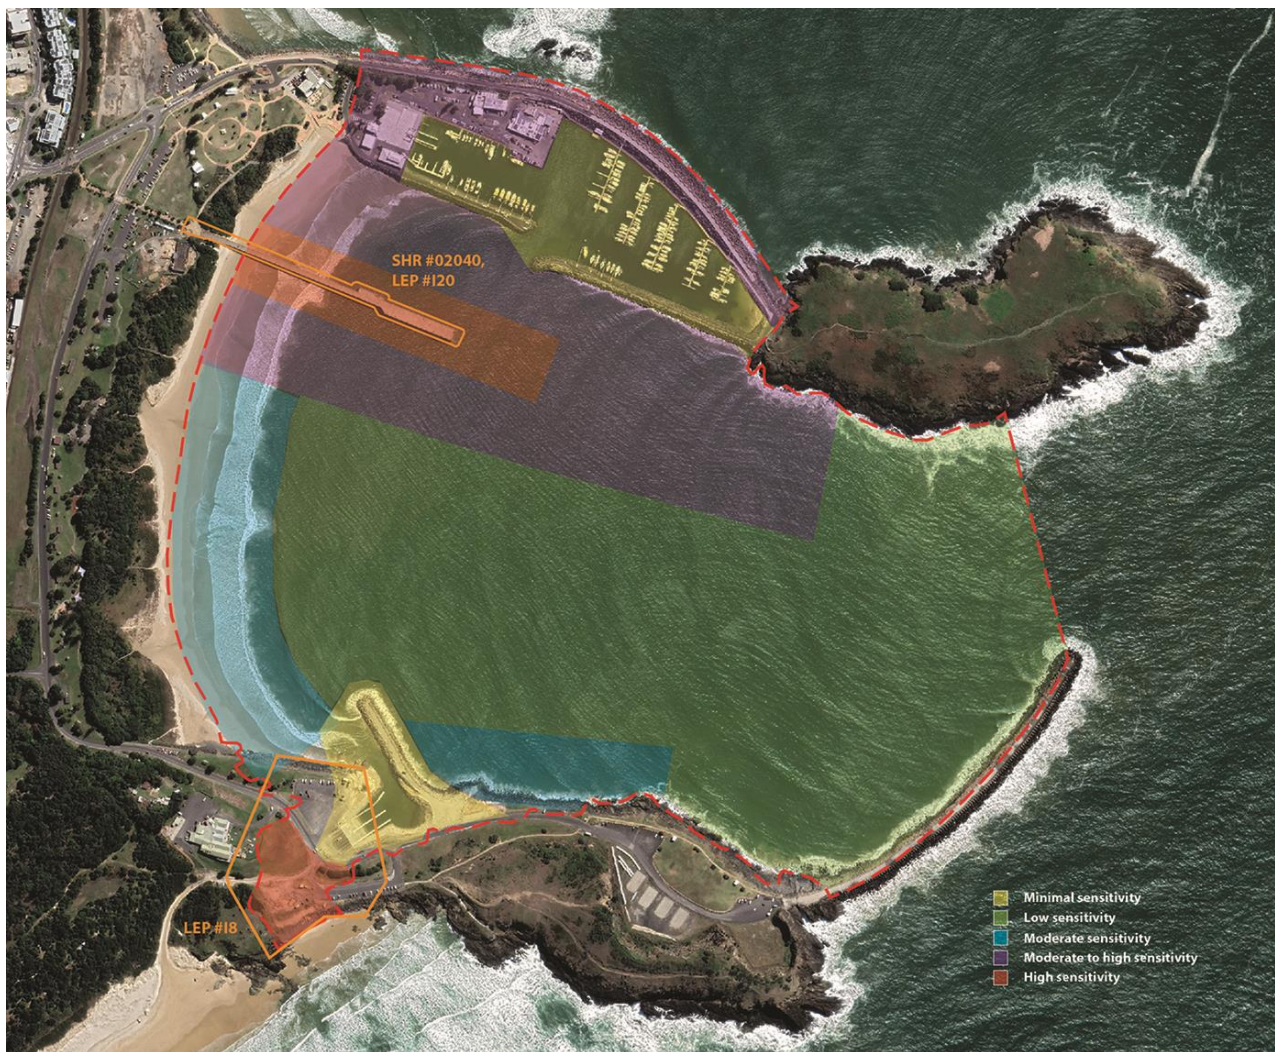
Figure 6.1: Areas of maritime archaeological sensitivity within Coffs Harbour maritime archaeological assessment study area (outlined in red).

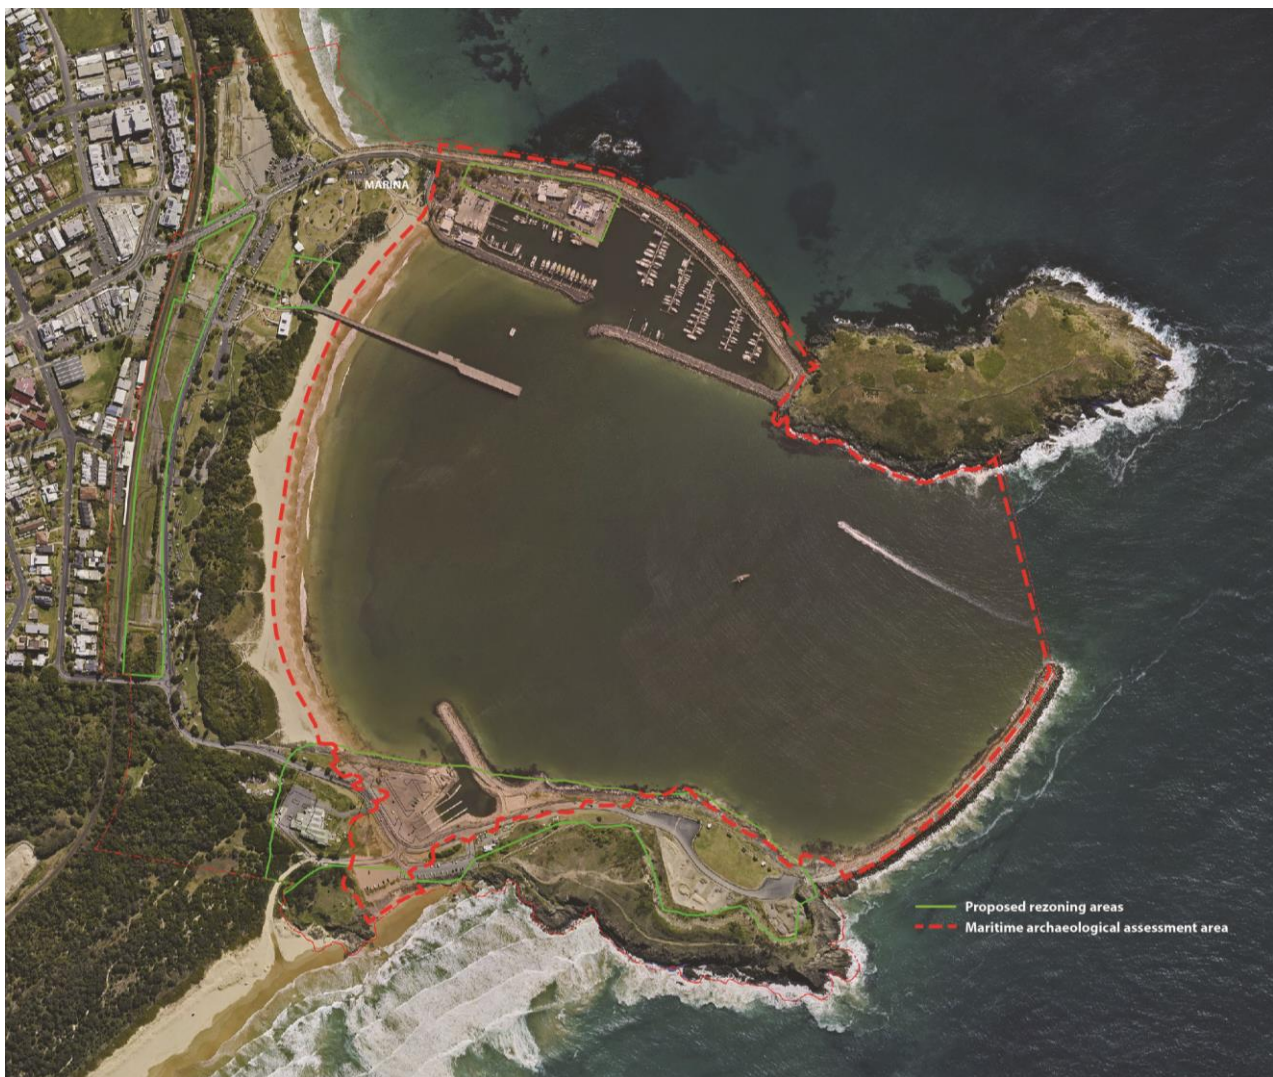
Figure 7.1: Proposed rezoning areas (outlined in green) in relation to the maritime archaeological assessment study area (outlined in red).

Only two of the proposed rezoning areas and Illustrative Masterplan sub-precincts fall within the maritime archaeological assessment study area; Corambirra Point and the Marina – see Figures 7.1 and 7.2. The North Park, Jetty Hub, Activity Hub, and Foreshore Parklands Illustrative Masterplan sub-precincts are outside the maritime archaeological assessment area and have no maritime archaeological constraints.

As shown in Figure 7.1, an area of proposed rezoning within the Foreshore Parklands sub-precinct, located just beyond the maritime archaeological assessment area, extends over the base of the Coffs Harbour Jetty. This proposed rezoning involves the following planning amendments in land use zoning only:

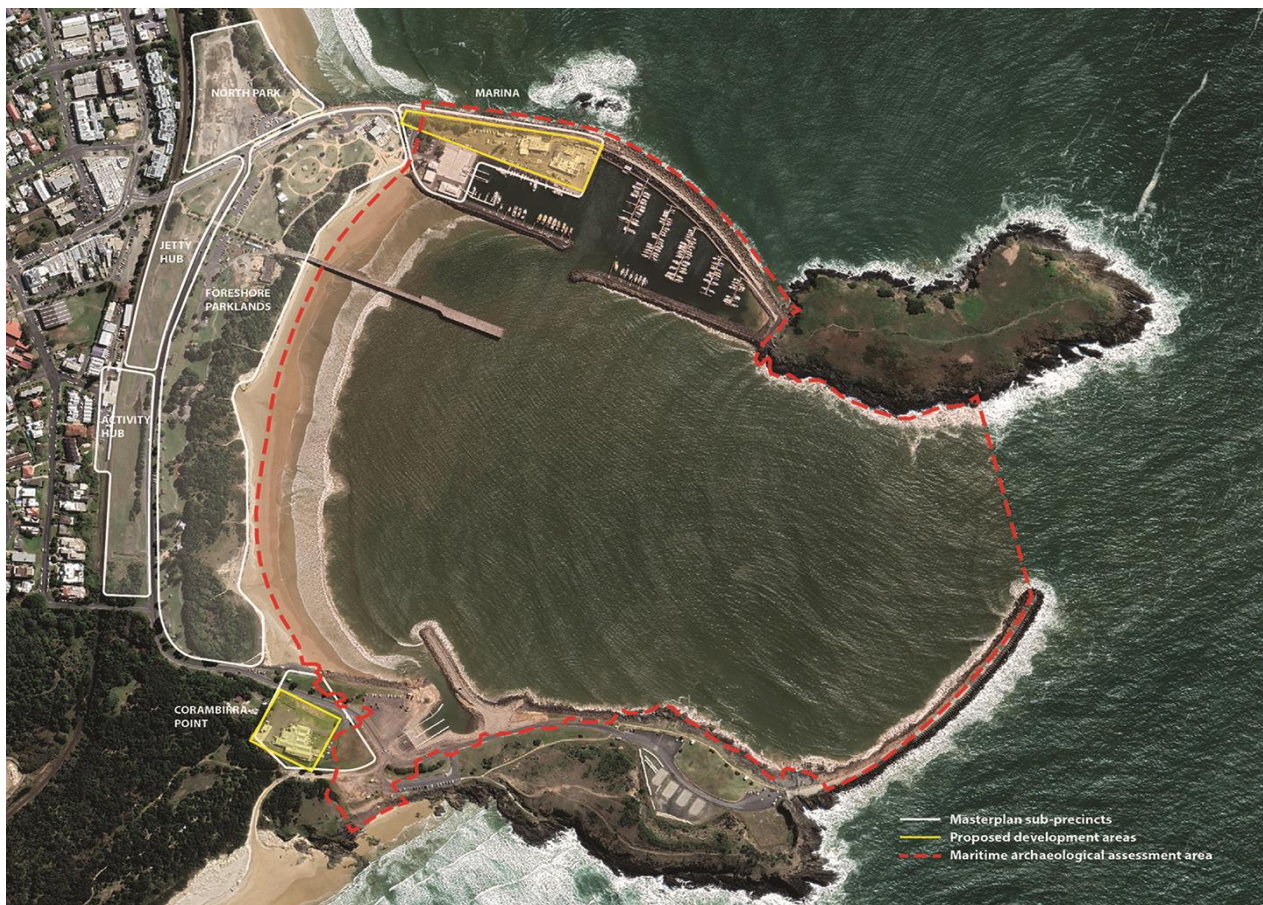
Figure 7.2: Illustrative Masterplan sub-precincts (in white) in relation to the maritime archaeological assessment area (in red).

Proposed development under the Illustrative Masterplan within the Corambirra Point and Marina sub-precincts is as follows (see Figure 7.2):

The proposed development area within the Corrambirra Point sub-precinct falls outside the maritime archaeological assessment area (see Figure 7.2) and does not have any maritime heritage or archaeological constraints.

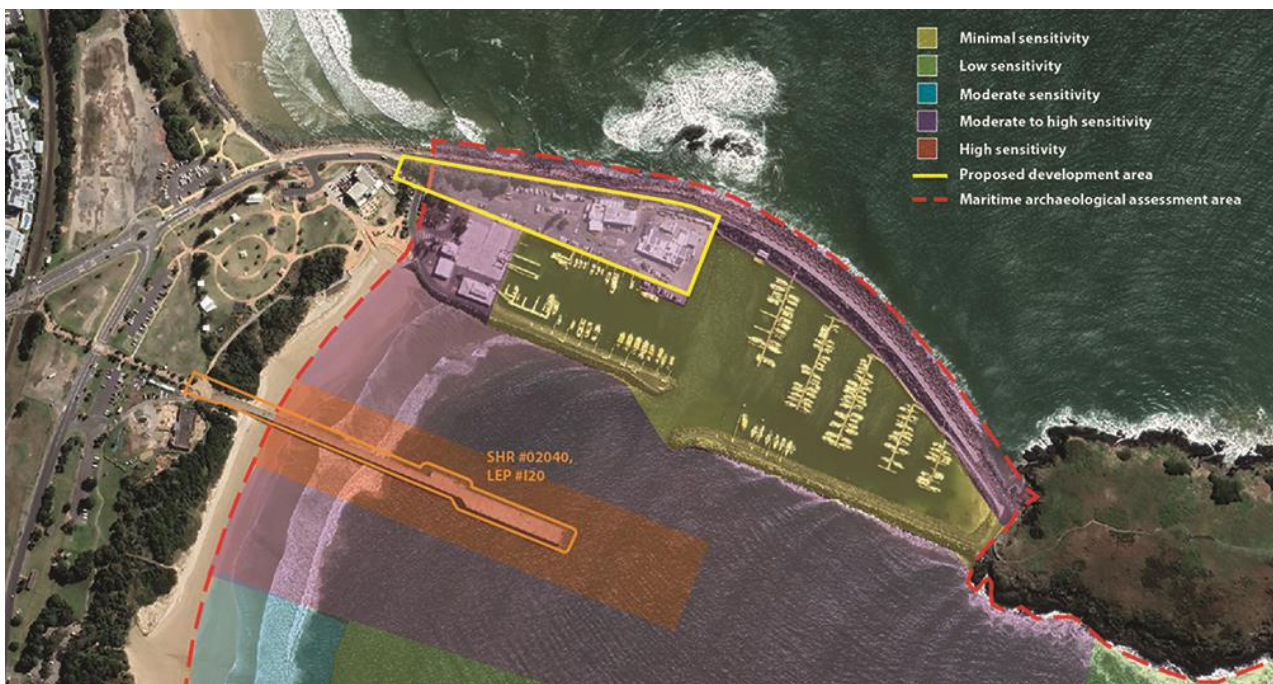
Figure 7.3: Marina sub-precinct proposed development area (outlined in yellow) in relation to areas of maritime archaeological sensitivity within the maritime archaeological assessment area (outlined in red).
