# Geotechnical Investigation Report

**Redmond Place, Orange NSW**

Landcom

15 May 2024

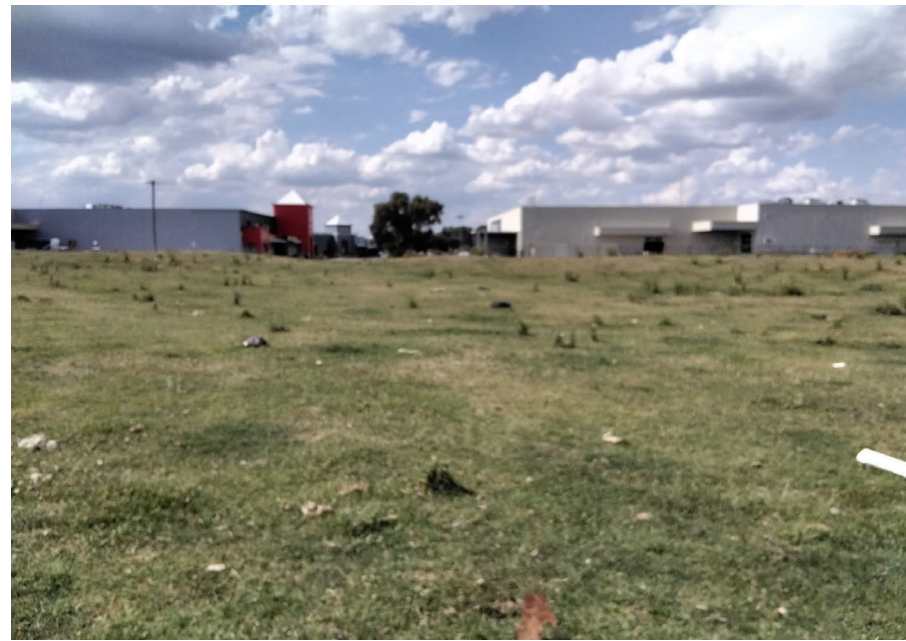
Photo 1 Looking north towards the northern boundary of the site, note neighbouring light industrial buildings built up compared to the surrounding land (photo dated: 30/01/2024).

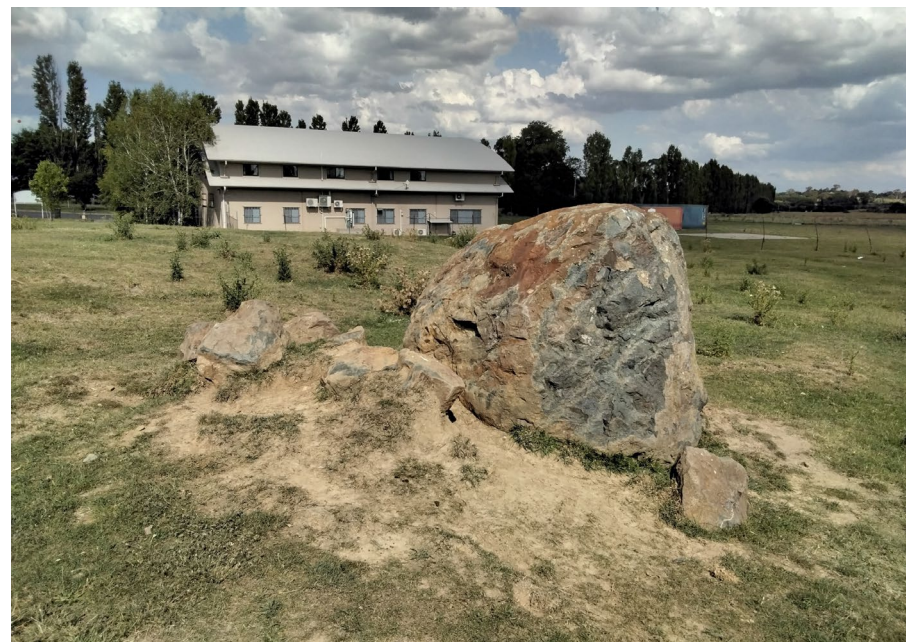
Photo 4 Overview of boulders observed in western portion of Lot 1 (photo dated 30/1/2024)

- The general gradient of the lot sloped towards the southwest, however, the northern portion of the lot was noted to be raised and uneven. Large boulders within the northeastern quadrant were noted on the surface.

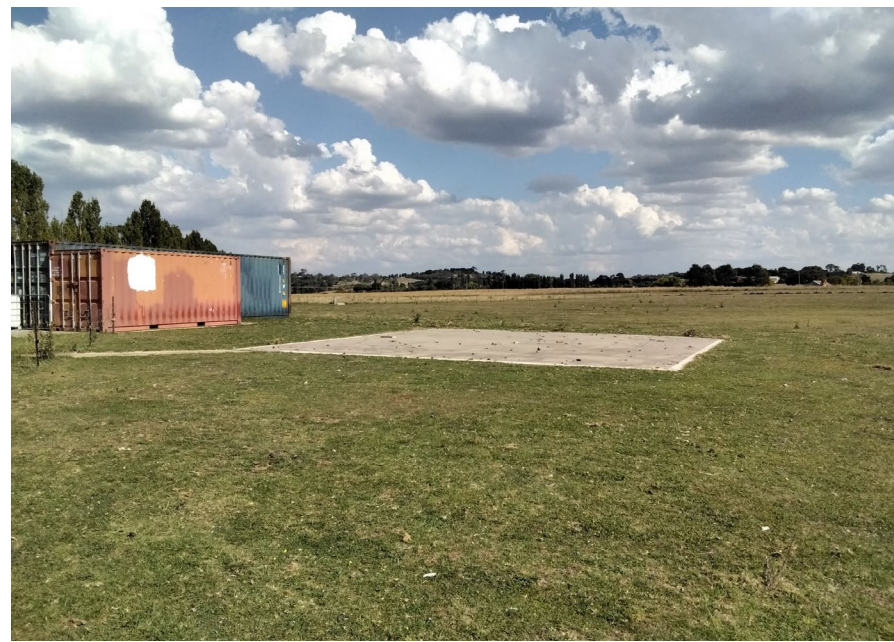
Photo 5 Looking southeast towards the central portion of Lot 6 (photo dated: 30/01/2024).

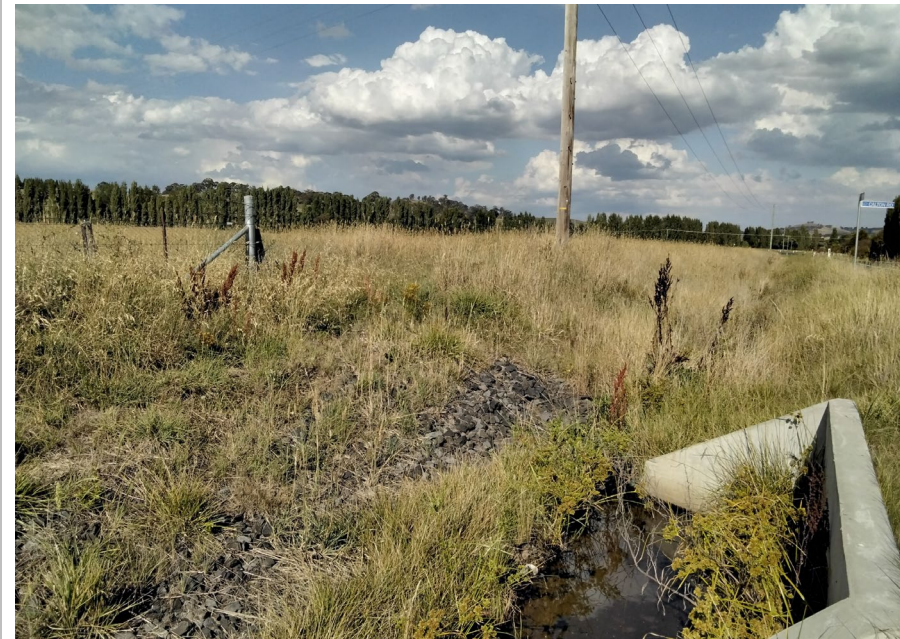
**Photo 8** Culvert noted within the southern boundary of Lot 200, adjacent to Dairy Creek Road (photo dated 30/01/2024)

- Lot 200 was noted to be inaccessible at the time of the site inspection, however the following was noted.
- Free flowing water was observed in the drainage line flowing west to east from the culverts along Dairy Creek Road.
- Drainage lines were also observed exiting Lot 200, flowing to the east, inferred surface water flow to south and south east towards the large drainage pipes that run beneath Dairy Creek Rd.

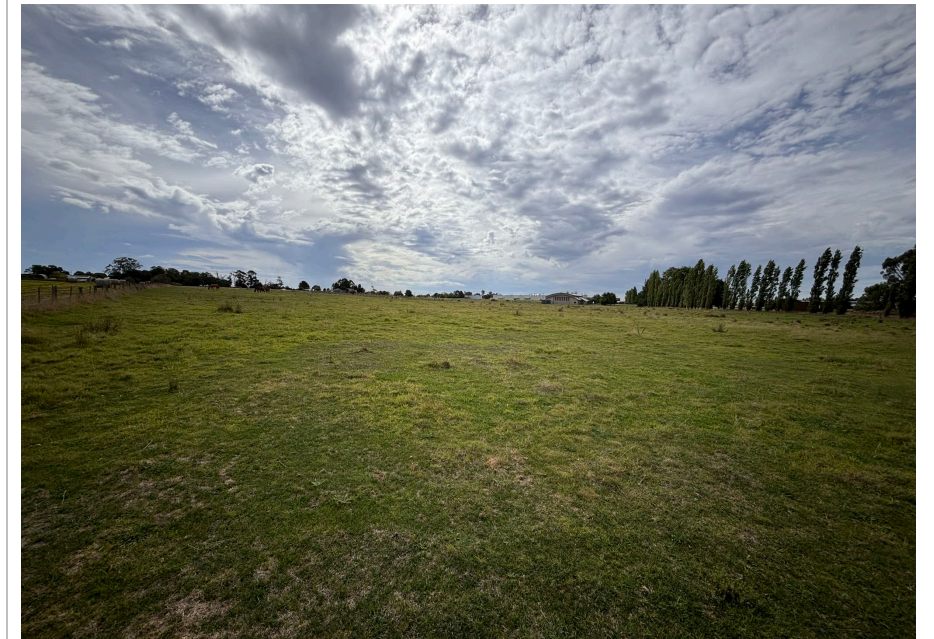
**Photo 9** Looking north, overview of northern portion of Lot 200 (photo dated 30/01/2024)

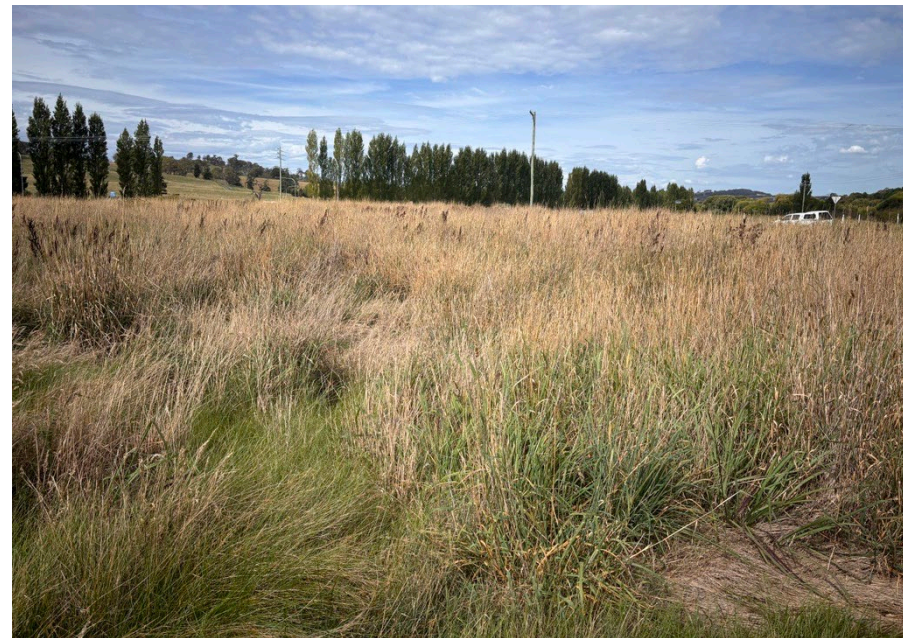
**Photo 10** View central portion of Lot 200, facing southeast, note thick grass and reeds indicative of wet ground conditions (photo dated 1/03/2024)

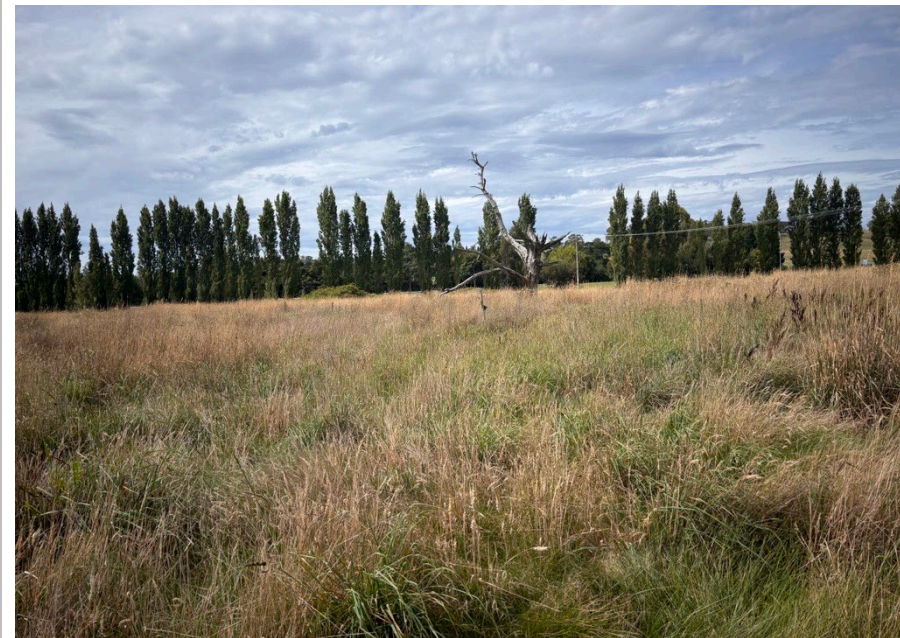
**Photo 11** Overview of southeastern portion of Lot 200, facing east (photo dated 01/03/2024)

- One small pond of water was observed on the southeastern portion of Lot 200, on the boundary of Mitchell Highway. At the time of the investigation the pond was noted to be at capacity of water.

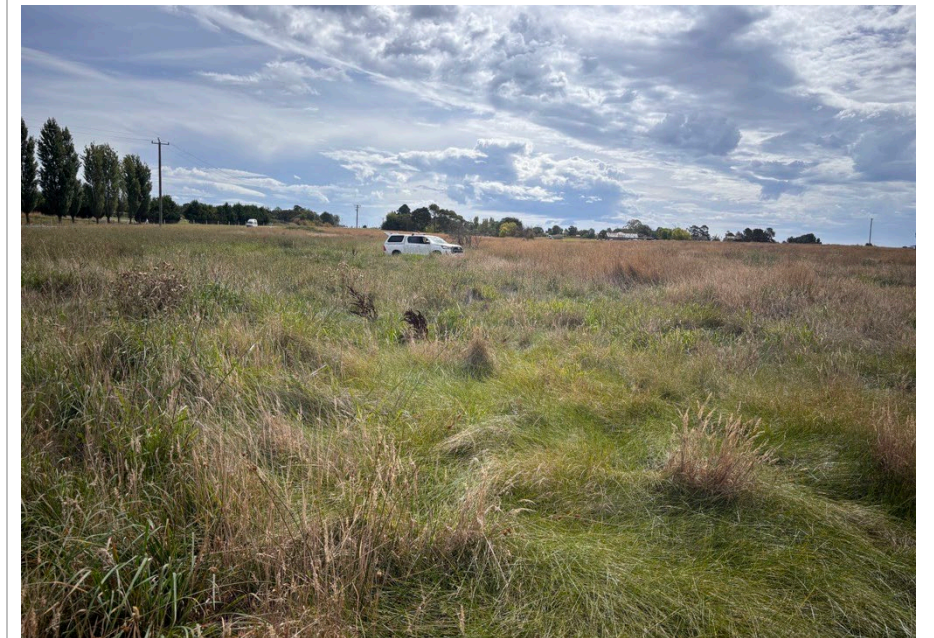
**Photo 12** Overview of southwestern portion of Lot 200, facing west (photo dated 01/03/2024)

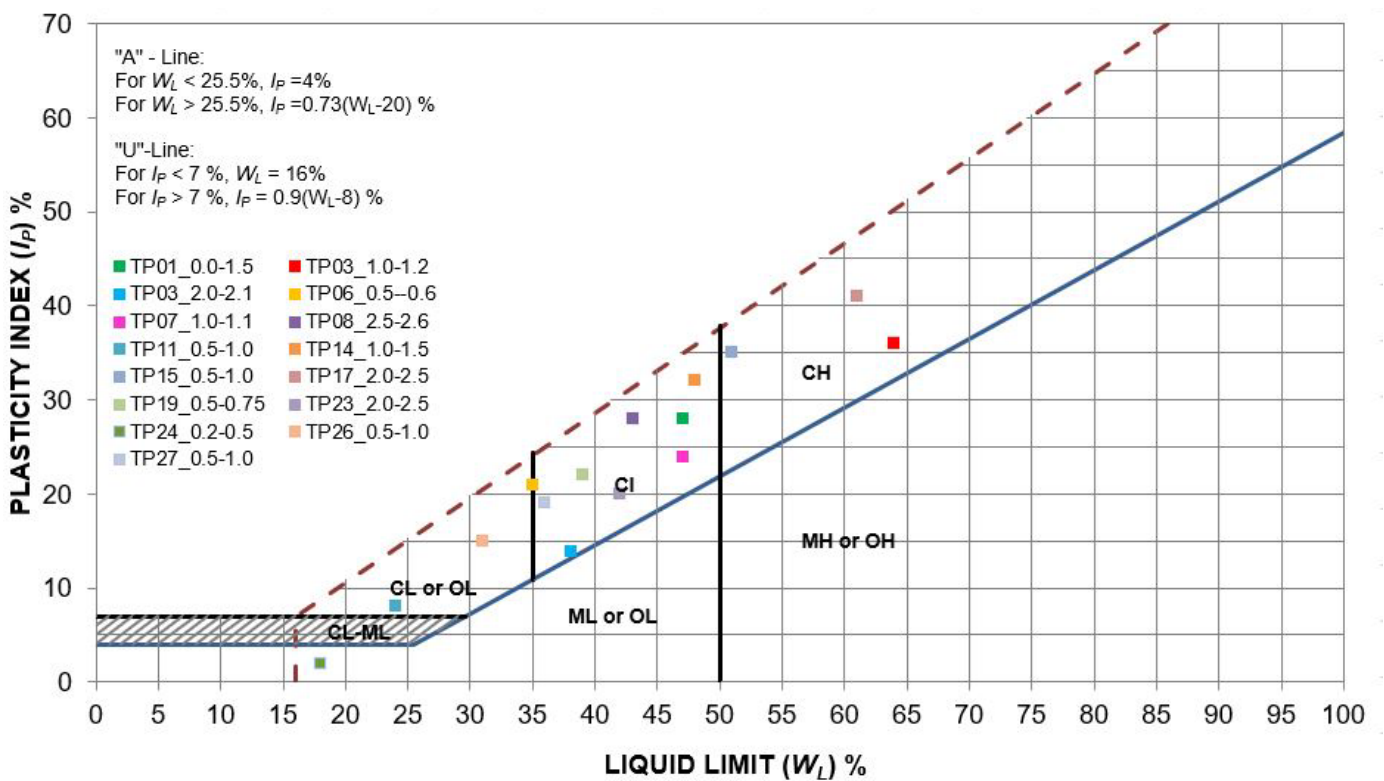
Figure 4 Plot of Plasticity, based on Atterberg limits of tested samples

Atterberg Limits test results indicate the clay content of the soils tested is of low to high plasticity and in turn would generally be classified as 'CL, CI or CH' or inorganic clays of low to high plasticity and includes gravelly clays, sandy clays & silty clays. Most samples were of medium plasticity. This is relatively consistent with the field description.
