Proposed Concept Plan Approval Modification **Bevian Road, Rosedale, NSW** *Geotechnical Investigation Report*

We are pleased to present our geotechnical investigation report to support modification of the 2008 Concept Plan Approval for a residential subdivision at Bevian Road, Rosedale, NSW.

The report outlines the methods and results of exploration, describes site subsurface conditions and provides recommendations for building footing design, excavation conditions, excavation support, preparation of subgrades, stability of cut and fill batters, retaining wall design, earthquake classification and site drainage advice.

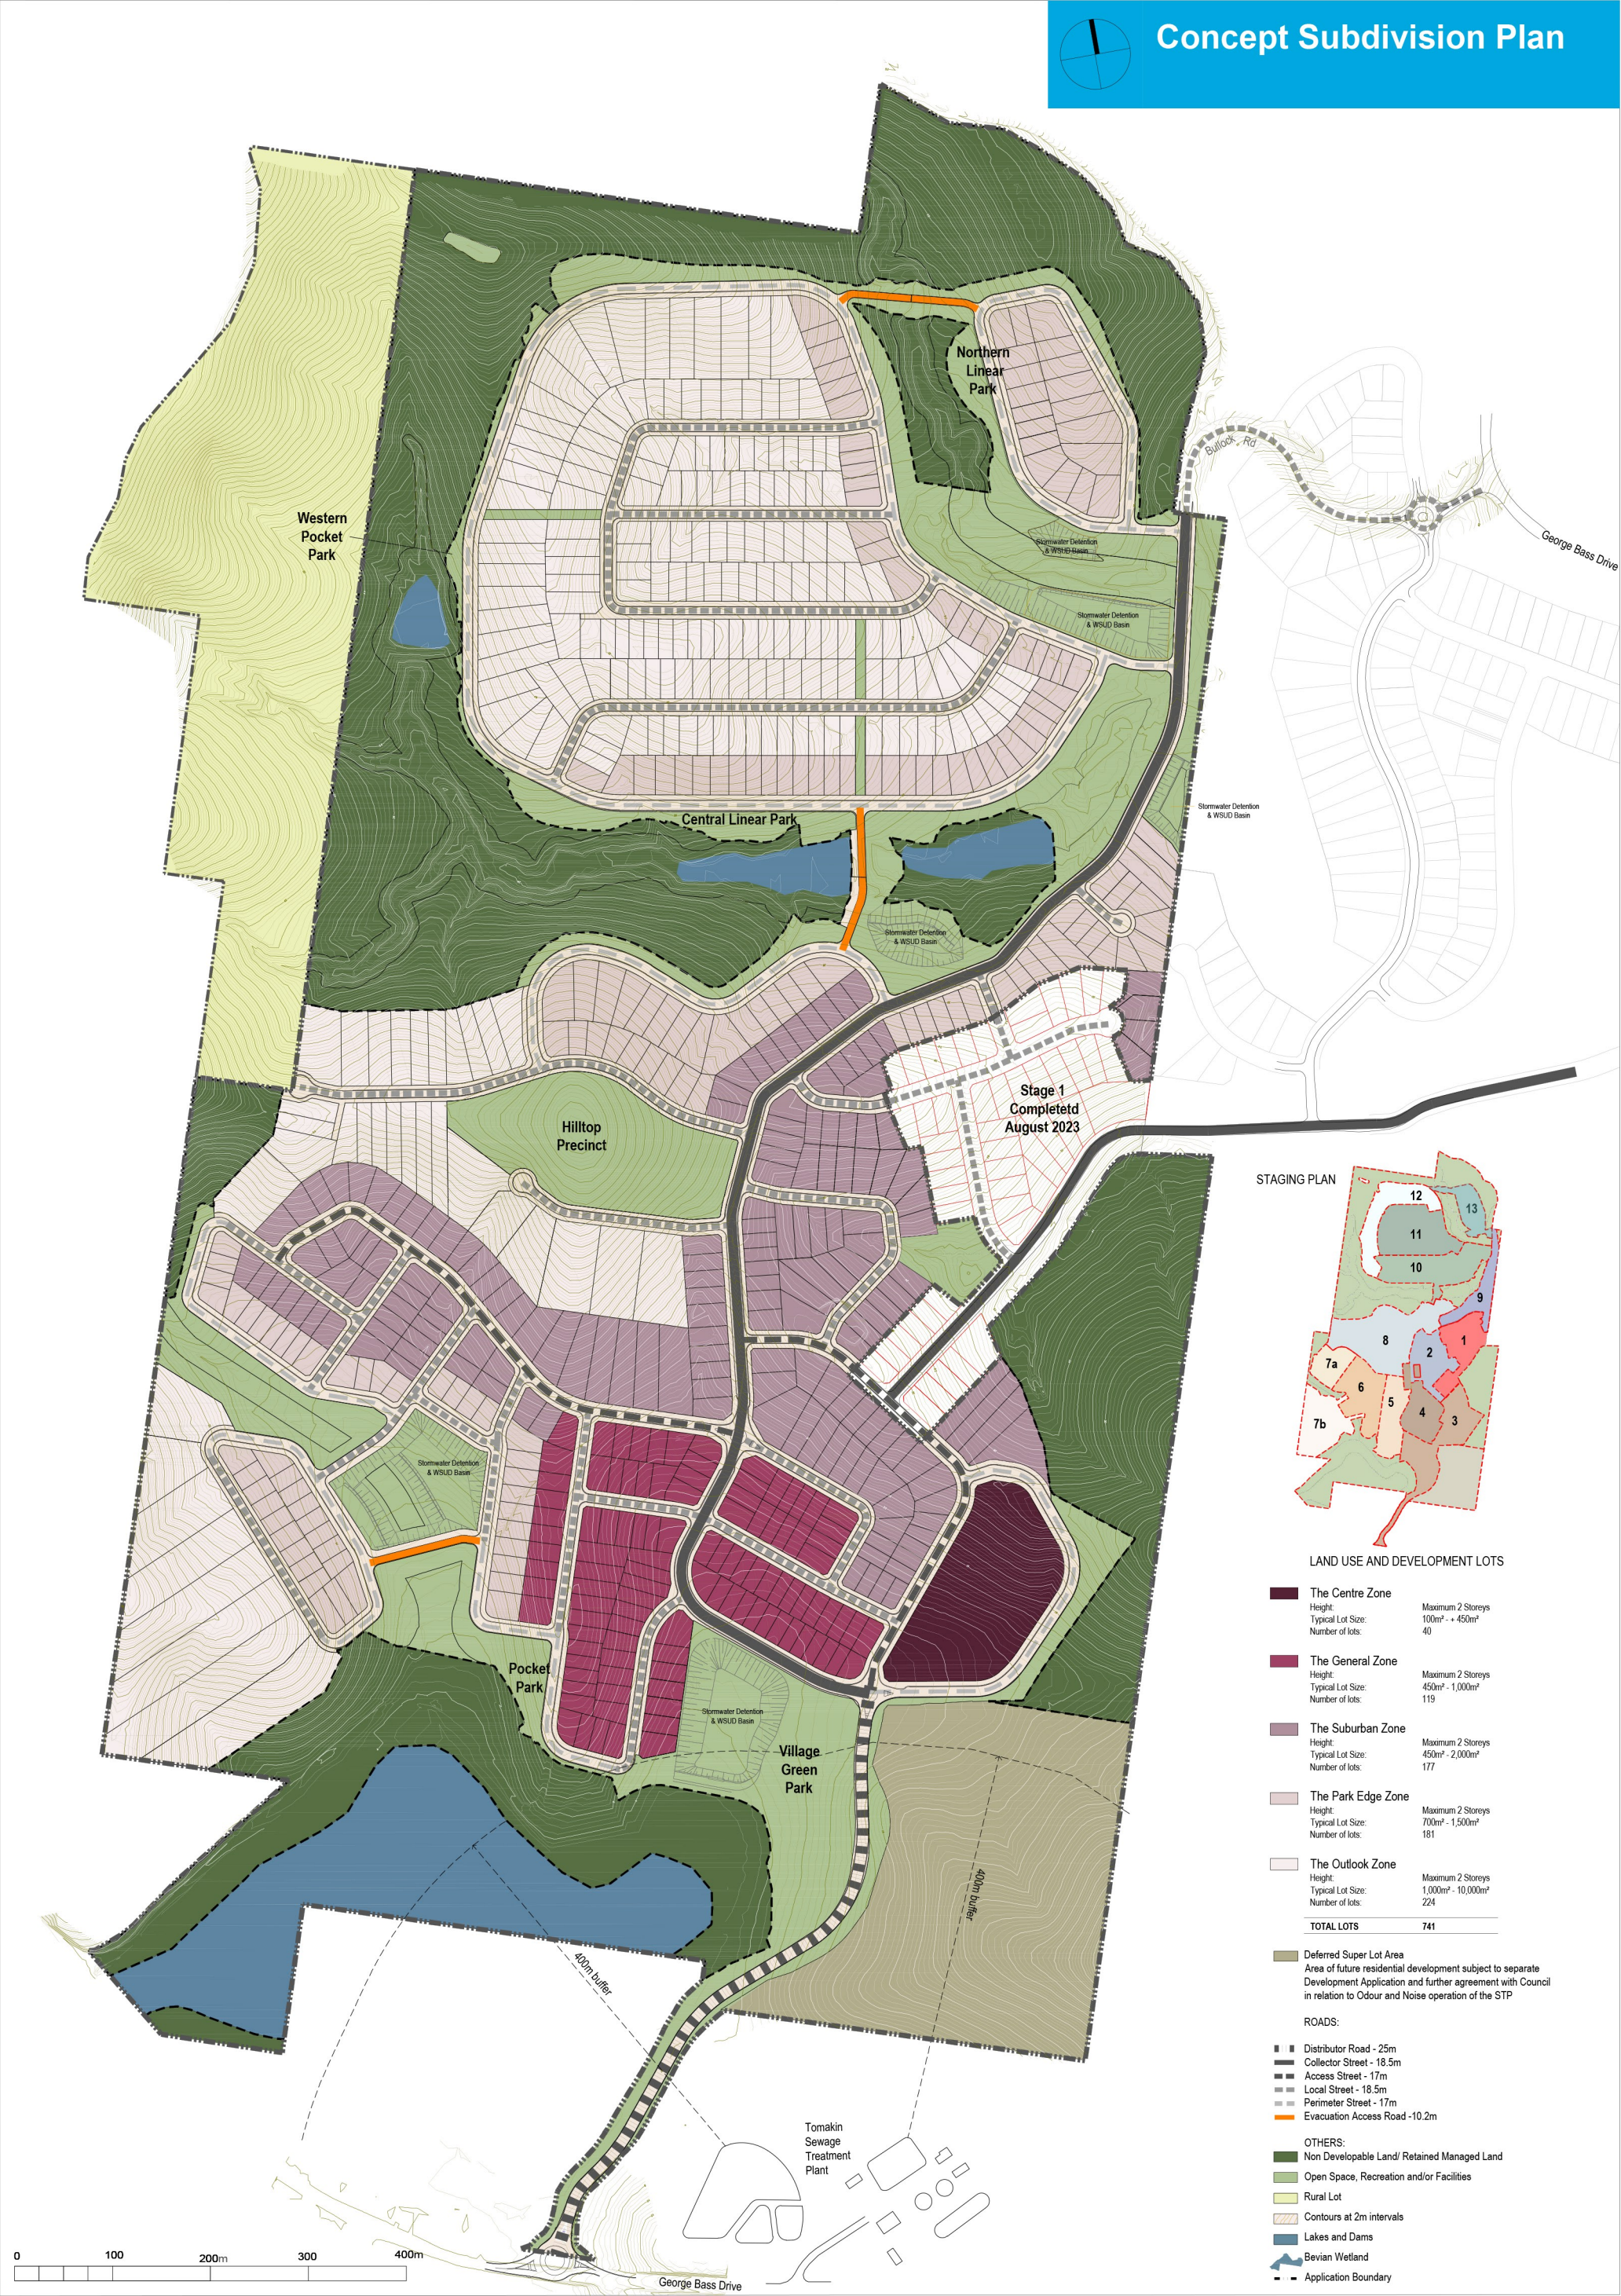
LAND USE AND DEVELOPMENT LOTS

- The Centre Zone**
Height: 100m² - 450m²
Typical Lot Size: 100m² - 450m²
Number of lots: 40

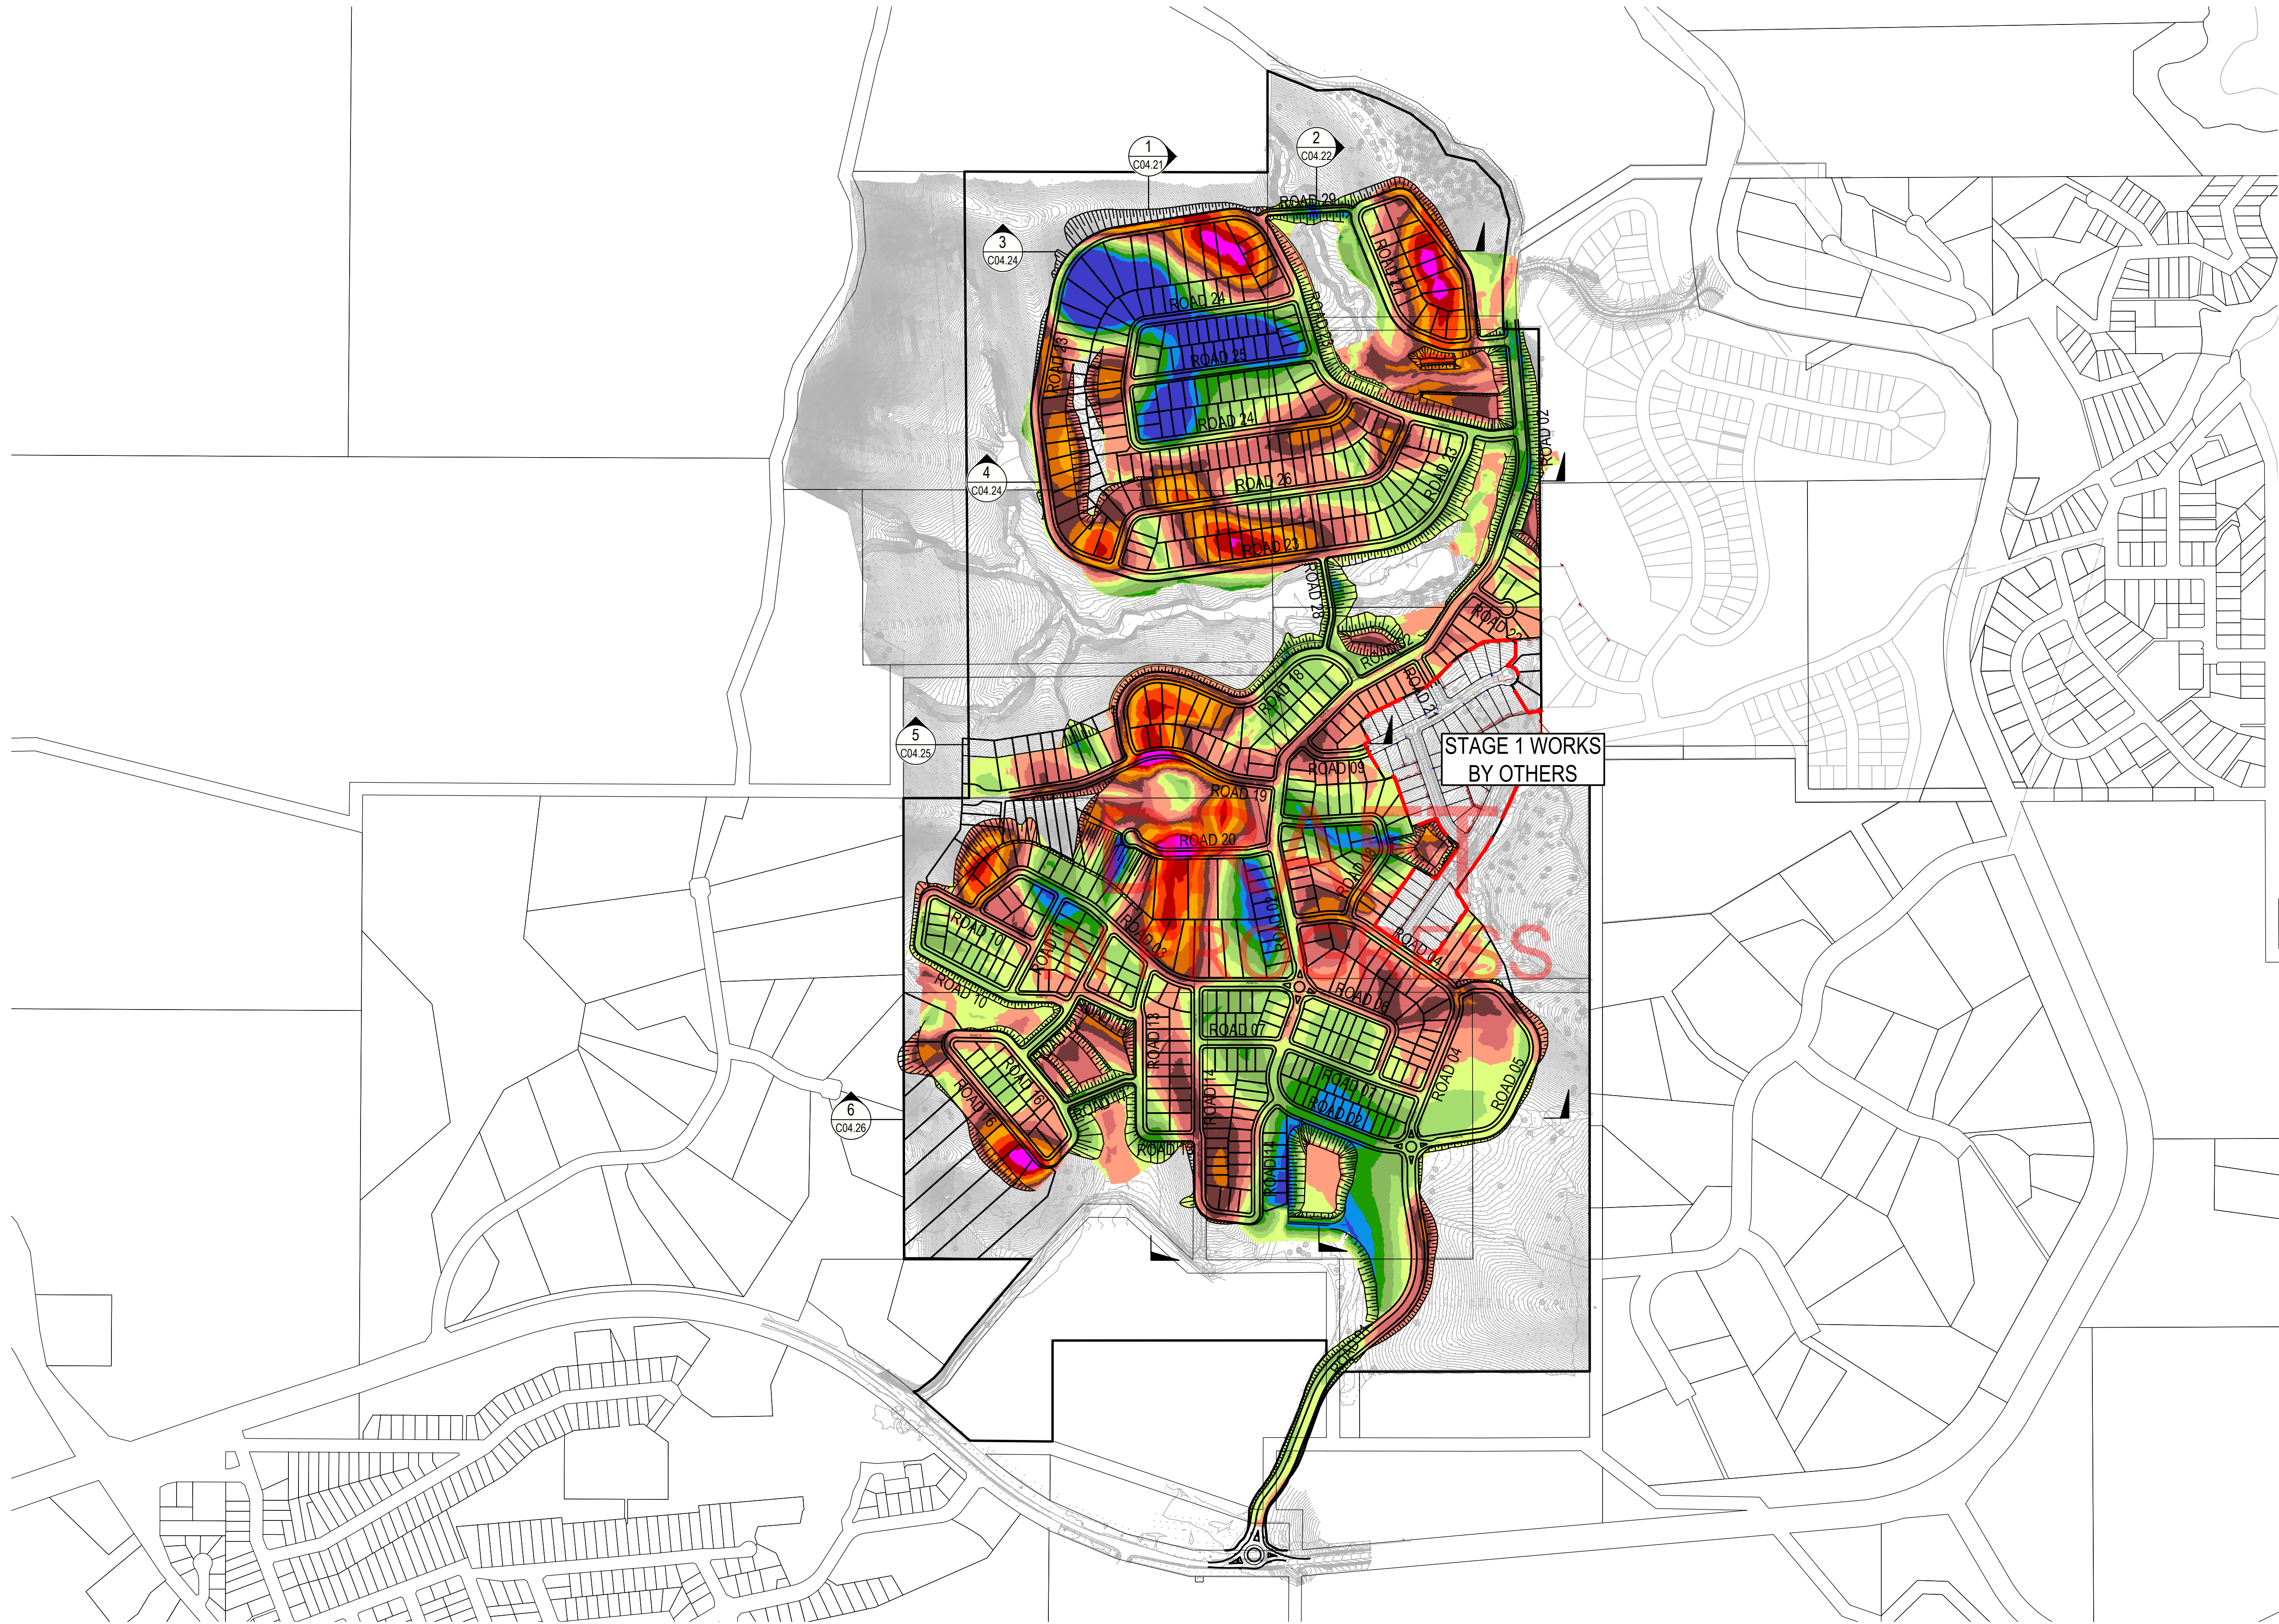
Concept Subdivision Plan and Bulk Earthworks Cut and Fill Plan

[Pink]	GREATER THAN 7.0m CUT
[Red]	6.0m TO 7.0m CUT
[Orange]	5.0m TO 6.0m CUT
[Yellow]	4.0m TO 5.0m CUT
[Light Orange]	3.0m TO 4.0m CUT
[Brown]	2.0m TO 3.0m CUT
[Light Brown]	1.0m TO 2.0m CUT
[Light Orange]	0.0m TO 1.0m CUT
[Light Green]	0.0m TO 1.0m FILL
[Green]	1.0m TO 2.0m FILL
[Dark Green]	2.0m TO 3.0m FILL
[Dark Green]	3.0m TO 4.0m FILL
[Blue]	4.0m TO 5.0m FILL
[Dark Blue]	GREATER THAN 5.0m FILL
