**PRELIMINARY SITE  
INVESTIGATION**

**FOR THE  
TOLLAND ESTATE  
RENEWAL PROJECT**

**AUGUST 2023**

**REPORT NO: 9494**

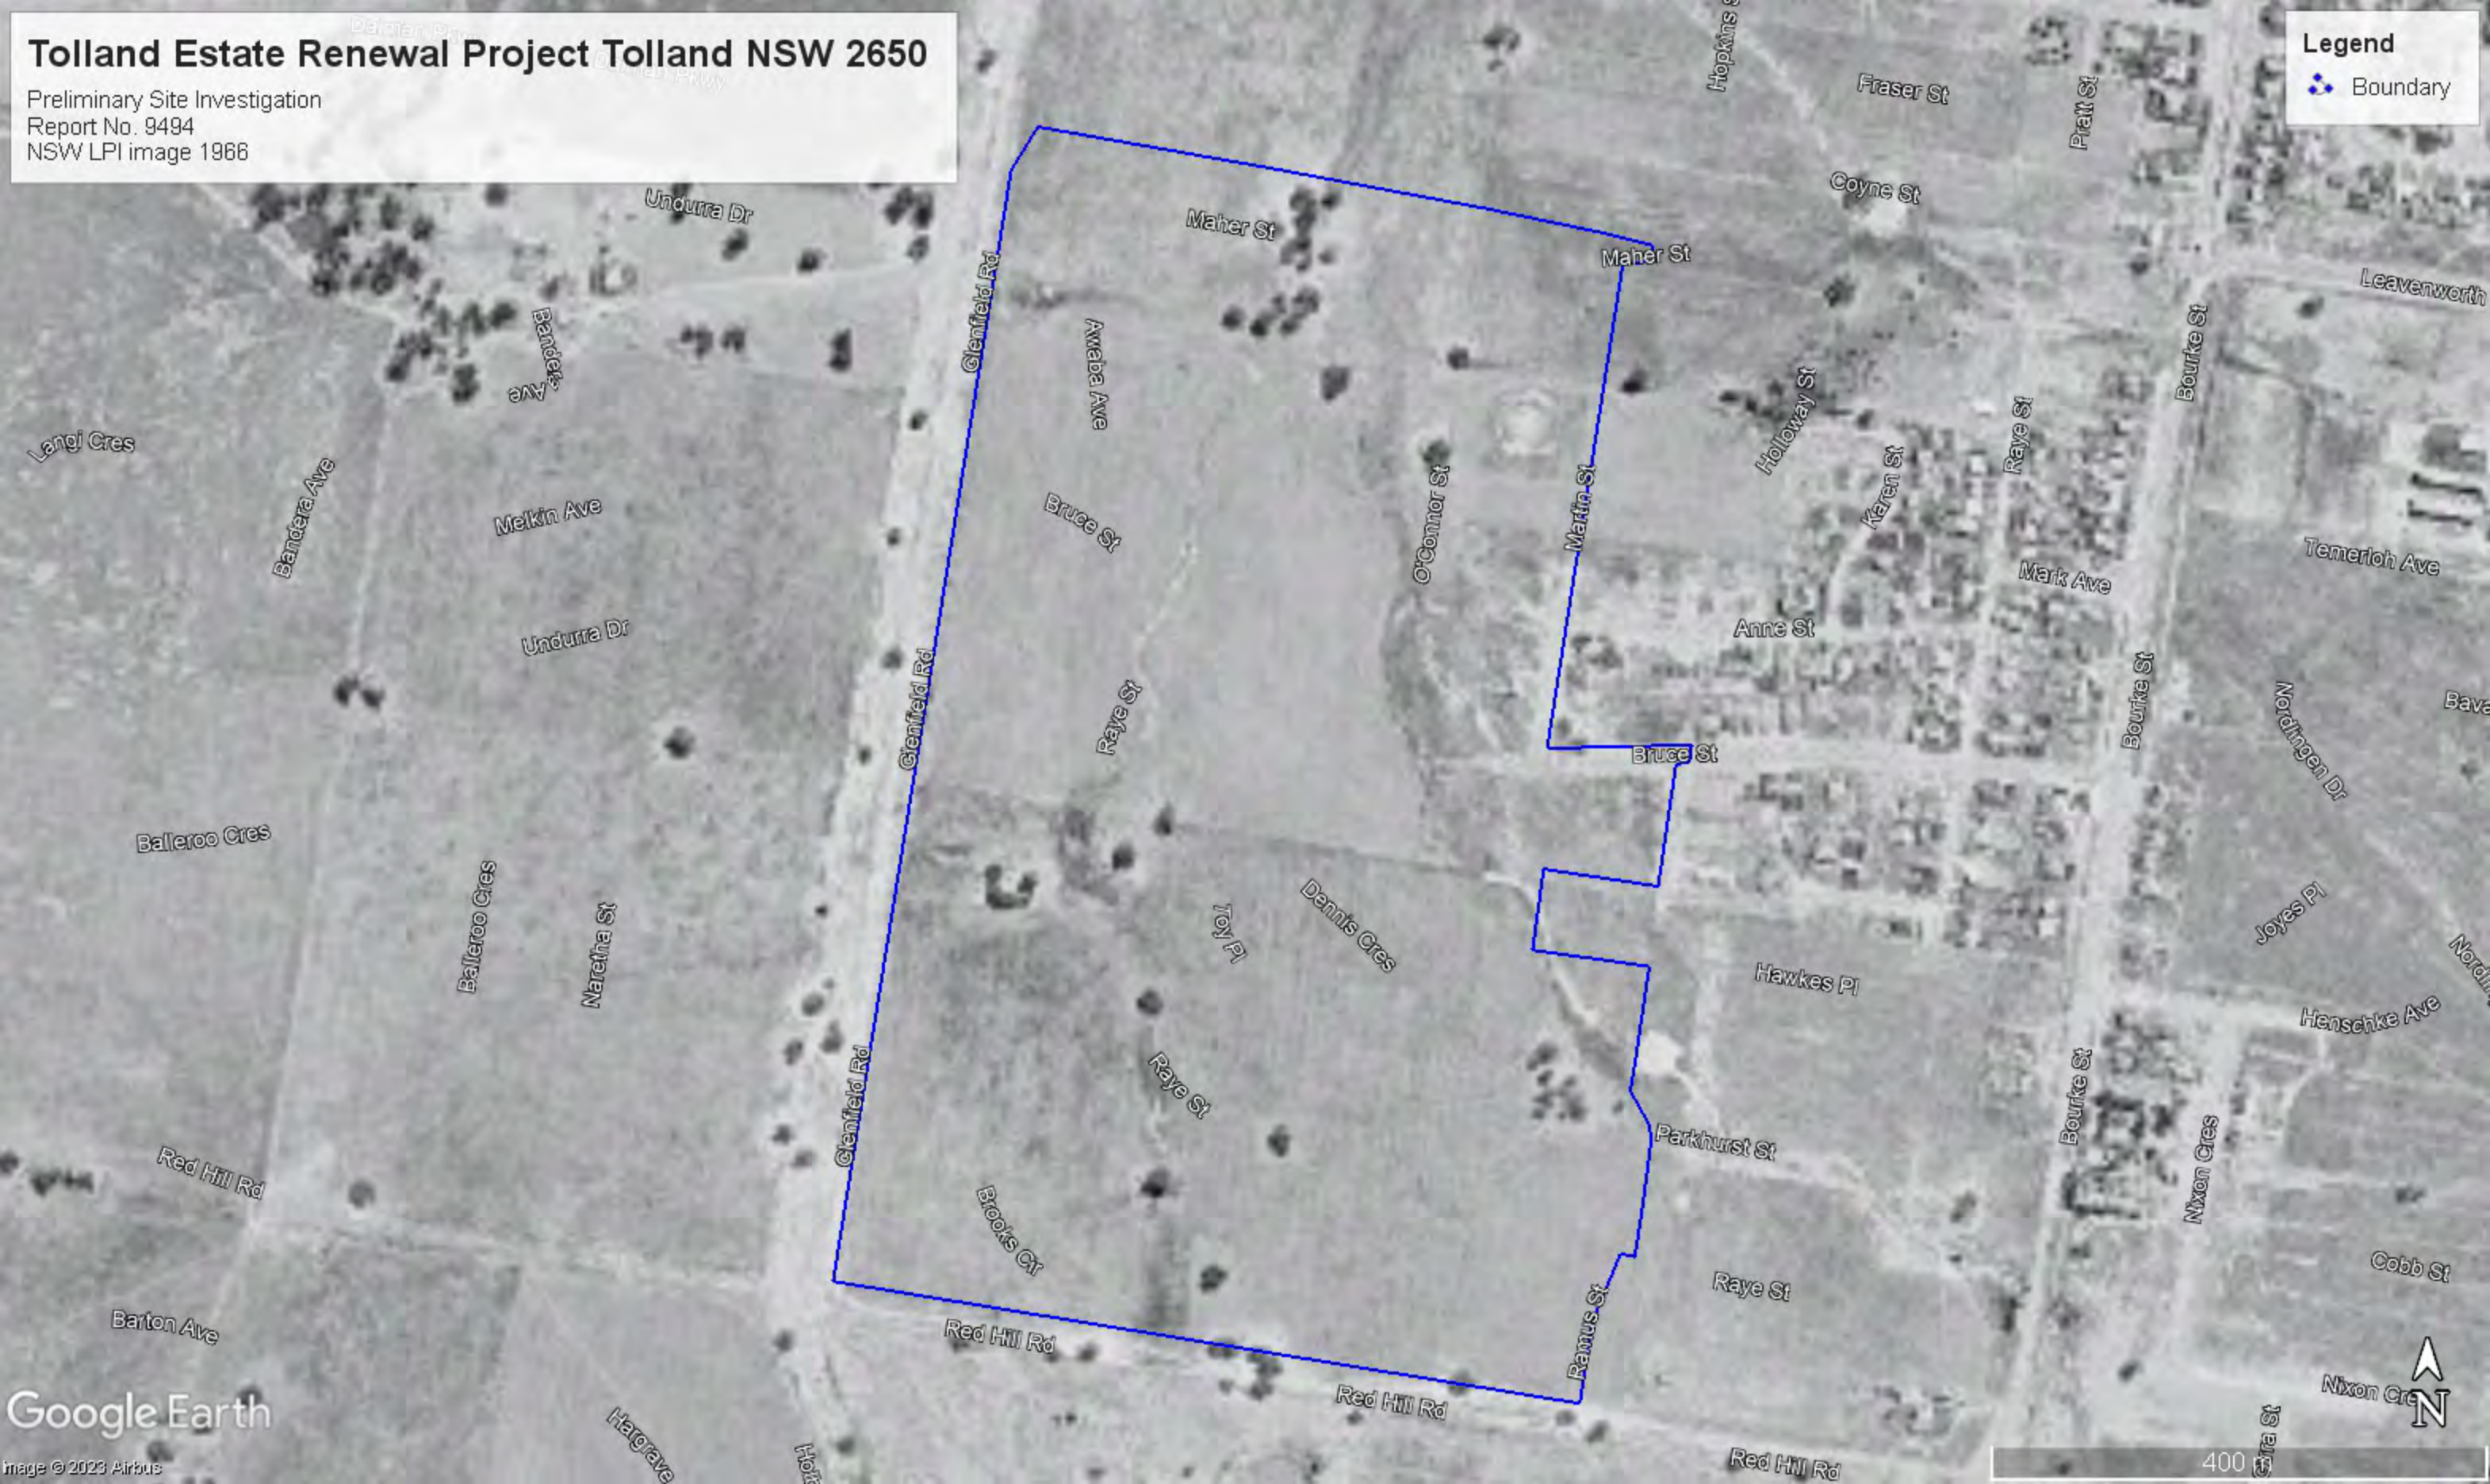
Preliminary Site Investigation  
Report No. 9494  
NSW LPI image 1966

**1966** – The site appears to be vacant agricultural land. A natural drainage channel diverts into two north south trending channels at the northern boundary of the site. One channel runs through the approximate centre of the site and drains to a dam across Red Hill Road, south of the site. The second channel runs to the south east and drains into a dam just outside of the eastern boundary. A dam exists in the north east of the site. Scattered paddock trees can be seen across the site. Some of Tolland has been developed to the east of the development area. Residential suburbs Mount Austin and Koorungal have been developed to the north east and east. The land to the south and west is agricultural.

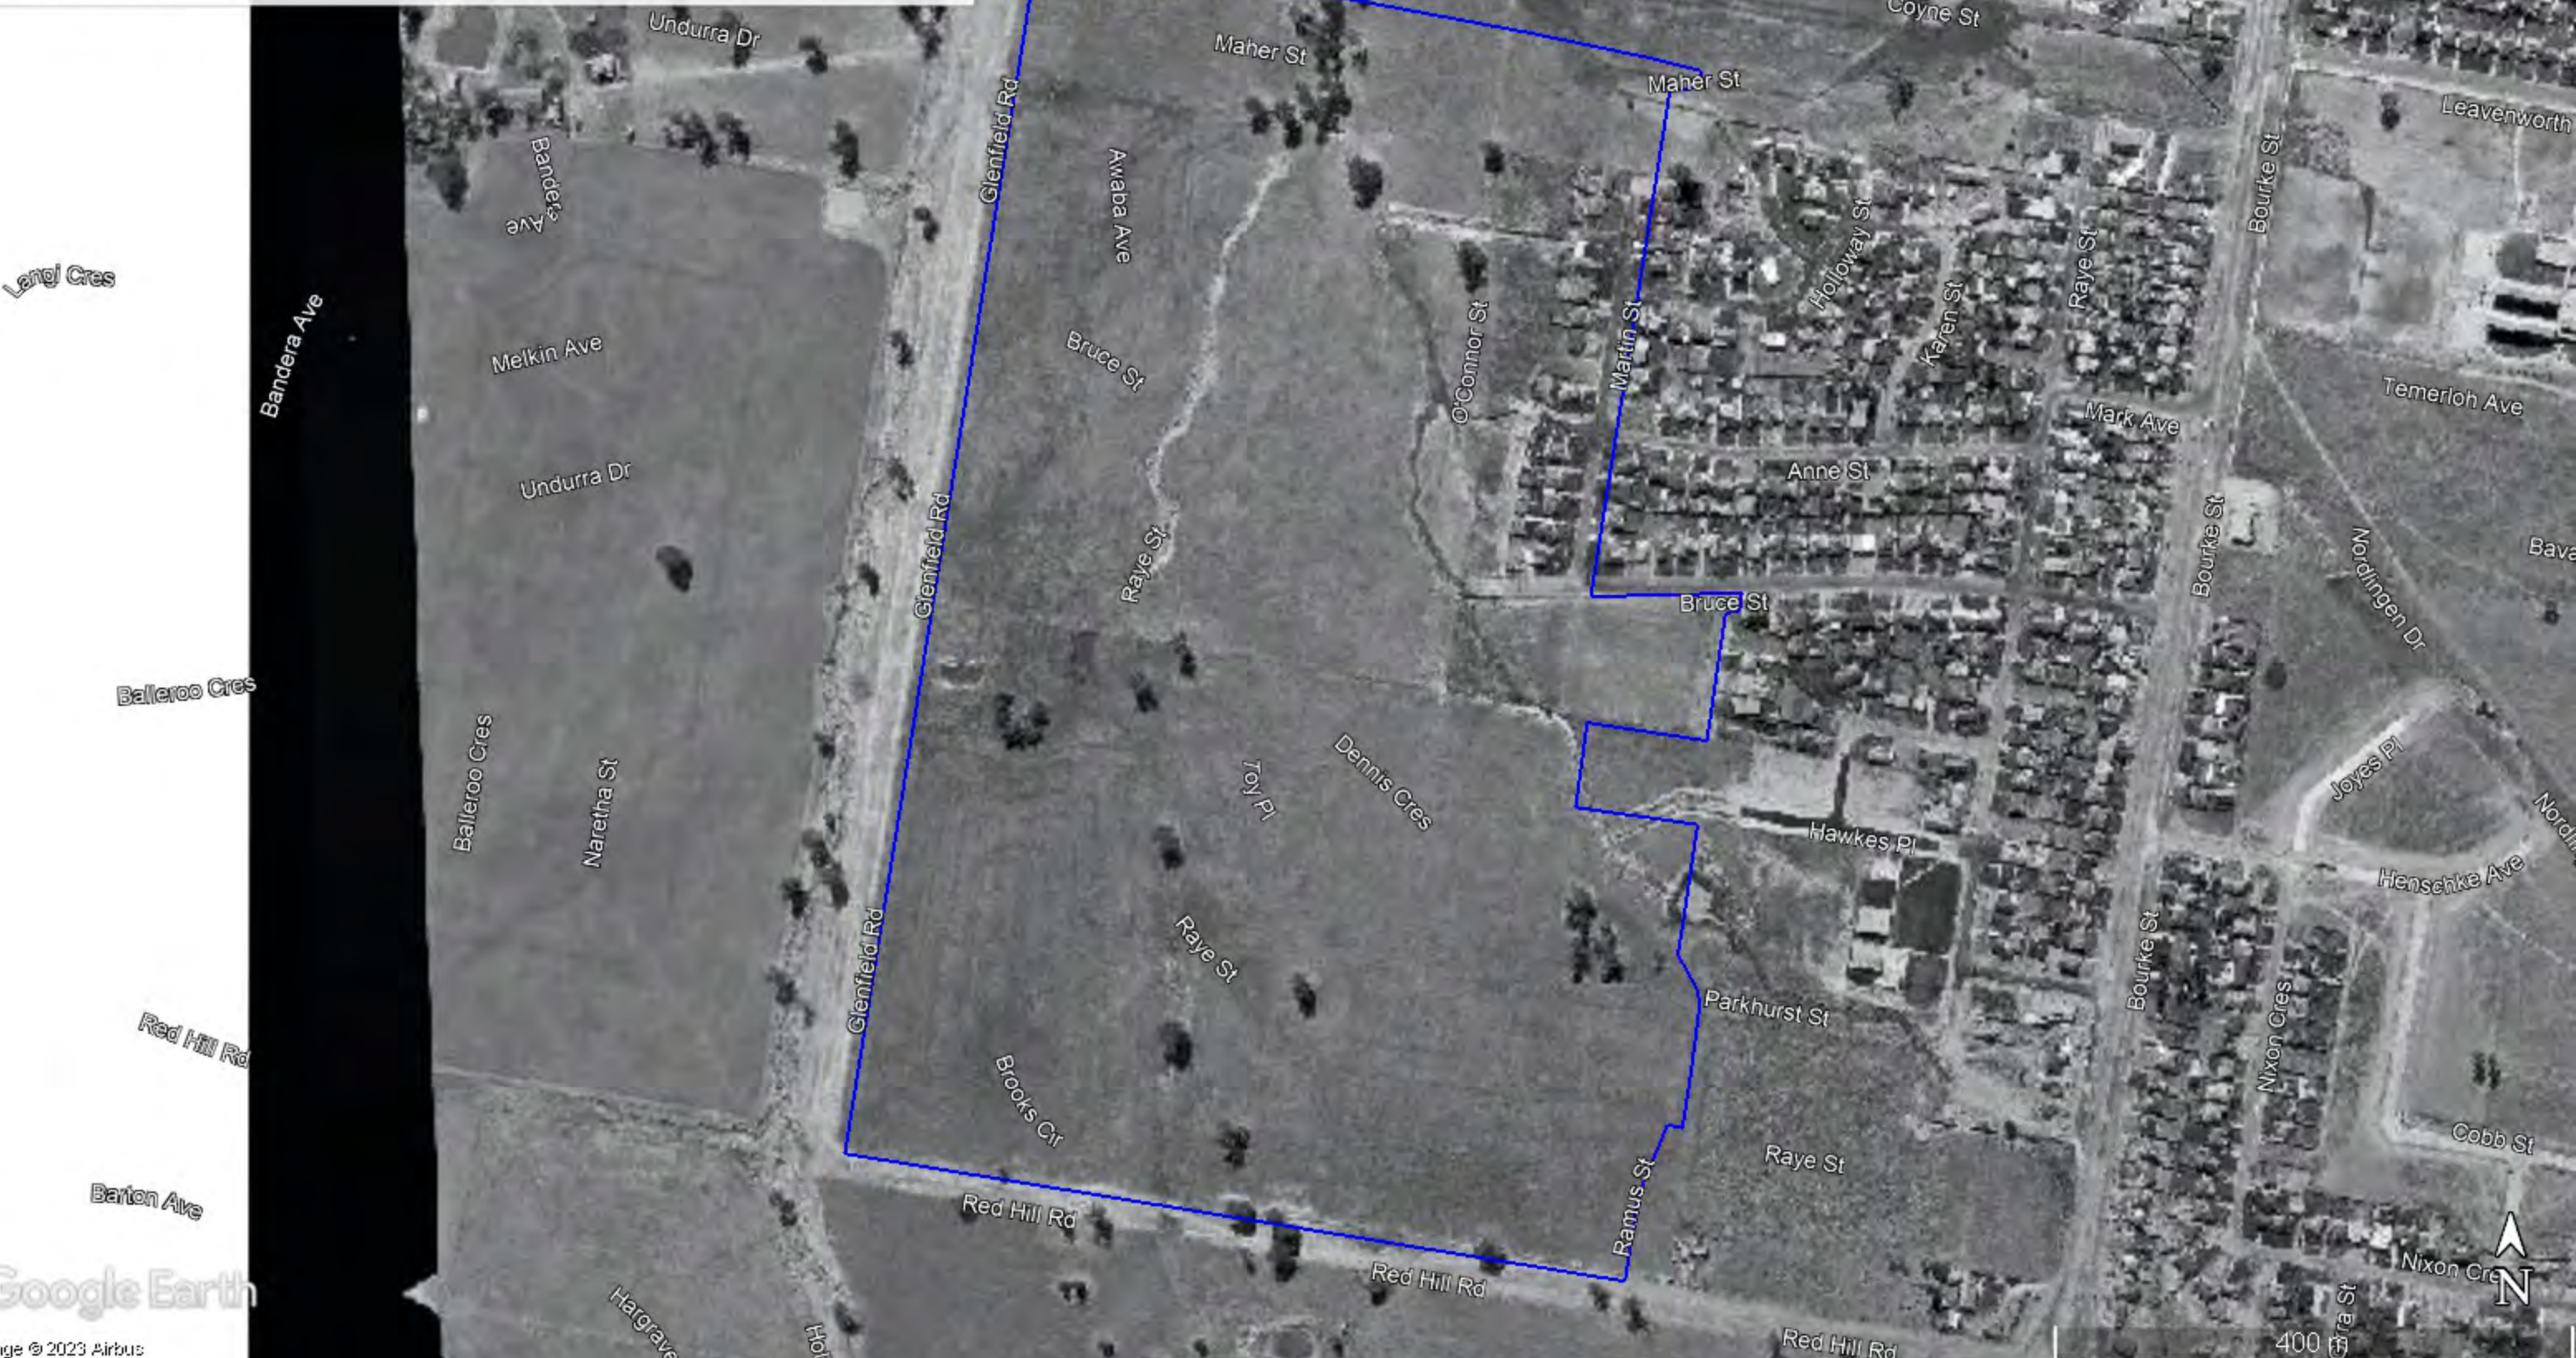
Preliminary Site Investigation  
Report No. 9494  
NSW LPI image 1971

**1971** – Houses have been built along the eastern boundary of the site, along Martin Street. The dam in the north east of the site appears to have been filled and houses built over it. More of Tolland to the east of the site has also been developed.

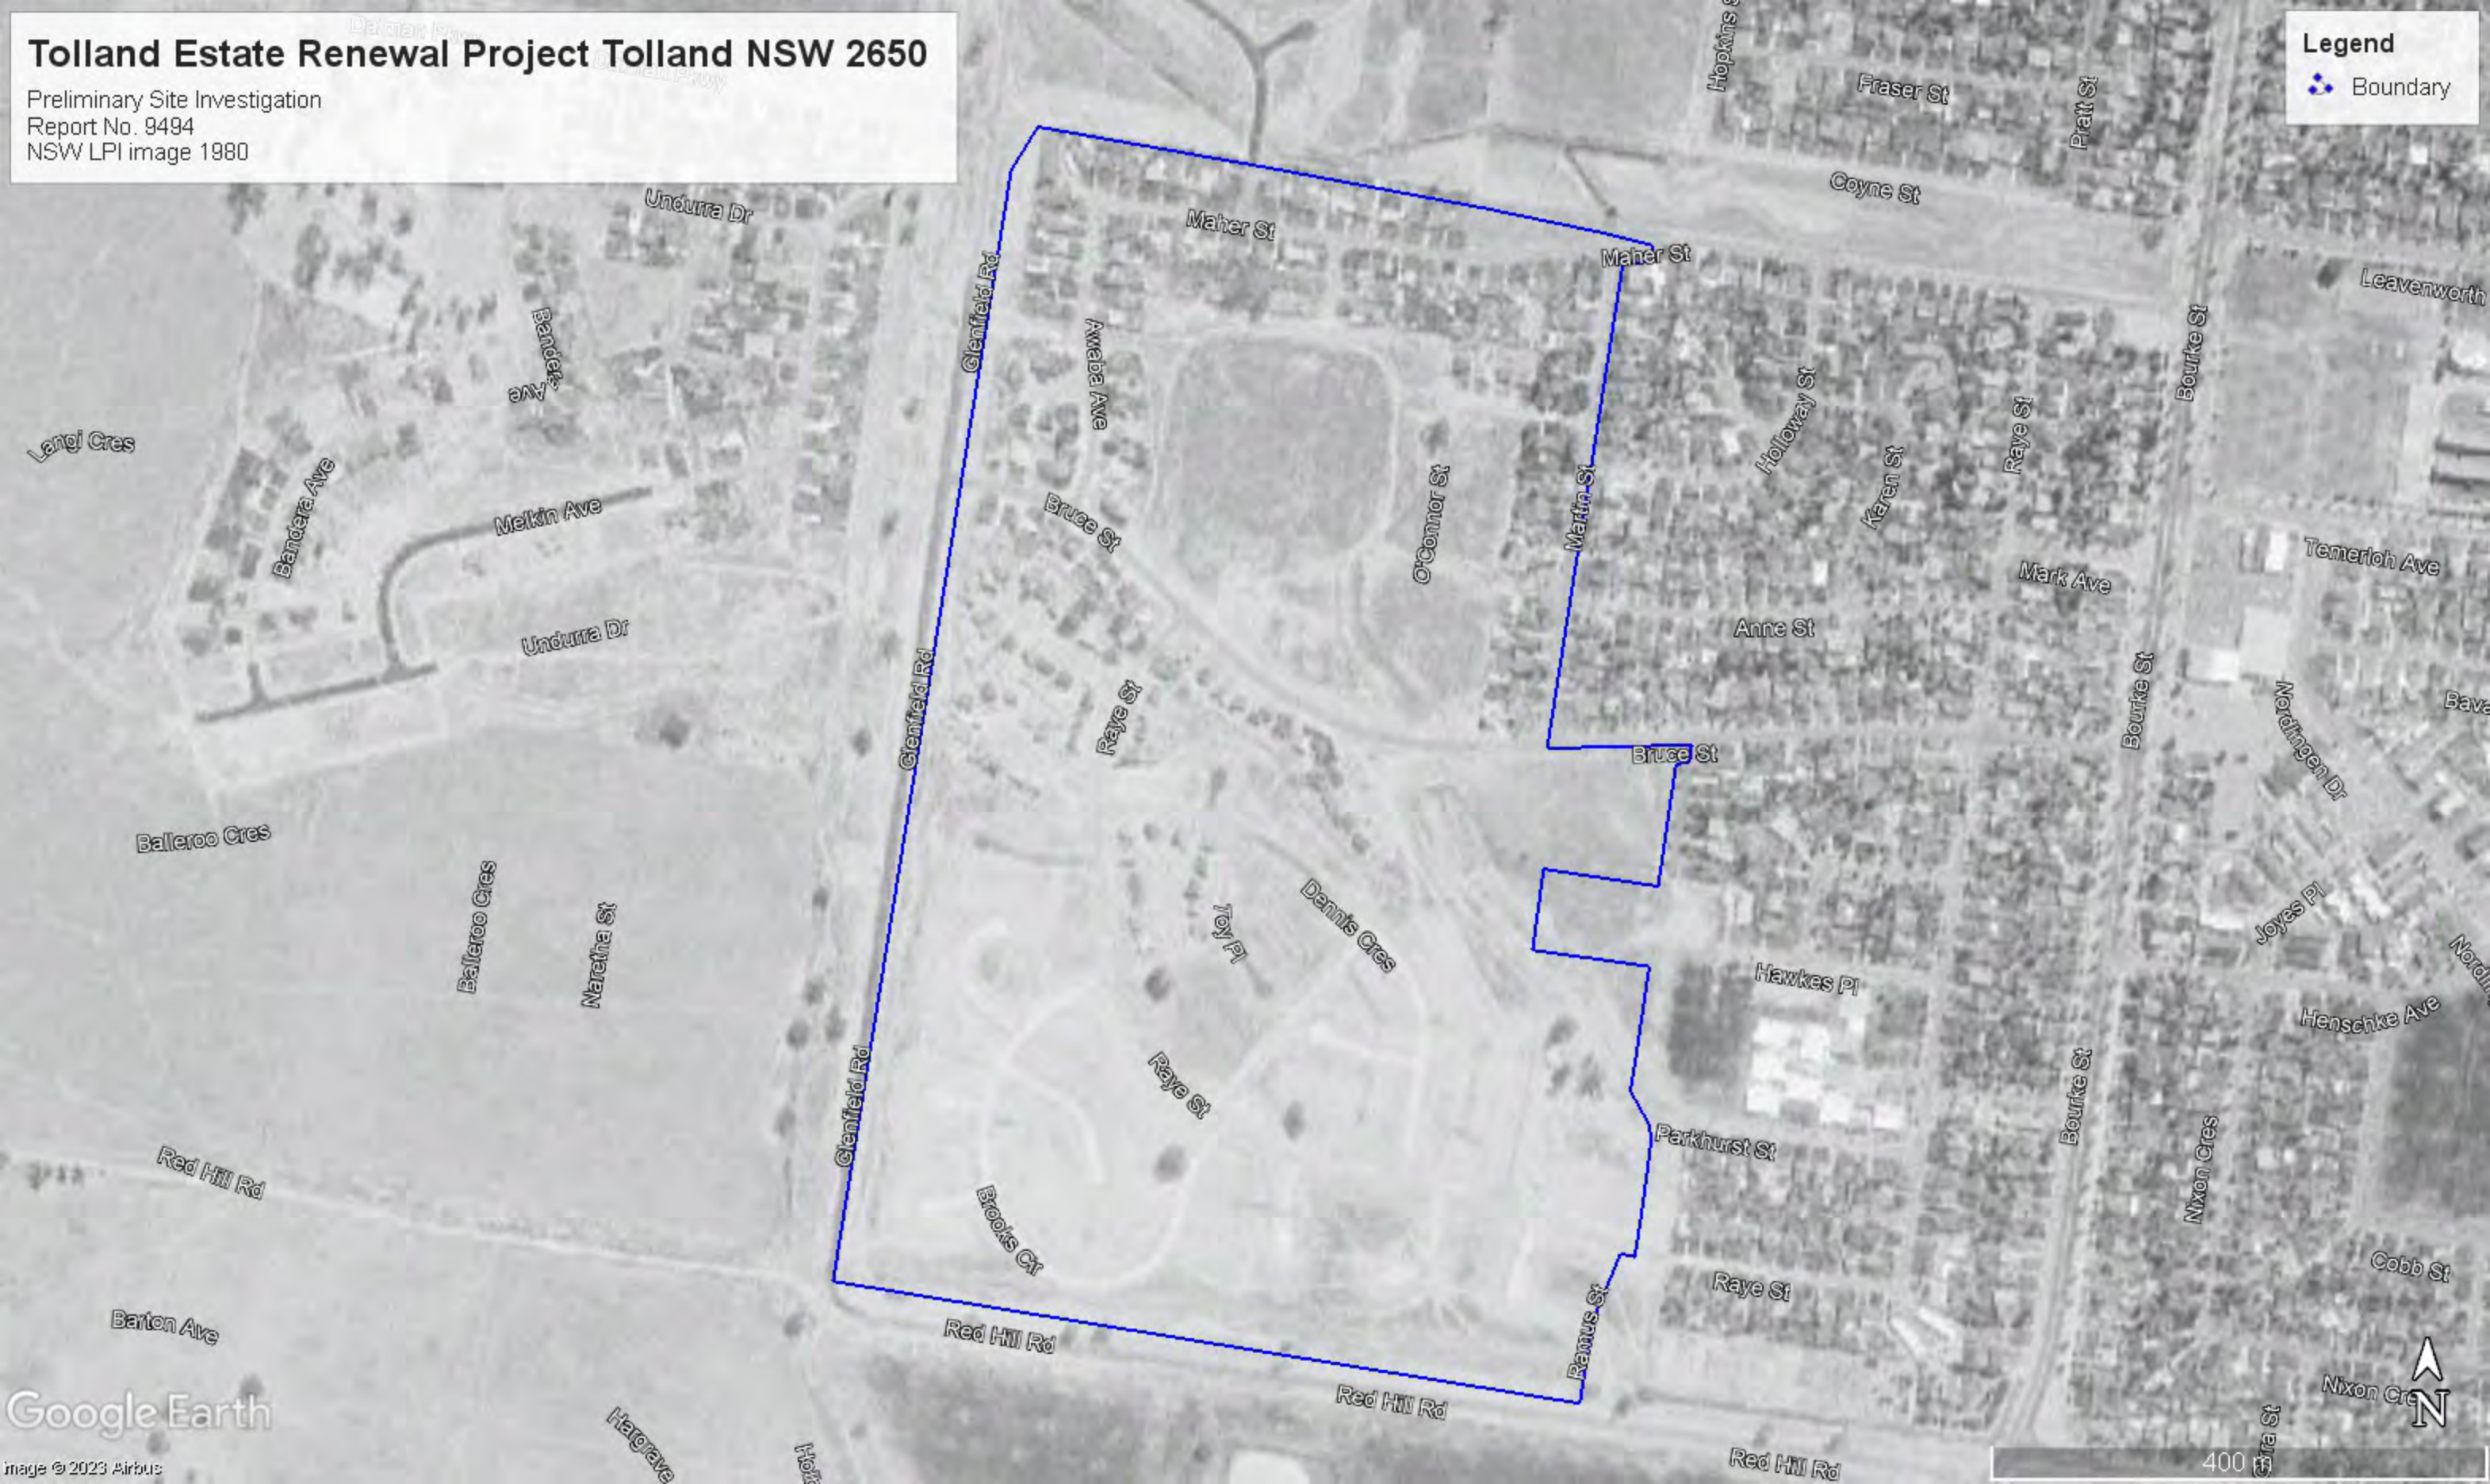
Preliminary Site Investigation  
Report No. 9494  
NSW LPI image 1980

**1980** – House have been developed in the northern part of the site, around Maher Street and Awaba Avenue. Some houses to the south of Bruce Street have also been built. Part of the second drainage channel has been filled to create the football oval at Chambers Park. The remainder of the channel appears shallower and is intersected by Bruce Street. The drainage channel through the centre of the site appears to have been filled. The roads have been established and some have been asphalted. Some scattered paddock trees remain. More of Tolland, Mount Austin and Koorungal have been developed and residential development in Glenfield Park has started to the west of the site. The service station to the east of the site has been built.

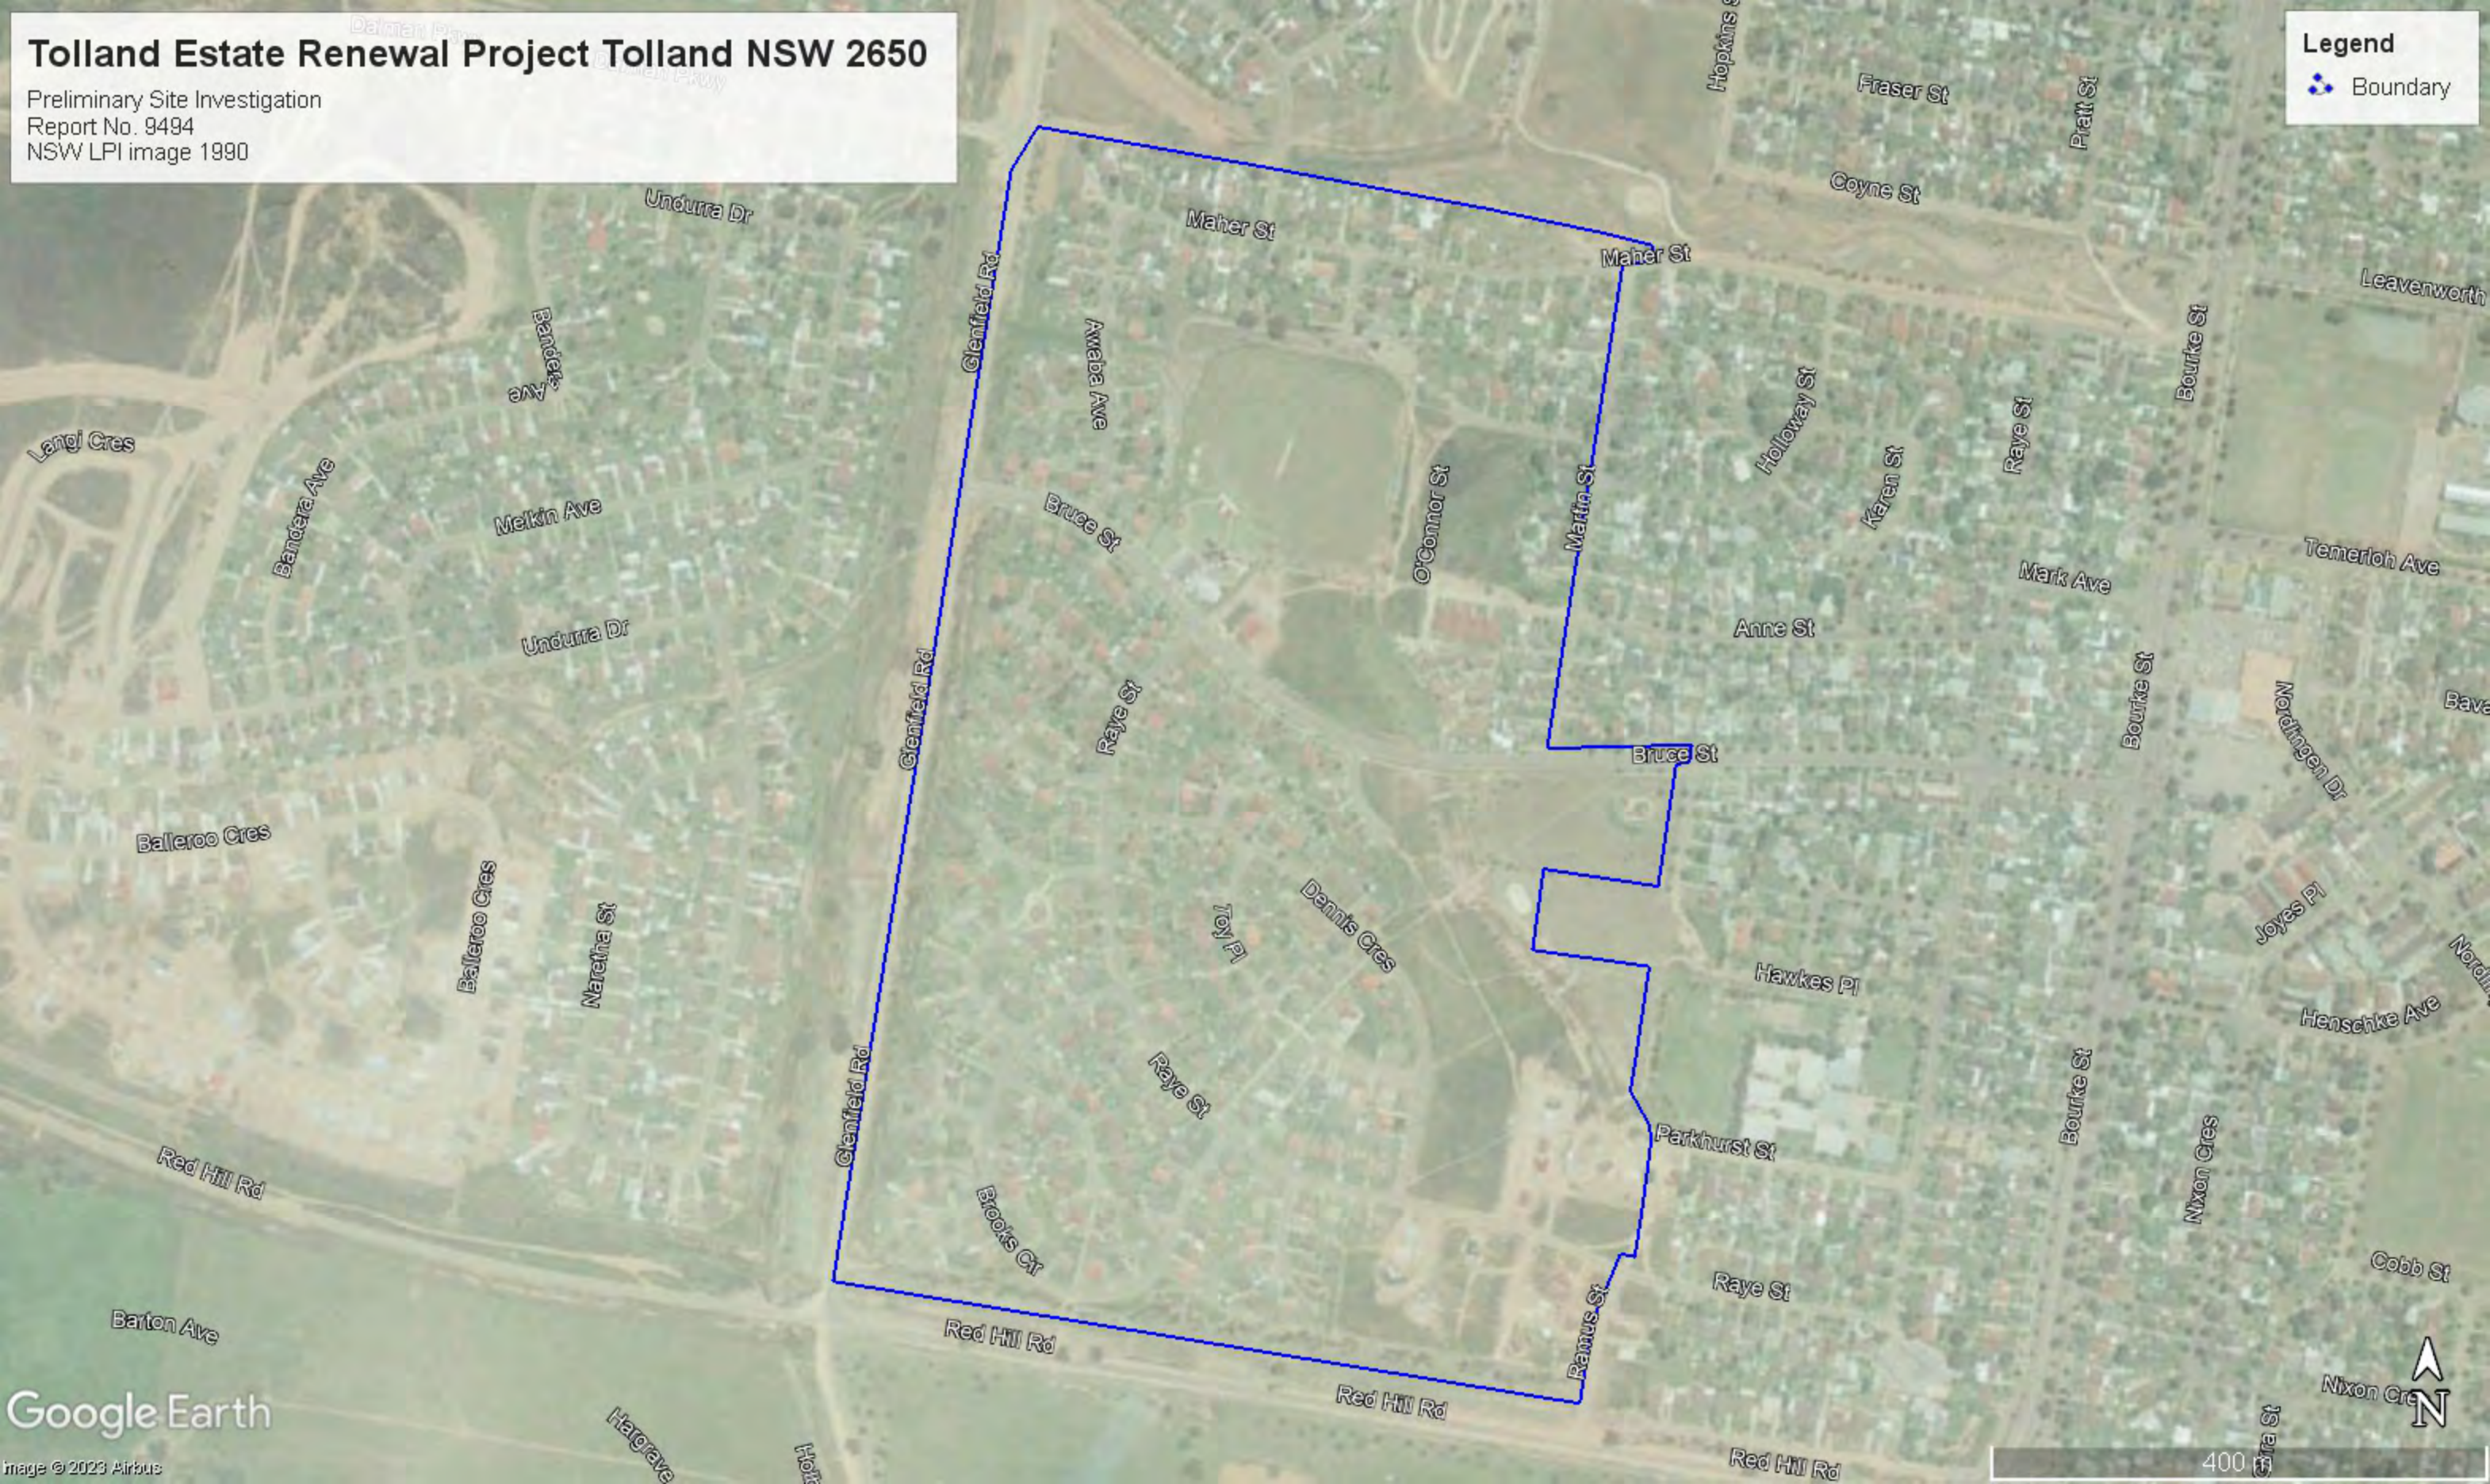
Preliminary Site Investigation  
Report No. 9494  
NSW LPI image 1990

**1990** – Most of the site has been developed. The Tolland Community Centre has been built. The playground, cricket pitches, undercover area and car park at Chambers Park have been built. The skate park and playground at Emblen Park have been built and the open spaces at both Emblen Park and Kilpatrick Park have been defined. Construction for Glenfield Park continues to the west of the site. Residential development in Tatton has also begun to the south east. Jubilee Park has been established to the south of the site.

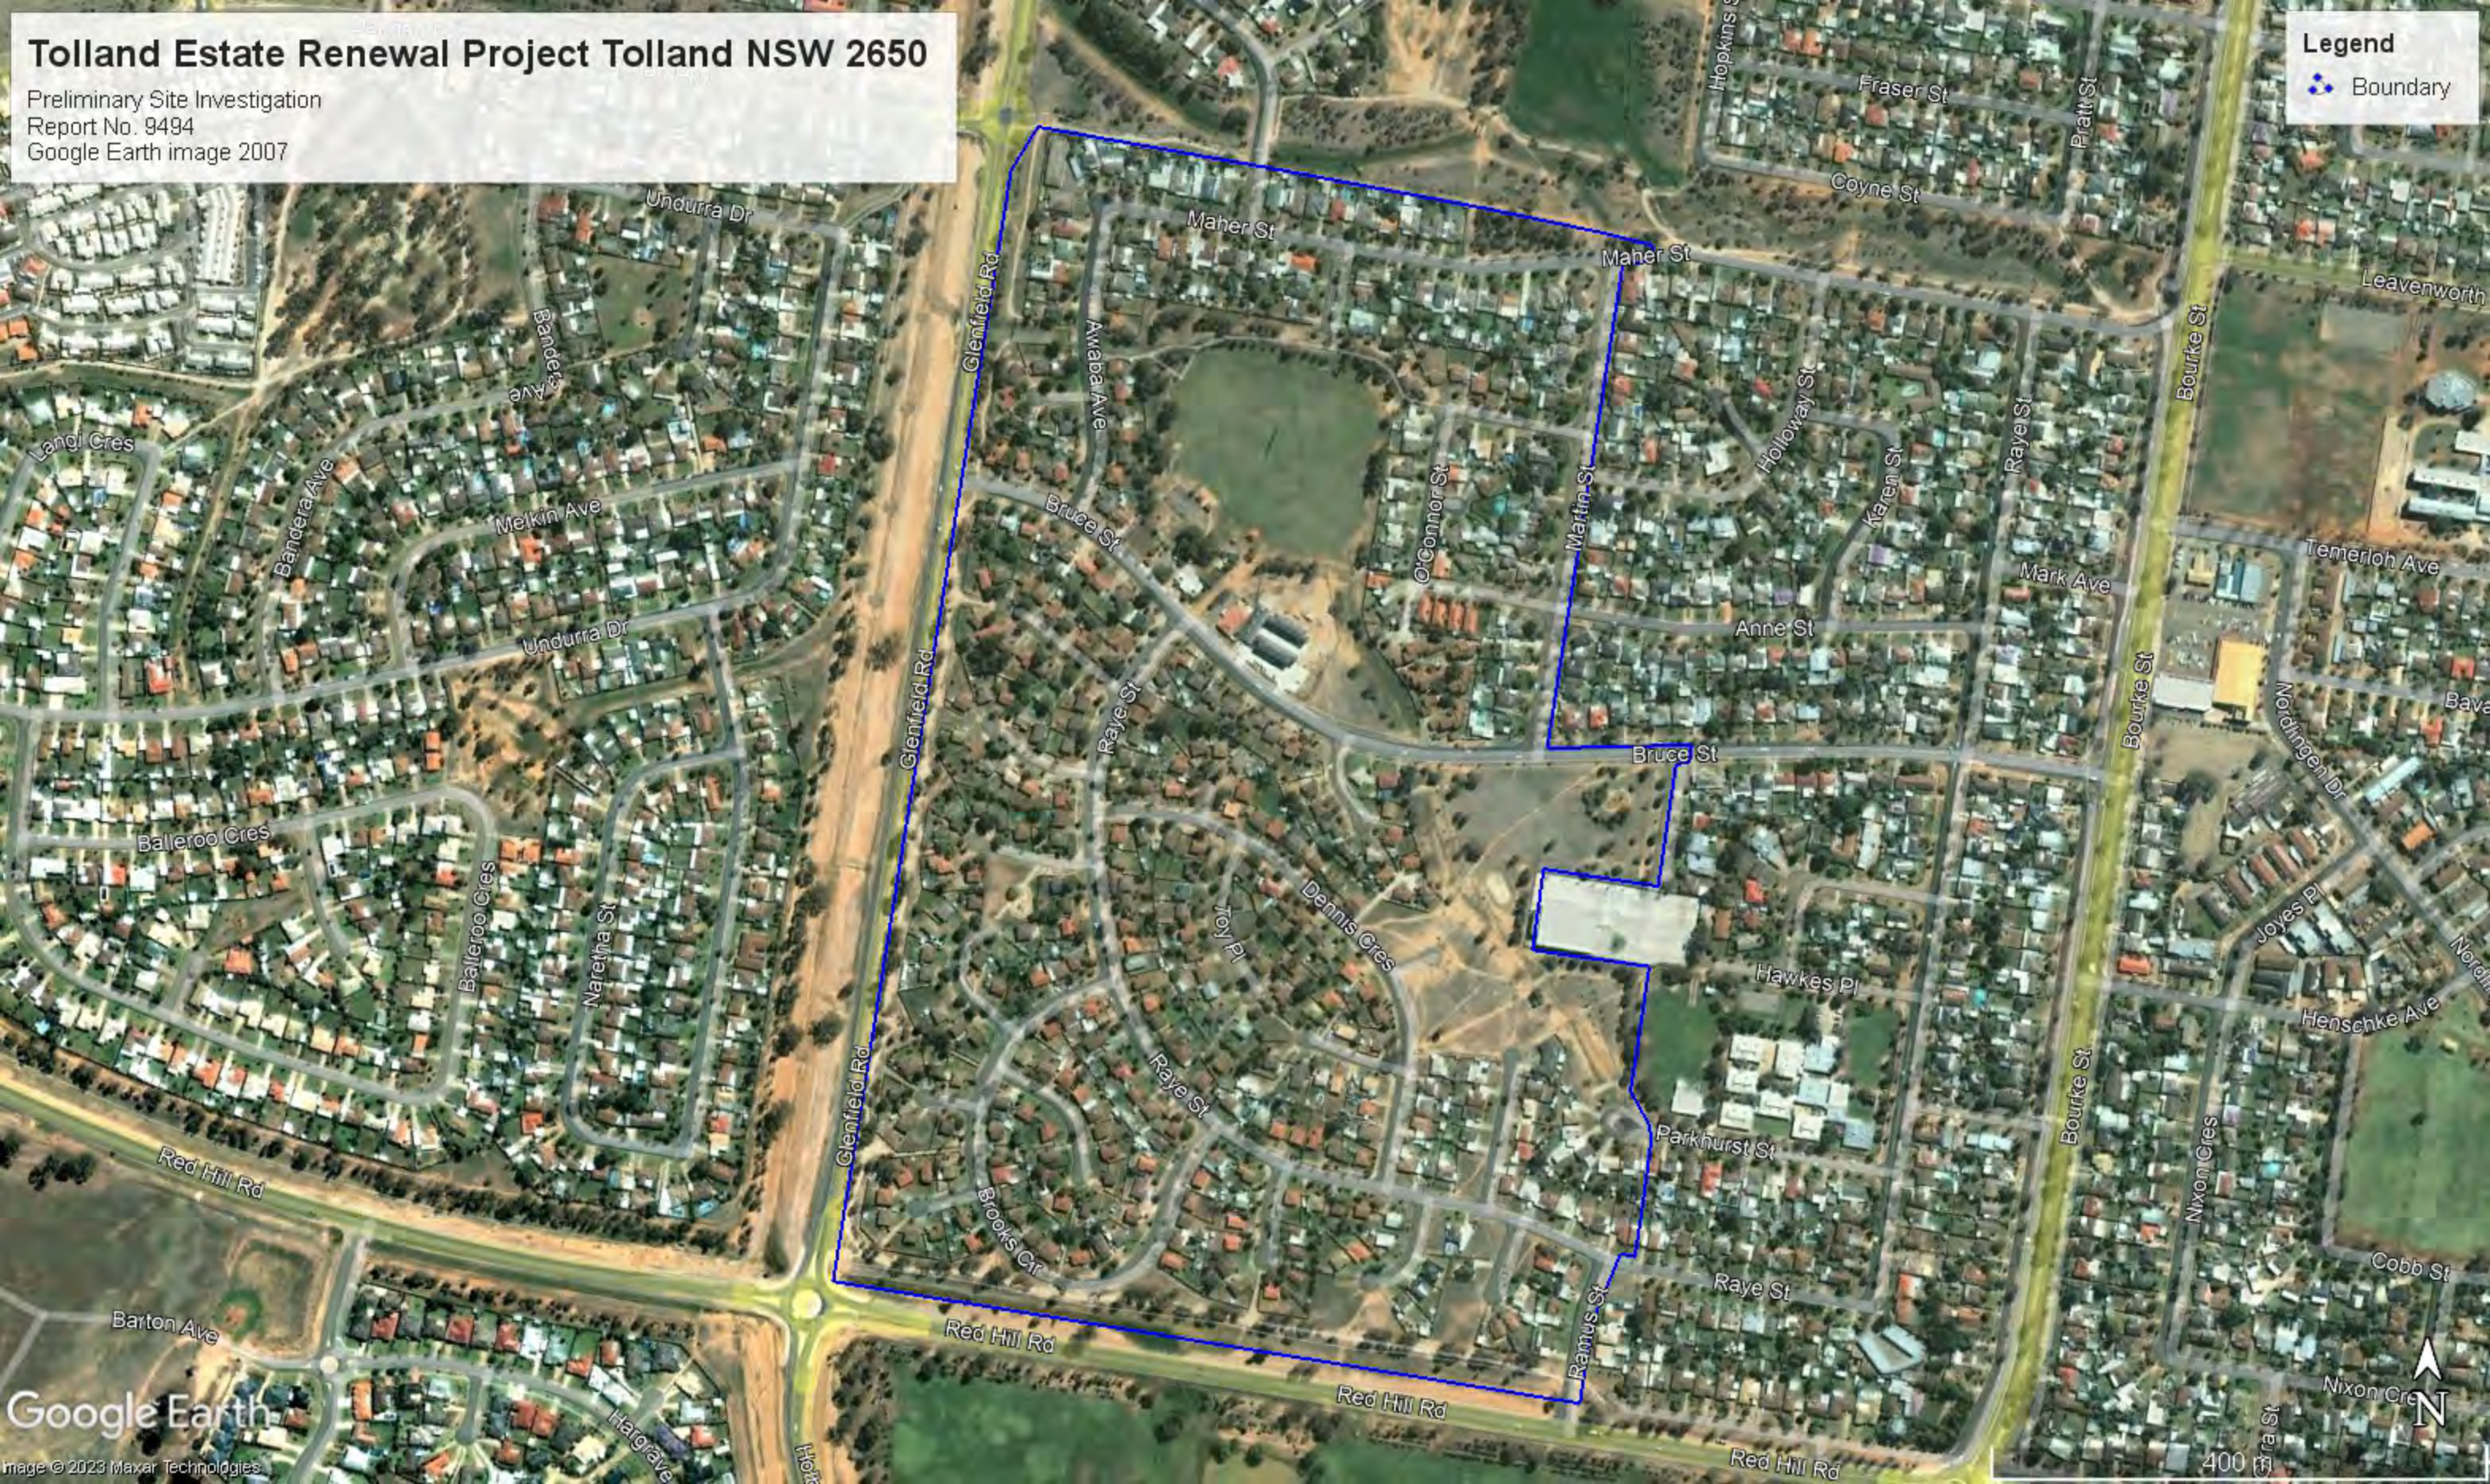
Preliminary Site Investigation  
Report No. 9494  
Google Earth image 2007

**2007** – The basketball court at Chambers Park has been built. The road for Tarra Place south of Bruce Street has been built but no houses have been developed along it.

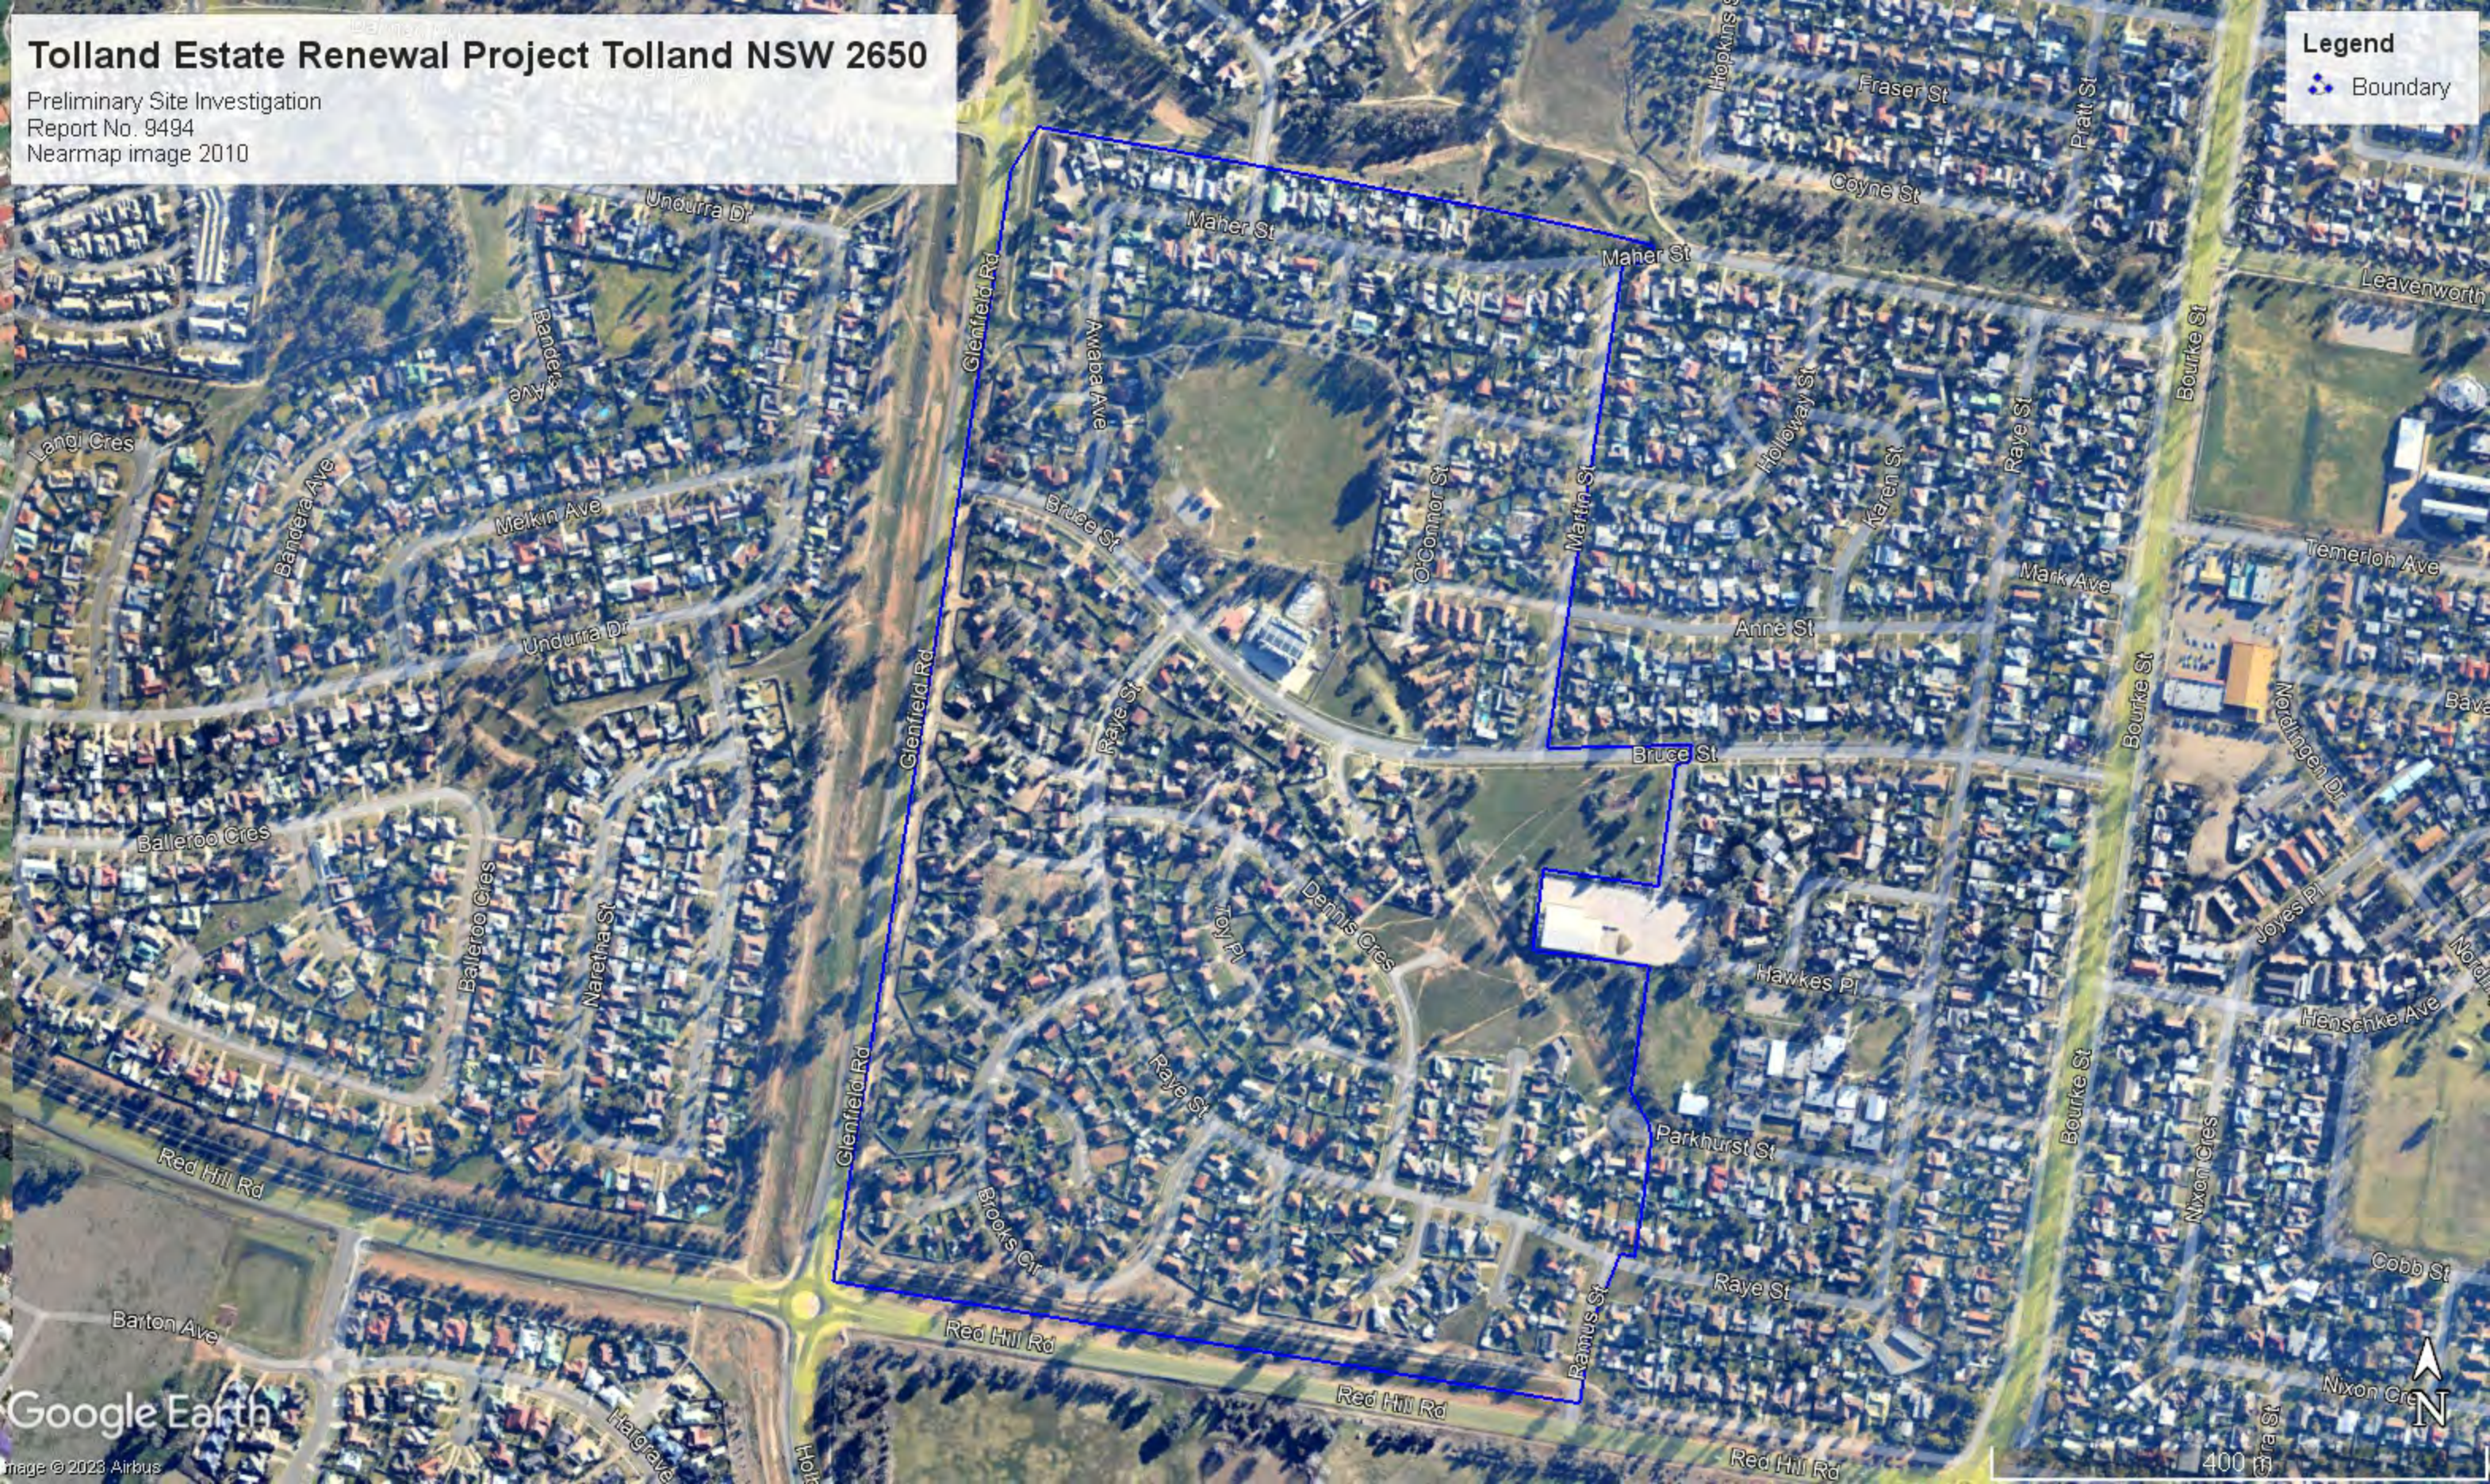
Preliminary Site Investigation  
Report No. 9494  
Nearmap image 2010

**2010** – OneSchool Global has been built.
