**PRELIMINARY SITE  
INVESTIGATION**

**FOR THE  
TOLLAND ESTATE  
RENEWAL PROJECT**

**AUGUST 2023**

**REPORT NO: 9494**

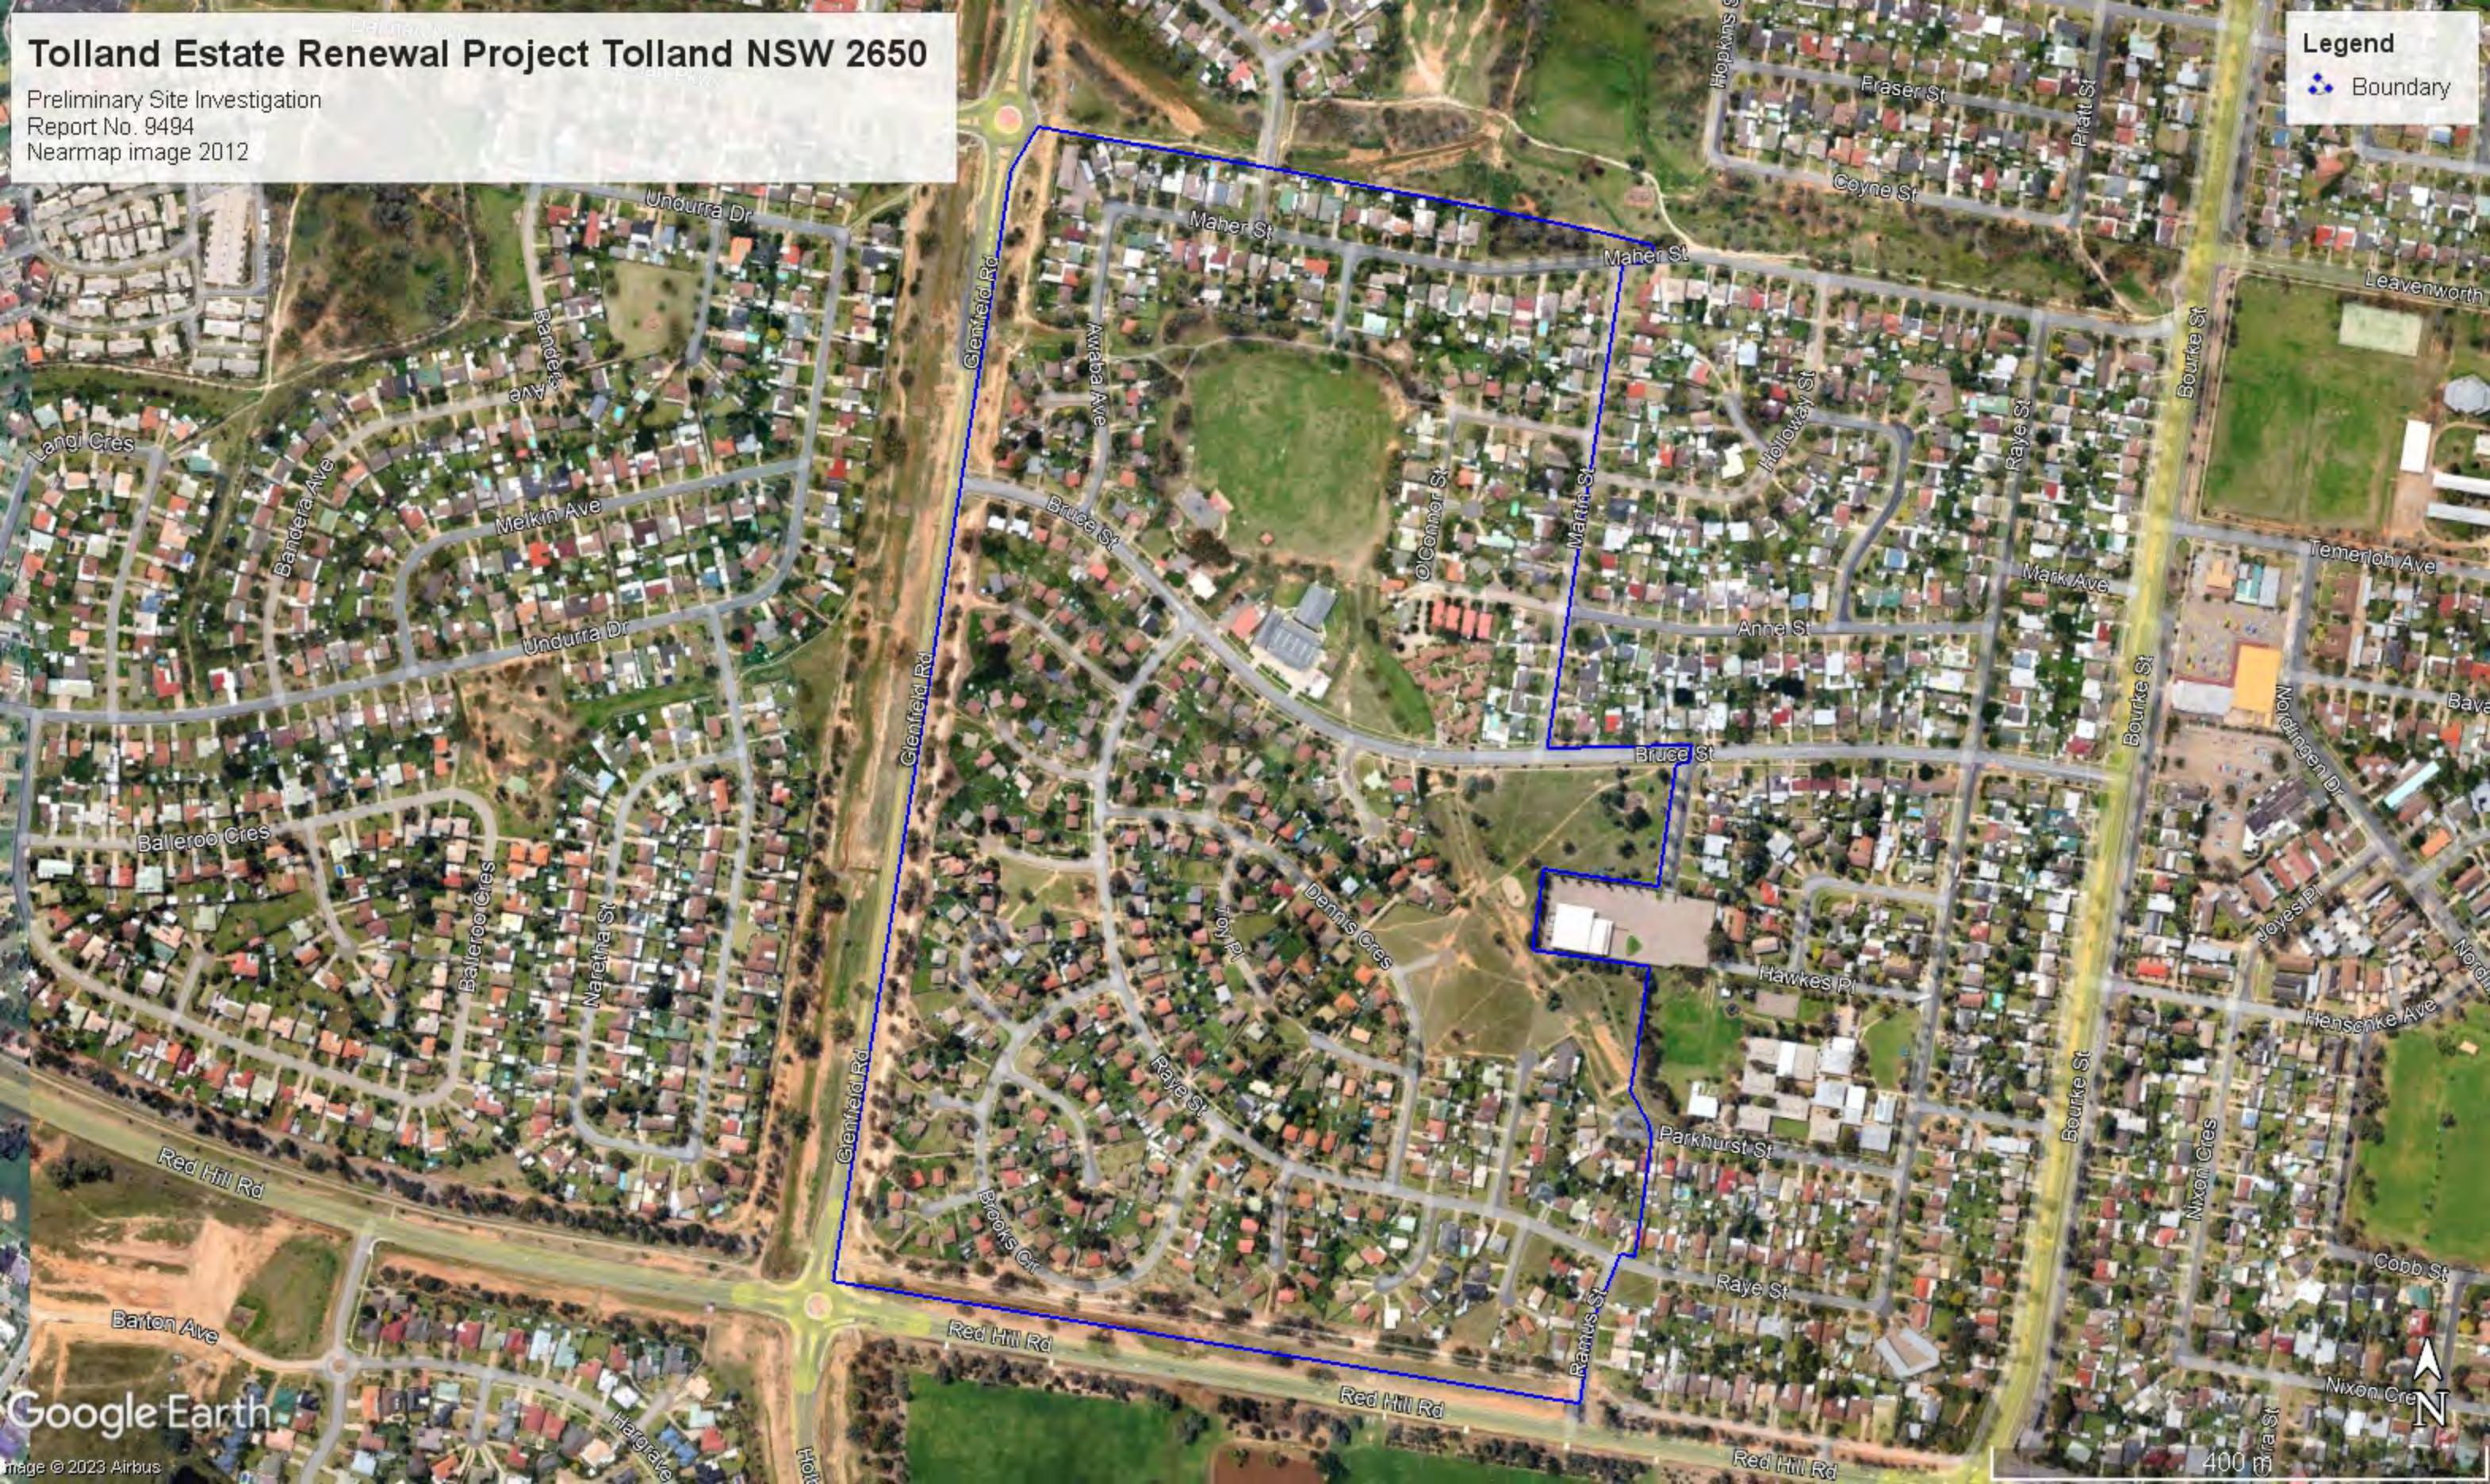
Preliminary Site Investigation  
Report No. 9494  
Nearmap image 2012

**2012** – Residential development continues in Tolland. Small raised garden beds in Kilpatrick Park can be seen.

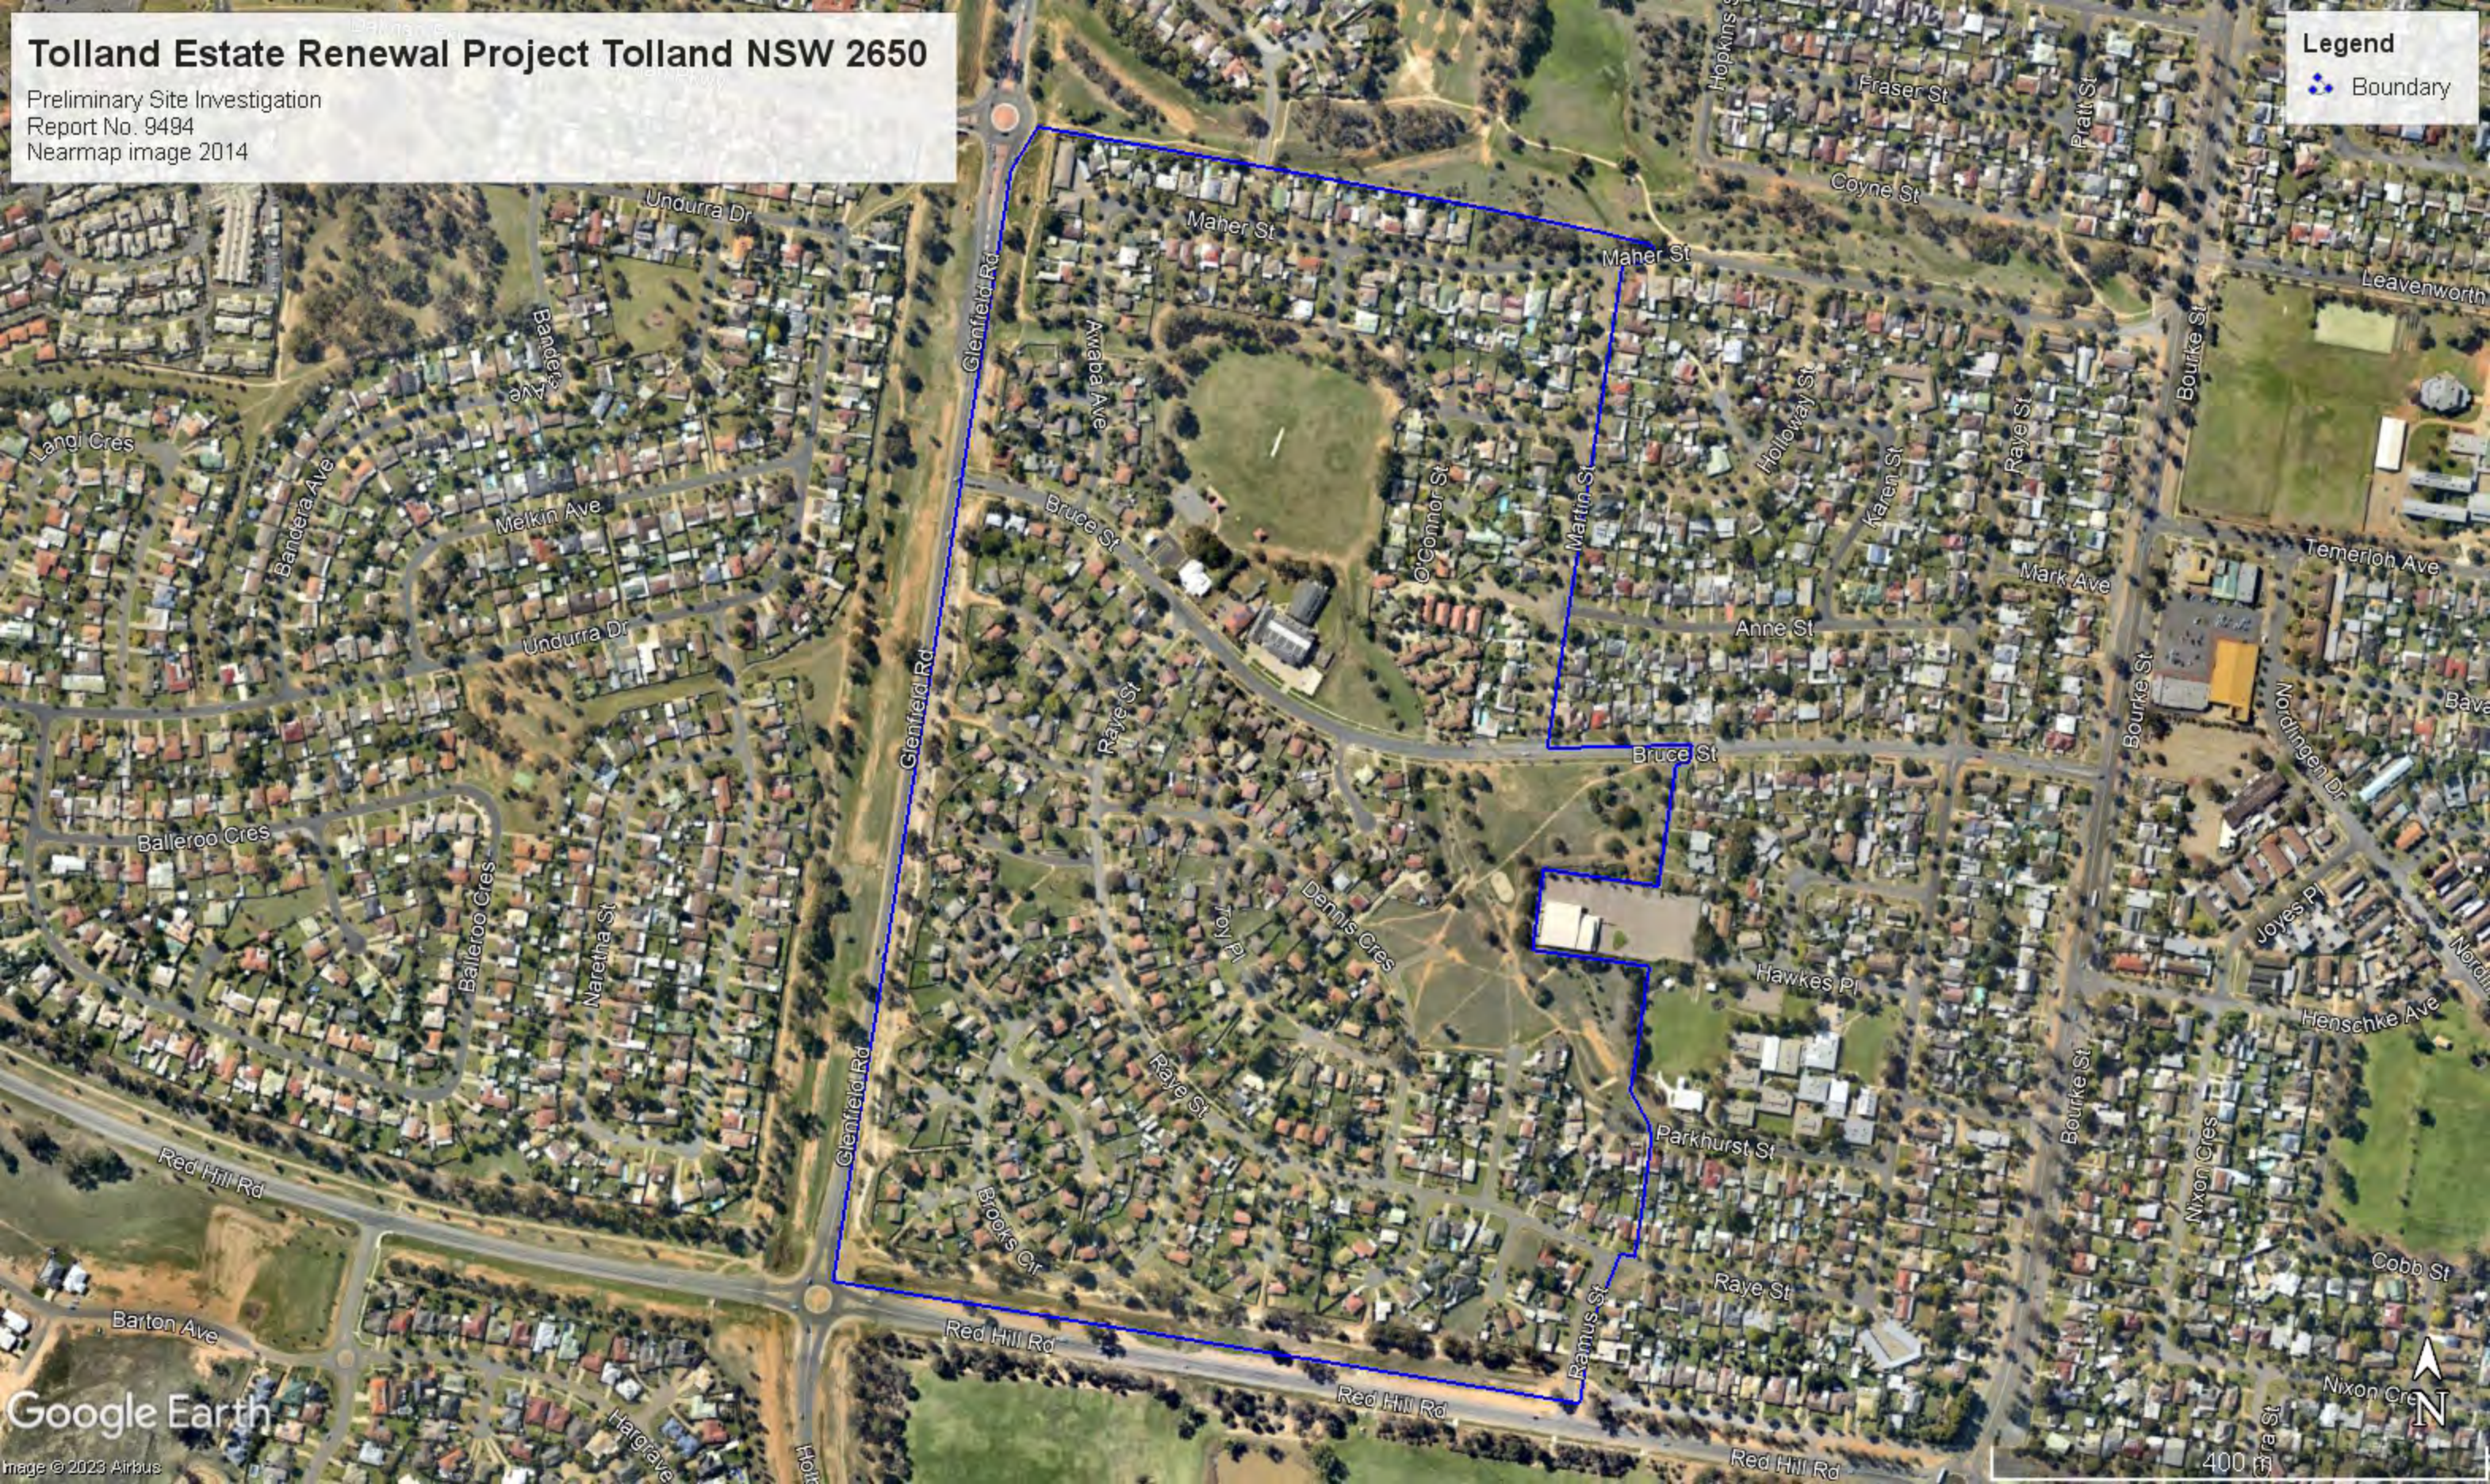
Preliminary Site Investigation  
Report No. 9494  
Nearmap image 2014

**2014** – The skate park has been built at Chambers Park and the car park extended.

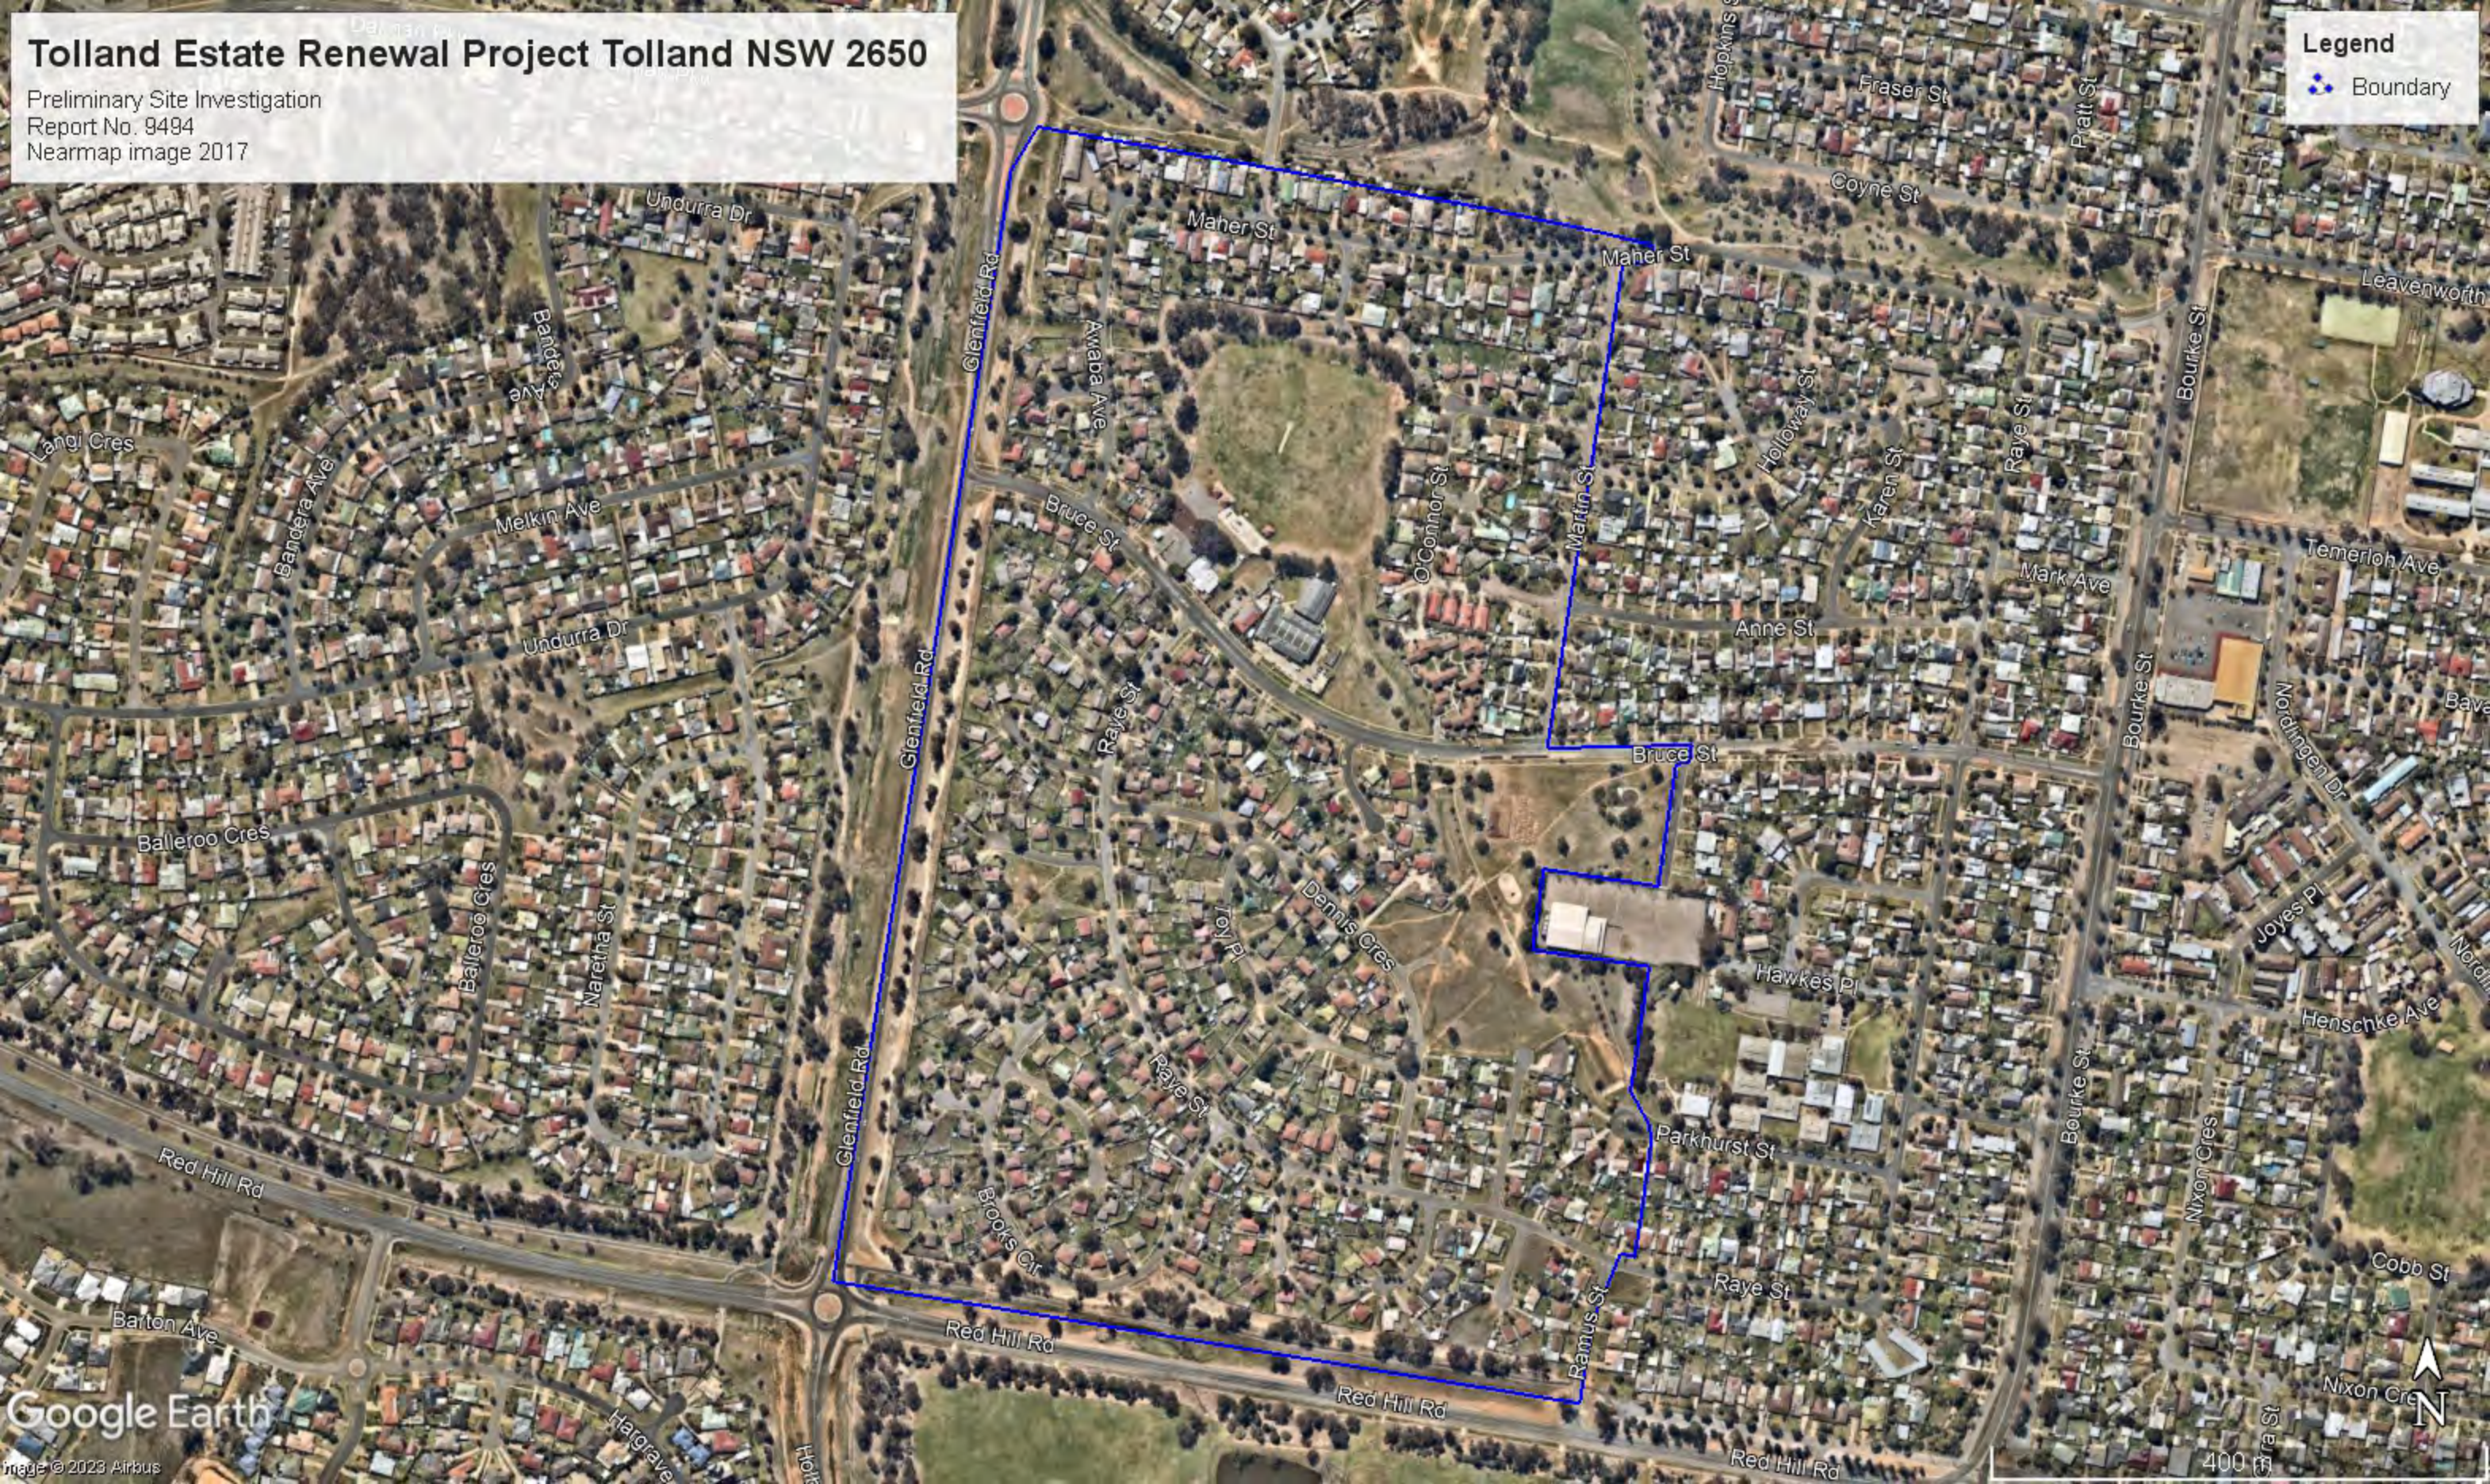
Preliminary Site Investigation  
Report No. 9494  
Nearmap image 2017

**2017** – The playground at Chambers Park has been expanded and updated. Construction has begun for the pump track at Emblen Park.

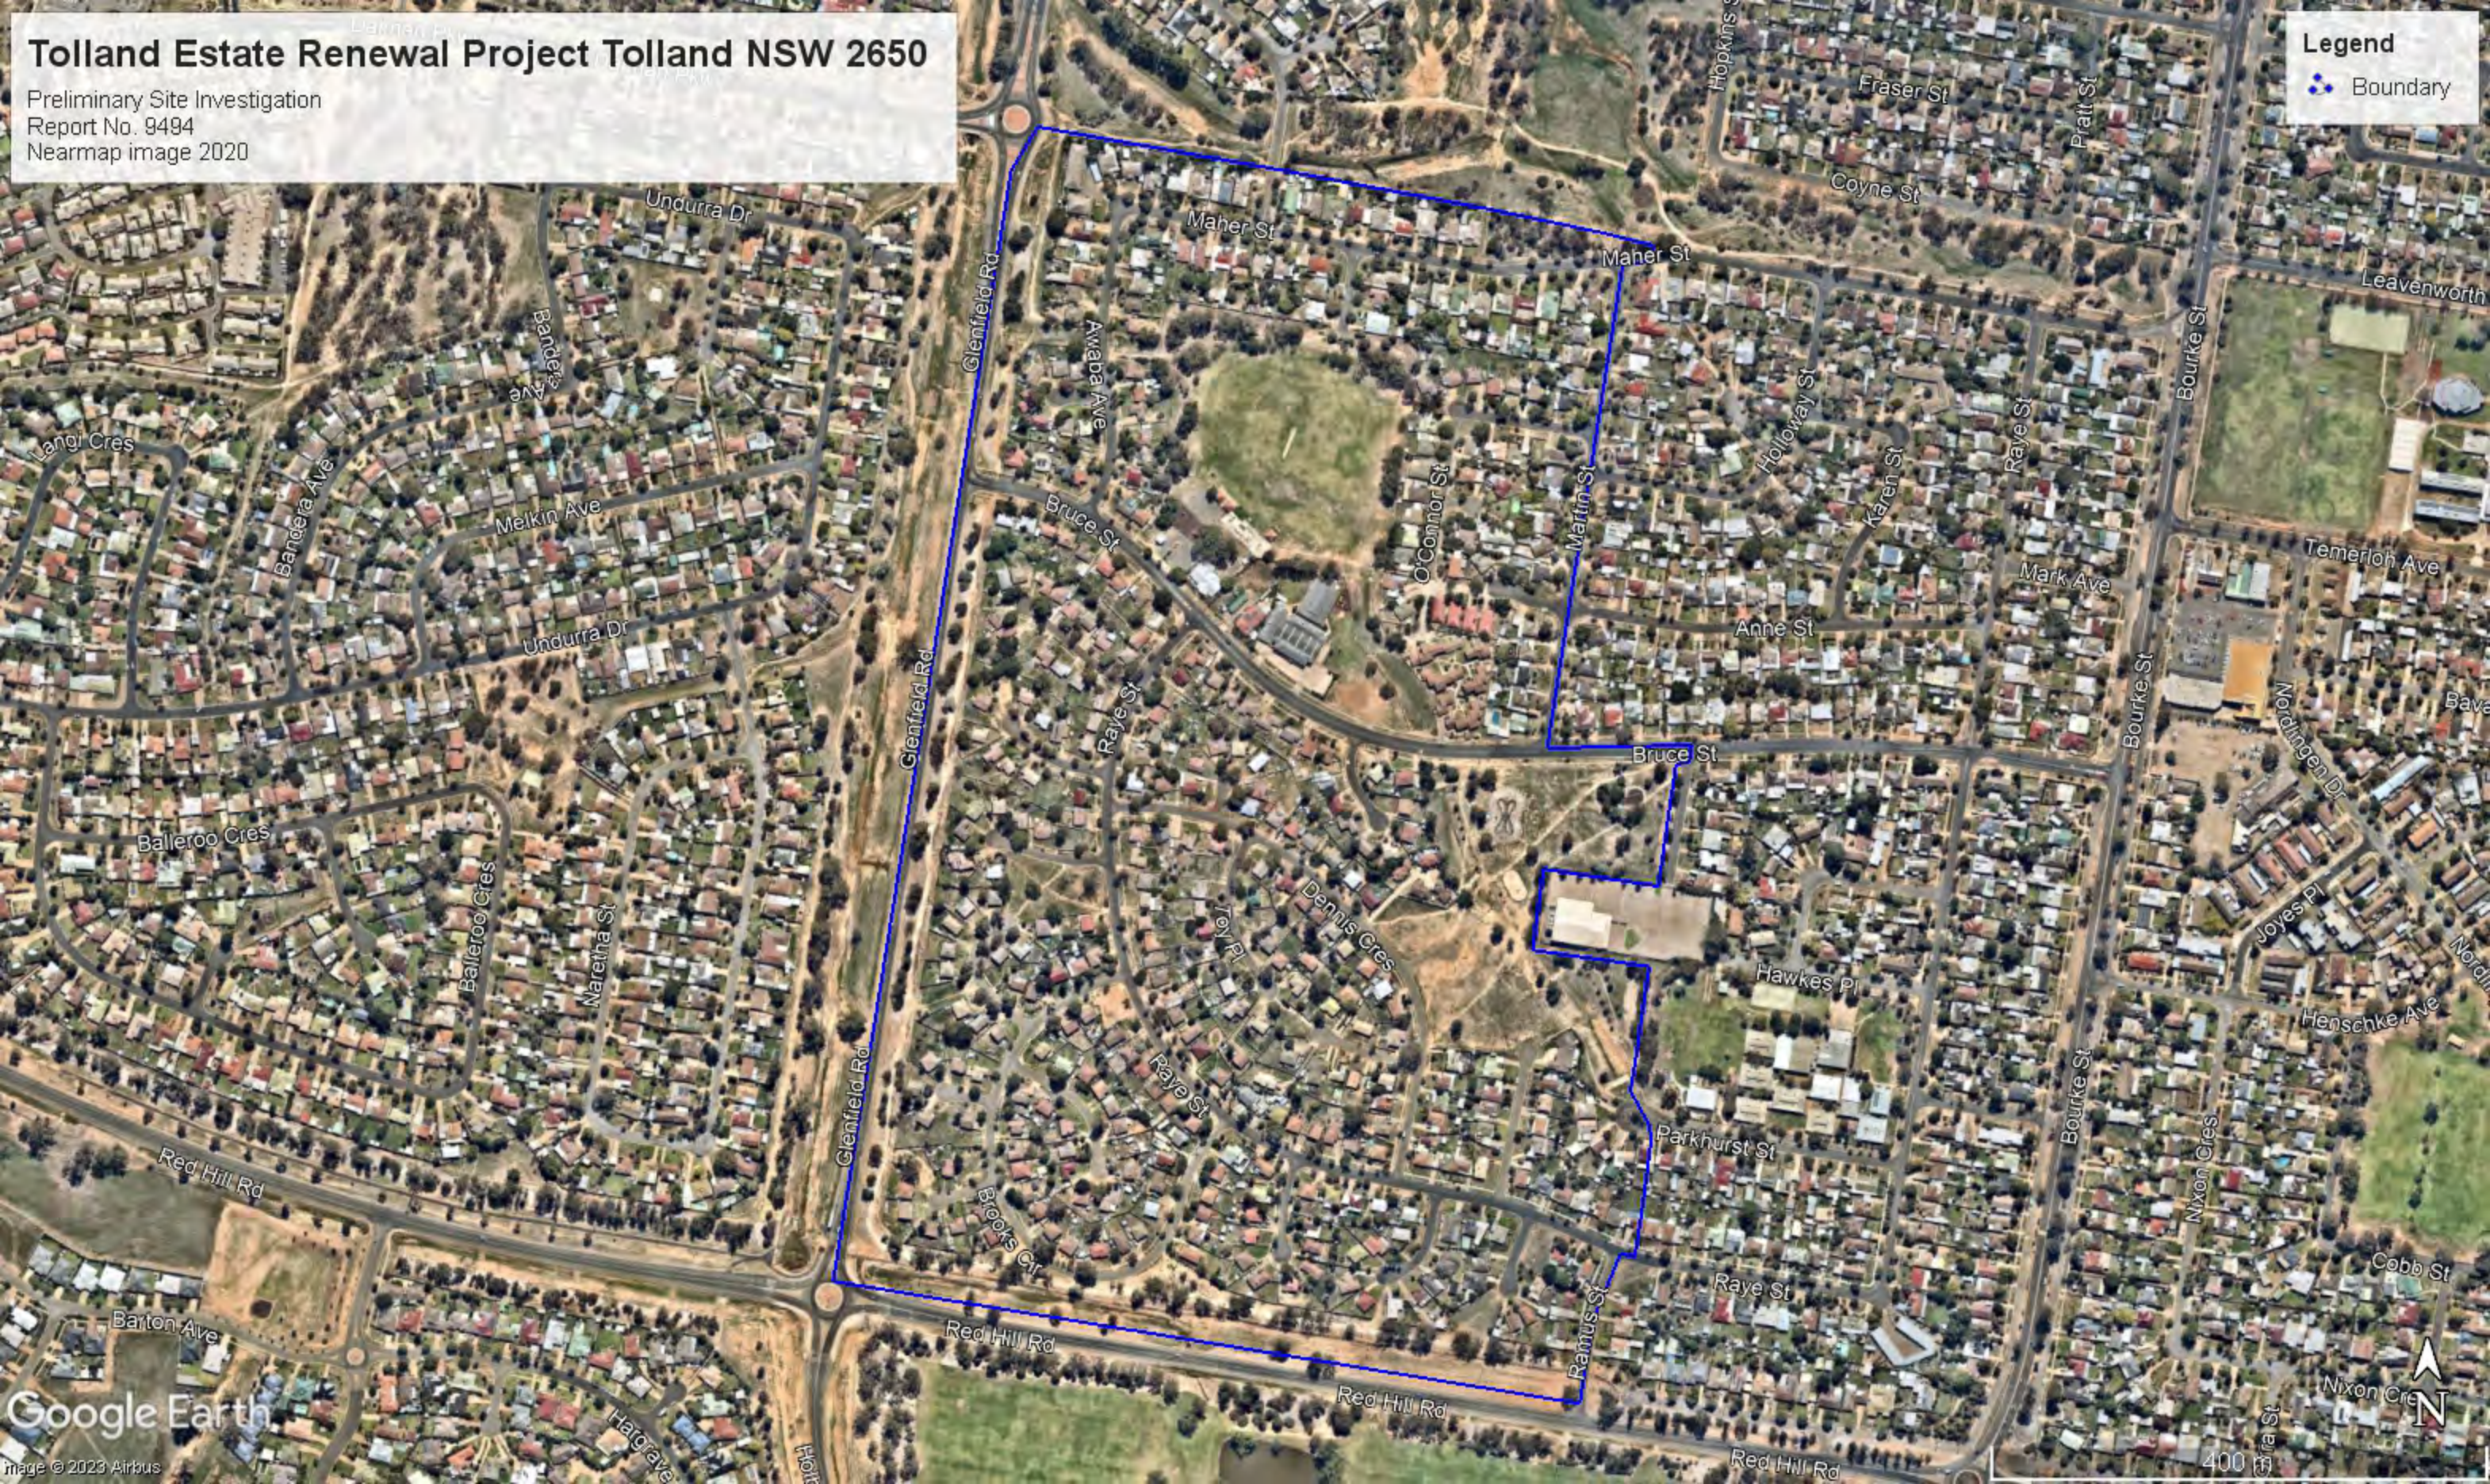
Preliminary Site Investigation  
Report No. 9494  
Nearmap image 2020

**2020** – The pump track has been completed.

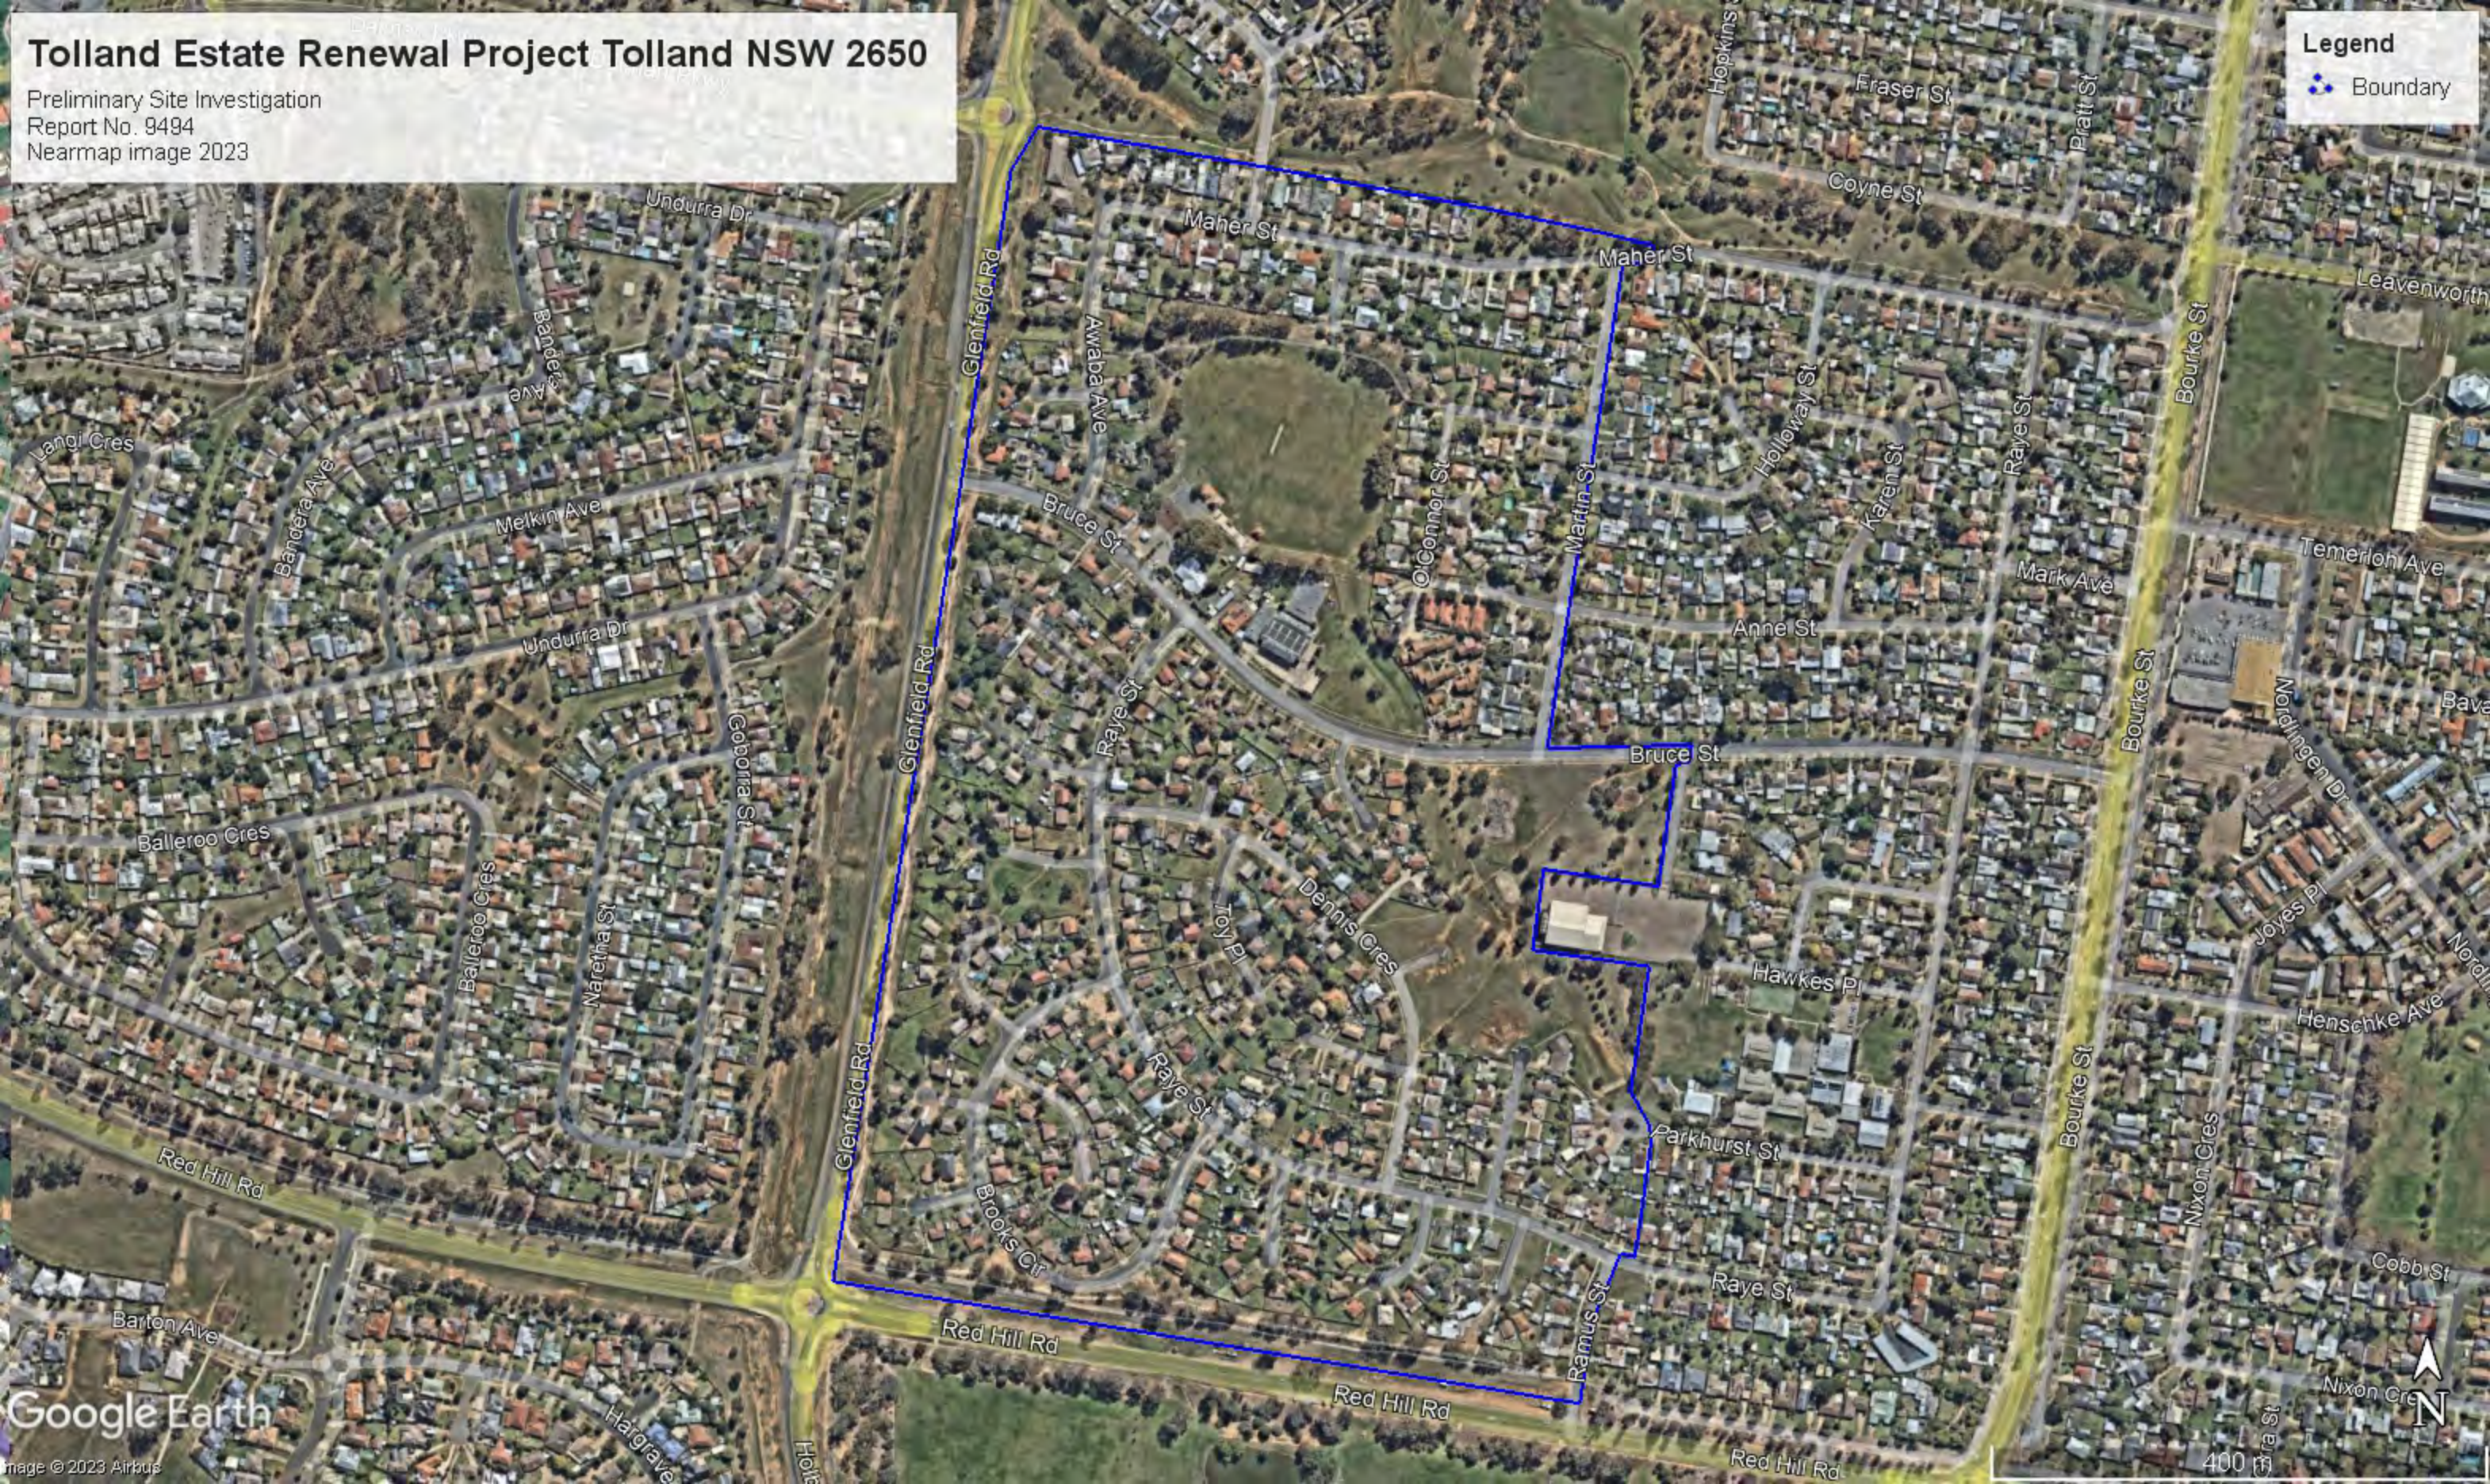
Preliminary Site Investigation  
Report No. 9494  
Nearmap image 2023

**2023** – No major changes to the site from 2020.

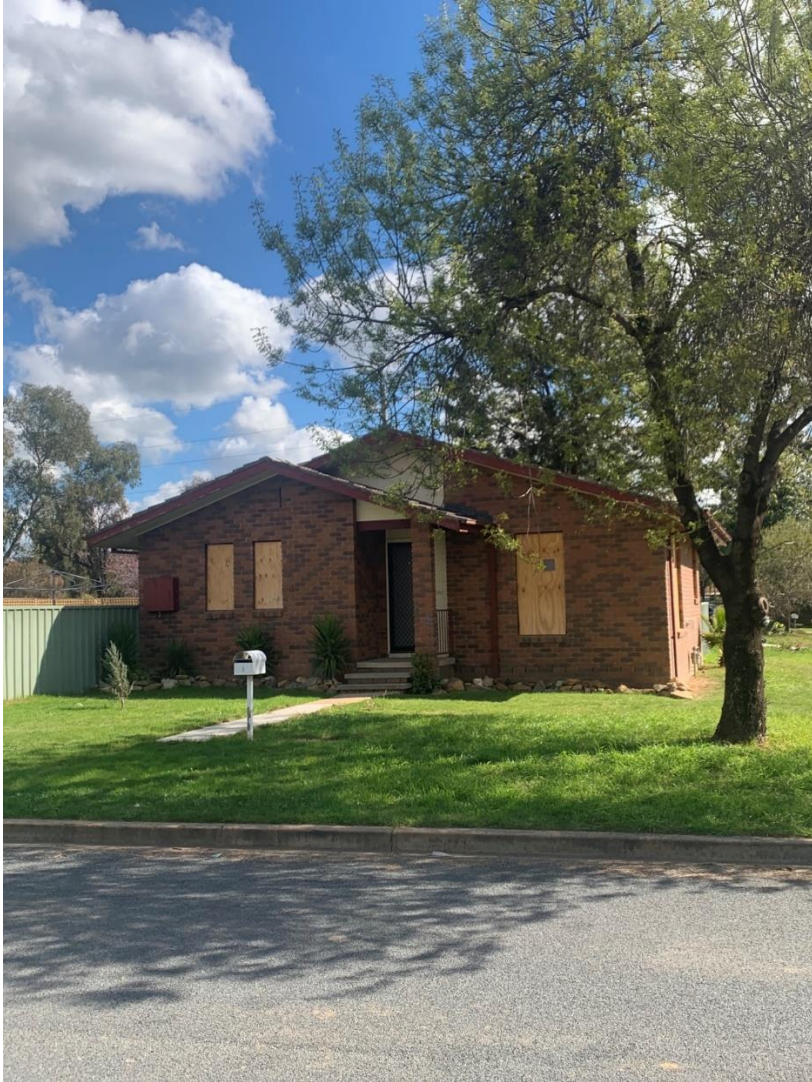
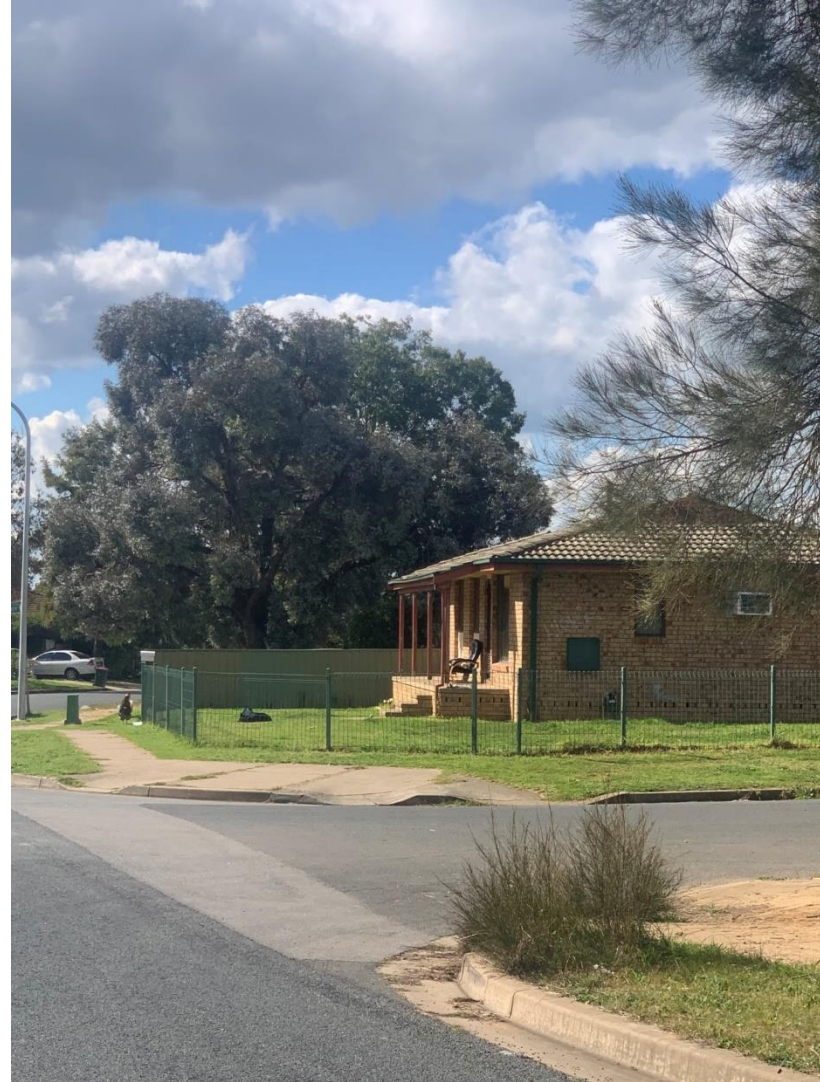
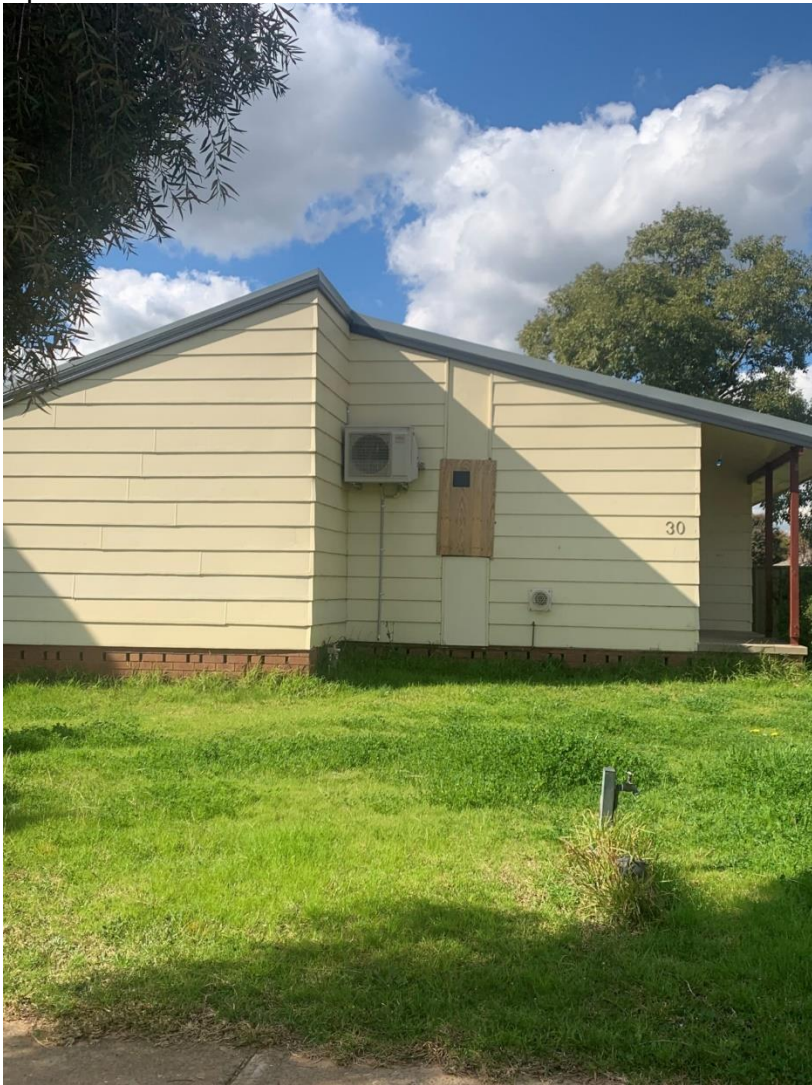
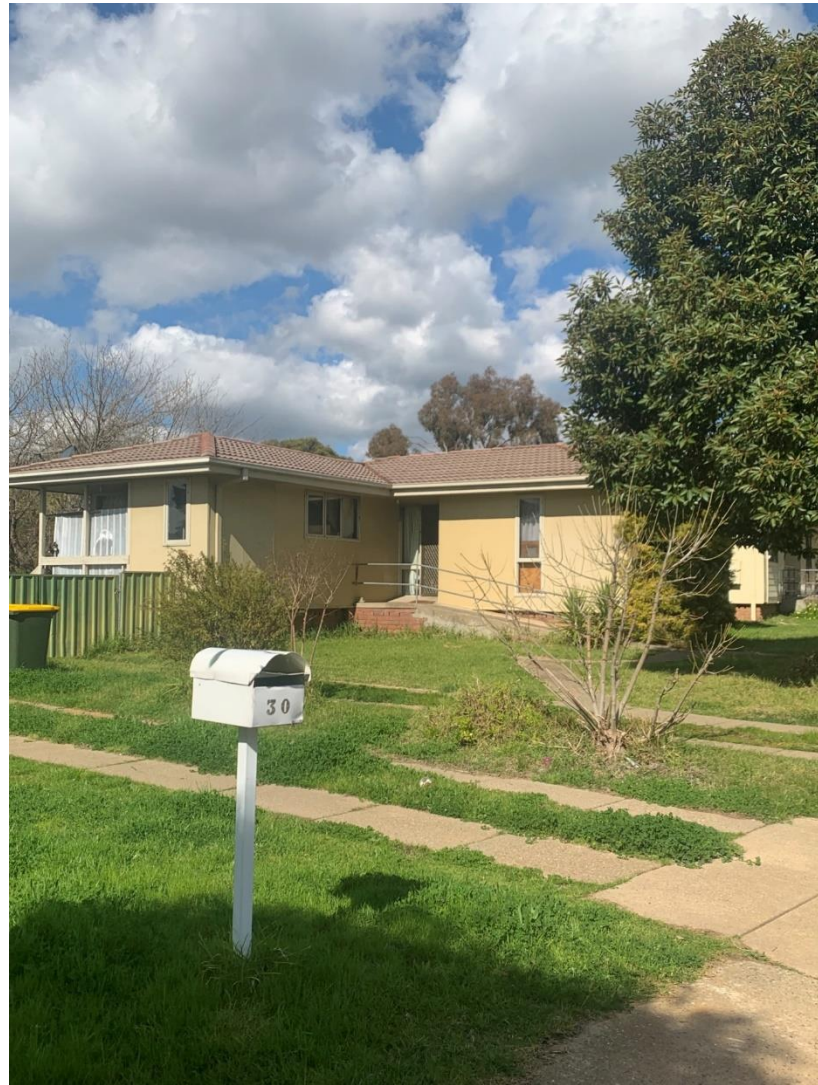
- The houses are a mix of brick veneer and fibrous sheeting, mostly built between the 1960s and 1990s. Many houses are vacant or damaged. Some houses have been damaged or destroyed by fire and the lots vacant. Thick grass hampered a thorough visual inspection of the vacant lots. One vacant corner block appears to have been used as rudimentary bike jumps, made from soil covered Council recycling bins.

Photograph 1: Typical house in Tolland

Photograph 2: Typical house in Tolland

Photograph 3: Typical house in Tolland

Photograph 4: Typical house in Tolland
