**PRELIMINARY SITE  
INVESTIGATION**

**FOR THE  
TOLLAND ESTATE  
RENEWAL PROJECT**

**AUGUST 2023**

**REPORT NO: 9494**

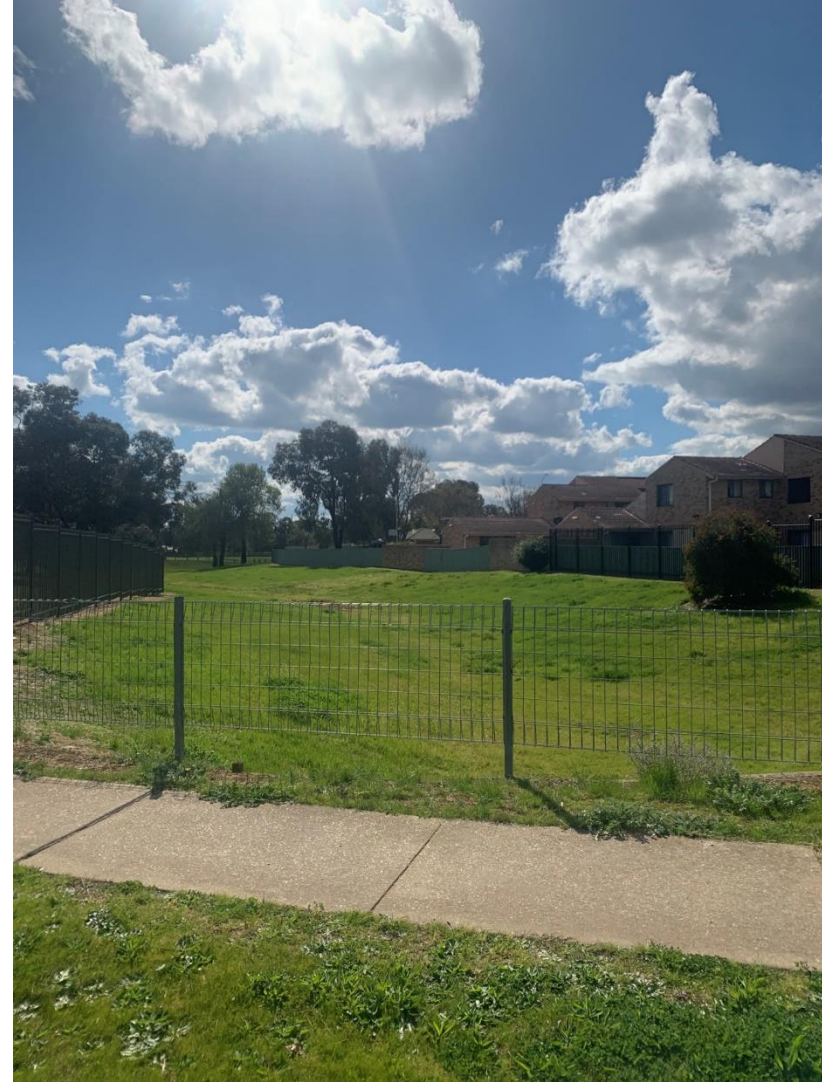
- A north south trending open drainage channel runs from the bottom of Chambers Park, alongside OneSchool Global, under Bruce Street and through Emblen Park. The channel follows the historical natural drainage channel identified in aerial photographs.

Photograph 12: Open drainage channel, adjacent to OneSchool Global

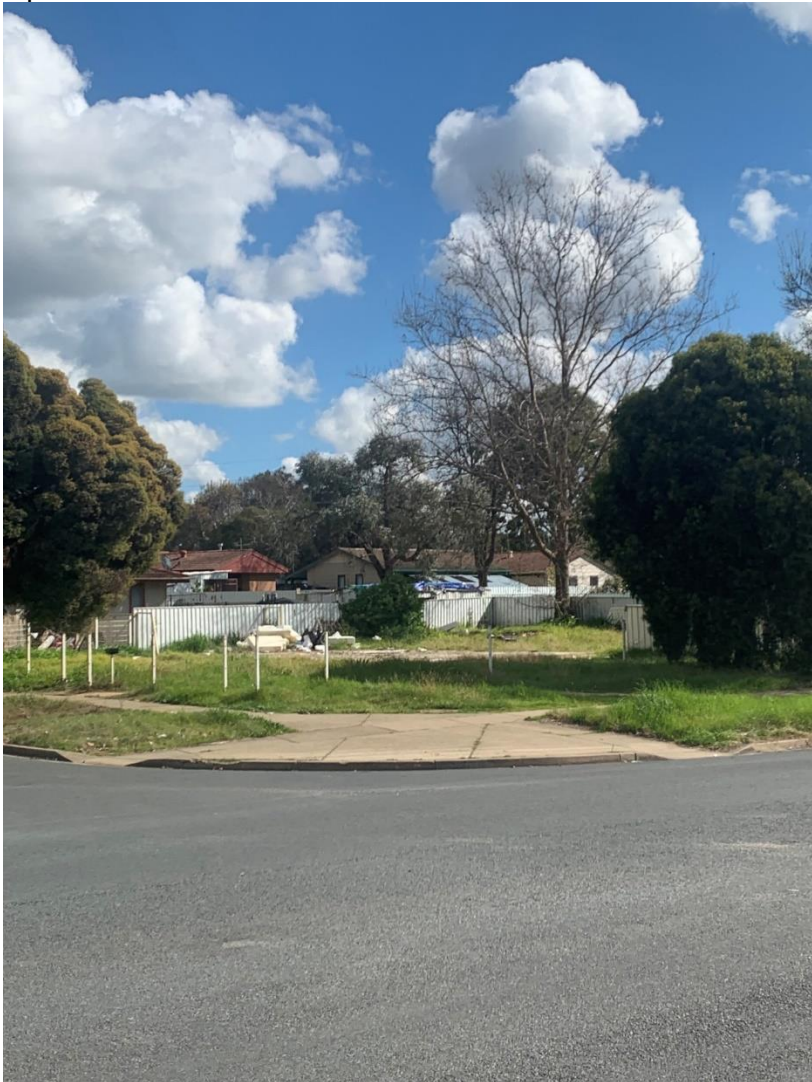
- Dumped rubbish was observed in front of multiple houses, in gutters and on vacant lots throughout the site.
- Surrounding land uses include residential in all directions with Jubilee Park, a multisport athletic park to the south.

Photograph 13: Dumped rubbish on a vacant site.

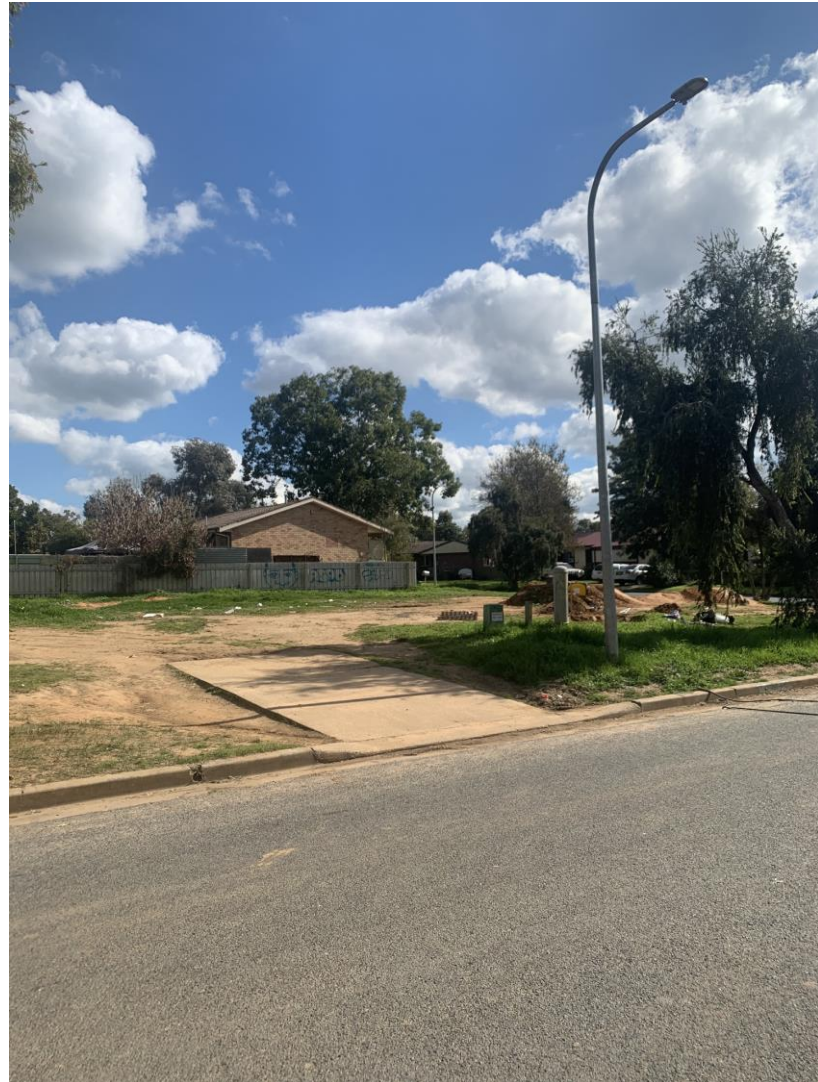
- The houses are a mix of brick veneer and fibrous sheeting, mostly built between the 1960s and 1990s. Many houses are vacant or damaged. Some houses have been damaged or destroyed by fire and the lots vacant. Thick grass hampered a thorough visual inspection of the vacant lots. One vacant corner block appears to have been used as rudimentary bike jumps, made from soil covered Council recycling bins.

Photograph 14: Dumped rubbish on a vacant site. The rudimentary bike jumps can be seen on the right.
