South Jerrabomberra Regional Job Precinct

Technical Report - Soils, Geology and
Contamination

26 May 2023

Project No.: 0621304

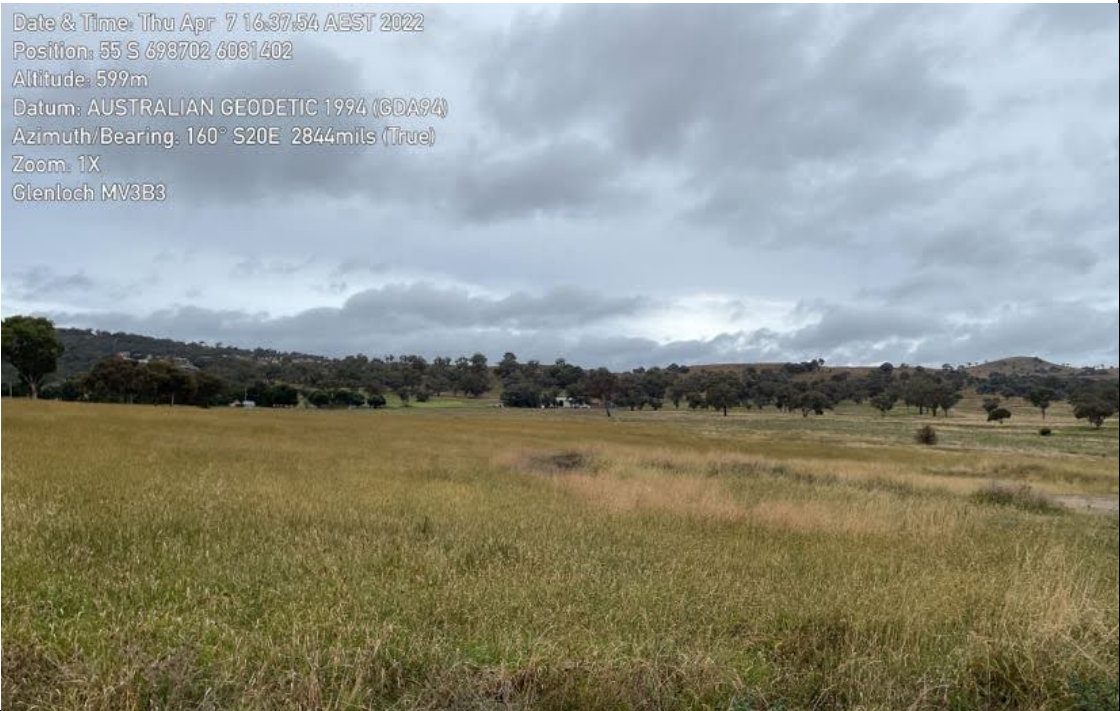
Photo No. 5	Date: 7 April 2022	<p>Date & Time: Thu Apr 7 16:37:54 AEST 2022 Position: 55 S 698702 6081402 Altitude: 599m Datum: AUSTRALIAN GEODETIC 1994 (GDA94) Azimuth/Bearing: 160° S20E 2844mils (True) Zoom: 1X Glenloch MV3B3</p>

Direction Photo Taken: South southeast		
Description: View to South southeast from roundabout to south of Jerrabomberra Creek.

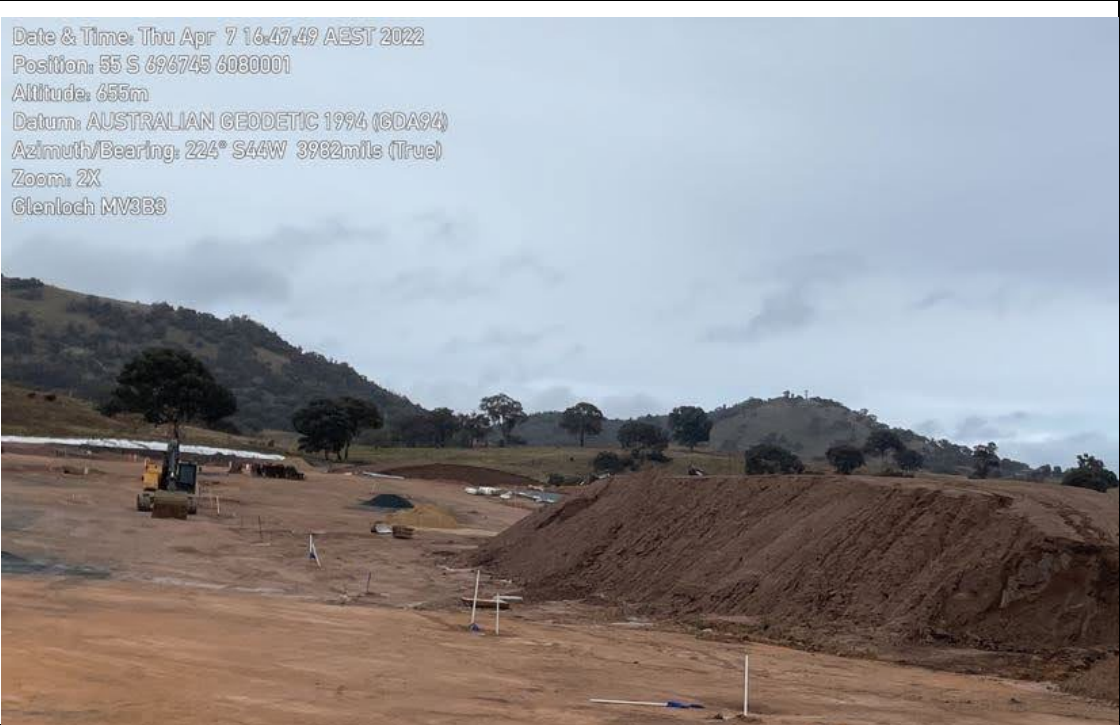
Photo No. 18	Date: 7 April 2022
Direction Photo Taken: South southwest	
Description: Construction compound on South Tralee Development

- 1 x rusted steel drum identified in the vicinity of the former piggery within the Poplars precinct (as discussed in Environmental Strategies, 2012).
- Earthmoving plant laydown / parking and construction compound areas associated with civil works for the South Tralee residential development.

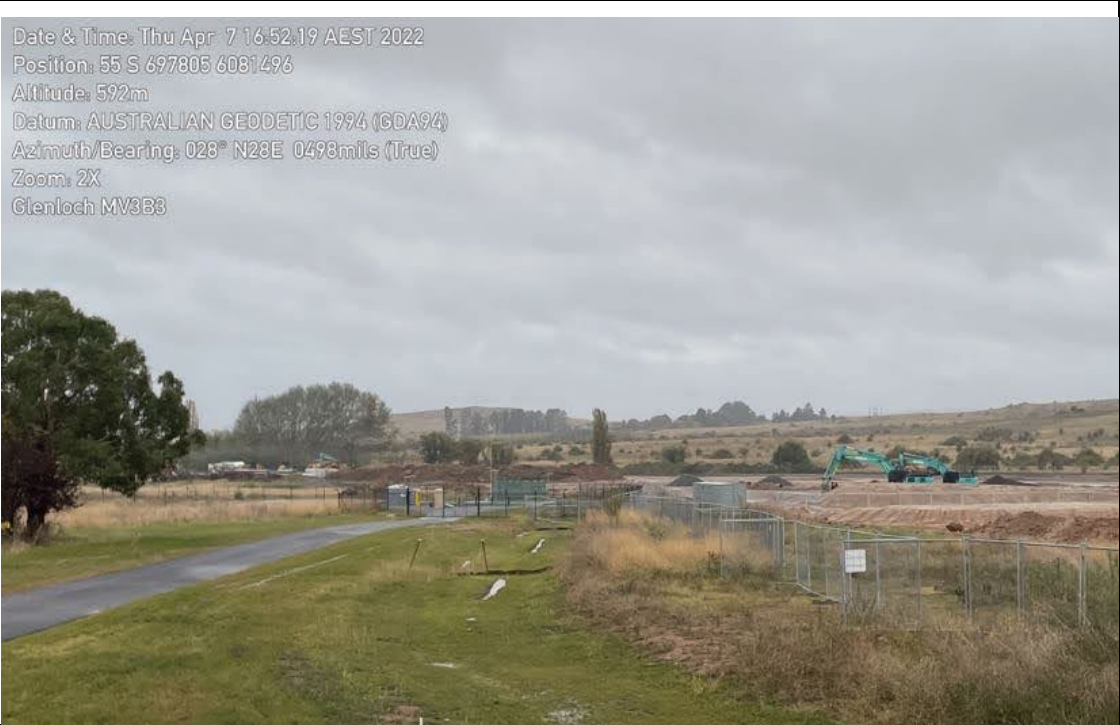
Photo No. 19	Date: 7 April 2022
Direction Photo Taken: North northeast	
Description: Sports complex development site

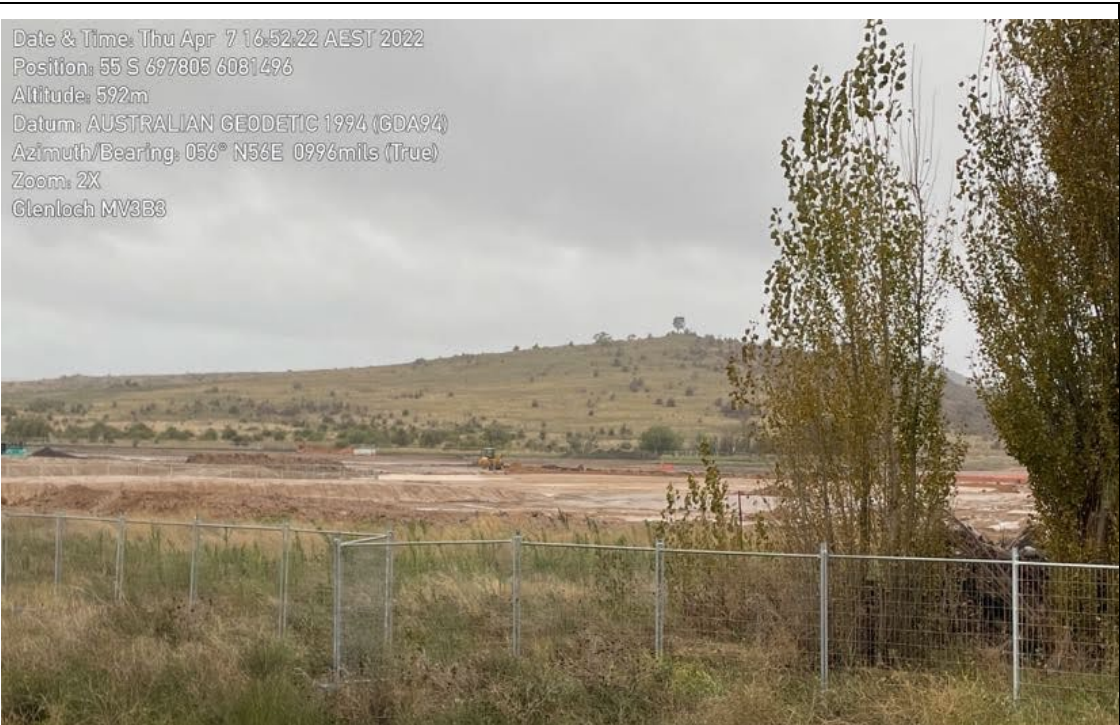
Photo No. 20	Date: 7 April 2022
Direction Photo Taken: Northeast	
Description: Sports complex development site

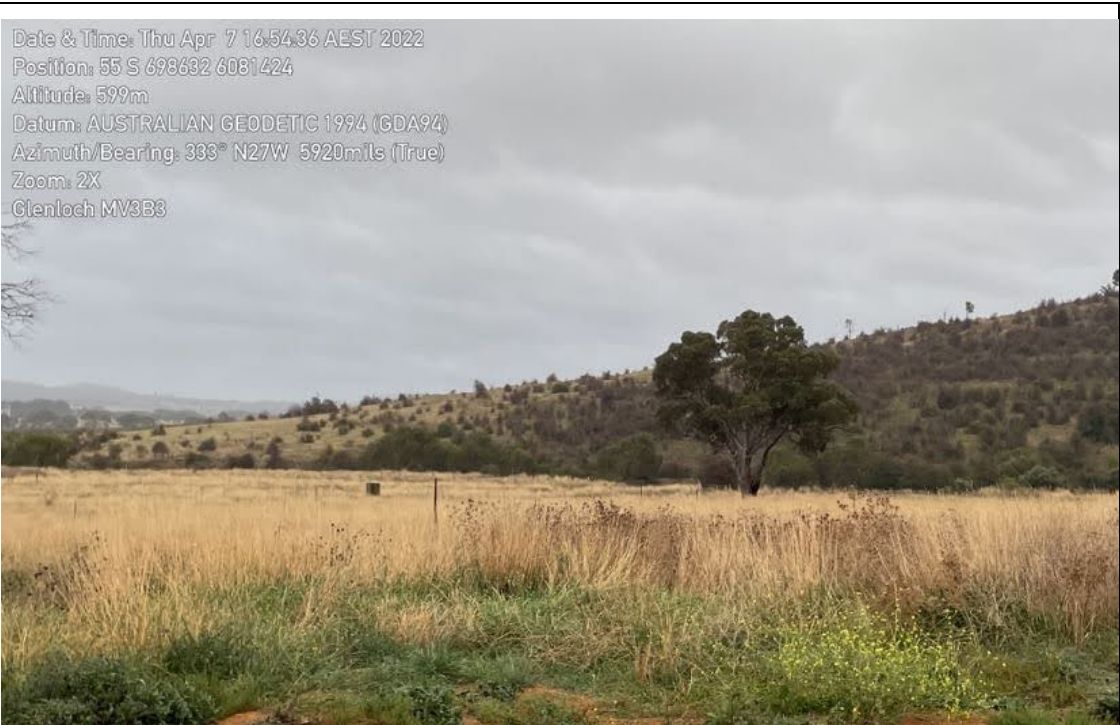
Photo No. 22	Date: 7 April 2022
Direction Photo Taken: North northwest	
Description: View north northwest from Environa drive with path of Jerrabomberra Creek visipble at foot of slope.
