# Geotechnical Site Investigation Report

IPG Badgerys Creek

80221014

Prepared for  
Ingham Property Group

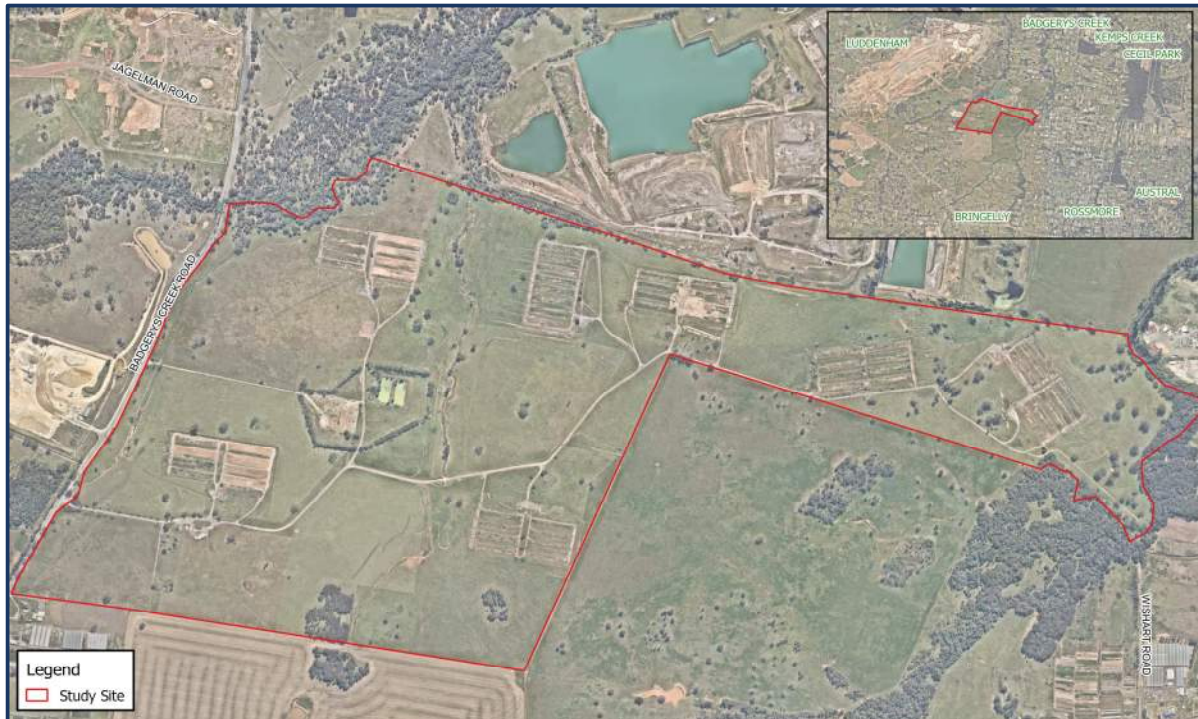
Figure 2-1 Site Plan of proposed development area

The site is located at 475 Badgerys Creek Road, Badgerys Creek, NSW. The current site consists of a mixed use agricultural area situated within Badgerys Creek, approximately 41 km to the west of Sydney centre business district. A site plan is presented in Figure 2-1 (and contained in **Appendix A**) detailing the proposed development site boundary. Further site details are presented in Table 2-1 below.

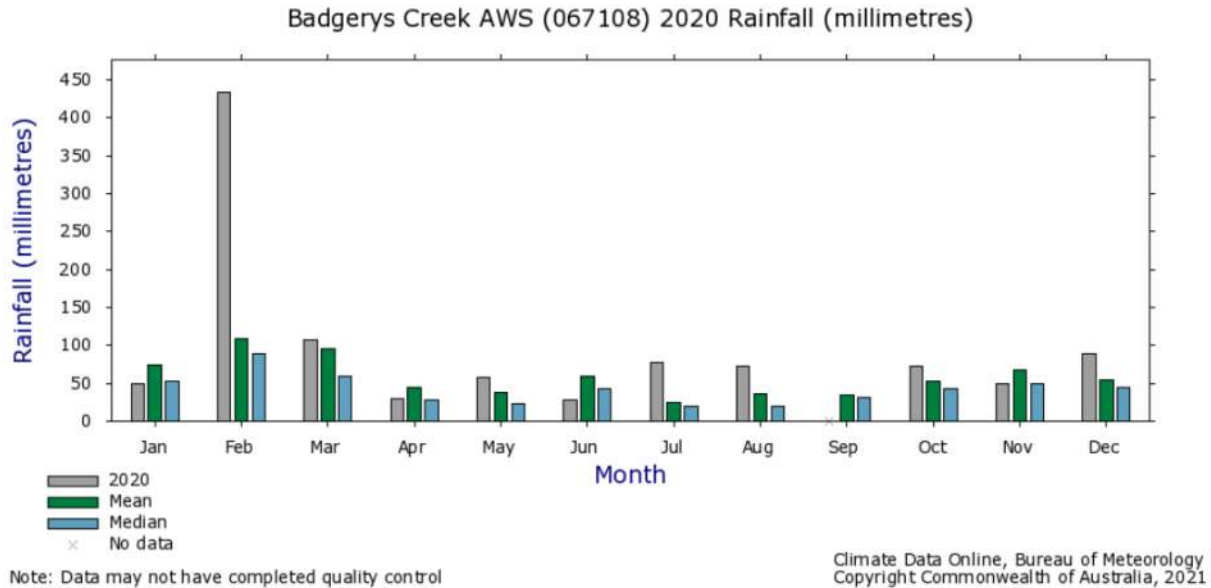
Figure 2-3 2020, mean and median Badgerys Creek rainfall data

Mean and factual monthly rainfall data from the Bureau of Meteorology’s Badgerys Creek monitoring station is presented in Figure 2-3. The mean rainfall ranges from 34.9mm (September) to 108.4mm (February) in a typical year.

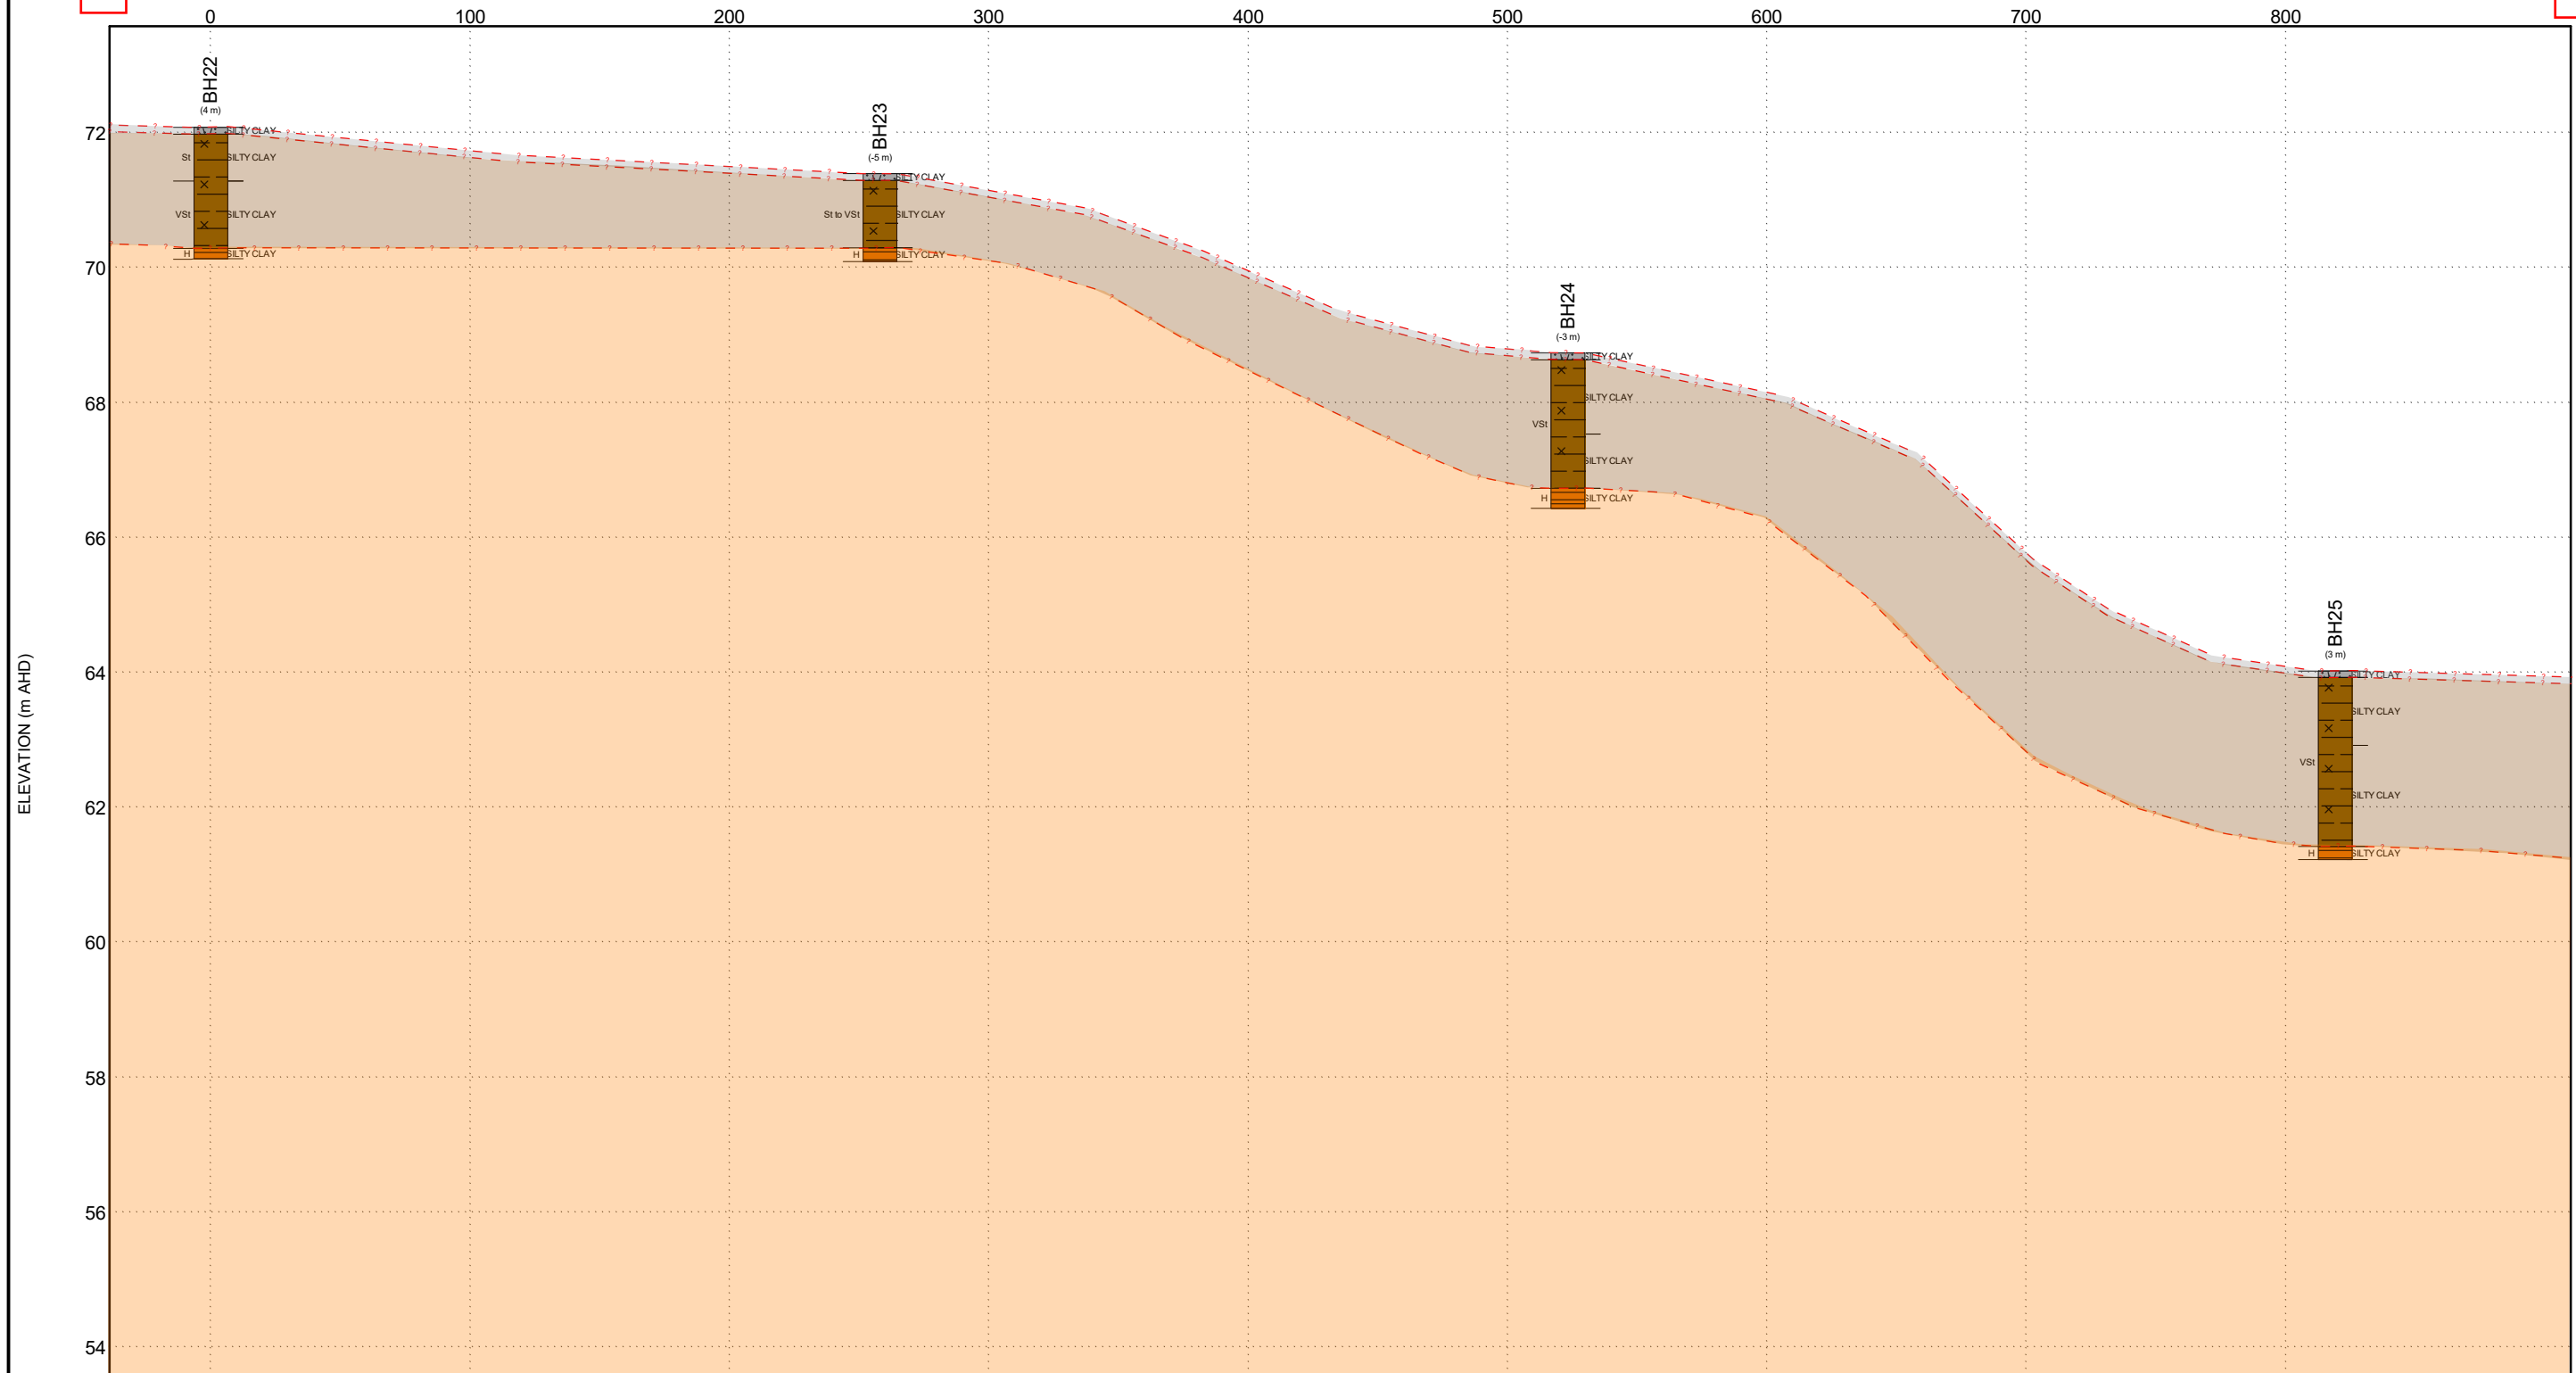
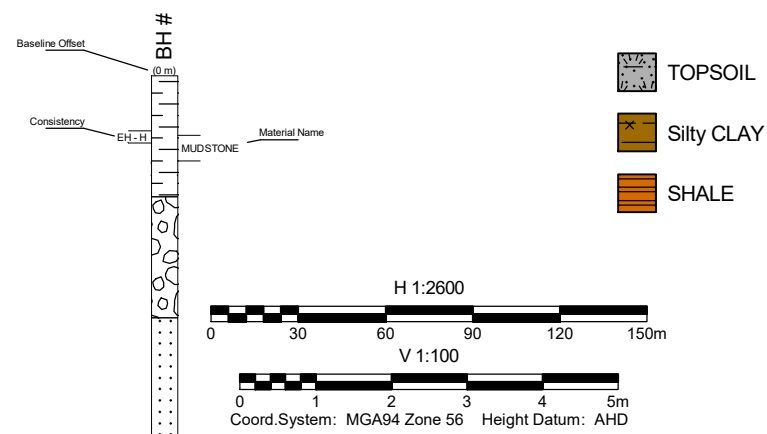
TITLE  
Inferred Subsurface Section

CLIENT	Ingham Property Group	PROJECT	IPG Badgerys Creek Badgerys Creek
DRAWN	A.T	DATE	23/11/2020
CHECKED	D.D	DATE	23/11/2020
SCALE	H 1:2600 V 1:100	A3	PROJECT No 80221014
			FIGURE No 1

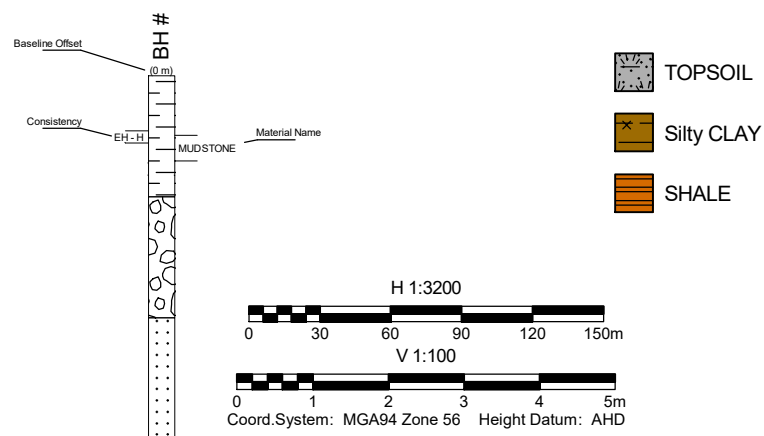
CLIENT Ingham Property Group		PROJECT IPG Badgerys Creek Badgerys Creek	
	DRAWN A.T	DATE 23/11/2020	TITLE Inferred Subsurface Section	
	CHECKED D.D	DATE 23/11/2020		
	SCALE H 1:3200 V 1:100		A3	PROJECT No 80221014

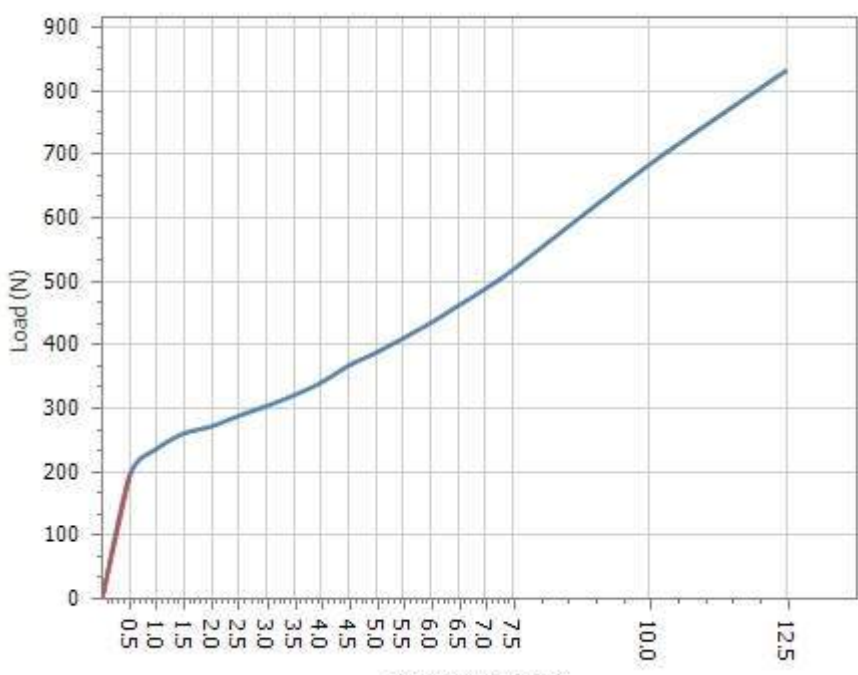
<table style="width: 100%;"> <tr><td>Maximum Dry Density (t/m<sup>3</sup>):</td><td style="text-align: right;">1.77</td></tr> <tr><td>Optimum Moisture Content (%):</td><td style="text-align: right;">18.0</td></tr> <tr><td>Field Moisture Content (%):</td><td style="text-align: right;">20.5</td></tr> <tr><td>Sample Percent Oversize (%):</td><td style="text-align: right;">0.0</td></tr> <tr><td>Oversize Included / Excluded</td><td style="text-align: right;">Excluded</td></tr> <tr><td>Target Density Ratio (%):</td><td style="text-align: right;">100</td></tr> <tr><td>Target Moisture Ratio (%):</td><td style="text-align: right;">100</td></tr> <tr><td>Placement Dry Density (t/m<sup>3</sup>):</td><td style="text-align: right;">1.78</td></tr> <tr><td>Placement Dry Density Ratio (%):</td><td style="text-align: right;">100.0</td></tr> <tr><td>Placement Moisture Content (%):</td><td style="text-align: right;">18.0</td></tr> <tr><td>Placement Moisture Ratio (%):</td><td style="text-align: right;">99.5</td></tr> <tr><td>Test Condition / Soaking Period:</td><td style="text-align: right;">Soaked / 4 Days</td></tr> <tr><td>CBR Surcharge (kg)</td><td style="text-align: right;">6.8</td></tr> <tr><td>Dry Density After Soak (t/m<sup>3</sup>):</td><td style="text-align: right;">1.72</td></tr> <tr><td>Total Curing Time (hrs)</td><td style="text-align: right;">50</td></tr> <tr><td>Liquid Limit Method</td><td style="text-align: right;">Estimation</td></tr> <tr><td>Moisture (top 30mm) After Soak (%)</td><td style="text-align: right;">27.3</td></tr> <tr><td>Moisture (remainder) After Soak (%)</td><td style="text-align: right;">19.1</td></tr> <tr><td>CBR Swell (%):</td><td style="text-align: right;">3.0</td></tr> <tr><td>Minimum CBR Specification (%):</td><td style="text-align: right;">-</td></tr> <tr><td><b>CBR Value @ 2.5mm (%):</b></td><td style="text-align: right;"><b>2.0</b></td></tr> </table>	Maximum Dry Density (t/m <sup>3</sup> ):	1.77	Optimum Moisture Content (%):	18.0	Field Moisture Content (%):	20.5	Sample Percent Oversize (%):	0.0	Oversize Included / Excluded	Excluded	Target Density Ratio (%):	100	Target Moisture Ratio (%):	100	Placement Dry Density (t/m <sup>3</sup> ):	1.78	Placement Dry Density Ratio (%):	100.0	Placement Moisture Content (%):	18.0	Placement Moisture Ratio (%):	99.5	Test Condition / Soaking Period:	Soaked / 4 Days	CBR Surcharge (kg)	6.8	Dry Density After Soak (t/m <sup>3</sup> ):	1.72	Total Curing Time (hrs)	50	Liquid Limit Method	Estimation	Moisture (top 30mm) After Soak (%)	27.3	Moisture (remainder) After Soak (%)	19.1	CBR Swell (%):	3.0	Minimum CBR Specification (%):	-	<b>CBR Value @ 2.5mm (%):</b>	<b>2.0</b>	<div style="text-align: center;"> <b>CBR PENETRATION PLOT</b> </div>

<table border="1" style="width: 100%; border-collapse: collapse; margin-top: 10px;"> <caption>Approximate Data Points from CBR Penetration Plot</caption> <thead> <tr> <th>Penetration (mm)</th> <th>Load (N)</th> </tr> </thead> <tbody> <tr><td>0</td><td>0</td></tr> <tr><td>0.5</td><td>200</td></tr> <tr><td>1.0</td><td>250</td></tr> <tr><td>2.0</td><td>300</td></tr> <tr><td>3.0</td><td>350</td></tr> <tr><td>4.0</td><td>400</td></tr> <tr><td>5.0</td><td>450</td></tr> <tr><td>6.0</td><td>500</td></tr> <tr><td>7.5</td><td>600</td></tr> <tr><td>10.0</td><td>700</td></tr> <tr><td>12.5</td><td>850</td></tr> </tbody> </table>	Penetration (mm)	Load (N)	0	0	0.5	200	1.0	250	2.0	300	3.0	350	4.0	400	5.0	450	6.0	500	7.5	600	10.0	700	12.5	850

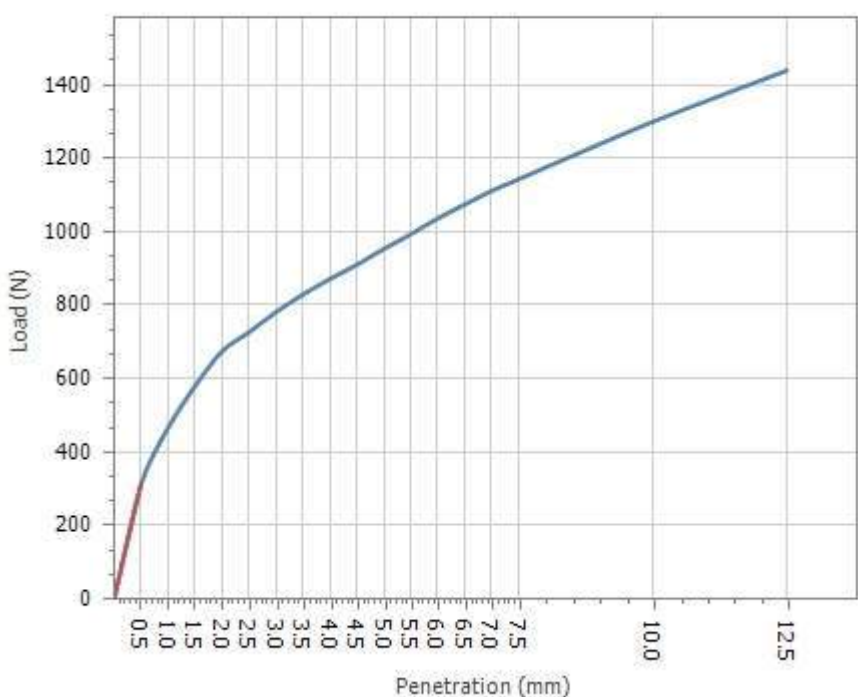
<table style="width: 100%;"> <tr><td>Maximum Dry Density (t/m<sup>3</sup>):</td><td style="text-align: right;">1.88</td></tr> <tr><td>Optimum Moisture Content (%):</td><td style="text-align: right;">15.5</td></tr> <tr><td>Field Moisture Content (%):</td><td style="text-align: right;">13.6</td></tr> <tr><td>Sample Percent Oversize (%):</td><td style="text-align: right;">0.0</td></tr> <tr><td>Oversize Included / Excluded</td><td style="text-align: right;">Excluded</td></tr> <tr><td>Target Density Ratio (%):</td><td style="text-align: right;">100</td></tr> <tr><td>Target Moisture Ratio (%):</td><td style="text-align: right;">100</td></tr> <tr><td>Placement Dry Density (t/m<sup>3</sup>):</td><td style="text-align: right;">1.87</td></tr> <tr><td>Placement Dry Density Ratio (%):</td><td style="text-align: right;">100.0</td></tr> <tr><td>Placement Moisture Content (%):</td><td style="text-align: right;">15.7</td></tr> <tr><td>Placement Moisture Ratio (%):</td><td style="text-align: right;">101.5</td></tr> <tr><td>Test Condition / Soaking Period:</td><td style="text-align: right;">Soaked / 4 Days</td></tr> <tr><td>CBR Surcharge (kg)</td><td style="text-align: right;">6.8</td></tr> <tr><td>Dry Density After Soak (t/m<sup>3</sup>):</td><td style="text-align: right;">1.83</td></tr> <tr><td>Total Curing Time (hrs)</td><td style="text-align: right;">44</td></tr> <tr><td>Liquid Limit Method</td><td style="text-align: right;">Estimation</td></tr> <tr><td>Moisture (top 30mm) After Soak (%):</td><td style="text-align: right;">22.2</td></tr> <tr><td>Moisture (remainder) After Soak (%):</td><td style="text-align: right;">17.8</td></tr> <tr><td>CBR Swell (%):</td><td style="text-align: right;">2.5</td></tr> <tr><td>Minimum CBR Specification (%):</td><td style="text-align: right;">-</td></tr> <tr><td><b>CBR Value @ 2.5mm (%):</b></td><td style="text-align: right;"><b>6</b></td></tr> </table>	Maximum Dry Density (t/m <sup>3</sup> ):	1.88	Optimum Moisture Content (%):	15.5	Field Moisture Content (%):	13.6	Sample Percent Oversize (%):	0.0	Oversize Included / Excluded	Excluded	Target Density Ratio (%):	100	Target Moisture Ratio (%):	100	Placement Dry Density (t/m <sup>3</sup> ):	1.87	Placement Dry Density Ratio (%):	100.0	Placement Moisture Content (%):	15.7	Placement Moisture Ratio (%):	101.5	Test Condition / Soaking Period:	Soaked / 4 Days	CBR Surcharge (kg)	6.8	Dry Density After Soak (t/m <sup>3</sup> ):	1.83	Total Curing Time (hrs)	44	Liquid Limit Method	Estimation	Moisture (top 30mm) After Soak (%):	22.2	Moisture (remainder) After Soak (%):	17.8	CBR Swell (%):	2.5	Minimum CBR Specification (%):	-	<b>CBR Value @ 2.5mm (%):</b>	<b>6</b>	<div style="text-align: center;"> <b>CBR PENETRATION PLOT</b> </div>

<table border="1" style="width: 100%; border-collapse: collapse; margin-top: 10px;"> <caption>Approximate Data Points from CBR Penetration Plot</caption> <thead> <tr> <th>Penetration (mm)</th> <th>Load (N)</th> </tr> </thead> <tbody> <tr><td>0</td><td>0</td></tr> <tr><td>0.5</td><td>300</td></tr> <tr><td>1.0</td><td>450</td></tr> <tr><td>1.5</td><td>550</td></tr> <tr><td>2.0</td><td>650</td></tr> <tr><td>2.5</td><td>700</td></tr> <tr><td>3.0</td><td>750</td></tr> <tr><td>4.0</td><td>850</td></tr> <tr><td>5.0</td><td>950</td></tr> <tr><td>6.0</td><td>1050</td></tr> <tr><td>7.0</td><td>1150</td></tr> <tr><td>8.0</td><td>1200</td></tr> <tr><td>10.0</td><td>1300</td></tr> <tr><td>12.5</td><td>1400</td></tr> </tbody> </table>	Penetration (mm)	Load (N)	0	0	0.5	300	1.0	450	1.5	550	2.0	650	2.5	700	3.0	750	4.0	850	5.0	950	6.0	1050	7.0	1150	8.0	1200	10.0	1300	12.5	1400
