WHITE BAY POWER STATION

CONSERVATION MANAGEMENT PLAN VOLUME III BUILDING FABRIC SURVEY (& Condition Report)

FINAL REPORT
SECOND EDITION JULY 2011
(Revised March 2013)

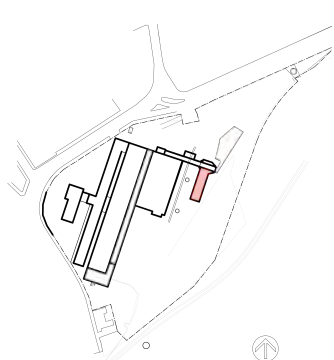
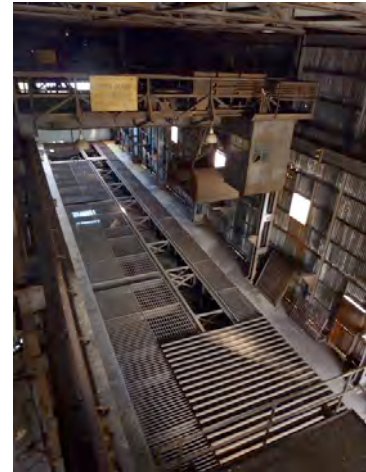
| Floor: | Concrete – seems in gd cndtn & sound Steel mesh - rusted & deformed in some sections, corroded, rails & walking in poor condition |
| Walls: | Structure seems gd Bases of some intermediate columns rusted thru W: corro iron punctured by random holes. Lower skirting level is breaking off – rusting out E: conc wall in gd condition – corro steel above appears to be recent & in gd condition S: lower corro steel recent – upper level rusted old corro steel |
| Ceiling: | Appears to have recent corro steel approx same age as E wall high section Trusses seem gd but rusted |
| Other: | Crane is rusted – mechanics appear to be intact |

| Other issues: | Birds nesting in crane Coal loader full of water Pits full of water – engineer Public safety: CHG.1 – should be sealed off only CHG.2 Entry outside- pallet of bricks, broken glass etc. |

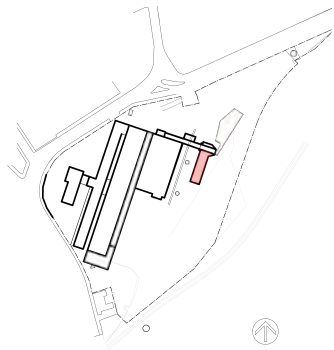
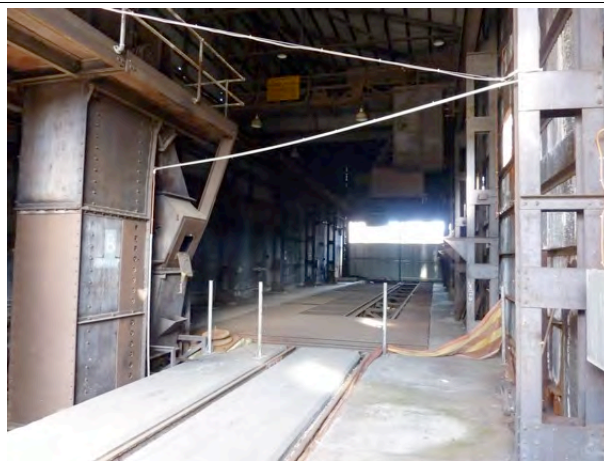
| Floor: | Looks to be in good & sound condition. Rail tracks and grates very rusted in some areas. |
| Walls: | Structure seems gd. Bases of some intermediate columns rusted thru. W: corro iron punctured by random holes. Lower skirting level is breaking off – rusting out N: corro iron on external face in need of replacement |
| Ceiling: | Appears to have recent corro steel approx same age as E wall high section Trusses seem gd but rusted |
| Door: | Ok, but rusting |

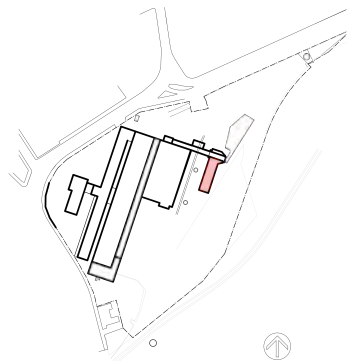
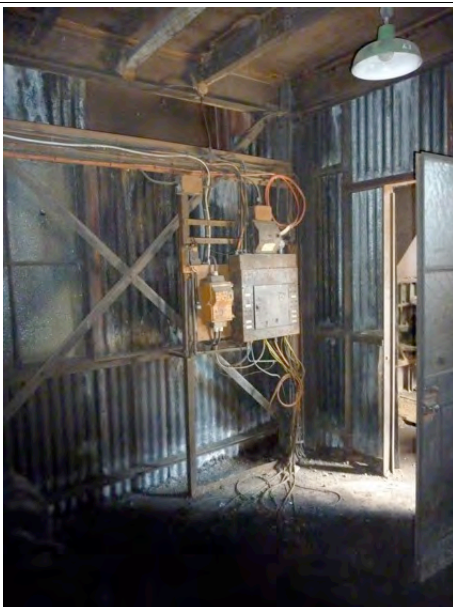
| Walls: | Reasonable. Beams rusted, some corrugated metal bent out of shape |
| Ceiling: | Some rust along beams |
| Doors: | Rusted but appears OK – bottom glass panel cracked |
| Windows: | Cracked glass |
| Other: | Switch boards: OK – some rust; Fuse box: OK; Rotary phone: OK; Generator: OK Pigeon damage |

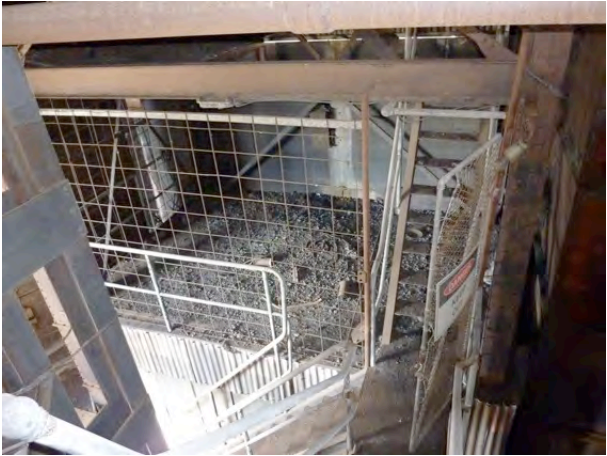
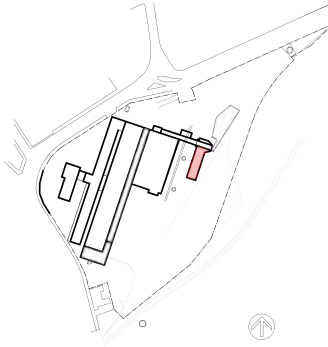
| Condition: | <p>Floor:</p> <p>Stair: Seems to be good. Looks sturdy no sign of rust severely eating away at load members. Paint on handrails appears to be red or white in some areas – spalling away. Coal & dirt build up on landing – will accelerate corrosion if not cleaned.</p> <p>Walls:</p> <p>Cornice:</p> <p>Ceiling:</p> <p>Doors:</p> <p>Windows:</p> <p>Other:</p> | | |

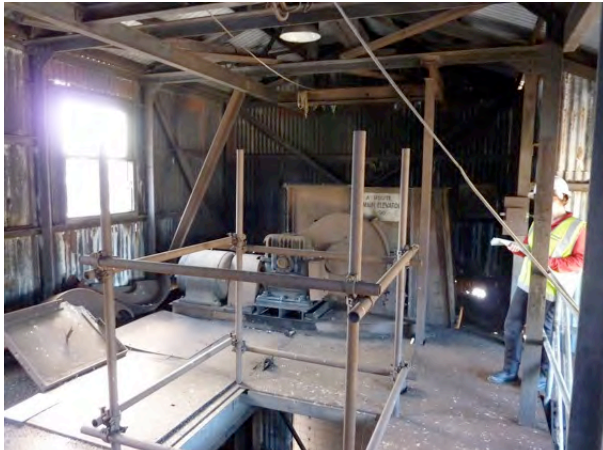
| Room/Item: | TOWER LEVEL 3 | Room reference: CH 3.1 |

| Floor: | Safe & sturdy, corrosion in some parts |
| Walls: | N: some holes W: sheet missing below window. Some holes in wall S: holes at lower level and corrosion E (S end): holes at lower level badly eroded |
| Ceiling: | SW corner: 1 sheet of steel missing |
| Windows: | E: Timbers rotted. Some sashes missing – only 1 pane W: 2 upper panes only. No bottom sashes. Timber deteriorated. |

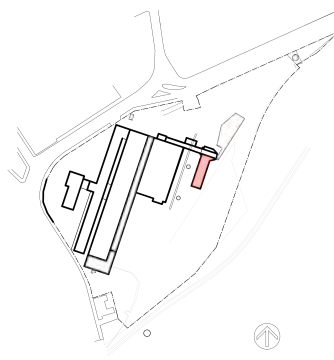
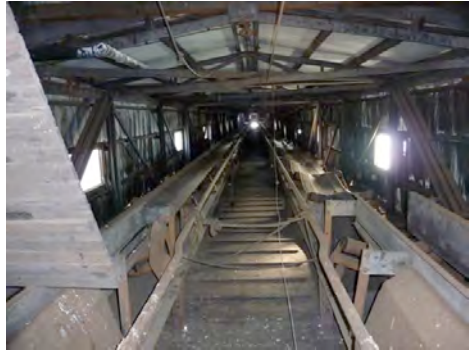
| Walls: | Poor. Rusted through in some places | |
| Windows: | 2 casements missing | |
| Other: | Conveyors: A - belt deteriorated; B - OK | |

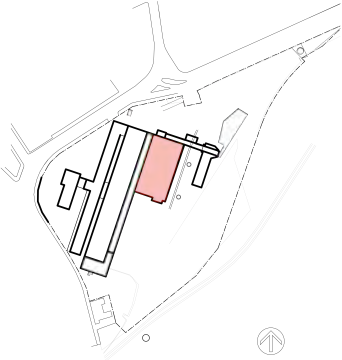
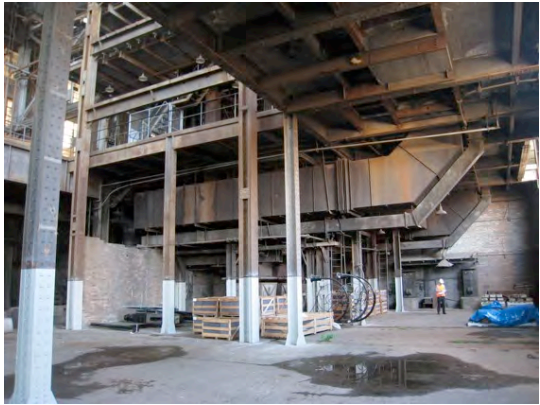
| <p>Floor:</p> <p>Skirting:</p> <p>Walls:</p> <p>Cornice:</p> <p>Ceiling:</p> <p>Doors:</p> <p>Windows:</p> <p>Other:</p> | <p>Concrete has some patches and less divots etc than other spaces.</p> <p>NA.</p> <p>Brick walls. E: Encased brick columns. Base of columns on north side have been replaced. Base of columns along east wall – concrete encased.</p> <p>NA</p> <p>Surface rust on steel beams - minor. Evidence of minor spalling. Holes look like punched through where they don't belong.</p> <p>E: Large central opening has punctured cor. iron.</p> | | |
| Base of steel columns have been repaired and painted. Bases are new and site welded c2008. | | | |

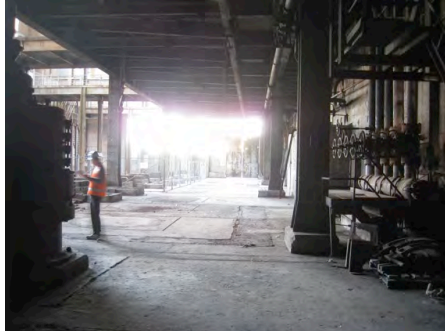
| Room/Item: | LOCATION OF NO.1 BOILER - GROUND | Room reference: | BH G.1B |

| Floor: | Cable tracks filled in - one remains covered by loose ply wood and metal. Plinth for pulverisers and other machines remain. Plinth for pulverisers is octagonal, otherwise removed from other areas (BH G.2, G.3, G.4B) | | |
| Walls: | <p>W: Punctured with conduits & pipes. Several brick infilled sections with non-matching bricks.</p> <p>E: Bricks very roughly laid and dotted with holes for conduits etc.</p> <p>South-most side part demolished.</p> <p>N: In good condition.</p> | | |
| Ceiling: | Minimal spalling. | | |
| Doors: | Early roll-a-door on east wall - repaired at base. | | |
| Other: | <p>Lift doors to enter lift, west elevation, is in damaged condition.</p> <p>All panels are rusted and very deteriorated.</p> <p>Lift car at bottom level - very rusty inside and not sitting at right level - steel retracting doors to car.</p> | | |

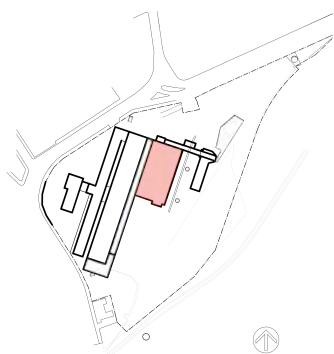
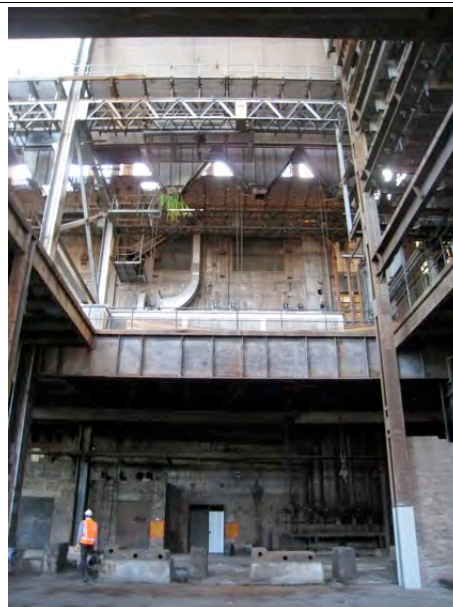
- Floor:** Patched in with roughly poured concrete. Generally no cracking; however, poor appearance.
- Skirting:**
- Walls:** W: Ok, Various punctures through walls with cables, pipes, conduits.
- Cornice:**
- Ceiling:** Steel structure appears fine. No rust. Some holes in concrete but no spalling. Hoppers rusting badly.
- Doors:** W: Both doors in good condition
- Windows:**
- Other:**

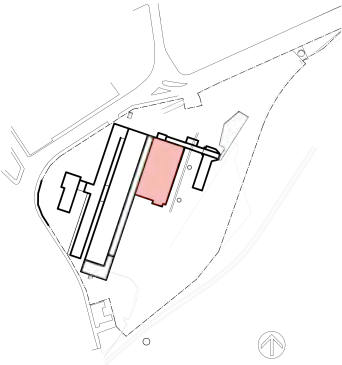
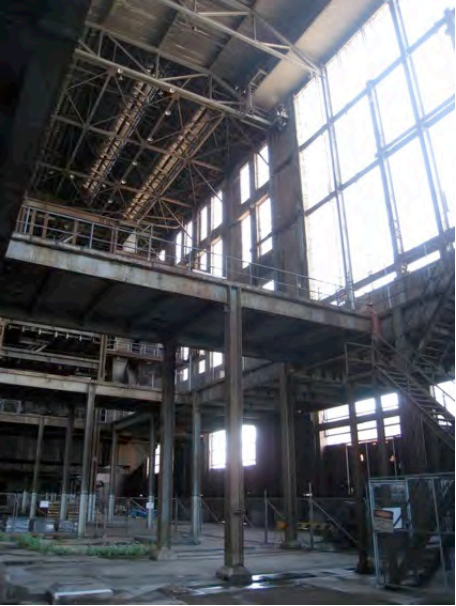
| Ceiling: | See BH G.4A. Formwork used on concrete above changes on N side. S side of building has later sheet formwork. N side has boards used as formwork and appears to be much earlier. Water leaking from ceiling (clear day outside). |

| Floor: | Central raised section on concrete has broken on E and N sides. Other sections of floor, see BH G.4A. Some cable trays covered with steel or plywood or concrete filled in. |
| Walls: | E: columns appear to be in good condition. Cleats and fixings appear to be removed. One column on east wall is encased in concrete at its base – recent repair work. |
| Ceiling: | See BH G.4A. Spalling concrete. |

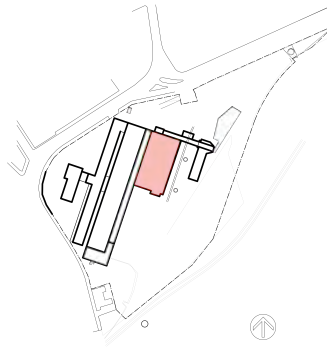
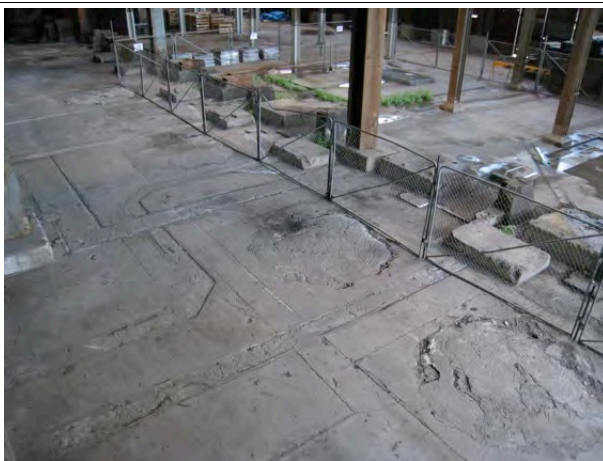
| <p>Condition:</p> <p>Floor: See BH G.4B.</p> <p>Skirting:</p> <p>Walls: Many more holes in wall at higher level than BH G.4A. Each hole is average 300mmx300mm linking into pump room. I-beams at plinth level have been cut - possible earlier floor level.</p> <p>Cornice: -</p> <p>Ceiling: See BH G.4B.</p> <p>Doors: Recent door poorly constructed. Boarded door ledged and braced seems to be original, in good condition.</p> <p>Windows:</p> <p>Other:</p> | |

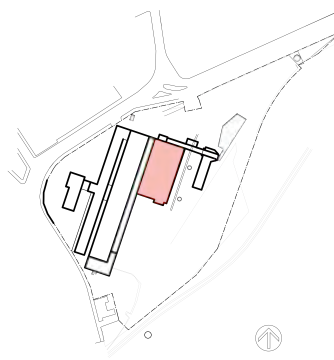
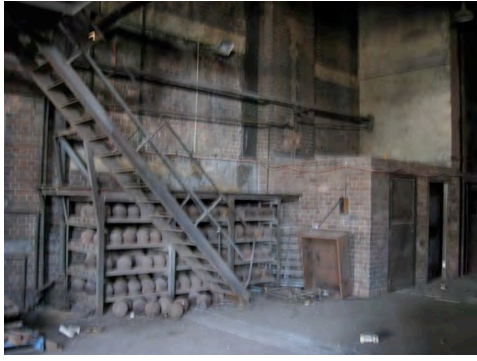
| Room/Item: | "NO. 2 AUX TRANS BOILER HOUSE" | Room reference: | BH G.8 |

| Condition: | <p>Floor: OK.</p> <p>Skirting: -</p> <p>Walls: OK.</p> <p>Cornice: -</p> <p>Ceiling: OK.</p> <p>Doors: Keeper missing. Door slightly damaged.</p> <p>Windows:</p> <p>Other:</p> |

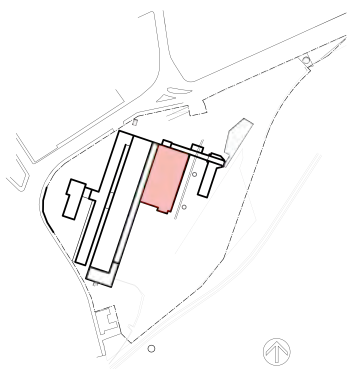
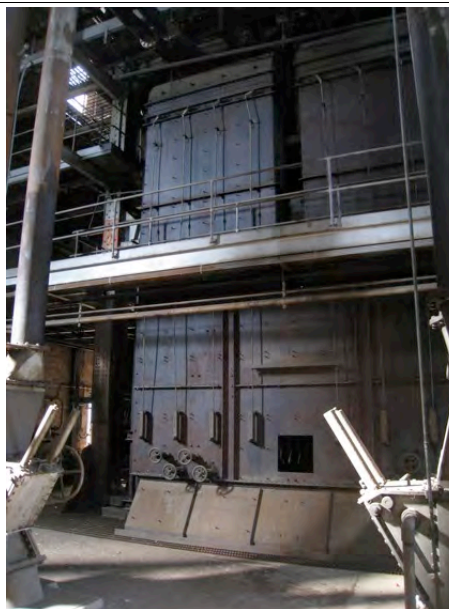
- Floor: OK.
- Skirting: -
- Walls: OK.
- Cornice: -
- Ceiling: -
- Doors: Door to lift shaft in better condition to that in BH G. 1a.
- Windows: W: 50% missing on west wall.
- Other: Steel work for platforms, ladders and stairs are increasingly being corroded due to water damage. All steelwork requires treatment and possible painting to ensure its further survival.
WC block: brick walls OK, no ceiling. Partition wall damaged (U/S).

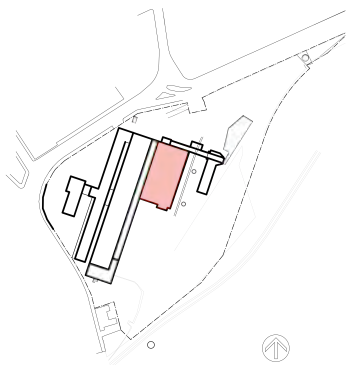
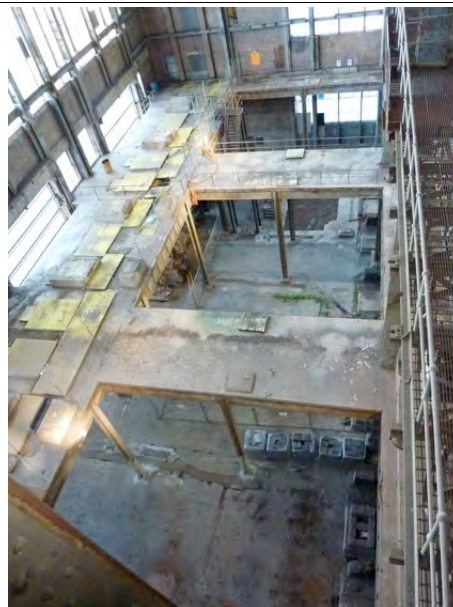
- Floor:** Plywood panels over void areas are a safety hazard. Floor on each side spalling underneath.
- Skirting:**
- Walls:** OK.
- Cornice:** -
- Ceiling:** Rusting.
- Doors:**
- Windows:** Approximately 30% of the panes are missing or damaged – some steel glazing bars missing.
- Other:**

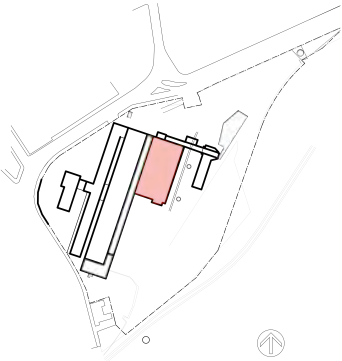
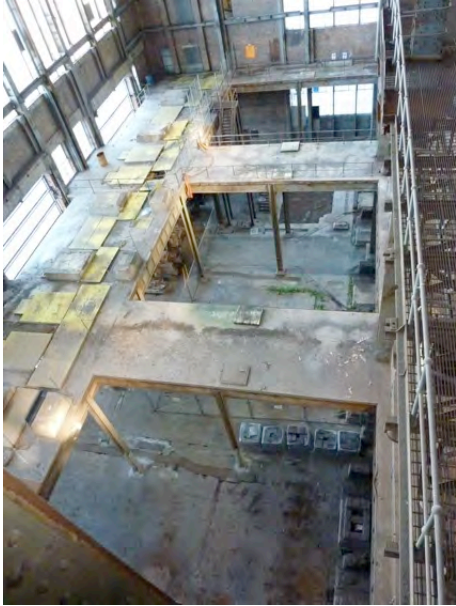
| Floor: | Plywood panels over void areas are a safety hazard. Floor on east side spalling underneath. |
| Ceiling: | Rusting |
| Windows: | Higher level windows generally OK – approximately 10% damaged. Some operable steel sashes (less than approximately 5% of total glass wall) off their hinges. |

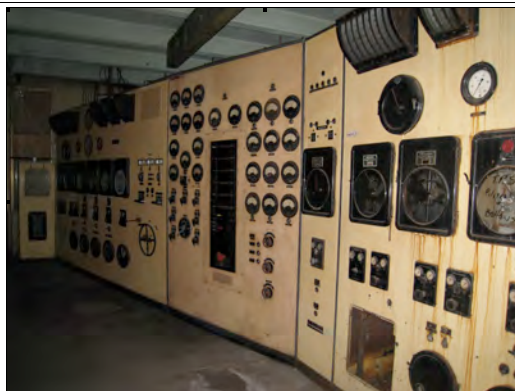
- Floor:** OK.
- Skirting:** -
- Walls:** OK. Carefully made purpose made light fittings set into structural bay – along east wall.
- Ceiling:** OK. Ducted ventilation system of air conditioning system.
- Doors:** E: North missing knob set & lock; South missing mortise lock.
W: Glazing missing.
- Windows:** N, S: Middle portion glass & frame missing.
E: Middle bay glazing - glass cut out of middle portion. 2 panels cracked. Fully glazed, boarded on outside.
- Other:** Control Board - some enamel cracking.
Timber cupboards - OK. Meters for boilers 2, 3 and 4 removed, but kept in place for soiler 1.

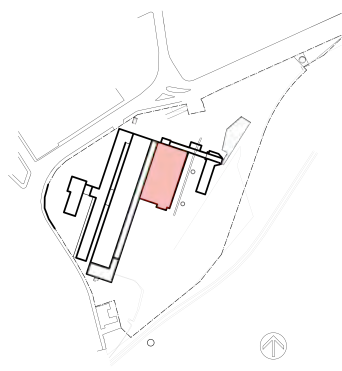
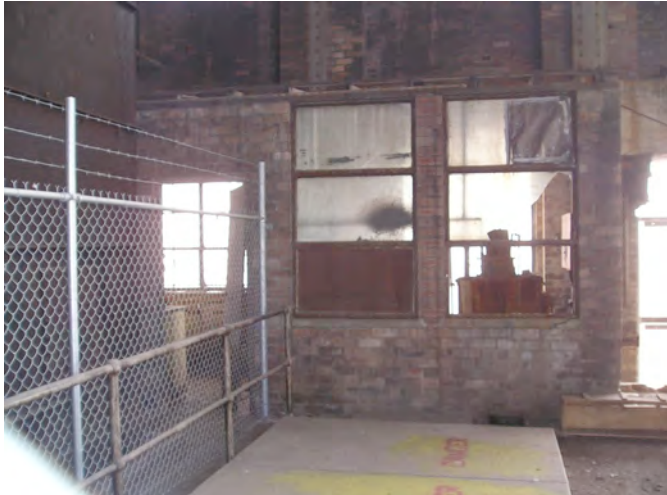
| Ceiling: | Missing. |
| Windows: | W wall: 4 missing, 3 broken. E wall: 10 cracked. |

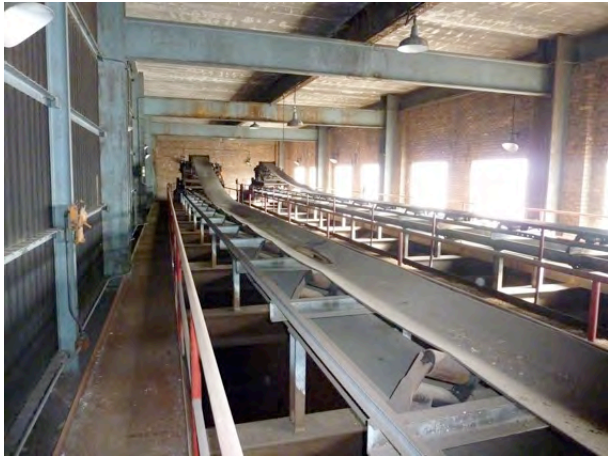
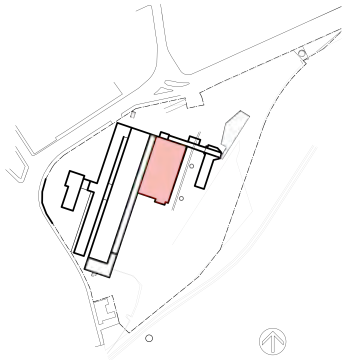
| Floor: | Floor in central spine looks deteriorated - poor condition. Side floor looks good. Very dirty. | | |
| Skirting: | Rusted in parts. | | |
| Walls: | All looks in good condition. E: Paint peeling. | | |
| Ceiling: | Concrete shows evidence of water ingress at joins. Stalactites if salt in places. No spalling. Central beam looks rusted & paint peeling. | | |
| Windows: | Some smashed & filled in. Most panes are in good condition - no cracks. | | |
| Other issues: | Conveyor machines at this end. Belt and rollers appear in reasonable condition – (not broken) – just surface rust and dirt. | | |

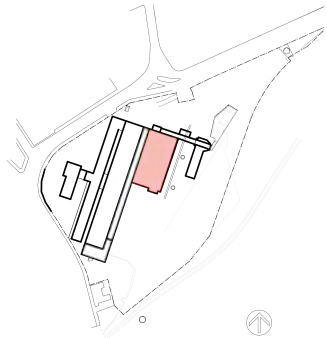
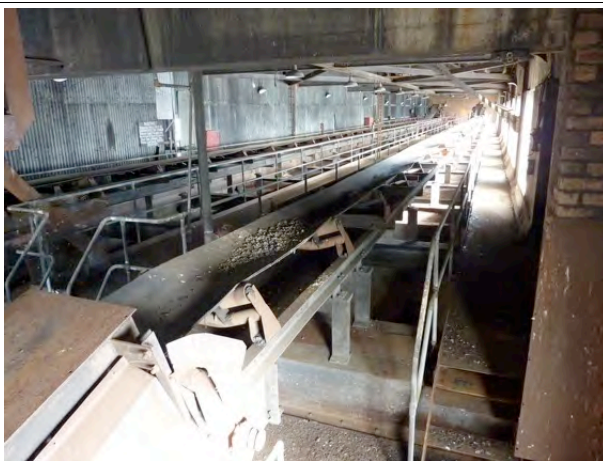
Floor: W: Badly rusted. Central spine - dirt on floor, rusted in parts. Strong enough to support weight. Good condition.
E: Ok

Ceiling: No holes. Good condition. Some rust.

Windows: Some panes cracked. All windows remain.

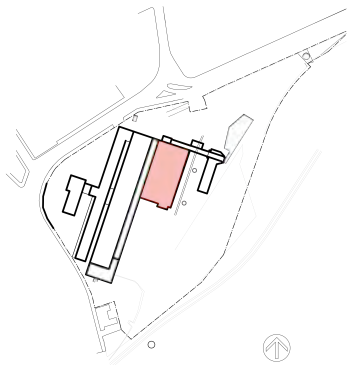
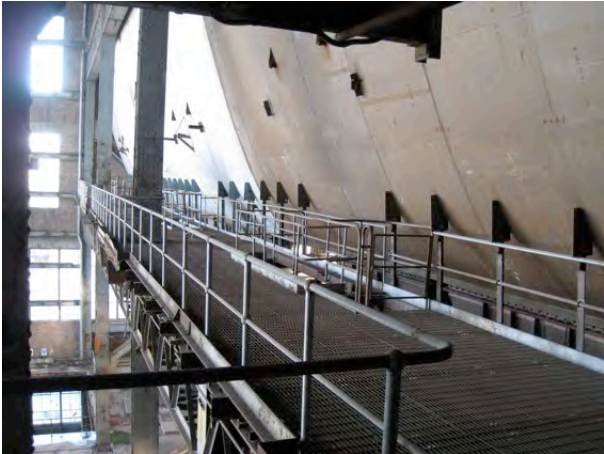
| Floor: | Appears to be OK but all with surface rust – thorough review of all panels may need to be carried out to ensure safety. Southern side appears much worse – against west wall – poor condition. Corrugated metal pitted and rusted at various locations. Water ingress. | | |
| Ceiling: | Spalling to concrete evident. Also See Volume IV - Structural condition survey | | |
| Windows: | Over 50% damaged. Bottom windows boarded up on outside. | | |
| Other issues: | Higher level clerestory windows missing. | | |

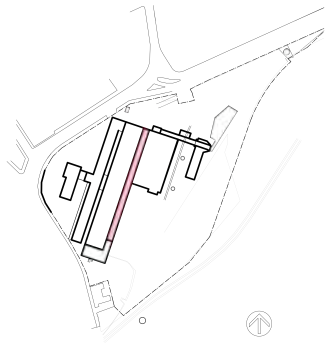
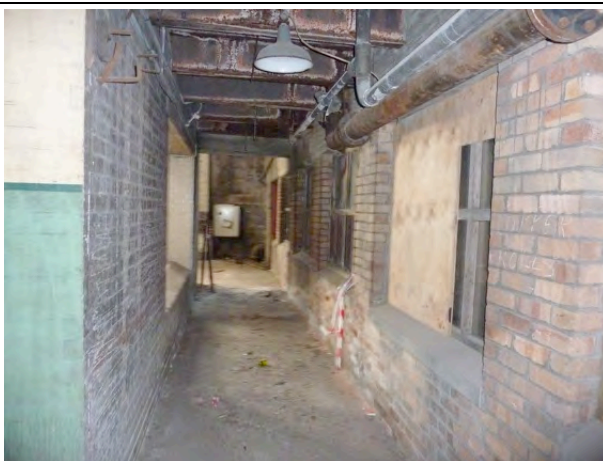
| Floor: | Steel plates rusting Concrete in good condition - patching evident. |
| Ceiling: | PH G.1A: Some steel beams are very corroded. Concrete slab is also very corroded & spalling. |

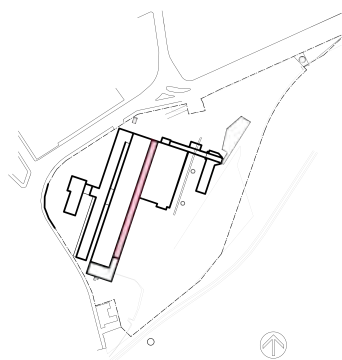
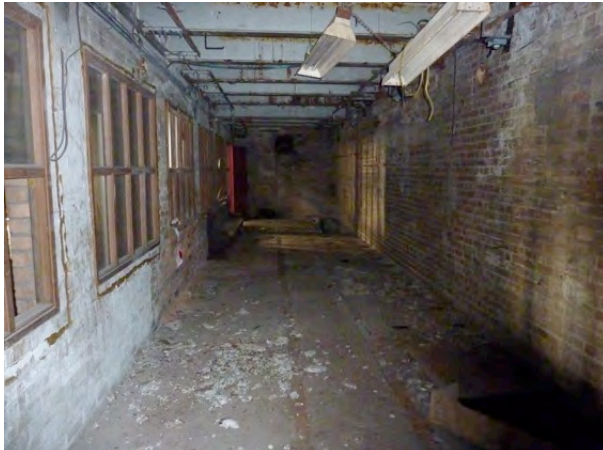
| <p>Condition:</p> <p>Floor: Some steel grates are missing - steel track is corroded - concrete generally in reasonable condition.</p> <p>Skirting:</p> <p>Walls: Messy brickwork. Otherwise, good.</p> <p>Cornice:</p> <p>Ceiling: All steel beams have rust and corrosion. 1 beam appears severe. Concrete slab has severe corrosion. Concrete below mesh has spalled away on several panels - severe salt attack.</p> <p>Doors:</p> <p>Windows: All windows on N side of W wall have been smashed-in glass over floor. Windows on S side of W wall good.</p> <p>Other:</p> | | |

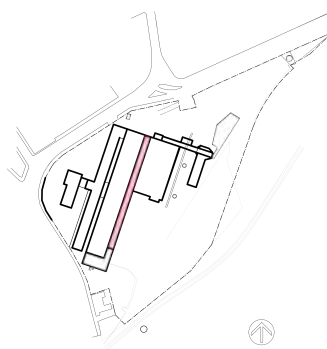
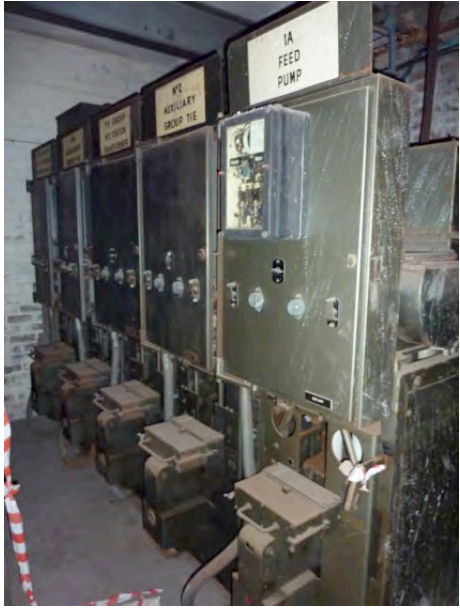
| Room/Item: GROUND FLOOR - ROOM | | Room reference: PH G.3 |

| Floor: | Good. Some steel panels over pit are missing. | |

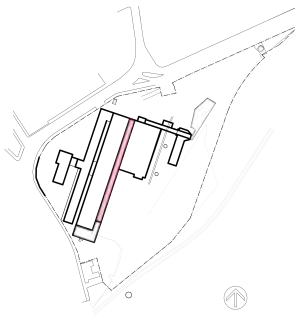
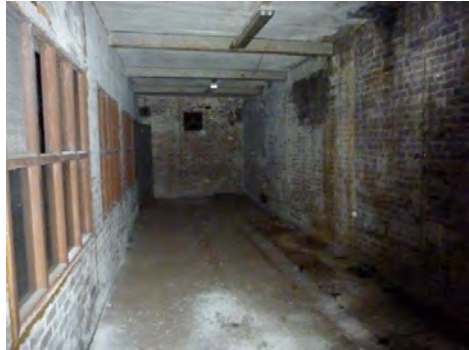
| Room/Item: GROUND FLOOR - ROOM | | Room reference: PH G.4 |

| Condition: | <p>Floor: Concrete- good. Steel sheets have various holes for machinery parts to drop down.</p> <p>Skirting:</p> <p>Walls: Ok E: holes at ceiling from removed services, evidence of corrosion.</p> <p>Cornice:</p> <p>Ceiling: Some beams have moderate rust. Not as bad as PH G.2.</p> <p>Doors: Doors are in good condition.</p> <p>Windows: W: Some windows are smashed and boarded. Most windows are intact.</p> <p>Other:</p> |

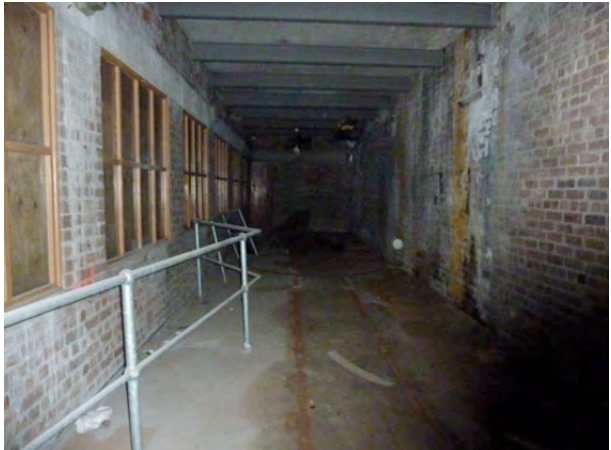
| Condition: | <p>Floor: Concrete- good. All steel sheets intact.</p> <p>Skirting:</p> <p>Walls: Good. Messy brickwork on all sides.</p> <p>Cornice:</p> <p>Ceiling: Some beams have moderate rust. Not as bad as PH G.2.</p> <p>Doors: Doors are in good condition.</p> <p>Windows: W: Some windows are smashed and boarded. Most windows are intact.</p> <p>Other:</p> |

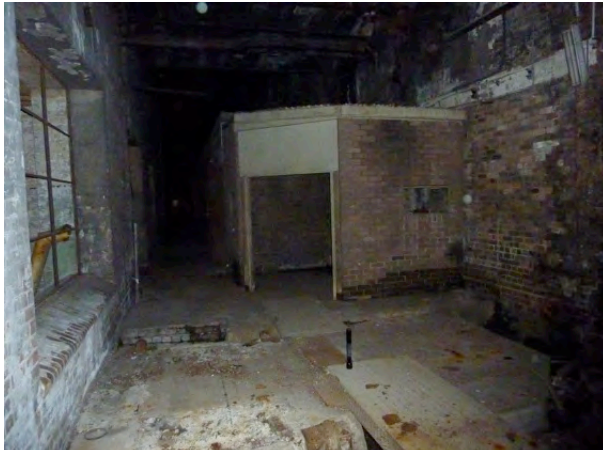
| Room/Item: GROUND FLOOR - ROOM | | Room reference: PH G.6 |

| Ceiling: | Rusted, water damage | |
| Doors: | Collapsed and lying on floor. Being used to bridge pits in adjacent floors, getting damaged. | |
| Windows: | Glass missing | |

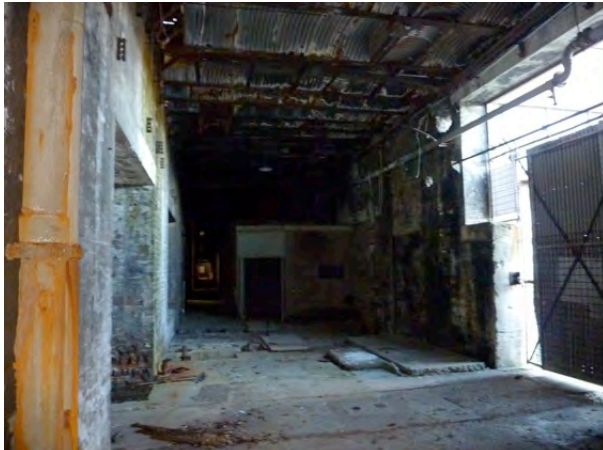
| Room/Item: GROUND FLOOR - ROOM | | Room reference: PH G.7 |

| Condition: | <p>Floor: Ev. Of equipment removed. Pits exposed (not covered)</p> <p>Skirting: -</p> <p>Walls: E: Water damage. Paint flaked off.</p> <p>Cornice: -</p> <p>Ceiling: Rusting beams. Rusting corrugated.</p> <p>Doors: Heath Robinson.</p> <p>Windows: No glazing. Surface rust on steel, otherwise frame is good.</p> <p>Other:</p> |

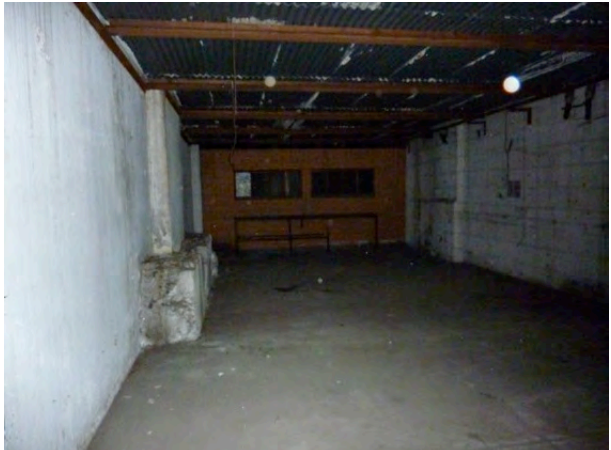
| Walls: | Stainless steel partition wall corroded at base |
| Ceiling: | Water damage, rusted corrugated sheets |

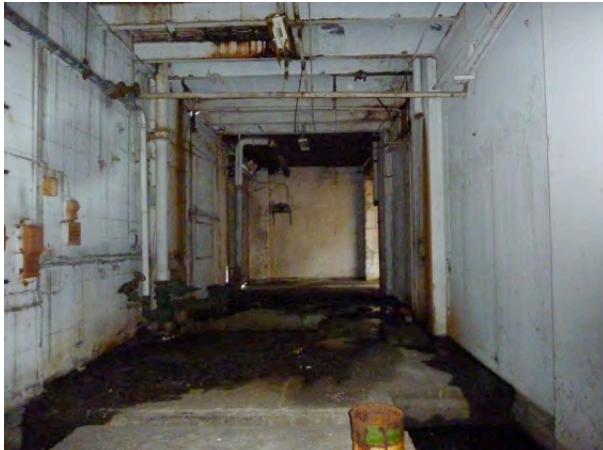
| Condition: Floor: OK. Pits and worn concrete as shown on plan. Very wet at S wall. Skirting: - Walls: OK. Multitude of redundant fixings on E wall and some on W wall. Cornice: - Ceiling: Corroded steel. Water damaged concrete infill sections. Doors: OK. Windows: - Other: | | |

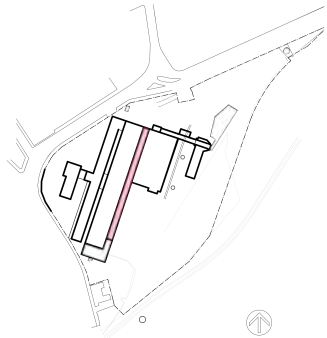
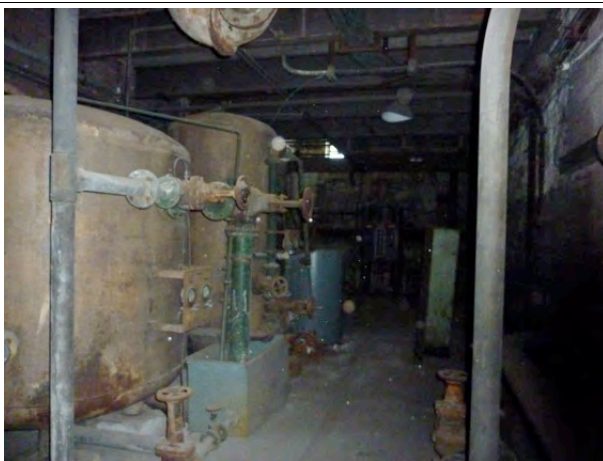
| <p>Condition:</p> <p>Floor: Good, but corroded underneath – see inventory PHG.2</p> <p>Skirting:</p> <p>Walls: Holes - brick patching. Conduits and pipes attached.</p> <p>Cornice:</p> <p>Ceiling: Good. Some holes poorly cut through to pass conduits down from the upper level.</p> <p>Doors:</p> <p>Windows:</p> <p>Other: Sections of balustrading missing. Bridges linking Ph 1.1A-1.1B are dangerous. Machinery including large liquid tanks are still in place.</p> | |

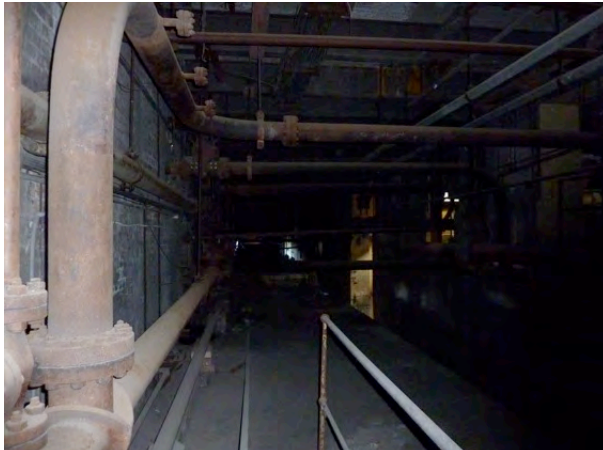
| <p>Building/Space: PUMP HOUSE</p> <p>Room/Item: LEVEL 1 - ROOF</p> <p>Construction date: 1952</p> | <p>Surveyor: 2002: Robert Gasparini 2010: Robert Gasparini</p> | <p>Room reference: 1.2A-1.2B</p> <p>Survey date: 19.08.10</p> |

| <p>Condition:</p> <p>Floor: Good.</p> <p>Skirting:</p> <p>Walls: Very messy. E: I-beams are cut. - Many holes through to Boiler House. - Many iron spikes. W: Many holes and recesses cut into wall. - Line of I-beams cut. PH 1-2.A: One large opening allowing pipes and other equipment to pass through into turbine hall. Brick wall above plinth line appears to be a later date than the bricks below plinth.</p> <p>Cornice:</p> <p>Ceiling: Some spalling. Beams look to be in good condition.</p> <p>Doors: N/A.</p> <p>Windows: N/A.</p> <p>Other:</p> | | |

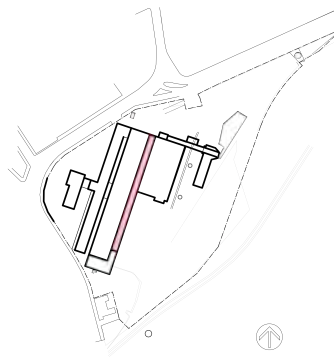
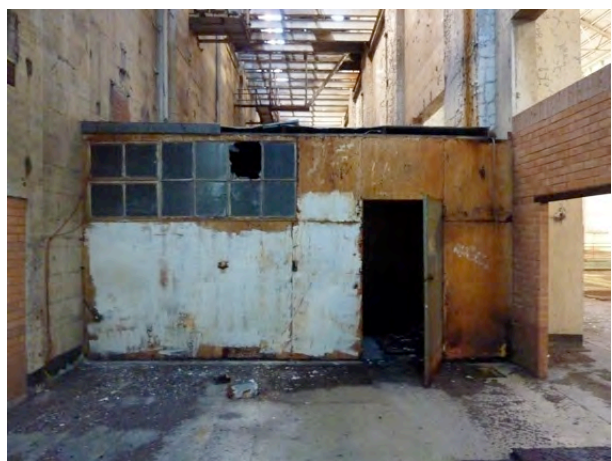
| Floor: | OK. Water damage. | | |
| Walls: | Peeling paint. Water damage. Some damp. | | |
| Windows: | Internal only 1 broken. External 7 missing, 16 broken. | | |
| Other: | Timber & metal clad workbench: rusting. | | |

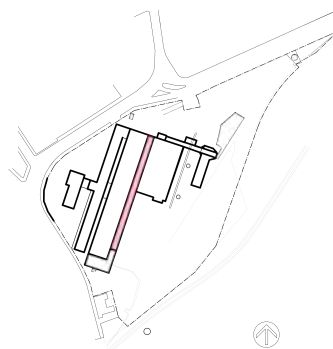
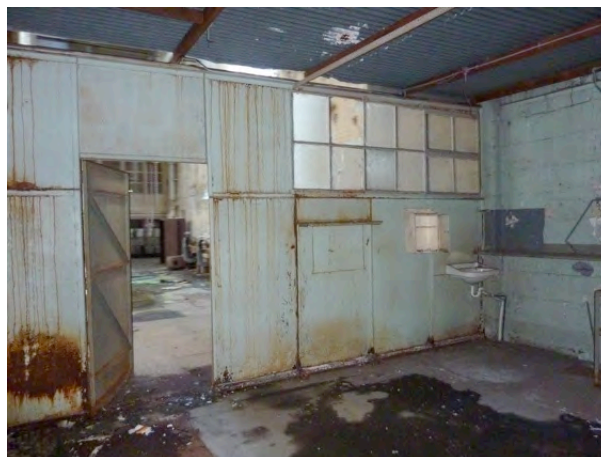
- Floor: OK.
- Skirting: -
- Walls: Peeling paint, damp.
- Cornice: -
- Ceiling: OK. Rusting beams.
- Doors: OK.
- Windows: 3 broken.
- Other: Bench rusting.

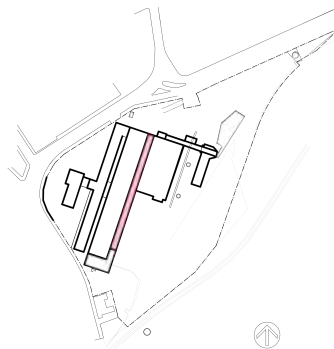
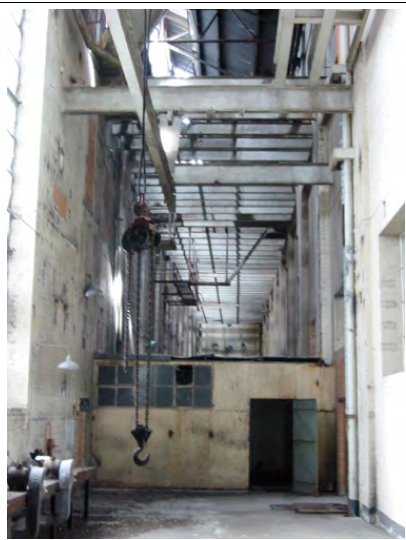
| Room/Item: LEVEL 2 - ROOM | | Room reference: PH 2.4 |

| Windows: One pane broken. | | |
| Other: Framed and sheeted S wall rusting. The rest OK. | | |

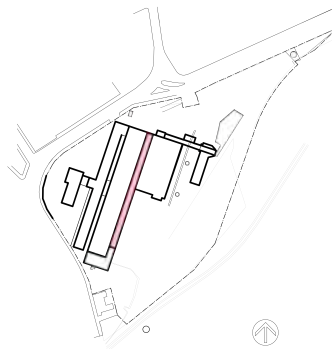
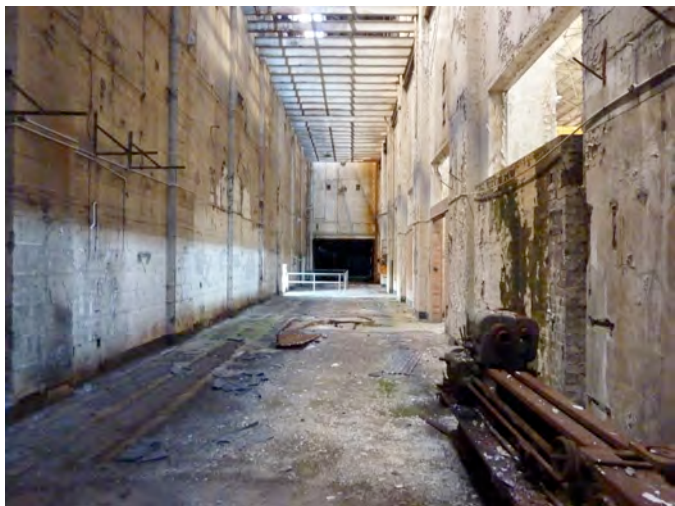
| Room/Item: LEVEL 2 - SPACE | | Room reference: PH 2.5 | |

| Floor: Concrete failing in places. Timber planking over void dangerous. | | | |
| Doors: Missing. | | | |
| Windows: Mid: 12 broken. S: 6 broken. | | | |

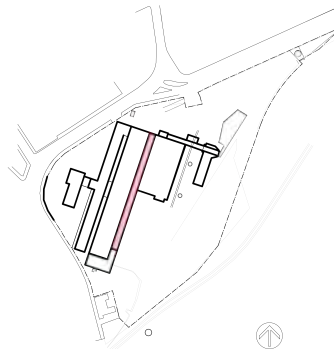
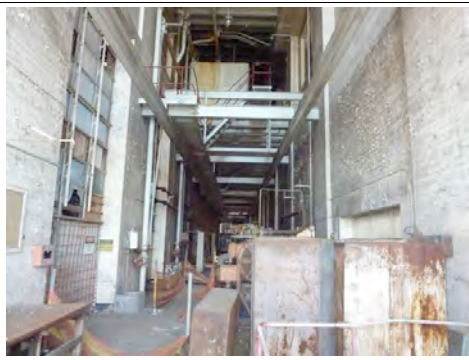
| <p>Building/Space: PUMP HOUSE</p> <p>Room/Item: LEVEL 3 - PUMPS</p> <p>Construction date: 1952</p> | <p>Surveyor: 2002: Stephen Couling 2010: Robert Gasparini/ Nina Pollock</p> | <p>Room reference: PH 3.1</p> <p>Survey date: 12.9.02</p> |

| <p>Condition:</p> <p>Floor: Steel plates rusting</p> <p>Skirting:</p> <p>Walls: OK. N wall: damp & water damage. E/W: Paint peeling.</p> <p>Cornice: -</p> <p>Ceiling: -</p> <p>Doors:</p> <p>Windows: N of E wall: Many missing. Most damaged. N: OK except lower 2 rows: damaged or missing.</p> <p>Other:</p> | | |

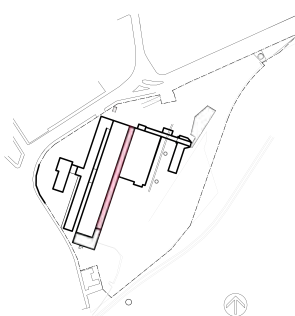
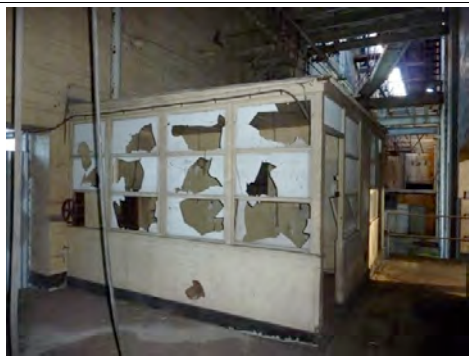
| Condition: | <p>Floor: OK.</p> <p>Skirting:</p> <p>Walls: Mouldy, holes</p> <p>Cornice:</p> <p>Ceiling: Mouldy, holes</p> <p>Doors: External missing. Internal runner missing</p> <p>Windows: 3.2 N: All broken. 3.3 S: All OK.</p> <p>Other:</p> |

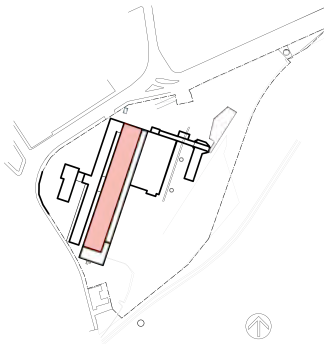
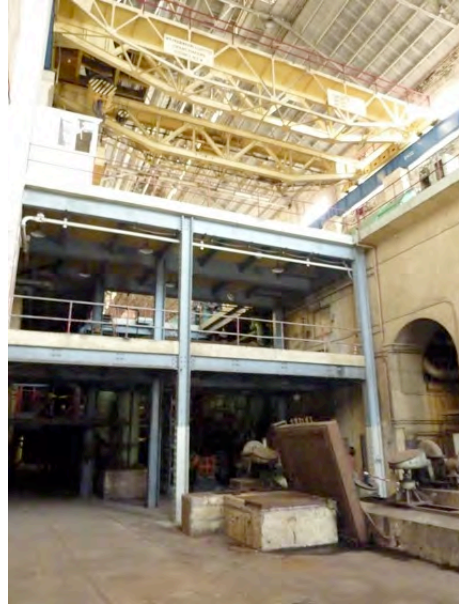
- Floor:** OK.
- Skirting:** Very damaged - worn - damp etc.
- Walls:** OK. Paint peeling revealing tiles above roller doors.
- Cornice:** -
- Ceiling:** OK.
- Doors:** OK.
- Windows:** OK.
- Other:** Equipment still present.

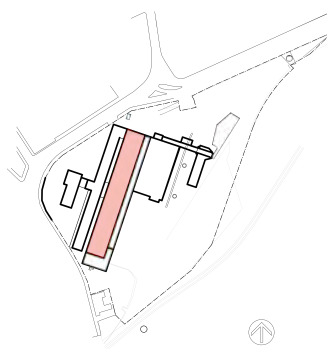
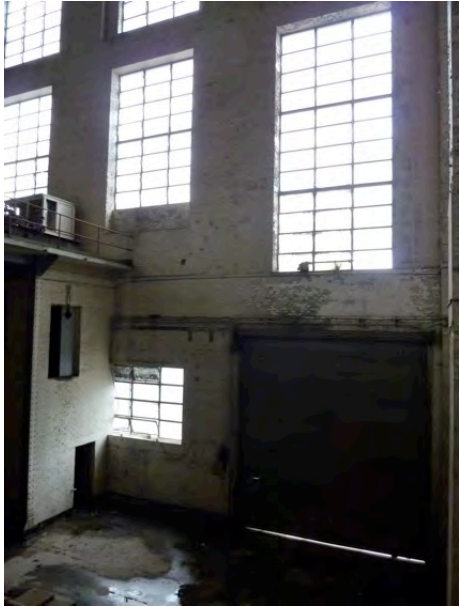
| Room/Item: SPACE | | Room reference: TH G.A.2 |

| Condition: | <p>Floor: Ok.</p> <p>Skirting: -</p> <p>Walls: OK.</p> <p>Cornice: -</p> <p>Ceiling: OK.</p> <p>Doors: OK.</p> <p>Windows: OK.</p> <p>Other:</p> | |

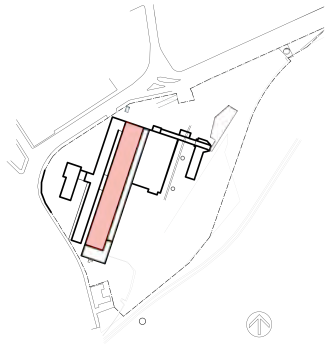
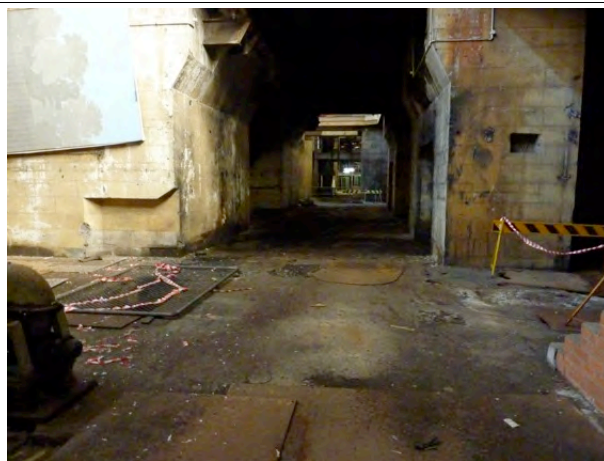
| Skirting: Poor to missing. | | | |
| Ceiling: Rusting girders. Water damage. | | | |
| Windows: One with missing glass. | | | |

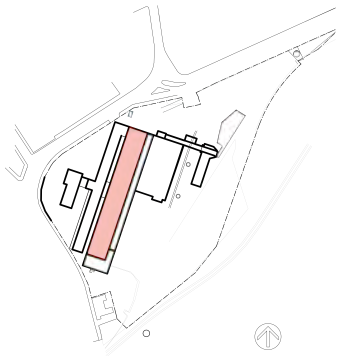
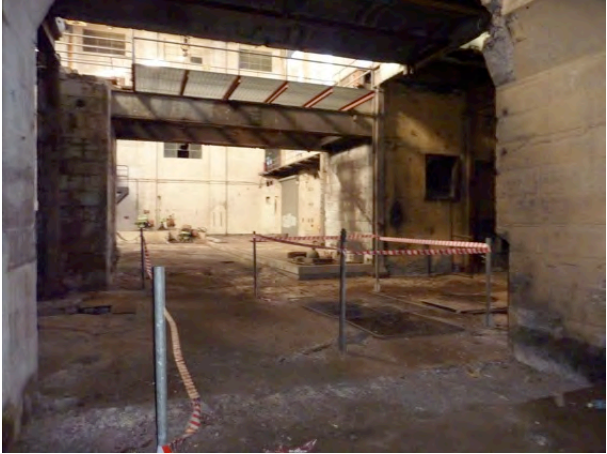
| Skirting: | Poor to missing. | |
| Walls: | Badly damaged but sound. Paint peeling. Water damage especially on E side. | |
| Ceiling: | Some rust on girders. | |

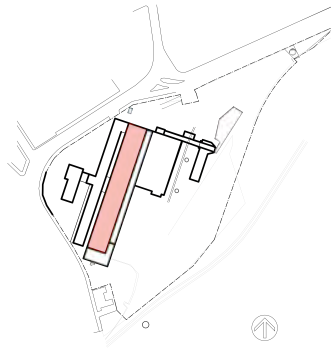
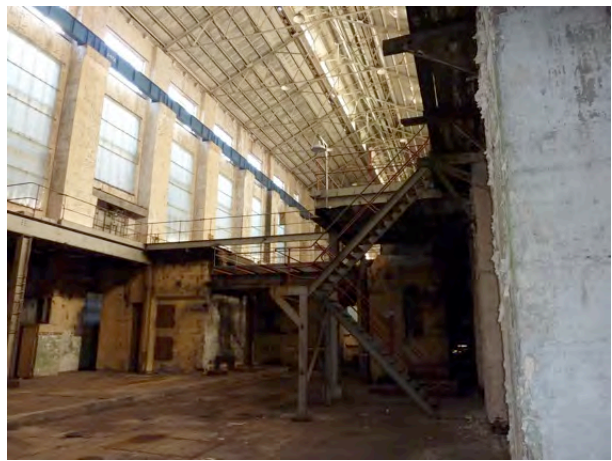
| Room/Item: GROUND FLOOR | | Room reference: TH G.E.1 |

| Skirting: | Poor to missing. | |
| Windows: | Missing. | |

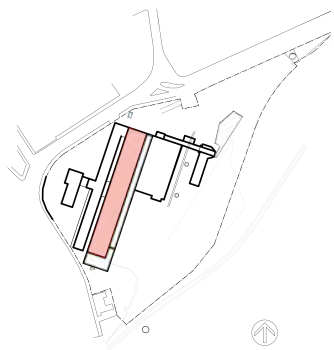
Walls: E: Very messy brickwork & concrete patching.
N: Balustrading is loose.
W: Some conduits are still on wall while others are missing. - Large opening made in wall covered by steel sheet at low level.

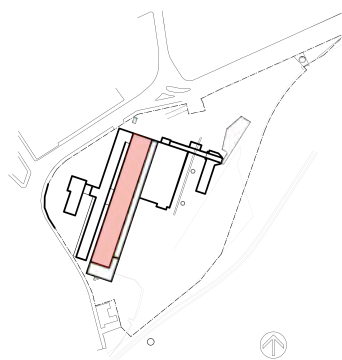
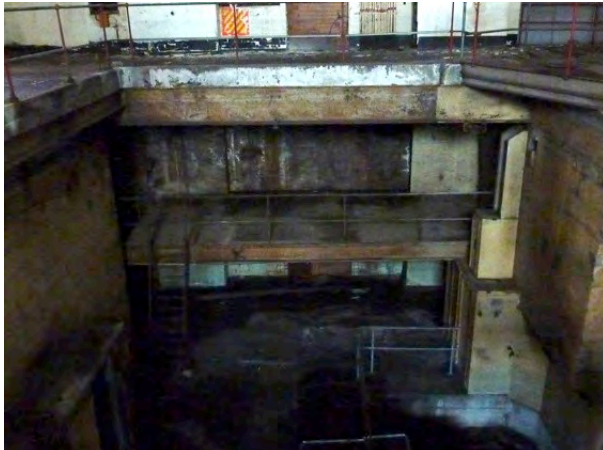
| Room/Item: LEVEL 1 - MEZZANINE | | Survey date: 19.08.10 | |

| Walls: | Dirty and punctured. N/S: Balustrading poor condition. Cracking in some areas of concrete where balustrade tied. |

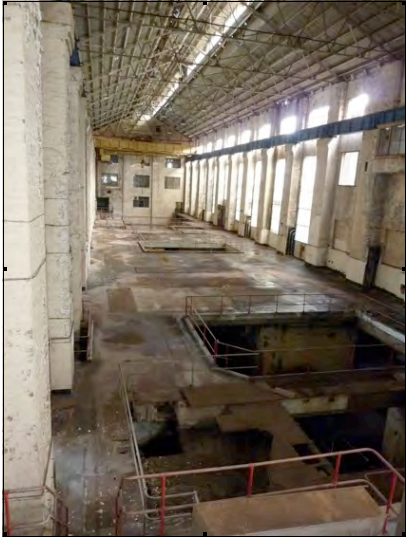
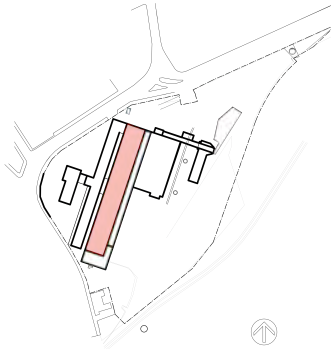
| Room/Item: | LEVEL 2 | | Room reference: TH 2 C.1 |

| Floor: | Steel plates rusting through, water on floor | | |
| Walls: | o.k. - paint peeling & flaking. W wall water damage upr level | | |
| Ceiling: | trusses o.k. - corro rusted with water ingress | | |
| Windows: | <p>E: upr 3 panes missing, lwr 1 pane broken;</p> <p>W: bay window 4 broken</p> | | |

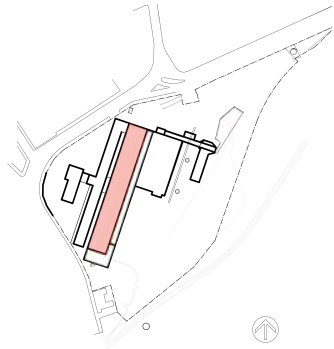
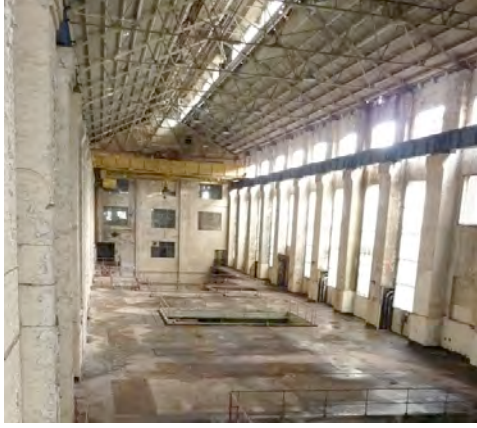
| Floor: | o.k., water present, steel plates rusting |
| Walls: | paint peeling & flaking, water damage |
| Ceiling: | trusses o.k. – corro rusted, open to weather |
| Windows: | E: some panes broken W: Lwr – missing. Upr – o.k., 1 pane in bay window broken |

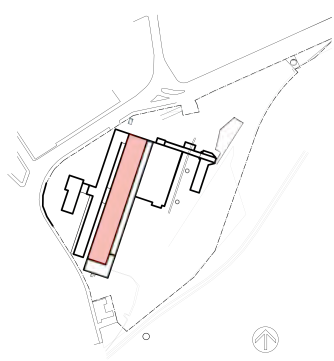
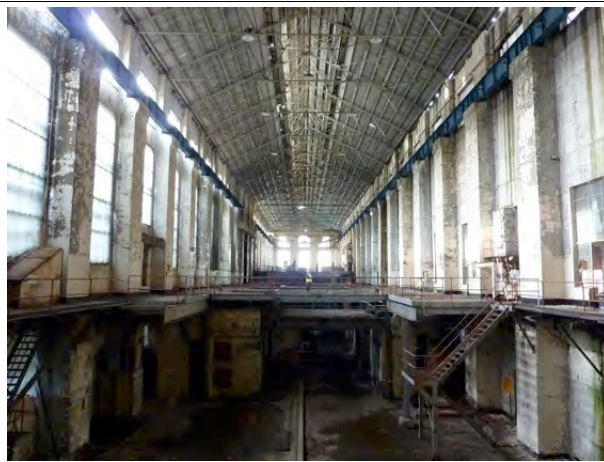
| Room/Item: LEVEL 2 | | Survey date: 06.08.10 | |

| Floor: | Timber rotted away. Unsafe to walk upon. Severe water damage beyond repair. |
| Walls: | All water damaged- paint peeling & flaking. |
| Ceiling: | trusses o.k., corrugated steel rusting & water penetrating through |
| Doors: | Steel door boarded shut, rusting through. |
| Windows: | <p>E upr: some panes broken. E lwr: N1 bay – 10 panes broken N3: 4 panes missing</p> <p>W: Upper ok, lower not visible under polycarbonate</p> <p>S: See N walls to administration rooms</p> |

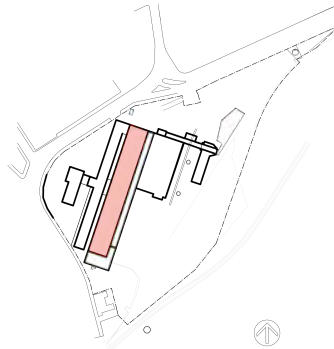
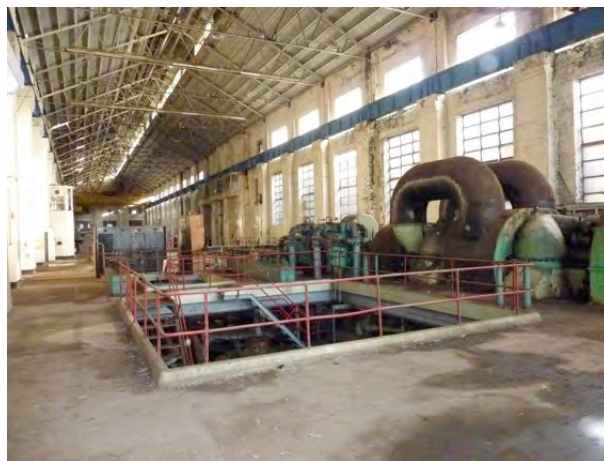
| Room/Item: | LEVEL 3 | | Surveyor: | Nina Pollock | Survey date: | 06.08.10 |

| Walls: | o.k. – paint peeling & flaking. Water damage and vegetation on W wall |
| Ceiling: | trusses o.k. – corro sheeting failing in places, holes and loose |
| Windows: | 50% cracked, 5 missing, several with holes |
| Other: | Sentry boxes – both fair condition. Glazing missing. Not tested for mobility. |

| Other issues: | Refer to machinery – water leaking onto turbine. Water on floor – ev. of leaking roof |

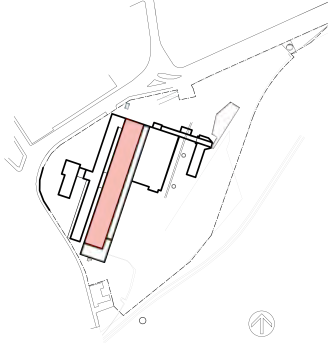
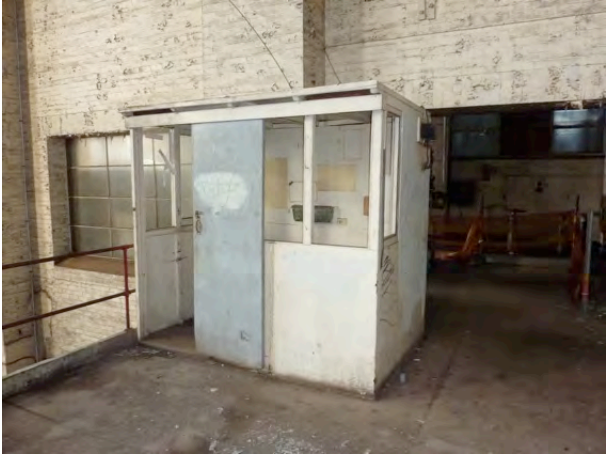
| Windows: | missing | |
| Other: | Cupboards internally in poor condition | |

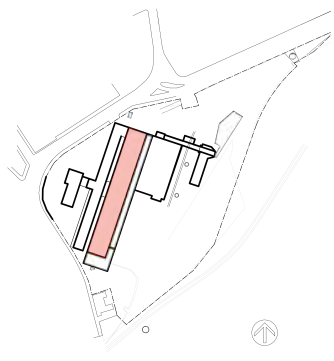
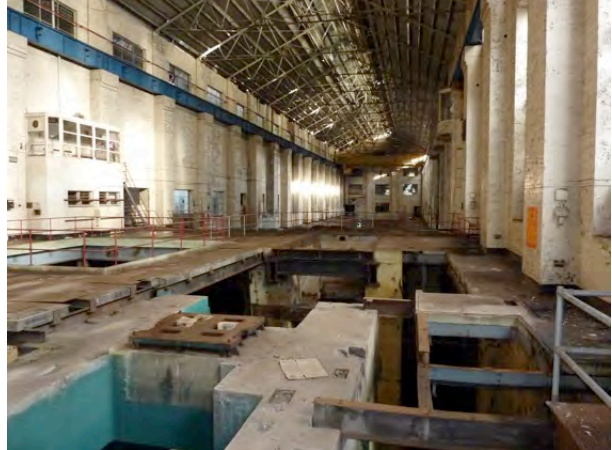
| Room/Item: LEVEL 3 | | Survey date: 30.07.10 | |

| Ceiling: | trusses o.k. – corro. o.k. |
| Windows: | E: upper o.k.; W: upper o.k., lwr 1 missing, 20 cracked |
