WHITE BAY POWER STATION

CONSERVATION MANAGEMENT PLAN VOLUME III BUILDING FABRIC SURVEY (& Condition Report)

FINAL REPORT
SECOND EDITION JULY 2011
(Revised March 2013)

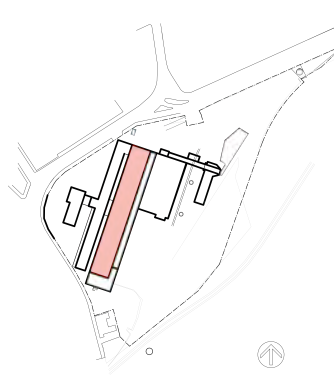
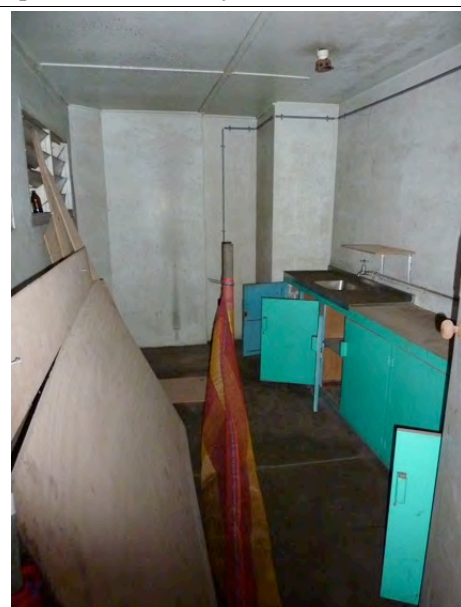
| Room/Item: CONTROL ROOM LOWER | Room reference: TH 3 B.2 | |

| <p>Condition:</p> <p>Floor: ok</p> <p>Stair:</p> <p>Walls: ok</p> <p>Cornice:</p> <p>Ceiling: ok</p> <p>Doors: ok. Shutter missing on hatch</p> <p>Windows: 4 louvres missing – all glass on upper level smashed</p> <p>Other: Cabinetry inside in fair – poor condition</p> | |

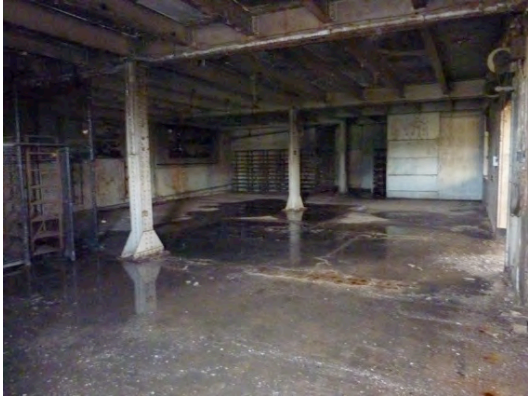
| Floor: | Good - some cracking – surface water. |
| Walls: | Good - paint spalling on all walls. N: Failed sections of render. |
| Ceiling: | Most beams have evidence of water damage and corrosion. Worst at E end and along N wall and SE corner. |
| Windows: | E: Fanlight windows are smashed. Other window is bricked up from outside, window frame and glass remain - many broken. S: All windows blocked up from the outside, glass panes have been painted and flaking off - most glass is cracked, all remain. N: 2 out of 8 panes are broken. One sash taken up by exhaust fan. |
| Other issues: Some corrosion at base of columns – water damage. Evidence of fire at E wall. | |

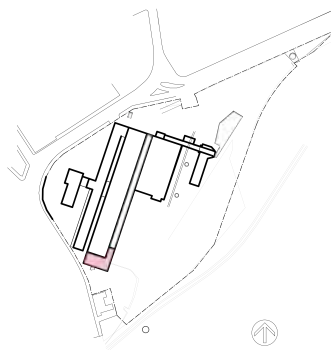
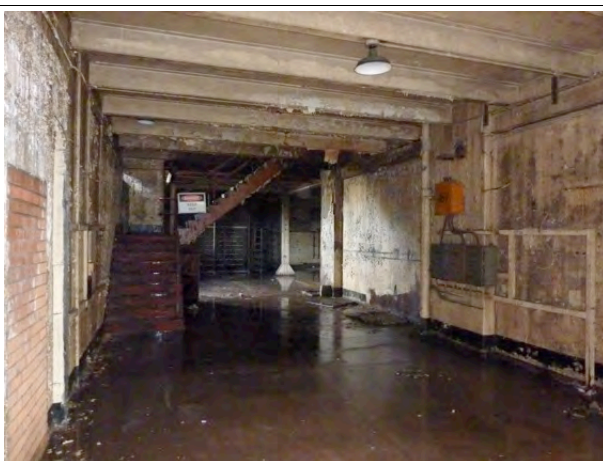
| Room/Item: GROUND FLOOR - SPACE | Room reference: AS G.2 |

| Floor: | Good. Some cracking which could be just surface? |
| Walls: | Paint spalling. Brickwork patched in. Storm water pipes coming in are extremely poor condition and leaking water inside. |
| Ceiling: | Paint spalling badly from beams and some sections of concrete. Steel beams corroded where water leaking through. |

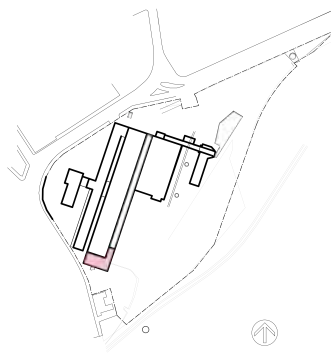
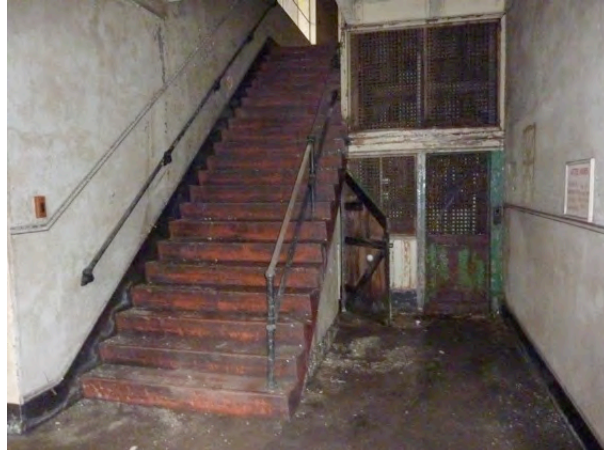
| Room/Item: AMBULANCE ROOMS FOYER | Room reference: AS G.3 |

| Walls: | Water damage in NE and SW corners and along stairwell. |
| Ceiling: | Beams rusted, water leaking through. Concrete water damaged. |
| Windows: | I broken. |
| Other: | Telephone cupboard. One door missing. Fuse box cupboard - glass smashed. |

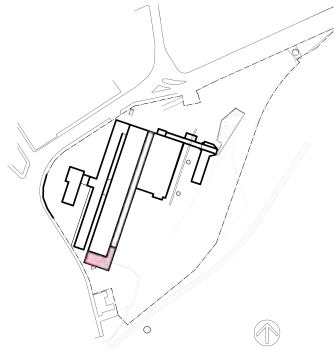
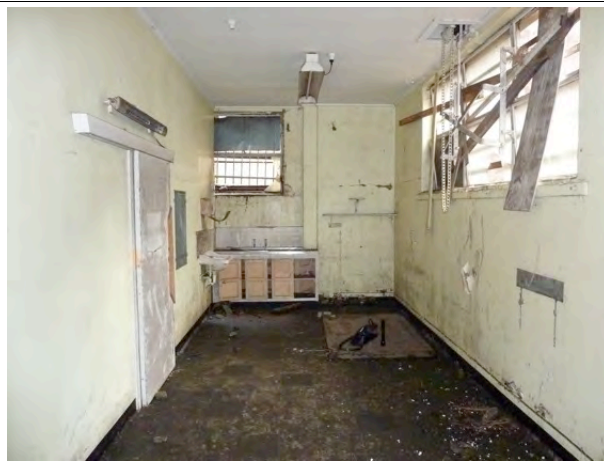
| Room/Item: AMBULANCE ROOM | | Room reference: AS G.4 | |

| Floor: Water damage. | | | |
| Skirting: OK – water damaged S wall. | | | |
| Walls: Horizontal cracks on W and S walls at window sill height. | | | |
| Ceiling: Some water damages on W wall. | | | |
| Windows: All glazing from windows missing or cracked. | | | |

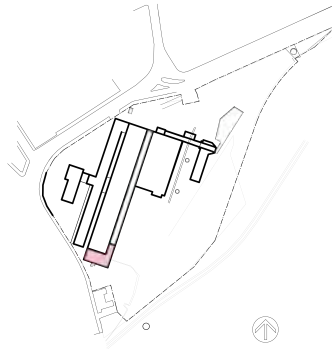
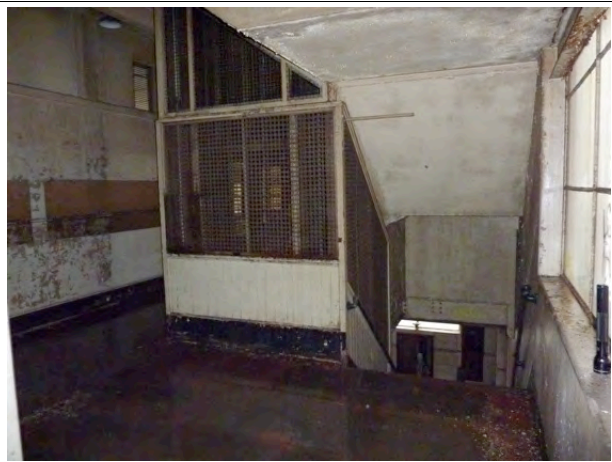
| Room/Item: HALL & LIFT WELL | Room reference: AS 1.1 |

| Floor: | 1.5m crack near W wall |
| Skirting: | Paint deteriorating. Timber skirt around lift, water damage. |
| Walls: | S – water damage. All have peeling paint. |
| Ceiling: | All steel beams have some level of water damage and corrosion. Worst around lift. |
| Windows: | 3 panels cracked. |

| Other issues: | <ul style="list-style-type: none"> - Lift cage – some water damage at floor/step level. - Pronounced water dropping from level above. - Pigeon damage |

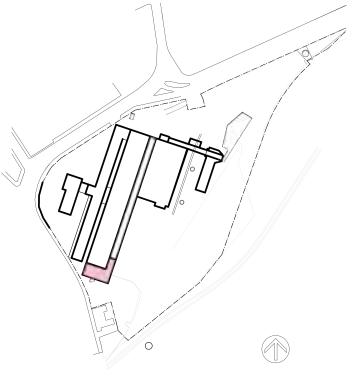
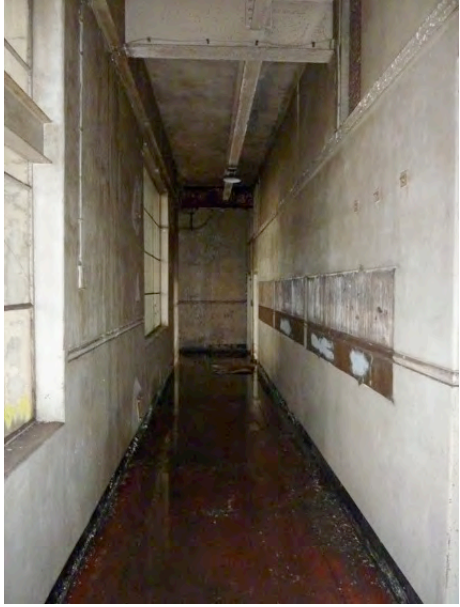
| Room/Item: HALL | Room reference: AS 1.2 |

| Walls: | N – ok – some water damage E – some water damage S – ok – 1 soft board panel water damage |
| Ceiling: | All steel beams have some level of water damage and corrosion. Worst at main steel beam at E end. |
| Windows: | 3 panes cracked at high level. |

| Other issues: | - Pronounced water dropping from level above. - Pigeon damage |

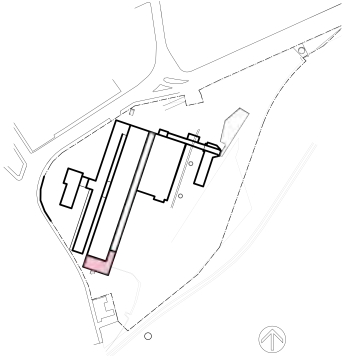
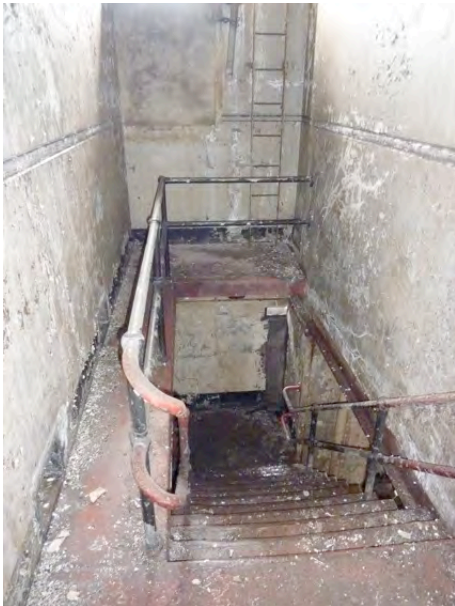
| Room/Item: HALL – STAIRS AT EAST END | | Room reference: AS 1.3 |

| <p>Condition:</p> <p>Floor: - ok – surface water.</p> <p>Skirting: Peeling/water damaged.</p> <p>Walls: N – water damaged. E – water damaged. S – water damaged. W – water damaged.</p> <p>Ceiling: As per AS 1.2.</p> <p>Doors:</p> <p>Windows: 2 panes cracked</p> <p>Other: Ladder - ok Stair-rail – ok, slightly rusted and very dirty. A/C/duct some rust.</p> | |
| <p>Other issues:</p> <ul style="list-style-type: none"> - Pronounced water dropping from level above. - Pigeon damage | |

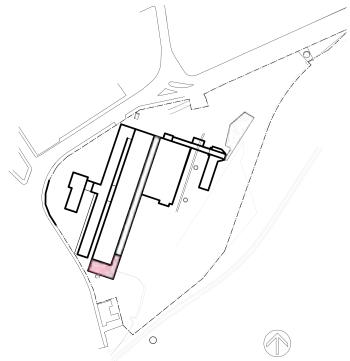
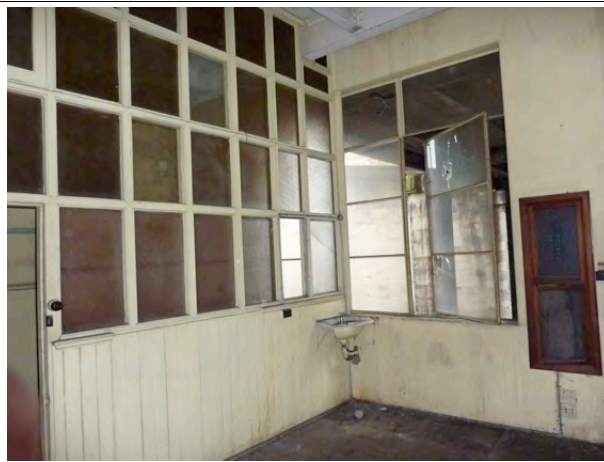
| Room/Item: WASHROOM | | Room reference: AS 1.4 | |

| Floor: | Water damaged holes (noted as OK in 2002). |
| Skirting: | 2 m missing in SE corner |
| Walls: | N – horizontal cracks at sill and 3 m, some water danger E – diagonal crack, some water damage S – sill missing (2m) W – crack to window head |
| Ceiling: | Ok, some water damage to W – render flaking off |
| Doors: | Glazing missing |
| Windows: | N – 1 pane smashed. S – 1 glazing panel missing, 2 panels replaced with door. Some obscure glass replaced with clear, at least four other panels cracked. W – 3 panels cracked/broken |

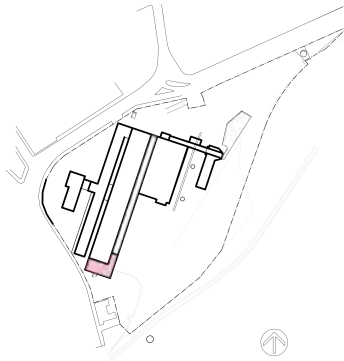
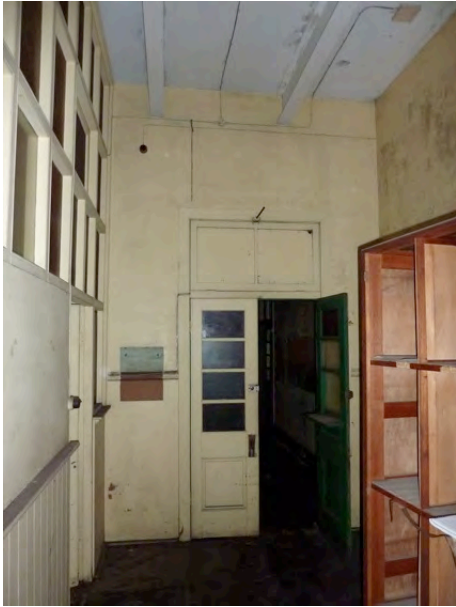
| Room/Item: CLOAK ROOM | | Room reference: AS 1.5 | |

| <p>Condition:</p> <p>Floor: Ok – water damaged – starting to break under weight of standing.</p> <p>Skirting: Ok but water damaged in some locations.</p> <p>Walls: N – Ok E – Ok S – OK W – diagonal crack at sill</p> <p>Ceiling: Ok – some water damage in NW corner – render flaking off</p> <p>Doors: Knob set missing, 1 glazing blocked in, fanlight blocked in</p> <p>Windows: N – refer to 1. 4. W – Ok</p> <p>Other: Shelf – doors removed</p> | |

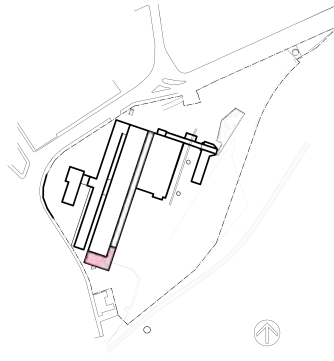
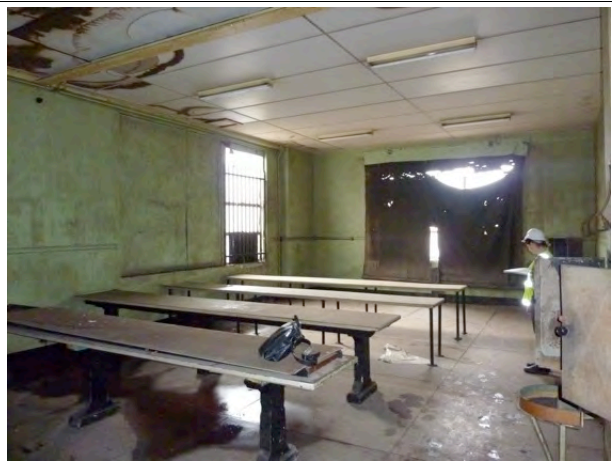
| Room/Item: DINING ROOM | | Survey date: 30.07.10 | |

| Walls: | Ok, some water damage |
| Ceiling: | Water stained and leaking from E half, some water damage at SW corner |
| Doors: | N – 1 panel broken, 3 panels – later figured glass S – Kiosk rusted |
| Windows: | S – window – 3 panels cracked, steel deteriorated 1/3 blocked W – steel rusted, 2 panes cracked |
| Other: | Tables: OK. Sinks: drainers OK, sink cracked. Slops: missing. Urn Stand: Rusted Pie Warmer: rusted Projection Screen: OK Blinds: stiff and ripped |

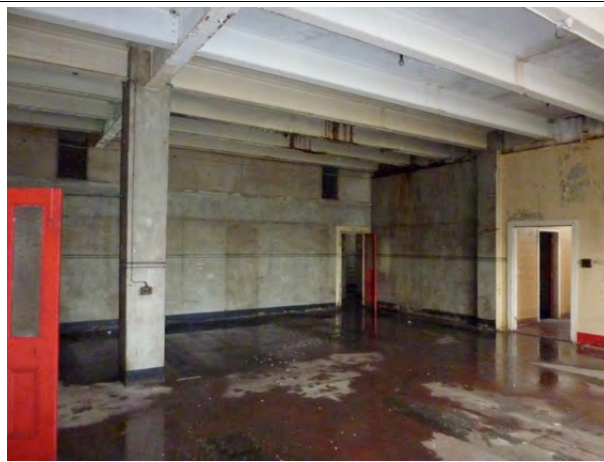
| Room/Item: LEVEL 1 - LOCKER ROOM | | Room reference: AS 1.7 | |

| Walls: | N – OK. E – Severe water damage S – Water damage around sill and DP W – Cracks in render and some water damage |
| Ceiling: | All beams rusted. Beam on wall to 1.8 significantly worse. Water damage to render – render flaking off, water leaking in from floor above. |
| Doors: | N – knob set missing W – 1 figured glass different, hardware missing |
| Windows: | Half boarded up, cracks in visible windows |

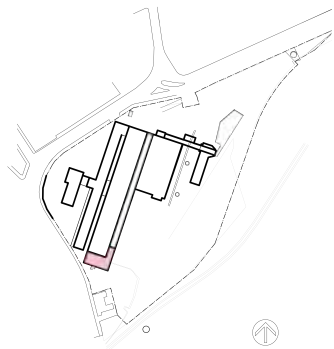
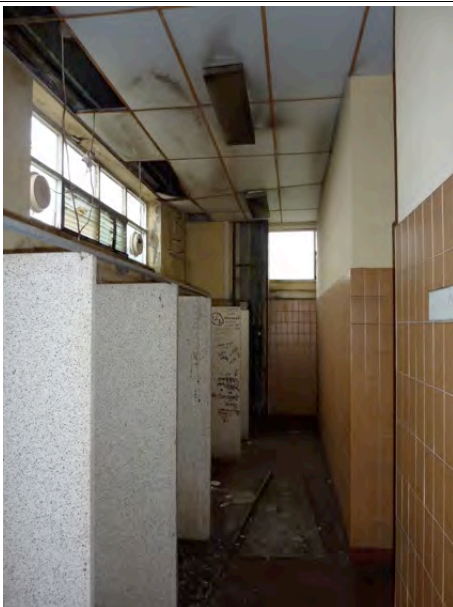
| Room/Item: LEVEL 1 - LAVATORY SOUTH | | Room reference: AS 1.8 | |

| <p>Condition:</p> <p>Floor: Ok, rough concrete in internal rooms with early brick walls showing in concrete.</p> <p>Skirting: Ok</p> <p>Walls: N – Ok, crack near entranceway E – Poorly patched and rendered. Severe water damage at window, tiles cracked S – Sheeting to pipes removed. Join between new and old render obvious and poorly done. Crack at original sill height. W – Water damage, join between new and old render obvious</p> <p>Ceiling: Main area - Cover strips rusting, 4 panels missing. Internal rooms – steel rusted</p> <p>Doors: Ok, knob set missing</p> <p>Windows: E - 4 panels cracked, panels where exhausts are different figured glass. S – 2 cracked panel.</p> <p>Other: 1 terrazzo partition broken. Shower heads missing.</p> | |

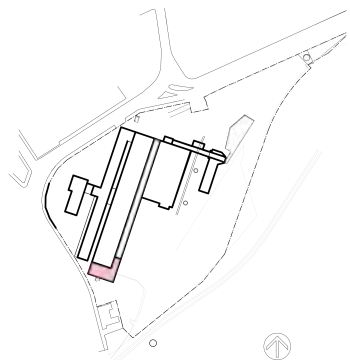
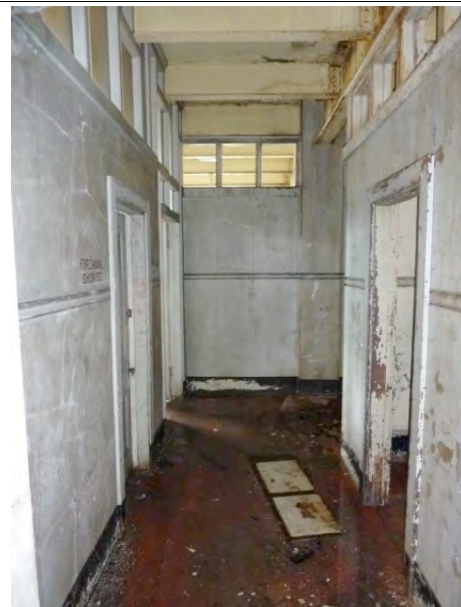
| Room/Item: HALL | | Room reference: AS 2.2 | |

| Floor: | Cracked at door to 2.8. Crack in line with north wall of 2.9. Crack at midpoint of hall. Crack at W end. |
| Skirting: | Paint deteriorated. |
| Walls: | N - (at 2.9) horizontal crack at door head height, full length. (at 2.8) diagonal crack. E - moderate cracking to 2.7m S - Ok W - (2.9) water damage |
| Ceiling: | Rusted beam to 2.9 and arm. |
| Doors: | Main steel beam corroded due to water damage including transverse beams. |

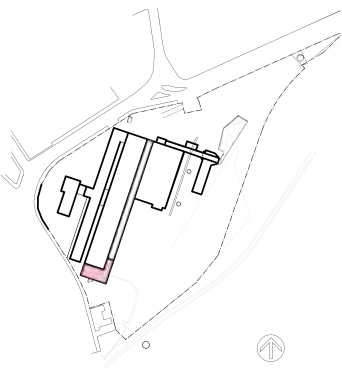
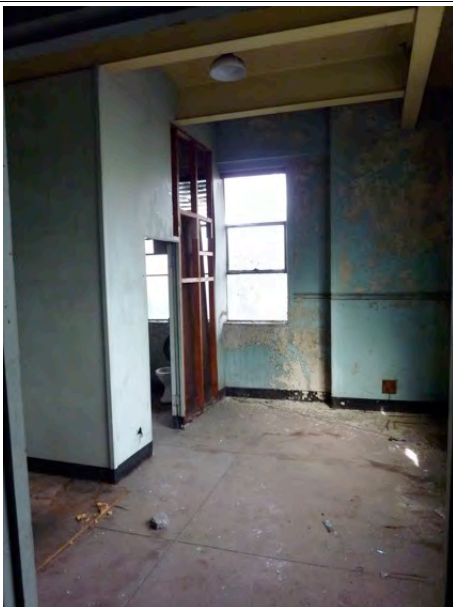
| Room/Item: EFFICENCY ENGINEERS | Room reference: AS 2.3 |

| Walls: | N – Ok. E – Some cracks in render evident. SW – evidence of water damage to paint Crack in render running along S/W walls at line of window sills and below Coat partition – 4 panels cracked WC partition – 1 large panel masonite missing, 2 cracked |
| Ceiling: | Cracking evident along beam running north/south beside W wall |
| Doors: | Missing with architrave. Coat door = knob set missing. WC door - Ok |
| Windows: | S – wire in glazing to louvres rusted. Panels cracked. W – 6 panels cracked with holes. |

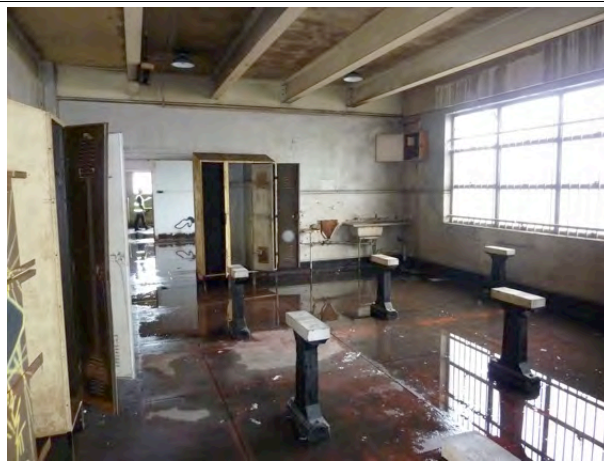
| Room/Item: DINING ROOM | Room reference: AS 2.4 |

| Walls: | N - Ok. E - evidence of cracking in render due to water damage. S - horizontal crack at sill level and 150 below window head level |
| Ceiling: | Ok - N-S crack in concrete in middle of room. |
| Windows: | E - 6 cracked panels W - 4 cracked panels |
| Other: | Sink - Ok. Tank stand - rusted and steel sheet deteriorated. Frame looks ok Lockers - most in fair condition, some rust evident, 1 door removed some doors bent. Heaters - Ok |

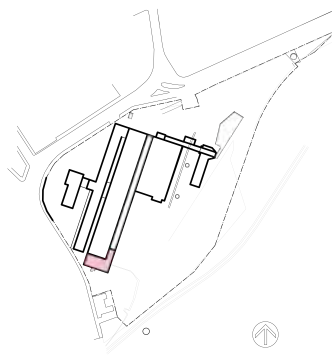
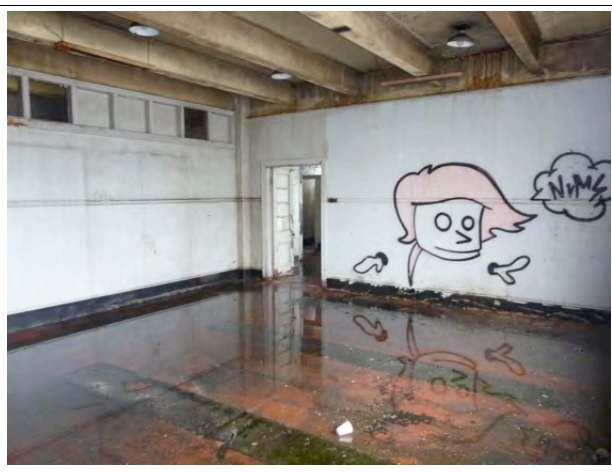
| Room/Item: LOCKER ROOM | Room reference: AS 2.5 |

| <p>Condition:</p> <p>Floor: Ok, evidence of walkways between lockers coming off</p> <p>Skirting: Water damage at floor</p> <p>Walls: N – Ok. E – slight water damage S – water damage at ceiling, horizontal crack at sill level and 150 below window head level</p> <p>Cornice:</p> <p>Ceiling: Crack running N/S near centre of room. Steel beams rusting in S/E corner</p> <p>Doors: 2 glazing panels cracked</p> <p>Windows: 4 panels cracked</p> <p>Other: Heaters appear Ok.</p> | |

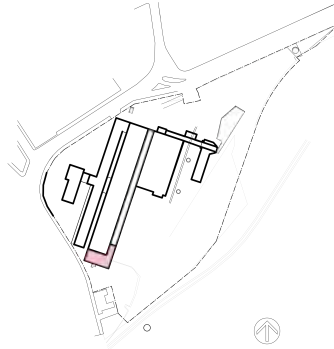
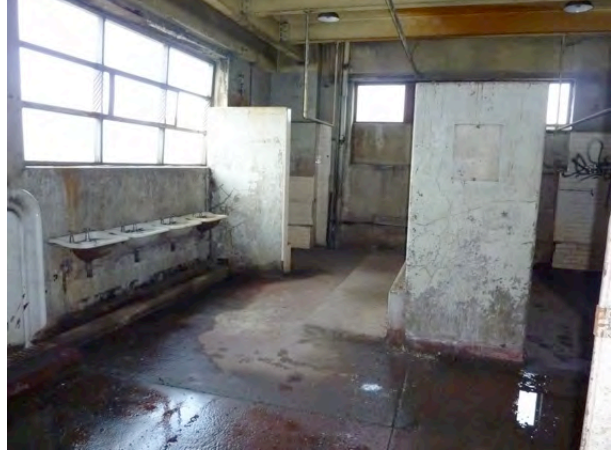
| Walls: | N – crack at door, water damage to E side. E – Ok, render flaking off. S – render knocked off near tiling on E side. Down pipes in poor condition. Cracking in line of original sill for cloaked in window. Cracking and water damage to bulkhead at ceiling. W – severe water damage | |
| Ceiling: | W cross beam badly rusted at S end | |
| Doors: | Entry – 2 cracked glazing panels, 2 missing panels, knob set missing. To 2.5 – 2 cracked glazing panels, paint flaking off | |
| Windows: | E – 3 panes missing S – all panes missing except for 1 | |

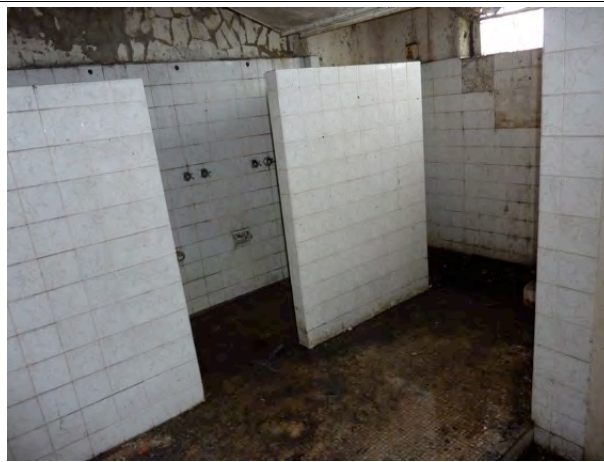
| Room/Item: FOREMAN'S SHOWERS | Room reference: AS 2.7 |

| Walls: | Water damage to all walls N – slight cracking E – water damage to window opening, some metal exposed, tiles fallen off. S – hole at E corner 150 radius, render cracking. W – timber framing deteriorating due to water damage, render cracking. |
| Ceiling: | E cross beam rusted, water damage evident in concrete |
| Doors: | Mortice lock missing, joinery cracked |
| Windows: | Fixed steel louvres deteriorated, rusty. All glazing cracked. |
| Other: | Cistern broken at back, missing shower hose, pipes etc. Exhaust vent – vent through windows rusted through |

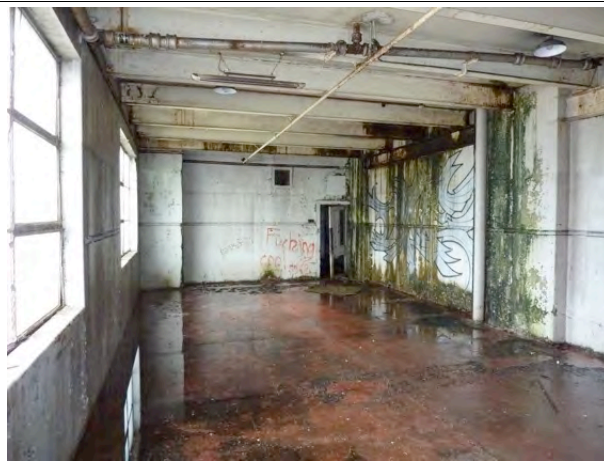
| Room/Item: LOCKER ROOM | Room reference: AS 2.8 |

| Floor: | Crack at 2 m from north wall. N/E panel lifting slightly. Crack in second from N wall on eastern side. Crack at 1m from south wall, soaked with water |
| Walls: | N - cracking to render, severe water damage E - cracking from sill corners and head. Horizontal cracks below sill and 400 below window head height, severely rusted DP allowing water to enter. S - Severe water damage to SW corner, cracking to wall W - Severe water damage at S end |
| Ceiling: | Water damage at W wall. 5 beams to south and 1 crossbeam, on W rusted very badly, others rusted to lesser degree. Water damage to concrete. Water leaking through. |
| Doors: | Collapsed, possibly beyond repair. |
| Windows: | 2 panels missing, 5 cracked, 3 different glass (wire reinforced) |

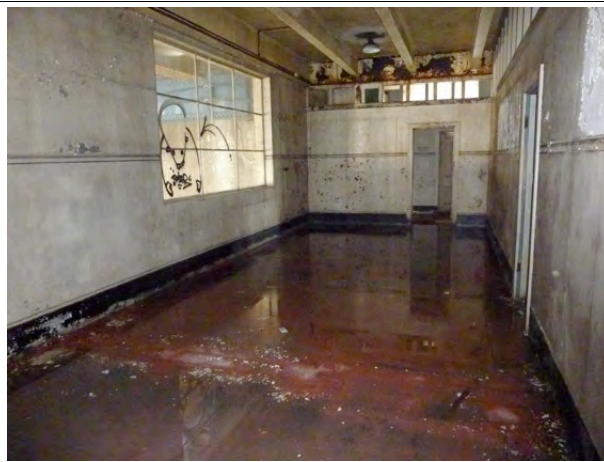
| Floor: | Crack to east of removed wall, soaked with water |
| Walls: | Severe water damage to N, E & W N - cracks from sill corners, crack with bulkhead at ceiling S - Ok W - cracks to S/W corner |
| Ceiling: | Slight rusting to centre 3 beams. E wall, cross beam severely rusted, concrete water damaged |
| Windows: | E – 1 cracked panel, frame rotten W - rough corner to W wall |

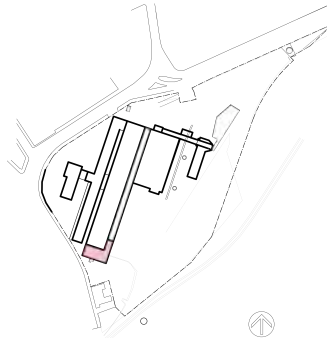
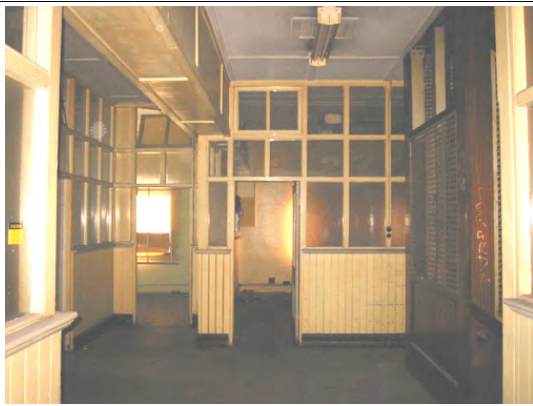
| <p>Condition:</p> <p>Floor: Good except E end where rotted, approx 3.5 west</p> <p>Skirting: Generally Ok</p> <p>Walls: Ok, evidence of damp at the N wall and lift well</p> <p>Cornice: Ok</p> <p>Ceiling: Ok except under box gutter at east end</p> <p>Doors: Doors ok, hardware missing Fanlights - 2 to north side sheeted over and glass missing</p> <p>Windows:</p> <p>Other:</p> | |

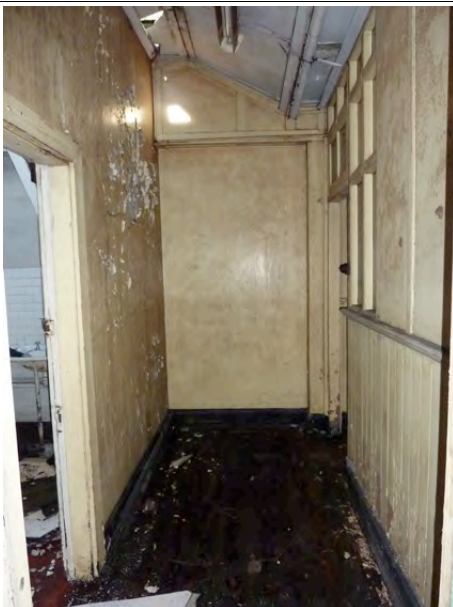
| Room/Item: HALL | | Room reference: AS 3.2 | |

| <p>Floor: Rotted out. (stuffed!)</p> <p>Skirting: Some loose, E – water damaged beyond repair</p> <p>Walls: All walls water damaged, particularly at lower level on W wall</p> <p>Cornice:</p> <p>Ceiling: Water damage – 1 panel fallen in</p> <p>Doors: 1 panel broken wired glazed in door E- water damaged</p> <p>Windows:</p> <p>Other:</p> | | | |

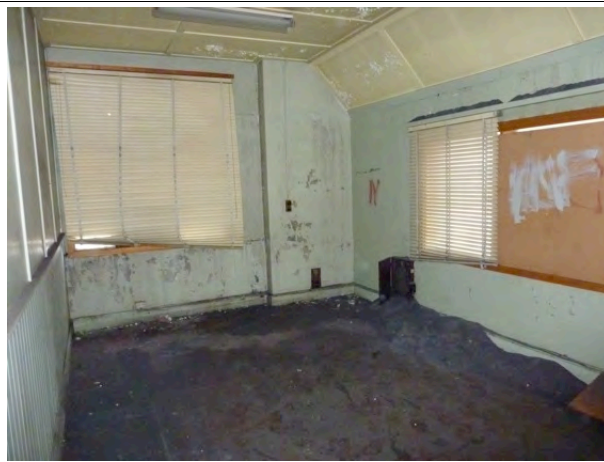
| <p>Floor: Ok, early signs of water damage on S end</p> <p>Skirting: Ok, but water damaged on S wall where window's broken</p> <p>Walls: S - evident damp beneath window and adjacent crack horizontal at sill level and also above. W - long cracks below and beside window</p> <p>Ceiling: Some evidence of damp from above, not serious</p> <p>Doors: Missing</p> <p>Windows: bad corrosion, broken panes</p> <p>Other: Megawatt dials on N wall missing since 2002. Previously noted as being in excellent order (visually)</p> | |

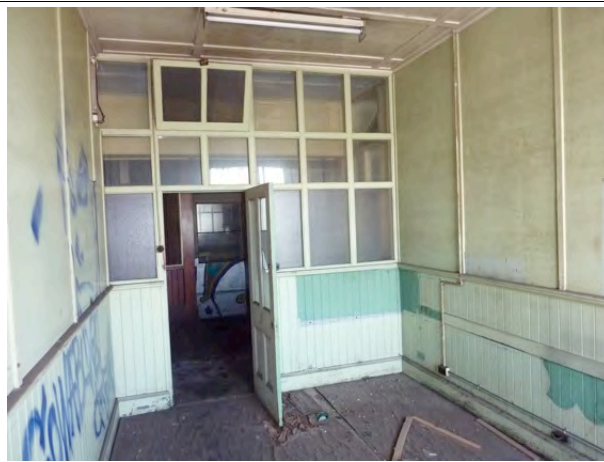
| Room/Item: POWERHOUSE SUPER 2 | Room reference: AS 3.5 |

| Floor: | All moderate water damage, but more severe at S wall |
| Skirting: | Ok, but damaged under S end window |
| Walls: | S - Water damage, horizontal crack near window head. W - damage at S end from earlier A/C unit. N & E - Ok |
| Ceiling: | Some water damage, particularly along S end. Ventilator panel distorted |
| Doors: | 1 broken glass pane, Mortice lock and Knobset missing. |
| Windows: | S - rusted panes broken and kept open. Hardware possibly salvageable |

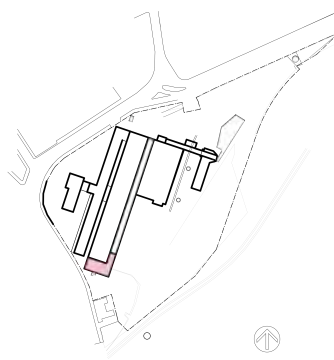
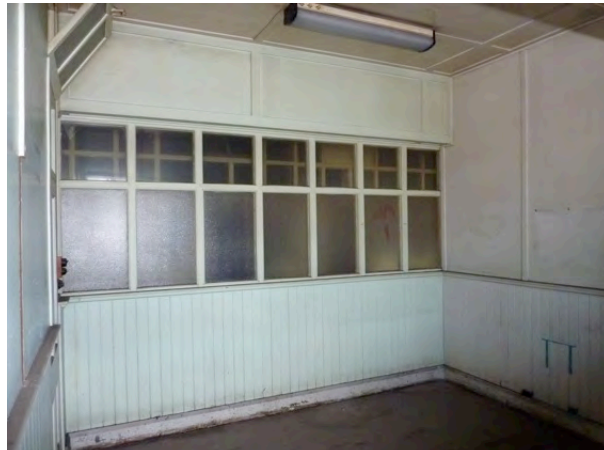
| Room/Item: FORMER CORRESPONDENCE RECORDS – NORTH ROOM | Room reference: AS 3.7 |

| Walls: | Ok, except for part of battens missing on W wall |
| Doors: | Knobset missing, door lock closed |
| Windows: | N – Ok, S – 2 panels missing |

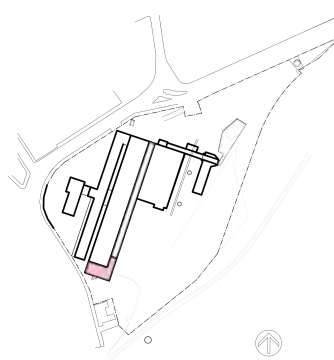
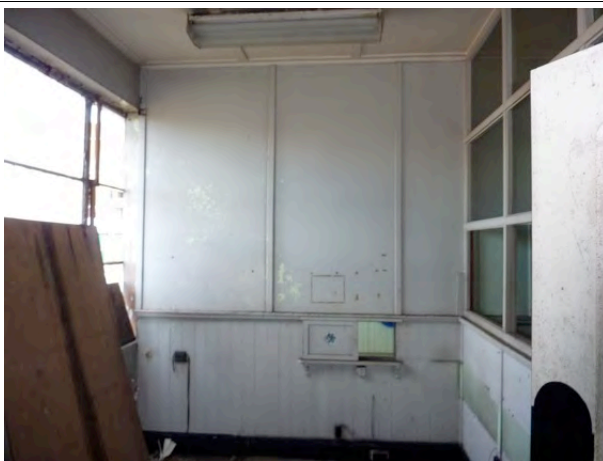
| Room/Item: | FORMER CORRESPONDANCE AND RECORDS - SOUTH ROOM | Room reference: | AS 3.8 |

| Condition: | <p>Floor: Water damage - lino shattered</p> <p>Skirting: Ok</p> <p>Walls: N - 1 small hole in caneite. S - SAME AS 3.5 with horizontal crack at sill level and about 150 below head level</p> <p>Cornice:</p> <p>Ceiling: Water damage</p> <p>Doors: No Knobset</p> <p>Windows: S - 2 panels missing, 2 broken and cracking</p> <p>Other:</p> |

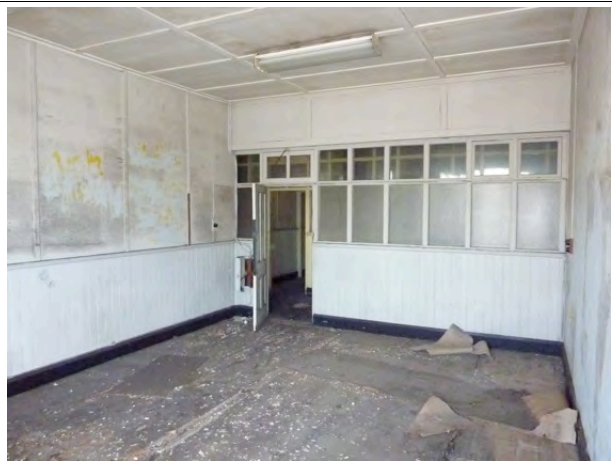
| <p>Floor: Water damage throughout but severe at S end</p> <p>Skirting: Ok, except S side damaged by water</p> <p>Walls: S – damaged by water, horizontal crack at sill level and about 150 below head level. Some related water exposure to adjacent E wall and W to other wall</p> <p>Cornice:</p> <p>Ceiling: 1 panel fibro missing and area adjacent on all sides affected by water</p> <p>Doors: Hardware missing</p> <p>Windows: Bad corrosion, lower parts and bowed in middle – no glass, open to weather</p> <p>Other: Phone unit hanging loose</p> | | | |
| <p>Window – 1, Roof and ceiling 2, wall 1-2 Pigeon roosting in ceiling space with tree access from outside. Floor heavily pigeon damaged.</p> | | | |

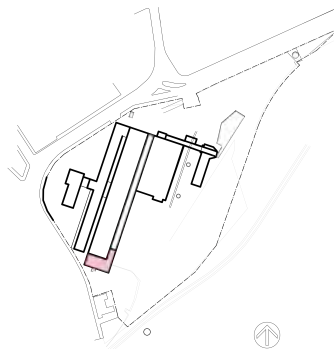
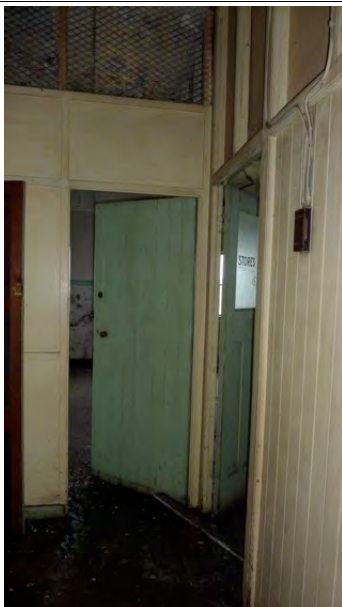
| Room/Item: LOBBY | | Room reference: AS 3.10 | |

| Floor: | Severe water damage from box gutter |
| Walls: | N- Water damage |
| Ceiling: | Water damage from box gutter, water seeping through |
| Doors: | Knob set missing to panel doors |

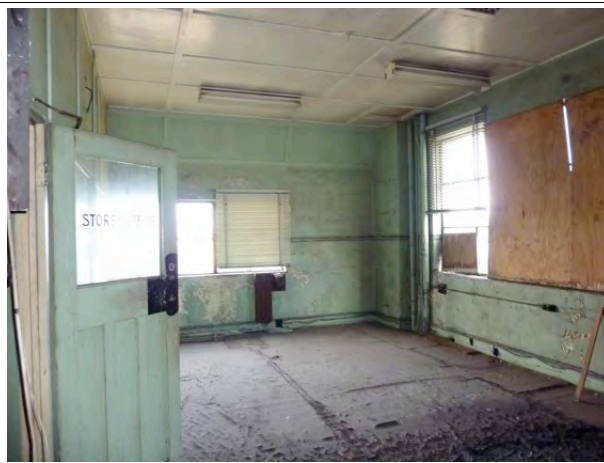
| Room/Item: STORES OFFICER | | Room reference: AS 3.11 | |

| Skirting: | Some loose around damaged floor |
| Walls: | Water damage to external walls. Horizontal crack at sill line and around reveals |
| Doors: | Ok, hardware missing |
| Windows: | Badly eroded and broken glass – 1 pane missing |

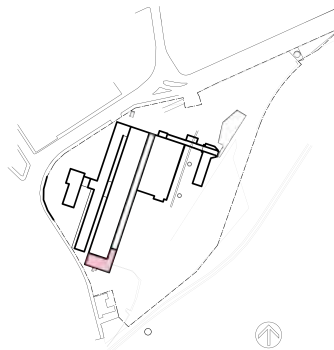
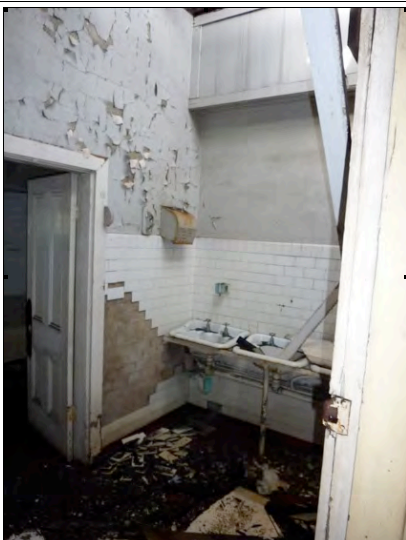
| <p>Floor: Ok</p> <p>Skirting:</p> <p>Walls: W, and E shower cubicle - severe water damage, tiles falling off N and S shower cubicle- tiles falling off Cracking in render to all walls All walls water damaged, W wall severely damaged, open to weather</p> <p>Cornice:</p> <p>Ceiling: Lining collapes, roof sheeting missing, open to weather at S end</p> <p>Doors: Toilets - Ok, Shower - knob set missing, Entry - knob set & mortise lock missing</p> <p>Windows: 1 crack in shower, poorly fitted</p> <p>Other: Urinal missing - rough concrete outline left, Toilets - Ok, Cisterns - 1 dislodged slightly from shelf, rest Ok, Basins - rusting, Shower - fixtures missing, 2 shower originally</p> | |

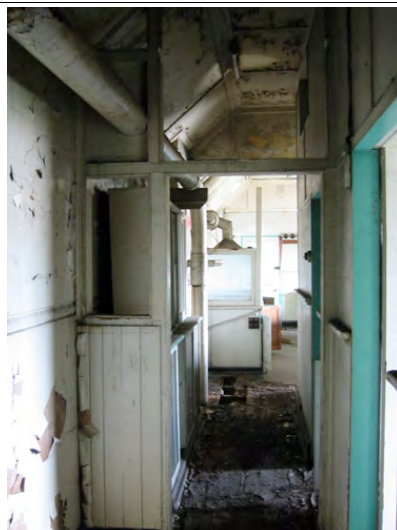
| Room/Item: LAB HALL | | Room reference: AS 3.14 | |

| Skirting: Loose but ok | | | |
| Walls: Severely water damaged (box gutter above?) | | | |
| Ceiling: Damaged along west wall | | | |
| Doors: E – Mortice lock missing S – joinery water damaged | | | |
| Other: DP severely rusted | | | |

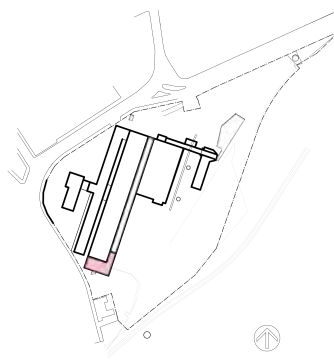
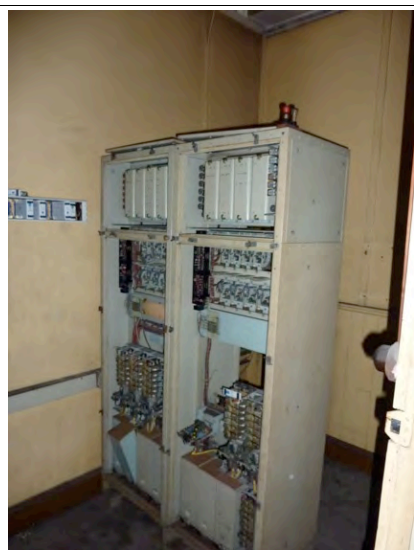
| Room/Item: STATIONARY STORE - SOUTH ROOM | Room reference: AS 3.19 |

| <p>Condition:</p> <p>Floor: Ok, lino lifting in places</p> <p>Skirting: Ok</p> <p>Walls: N - Ok E & W - Ok S - Small crack in fibro (asbestos)</p> <p>Cornice:</p> <p>Ceiling: Ok</p> <p>Doors:</p> <p>Windows:</p> <p>Other:</p> |

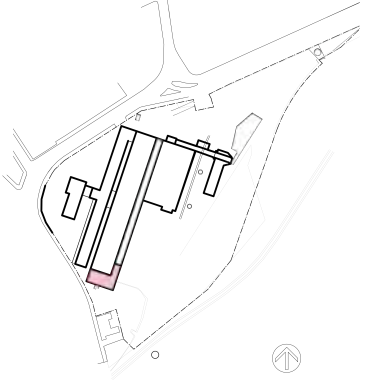
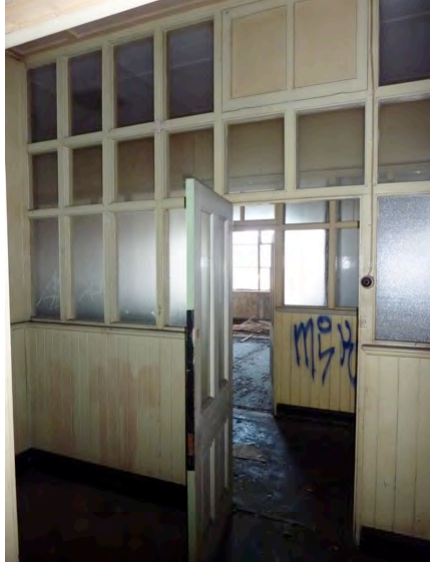
| Room/Item: STATIONARY STORE - NORTH ROOM | | Room reference: AS 3.20 | |

| <p>Condition:</p> <p>Floor: Ok</p> <p>Skirting: Ok</p> <p>Walls: N & W – Ok (N contains asbestos) E - water damaged S - 1 fibro panel cracked</p> <p>Cornice:</p> <p>Ceiling: Water damage</p> <p>Doors: Knobset and Mortice lock and keeper missing</p> <p>Windows:</p> <p>Other:</p> | |

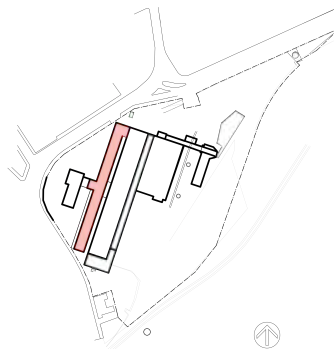
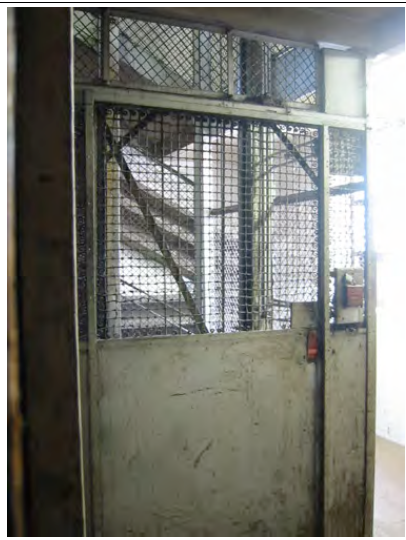
| Room/Item: STAIRWELL & LIFT | | Room reference: SH G.1-3.1 |

| Condition: | <p>Floor: OK.</p> <p>Skirting:</p> <p>Walls: Some damage including broken tiles, graffiti and cover missing from service conduits.</p> <p>Cornice: -</p> <p>Ceiling: OK.</p> <p>Doors: OK.</p> <p>Windows: Many broken.</p> <p>Other: Lift - dirty</p> |

| Other issues: | <p>Some corrosion to steel framed stair, particularly where steel elements abut outer masonry walls</p> <p>Water pooling in lift base</p> |

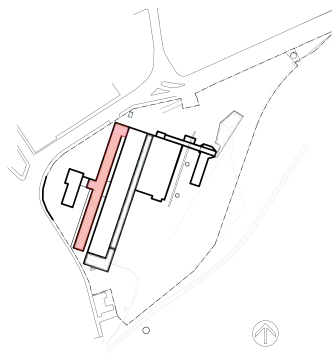
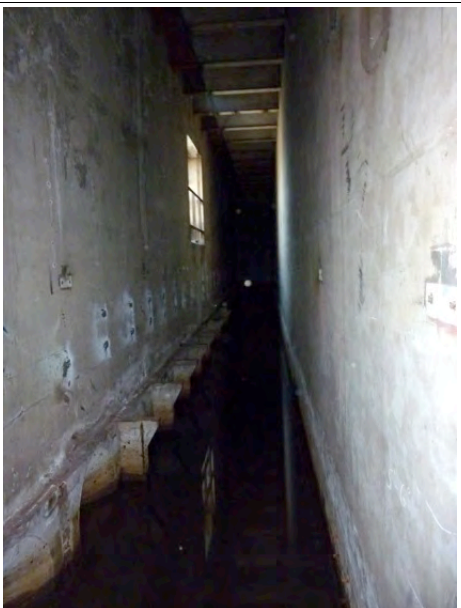
| Room/Item: GROUND FLOOR - CORRIDOR | | Room reference: SH G.2A & B |

| Walls: OK. Water damage. | | |
| Windows: Some damaged. | | |

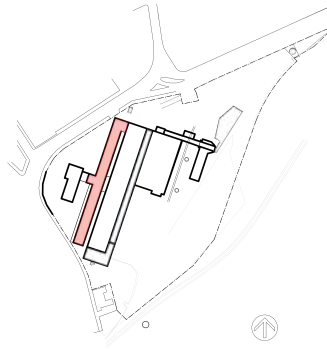
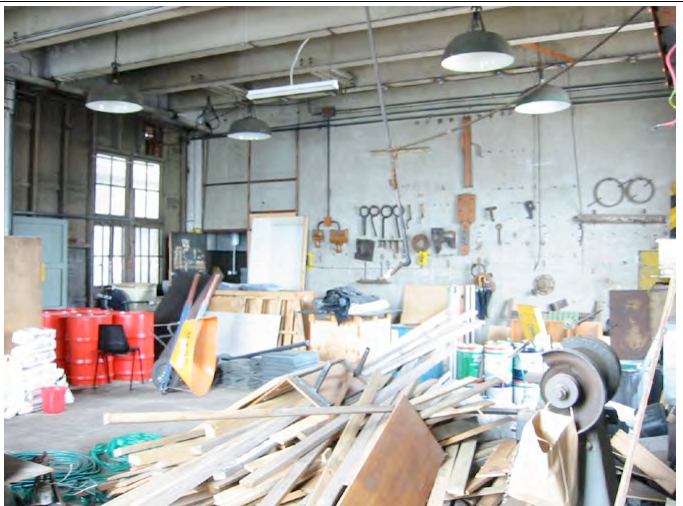
| <p>Condition:</p> <p>Floor: Good.</p> <p>Walls: N: good - chalk graffiti - some very old i.e. 1960s. E: good. W: good - some holes in temporary metal cladding. S: good - original tools attached to wall.</p> <p>Ceiling: Good.</p> <p>Doors: S: temporary timber door. W: boarded door OK.</p> <p>Windows: N: most smashed or cracked. E: middle window, some panes are smashed only. W: one pane smashed. General note: steel sash components for opening and closing are missing.</p> | |

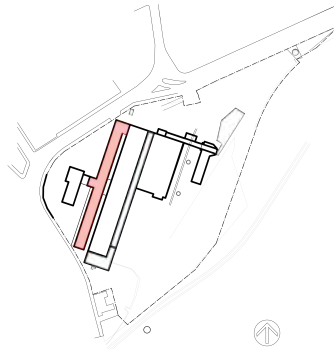
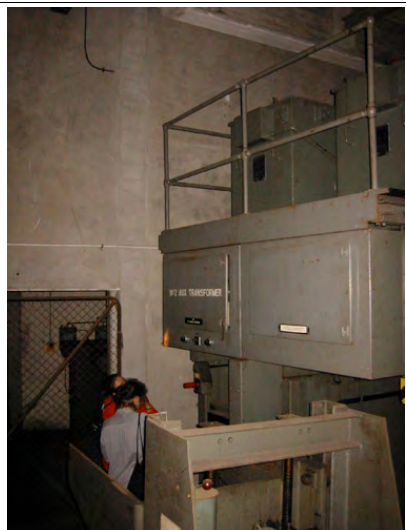
| Room/Item: GROUND FLOOR - | | Room reference: SH G.4 |

| <p>Condition:</p> <p>Floor: OK.</p> <p>Skirting: -</p> <p>Walls: OK. Some damage to partition.</p> <p>Cornice: -</p> <p>Ceiling: OK.</p> <p>Doors: OK. Worn sign Electrical Workshop. Remnants of notices.</p> <p>Windows: OK.</p> <p>Other: Door - Interpretation possibilities.</p> | |

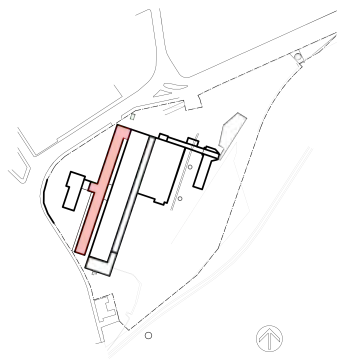
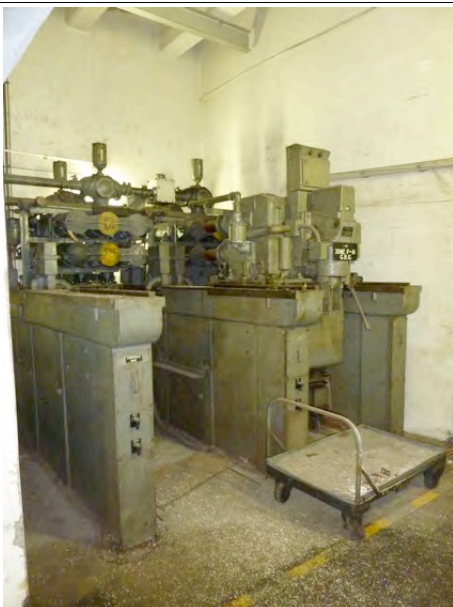
| Room/Item: | GROUND FLOOR - ROOM | Room reference: SH G.5 |

| <p>Condition:</p> <p>Floor: OK. Skirting: - Walls: OK. Cornice: - Ceiling: OK, paint flaking off Doors: OK. S come off runner Windows: 2 broken. Other:</p> | |

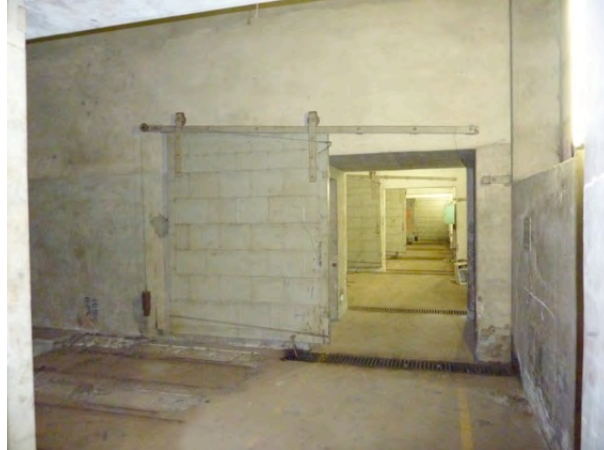
| Floor: | Good condition through corridor. Generally poor where machinery has been removed. |
| Walls: | E: good. Some boxes for tools etc are missing. W: evidence of conduits etc mssing. Partitions: evidence of machinery with plugs still in wall, once housed conduits and switches. Some render broken off at corners and openings. |
| Ceiling: | Generally in good condition. Patching evident. |
| Windows: | East wall. G.6: many broken - fixed panes wire. G.7: fixed panes broken, operable and fixed window. G.8: fixed - all panes good. G.9: fixed - 5 out of 12 broken. G.10: operable - many broken. G.11: half window - looking into partition - many broken. |

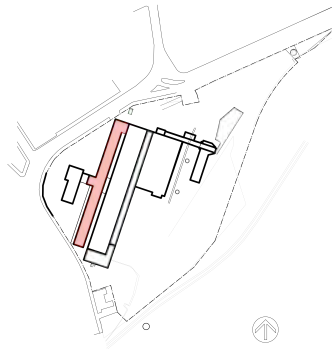
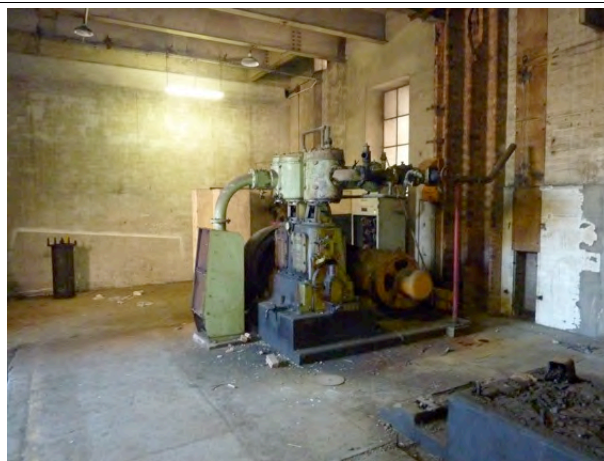
| Floor: | OK, broken glass from windows, pigeon damage NE corner. |
| Walls: | OK, water damage to N wall E: hole in SE corner |
| Ceiling: | Some damage NW corner (plaster fallen off ext. metal), some holes |
| Doors: | Mesh gate corroded |
| Windows: | E: 4 panels broken to N W: All panels broken except one S: panel cracked. |

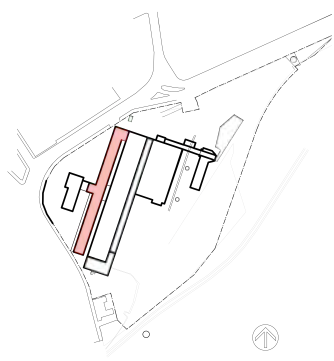
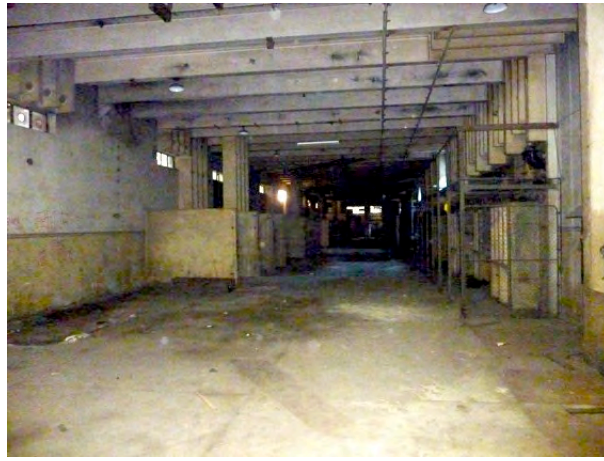
| Room/Item: | GROUND FLOOR - SPACE (divided for the purposes of survey only) | Room reference: | SH G.13A - G.13D |

| Floor: | Ok, some pits and pigeon damage |
| Ceiling: | Ok: beams rusting, concrete Ok. |
| Windows: | E: most windows are smashed - some sections of steel frame are also missing on most windows - brick wall on outside butting up against windows allows only light at top level. W: most panes are smashed but blocked up with steel sheets externally. |

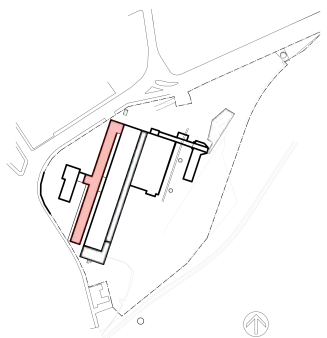
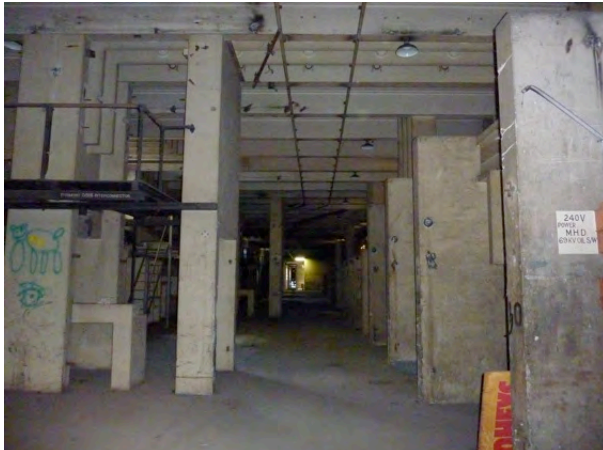
| Room/Item: GROUND FLOOR SPACE | | |

| <p>Floor: Good.</p> <p>Skirting: Good.</p> <p>Walls: Good. W: some cavities leading into cable chamber.</p> <p>Cornice: Good.</p> <p>Ceiling: Good. Large hole (purpose-made) at S-W corner.</p> <p>Doors: Roll-a-door corroded at bottom.</p> <p>Windows: W: Most glass is smashed.</p> <p>Other:</p> |

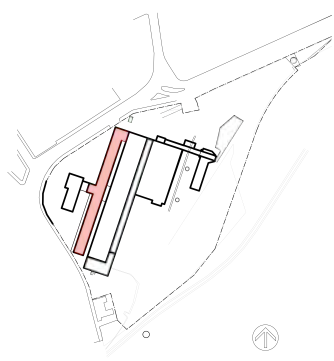
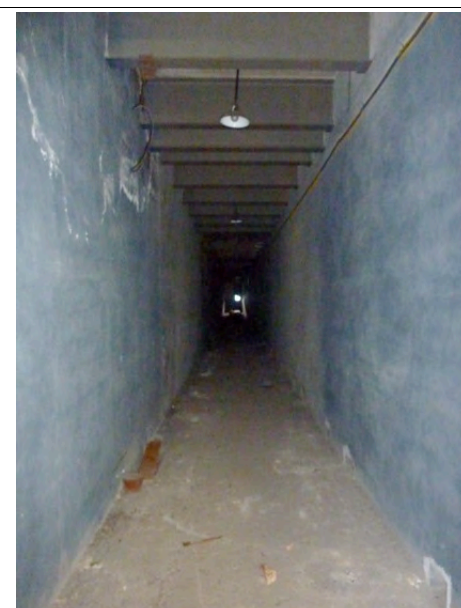
| Room/Item: LEVEL 1 - CORRIDOR | | |

| <p>Condition:</p> <p>Floor: Large holes scattered to floor below, poorly covered over with steel plates.</p> <p>Skirting:</p> <p>Walls: OK.</p> <p>Cornice:</p> <p>Ceiling: OK, holes in parts</p> <p>Doors:</p> <p>Windows: OK</p> <p>Other:</p> | |

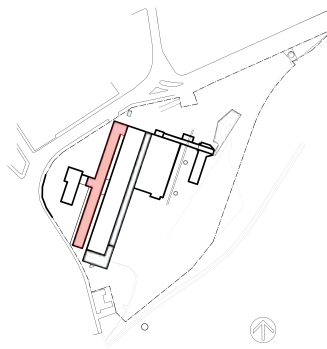
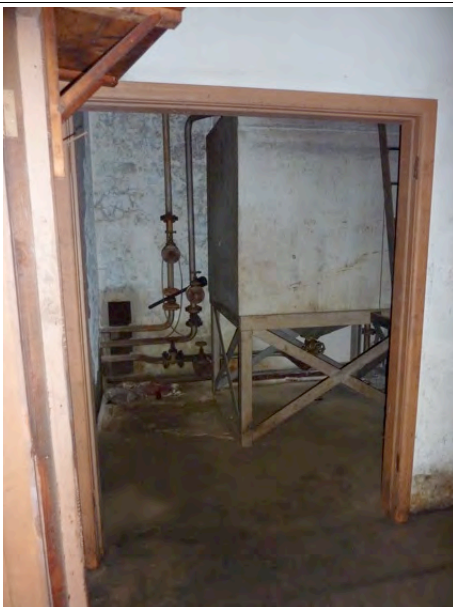
| Room/Item: INNER ELECTRIC OIL FILTER ROOM | | Room reference: SH 1.3A |

| Doors: | Frame only – doors missing | |

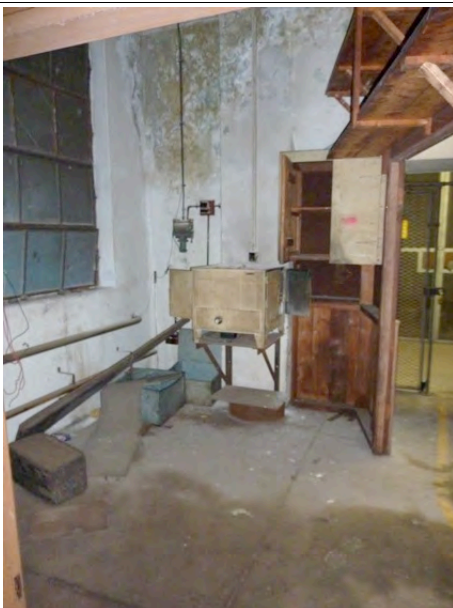
| Room/Item: ELECTRIC OIL FILTER ROOM | | Room reference: SH 1.3B |

| Doors: 1 missing. | | |

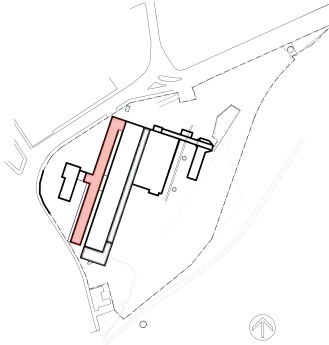
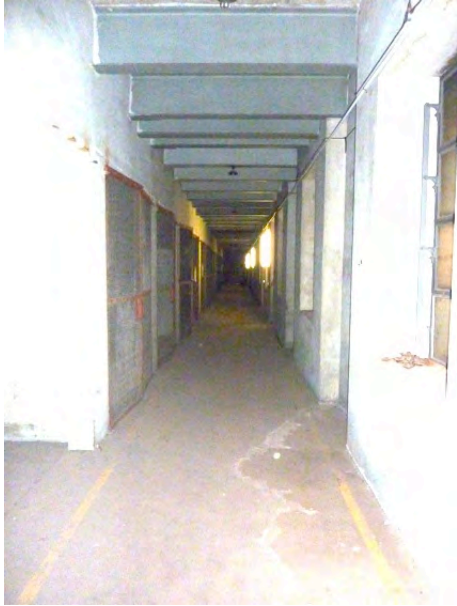
| Room/Item: LEVEL 1 - CORRIDOR | | Room reference: SH 1.4 |

| Condition: Floor: OK. Skirting: - Walls: OK, some damp on E wall, N end. Cornice: - Ceiling: OK – some damp N end. Doors: OK. Windows: Most OK, some damage. Other: | | |
