WHITE BAY POWER STATION

CONSERVATION MANAGEMENT PLAN VOLUME III BUILDING FABRIC SURVEY (& Condition Report)

FINAL REPORT
SECOND EDITION JULY 2011
(Revised March 2013)

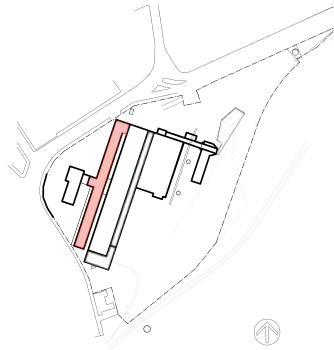
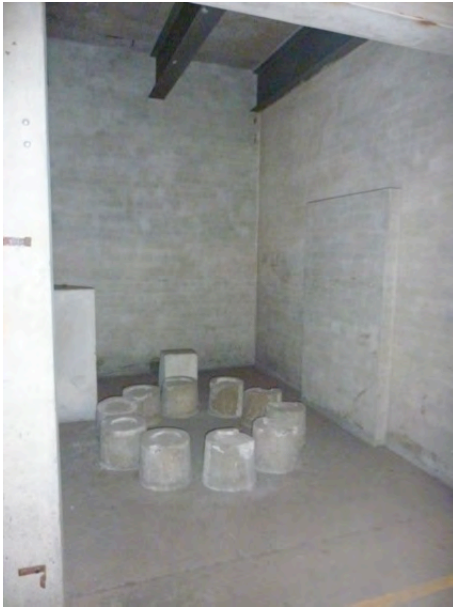
| Condition: | <p>Floor: OK.</p> <p>Skirting: -</p> <p>Walls: OK.</p> <p>Cornice: -</p> <p>Ceiling: OK.</p> <p>Doors: OK. Right missing. Security locks - only #26 works.</p> <p>Windows:</p> <p>Other:</p> |

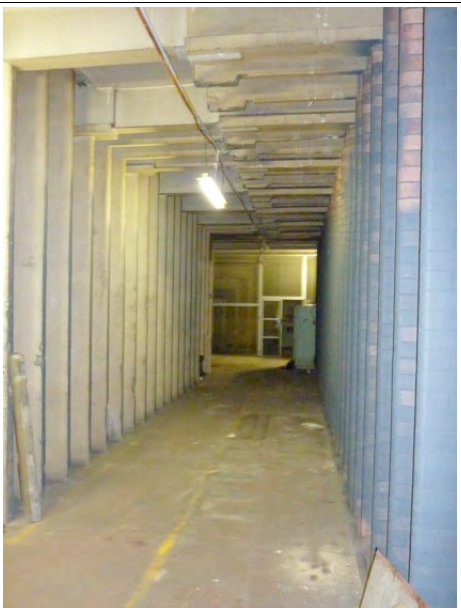
| Room/Item: LEVEL 1 - SPACE | | Room reference: SH 1.6 |

| Ceiling: OK some concrete damage | | |
| Windows: I pane missing. | | |

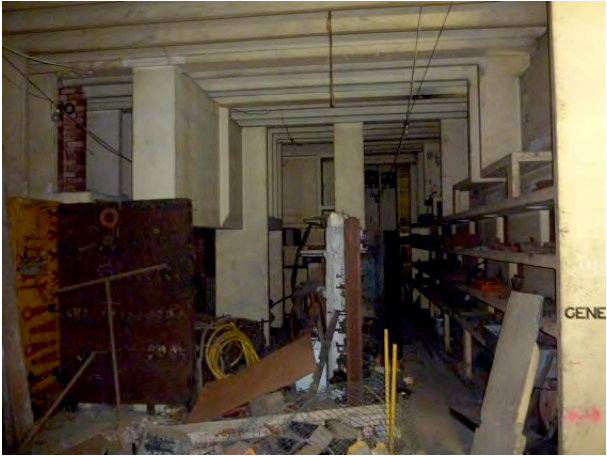
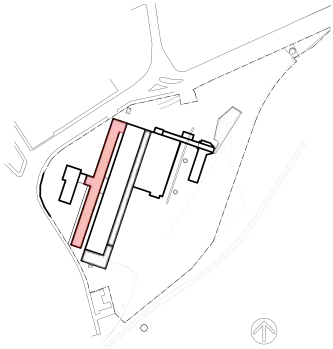
| Ceiling: OK, some beams damaged | |
| Windows: E: 1 pane damaged. | |

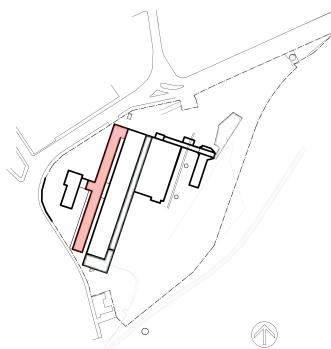
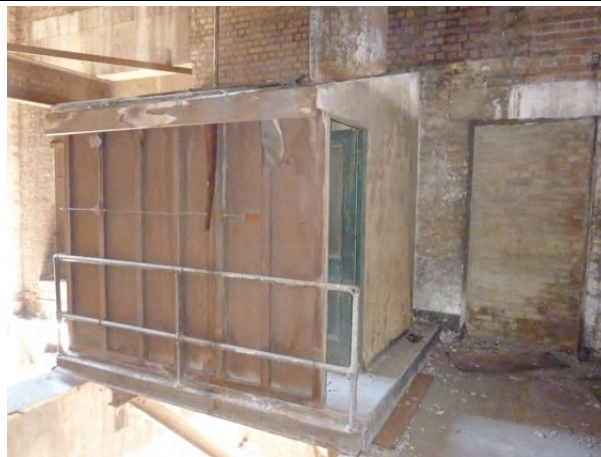
- Floor: OK.
- Skirting: -
- Walls: SH 1.14: Heavy water damage on E wall, Internal partitions water damaged
SH 1.15: Water damage
- Cornice: -
- Ceiling: SH1.14 - poor – partial collapse due to water damage (2002 noted as OK)
SH 1.15 - poor.
- Doors: Both doors in poor condition but repairable
- Windows: Some missing.
- Other: -

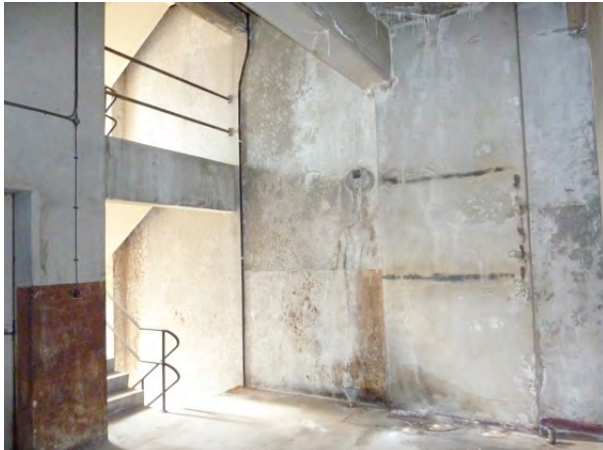
| Building/Space: 1925 SWITCH HOUSE Room/Item: STAIRWELL & LIFT Construction date: 1950s | Room reference: SH 2.2 Surveyor: 2002: Stephen Couling 2010: Robert Gasparini | Survey date: 19.08.10 |

| Condition: <ul style="list-style-type: none"> Floor: OK. Skirting: OK. Walls: OK. Damp staining on E & W walls Cornice: - Ceiling: Water ingress. Salt stalactites appearing through cracks in concrete. Doors: OK. Windows: Cracked. Other: | | |

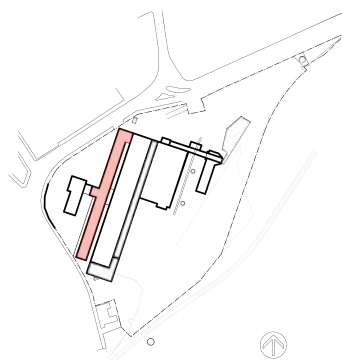
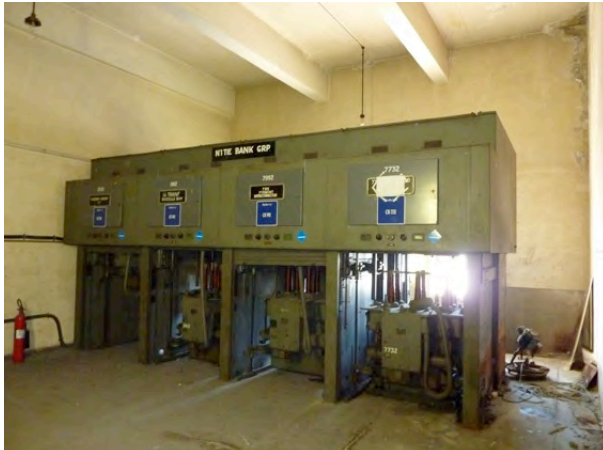
| Room/Item: TIE BANK ROOM | | Room reference: SH 2.4 |

| Ceiling: | Cracked. Water damage. | |
| Windows: | Some cracked. | |
| Other: | Suspended lights- some with coolly shades missing Corrosion to machinery – low level – N end. | |

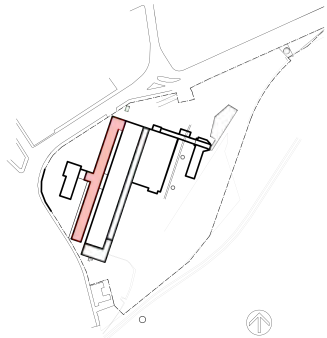
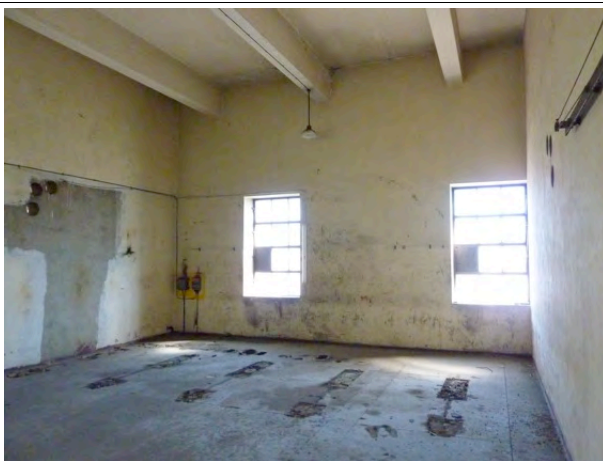
| Room/Item: LEVEL 2 - ROOM | Surveyor: 2002: Stephen Couling 2010: Nina Pollock | Survey date: 19.08.10 |

| Walls: | OK. Holes where machinery was., some water damage to S, E & W |
| Doors: | N: Plaster damage around right machinery. |
| Windows: | W: 1 broken, 4 cracked, 2 missing E: OK |

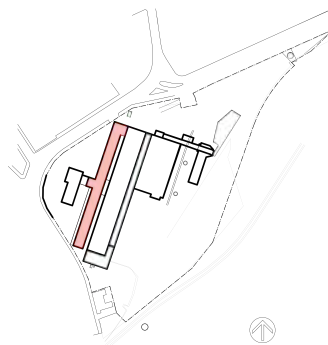
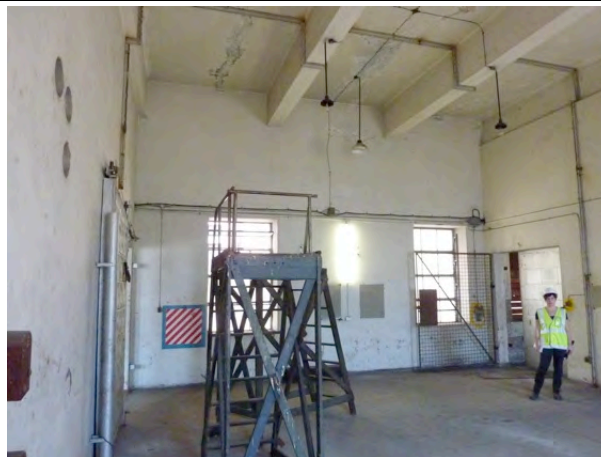
- Floor: OK.
- Skirting:
- Walls: W: Severe water damage & salt attack
E & N: Some water damage
- Cornice:
- Ceiling: Severe water damage & salt attack
- Doors: N: 1 metal sheet off revealing timber core.
S: OK.
- Windows: W: 1 pane missing, frame distorted
E: OK
- Other:

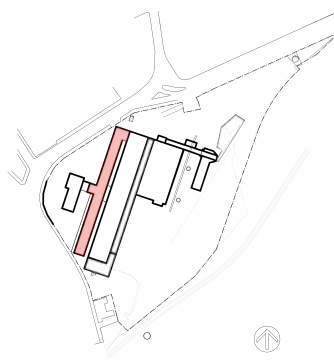
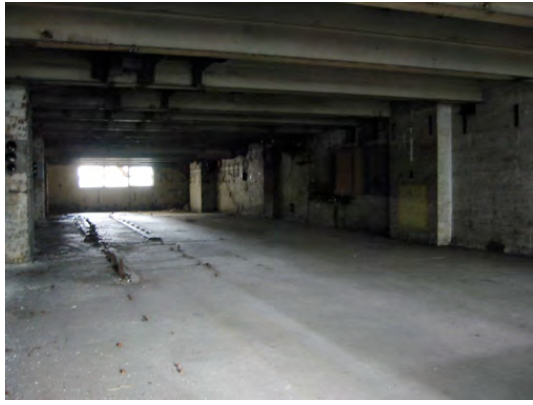
| Windows: | S: 4/6 panes missing. N: boarded up, all panes damaged. | | |

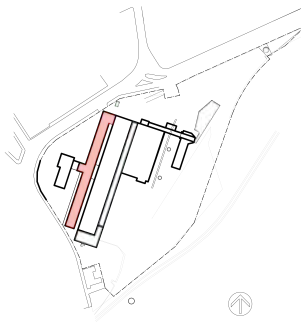
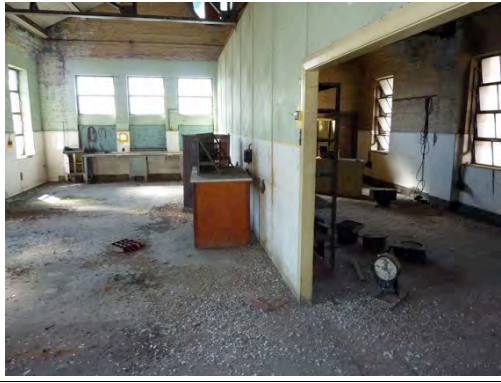
| Floor: | ok. Large cracks in conc. floor along W wall. Severe pigeon damage. | | |
| Walls: | Water damage to all walls N: bad water damage in W corner, structural crack, tiles missing at skirting level. W: severe water and pigeon damage | | |
| Windows: | N: 2 panes cracked E: OK W: 4 panes cracked | | |

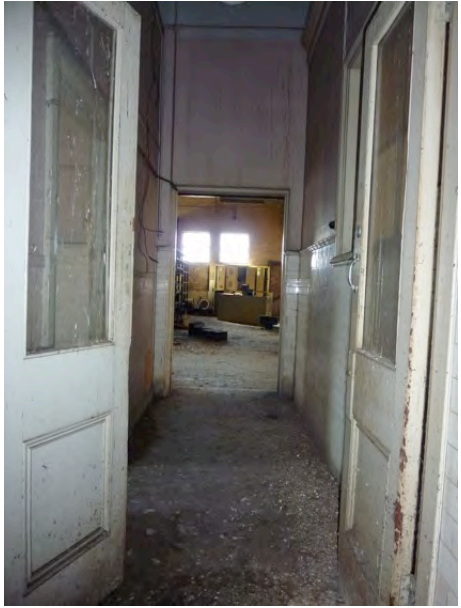
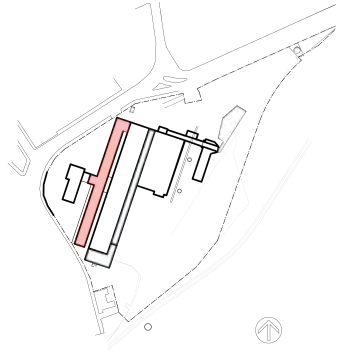
| Walls: Pigeon damage | |
| Ceiling: missing | |

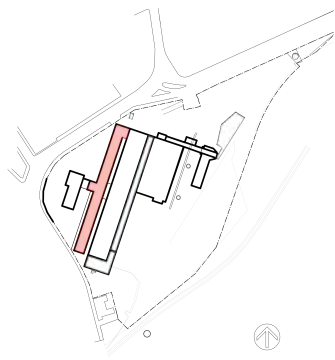
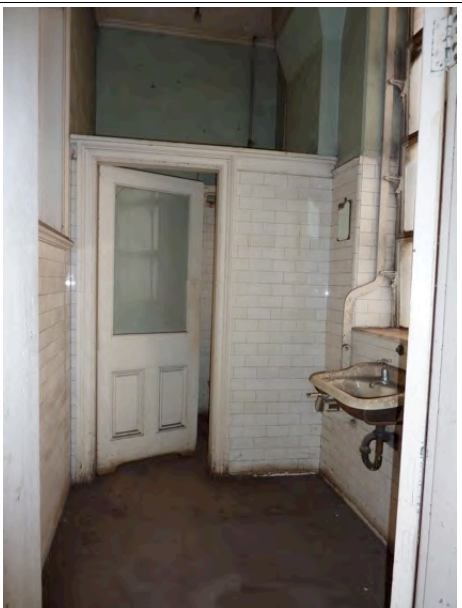
| Room/Item: TOILET | | Room reference: SH 3.4 |

| Ceiling: ok, small hole in one panel, evidence of water damage. | | |
| Doors: Ok, architrave missing on outer door | | |

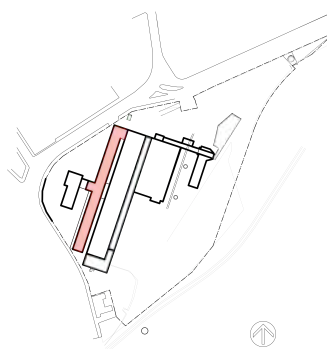
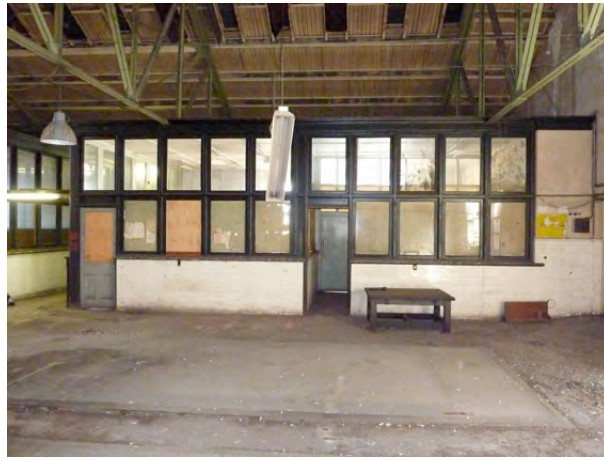
| Room/Item: ROOM | | Room reference: SH 3.7 | |

| Walls: | Ok, except for severe water damage to W wall. |
| Ceiling: | Badly water damaged |
| Other: | Old telephone in poor condition |

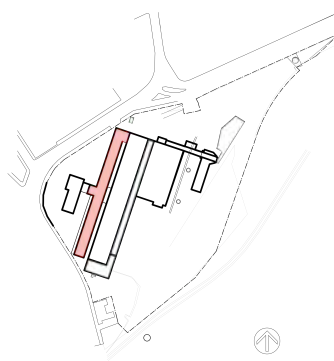
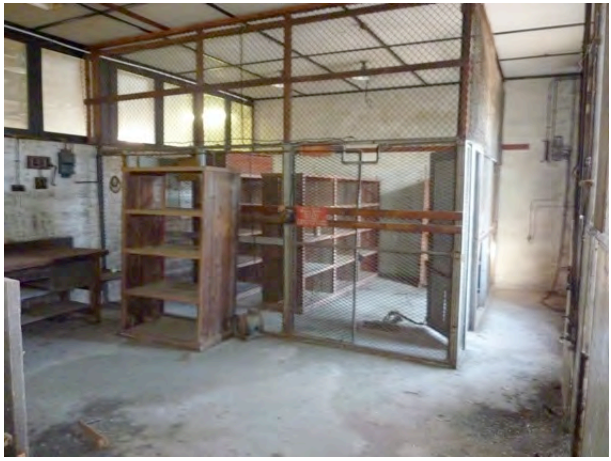
| Condition: Floor: ok Skirting: Walls: W: bad water damage, render has come off, rest OK. Cornice: Ceiling: ok – 1 sheet holed Doors: Missing Windows: W: 9 broken E: Good N: 1 pane missing Other: | | |

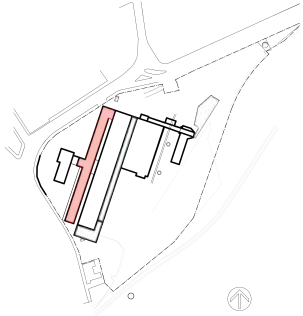
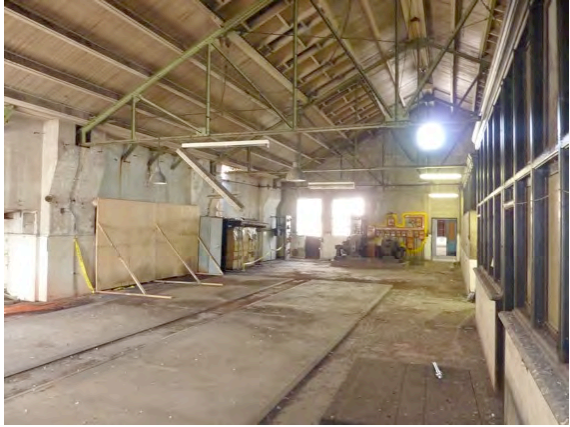
| <p>Floor: Water damaged floor to bay window over TH. Two have caution tape and are blocked for safety.</p> <p>Walls: OK. Some water damage on E wall. E side: Failed gutter above S oriol window – new roof over machinery with gutter & DP as temporary repair. W: Partition walls - OK. - Timber excellent. - Glazing intact. - Good joinery.</p> <p>Cornice: -</p> <p>Ceiling: Some water ingress.</p> <p>Doors: N: Both OK. S: To SH 4.7 missing. – N & S to fire escape rusty but repairable.</p> <p>Windows: Oriol: N: 3 broken, 2 whole. M: 1 holed but OK, S 1 broken but OK. N: OK - 1 missing. S: 8 damaged, 1 missing. Circular joinery in S might need replacement.</p> <p>Other:</p> | |

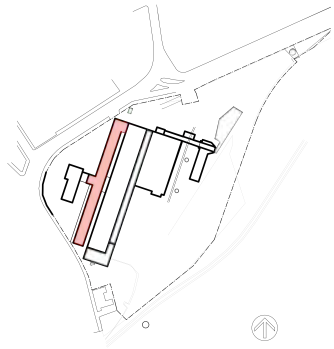
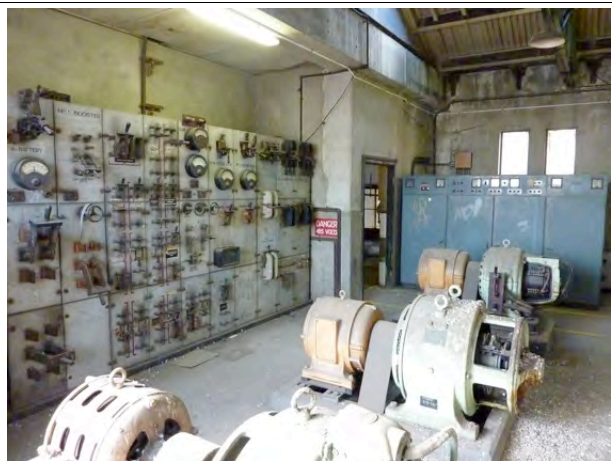
| Condition: | <p>Floor: OK, pigeon damage</p> <p>Skirting: -</p> <p>Walls: Water damage, tiles missing to W</p> <p>Cornice: -</p> <p>Ceiling: OK. Some water damage. W: Skylights corrugated over. E: skylight glass cracked.</p> <p>Doors: S: See 3.11</p> <p>Windows: W: 6 cracked. E: OK.</p> <p>Other:</p> |

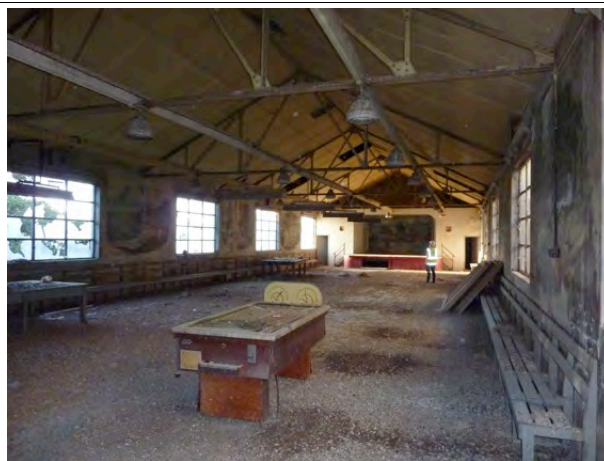
| Room/Item: LEVEL 4 - ENTERTAINMENT ROOM | | Room reference: SH 3.14 |

| Walls: | Water damage to all murals. | |
| Ceiling: | Fibro panels missing x4. | |
| Windows: | Minor aluminium corrosion. W & S most panes smashed, E: All panes in good condition. | |

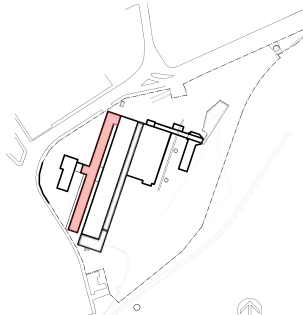
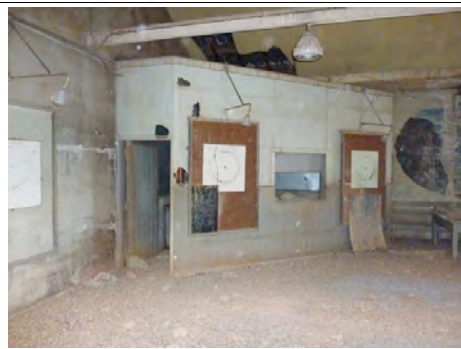
| Room/Item: | ENTERTAINMENT HALL - KITCHEN | Room reference: SH 3.15 |

| Walls: | N/E: Some FC sheets have holes. Very little pigeon damage to wall. S: Tiles in good condition - crack in render. W: Render cracking. |
| Doors: | Damaged by pigeon. |
| Other: | All cupboards are very badly damaged by pigeon matter; otherwise intact. Birds using these cupboards as nesting space. Record player damaged by pigeons. Water heater - pigeon nesting inside. |

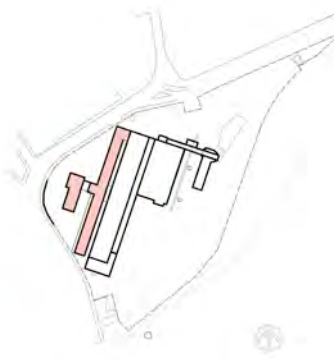
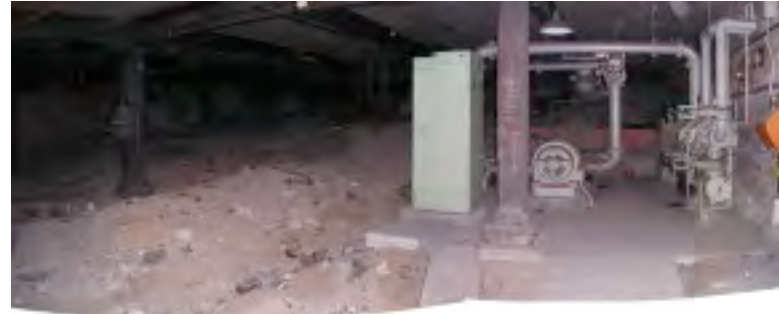
| Room/Item: 1948 SUB FLOOR (CENTRE) | | Survey date: 20.6.02 | |

| Doors: | 1 door leaf missing. Existing requires repair. Timber hatches require repair and 1 is missing. |
| Other: | Timber wall requires repair |

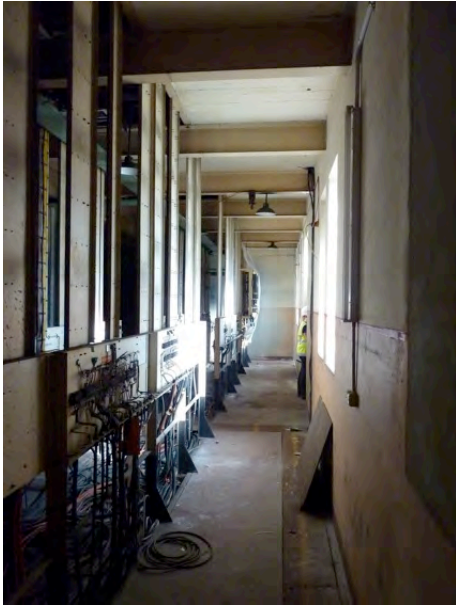
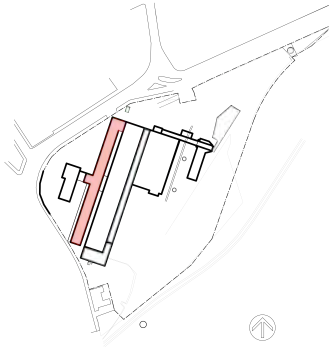
| Room/Item: CABLE ROOM | | Room reference: CS 1.1 |

| Floor: | Good – some cover plates moved around and possible a couple missing | |
| Doors: | - ok – minor repair needed | |

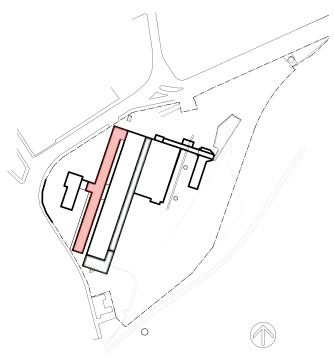
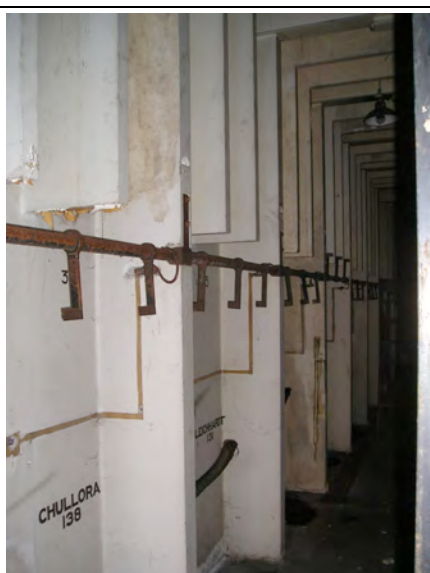
| Room/Item: BUS FLOOR (MIDDLE) WEST & EAST HALVES | | Survey date: 19.08.10 | |

| Walls: Good except S in W corner – damp damage to render | | | |

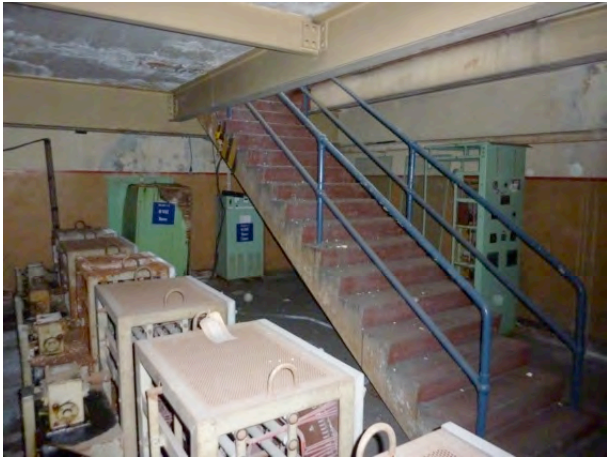
| Room/Item: RHEOSTAT ROOM | Survey date: 19.08.10 |

| Floor: OK, paint peeling and salt damaged |
| Walls: OK. Some water damage. |
| Ceiling: Cracks & water damage, some spalling |

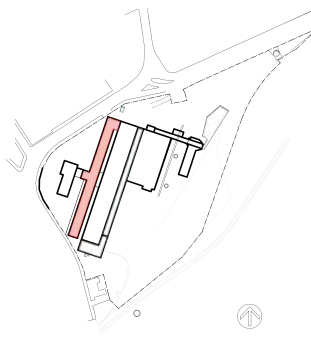
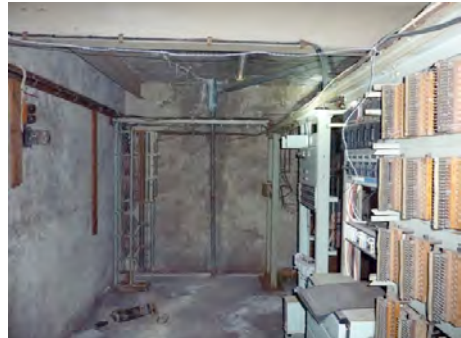
| Condition: Floor: Ok. Skirting: - Walls: OK. Cornice: - Ceiling: Some cracking and salt stalactites Doors: OK. Windows: Other: |

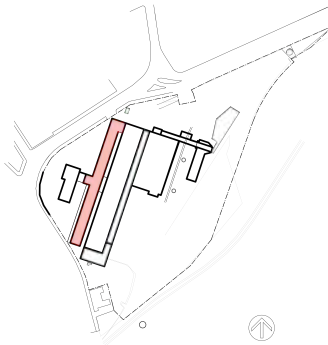
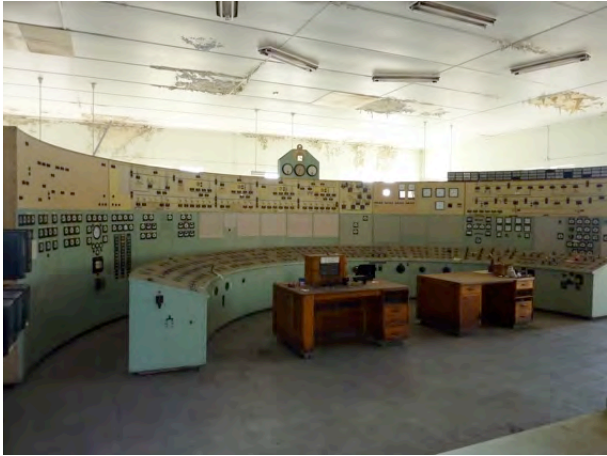
| Walls: | Paint cracking & peeling due to water damage on all walls, but worse on W wall. Graffiti painted over. | | |
| Ceiling: | Water damage due to some panels. At least 2 panels missing. | | |

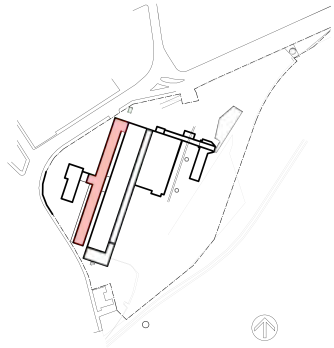
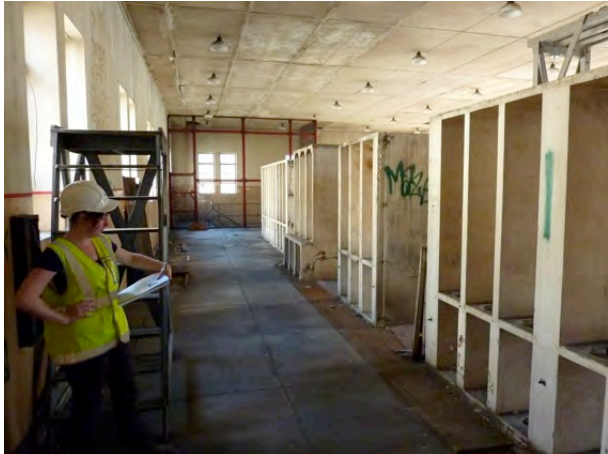
| Room/Item: | 25 CYCLE SWITCH FLOOR | | Room reference: CS 2.2 |

Walls: Ivy growing through W/S corner, badly water damaged esp. at corners

Ceiling: Severe water damage. 5 sheets broken and collapsed from water entry & weight of soot/dirt in ceiling

Doors: 1 leaf on floor, glazing missing, 2nd door missing.

Windows: Steel generally ok – some corrosion but not serious. Many glass panes broken

Other: Box gutters along E & W walls in bad condition (copper broken)

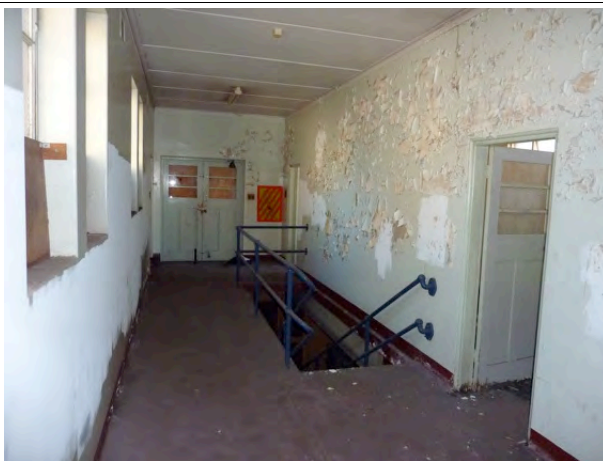
| Walls: Water damage. Paint flaking off. | | | |
| Windows: Broken panes, boarded up | | | |

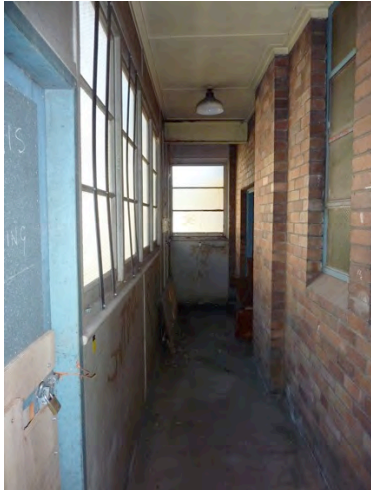
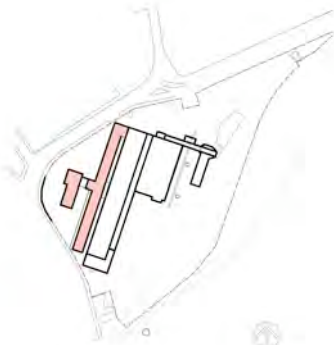
| Room/Item: PASSAGE | | Survey date: 19.08.10 | |

| Ceiling: Water damage at N end. | | | |
| Windows: All noted as intact in 2002. Now 1 smashed and 1 cracked. | | | |
