Waterloo Estate (South) – wind assessment report

Further to our recent correspondence, please find herein a brief comparative report detailing the impact of the changes to the Waterloo Estate (South) envelope Masterplan on the expected wind conditions in and around the site. This report follows on from the Arup environmental wind assessment report dated 28 January 2021, and a review of the Hassell Waterloo Estate South, Urban Design review Envelope Approach document dated 21 October 2021.

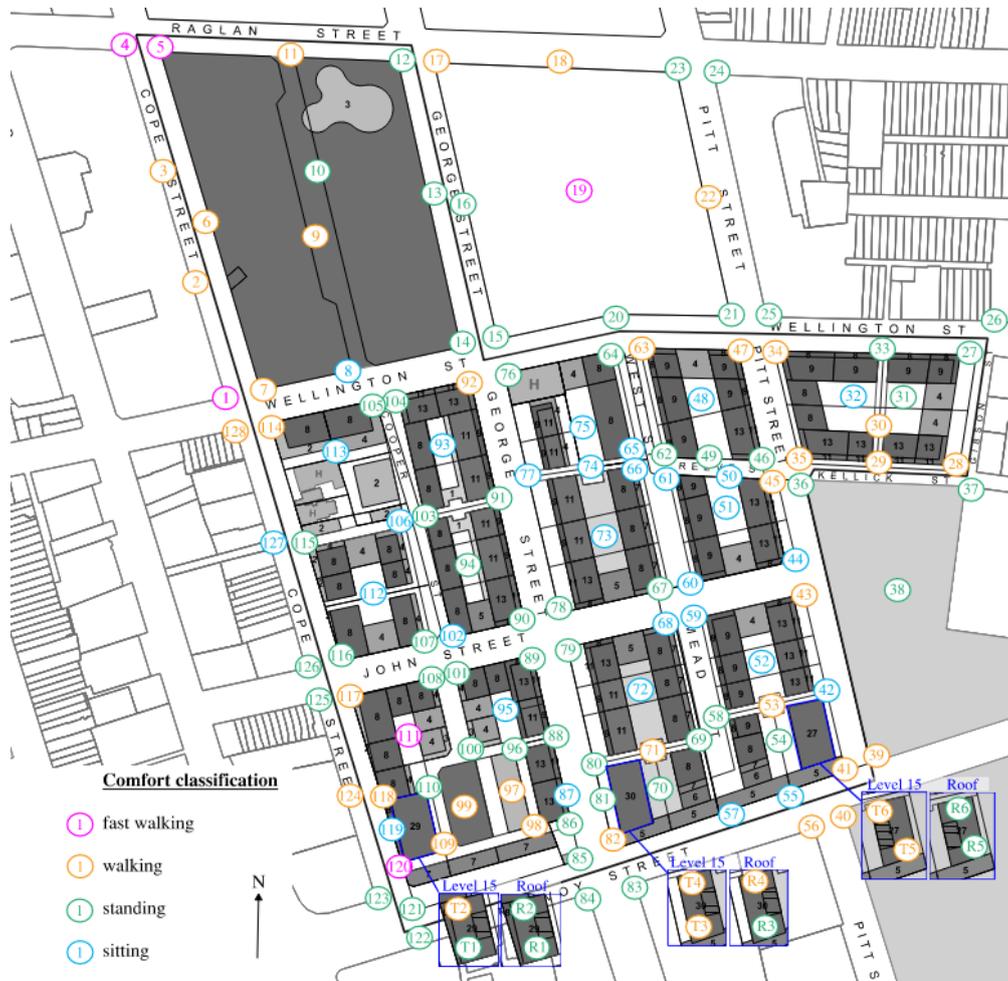
Figure 1: Summary of test locations and comfort classification

From the previous wind-tunnel testing on a base scheme, the wind conditions on the ground plane at all locations around the site met the safety criterion. Test locations around the outer corners of the entire development, particularly close to the southern towers were close to the safety limit, and caused by the proposed development. The results for comfort classification are reproduced in Figure 1. Locations classified as suitable for walking (orange), or fast walking (pink) approached the safety criterion. The poor wind conditions to the north of Wellington Street were not caused by the Waterloo Estate (South) buildings.

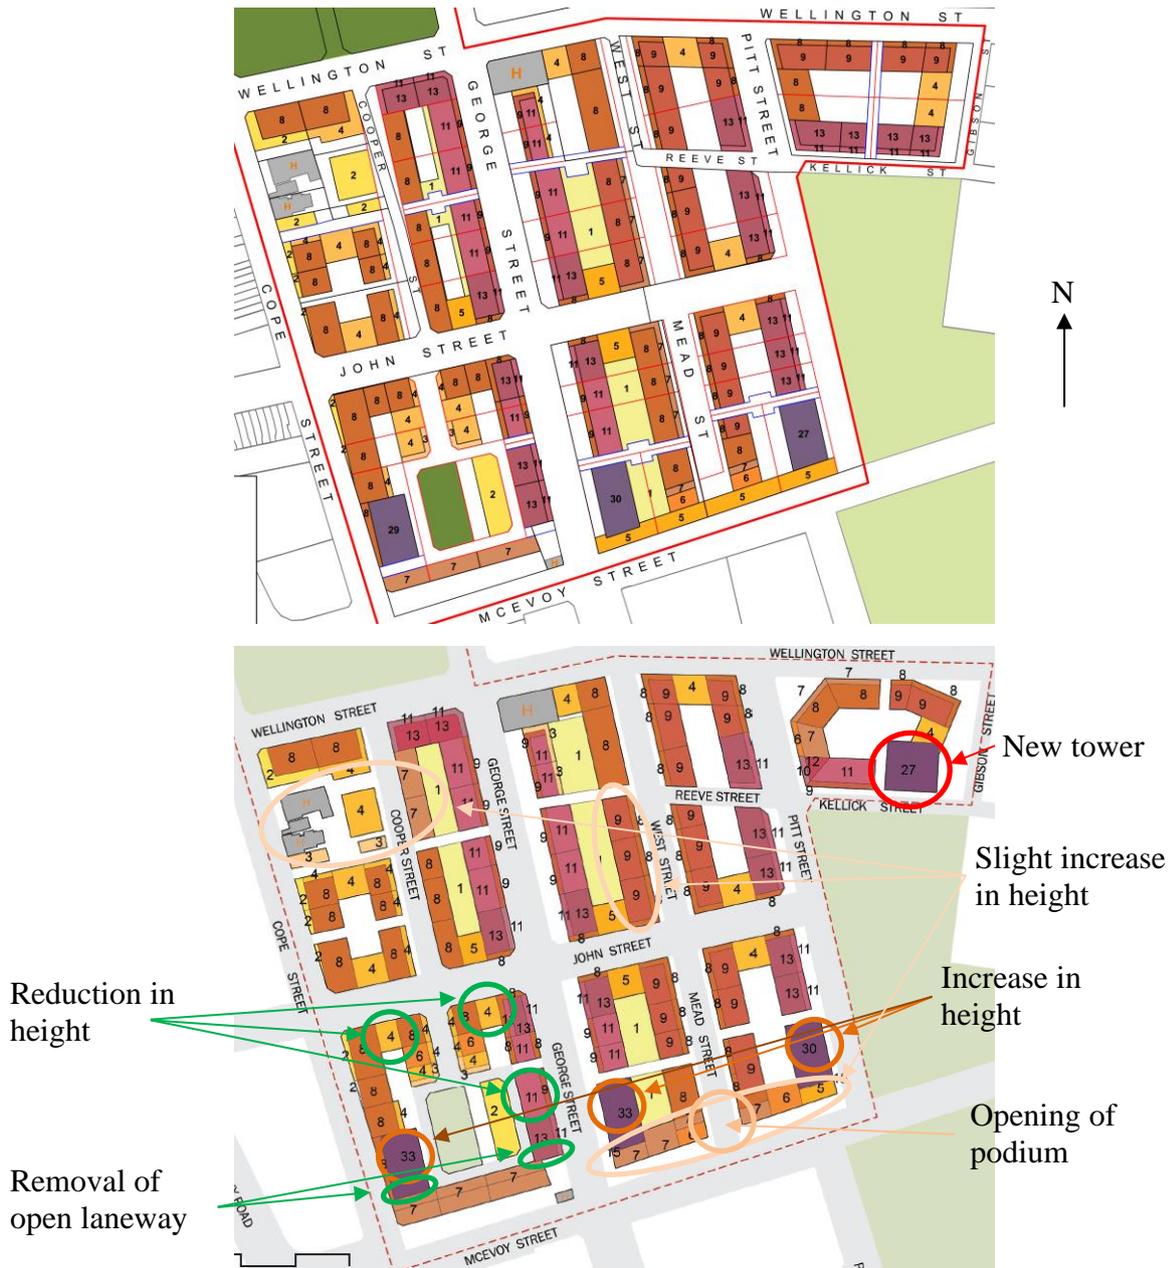
Figure 2: Building height in storeys: as tested (T), preferred proposed (B)

Comparative drawings between the building heights used for the wind-tunnel testing and the current configuration are presented in Figure 2. The tower heights tested in the original wind-tunnel study were lower than the maximum envelope height of RL126.4 m, which are retained in the current scheme. In Figure 2, the primary changes are annotated on the proposed scheme and colour coded with benefit from a wind perspective. It is evident the general orientation, layout, and massing of the development precinct has not changed. The main changes from a wind safety perspective, in order of importance, are:

1. the additional tall tower in the north-east corner,
2. enclosing the laneway from Cope Street in the south-west corner,
3. increase in height of the three southern towers,
4. proposed removal of the mid-height building slots, Figure 3, and
5. the opening of the southern podium along McEvoy Street.

The preferred location of the additional tower on Kellick Street to the north-east of the site, Figure 2, is not ideally located from a wind perspective. A tall building in this elevated location is exposed to all prevailing strong wind directions. The wind conditions at Location 28, on the corner of Kellick and Gibson Streets, Figure 1, approached the safety criterion. With the significant increase in building massing, this and nearby locations along Gibson and Kellick Streets, and Waterloo Park would be expected to exceed the safety criterion. The ground level wind conditions would improve significantly if the tower were moved to the west away from the corners of the block. The tower location allows the retention of three mature trees on the corner of Kellick and Gibson Streets, which will improve the wind conditions around this corner, but as not permanent should not be relied on to mitigate safety conditions. If this is not possible to move the tower for other design

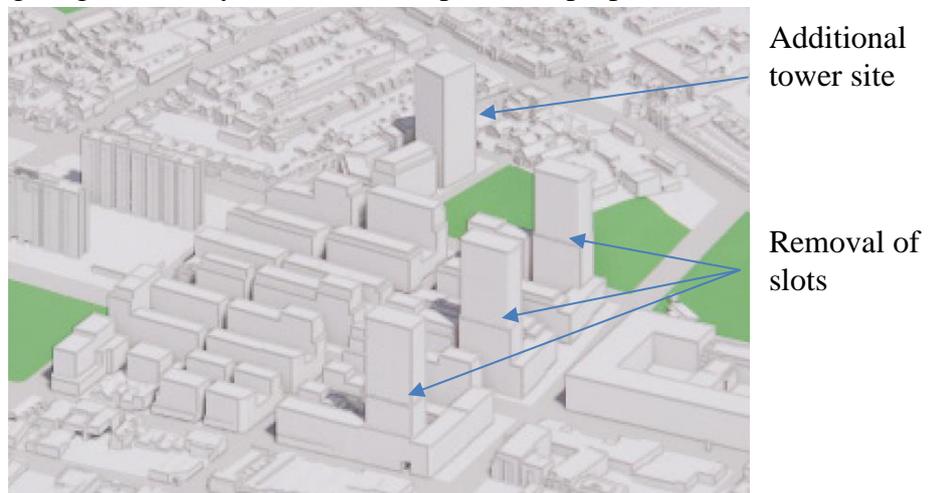
Figure 3: Aerial view looking east of preferred scheme

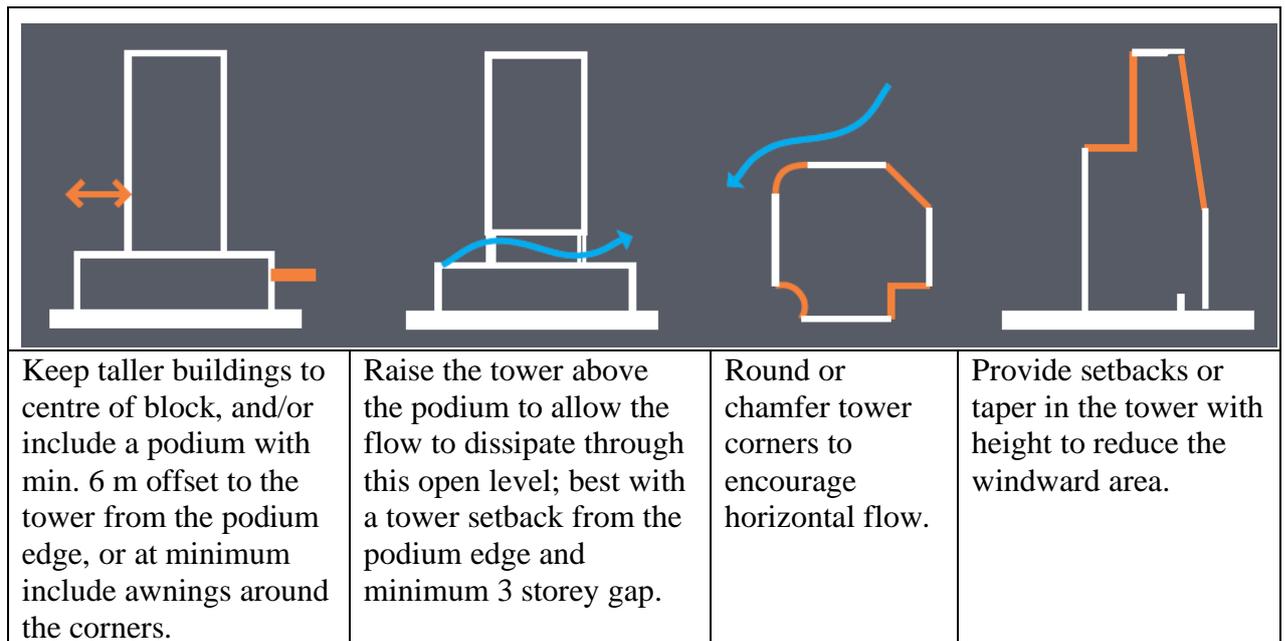
Figure 4: Methods to improve pedestrian level wind conditions

The removal of the mid-height slots and 3-4 storey increase in height to the three southern towers, and the enclosing of the Laneway from Cope Street, would all be expected to increase the wind conditions around the corner of McEvoy and Cope Streets. Without the mature trees in the vicinity of the corner, the wind conditions would be expected to exceed the safety criterion. It is understood that the current design is an envelope, and the final tower volume would be smaller by 10-15%. With appropriate sculpting of the Envelope tower form, it is considered that the safety wind conditions could be achieved, as per the previous testing. The safety wind conditions could be ameliorated with altering the building massing for example by rounding the south-west corner, increasing the tower setback from the podium edge to the west, reducing the height of the tower, introducing appropriate place articulation, and incorporating an awning structure around the corner. Some generic information to improve the wind conditions around an isolated tall building is provided in Figure 4.

requirements, the amelioration techniques through shaping of the tower, as discussed above and in Figure 4, should be used to improve the wind conditions. The wind conditions around this isolated tall tower will require significant consideration of the building geometry to improve the wind conditions to a safe level
