RE: DIGITAL SIGNAGE – M2 MOTORWAY, EPPING RESPONSE TO SUBMISSIONS

As requested, please find herein The Transport Planning Partnership (TTPP)'s Response to Submissions to road safety queries made by government agencies for the proposed digital signage on the M2 Motorway in Epping.

Sydney Trains is seeking approval to install two new digital sign boards off the sides of the existing overhead railway bridge above the M2 Motorway in Epping. The proposed digital signage is to be located on both sides of the rail bridge, facing eastbound and westbound travel lanes on the M2 Motorway.

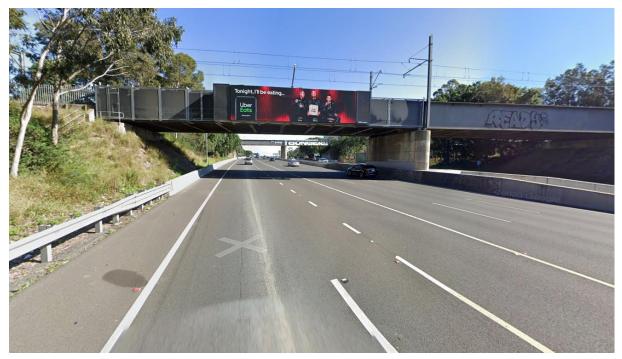
Figure 3: M4 Motorway (Homebush) On-Ramp Merge Point

Unlike the proposed signage on the M2 Motorway, the on-ramp merge point with the adjacent through lane on the M4 Motorway is located prior to the signage at which point the digital signage is visible to motorists. This is shown in Figure 3. On the M2 Motorway, the merge point is located beyond the proposed digital signage as shown in Figure 4.

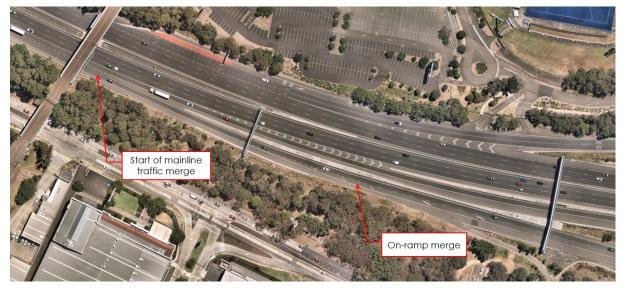
Figure 5: M4 Motorway Merge on On-Ramp

In addition, the M4 Motorway example includes a merge prior on the on-ramp (prior to the merge with the mainline traffic) which is similar to the M2 Motorway. This is shown in Figure 5.

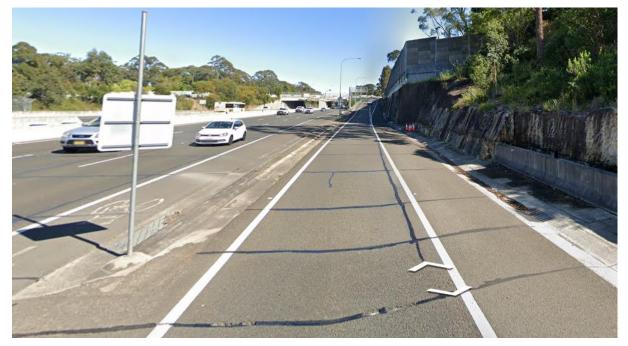
Figure 6: Cyclist's View of M2 Motorway On-Ramp at the Cycle Crossing

Firstly, a cyclist is required to give-way to oncoming traffic and find a suitable gap prior to crossing the traffic stream. From this location, a cyclist has sufficient sight distance to the top of the on-ramp to observe a safe gap in the traffic stream. From the cyclist give-way point, a bicycle rider has a sight distance of approximately 250 m towards oncoming traffic on the on-ramp which is shown in Figure 6.

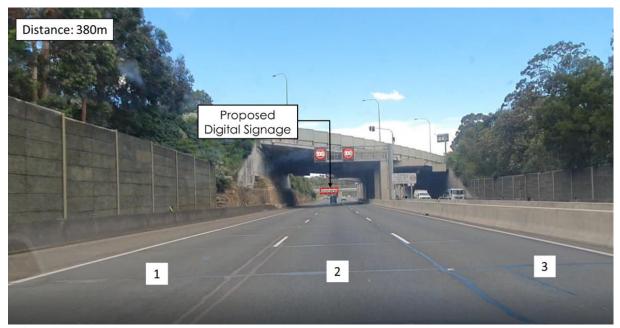
Figure 7: Primary Variable Speed Sign

On the main carriageway the primary variable speed limit signs are located approximately 360m prior to the digital signage at which point the proposed digital signage would not be readable. This is shown in Figure 7. Only momentarily would the secondary variable speed signs overlap with the digital signage behind it. However, given this the secondary set of speed signs and that motorists would have initially observed the speed limit at the primary set of speed signs, the brief overlap of signs would have a minor impact only.

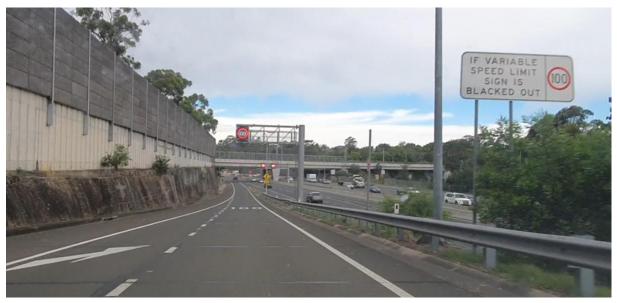
Figure 8: On-Ramp Variable Speed Sign

Within the viewable distance of the digital signage from the on-ramp, the variable speed sign would be positioned well above the proposed digital signage as shown in Figure 8. Therefore, there is minimal potential for the signs to overlap and for the speed sign in the foreground to be obscured by the digital signage in the distance.

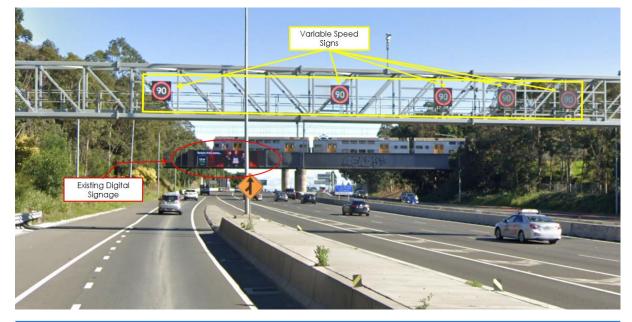
Figure 9: Digital Signage and Variable Speed Signs on M4 Motorway

The location of the proposed digital signage along the M2 Motorway is comparable to that of the earlier example of the M4 Motorway. Within the viewable distance of the digital signage on the M4Motorway there are variable speed signs in front of the digital signage which face the westbound traffic flow as shown in Figure 9. Notably, there is only one set of variable speed signs in the vicinity; the next nearest speed signs are approximately 1 km prior (near Bedford Road side road in Homebush). However, on the M2 Motorway, there are two sets of speed signs which increases the probability of drivers observing the speed zone. The results of the historic crash data analysis for the M4 Motorway show that the presence of the digital signage at this location has not contributed to further crashes. As such, it could be concluded that motorists approaching a digital signage and speed sign within proximity to each other would not result in missed information and unsafe driving conditions.

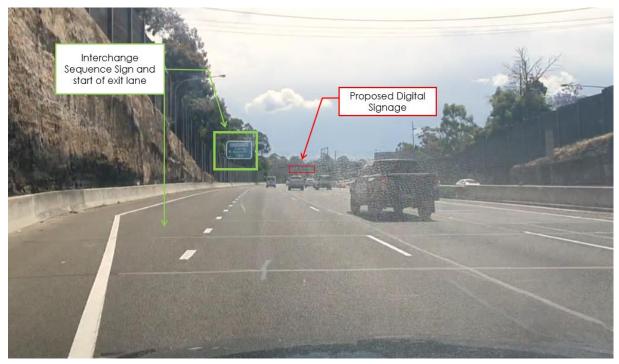
Figure 10: Beecroft Road Exit Ramp

Also, at the diverge point the Beecroft Road exit sign is fully visible and readable by motorists while the digital signage, that is located further in the distance, is not readable (approximately 250 m away from the digital signage). This is shown in Figure 10. Naturally, motorists' attention would be drawn to the Beecroft Road exit sign and diverge point since they are more visible than the digital signage in the background. Therefore, the digital signage is unlikely to distract motorists' attention resulting in a sudden lane change to exit the M2 Motorway.

As addressed in the response to City of Parramatta Council Submission #4, at the diverge point the Beecroft Road exit sign is fully visible and readable by motorists while the digital signage, that is located further in the distance, is not readable (approximately 250 m away from the digital signage). This is shown in Figure 10. Naturally, motorists who are planning to exit the motorway would direct their attention to the Beecroft Road exit sign and diverge point since they are more visible than the digital signage in the background. Therefore, the digital signage is unlikely to distract motorists' attention resulting in a sudden lane change to exit the M2 Motorway.

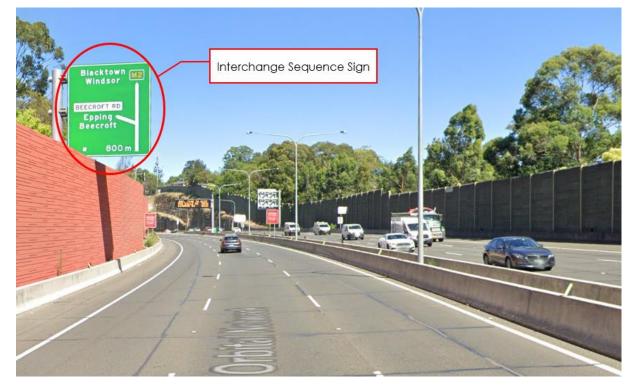
Figure 11: Existing Guidance Sign

In addition, there is an existing guidance sign prior to entering the tunnel, as shown in Figure 11. This advanced directional sign would inform motorists of the upcoming exit to Beecroft Road well ahead of the start of the exit lane.

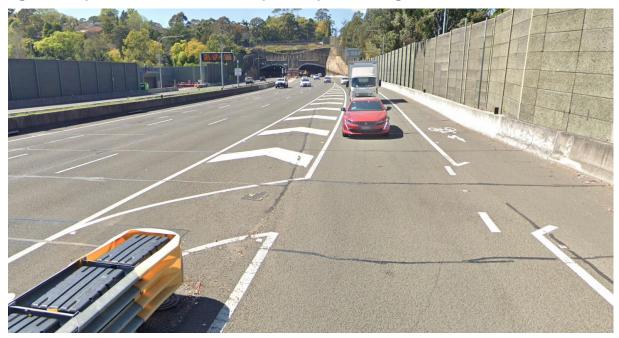
Figure 12: Cyclist's View of M2 Motorway from Cycle Crossing near Beecroft Road Exit

As addressed in Submission #2, a cyclist is required to give-way to oncoming traffic and find a suitable gap prior to crossing the traffic stream. From this location, a cyclist has sufficient sight distance to the tunnel exit to observe a safe gap in the traffic stream. From the cyclist give-way point, a bicycle rider has a sight distance of 240 m towards oncoming traffic from the tunnel exit as shown in Figure 12.

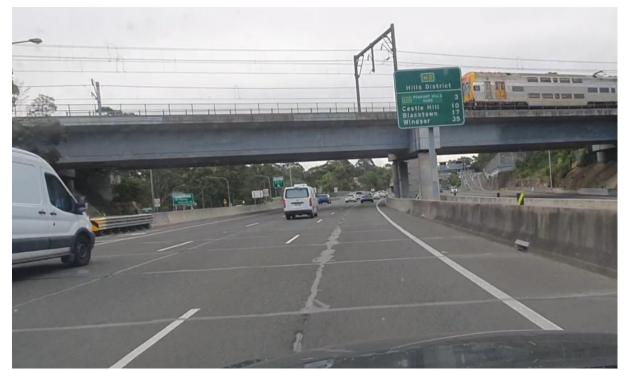
Figure 13: Reassurance Direction Sign

Notwithstanding the above, the nearby signage is a reassurance direction sign which displays distances to the next few suburbs/ areas as shown in Figure 13. The sign does not illustrate diagrammatic information which typically requires greater cognitive capacity to read and interpret when compared to letters and numbers. Therefore, the guidance sign would be visible to motorists and easily interpreted without being obstructed or misconstrued by the digital signage.

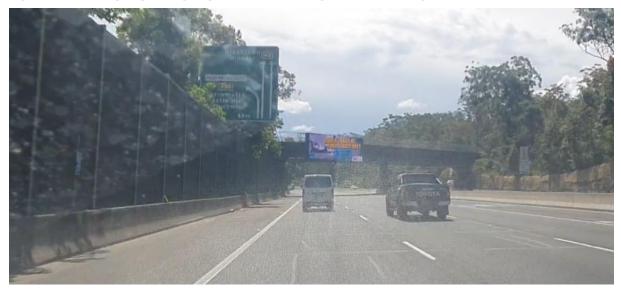
Figure 14: Existing Digital Signage and Interchange Sequence Sign on M2 Motorway

Further to the above, it is noted that there is an existing digital signage located on the M2 Motorway that is within close proximity to an interchange sequence sign. This arrangement is located at the Murray Farm Road overhead bridge approximately 1.6 km west of the proposed digital signage. As shown by the driving view in Figure 14 both signs are within the same line of sight yet do not cause information overload for motorists.

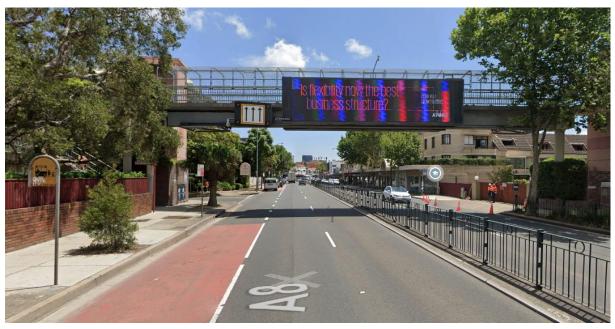
Figure 15: Existing Digital Signage and Lane Directional Sign on Military Road

Another example can be observed on Military Road in Neutral Bay, where there is a digital signage installed adjacent to a lane directional sign on the overhead footbridge. As shown in in Figure 15, the digital signage and the directional sign are within the same line of sight without causing information overload for motorists.

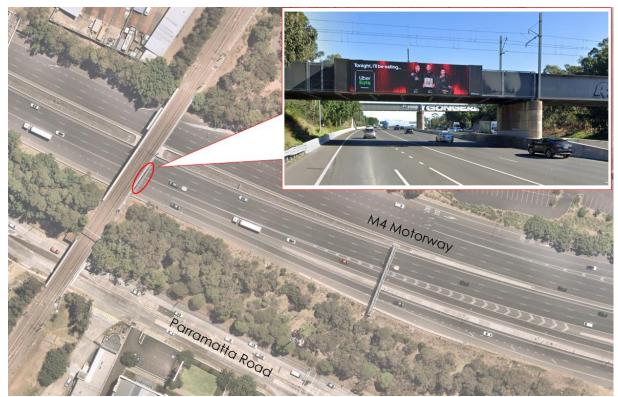
Figure 1: M4 Motorway, Homebush

A digital signage is located on the eastern side of an overhead railway bridge across the M4 Motorway as shown in Figure 1. This digital signage, which was installed on 25 July 2016, is visible to motorists travelling on the M4 Motorway east approach within approximately 350m.

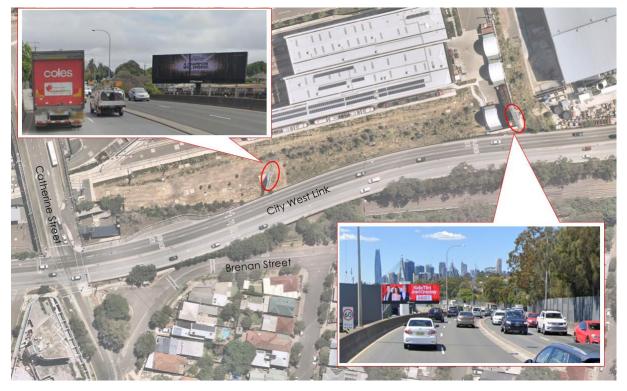
Figure 3: City West Link, Lilyfield

A digital signage is located on the northern side of City West Link at Lilyfield, facing westbound traffic as shown in Figure 3. This digital signage is located 100m east of the intersection of City West Link – Catherine Street. The digital signage, which was installed on 31 October 2016, is visible to motorists travelling on the eastern approach on City West Link within approximately 230m.

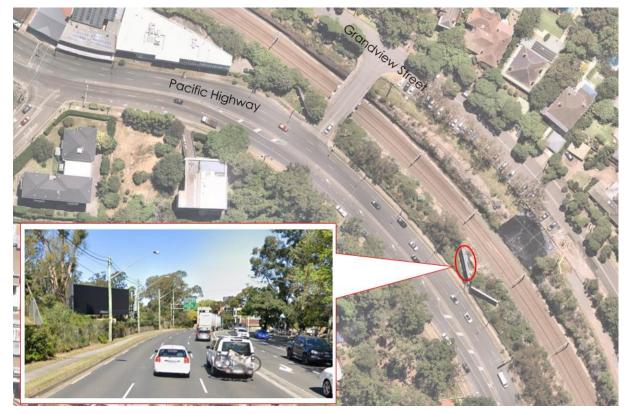
Figure 4: Pacific Highway, Pymble

A digital signage is located on the eastern side of Pacific Highway in Pymble as shown in Figure 4. This digital signage, which was installed on 23 March 2015, is visible to motorists travelling on the north approach on Pacific Highway. The digital signage would become visible immediately after passing the Pacific Highway - Livingstone Avenue intersection which is approximately 180m from the signage.

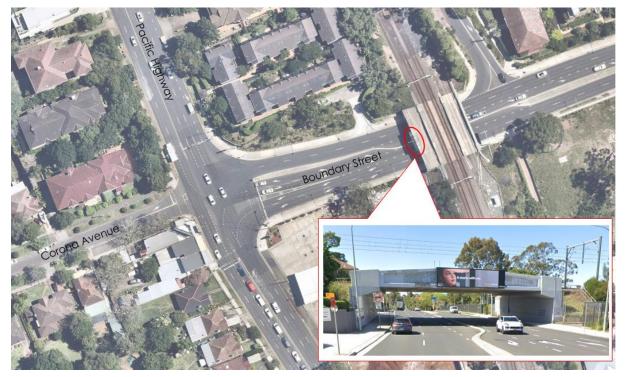
Figure 5: Boundary Street, Roseville

A digital signage is located on the western side of the overhead railway bridge across Boundary Street as shown in Figure 5. This digital signage was installed on 17 July 2017.

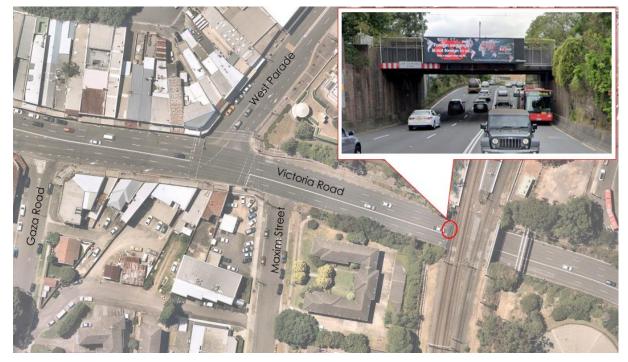
Figure 6: Victoria Road, West Ryde

A digital signage is located on the western side of an overhead railway bridge across Victoria Road in West Ryde as shown in Figure 6 This digital signage, which was installed on 3 October 2016, is visible to motorists travelling on the west approach on Victoria Road from 265m.

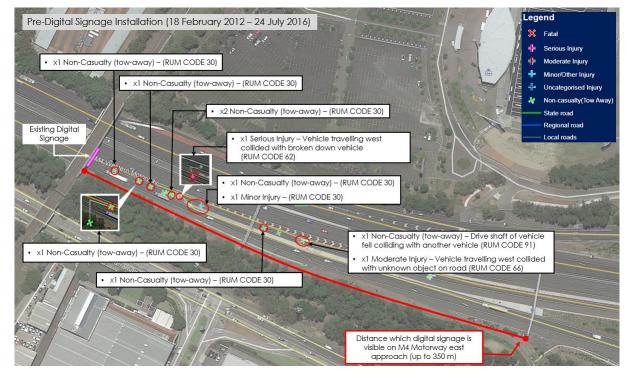
Figure 7: Crash Locations at M4 Motorway, Homebush – Pre-Installation

From Table 1, a total of 11 incidents occurred in the time period prior to the digital signage. The majority of the crashes resulted in no injuries or casualties, only vehicles being towedaway; that is, 8 out of 11 crashes. As a result of the crashes, there was one serious injury, one moderate injury, and one minor injury.

A comparison of crashes pre-installation and during operation of the digital signage is presented in Table 1. The location of crashes recorded during these periods are illustrated in Figure 7 and Figure 8 respectively.

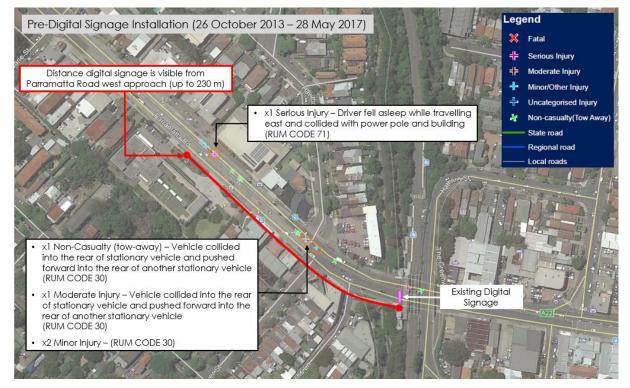
Figure 9: Crash Locations at Parramatta Road, Lewisham – Pre-Installation

In the time period prior to the digital signage, there were a total of five crashes recorded within the visible distance of the digital signage. The serious injury crash was the result of driver fatigue which caused the driver to veer from the carriageway and collide into a power pole (RUM CODE 71). The moderate injury crash was related to a rear end incident. There two minor injuries resulting from rear end collisions (RUM CODE 30), and one crash that resulted in no injuries (tow-away).

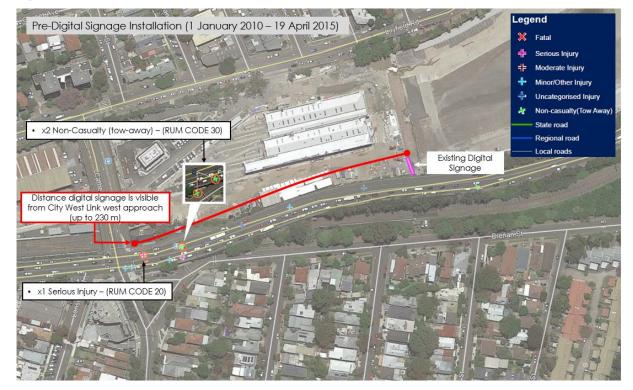
Figure 11: Crash Locations at City West Link (Eastbound), Lilyfield – Pre-Installation

A total of three crashes have been recorded during the five-year period prior to the digital signage. One incident occurred east of the City West Link – Catherine Street intersection which was a head on crash (RUM CODE 20) that resulted in a serious injury. The other two incidents were rear end crashes which resulted in vehicles being towed away.

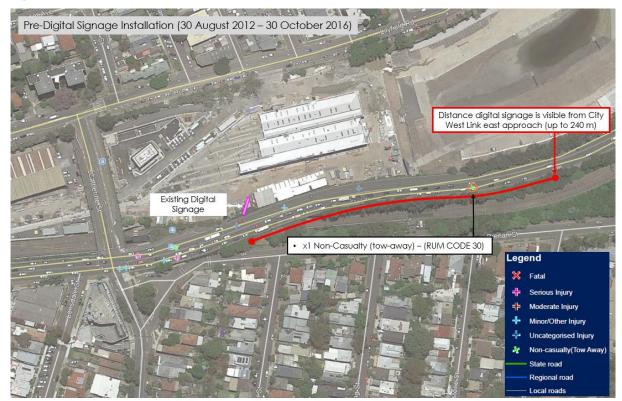
Figure 13: Crash Locations at City West Link (Westbound), Lilyfield – Pre-Installation

During the time period prior to the digital signage, there was one rear end crash which resulted in no injuries and only the vehicle/s being towed away. Since the signage was installed, there have been no crashes recorded within the visible distance on City West Link in the westbound direction.

It is noted that there have been no crashes recorded following installation of the digital signage. A summary of crashes pre-installation of the digital signage is presented in Table 4. The location of crashes recorded pre-installation is illustrated in Figure 13.

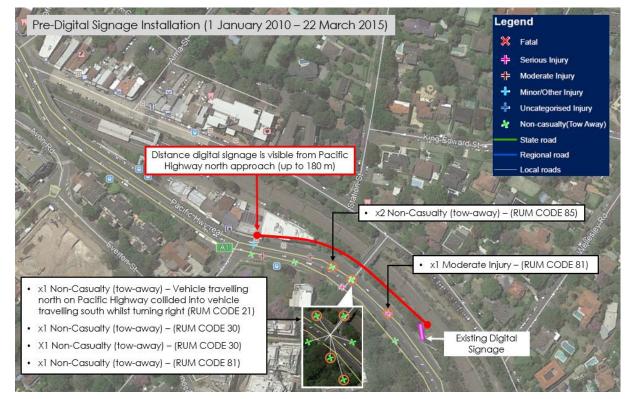
Figure 14: Crash Locations at Pacific Highway, Pymble – Pre-Installation

There were seven crashes recorded within the time period prior to the digital signage. Most of these crashes occurred at the intersection of Pacific Highway with the side road bridge crossing towards Grandview Street, and resulted in no injuries. The crashes include two rear end collisions, a vehicle travelling south colliding into vehicle turning right onto the bridge (RUM CODE 21), and three vehicles veering from carriageway at the bend into an object (RUM CODE 81 and RUM CODE 85). A similar incident occurred approximately 40m south of the bridge where a vehicle veered from the carriageway at the bend into an object resulting in a moderate injury.

A comparison of crashes pre-installation and during operation of the digital signage is presented in Table 5. The location of crashes recorded during these periods are illustrated in Figure 14 and Figure 15 respectively.

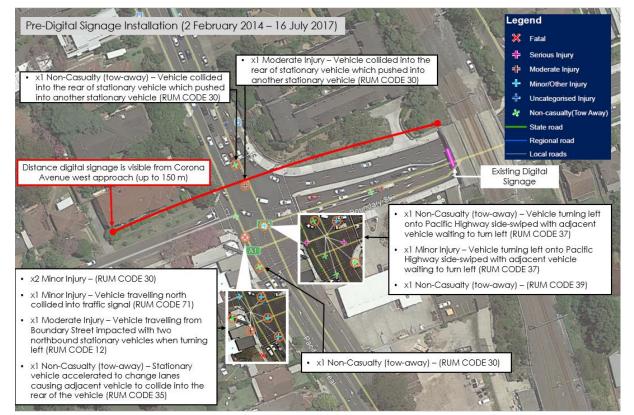
Figure 17: Crash Locations at Boundary Street, Roseville – Pre-Installation

From Table 6, the recorded crashes have all occurred at the intersection of Pacific Highway-Boundary Street. There was a total of 11 crash incidents within the time period prior to the digital signage. Of those 11 crashes, there were two moderate injuries, four minor injuries, and five non-casualties (tow-away). It is noted that these crashes occurred at the signalised intersection of Pacific Highway - Boundary Street where vehicles were recorded as travelling north and south through the intersection. Given that the digital signage is partially obstructed or not visible from the north approach and south approach, such crashes would be unrelated to the presence of a digital signage on Boundary Street.

A comparison of crashes pre-installation and during operation of the digital signage is presented in Table 6. The location of crashes recorded during these periods are illustrated in Figure 17 and Figure 18 respectively.

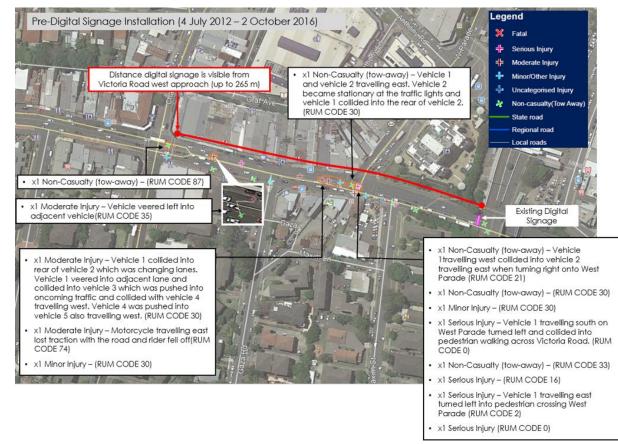
Figure 19: Crash Locations at Victoria Road, West Ryde - Pre-Installation

From Table 7, there are a total of 14 crashes recorded in the period prior to the digital signage. Of these incidents, four crashes resulted in serious injuries, three crashes with moderate injuries, and two crashes with minor injuries. Five crashes resulted in no injuries and a vehicle tow-away.

A comparison of crashes pre-installation and during operation of the digital signage is presented in Table 7. The location of crashes recorded during these periods are illustrated in Figure 19 and Figure 20 respectively.
