Warrawong Plaza

Preliminary Geotechnical Desktop Study

Reference: 296838-REP-GE-DS1

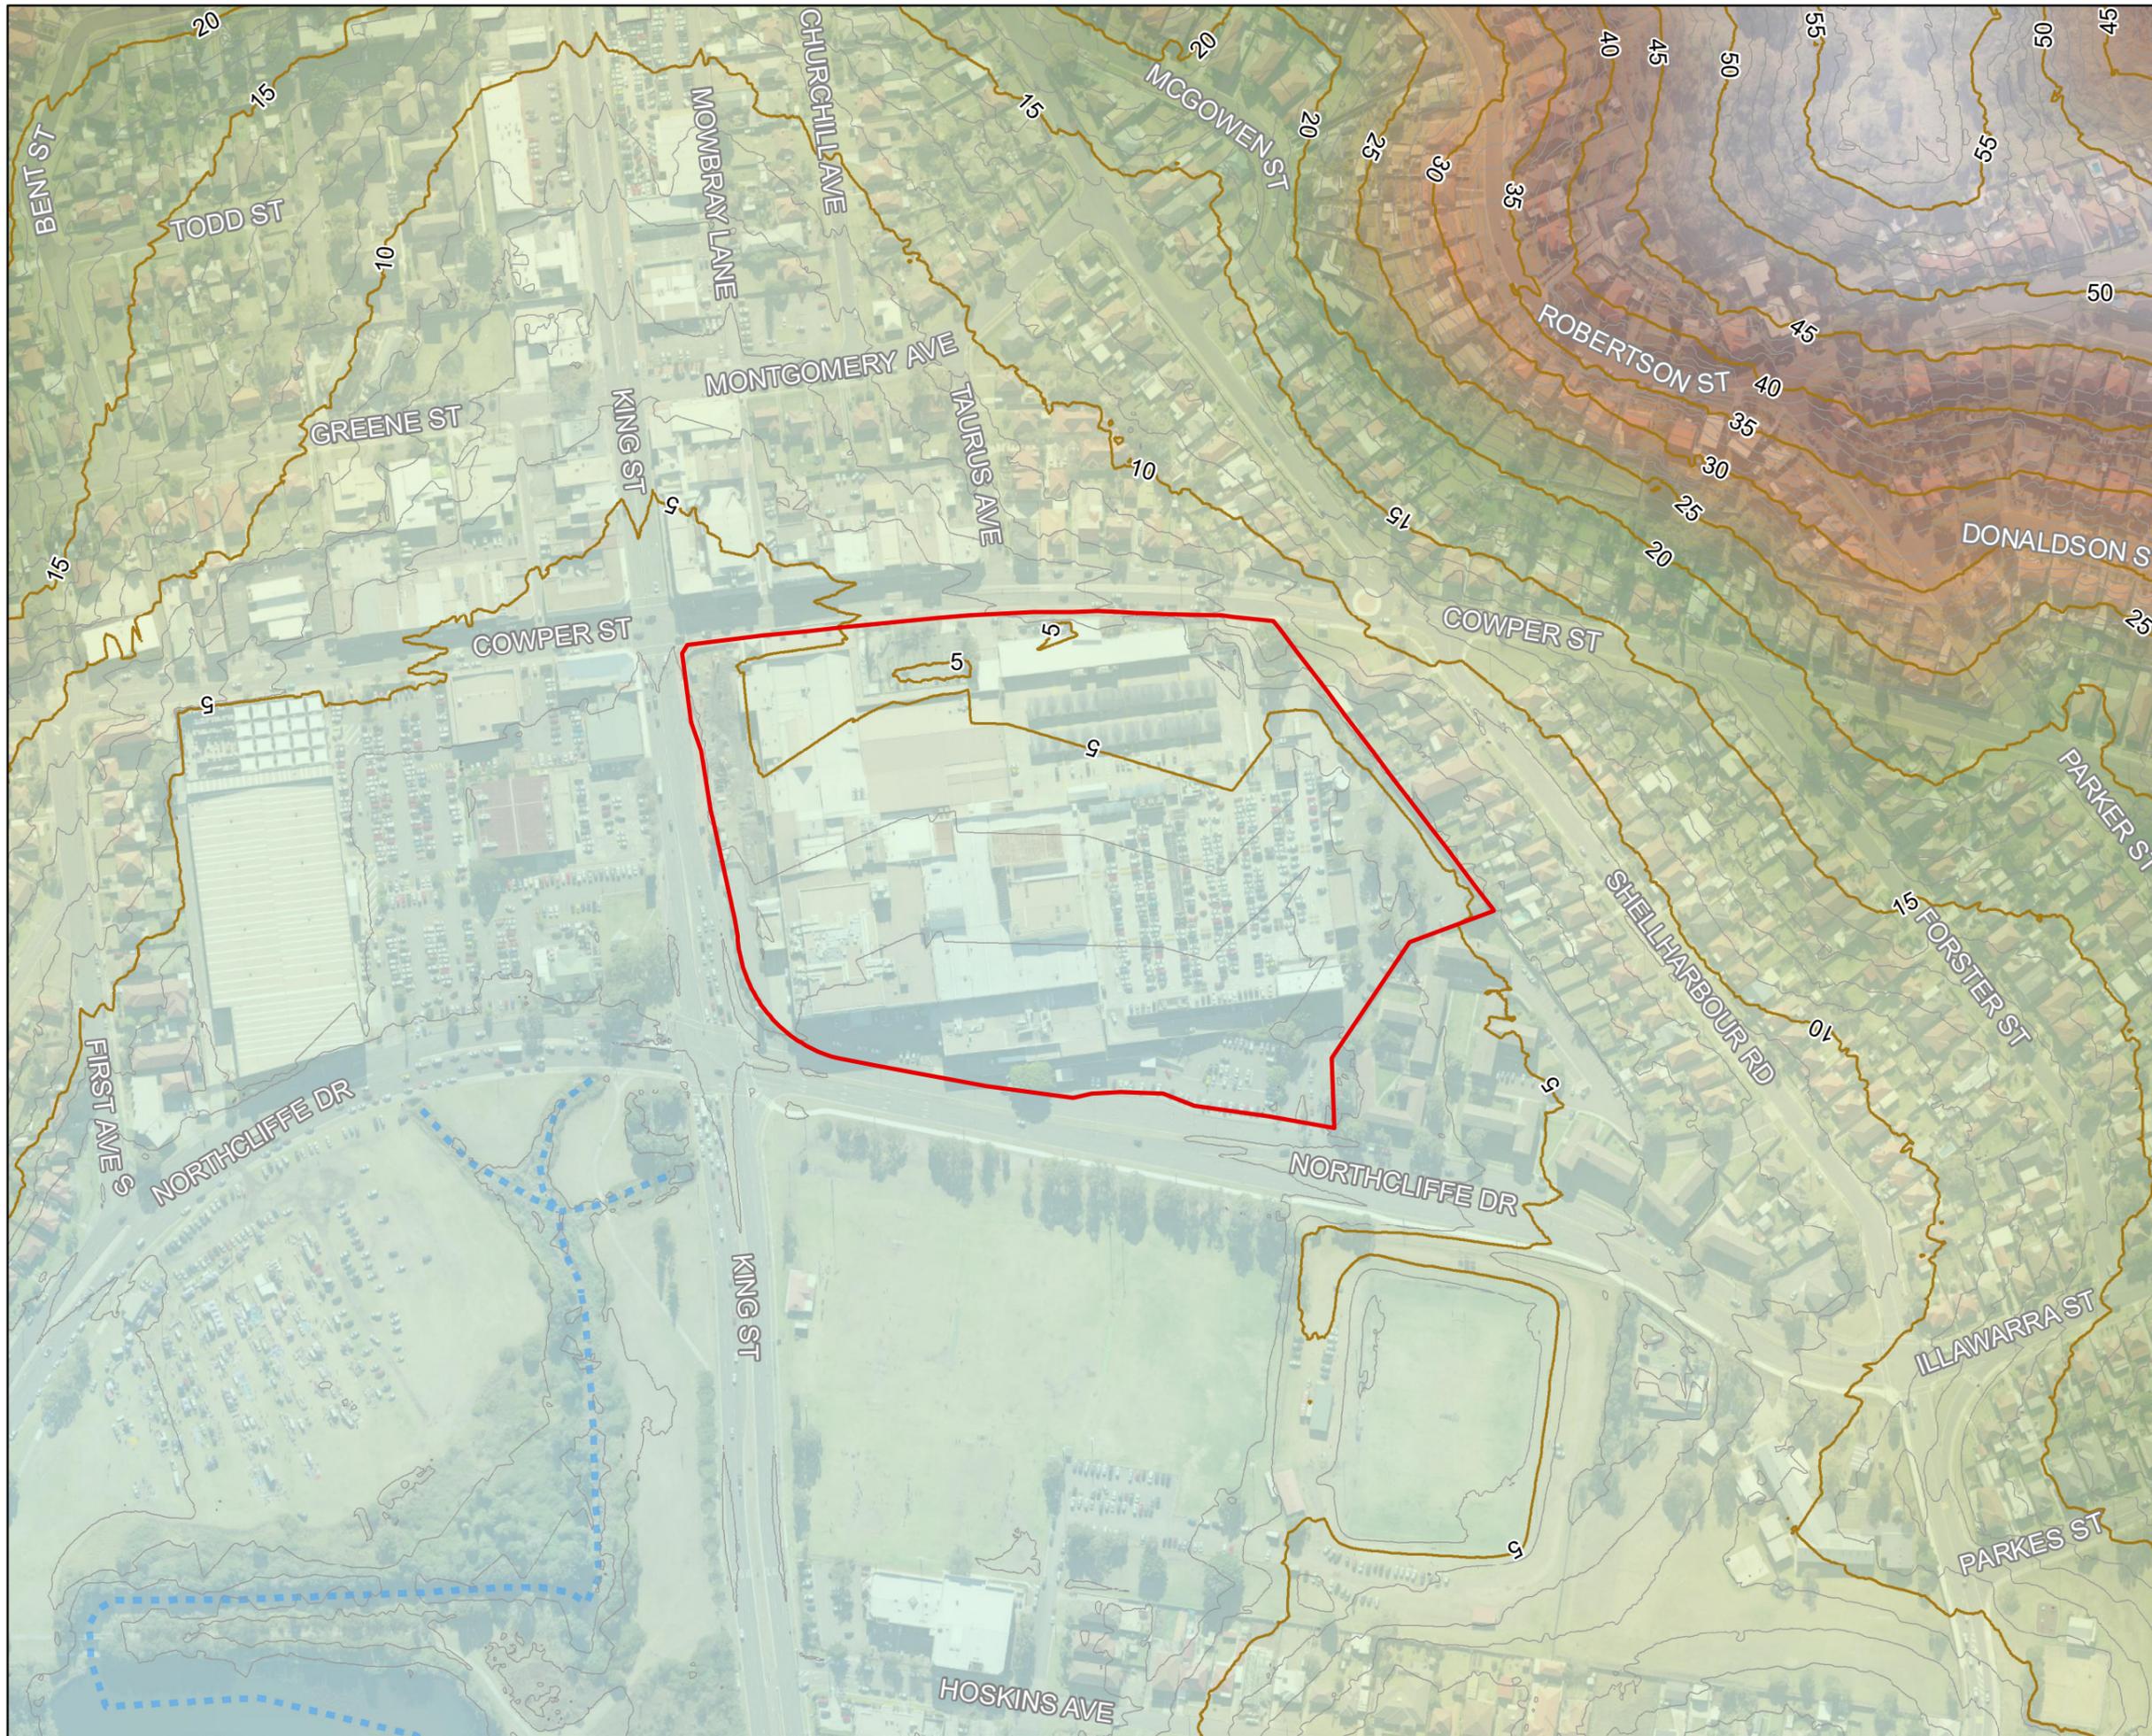
Job No 296838	Figure No 002
-------------------------	-------------------------

- Legend**
- Site Boundary
 - Drainage Lines
 - Contour (5m interval)
 - Contour (1m interval)

A topographic map of the Site is presented in Appendix A Figure 002. The Site is located at a local topographic low bordering the original shoreline of Lake Illawarra prior to reclamation (approximately along Northcliffe Drive). A valley approximate aligns with King Street and may indicate the location of a historic stream. The elevation of the Site is generally level with a gradual dip of approximately 2% from +8.5m AHD in the north-east corner to +3m AHD at the southern / south-eastern boundary of the Site towards Kully Bay which is approximately 500m south-west of the Site.

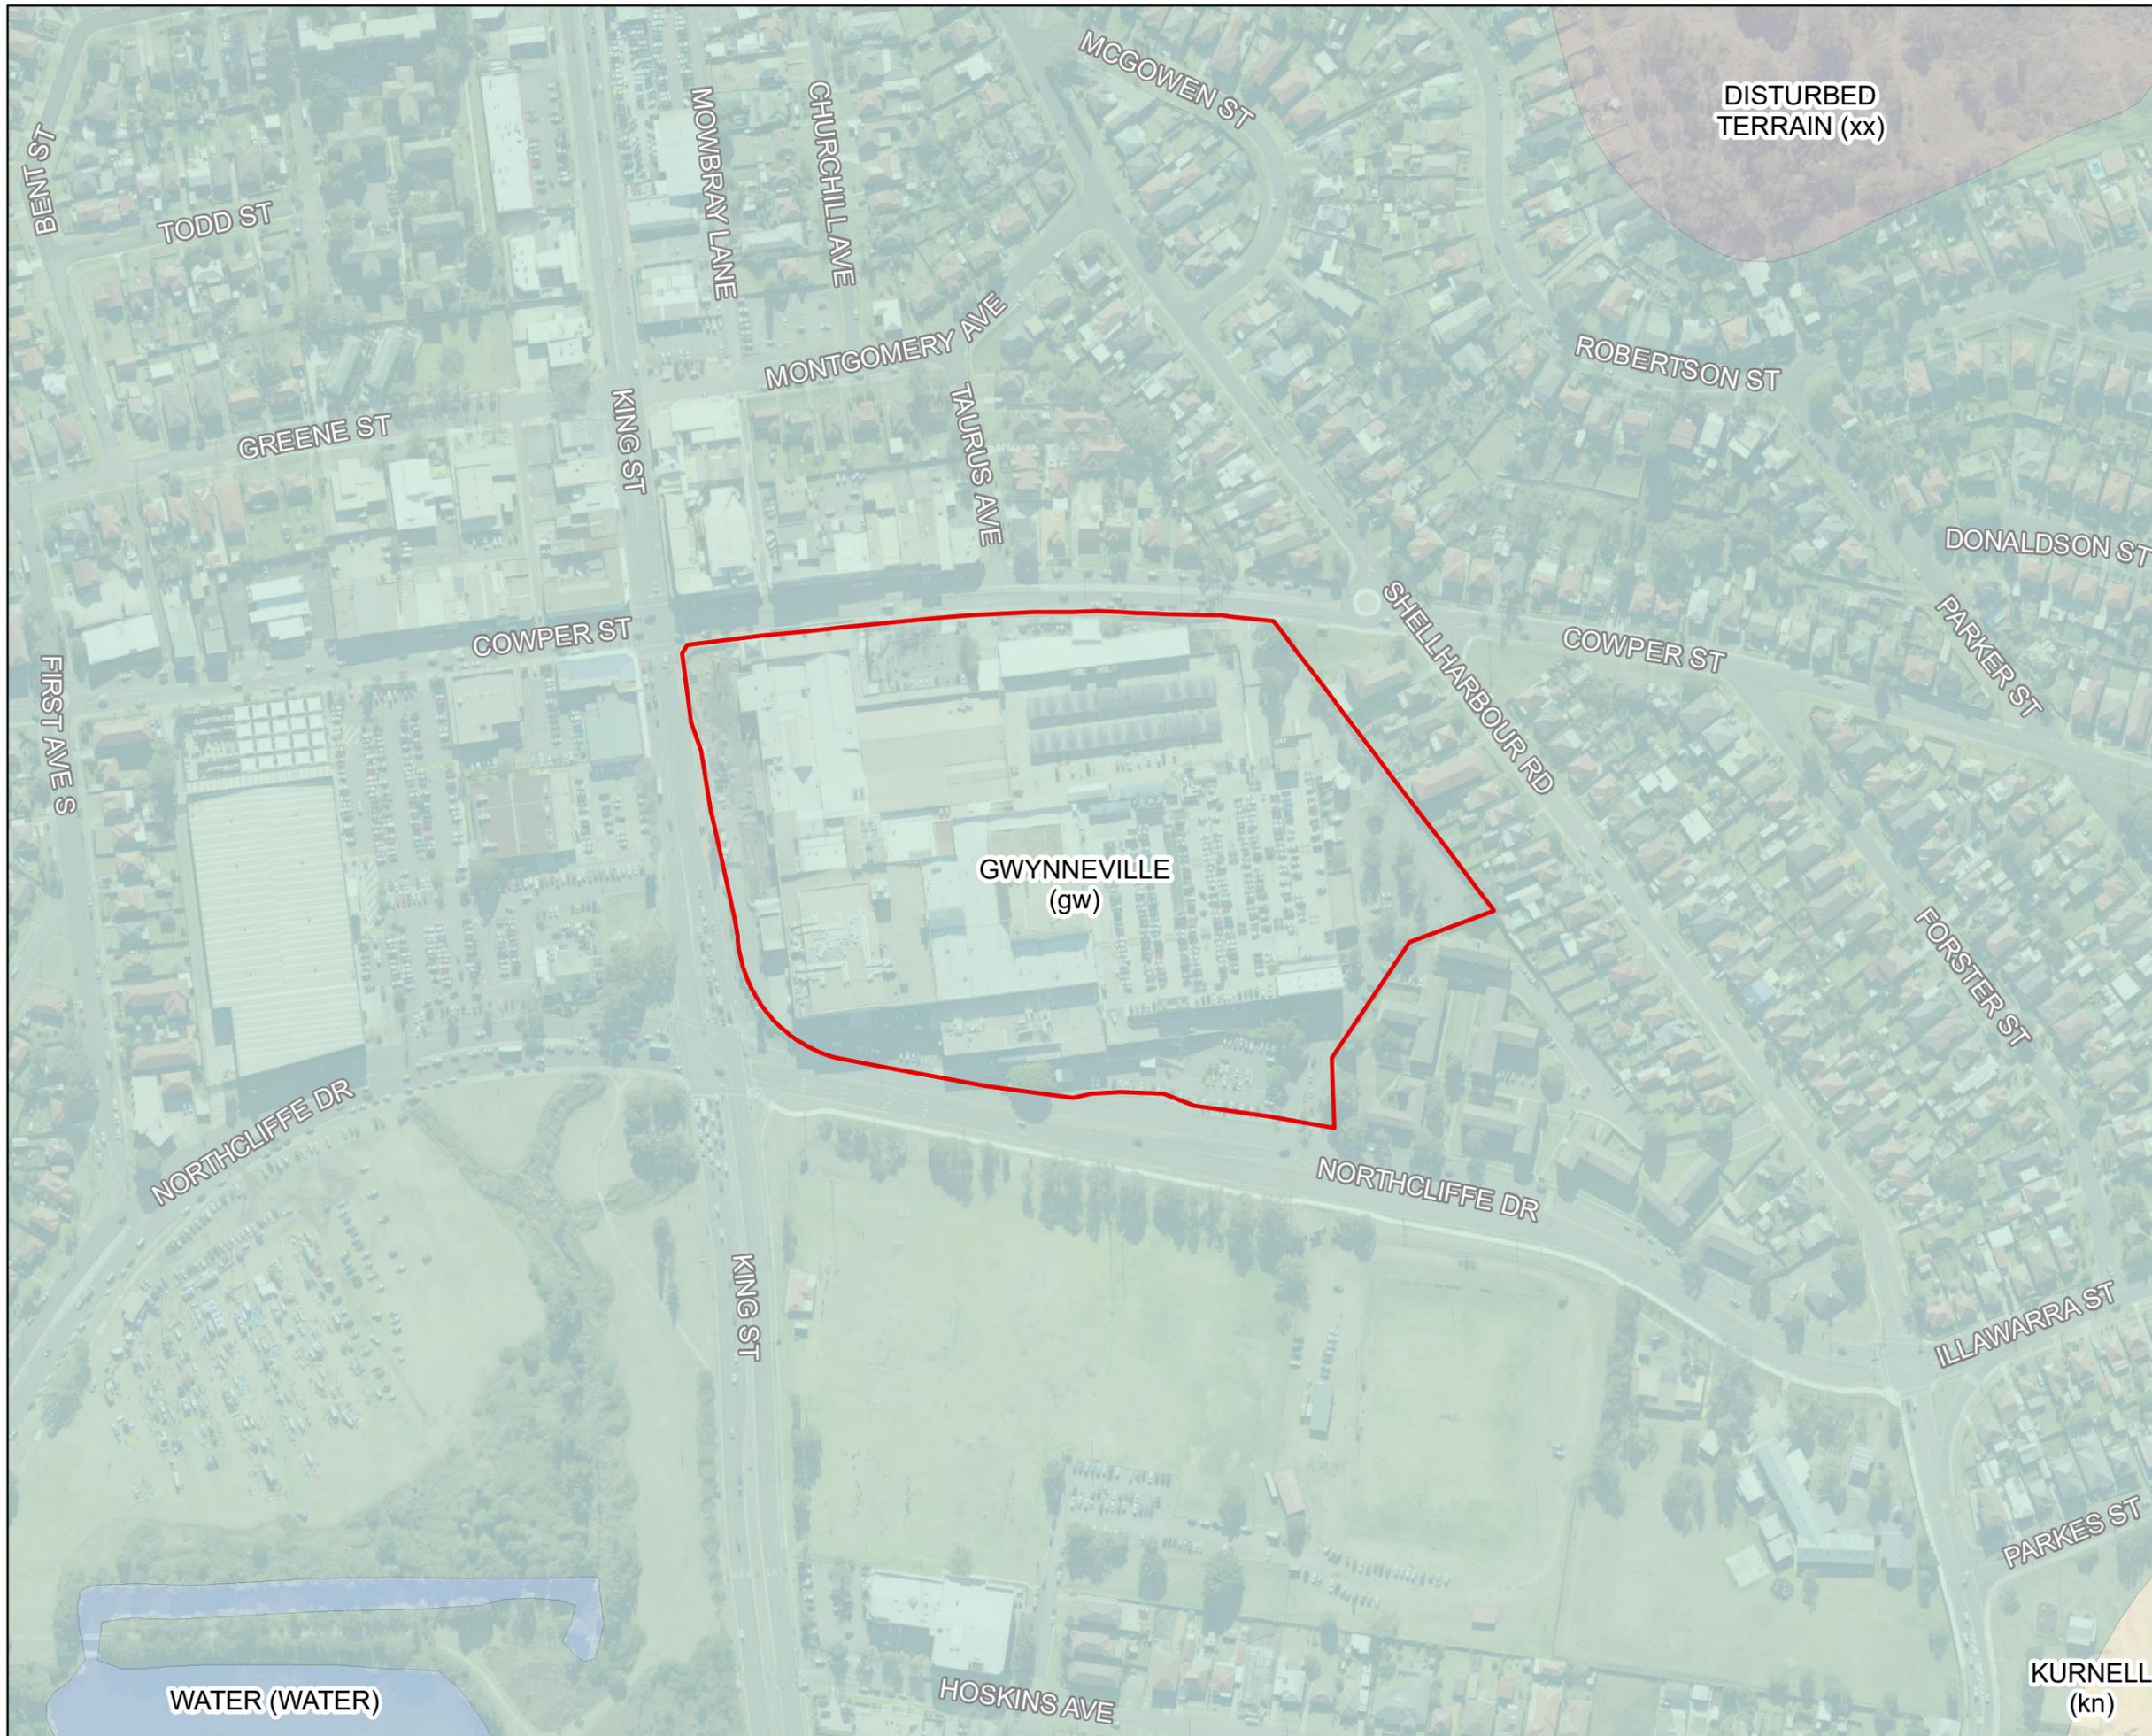
Job No 296838	Figure No 004
-------------------------	-------------------------

RESIDUAL (gw)

WATER

The soil landscape map for the Site is presented in Appendix A Figure 004. The map indicates that the soil landscape of the Site is composed of the Gwynneville landscape which generally can be described as usually shallow (<500-1000mm thick) clay residual soil overlying bedrock (Illawarra Coal Measures), formed at the footslopes of the Illawarra Escarpment and isolated rises of the Wollongong Plain. Limitations include extreme erosion hazard, steep slopes, mass movement hazard, local flooding, reactive subsoils and impermeable and low wet bearing strength clay subsoils.

It should be noted that soil landscape mapping is based on wide scale topographic mapping and may not be representative of conditions at a site level. With reference to the geological map and other soil landscapes along the northern side of Lake Illawarra, the Fairy Meadow landscape is considered more representative. This landscape is generally described as sandy clay loams or heavy clays to a depth <1.5m, formed in a swamp environment at alluvial plans, floodplains, valley flats and terraces below the Illawarra Escarpment. Limitations include flood hazard, low wet bearing strength, highly permeable soils and high seasonal watertables.

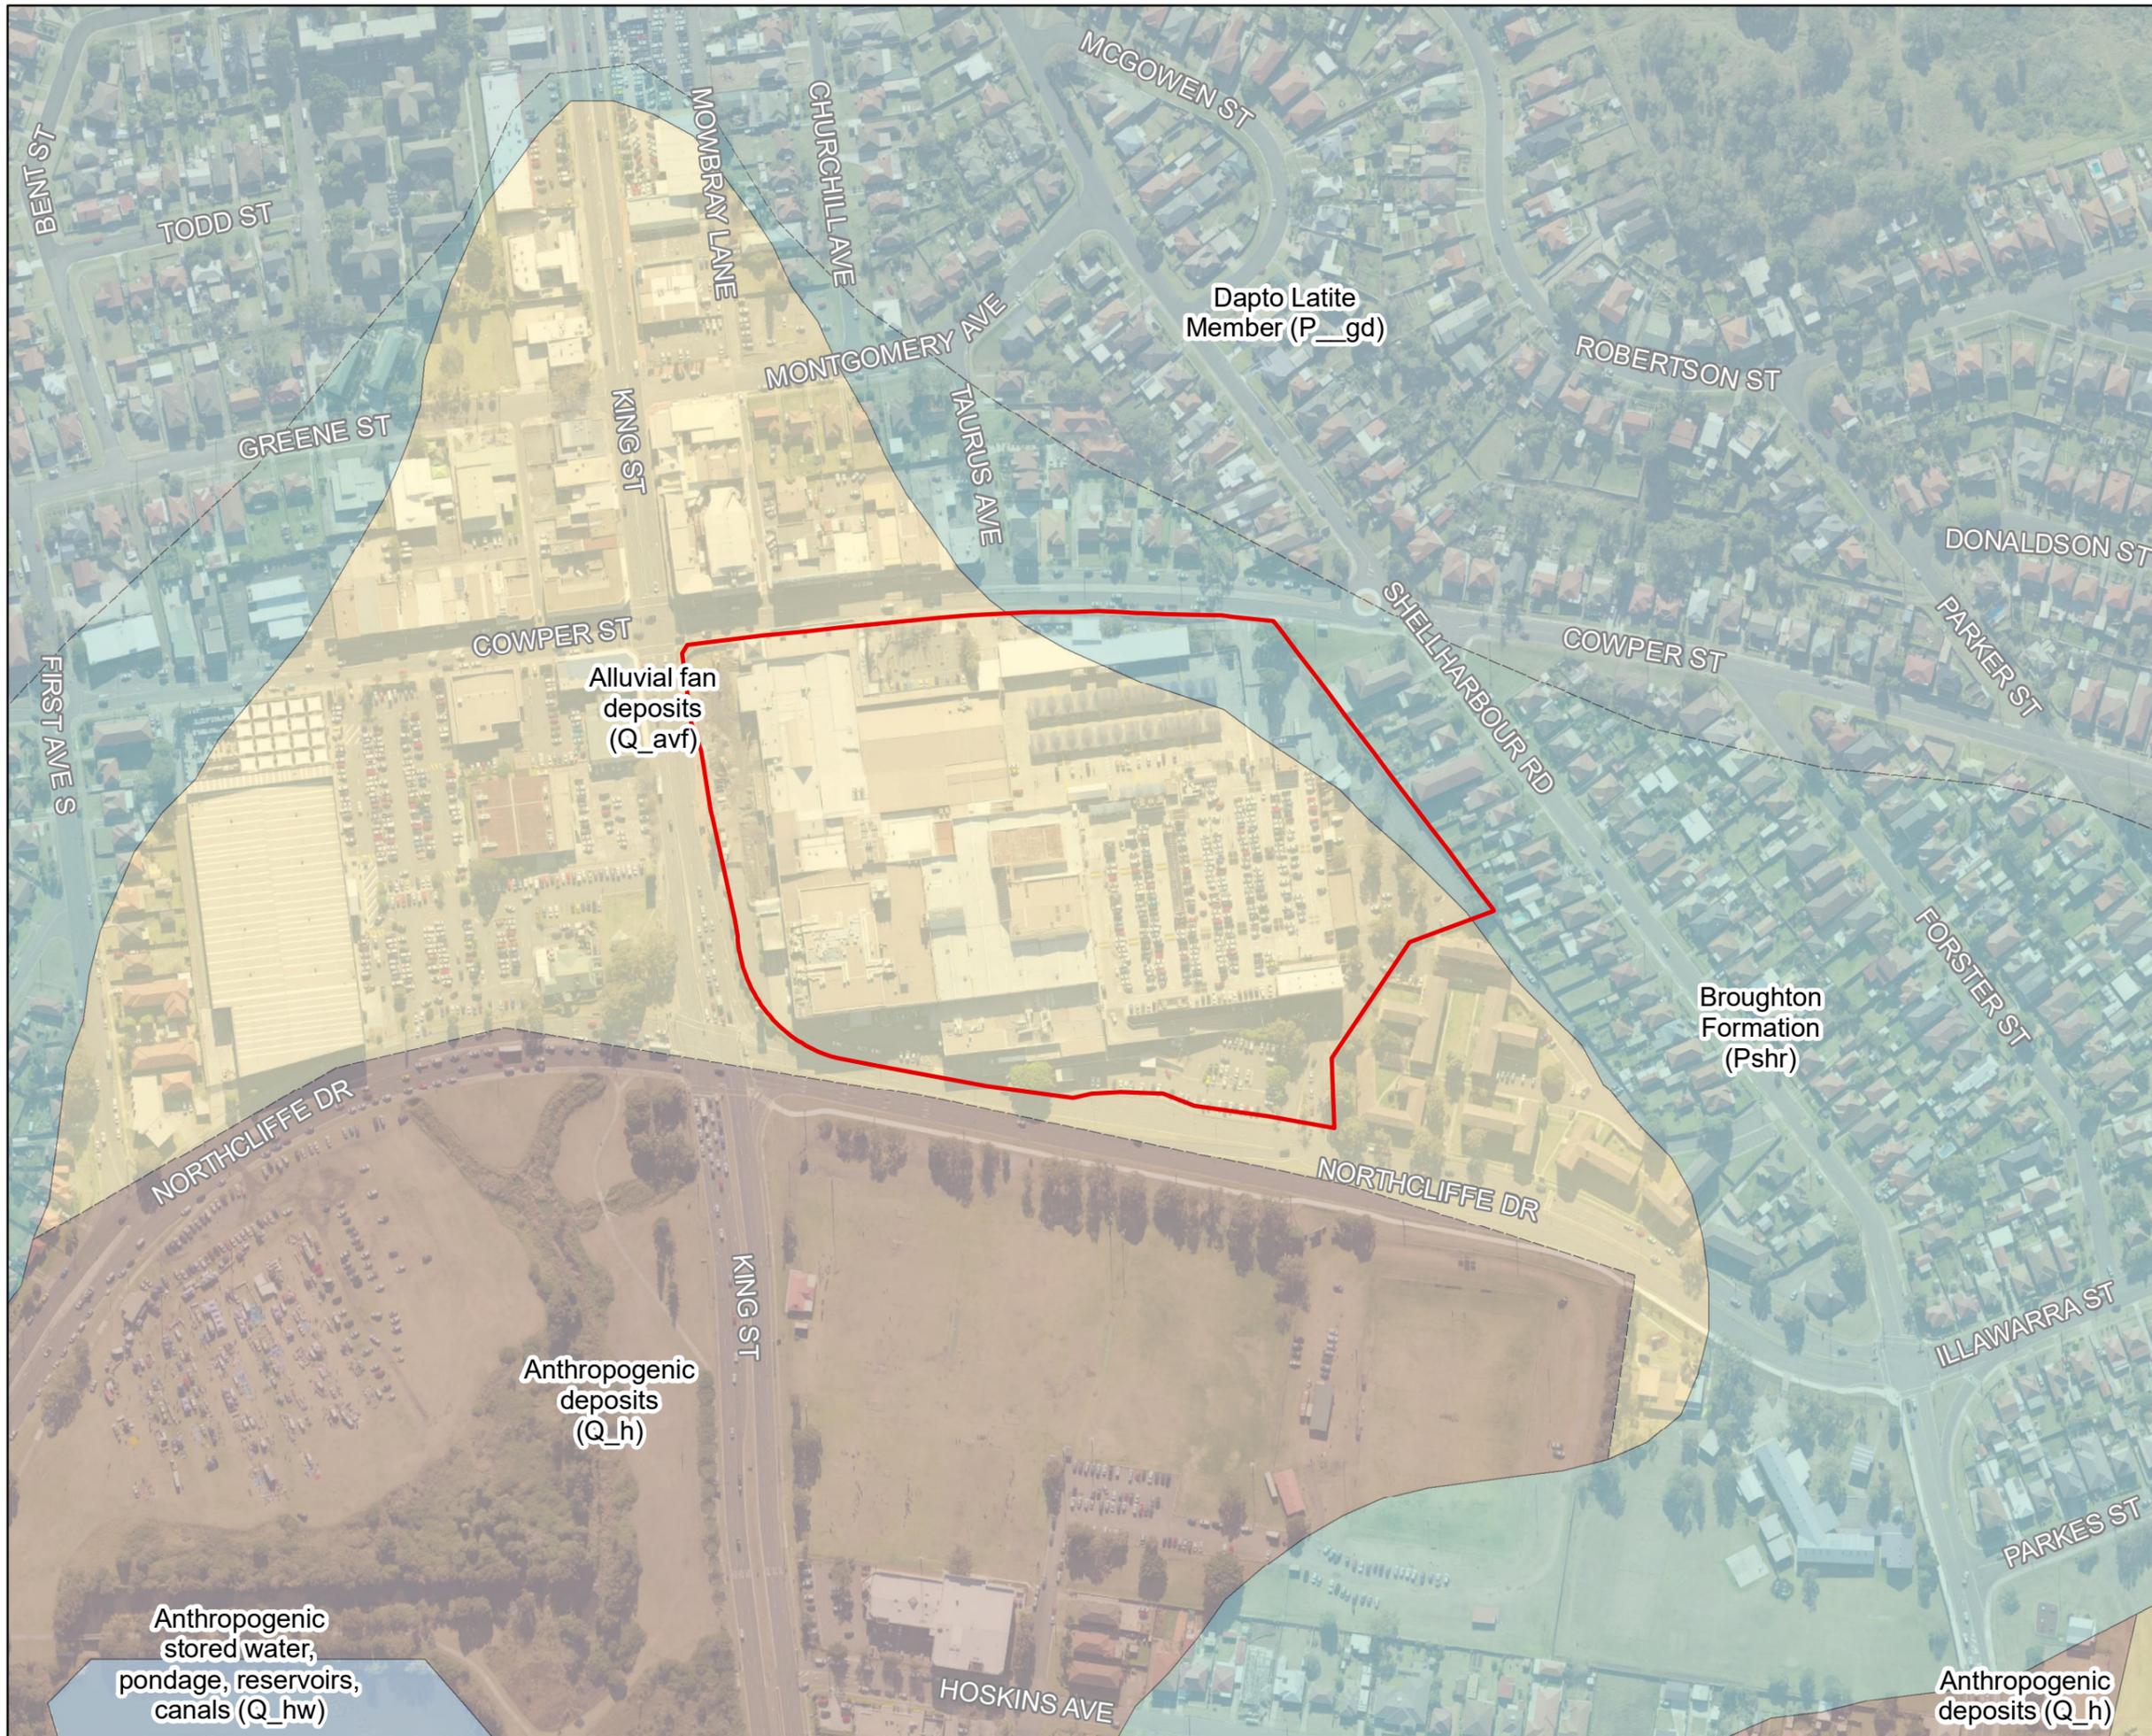
Job No 296838	Figure No 005
-------------------------	-------------------------

- Site Boundary
- Geological boundary, position accurate
- Geological boundary, position approximate

- Dapto Latite Member (P_gd)
- Broughton Formation (Pshr)

A geological map for the Site is presented in Appendix A Figure 005. The map indicates that the Site is mostly underlain by the alluvial fan deposits which overlies bedrock of the Shoalhaven Group – Broughton Formation and Dapto Latite Member. It should be noted that the Geological Map is a regional scale map which may not be representative of conditions at a site level and hence geological boundaries may be shown as approximate.

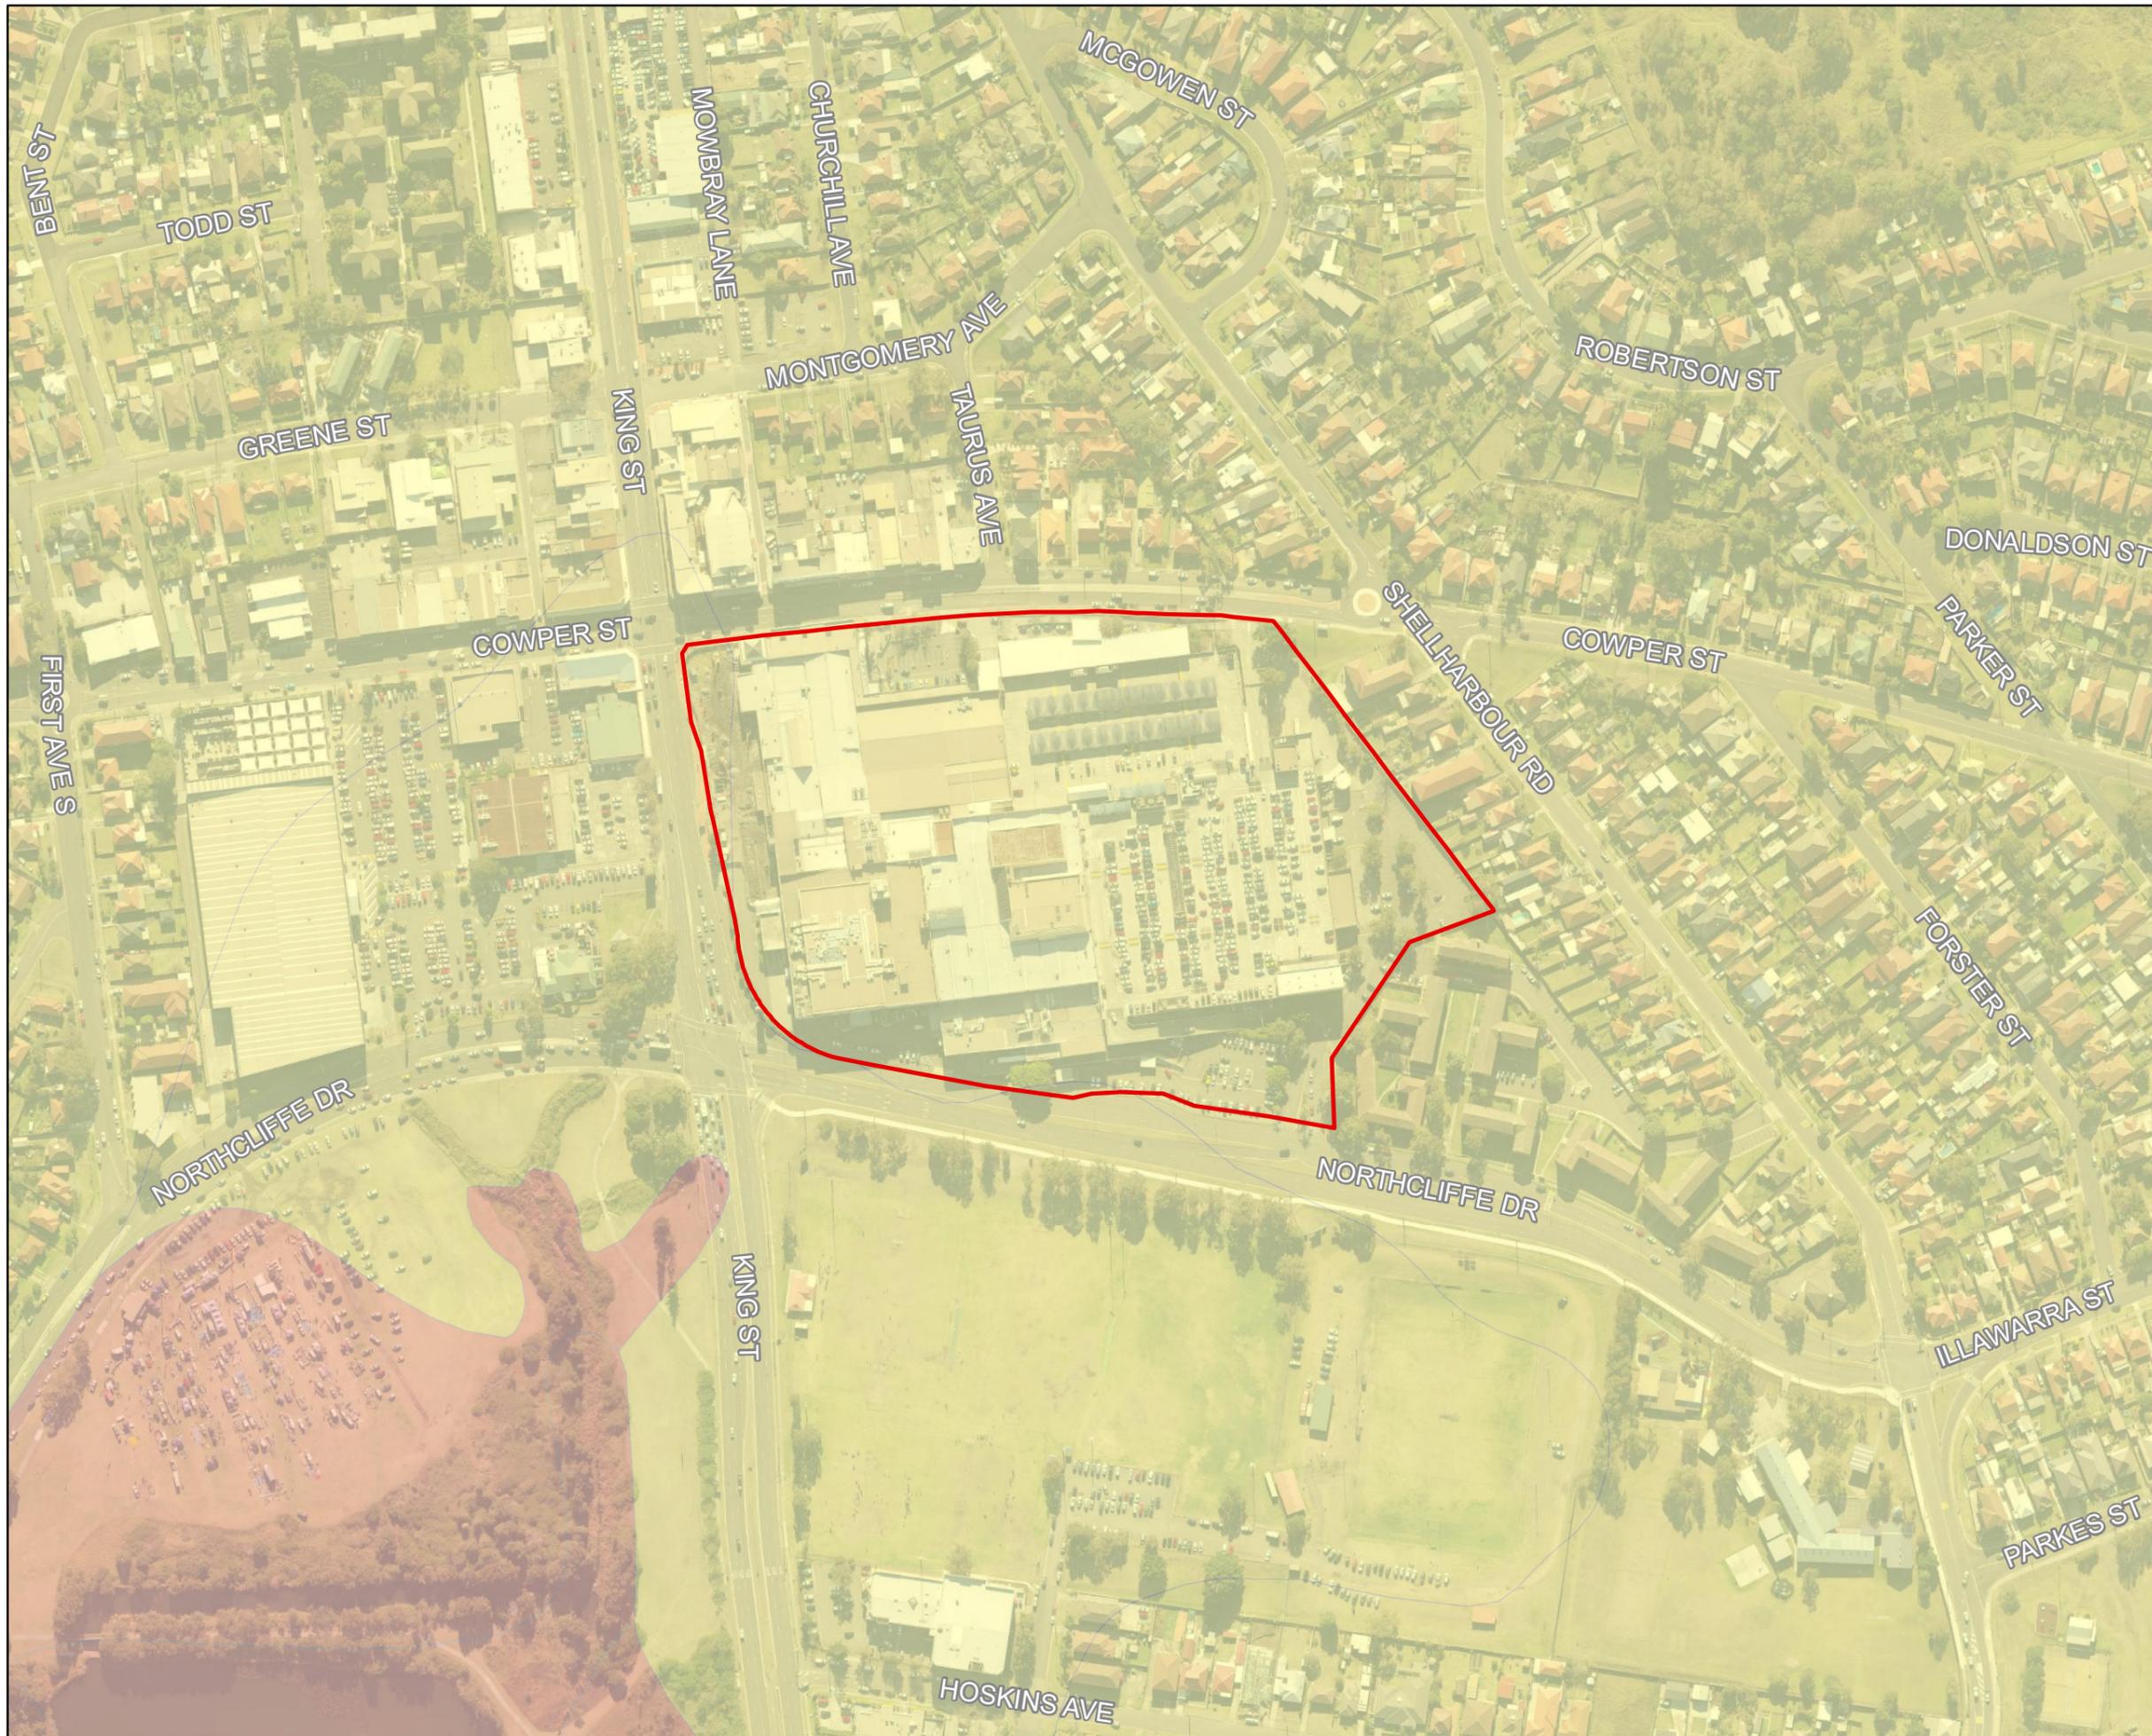
Job No 296838	Figure No 006a
-------------------------	--------------------------

- Site Boundary
- Acid Sulfate Soil Risk**
- High Probability of PASS
- Low Probability of PASS

Published information indicates no identified occurrence of acid sulfate soil (Naylor, et al. 1998) and low probability of PASS (CSIRO 2013) (refer to Appendix A Figure 006a and 006b).

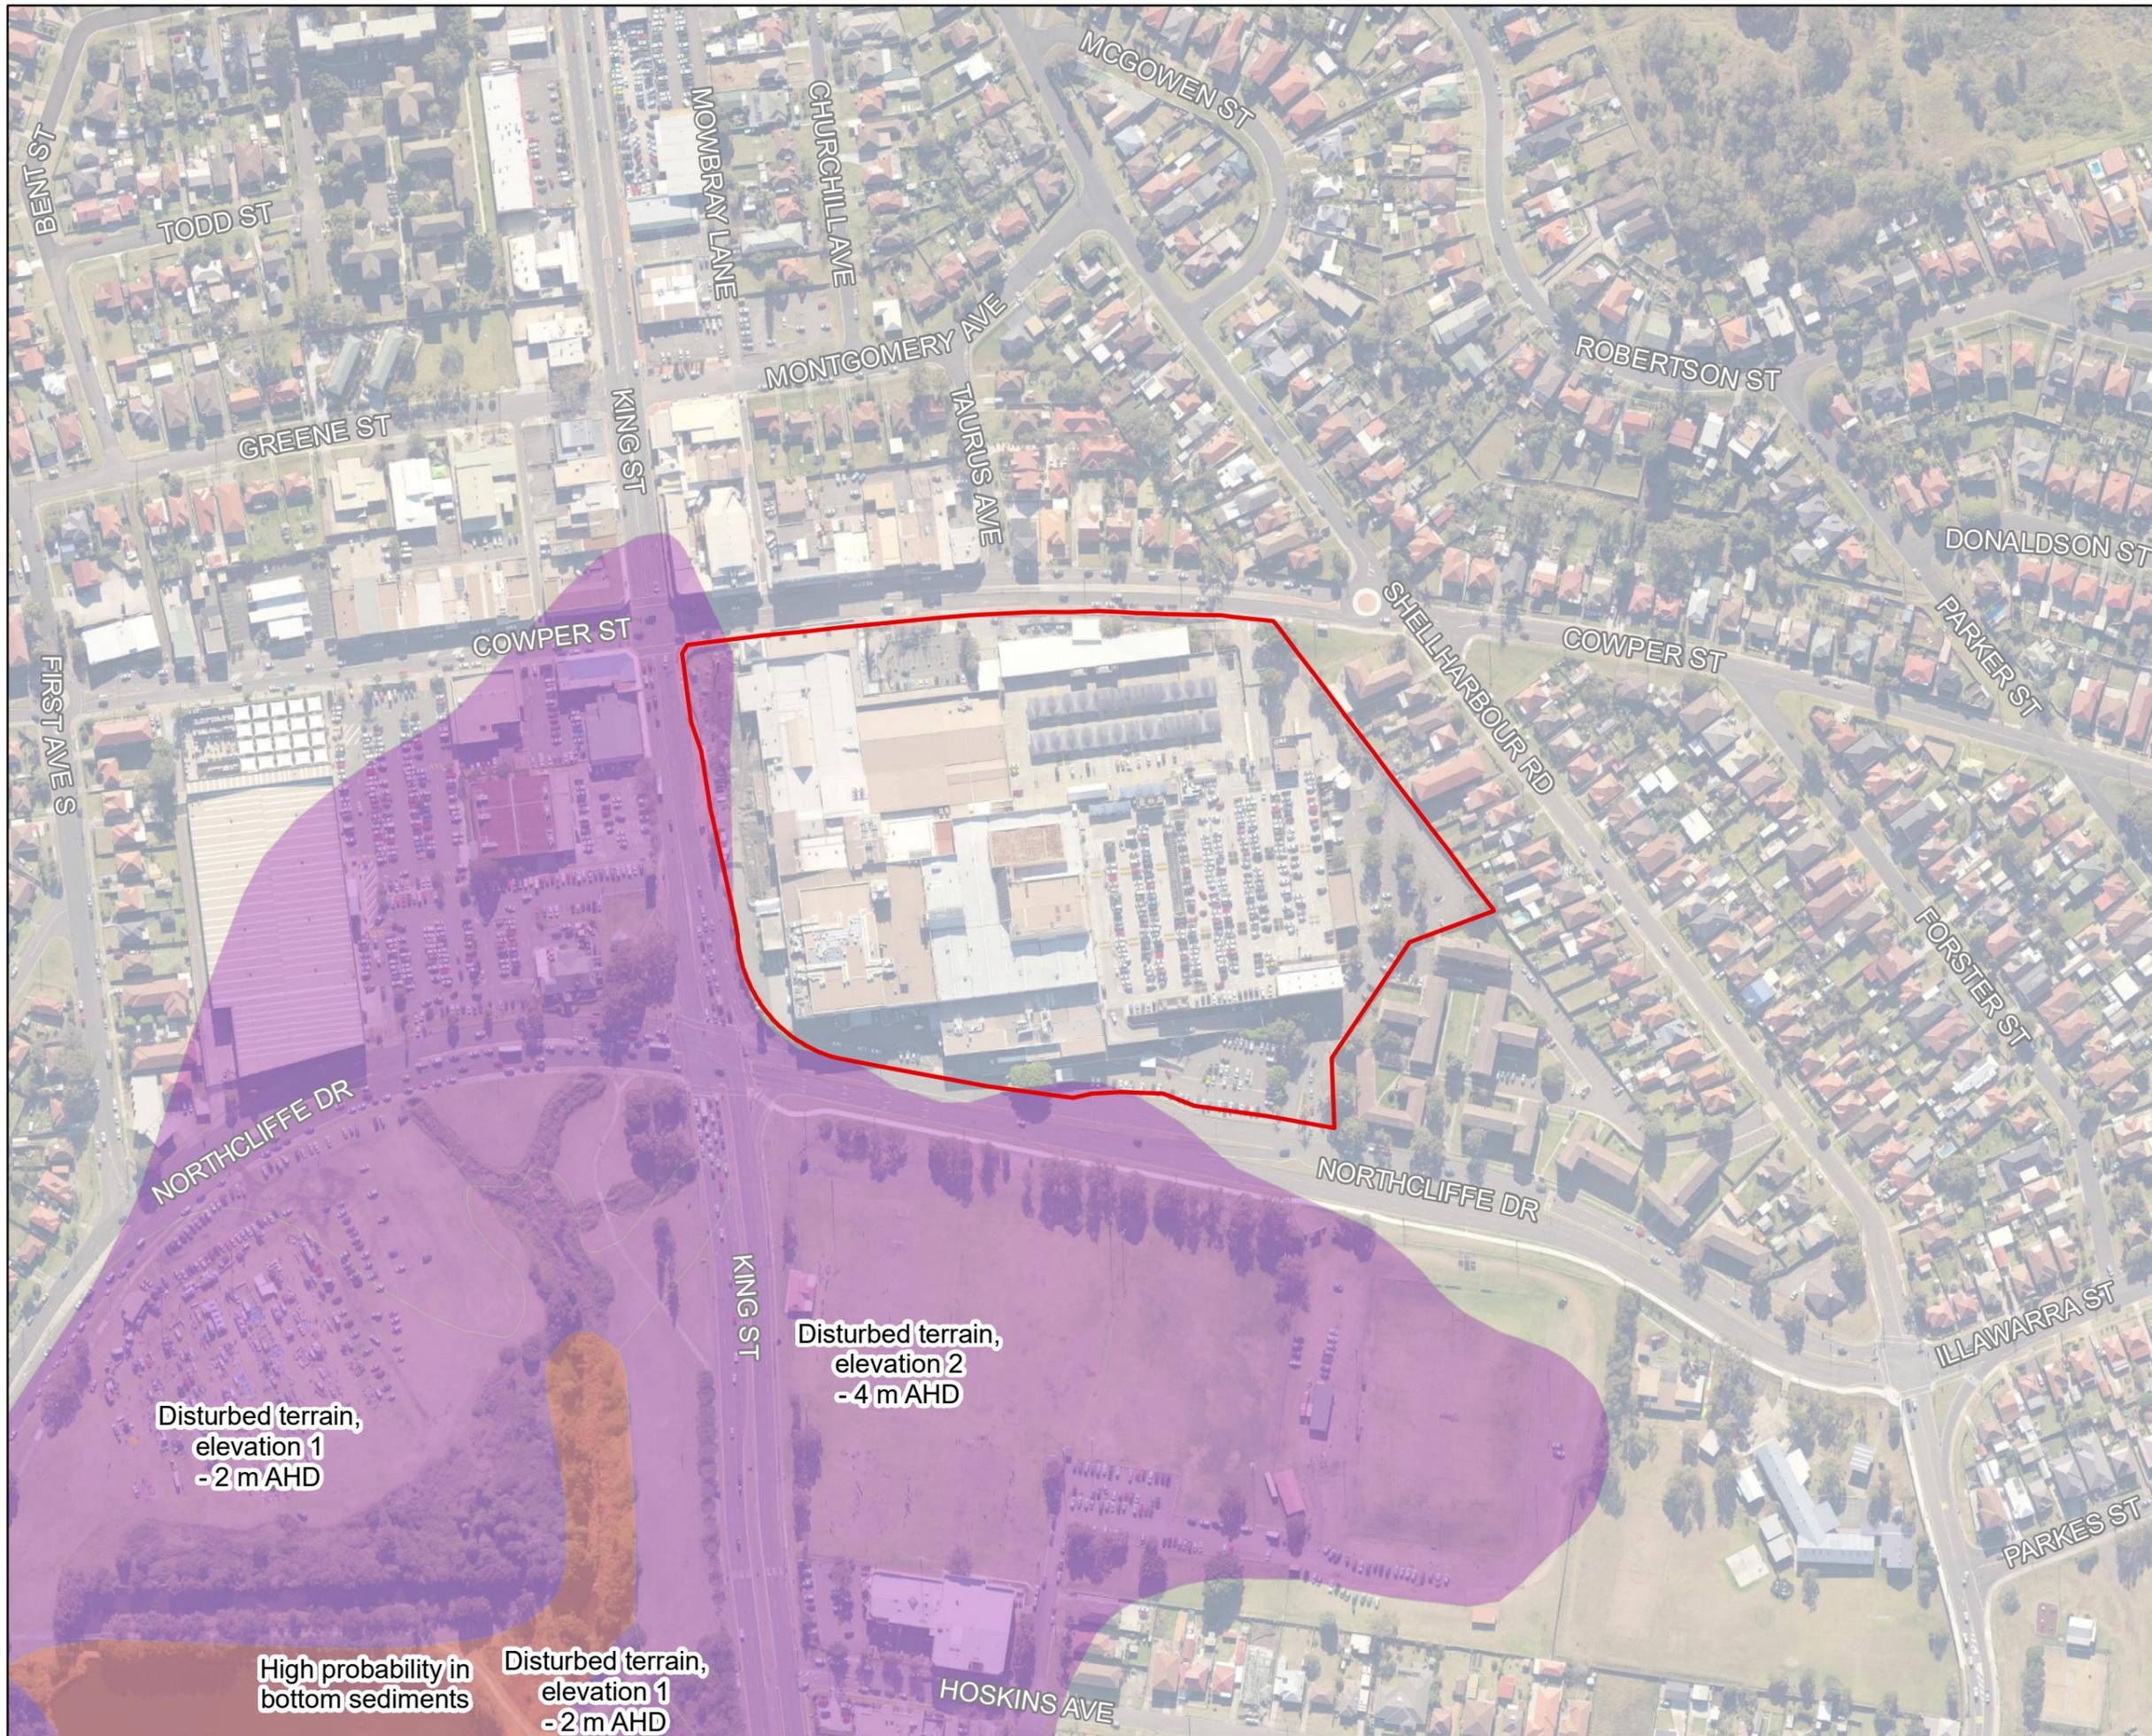
Figure No
006b

- Site Boundary
- Acid Sulfate Soil Risk
- High probability of occurrence
- Disturbed terrain
