Warrawong Plaza

Preliminary Geotechnical Desktop Study

Reference: 296838-REP-GE-DS1

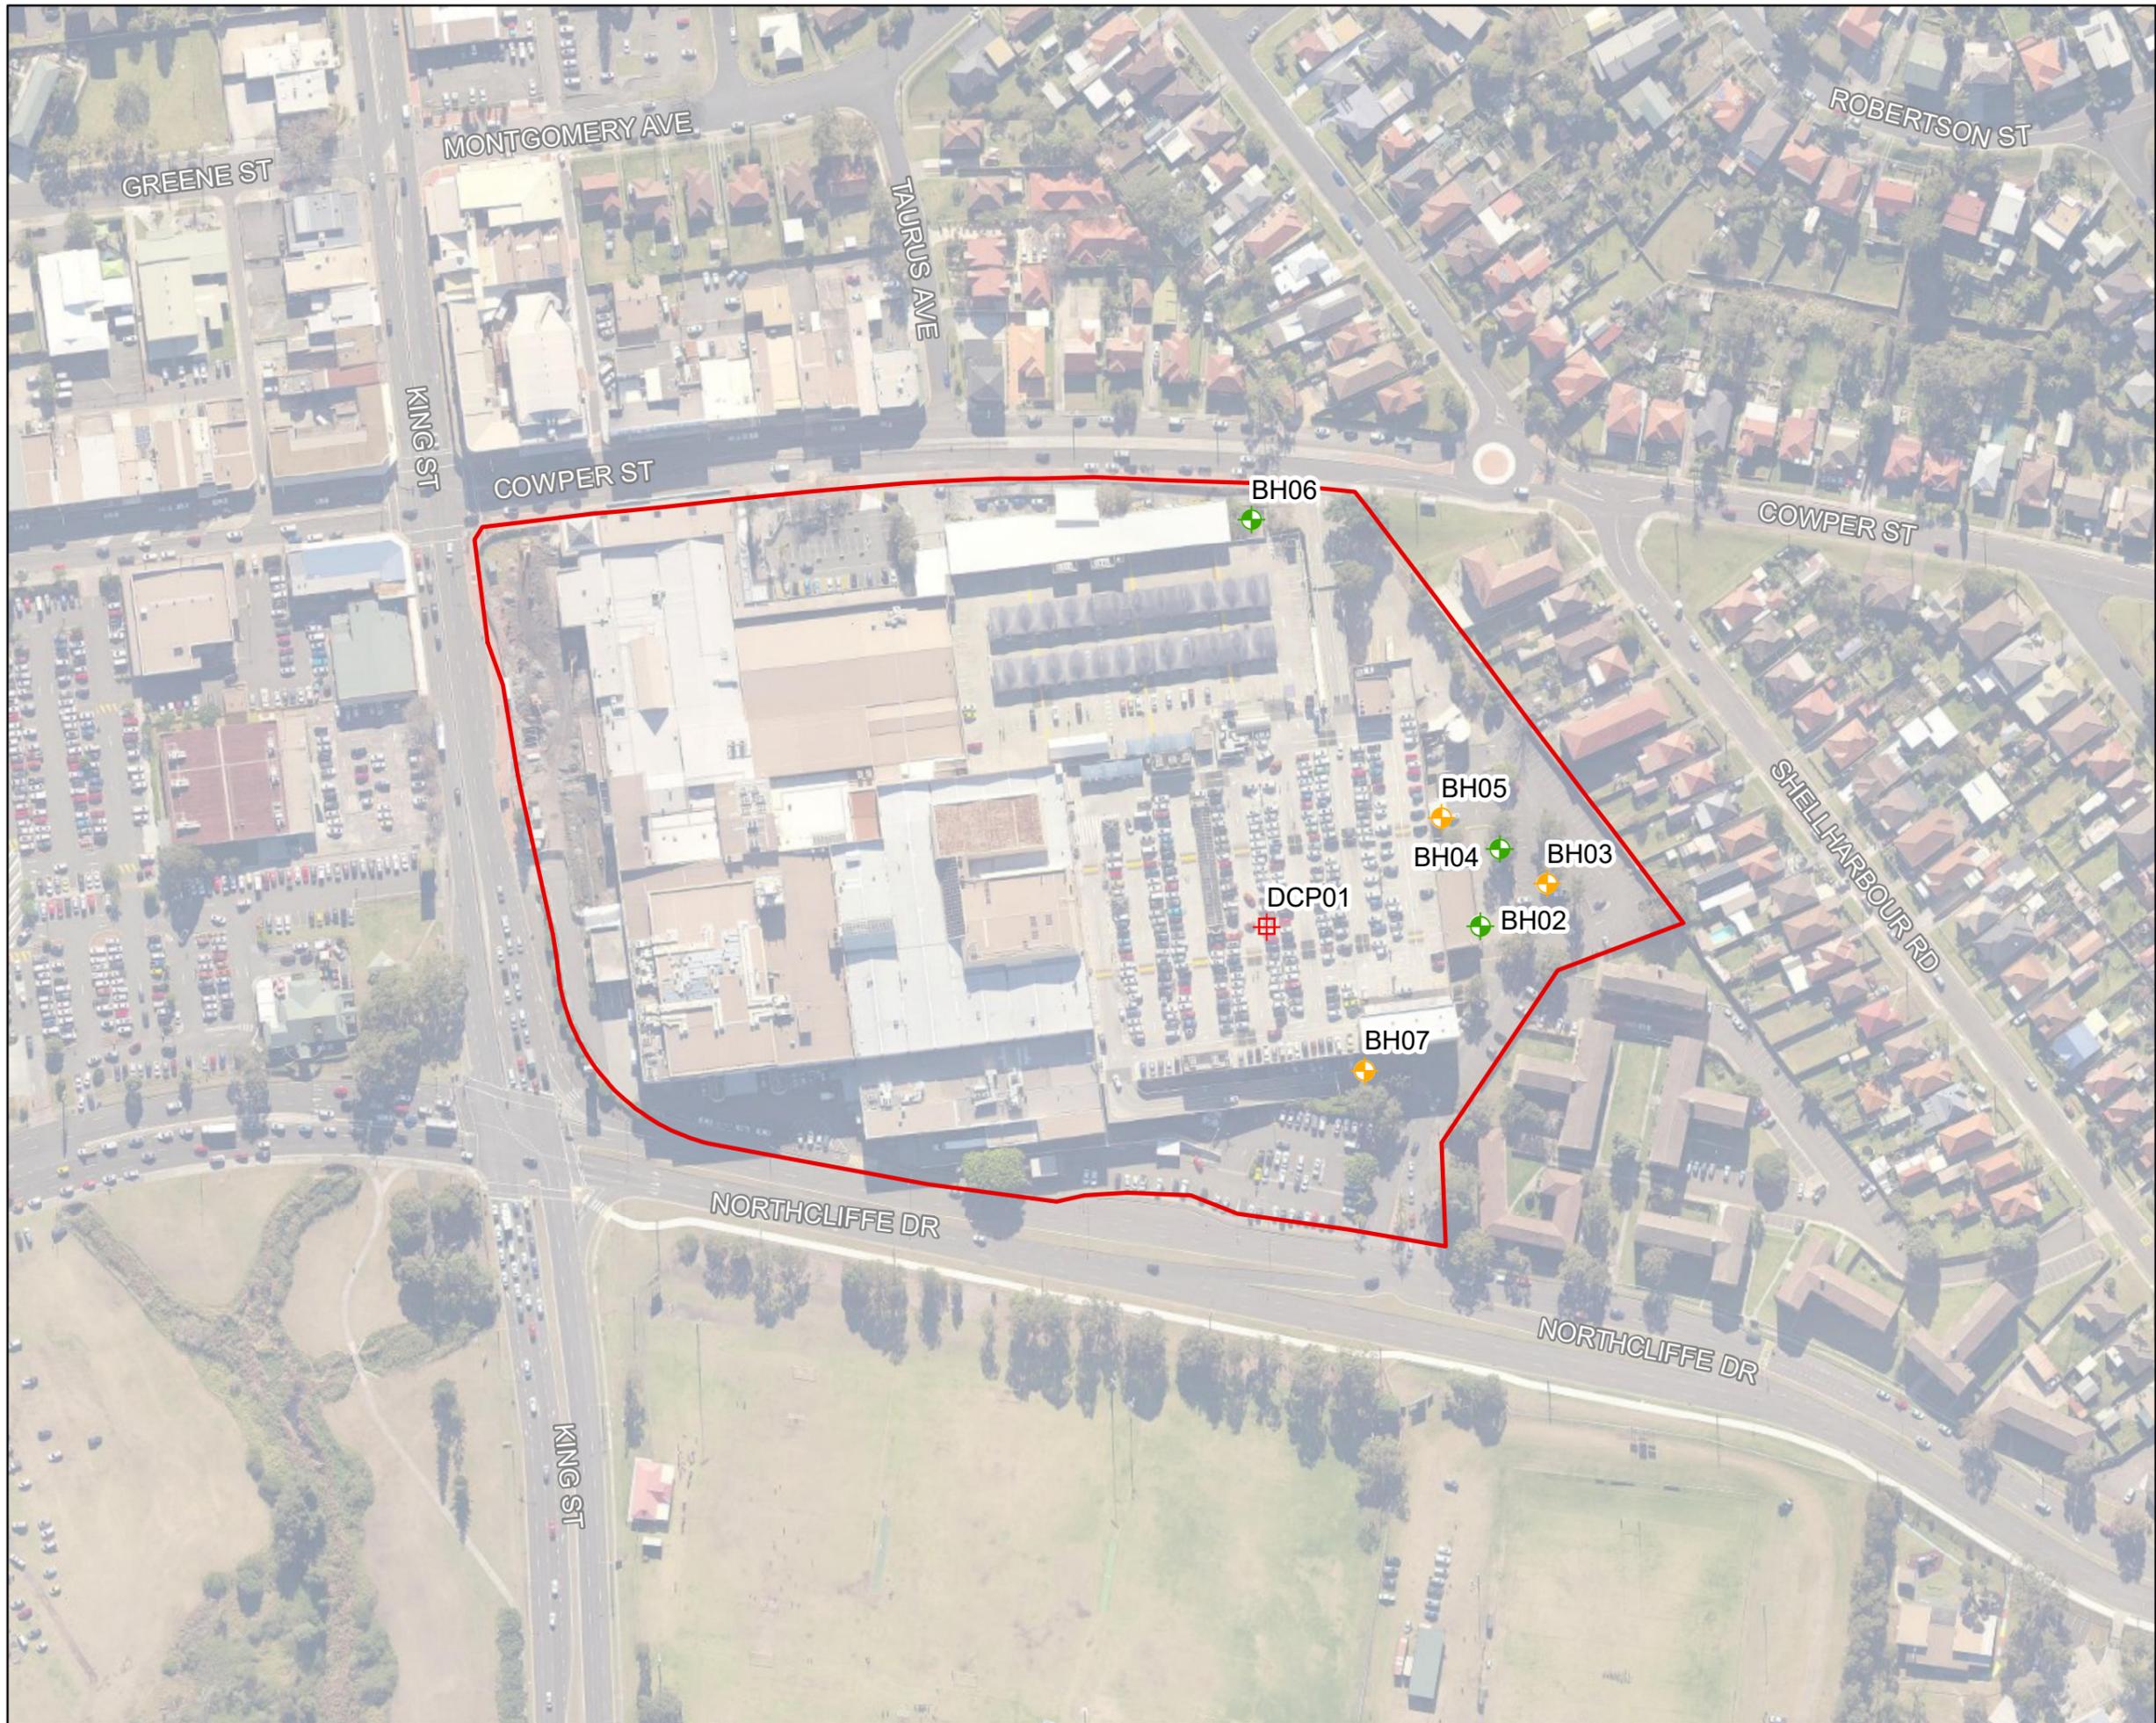
- Site Boundary
- ◆ Borehole
- ◆ Borehole (cored)
- ⊞ Dynamic Cone Penetration (DCP)

Available geotechnical investigation data for the Site was reviewed for interpretation of the ground conditions. This investigation data is summarised in Table 3 below and locations are presented in Appendix A Figure 007. Laboratory testing included Atterberg Limits, field moisture content, soil aggressivity and point load strength index.

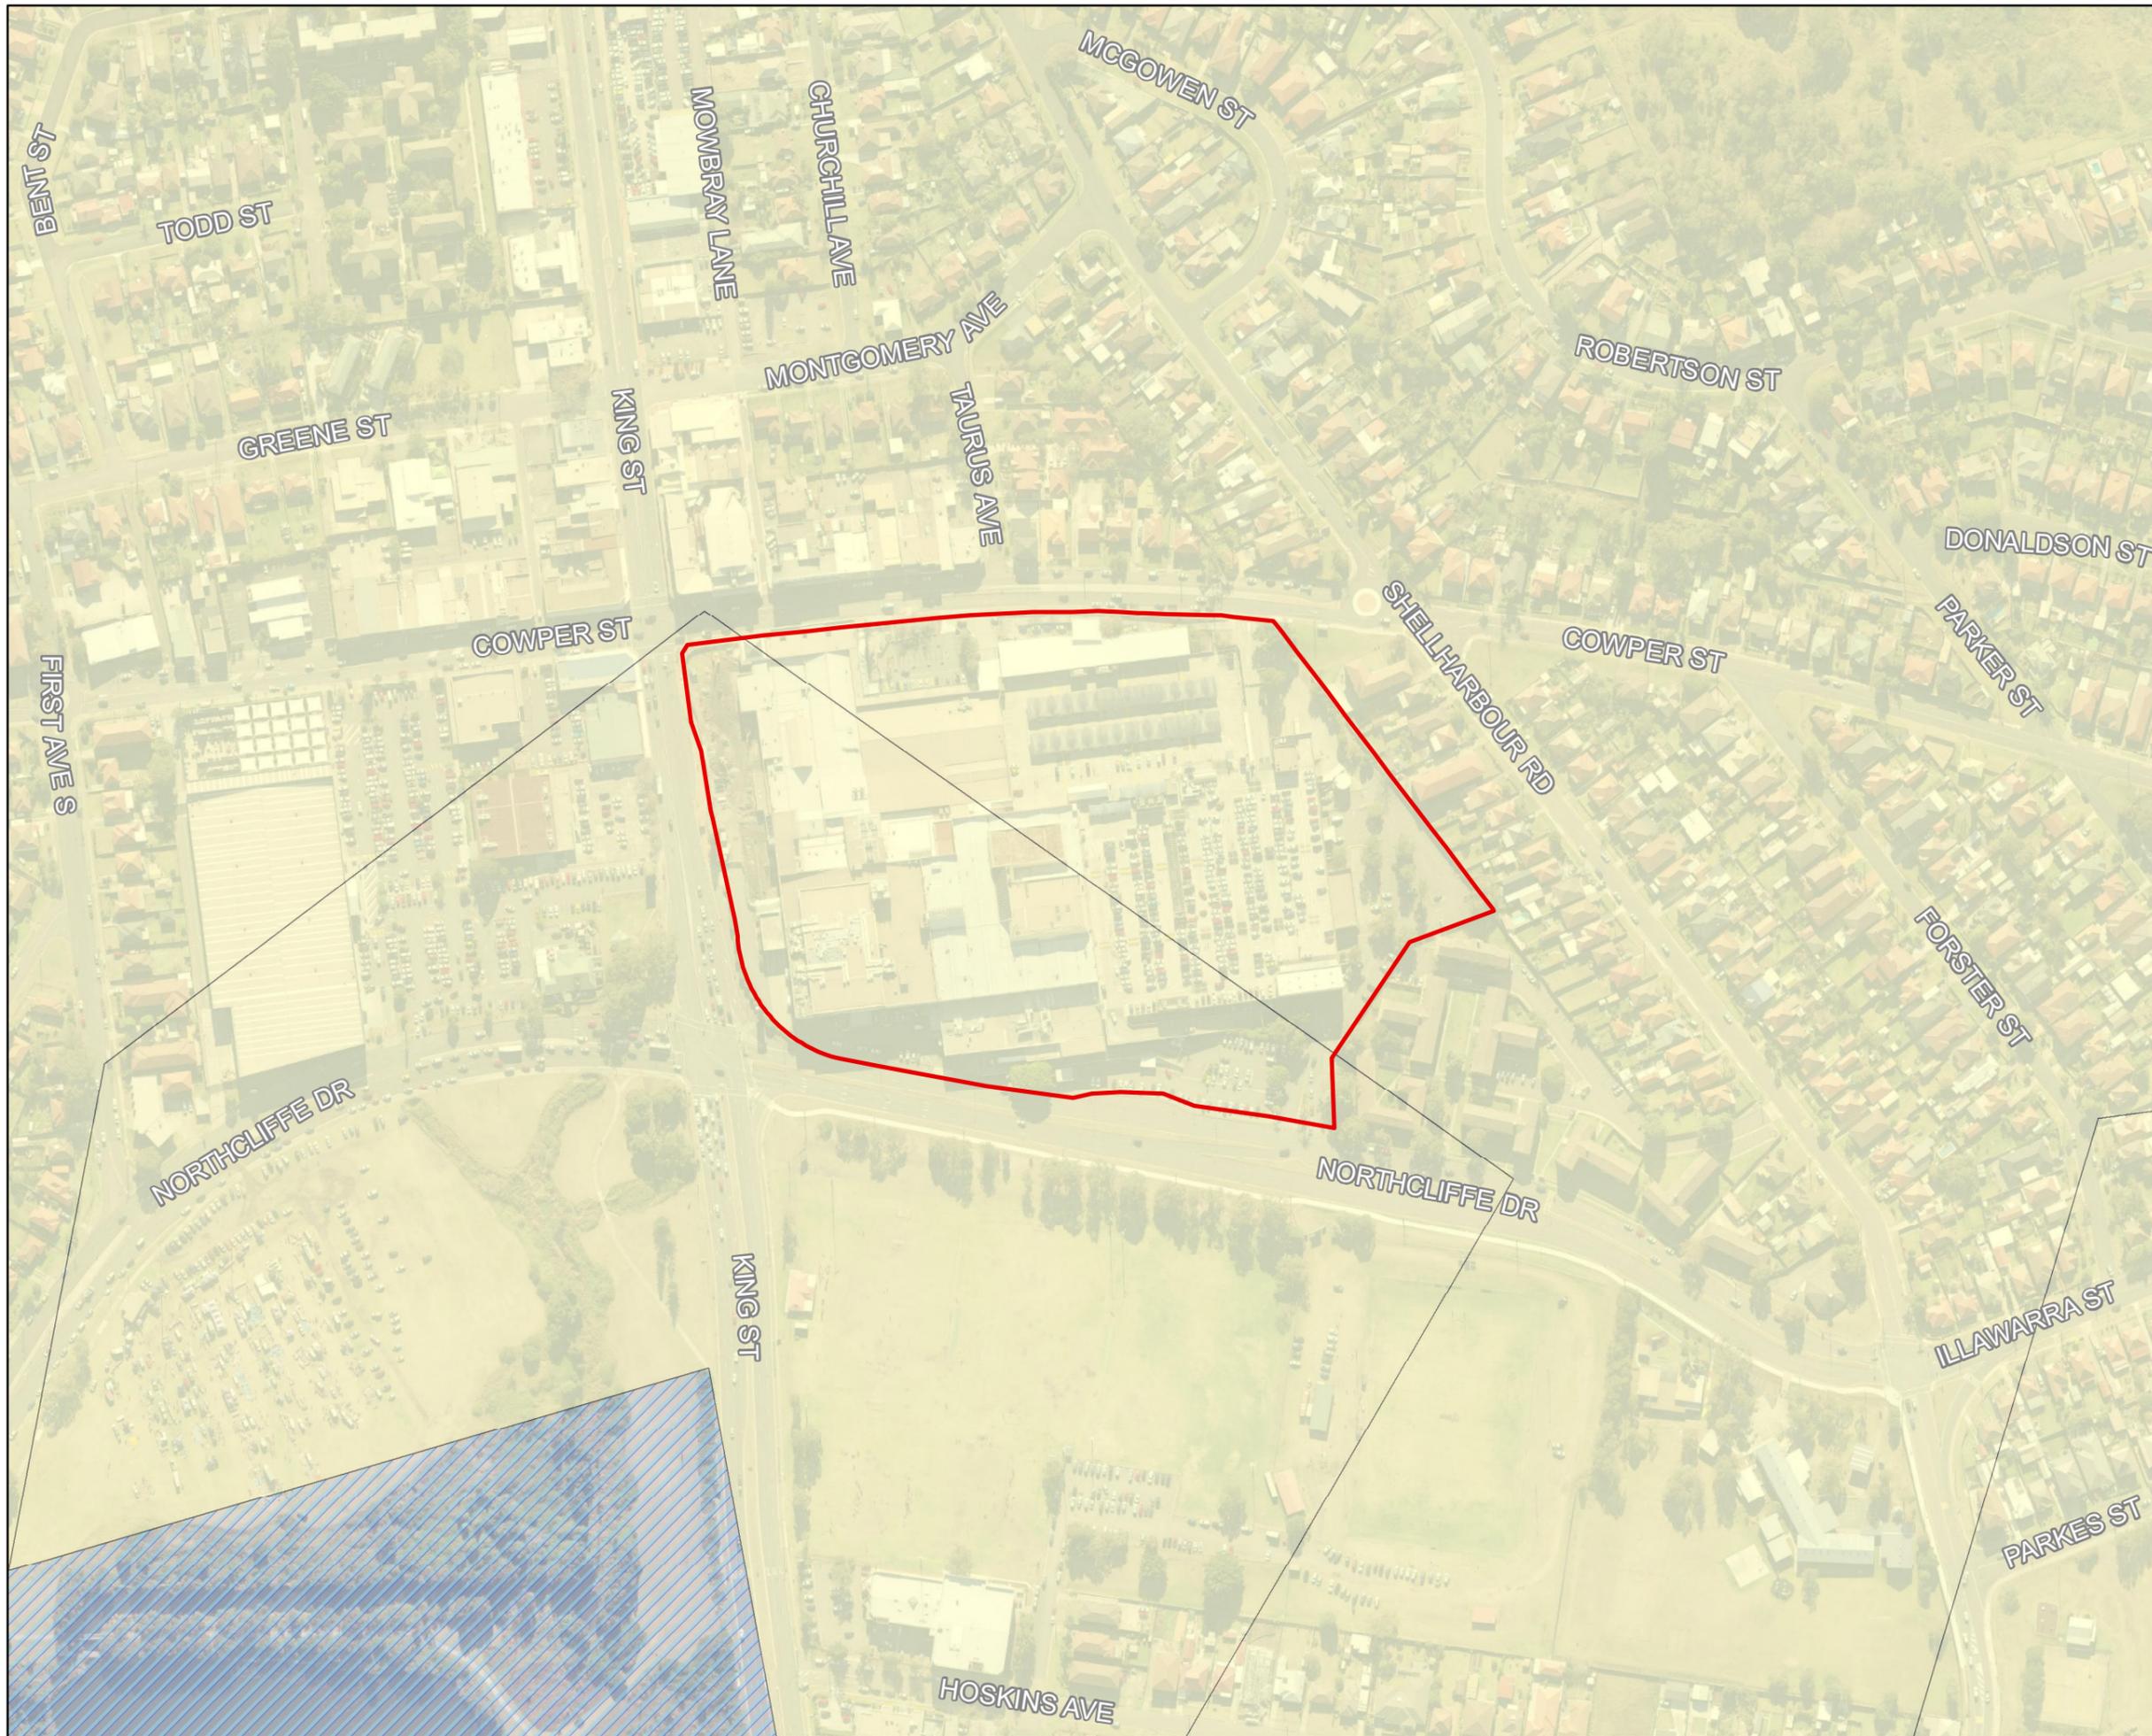
Job No 296838	Figure No 008
-------------------------	-------------------------

Figure Title
Salinity Hazard

Published information indicates a moderate salinity hazard (Department of Planning and Environment 2020) (refer to Appendix A Figure 008).
