Asbestos Management Plan

475 Badgerys Creek Road, Badgerys Creek NSW

9 November 2023

Badgerys Creek Asbestos Management Plan 475 Badgerys Creek Road, Badgerys Creek NSW

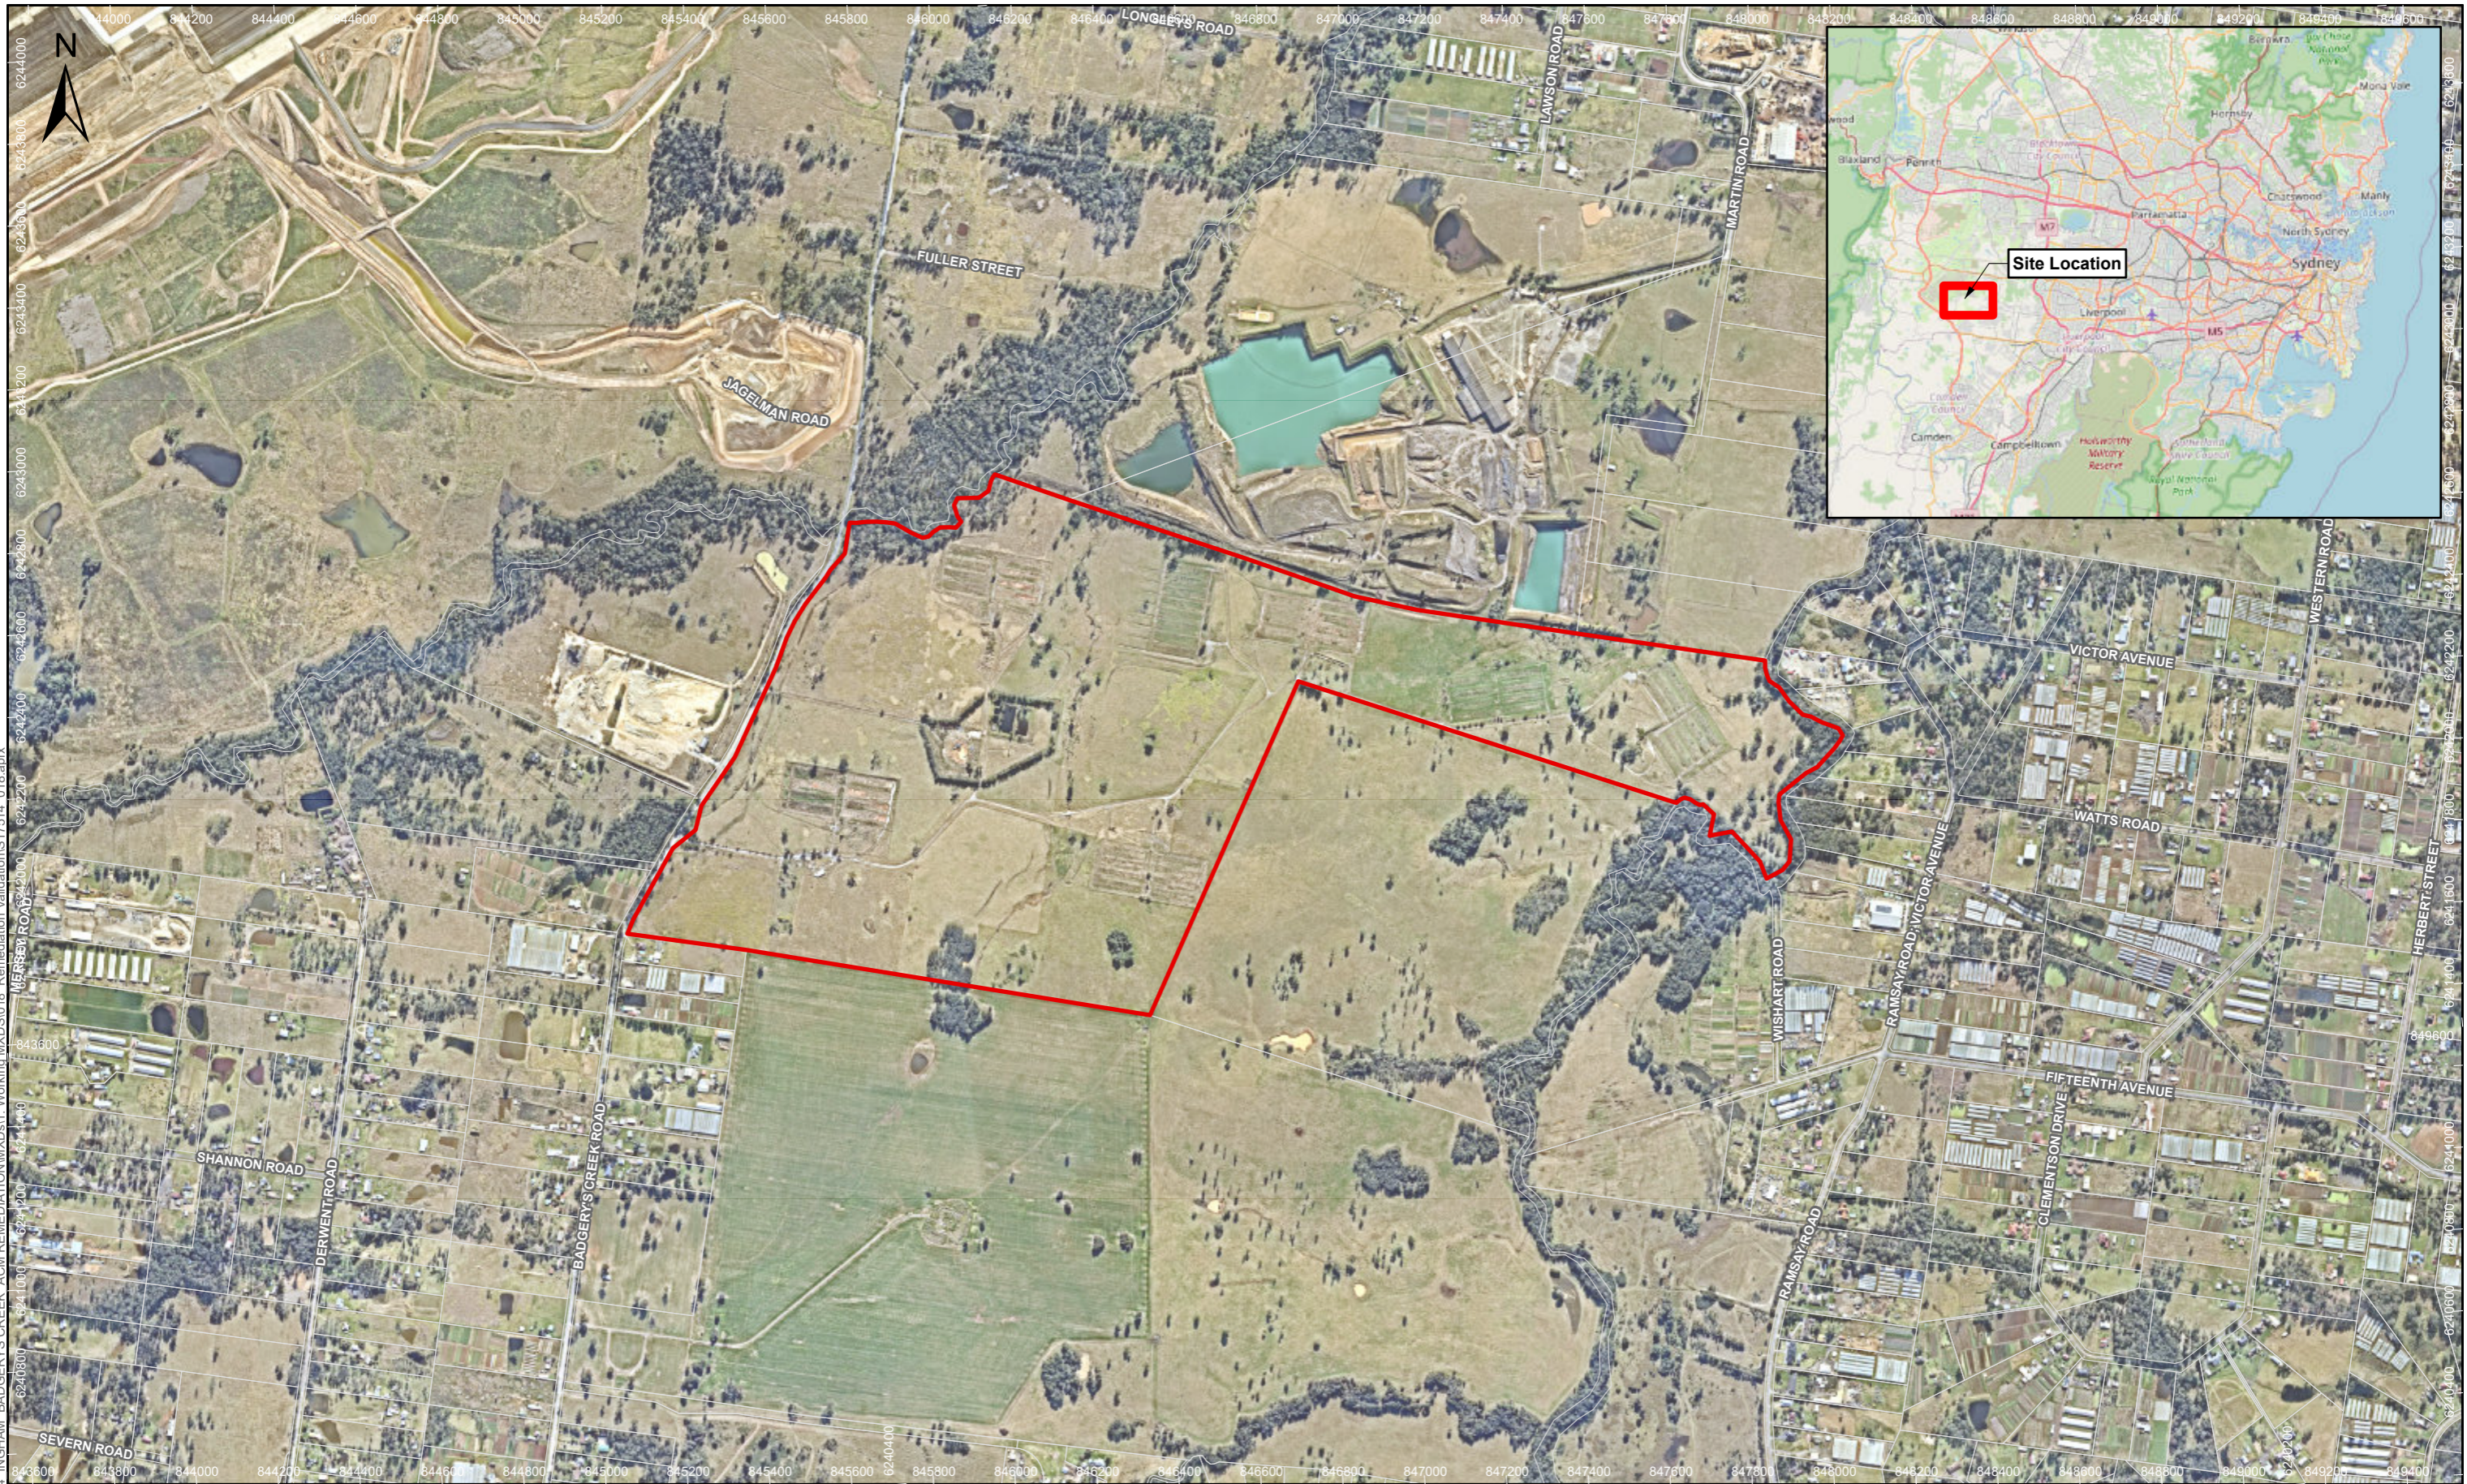
Figure 1: Site Location

Figure No:	1
Title:	Site Location
Project:	Environmental Report
Location:	475 Badgerys Creek Road, Badgerys Creek, NSW 2555
Client:	Ingham Rural Property Group

Senversa Pty Ltd (Senversa) was engaged by Ingham Property Group Pty Ltd (IPG) to prepare an Asbestos Management Plan (AMP) for the site located at 475 Badgerys Creek Road, Badgerys Creek, NSW (the site). The site is indicated on **Figure 1**. The site is legally described as Lot 100 in Deposited Plan (DP) 1287207 and encompasses approximately 180 hectares.

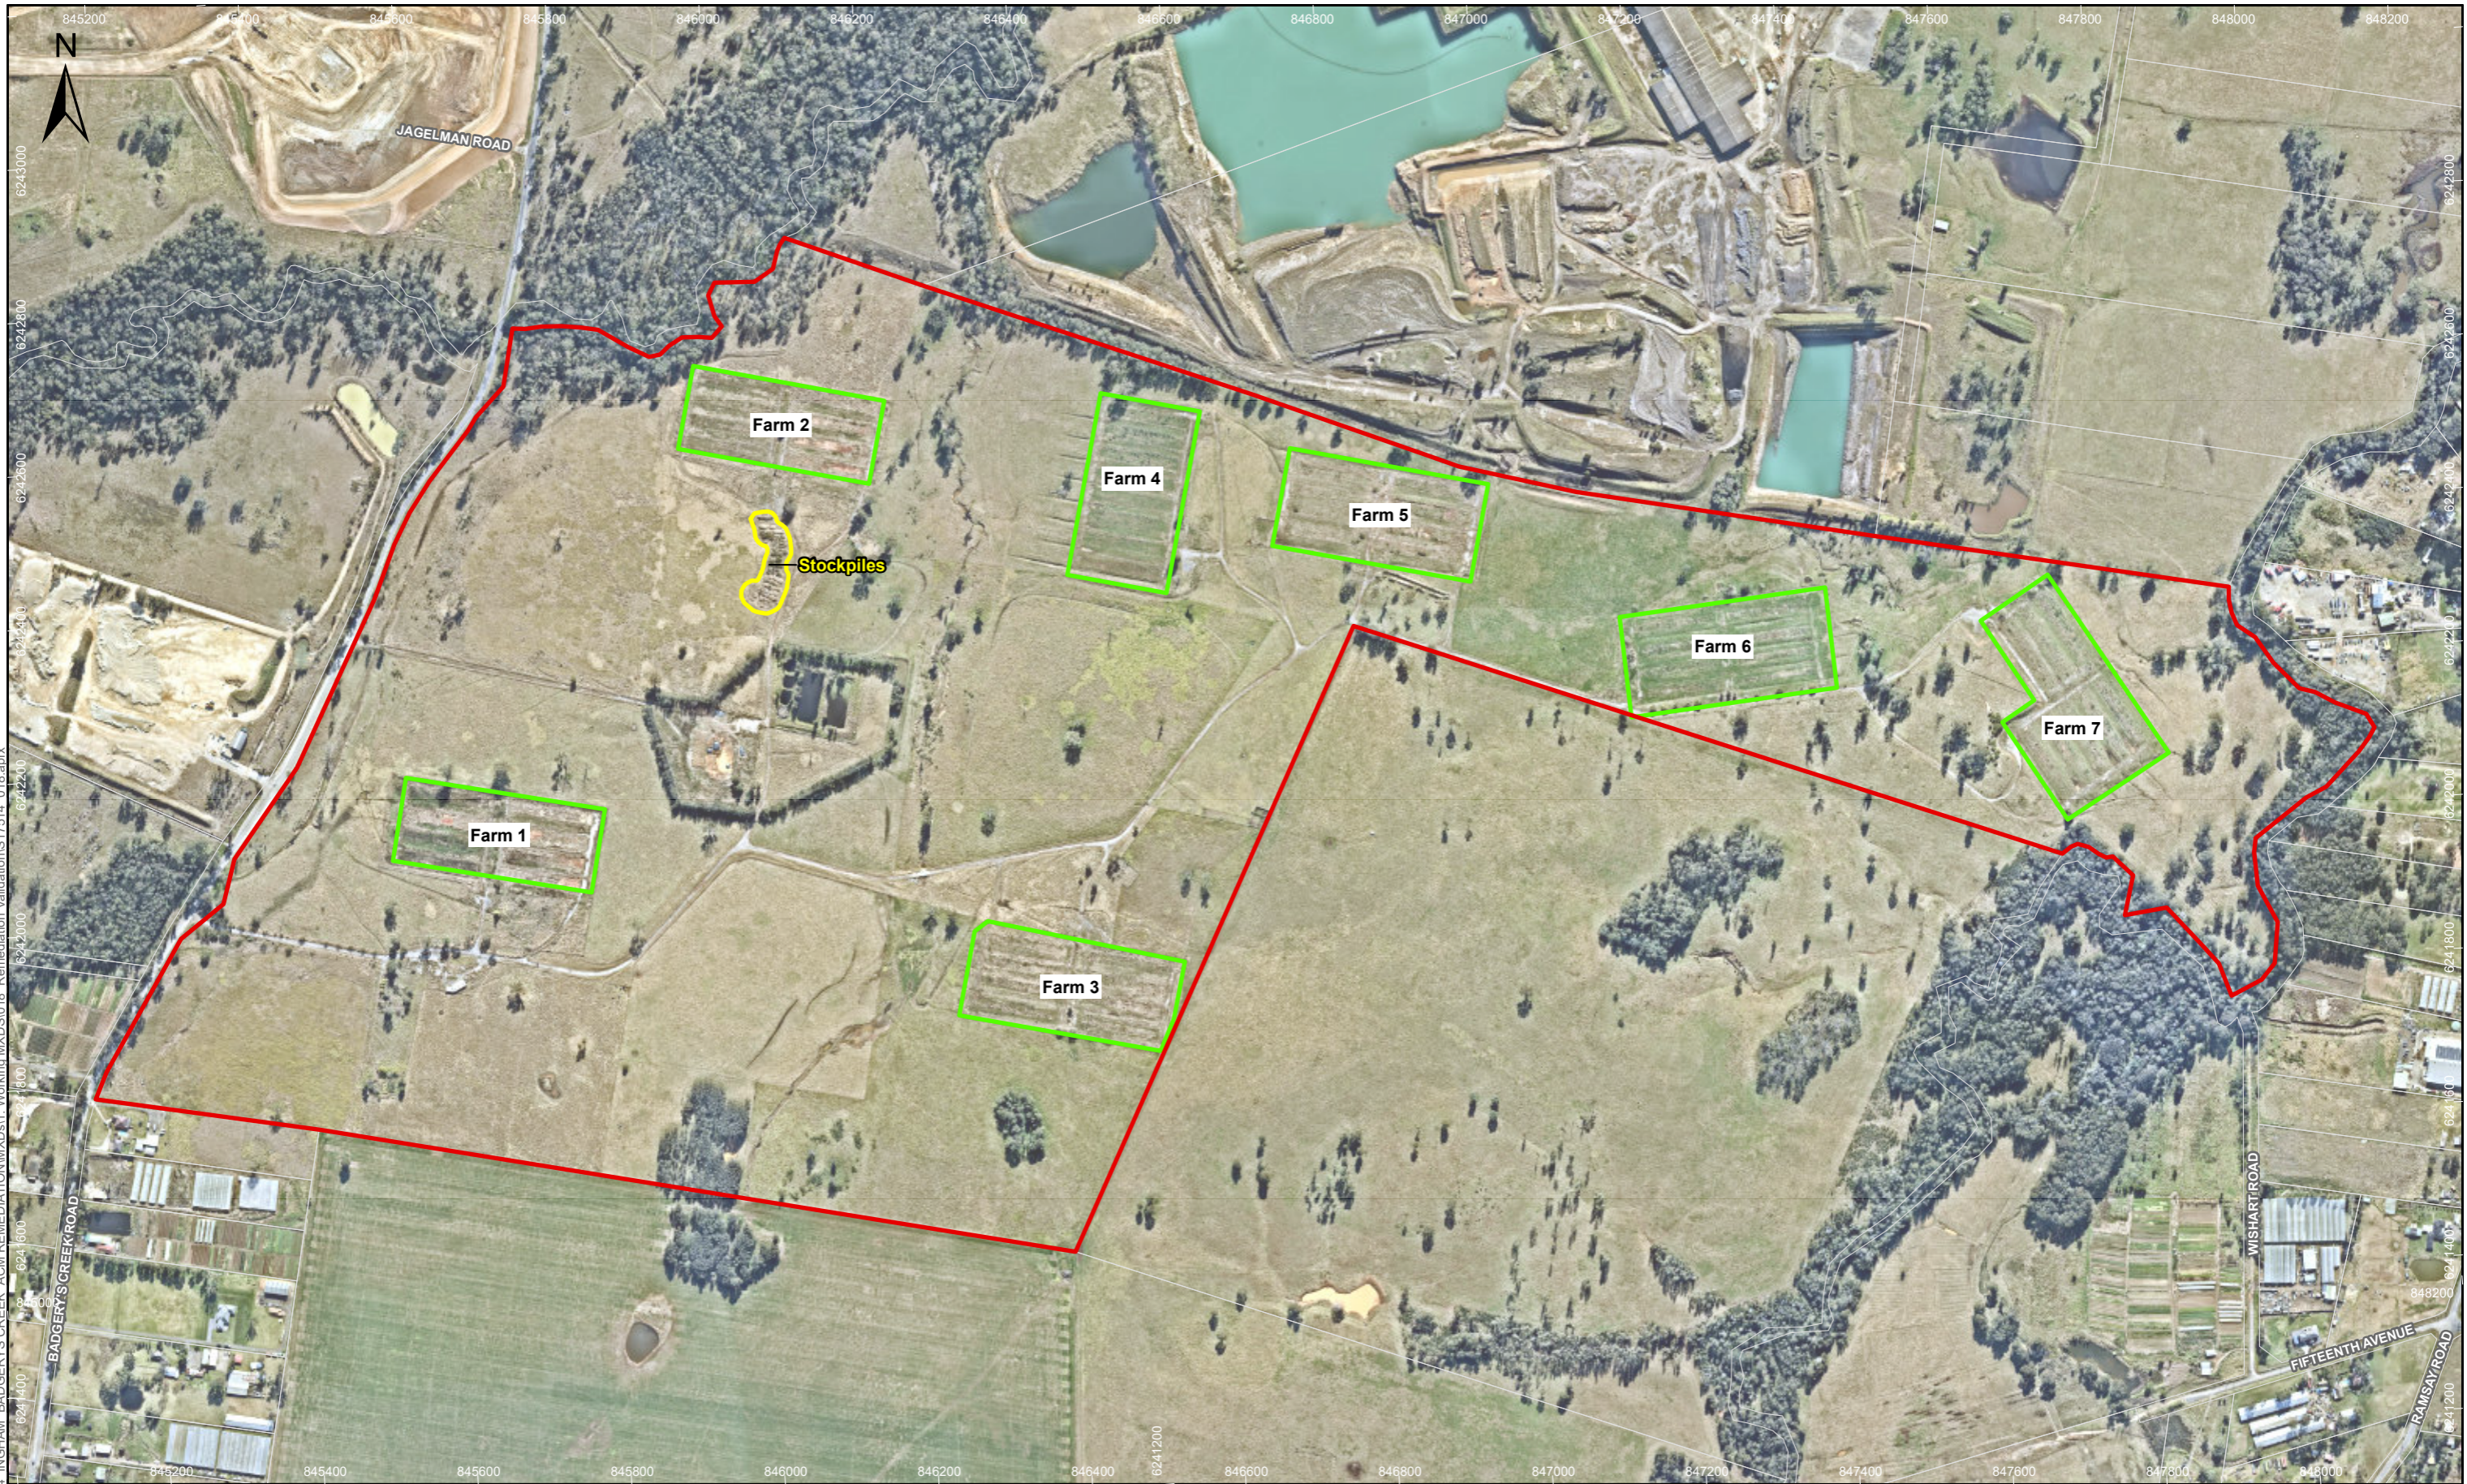
Figure 2: Site Layout

Legend	
	Approximate Farm Extent
	Stockpiles
	Cadastre
	Site Boundary

The former site layout and property boundary is indicated on **Figure 2**.
