# AMENDED ARBORICULTURAL IMPACT ASSESSMENT S34 2021/00269445

Prepared for LDJ Solutions Pty Ltd.54 Adderton Road Telopea 20.12.2021

Prepared by Lee Hancock Consulting Arborist AQF Level 5 lee@leehancockarborist.com.au

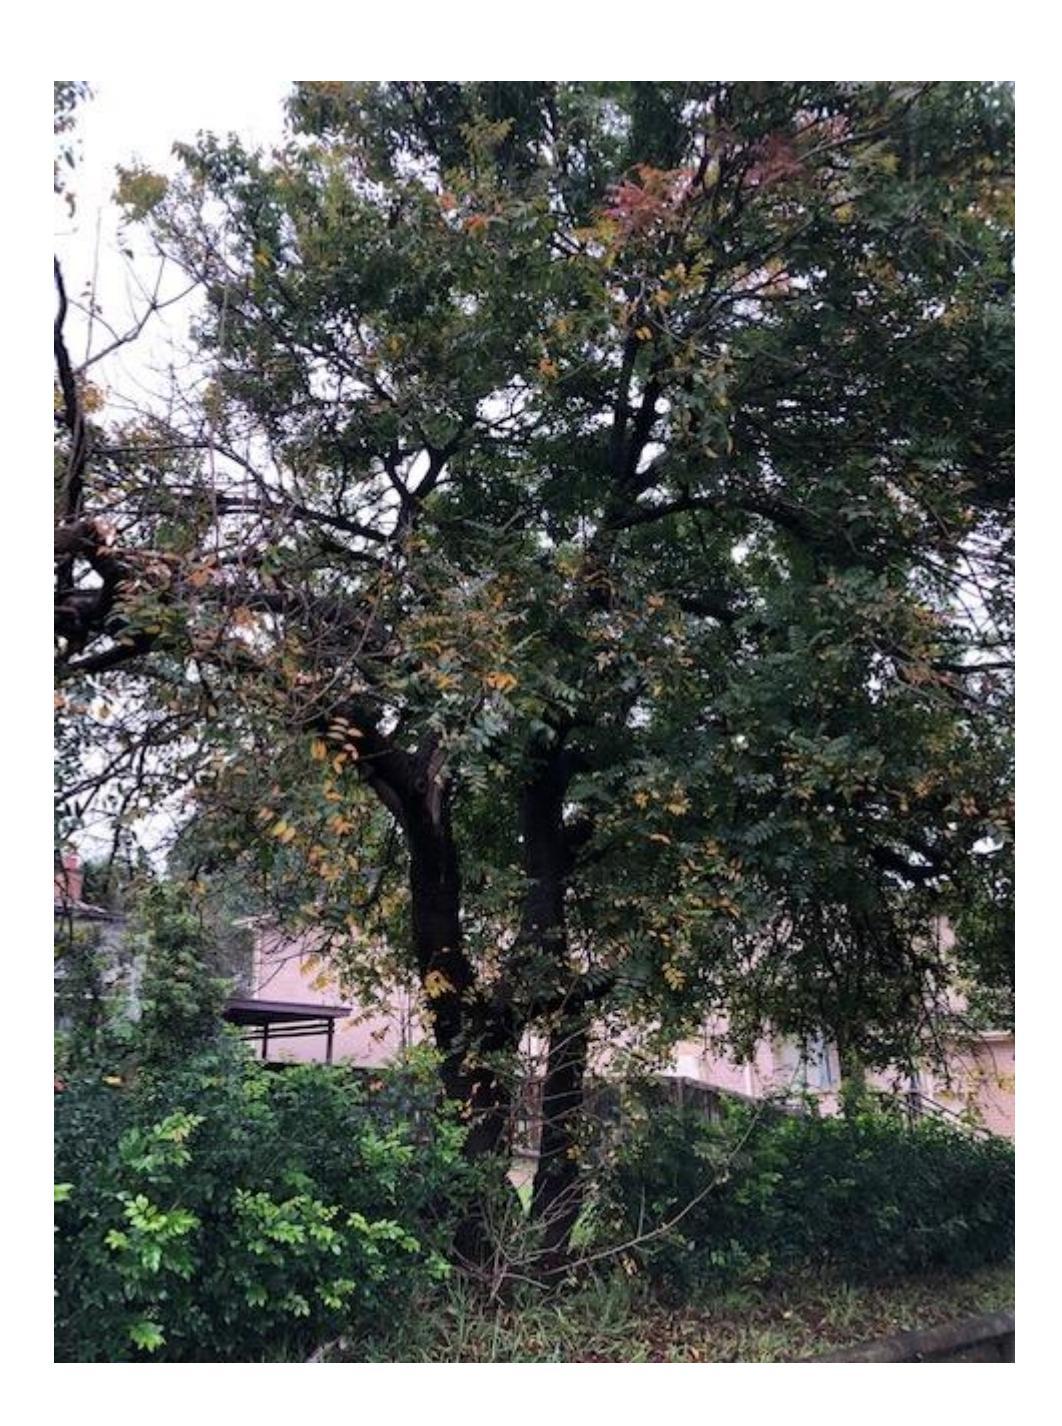
Plate 1.

# Tree 1. Pistacia chinensis (Chinese Pistacia)

Mature tree with a broad canopy, in good form and vigour, positioned in retaining wall front of site. The revised plans show basement will not encroach inside the tree protection zone. The proposed fire booster has been relocated outside the SRZ of the subject tree to mitigate any issues with woody tree roots inside structural root zone. Rated as high landscape significance and amenity value. High retention value.

6.1 Tree 1. *Pistacia chinensis* (Chinese Pistacia) is nominated for retention. The revised architectural plans show trees protection zone is outside the proposed basement excavations, however Project Arborist to supervise basement excavations outside of tree protection zone to ensure no woody roots are damaged.. Rumble boards shall be placed inside tree protection zone to minimise compaction from plant and equipment and shall remain in place for the duration of the proposed development. The proposed fire booster has been relocated outside SRZ and TPZ to mitigate root issues inside SRZ. The tree will remain viable into the future.

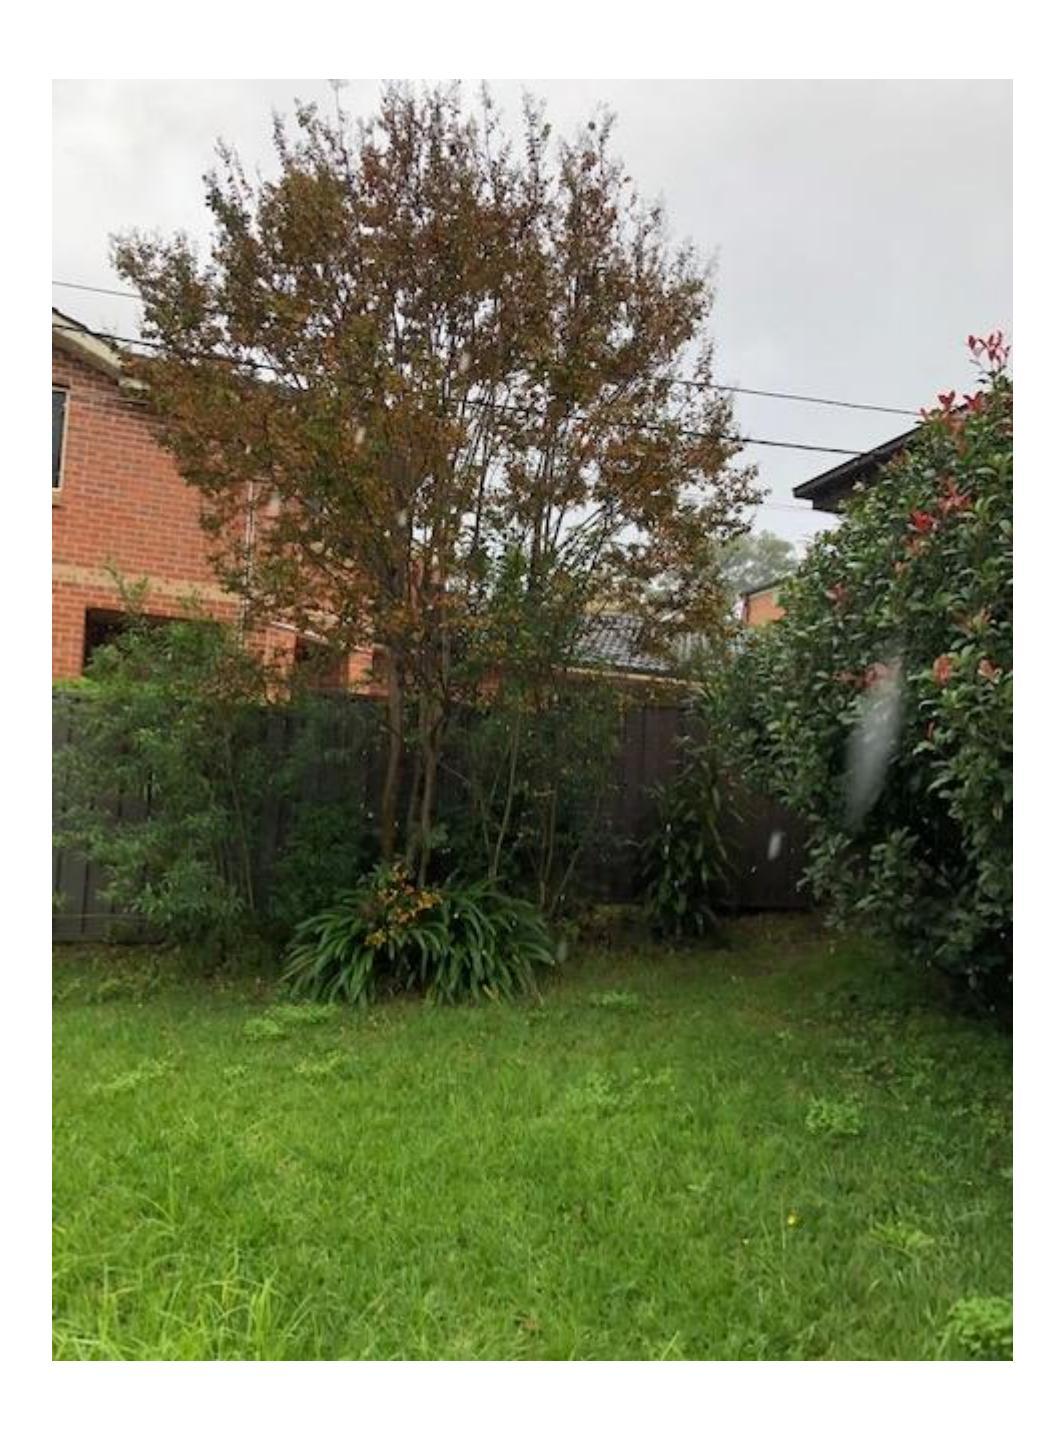
Plate 2.

# Tree 2. Lagerstroemia indica (Crepe Myrtle)

Mature small tree positioned northern boundary front of site. The supplied plans show tree will be adversely impacted upon by the proposed basement excavations. Tree is not considered worthy of any special measures for its retention. Rated as moderate landscape significance and amenity value. Low retention value.

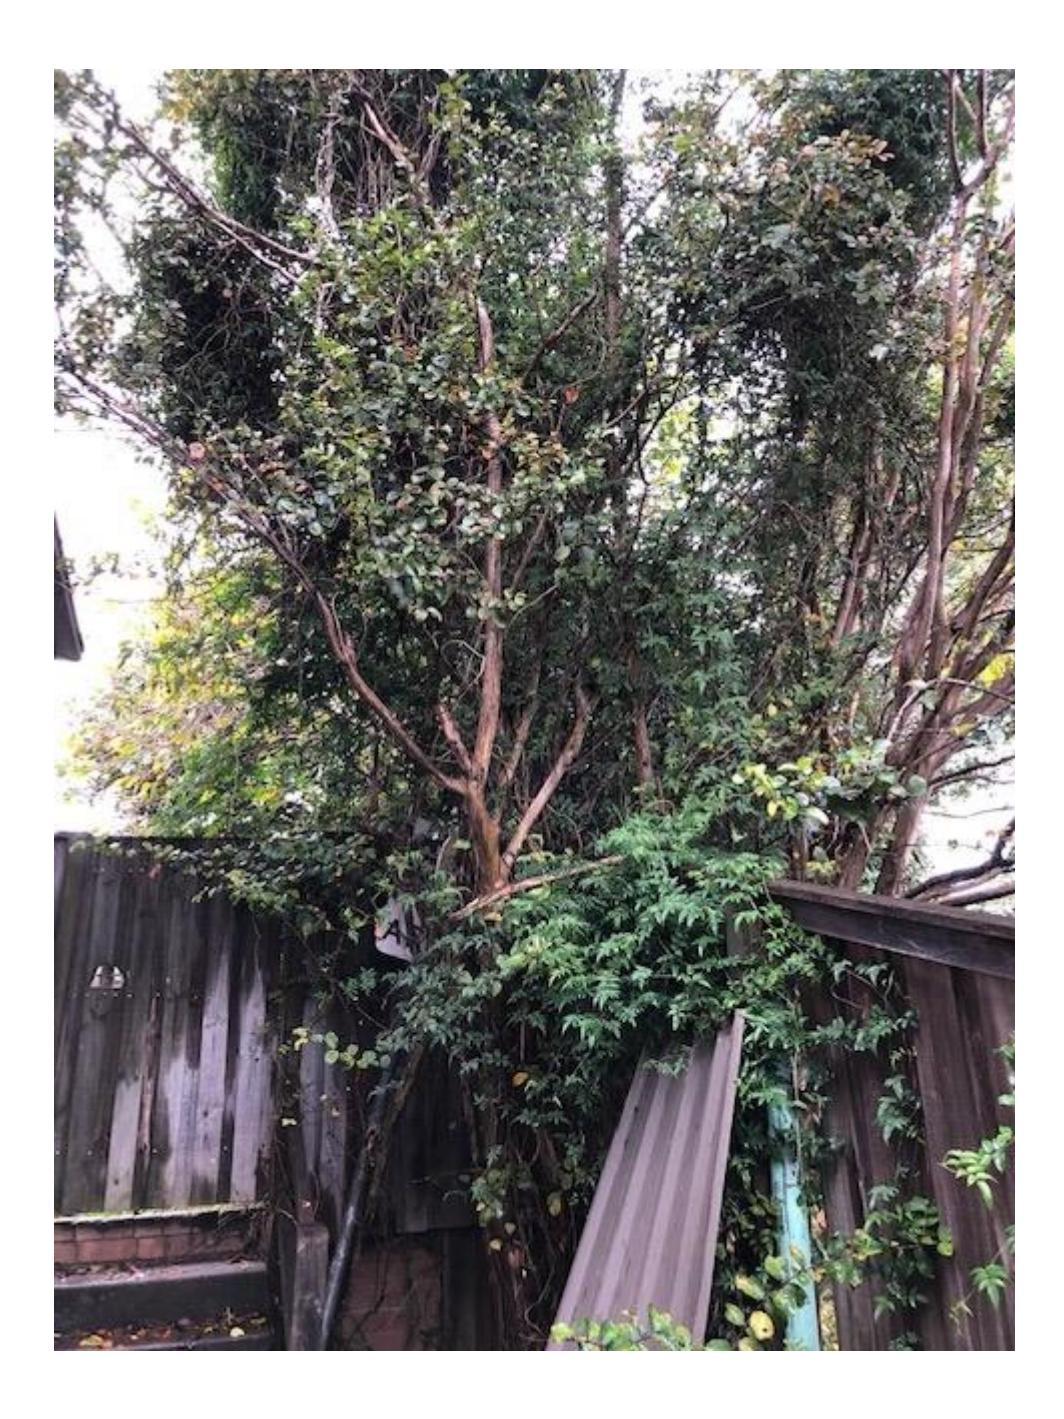
Plate 3.

# Tree 3. Lagerstroemia indica (Crepe Myrtle)

# Background offsite Tree A & B

Mature shrub/tree positioned southern boundary gateway to rear of site, tree is also in close proximity to another Tree A. *Lagerstroemia indica* (Crepe Myrtle) and Tree B. Morus Spp. (Mulberry) on the adjacent boundary. The supplied plan shows the proposed basement excavations will adversely impact the tree and to a lesser extent trees A & B Crepe Myrtle and Mulberry on the adjacent site. The basement will be

constructed using contiguous pilings which will mitigate any issues with the below ground parts of the two trees offsite. As stated in AS 4970 Clause 3.3.4 AS4970 (2009) outlines that *tree species and tolerance to root disturbance should be considered when determining the potential impact of the encroachment. Lagerstroemia indica* (Crepe Myrtle) is a common street tree in surrounding Council areas and can withstand alterations to site conditions, such as high levels of root disturbance/loss from footpath and kerb work. Clause 3.3.4 AS4970 (2009) *The area lost to this encroachment should be compensated for elsewhere and contiguous with TPZ.* Tree 3. Is rated as moderate landscape significance and amenity value. Low retention value.

6.2 Trees A and B southern boundary, offsite Tree A has an offset of 2.5m (including 1m offset from development site) as does Tree B which has an offset of 2.74m. The supplied plans show basement walls will be constructed using contiguous pilings 2m apart. This shall mitigate any issues with below ground parts of both trees offsite.

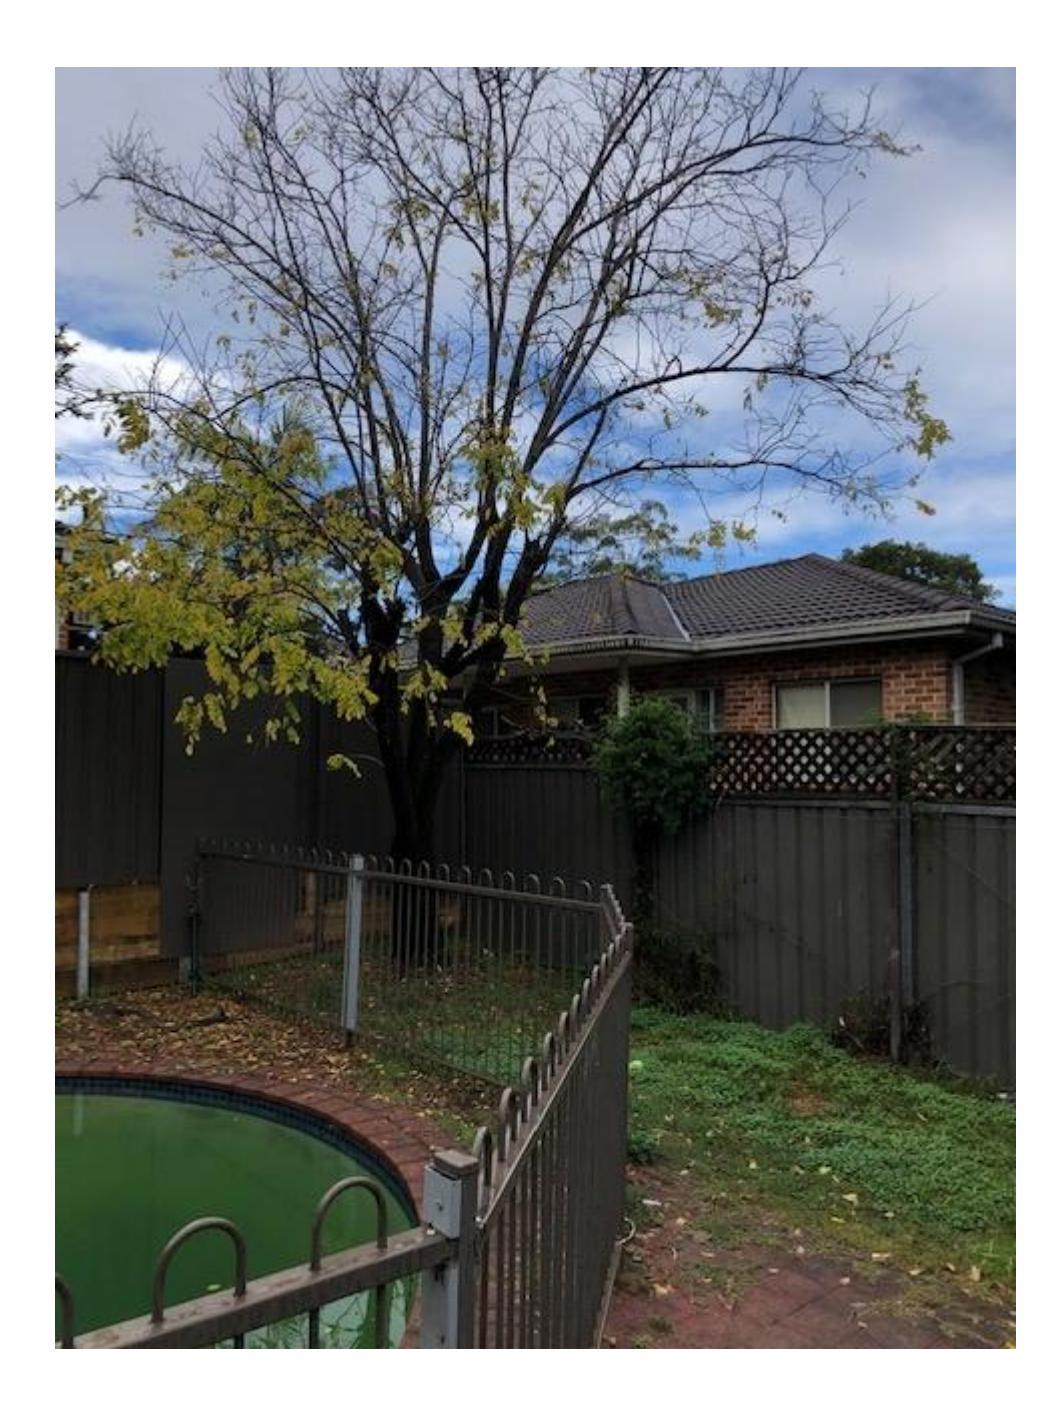
Plate 4.

# Tree 4. Robinia pseudoacacia (Black Locust)

Semi mature tree in good form and vigour, tree is considered a weed in some states of Australia, the supplied plans show the proposed basement and removal of existing pool, during demolition will adversely impact upon tree. Tree should not be considered as a constraint to the potential development of the site. Rated as moderate landscape significance and amenity value. Low retention value.

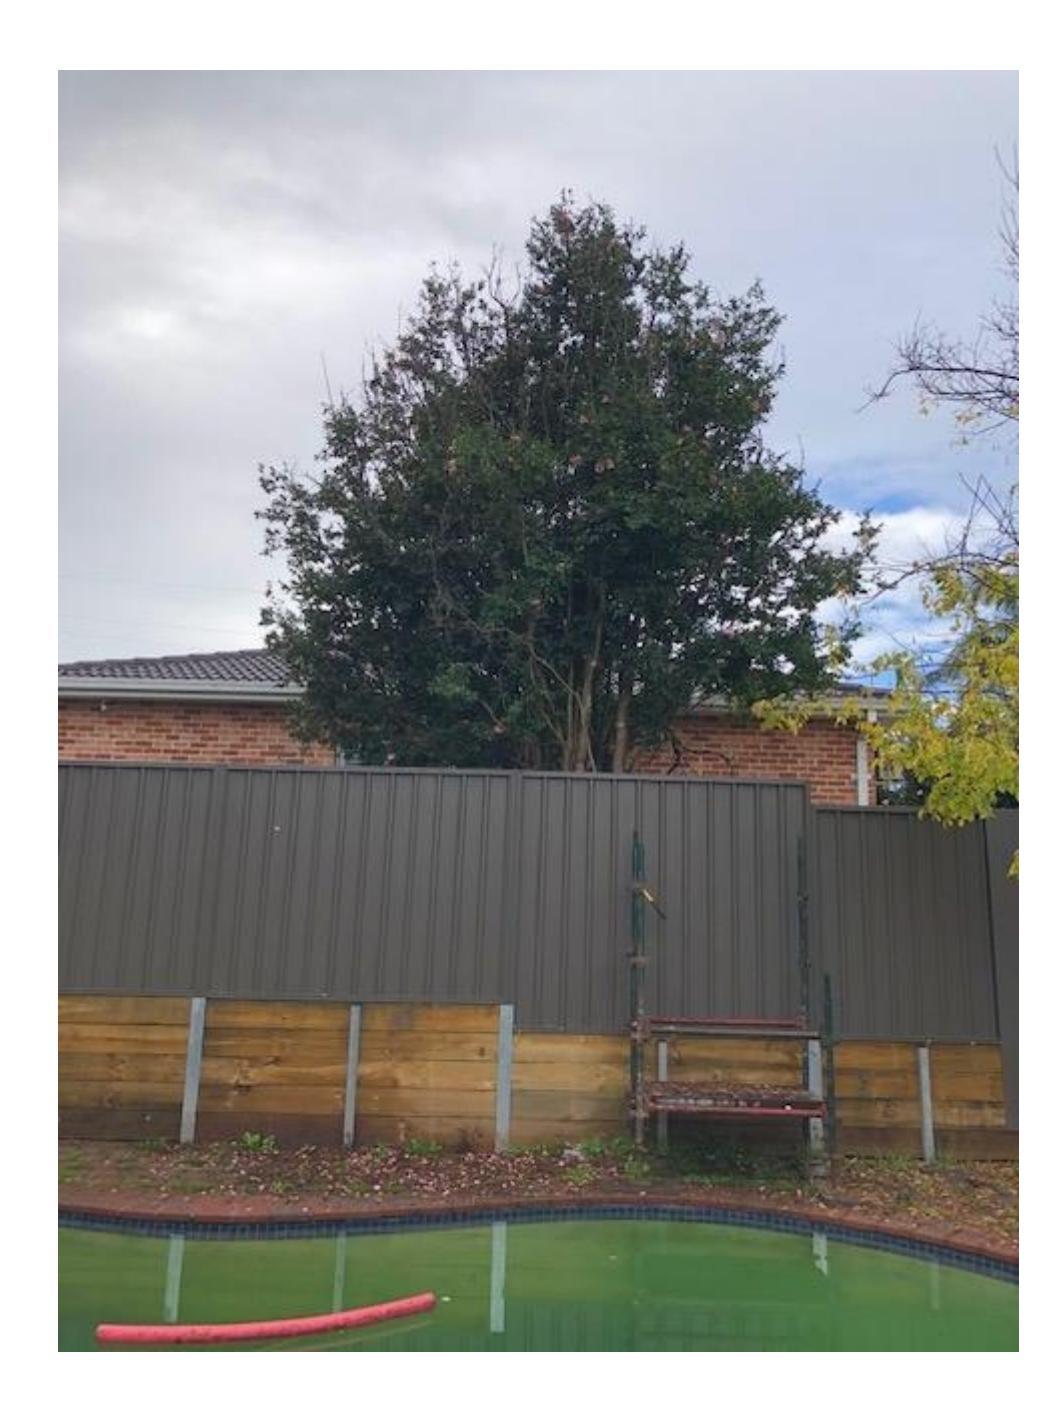
Plate 5.

# Tree C. *Camellia sasanqua* (Sasanqua Camellia)

Positioned offsite rear property in good form and vigour, the tree shrub located in a 1metre high retaining wall, the supplied plans show tree/shrub shall not be adversely impacted upon by the proposed development. Rated as high landscape significance and amenity value. High retention value.

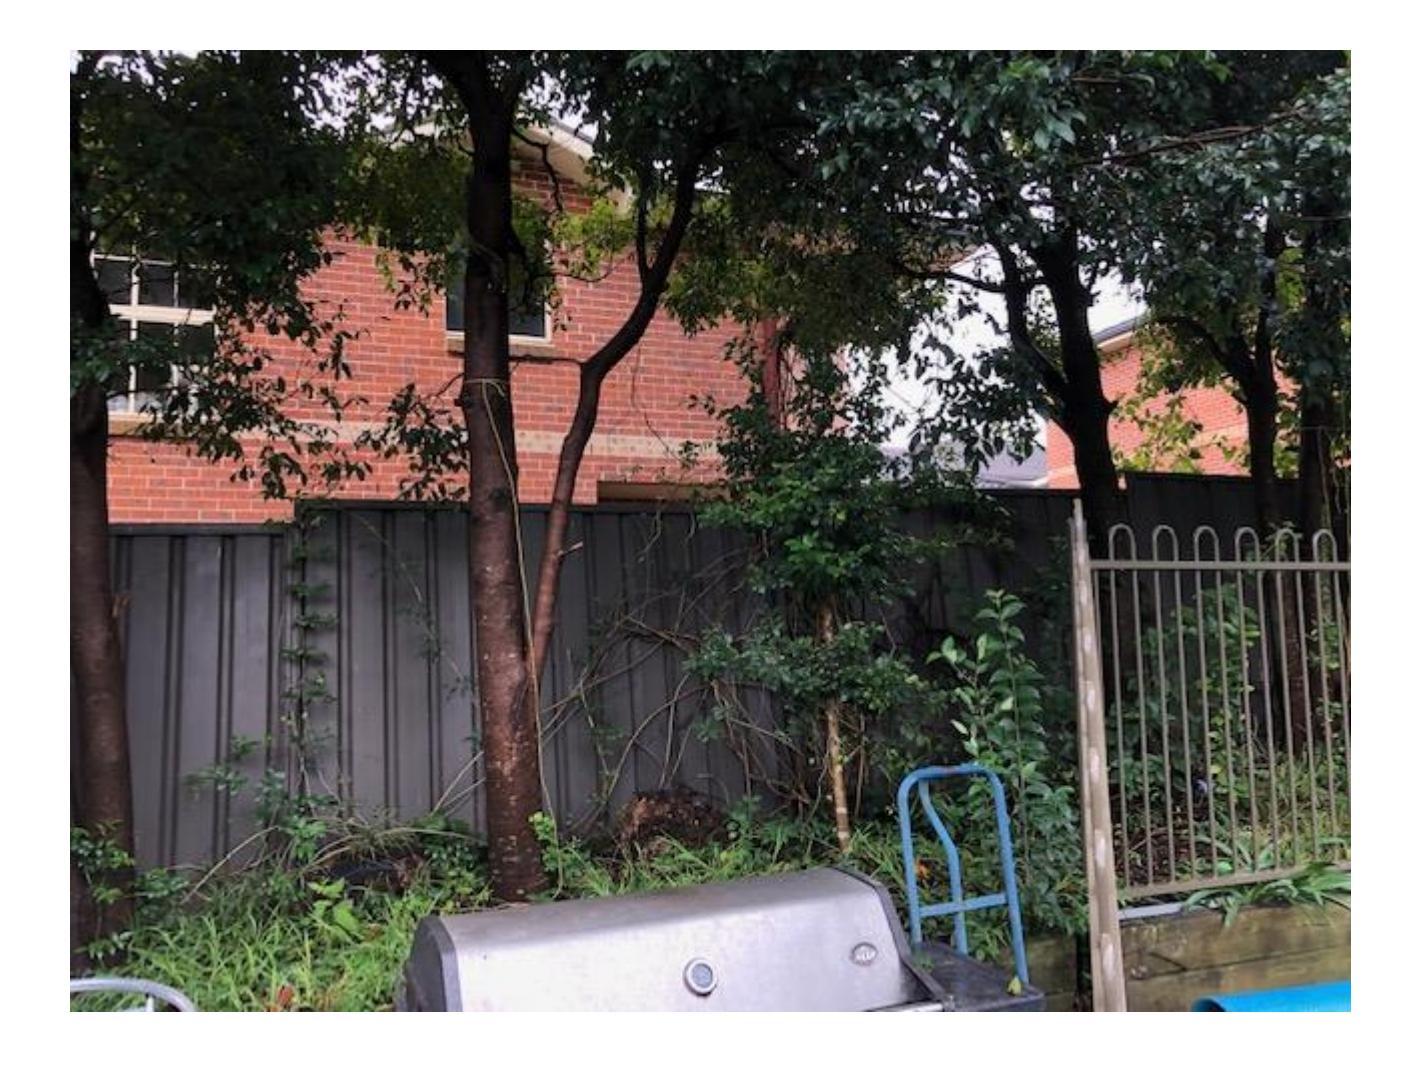
# Plate 6. Trees 5 x 5 *Syzygium australe* (Lilli Pilly) Informal screening hedge

Informal hedge of semi mature trees, positioned in 1m high retaining wall, in close proximity to existing pool, the trees appear in good form and vigour, 2 trees have co-dominant stems showing early formation of branch bark inclusion, although the trees provide amenity and screening, the demolition of the pool shall adversely impact upon them structurally. *Grade changes made near trees will seriously disturb the delicate relationship between roots and the surrounding soil. This results in root mortality, decline in vigour and frequently, death of the tree.* E. Thomas Smiley, PhD, Urban Forestry. The trunks all varied in their diameter, the tree with the largest trunk DBH was calculated for the structural root zone and tree protection zones of all the trees forming part of the hedge, this method provided a generous protection zone for the small diameter trees. Although, the proposed basement will adversely impact upon the above and below ground parts of the hedge. Rated as high landscape significance amenity and ecological value. Low retention value.

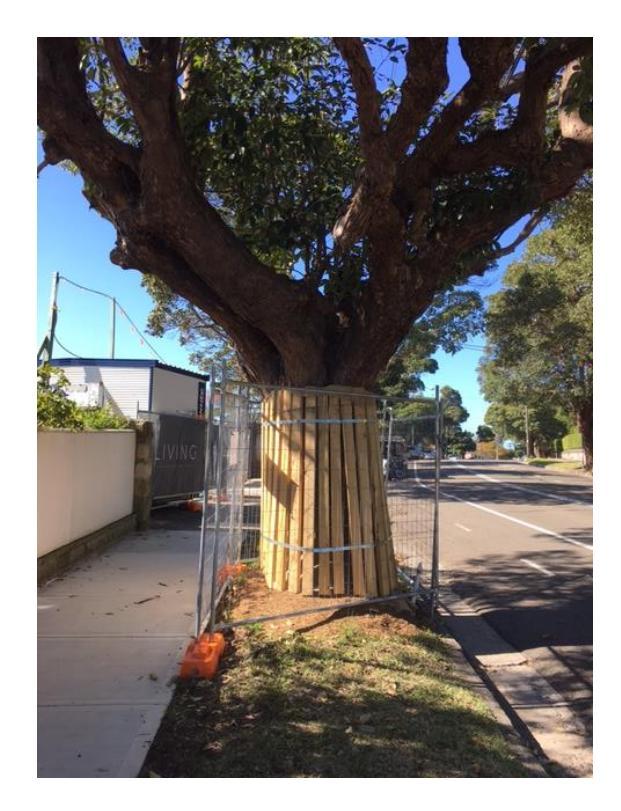
Figure 1. Indicative Street Tree Protection

Trunk Protection by way of Timber planks (50mmx 100mm or similar) with a geotextile fabric shall be placed around Street tree. The timber planks shall be spaced at 100mm intervals, and must be fixed against the trunk secured together with 2mm galvanised wire. These shall be strapped around the trunk (not fixed in anyway) to avoid mechanical injury or damage. Trunk protection should be installed prior to any site works and maintained in good condition for the duration of the construction period. The hessian and timber planks must not be fixed to the tree in any instance or in any fashion.

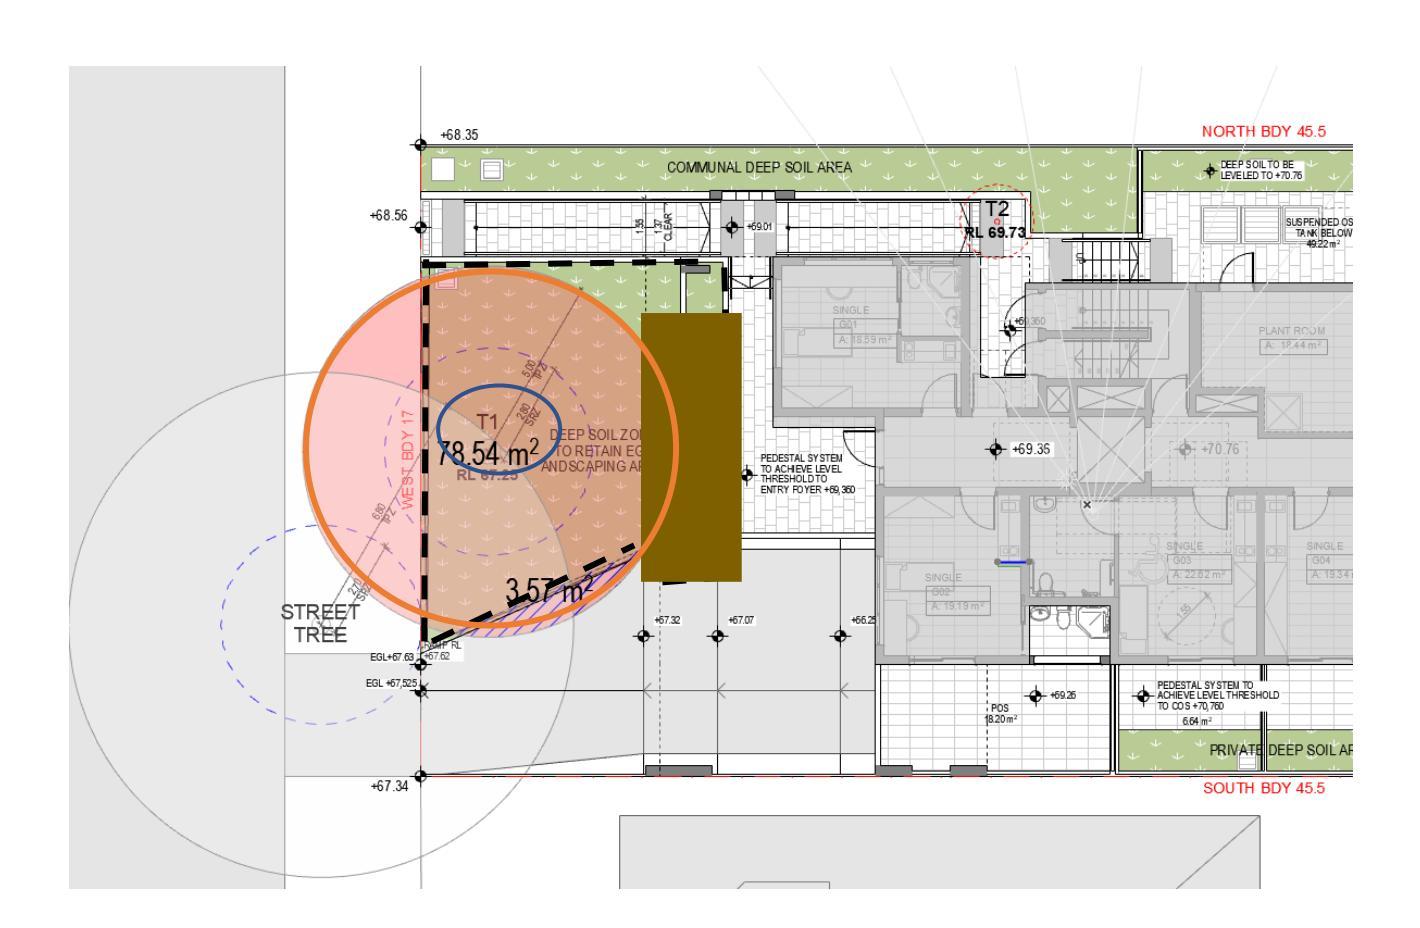
SRZ = 2.8m radius (No incursion proposed)

TPZ = 5m radius (78.54m<sup>2</sup>, with 3.57m<sup>2</sup> incursion due to driveway widening only) = 4.5% incursion due to proposed works

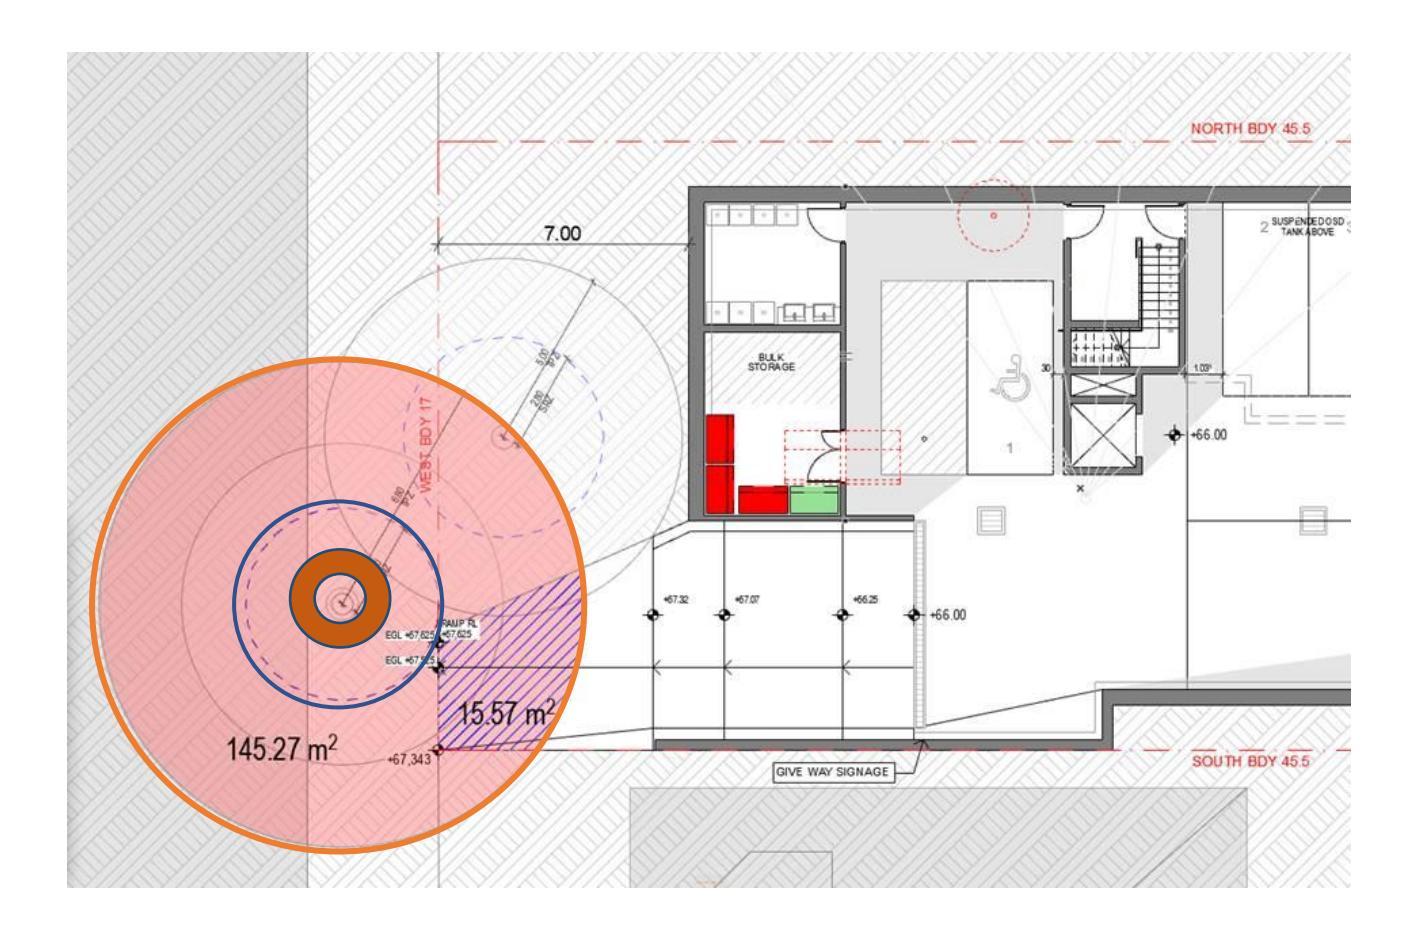
SRZ = 2.7m radius (No incursion proposed)

TPZ = 6.8m radius (145.27m<sup>2</sup>, with 16.98m<sup>2</sup> incursion due to driveway extent) = 10.7% incursion

Street tree is to be retained; the revised plans show the tree will experience an incursion of 10.07% which is within acceptable limits as stated in AS 4970. Clause 3.3.4 of the AS4970 outlines *that tree species and tolerance to root disturbance should be considered when determining the potential impact of an encroachment*. Melaleuca quinquenervia are commonly used Street Trees in most Councils in the Sydney as they can withstand alterations to site conditions, such as high levels of root disturbance/loss from footpath and kerb work.

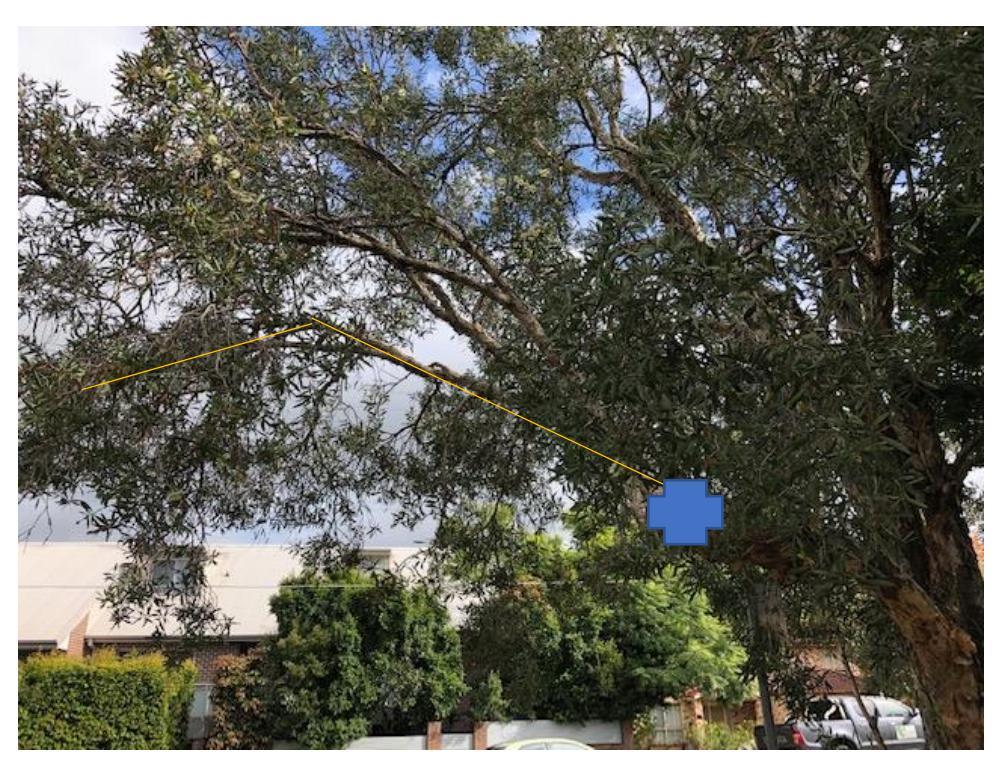
The removal of the one branch pictured below, removed to the nearest collar to provide clearance for plant and equipment. Estimated percentage of foliage removed is 10% of overall canopy.

Remove one (1) branch in yellow extending south over existing driveway to the nearest collar blue cross.

Insitu Branch facing south over driveway, 80mm in diameter.
