Terrace Houses Development 2-6 Martin Street, Roselands NSW

Geotechnical Investigation

Our ref: 7447-R1
25 January 2024

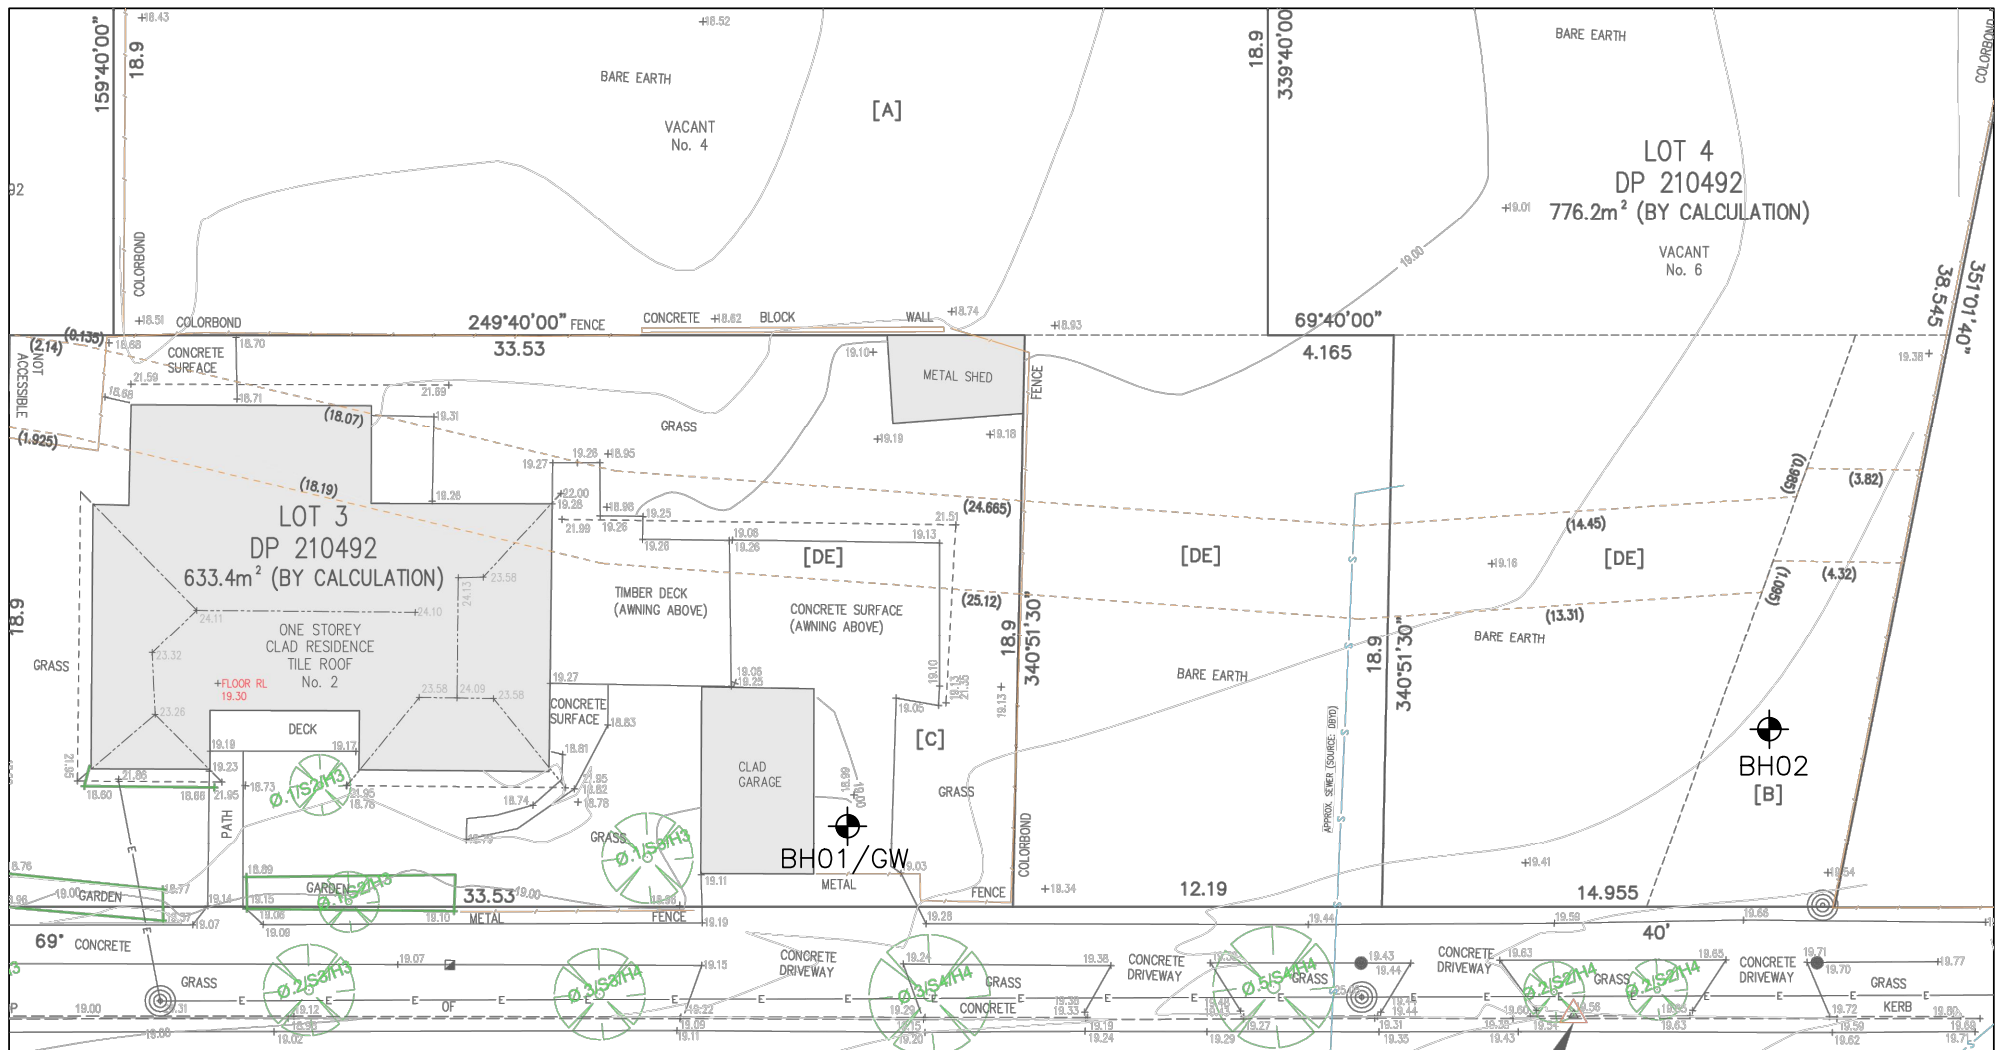
Figure 2 – Test Locations

APPROXIMATE ONLY - SUBJECT TO DETAIL SURVEY.
SOURCE: Survey Plan by Innovative Surveying Associates, JOB NO: 310906, DATE: 30 November 2021

THIS DRAWING IS USED TO ILLUSTRATE TEST LOCATIONS ONLY, AND MUST NOT BE USED FOR ANY OTHER PURPOSE.

The invasive investigation included drilling of boreholes at two locations, BH01 and BH02 respectively as seen in Figure 2, drilled using a ute-mounted drilling rig. The boreholes BH01 and BH02 were auger drilled to refusal at depths of 4.1m and 4.3m bgl respectively. Standard Penetrometer Testing (SPT) was carried out within the soils at nominally 1.5m depth intervals to aid with an assessment of in-situ conditions.

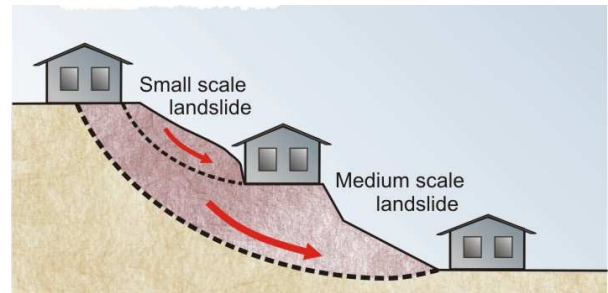
Figure 1

Rotational or circular slip failures (Figure 1) - can occur on moderate to very steep soil and weathered rock slopes (Table 1). The sliding surface of the moving mass tends to be deep seated. Tension cracks may open at the top of the slope and bulging may occur at the toe. The ground may move in discrete "steps" separated by long periods without movement. More rapid movement may occur after heavy rain.

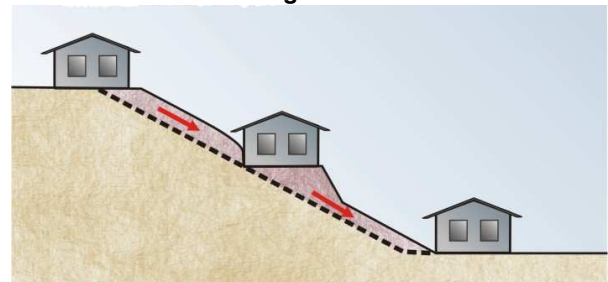
Figure 2

Translational slip failures (Figure 2) - tend to occur on moderate to very steep slopes (Table 1) where soil, or weak rock, overlies stronger strata. The sliding surface is often relatively shallow. It can move, or deform slowly (creep) over long periods of time. Extensive linear cracks and hummocks sometimes form along the contours. The sliding mass may accelerate after heavy rain.

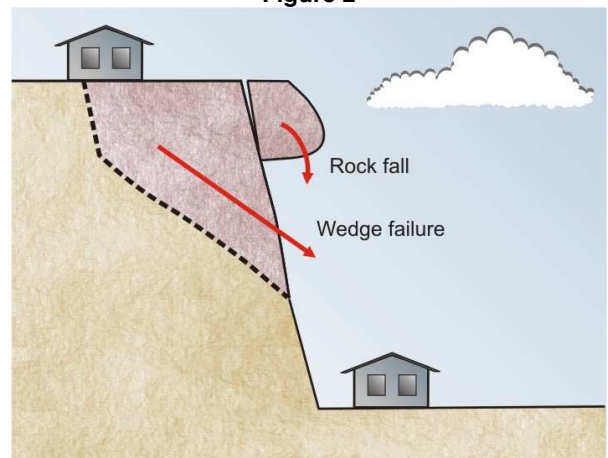
Figure 3

Wedge failures (Figure 3) - normally only occur on extreme slopes, or cliffs (Table 1), where discontinuities in the rock are inclined steeply downwards out of the face.

Rock falls (Figure 3) - tend to occur from cliffs and overhangs (Table 1).

Cliffs may remain apparently unchanged for hundreds of years. Collections of boulders at the foot of a cliff may indicate that rock falls are ongoing. Wedge failures and rock falls do not "creep". Familiarity with a particular local situation can instil a false sense of security since failure, when it occurs, is usually sudden and catastrophic.

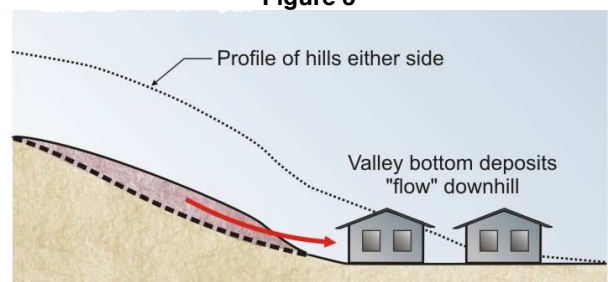
Figure 4

Debris flows and mud slides (Figure 4) - may occur in the foothills of ranges, where erosion has formed valleys which slope down to the plains below. The valley bottoms are often lined with loose eroded material (debris) which can "flow" if it becomes saturated during and after heavy rain. Debris flows are likely to occur with little warning; they travel a long way and often involve large volumes of soil. The consequences can be devastating.

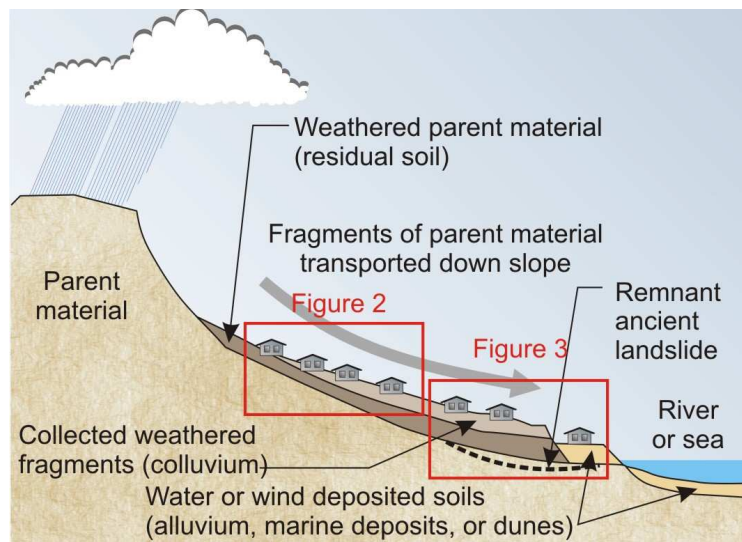
Figure 1

It is always worth asking the question *"why is this slope here?"*, because the answer often leads to an understanding of what might happen in the future. Slopes are usually formed by weathering (breakdown) and erosion (physical movement) of the natural ground - the "parent material". Many factors are involved including rain, wind, chemical change, temperature variation, plant growth, animal activity and our own human enthusiasm for development. The general process is outlined in Figure 1.

The upper levels of the parent material progressively weather over thousands, or millions, of years, losing strength. This can result in a surface layer which looks similar to the parent material (although its colour has probably changed) but has the strength of a soil - this is called "residual soil". At some stage the weathered surface layer is exposed to the elements and fragments are transported down the slope. In this context a fragment could be a single sand grain, a boulder, or a landslide. The time scale could be anything from a few seconds to many thousands of years. The transported fragments often collect on the lower slopes and form a new soil layer that blankets the original slope - "colluvium". If material reaches a river or the sea it is deposited as "alluvium" or as a "marine deposit". With appropriate changes in river and sea level this material can again find itself on the surface to commence another cycle of weathering and erosion. In places often, but not only, near the coast, this can include sand sized fragments which form beaches and are sometimes blown back onto the land to form dunes.

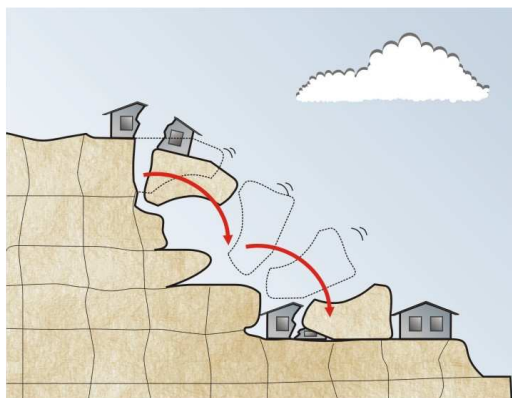
Figure 1 - Failure of an undercut block

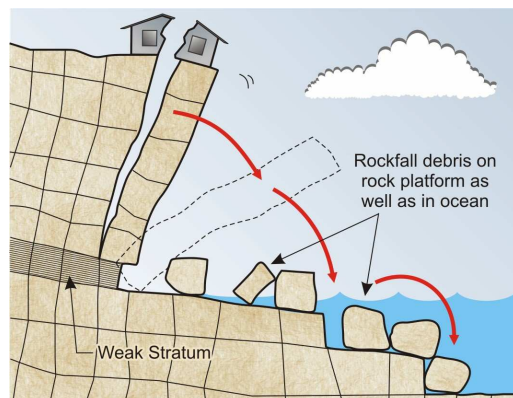
Figure 2 - Toppling failure

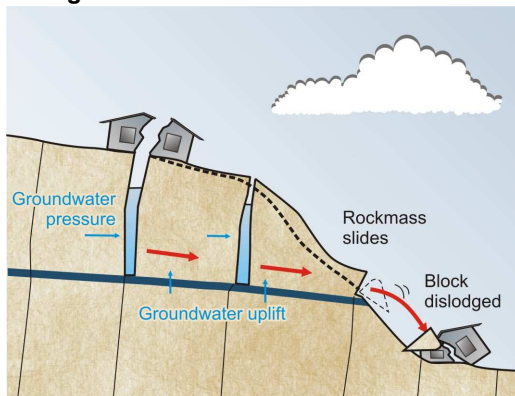
Figure 3 - Block slide on weak layer

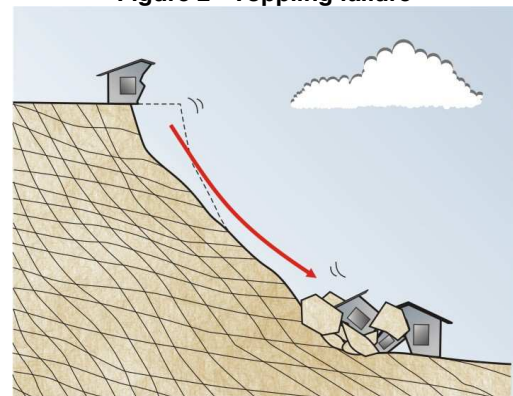
Figure 4 - Wedge failure along discontinuities

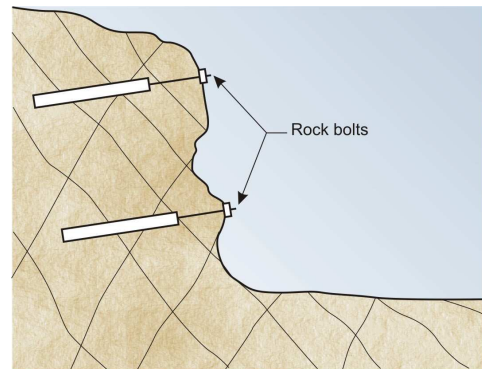
Figure 5

Rock bolts and rock anchors (Figure 5) - can be installed in the ground to improve its strength and prevent individual blocks from falling. Rock bolts are usually tightened using a torque wrench, whilst rock anchors carry higher loads and require jacking. Both can be designed to be "permanent" using stainless steel, or sheathing, to inhibit corrosion, but the cost can be up to 10 times that of the "temporary" alternative. You should inspect rock bolts and rock anchors for signs of water seepage, rusting and deterioration around the heads at least once every 5 years. If you notice any of these warning signs, have them checked by a geotechnical practitioner. It is recommended that you keep copies of design drawings and maintenance records (GeoGuide LR11) for the anchors on your site and pass them on to the new owner should you sell.

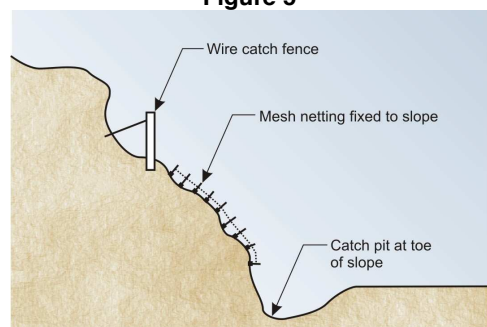
Figure 6

Rock fall netting, catch fences and catch pits (Figure 6) - are designed to catch or control falling rocks and prevent them from damaging nearby property. You should inspect them at least once every 5 years, and after major falls, and arrange for fallen and trapped rocks to be removed if they appear to be filling up. Check for signs of corrosion and replace steel elements and fixings before they lose significant strength.

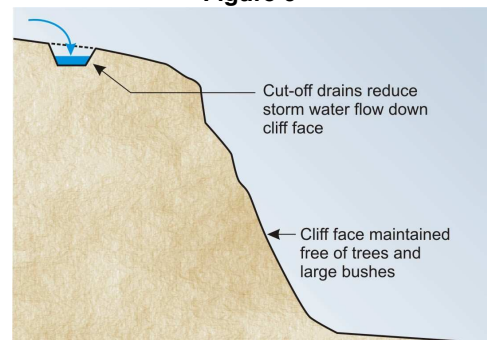
Figure 7

Cut-off drains (Figure 7) - can be used to intercept surface water run-off and reduce flows down the cliff face. Suitable drains are often excavated into the rock, or constructed from mounds of concrete, or stabilised soil, depending on conditions. Drains must be laid to a fall of at least 1% so they drain adequately. Frequent inspection is needed to ensure they are not blocked and continue to function as intended.

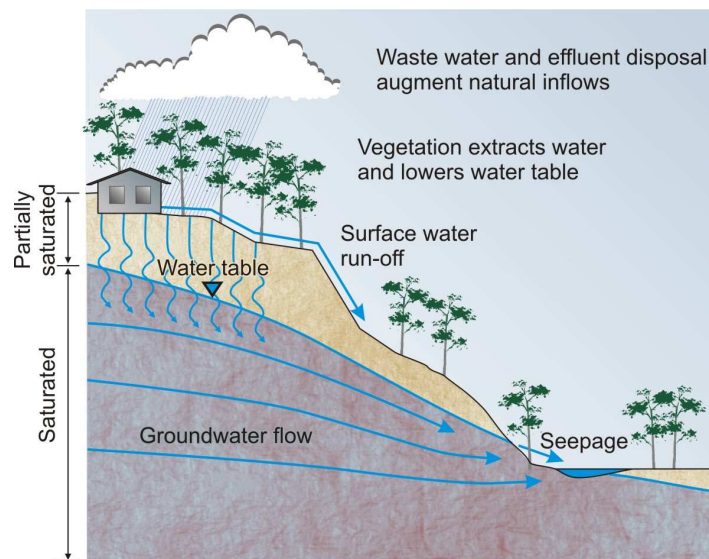
The ground is permeable and water flows through it as illustrated in Figure 1. When rain falls on the ground, some of it runs along the surface ("surface water run-off") and some soaks in, becoming groundwater. Groundwater seeps downwards along any path it can find until it meets the water table: the local level below which the ground is saturated. If it reaches the water table, groundwater either comes to a halt in what is effectively underground storage, or it continues to flow downwards, often towards a spring where it can seep out and become surface water again. Above the water table the ground is said to be "partially saturated", because it contains both water and air. Suctions can develop in the partially saturated zone which have the effect of holding the ground together and reducing the risk of a landslide. Vegetation and trees in particular draw large quantities of water out of the ground on a daily basis from the partially saturated zone. This lowers the water table and increases suctions, both of which reduce the likelihood of a landslide occurring.

Figure 1 - Groundwater flow

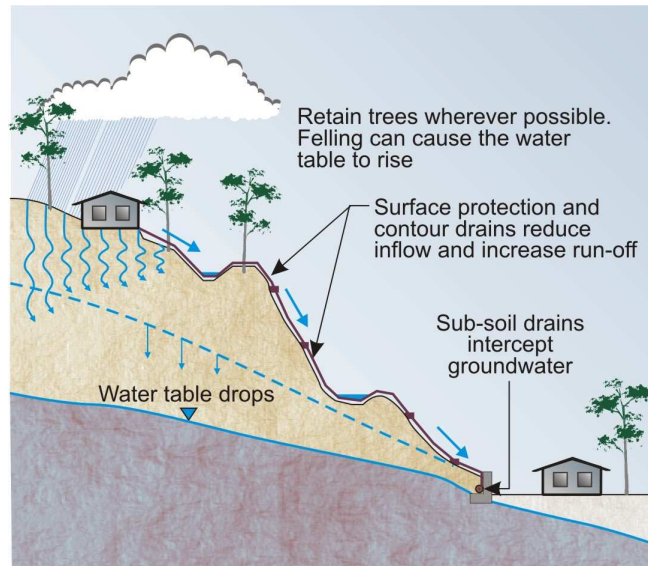
The following techniques may be considered to limit the destabilising effects of rising groundwater due to development and are illustrated in Figure 2.

Figure 2 - Techniques used to control groundwater flow

Surface water drains (dish drains, or table drains) - are often used to prevent scour and limit inflow to a slope. Other than in rock, they are relatively ineffective unless they have an impermeable lining. You should clear them regularly, and as required, and not less than once a year. If you live in an area with seasonal rainfall, it is best to do this near the end of the dry season. If you notice that soil or rock debris is falling from the slope above, determine the source and take appropriate action. This may mean you have to seek advice from a geotechnical practitioner.

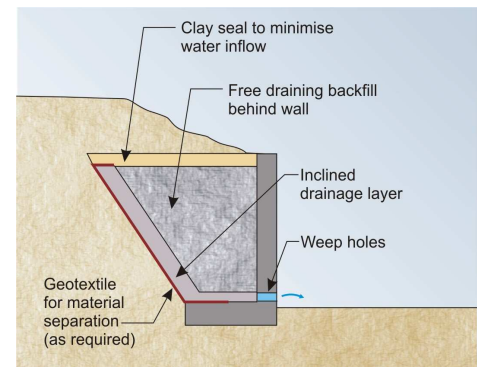
Figure 1- Typical formed concrete wall

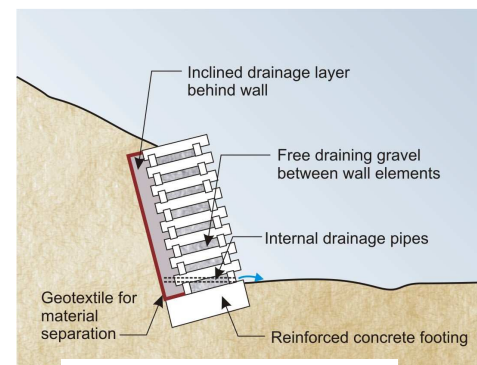
Figure 2 -Typical crib

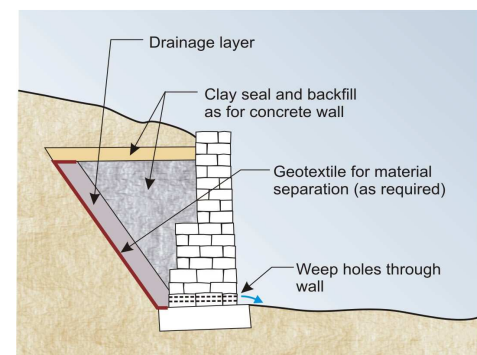
Masonry walls: natural stone, brick, or interlocking blocks (Figure 3) - more than about 1m high, should be wider at the bottom than at the top and include specific measures to permit drainage of the backfill. They should be checked as for formed concrete walls. Natural stone walls should be inspected for signs of deterioration of the individual blocks: strength loss, corners becoming rounded, cracks appearing, or debris from the blocks collecting at the foot of the wall.

Figure 3 -Typical masonry wall

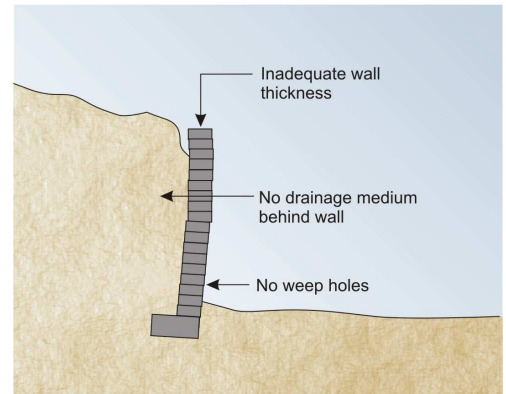
Figure 4 - Poorly built masonry wall

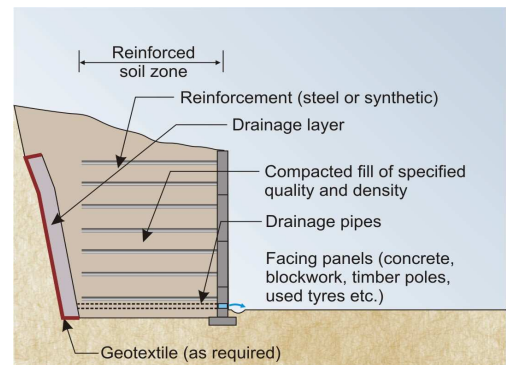
Figure 5 - Typical reinforced soil wall

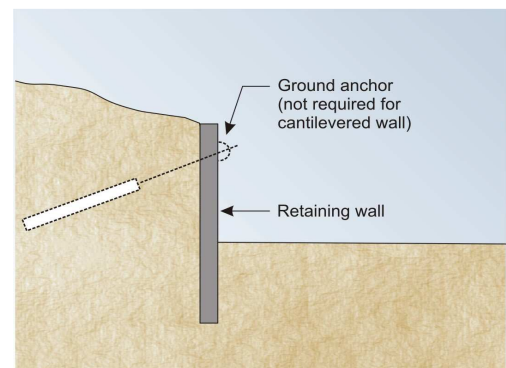
Figure 6 - Typical cantilevered or anchored wall

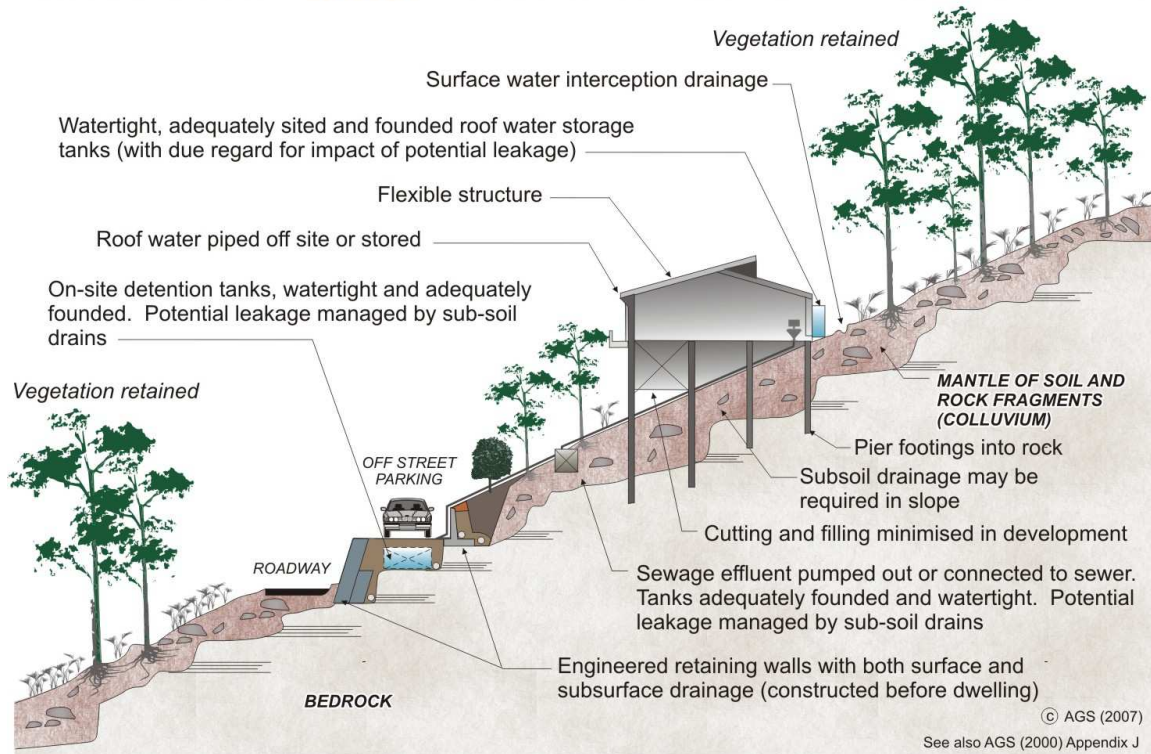
EXAMPLES OF GOOD HILLSIDE CONSTRUCTION PRACTICE

WHY ARE THESE PRACTICES GOOD?

Roadways and parking areas - are paved and incorporate kerbs which prevent water discharging straight into the hillside (GeoGuide LR5).

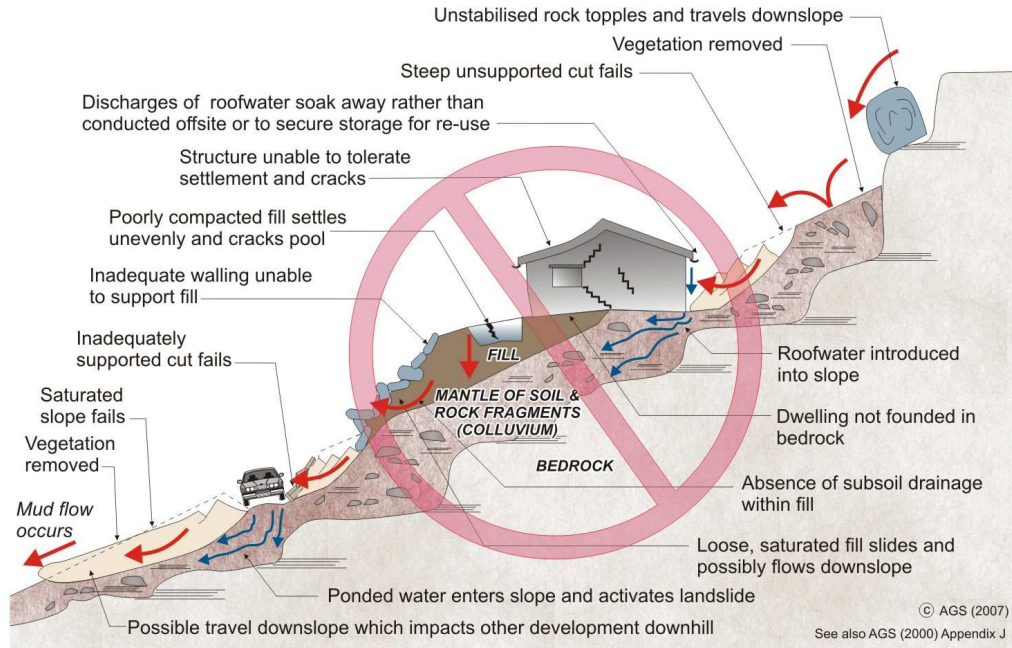
EXAMPLES OF **POOR** HILLSIDE CONSTRUCTION PRACTICE

WHY ARE THESE PRACTICES POOR?

Roadways and parking areas - are unsurfaced and lack proper table drains (gutters) causing surface water to pond and soak into the ground.

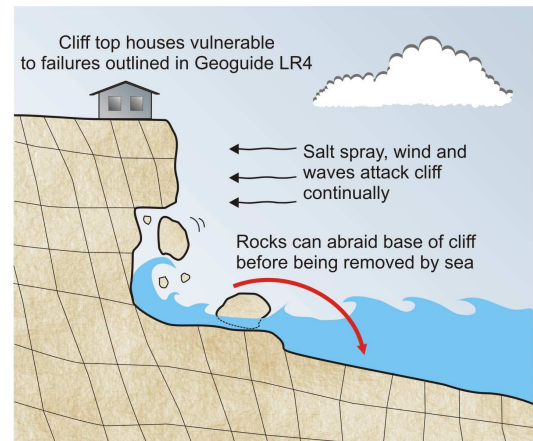
Figure 1

Coastal cliffs and headlands exist because the rock that they are made from is able to resist erosion. Even so, cliff-faces are not immune and will continue to collapse (Figure 1) by one or other of the mechanisms shown on GeoGuide LR4. If you live on a coastal cliff, you should undertake inspection and maintenance as recommended in LR4 and the other GeoGuides, as appropriate. The top of the cliff, its face, and its base should be inspected frequently for signs of recent rock falls, opening of cracks, and heavy seepage which might indicate imminent failure. Since the sea can remove fallen rocks rapidly, inspections should be made shortly after every major storm as a matter of course. **If collapses are occurring seek advice from an appropriately experienced geotechnical practitioner. Advise you local council if you believe erosion is rapid or accelerating.**
