POST CONSTRUCTION CONDITION SURVEY - GPS

Nepean Business Park - Penrith NSW

Council Assets
Lugard Street, Leland Street and Old Castlereagh Road
PENRITH NSW 2750

27 July 2022

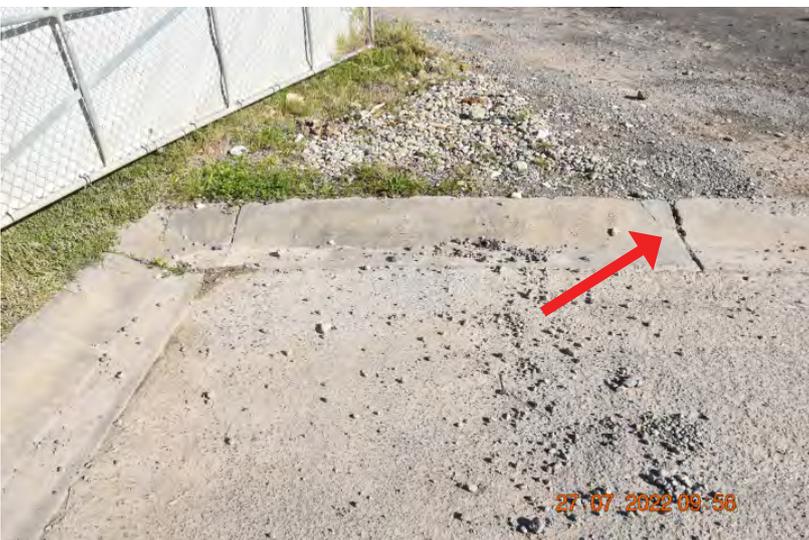
Figure: 0002 Chipping in the kerb and gutter, looking to the west. | **CHANGE:** None

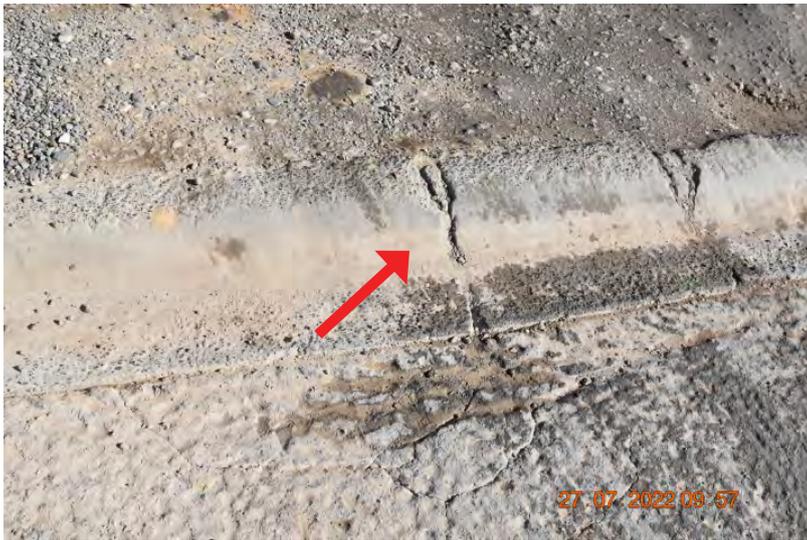
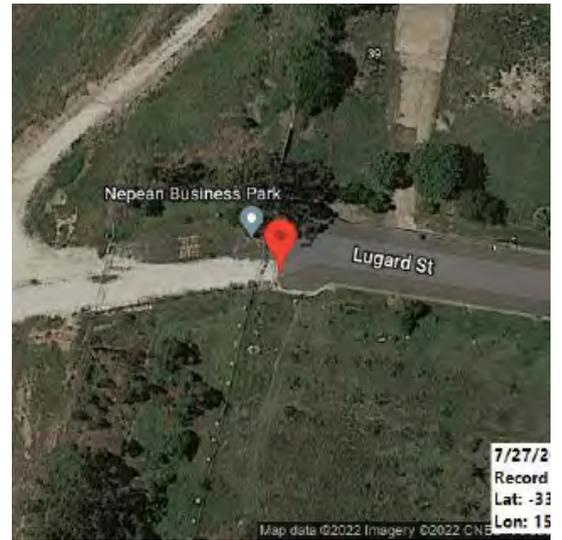
Figure: 0004 Slight cracking in the kerb and gutter, looking to the west. (RPT FOR FIGURES 4-5) | **CHANGE:** None

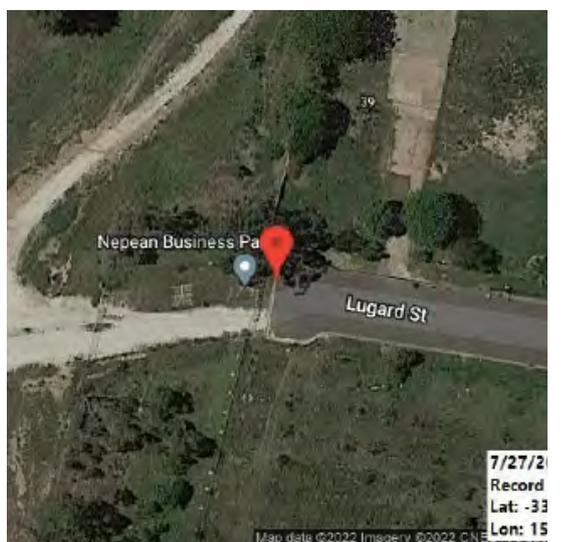
Figure: 0006 Fine cracking in the kerb and gutter, looking to the west. | **CHANGE:** None

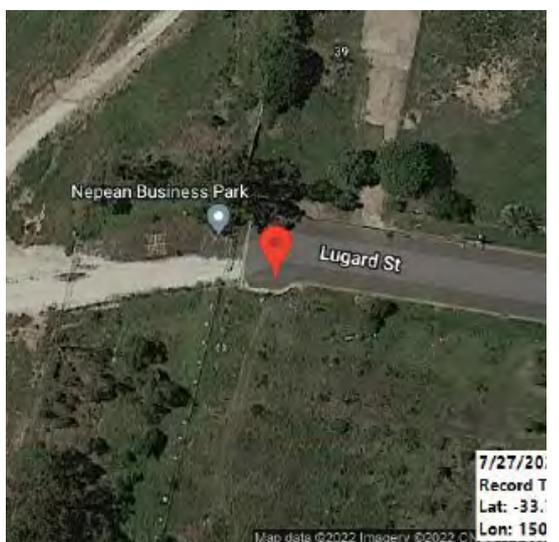
Figure: 0012 Slight cracking in the kerb and gutter. | **CHANGE:** None

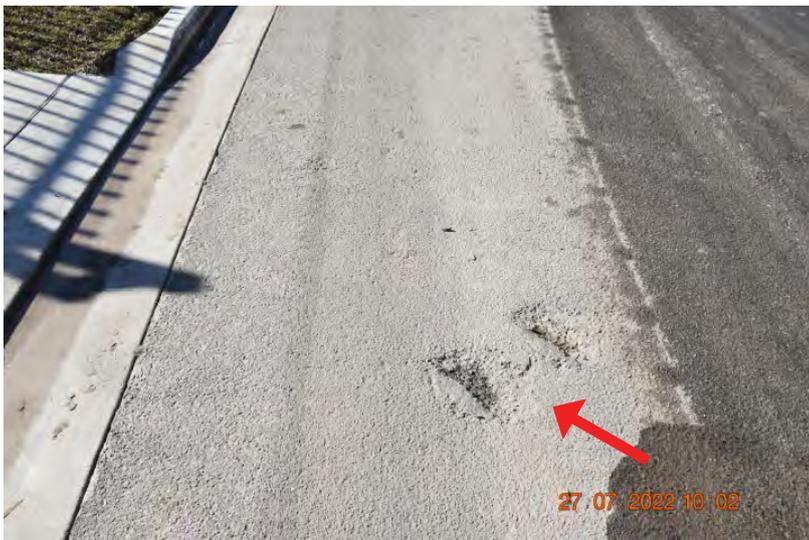
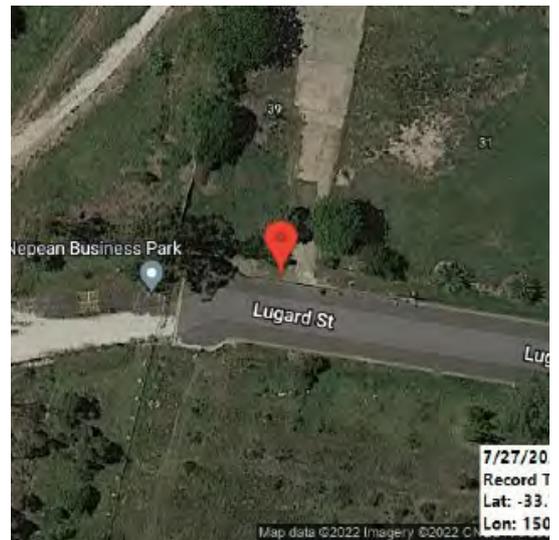
Figure: 0019 Scoring in the paving. | **CHANGE:** None

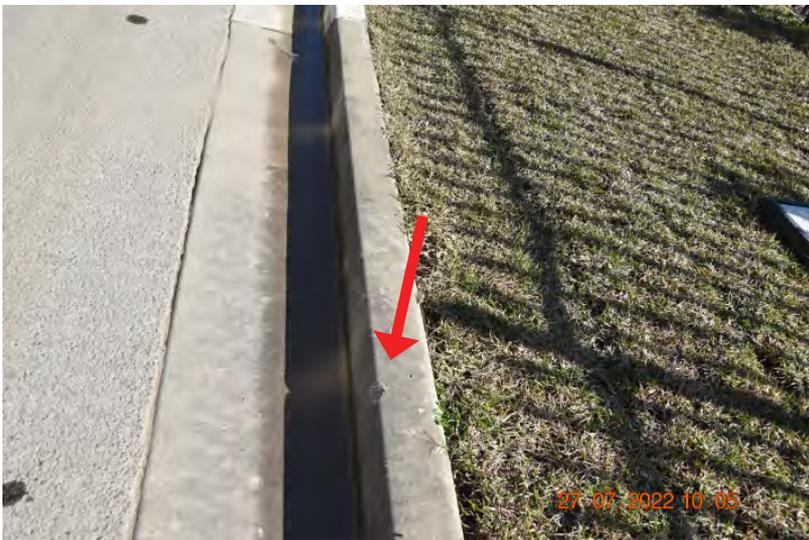
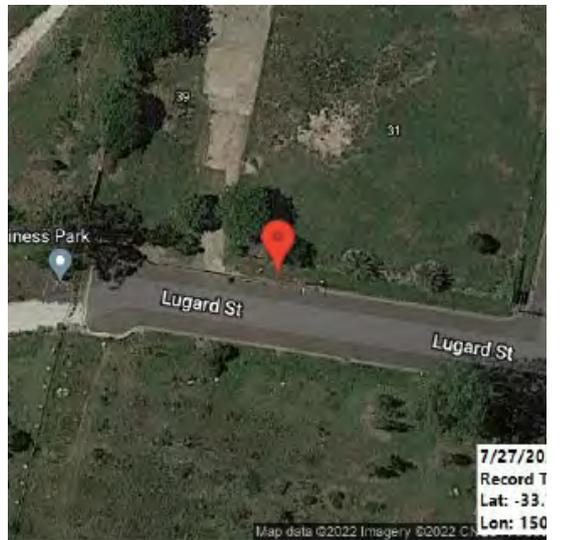
Figure: 0029 Chipping in the kerb. | **CHANGE:** None

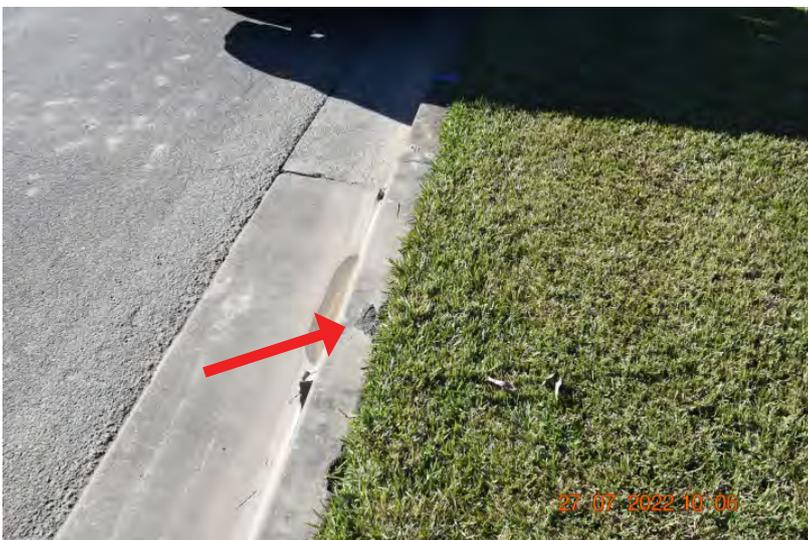
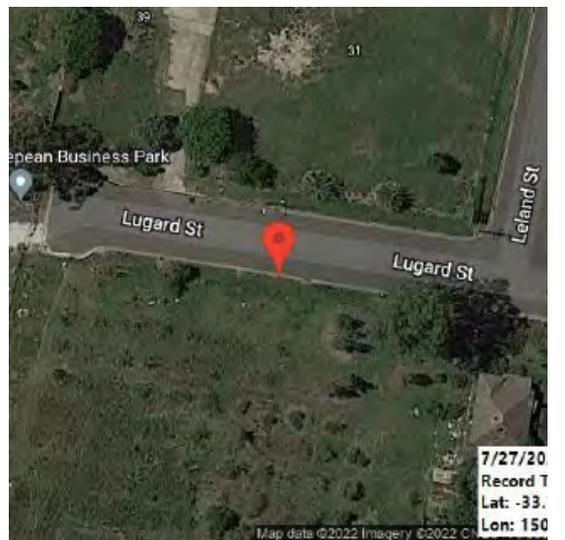
Figure: 0032 Chipping in the kerb. | **CHANGE:** None

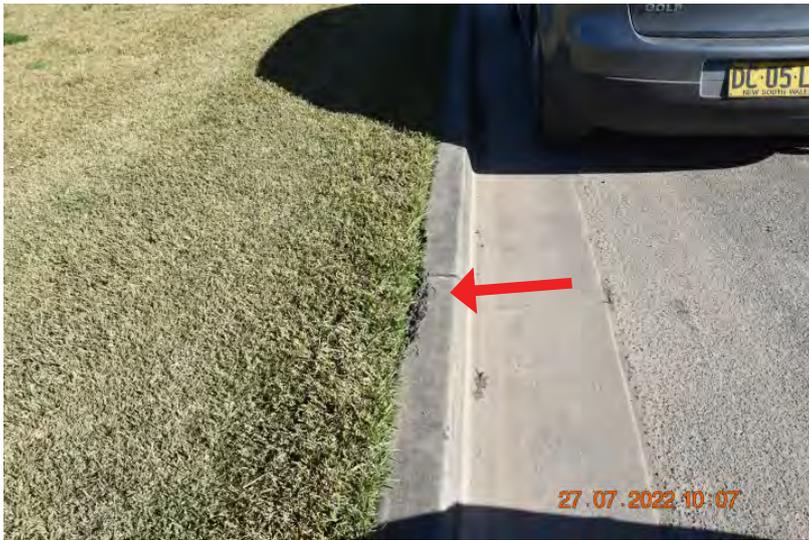
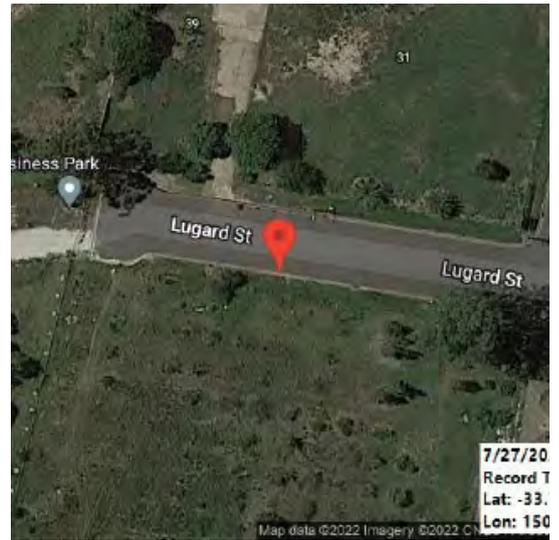
Figure: 0034 Chipping in the kerb, looking to the west. | **CHANGE:** None

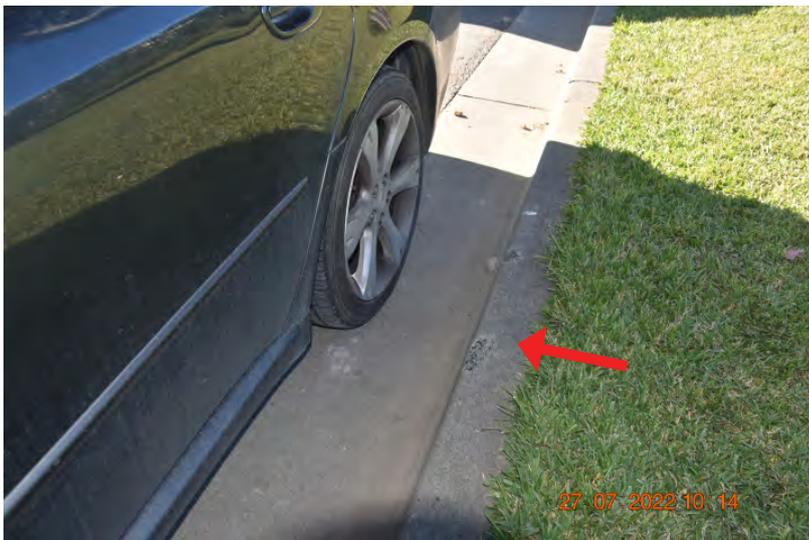
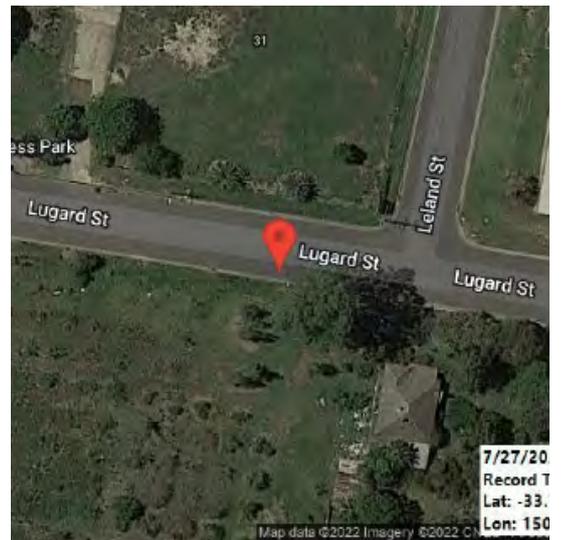
Figure: 0040 Chipping in the kerb and scoring in the paving. | **CHANGE:** None

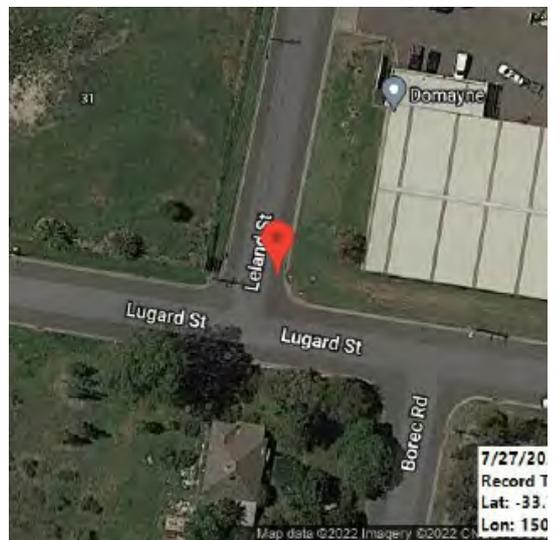
Figure: 0062 Bent street sign. | **CHANGE:** None

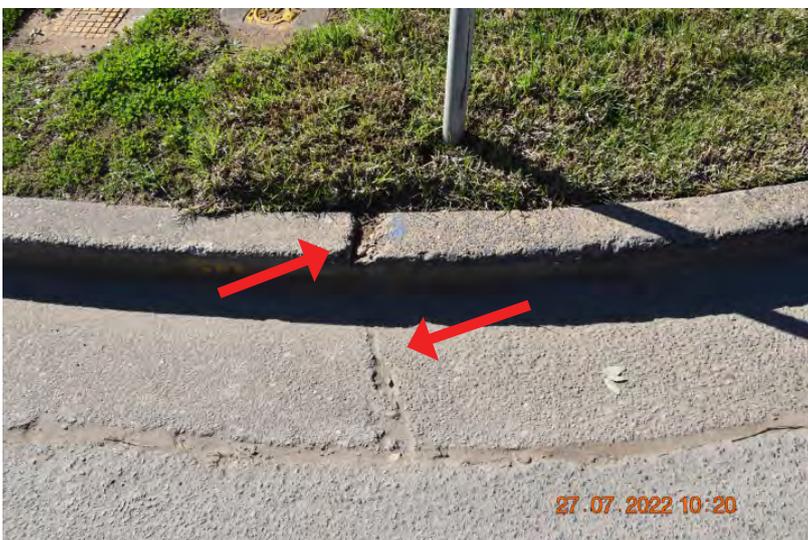
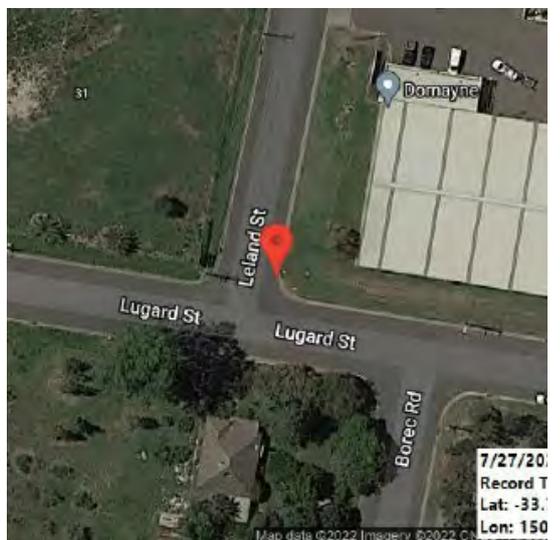
Figure: 0063 Slight cracking and chipping in the kerb and gutter. | **CHANGE:** None

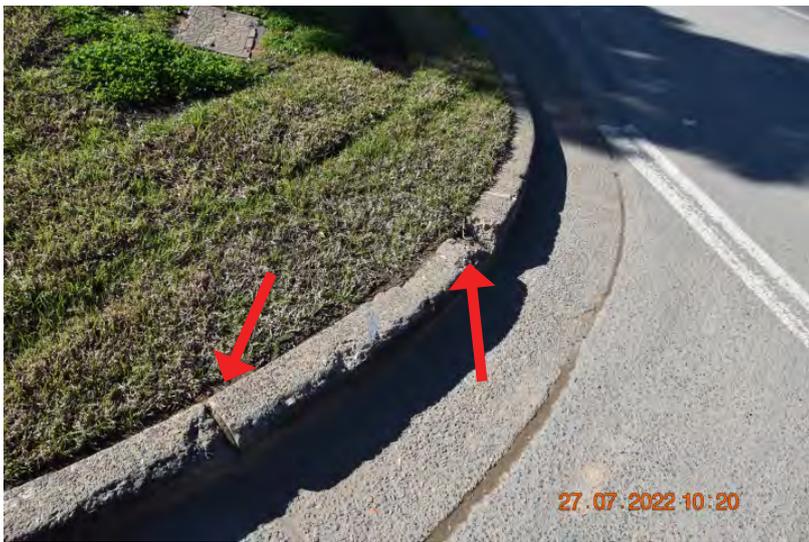
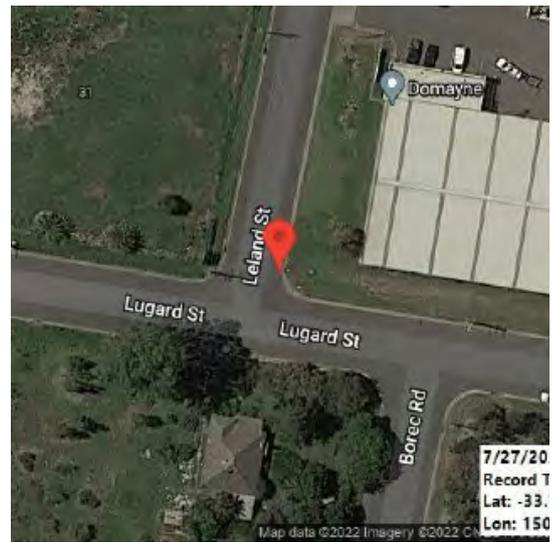
Figure: 0064 Chipping in the kerb. | **CHANGE:** None

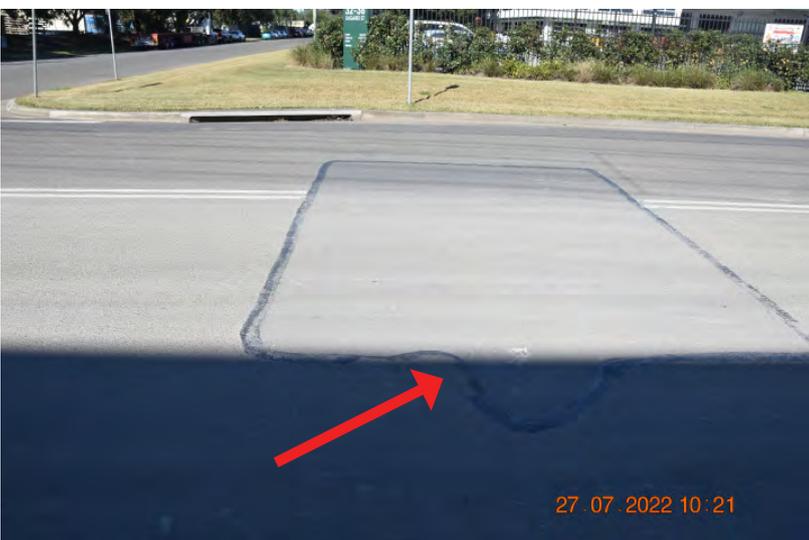
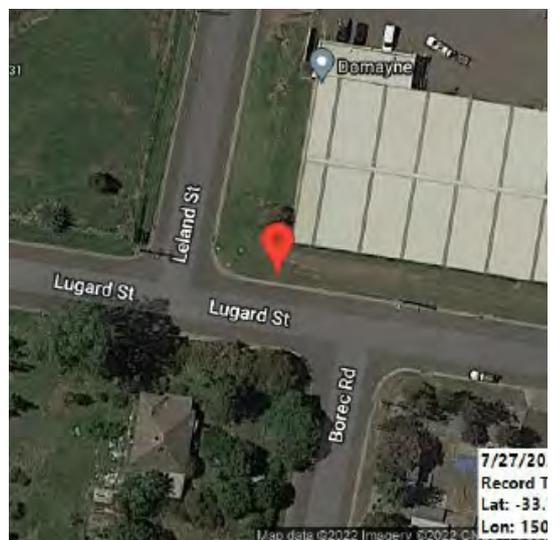
Figure: 0068 Patching in the paving. | **CHANGE:** None

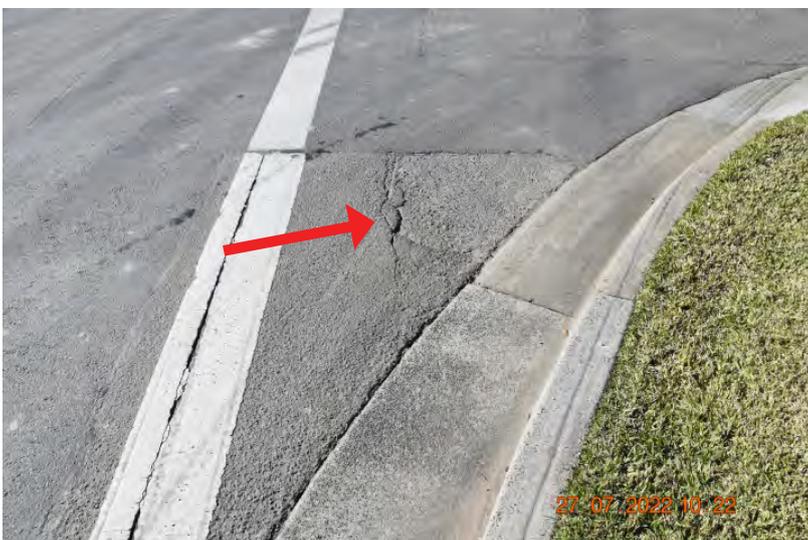
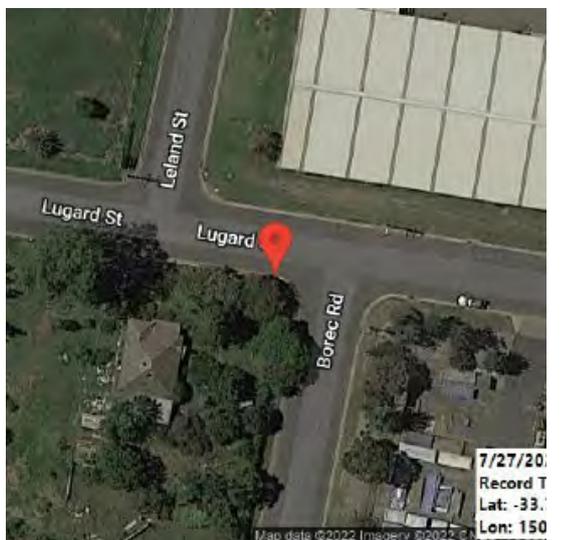
Figure: 0072 Slight cracking in the paving. | **CHANGE:** None

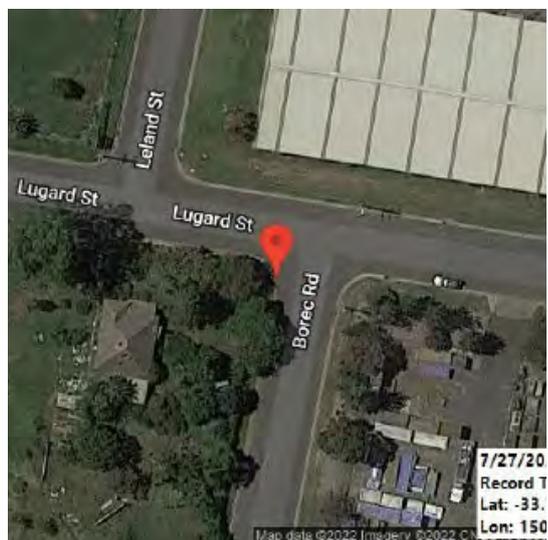
Figure: 0074 Fine alligator cracking in the paving. | **CHANGE:** None

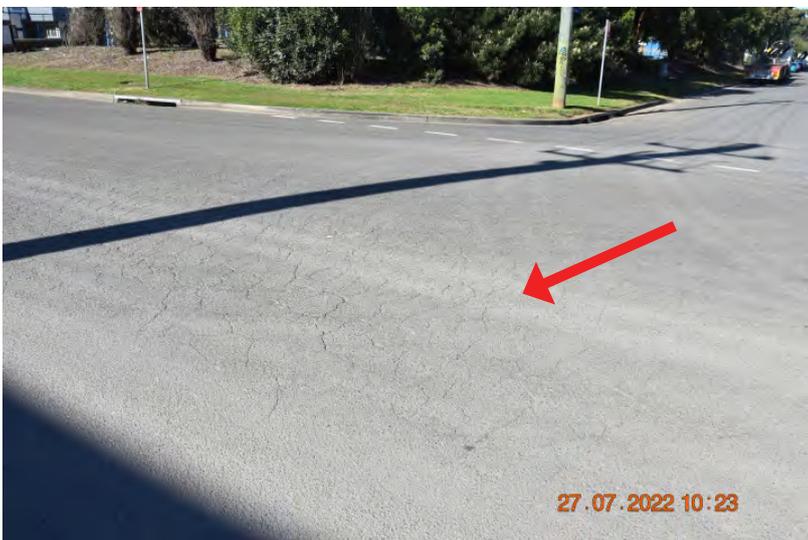
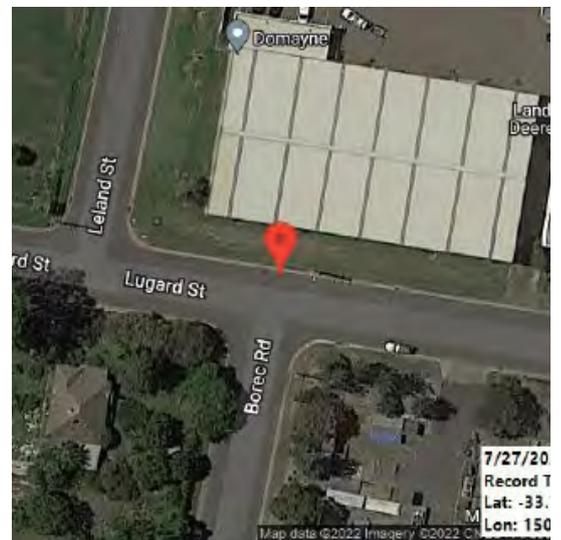
Figure: 0080 Slight alligator cracking in the paving. (RPT FOR FIGURES 80-85) | **CHANGE:** None

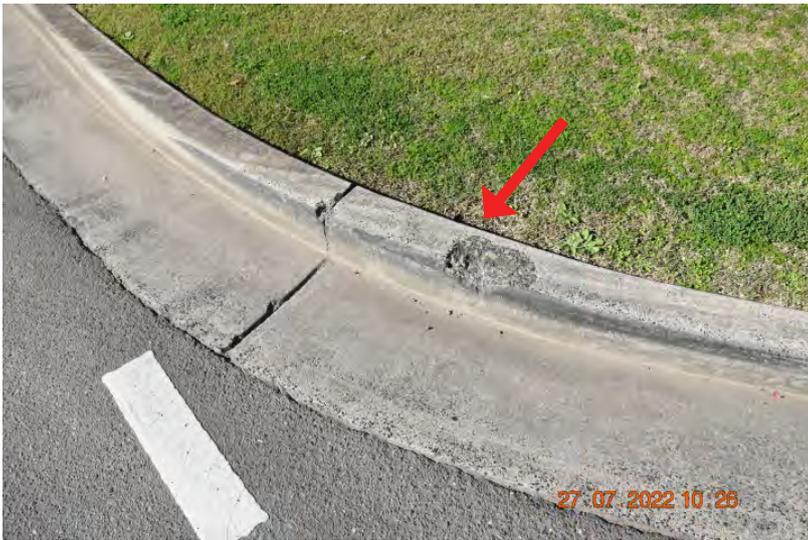
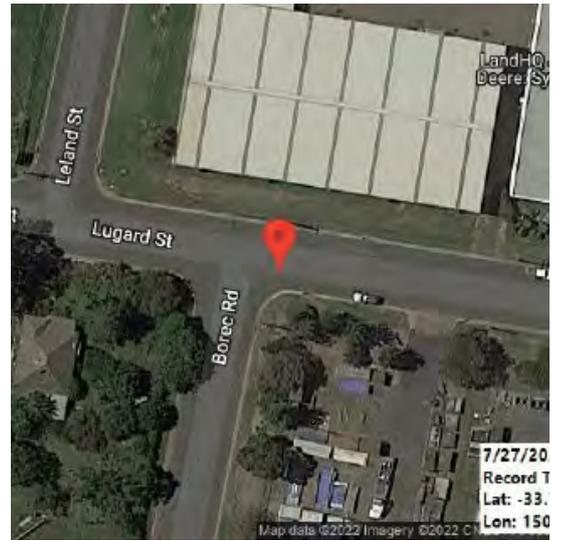
Figure: 0091 Chipping in the kerb. | **CHANGE:** None

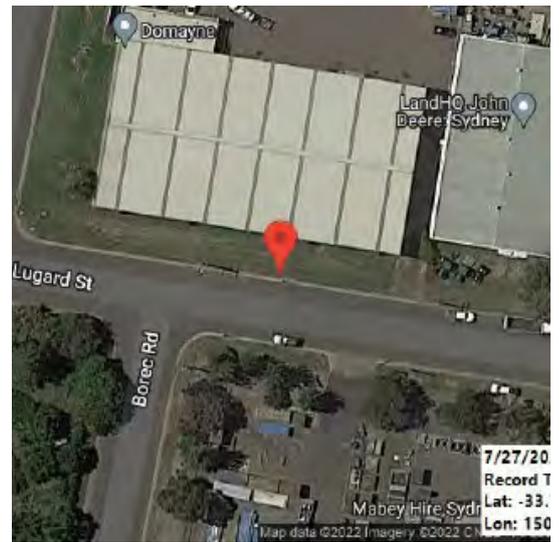
Figure: 0097 Fine alligator cracking in the paving. (RPT FOR FIGURES 97-99) | **CHANGE:** None

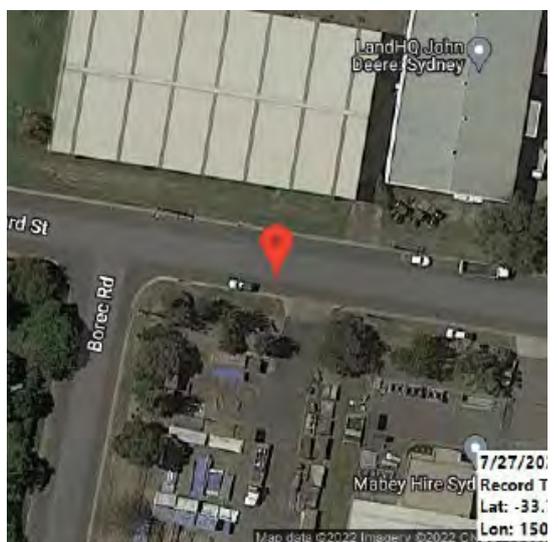
Figure: 0102 Slight cracking and chipping in the kerb and gutter. | **CHANGE:** None

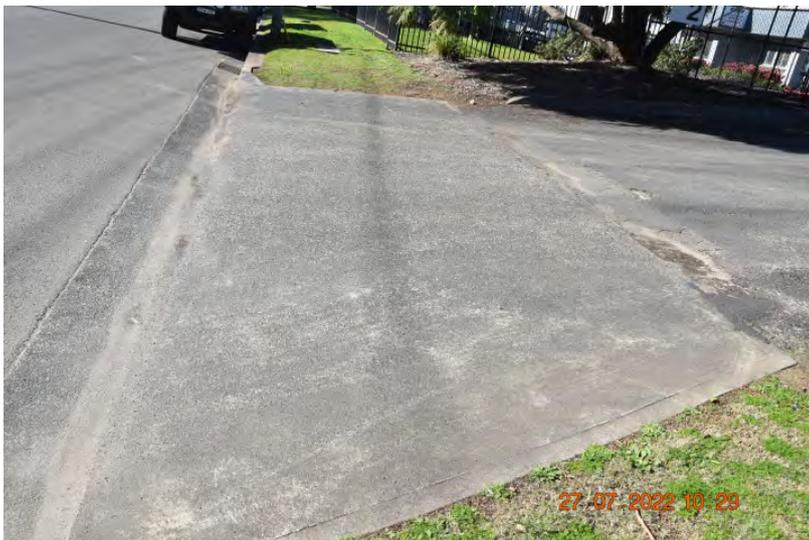
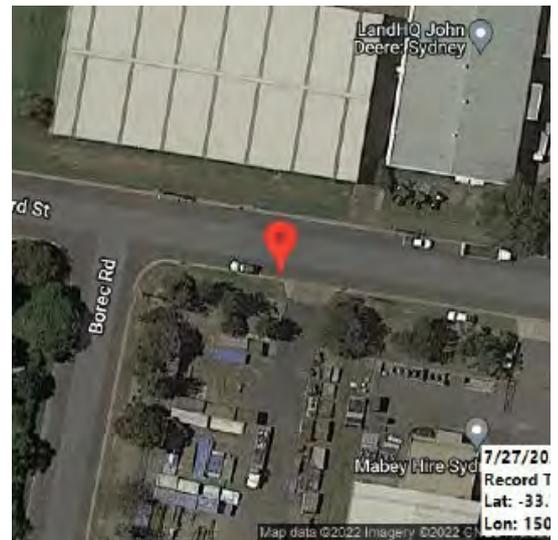
Figure: 0104 Cracking and chipping in the kerb and gutter, looking to the north. | **CHANGE:** None

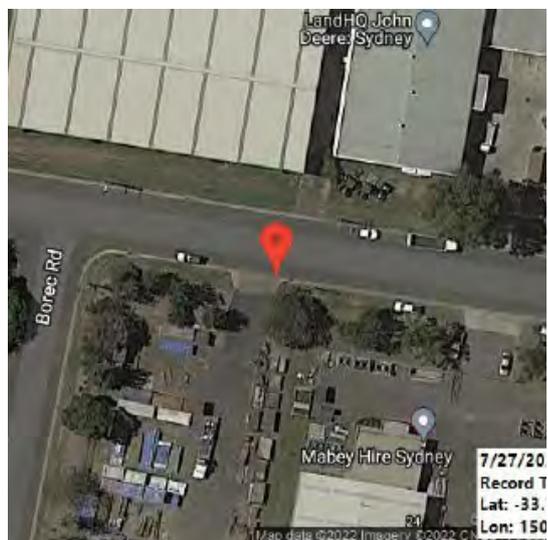
Figure: 0113 Slight cracking in the kerb and gutter, looking to the south. | **CHANGE:** None

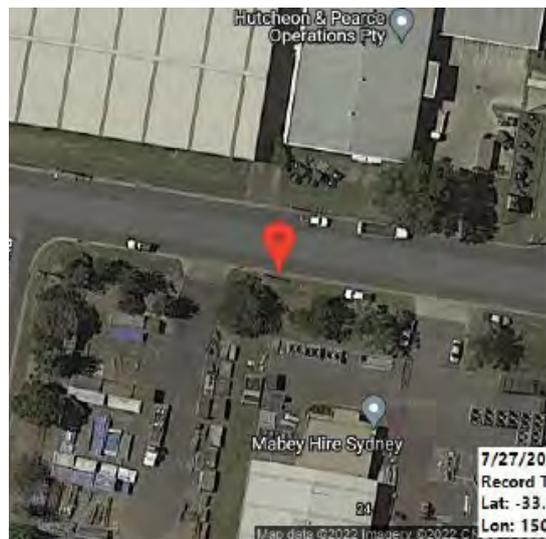
Figure: 0118 Fine cracking in the paving, looking west. | **CHANGE:** None
Figure: 0119 Fine cracking in the paving, looking south. (RPT FOR FIGURES 119-120) | **CHANGE:** None
Figure: 0122 Fine cracking in the crossover, looking to the south. (RPT FOR FIGURES 122-123) | **CHANGE:** None
Figure: 0133 Slight cracking in the kerb and gutter, looking to the south. | **CHANGE:** None
Figure: 0136 Slight cracking in the kerb and gutter, looking to the east. | **CHANGE:** None
Figure: 0137 Slight cracking and chipping in the kerb and gutter, looking to the south. | **CHANGE:** None
Figure: 0138 Slight cracking in the kerb and gutter, looking to the south. | **CHANGE:** None
Figure: 0139 Fine cracking in the paving, looking to the north. | **CHANGE:** None
Figure: 0140 Cracking and scoring in the crossover. | **CHANGE:** None
Figure: 0142 Slight cracking and chipping in the crossover. | **CHANGE:** None
Figure: 0143 Fine cracking and chipping in the crossover. | **CHANGE:** None

Figure: 0119 Fine cracking in the paving, looking south. (RPT FOR FIGURES 119-120) | **CHANGE:** None

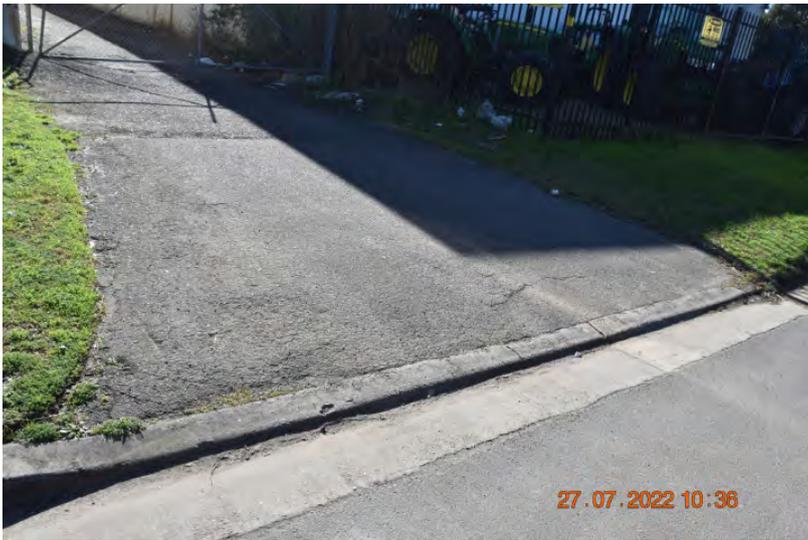
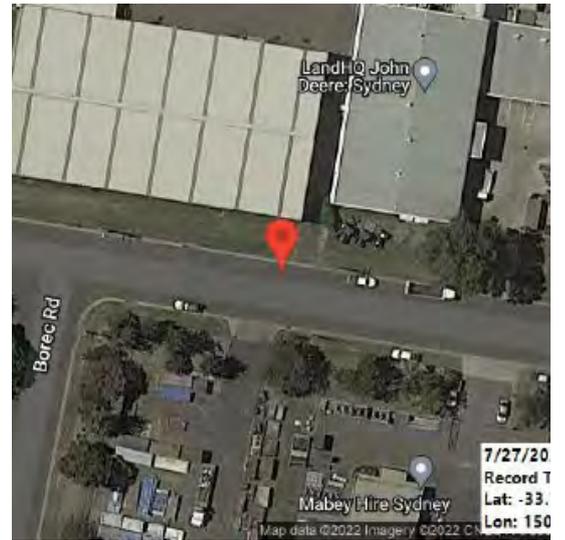
Figure: 0123

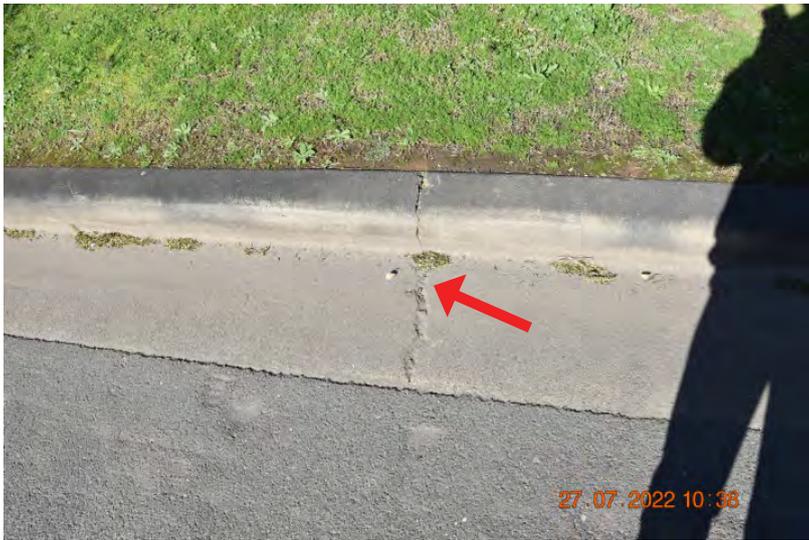
Figure: 0133 Slight cracking in the kerb and gutter, looking to the south. | **CHANGE:** None

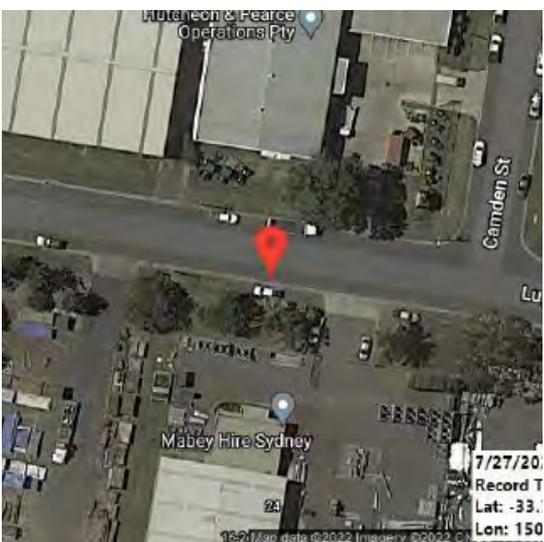
Figure: 0138 Slight cracking in the kerb and gutter, looking to the south. | **CHANGE:** None

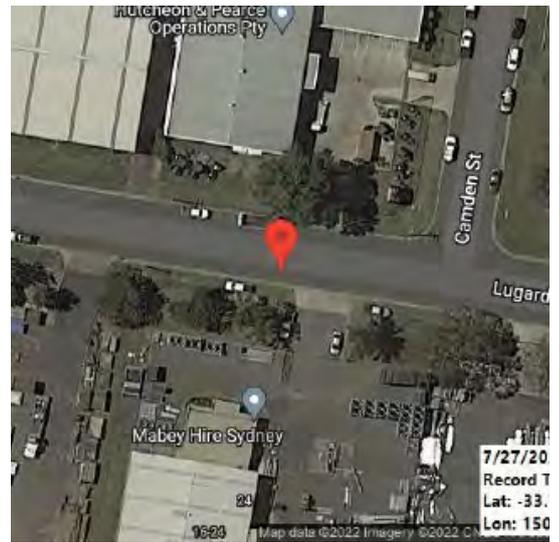
Figure: 0139 Fine cracking in the paving, looking to the north. | **CHANGE:** None

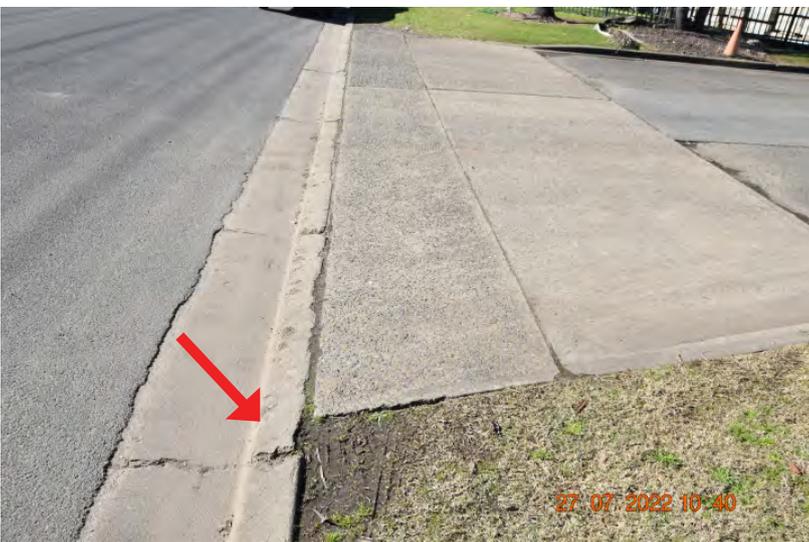
Figure: 0140 Cracking and scoring in the crossover. | **CHANGE:** None

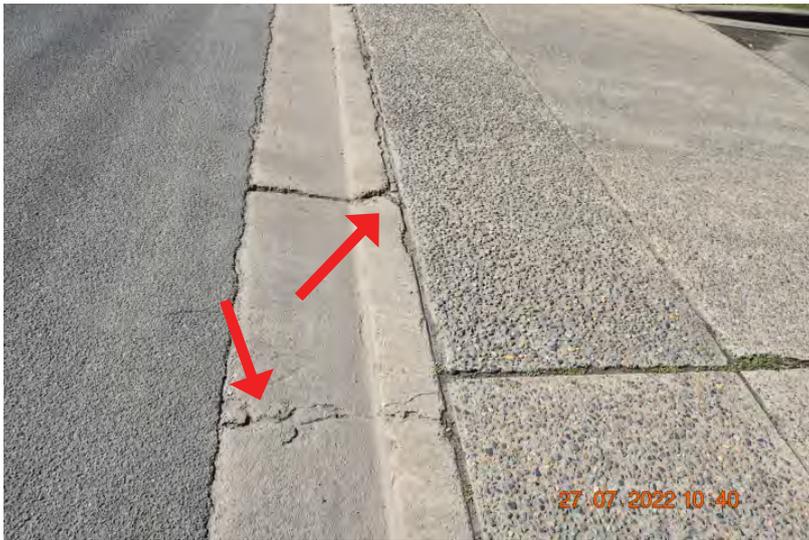
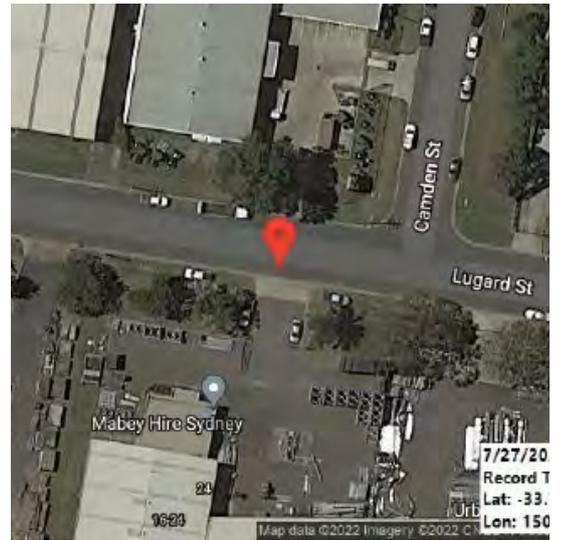
Figure: 0142 Slight cracking and chipping in the crossover. | **CHANGE:** None

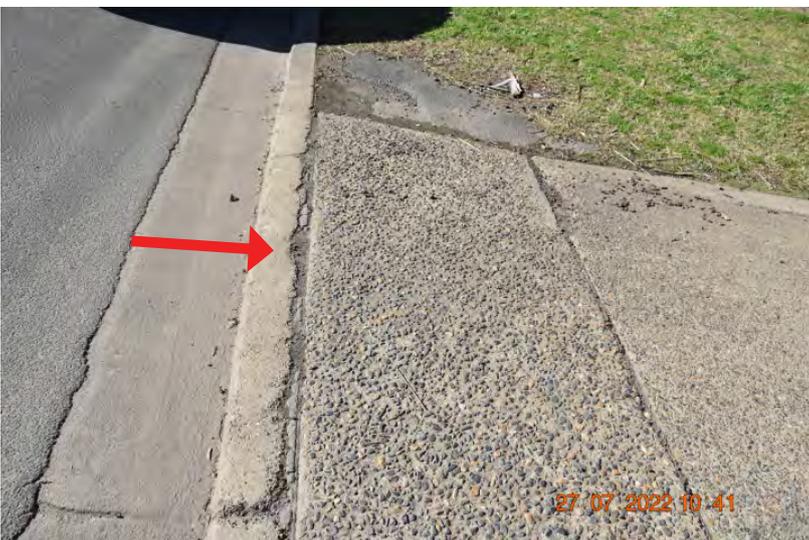
Figure: 0143 Fine cracking and chipping in the crossover. | **CHANGE:** None

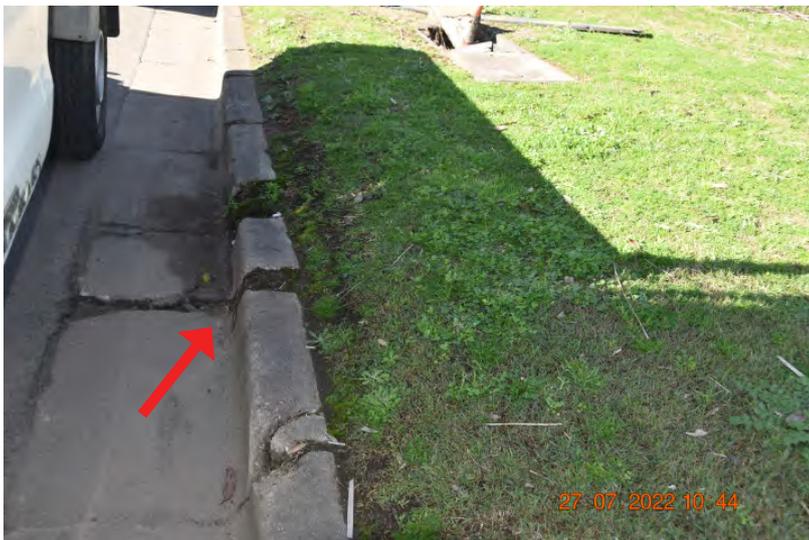
Figure: 0146 Slight cracking in the crossover. (RPT FOR FIGURES 146-148) | **CHANGE:** None
Figure: 0154 Substantial cracking in the kerb and gutter. | **CHANGE:** None
Figure: 0156 Substantial cracking in the kerb and gutter. | **CHANGE:** None
Figure: 0157 Slight cracking in the kerb and gutter. (RPT FOR FIGURES 157-159) | **CHANGE:** None
Figure: 0165 Chipping in the kerb and gutter. | **CHANGE:** None
Figure: 0168 Fine cracking in the kerb and gutter. | **CHANGE:** Showing exacerbated cracking. | **CHANGE:** None

Figure: 0154 Substantial cracking in the kerb and gutter. | **CHANGE:** None

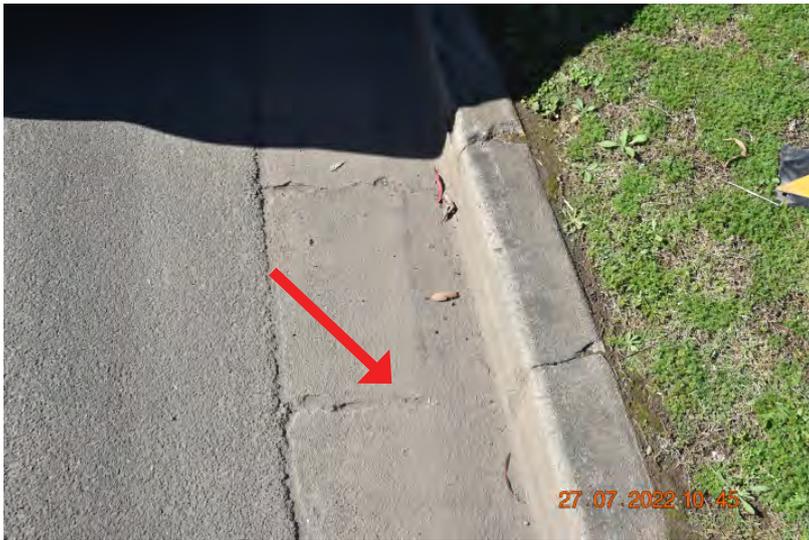
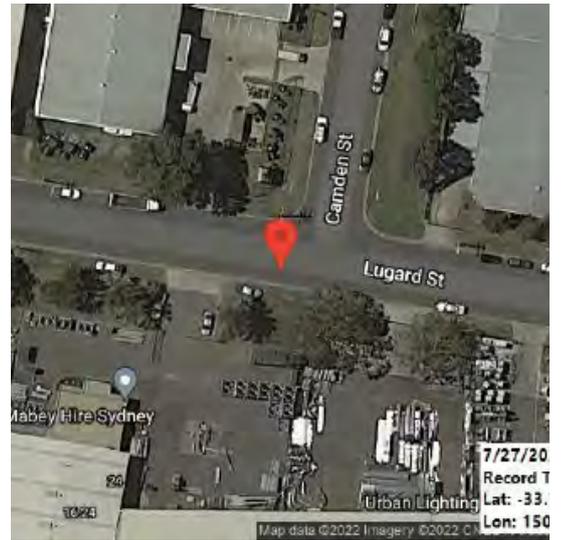
Figure: 0157 Slight cracking in the kerb and gutter. (RPT FOR FIGURES 157-159) | **CHANGE:** None

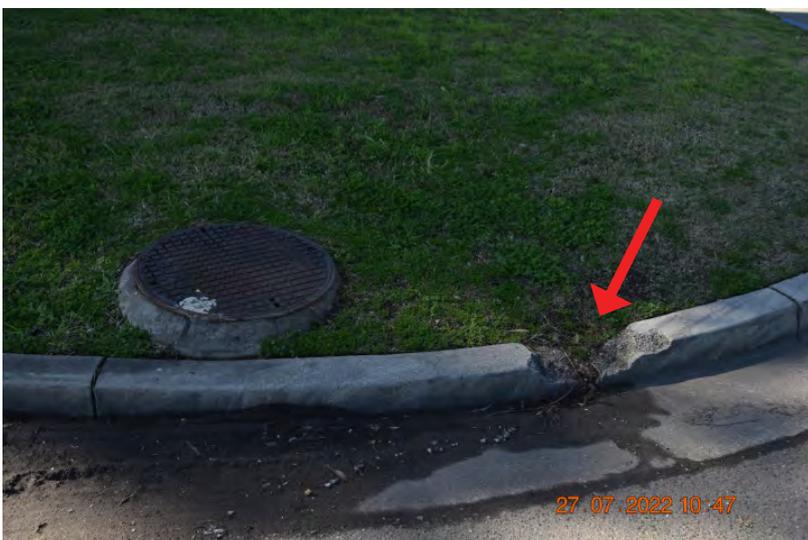
Figure: 0165 Chipping in the kerb and gutter. | **CHANGE:** None

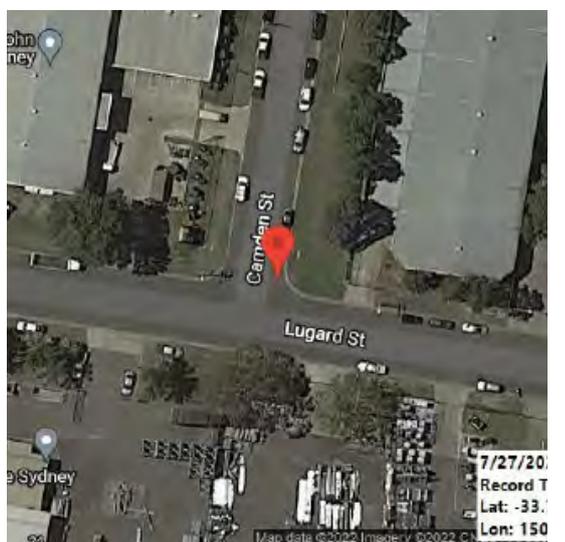
Figure: 0168 Fine cracking in the kerb and gutter. | **CHANGE:** Showing exacerbated cracking. | **CHANGE:** None

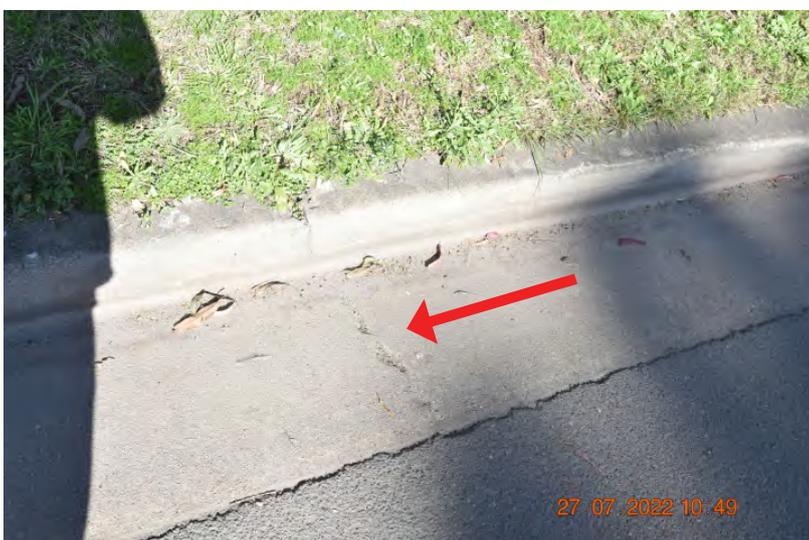
Figure: 0171 Slight cracking in the kerb and gutter, looking to the west. | **CHANGE:** None

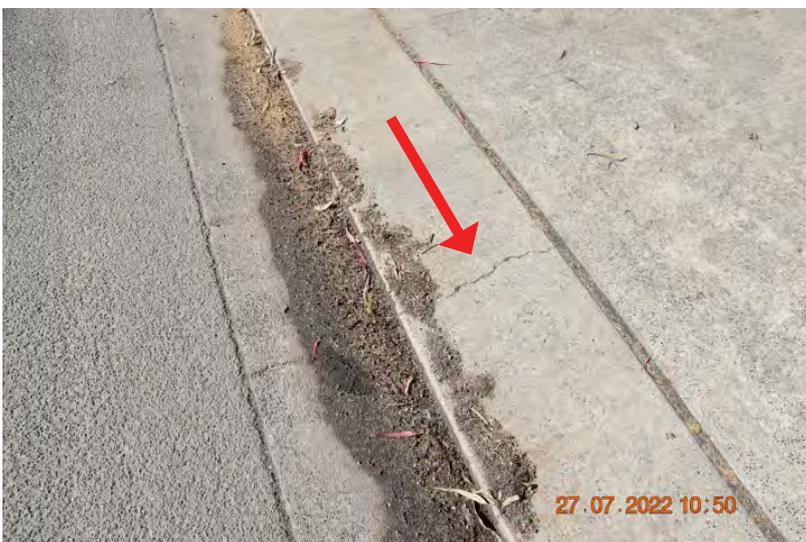
Figure: 0177 Slight cracking in the crossover. (RPT FOR FIGURES 177-178) | **CHANGE:** None

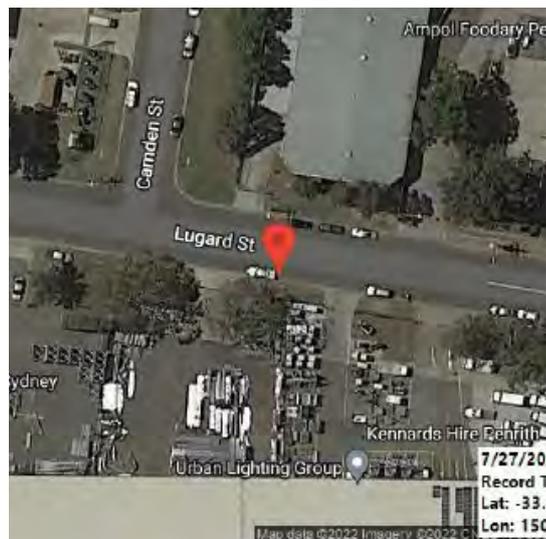
Figure: 0191 Chipping and fine cracking in the kerb and gutter. | **CHANGE:** None

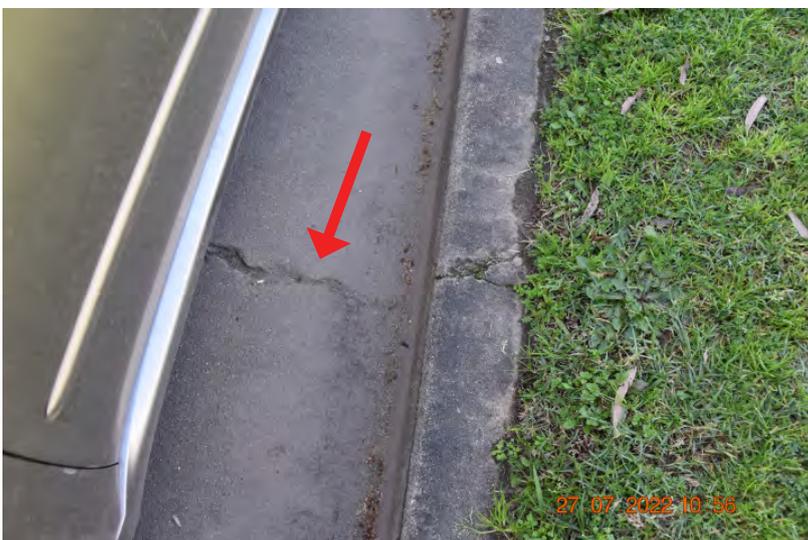
Figure: 0195 Fine cracking in the kerb and gutter. (RPT FOR FIGURES 195-197) | **CHANGE:** None

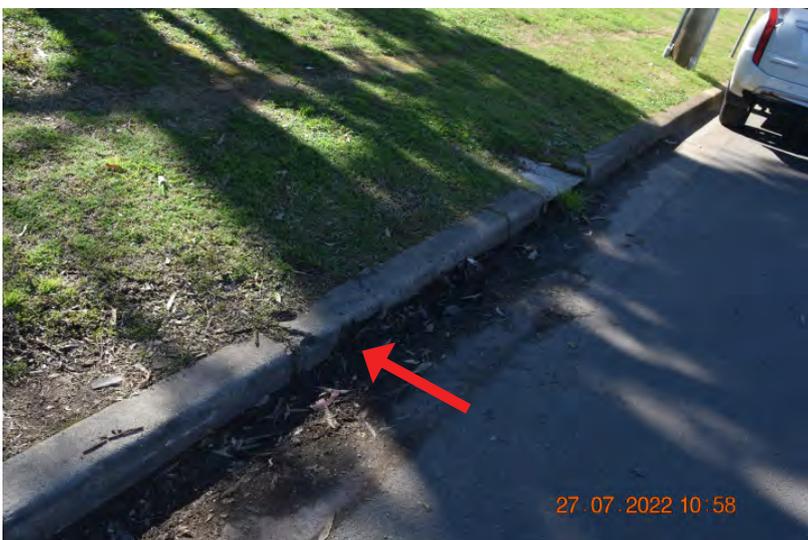
Figure: 0204 Fine cracking in the paving, looking to the east. (RPT FOR FIGURES 205-207) | **CHANGE:** None

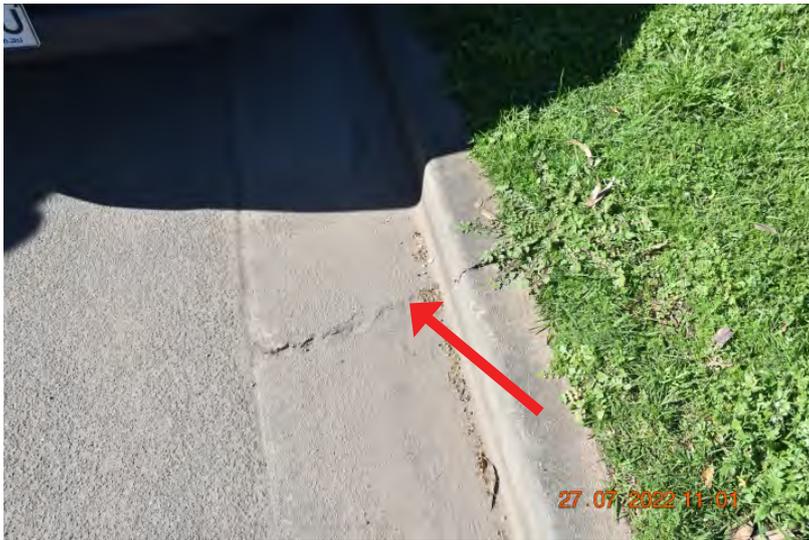
Figure: 0211

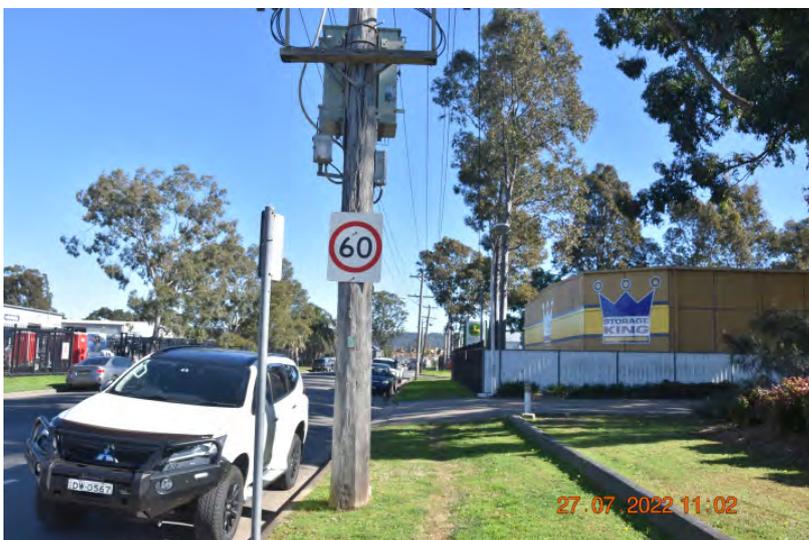
Figure: 0212

Figure: 0210 Slight cracking in the kerb and gutter. (RPT FOR FIGURES 211-212) | **CHANGE:** None

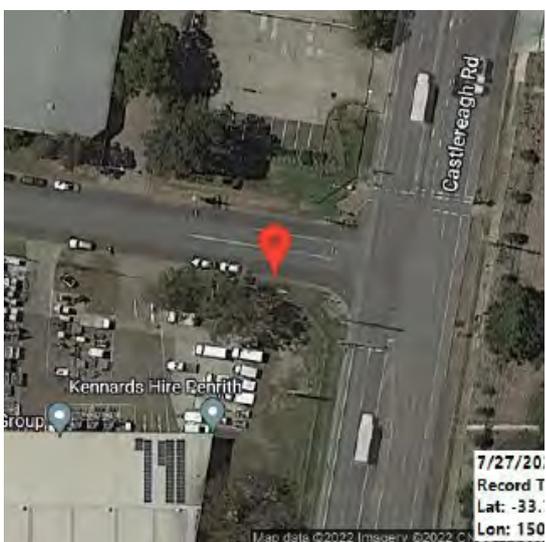
Figure: 0227 Slight cracking to the paving and the kerb and gutter. | **CHANGE:** None

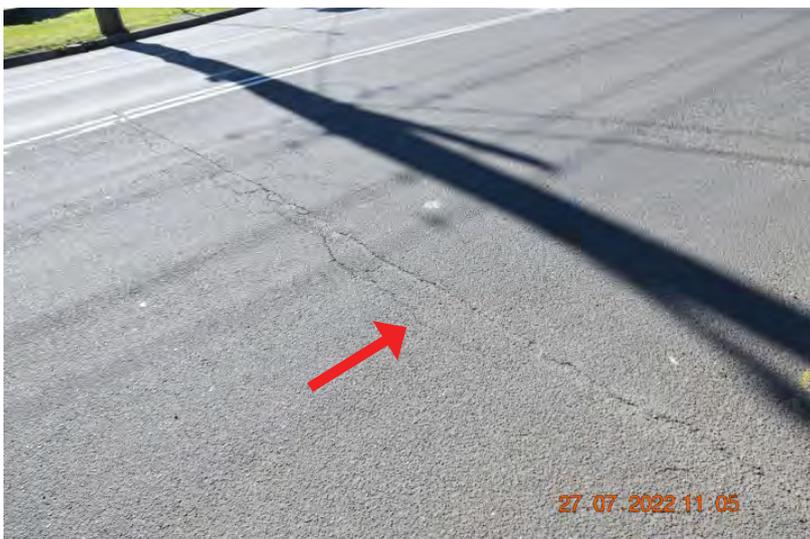
Figure: 0228 Cracking in the paving. | **CHANGE:** None
