POST CONSTRUCTION CONDITION SURVEY - GPS

Nepean Business Park - Penrith NSW

Council Assets
Lugard Street, Leland Street and Old Castlereagh Road
PENRITH NSW 2750

27 July 2022

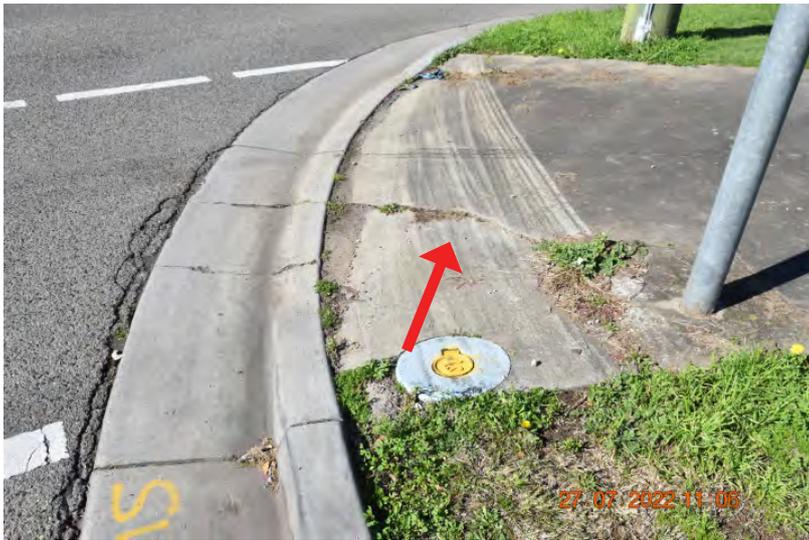
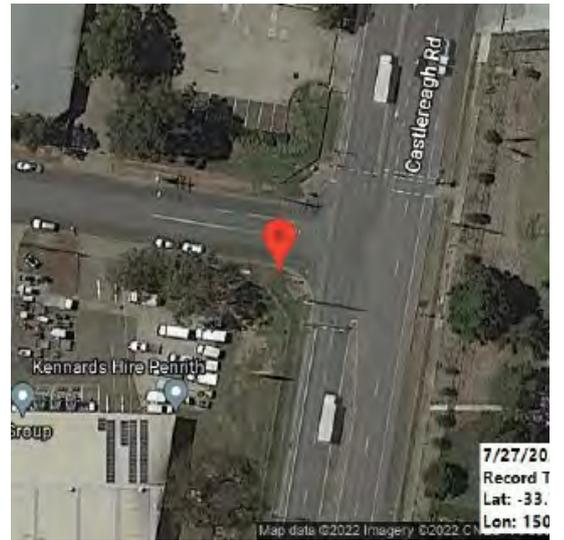
Figure: 0231 Slight cracking in the crossover. | **CHANGE:** None

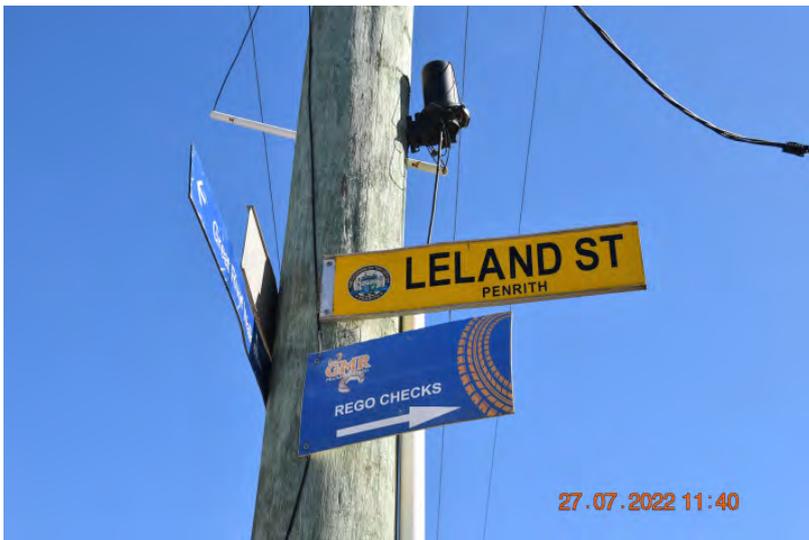
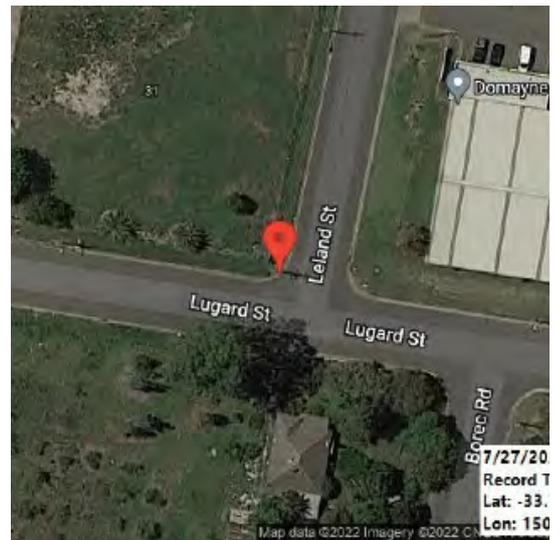
Figure: 0235 Slight cracking in the kerb and gutter. | **CHANGE:** None

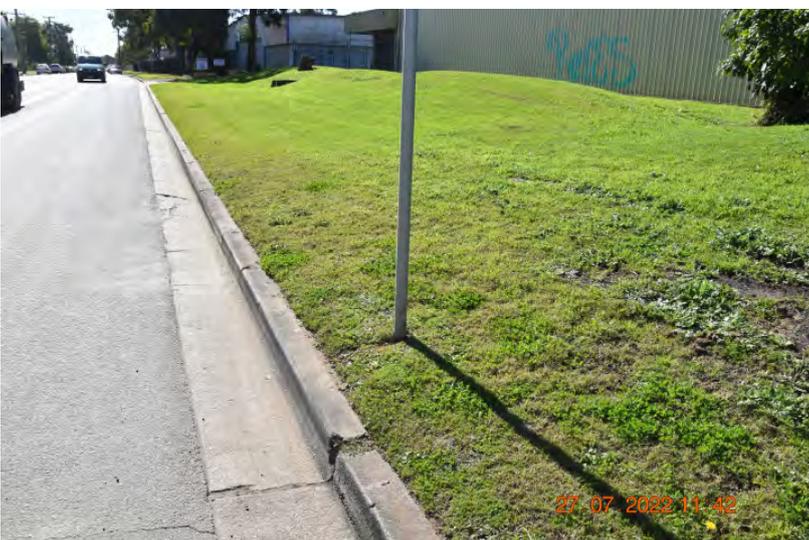
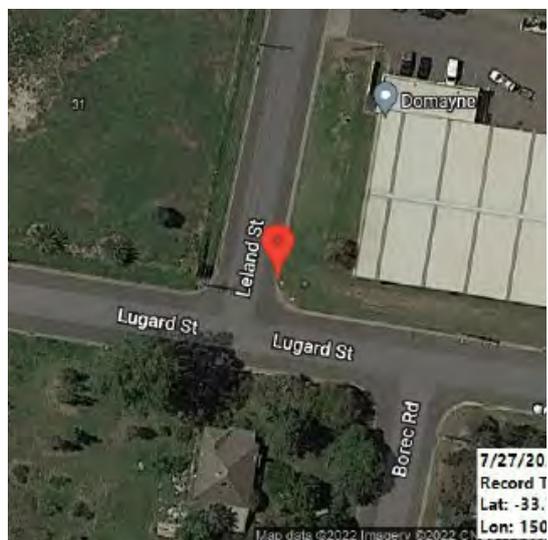
Figure: 0242 Slight cracking in the kerb and gutter. (RPT FOR FIGURES 243-245) | **CHANGE:** None

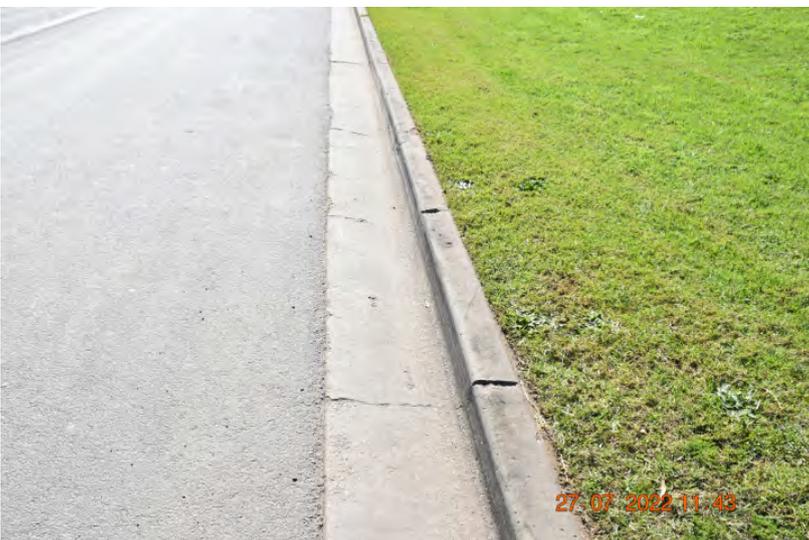
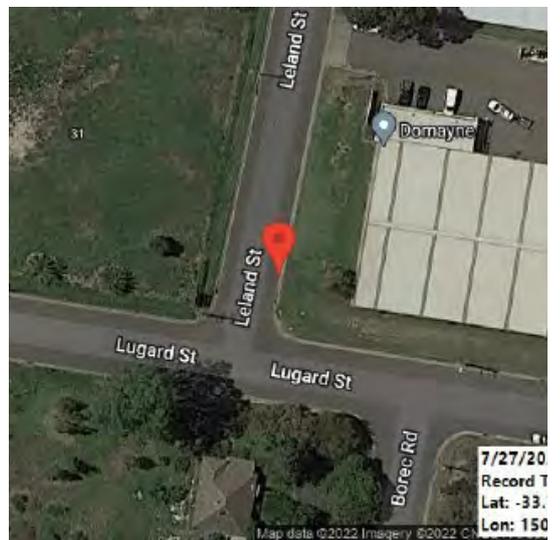
Figure: 0245 Chipping and cracking to the kerb and gutter. | **CHANGE:** None

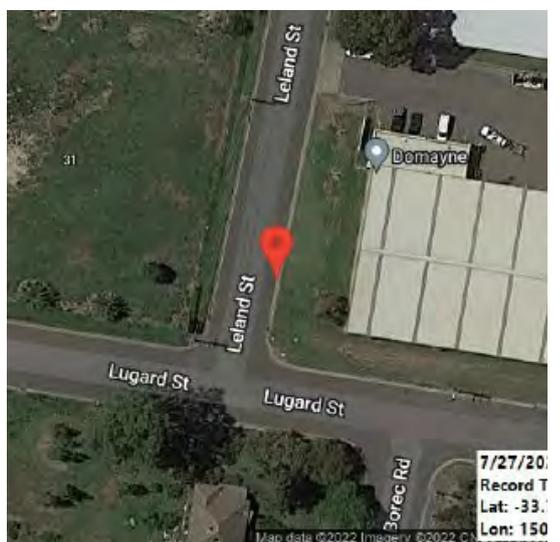
Figure: 0246 Slight cracking in the kerb and gutter. | **CHANGE:** None

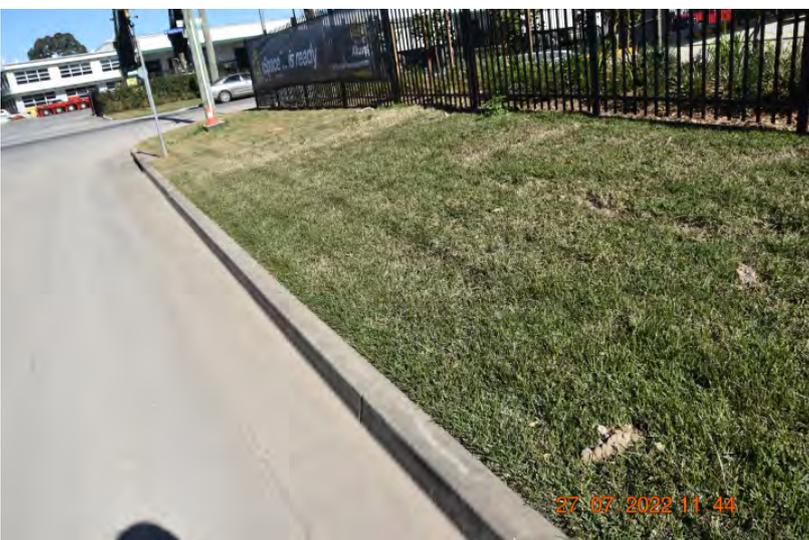
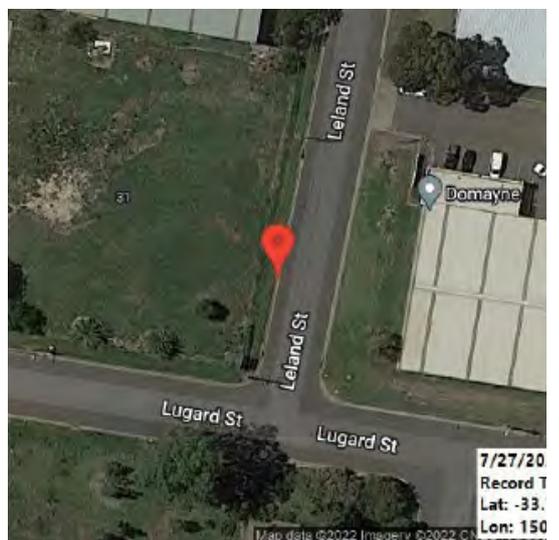
Figure: 0251 Fine cracking in the paving. | **CHANGE:** None

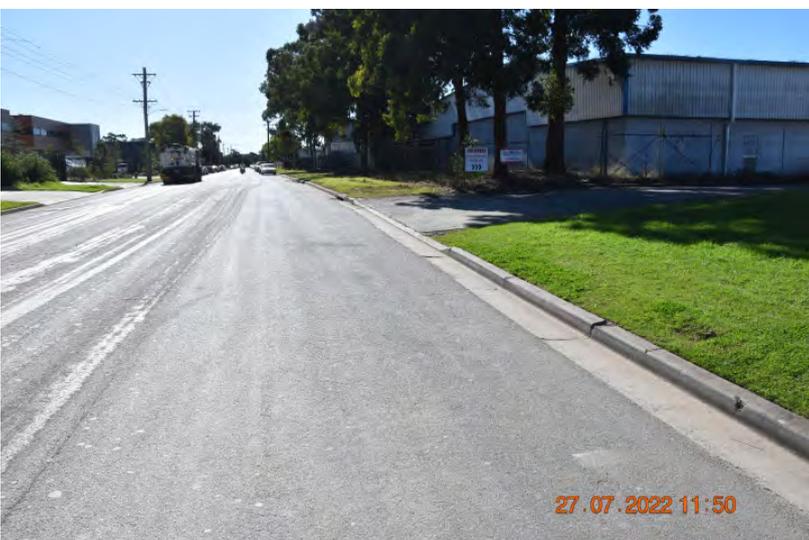
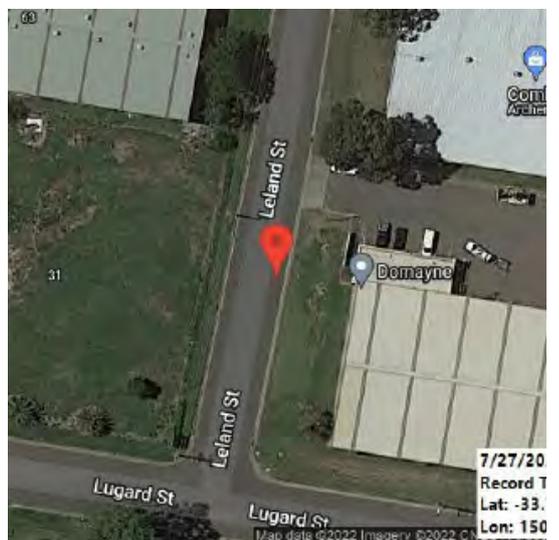
Figure: 0254 Chipping in the kerb and gutter. | **CHANGE:** None

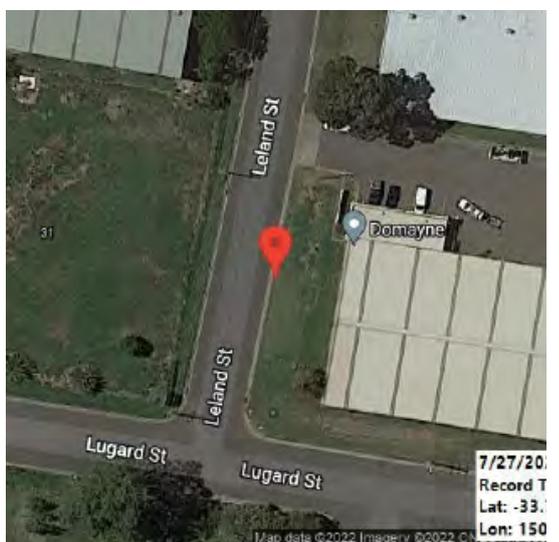
Figure: 0255 Fine cracking in the kerb and gutter, looking to the east. (RPT FOR FIGURES 256-257) | **CHANGE:** None

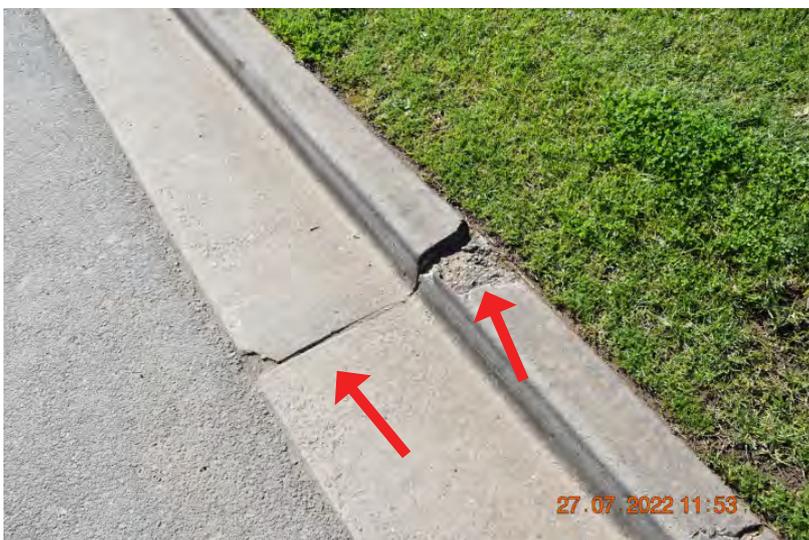
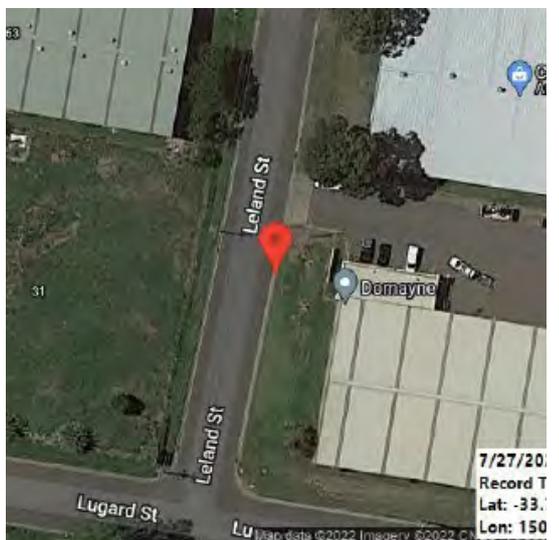
Figure: 0266 Fine cracking and chipping in the kerb and gutter, looking to the east. (RPT FOR FIGURES 267-269) | **CHANGE:** None

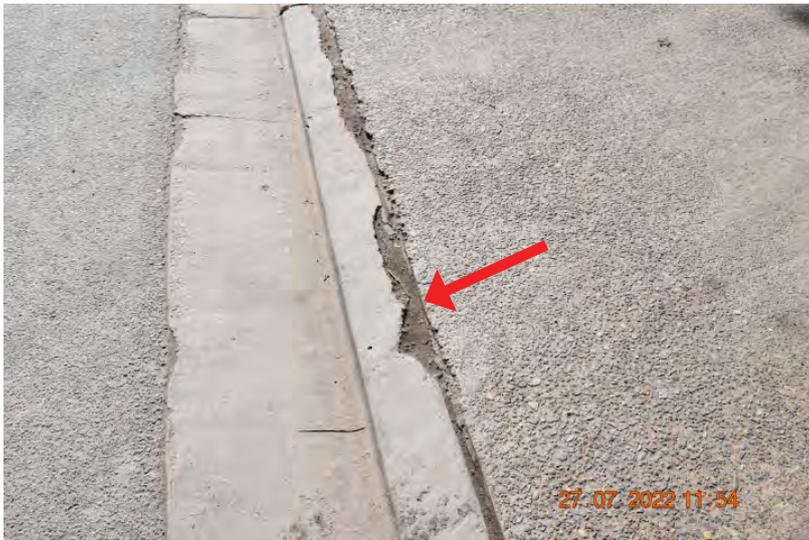
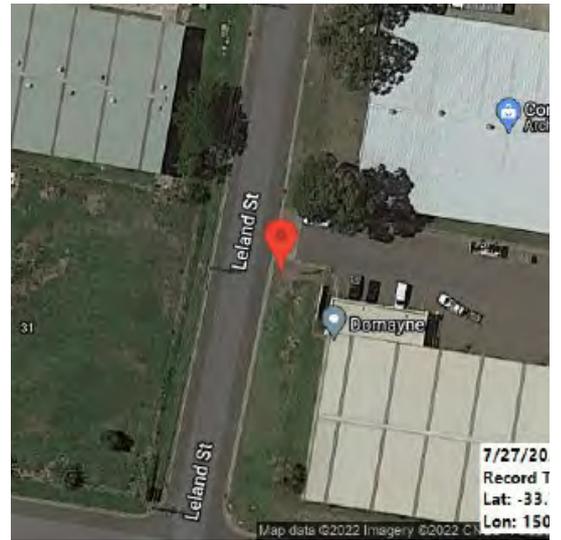
Figure: 0270 Chipping and fine cracking in the crossover. (RPT FOR FIGURES 271-273) | **CHANGE:** None

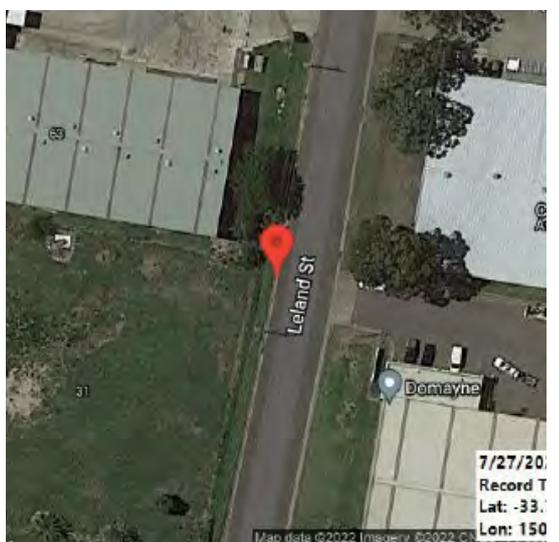
Figure: 0276 Slight alligator cracking in the paving. (RPT FOR FIGURES 277-280) | **CHANGE:** None

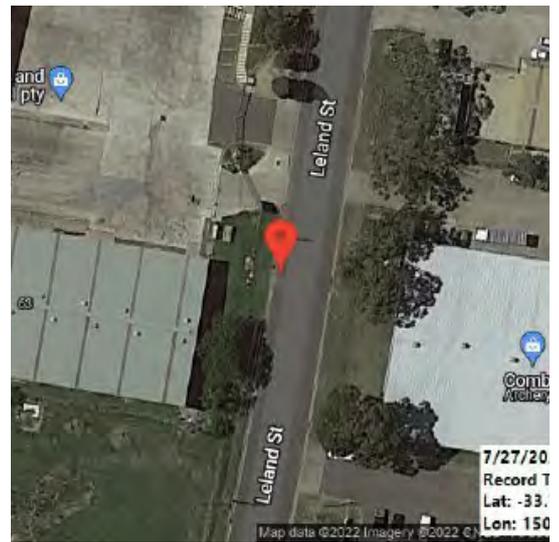
Figure: 0288 Fine alligator cracking. | **CHANGE:** None

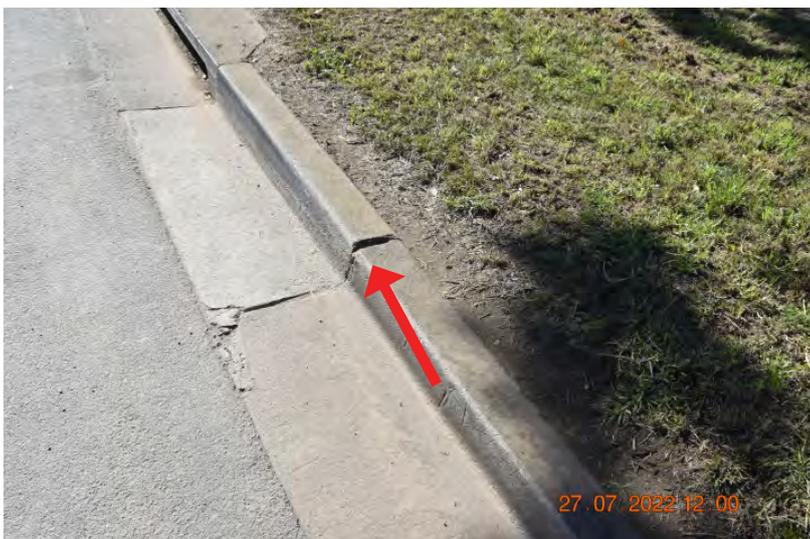
Figure: 0297 Fine cracking in the kerb and gutter. | **CHANGE:** None

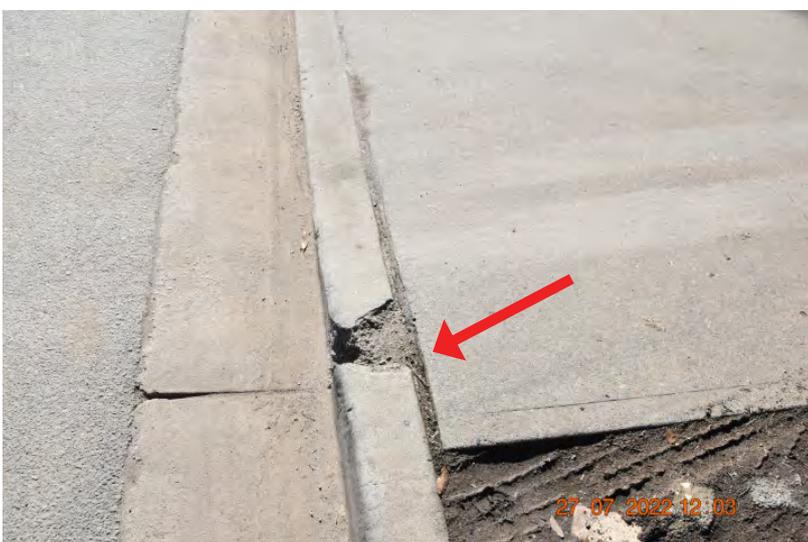
Figure: 0314 Chipping in the crossover. | **CHANGE:** None

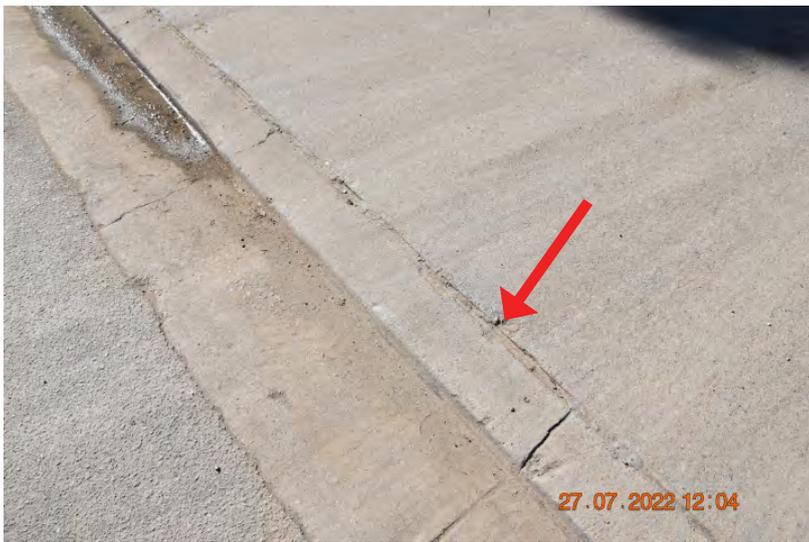
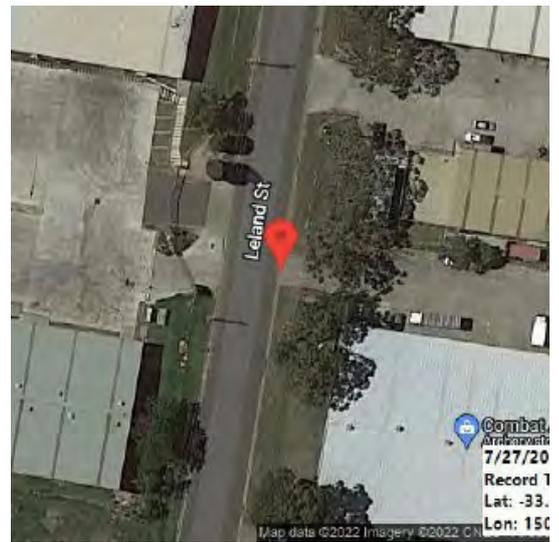
Figure: 0315 Chipping in the crossover. | **CHANGE:** None

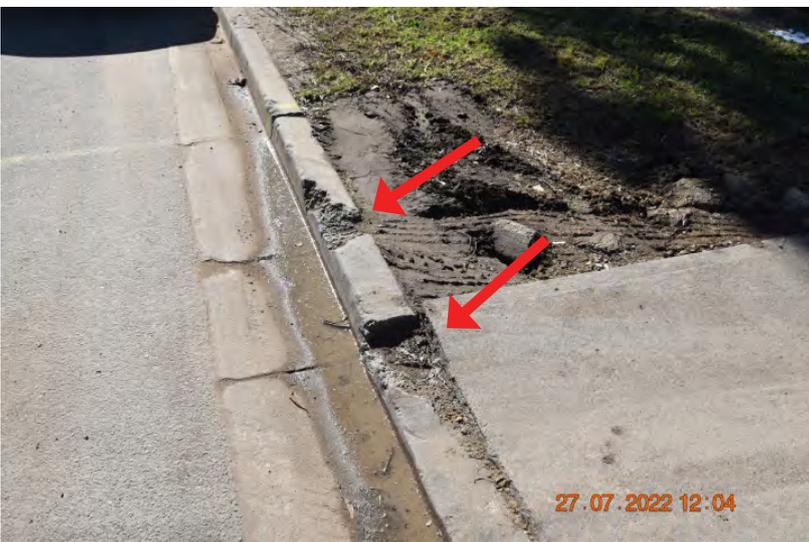
Figure: 0293 Slight cracking in the paving. (RPT FOR FIGURES 294-296) | **CHANGE:** None
Figure: 0297 Fine cracking in the kerb and gutter. | **CHANGE:** None
Figure: 0299 Slight cracking in the paving. (RPT FOR FIGURES 300-301) | **CHANGE:** None
Figure: 0304 Slight cracking in the kerb and gutter. (RPT FOR FIGURES 305-306) | **CHANGE:** None
Figure: 0307 Slight cracking in the paving. (RPT FOR FIGURES 308-311) | **CHANGE:** None
Figure: 0314 Chipping in the crossover. | **CHANGE:** None
Figure: 0315 Chipping in the crossover. | **CHANGE:** None
Figure: 0316 Chipping in the kerb. (RPT FOR FIGURES 317-319) | **CHANGE:** None

Figure: 0316 Chipping in the kerb. (RPT FOR FIGURES 317-319) | **CHANGE:** None

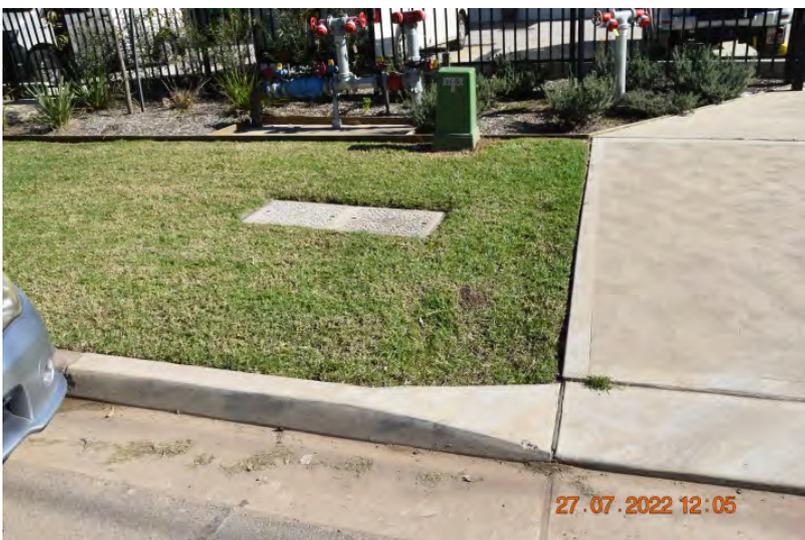
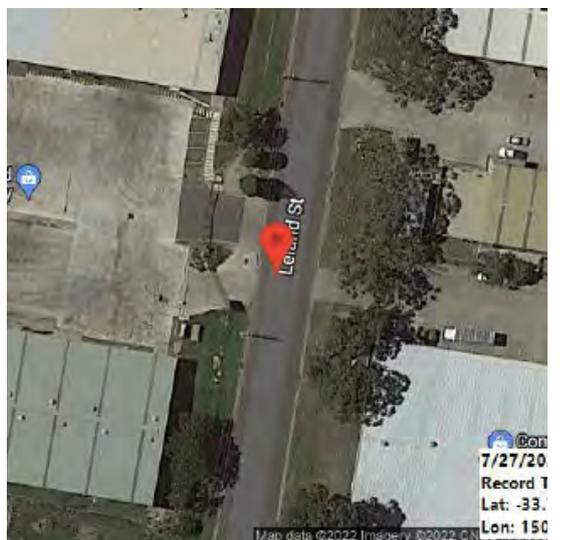
Figure: 0320 Slight cracking in the kerb and gutter. | **CHANGE:** Showing new condition.

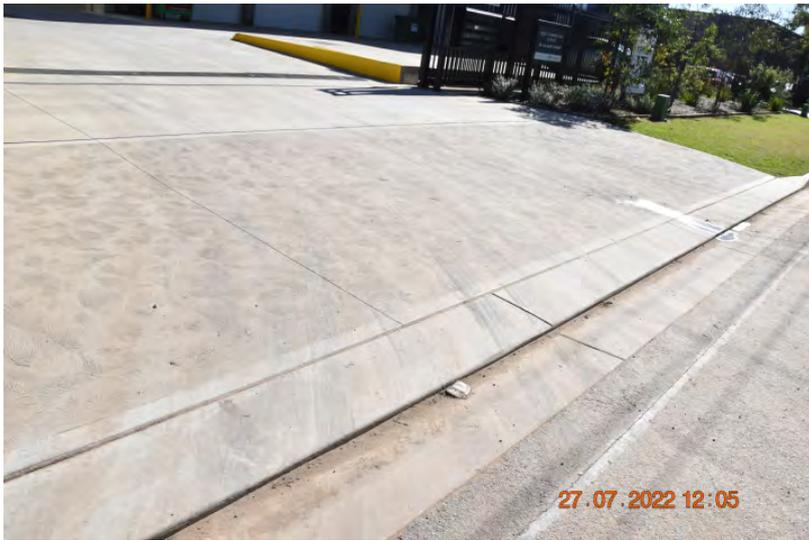
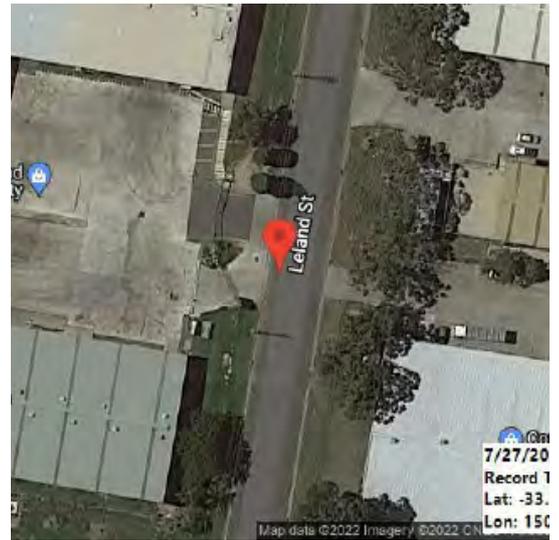
Figure: 0321 Slight cracking in the crossover. | **CHANGE:** Showing new condition.

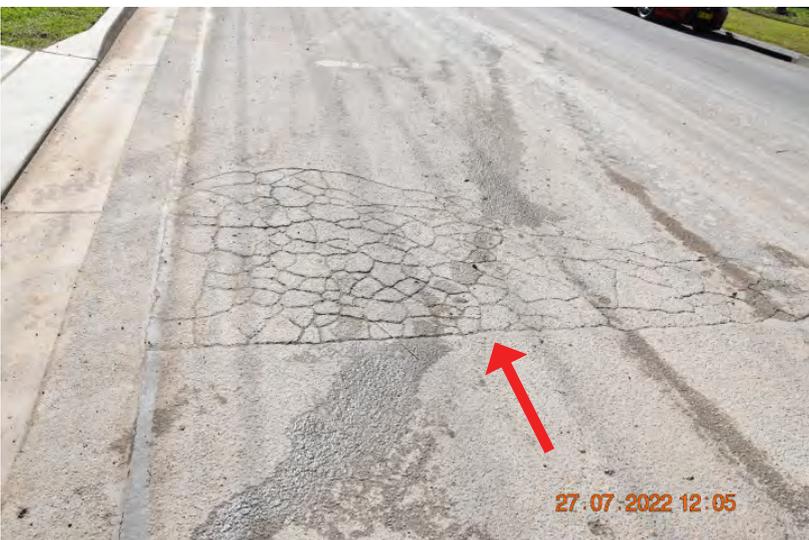
Figure: 0322 Slight alligator cracking in the paving. (RPT FOR FIGURES 323-324) | **CHANGE:** None

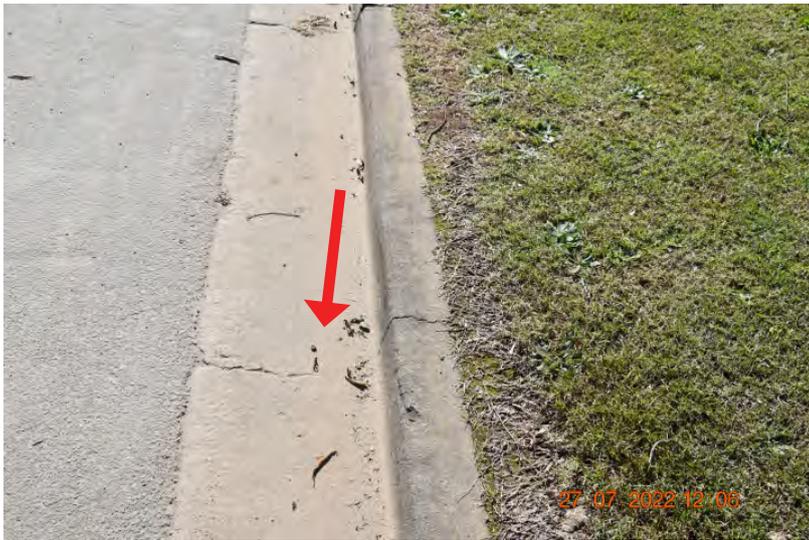
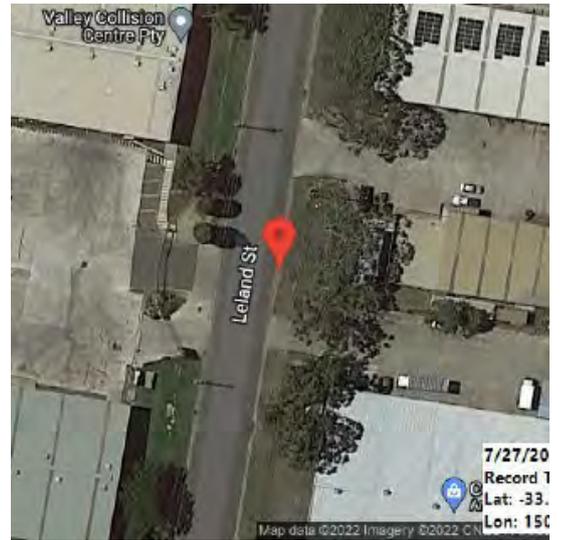
Figure: 0327 Slight cracking in the kerb and gutter. | **CHANGE:** None

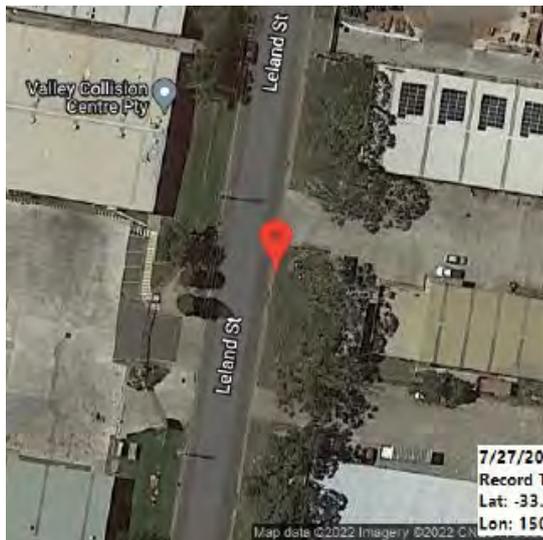
Figure: 0333 Fine cracking in the kerb and gutter. | **CHANGE:** None

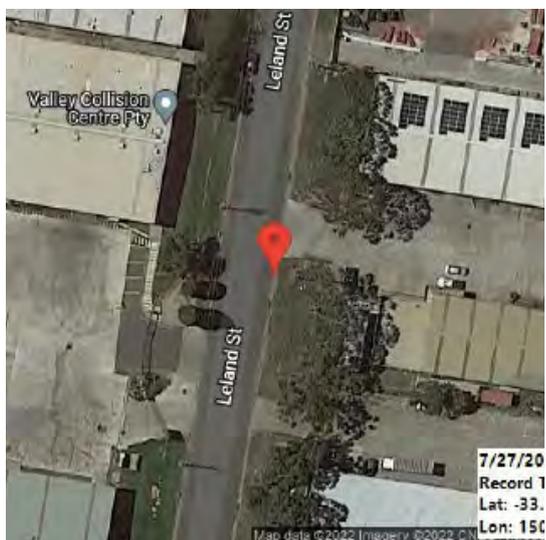
Figure: 0334 Slight cracking in the kerb and gutter. | **CHANGE:** None

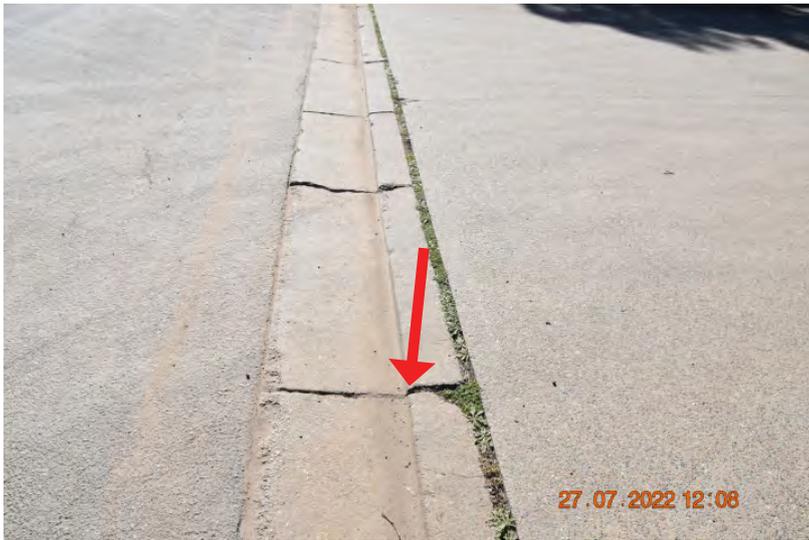
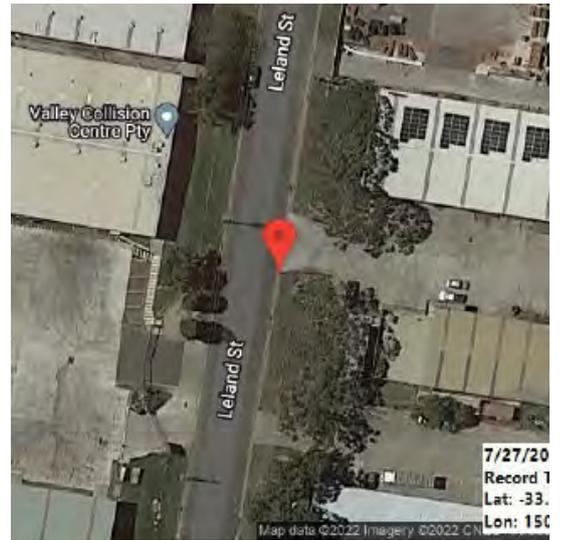
Figure: 0336 Slight cracking in the crossover. (RPT FOR FIGURES 337-339) | **CHANGE:** None

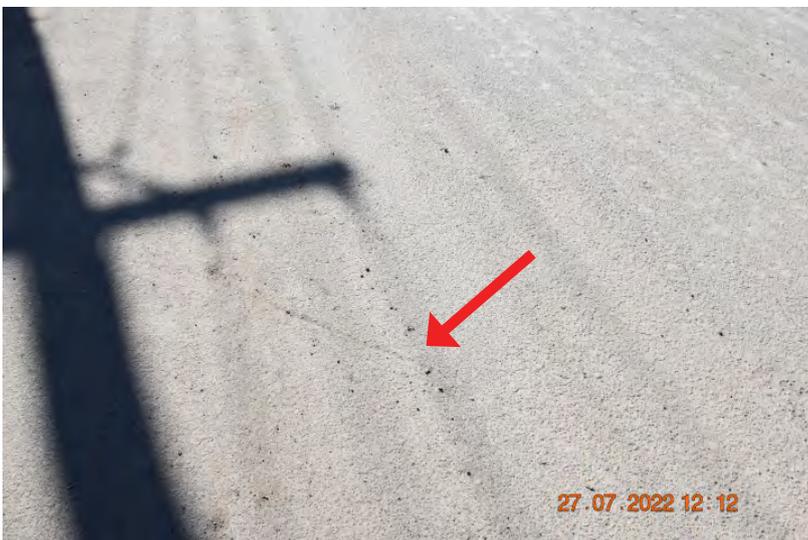
Figure: 0352 Scoring in the paving. | **CHANGE:** None

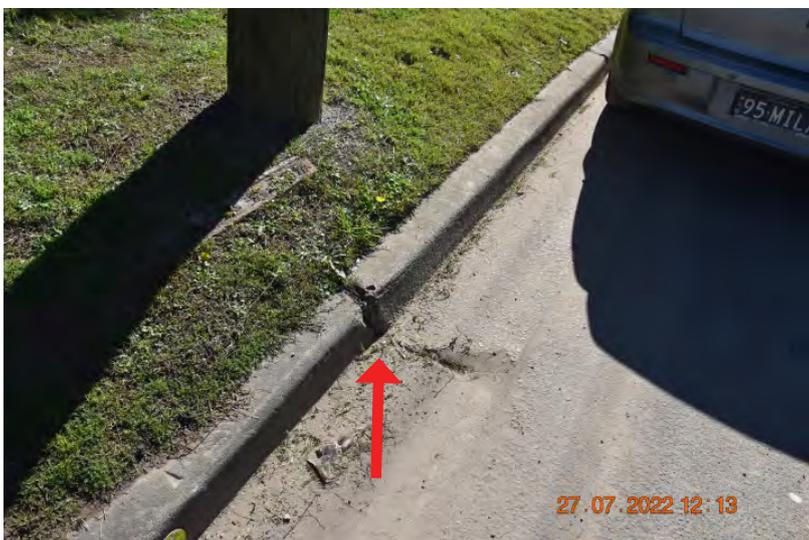
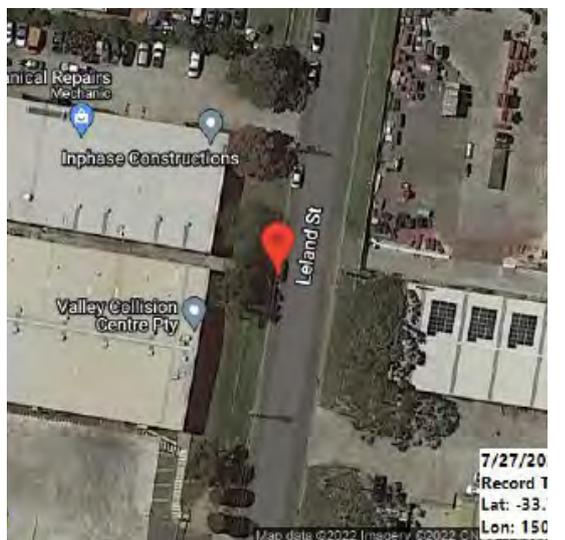
Figure: 0319 Slight cracking in the roadway, looking to the west. | **CHANGE:** None
Figure: 0320 Slight cracking in the kerb and gutter. | **CHANGE:** Showing new condition.
Figure: 0321 Slight cracking in the crossover. | **CHANGE:** Showing new condition.
Figure: 0322 Slight alligator cracking in the paving. (RPT FOR FIGURES 323-324) | **CHANGE:** None
Figure: 0327 Slight cracking in the kerb and gutter. | **CHANGE:** None
Figure: 0333 Fine cracking in the kerb and gutter. | **CHANGE:** None
Figure: 0334 Slight cracking in the kerb and gutter. | **CHANGE:** None
Figure: 0335 Chipping and slight cracking in the crossover. | **CHANGE:** None
Figure: 0336 Slight cracking in the crossover. (RPT FOR FIGURES 337-339) | **CHANGE:** None
Figure: 0352 Scoring in the paving. | **CHANGE:** None
Figure: 0353 Fine cracking in the paving. (RPT FOR FIGURES 354-356) | **CHANGE:** None
Figure: 0359 Slight cracking in the kerb and gutter. | **CHANGE:** None

Figure: 0359 Slight cracking in the kerb and gutter. | **CHANGE:** None

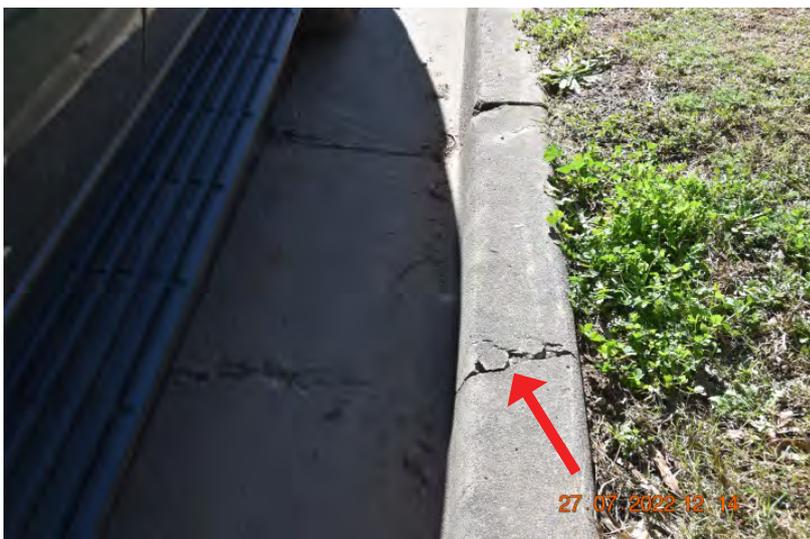
Figure: 0360 Fine cracking and chipping in the kerb and gutter. | **CHANGE:** None
Figure: 0369 Fine cracking in the kerb and gutter. | **CHANGE:** None
Figure: 0376 Chipping in the kerb. | **CHANGE:** None
Figure: 0378 Chipping and substantial cracking in the kerb and gutter. | **CHANGE:** None
Figure: 0385 Chipping in the kerb. | **CHANGE:** None
Figure: 0387 Substantial cracking and chipping in the kerb and gutter. | **CHANGE:** None
Figure: 0388 Fine cracking in the kerb. | **CHANGE:** None
Figure: 0389 Fine cracking in the kerb and gutter. | **CHANGE:** None
Figure: 0391 Fine cracking in the roadway. | **CHANGE:** None
Figure: 0392 Alligator cracking in the paving. | **CHANGE:** None
Figure: 0402 Alligator cracking in the paving. | **CHANGE:** None
Figure: 0403 Slight cracking in the paving. | **CHANGE:** None
Figure: 0404 Chipping and slight cracking in the crossover. (RPT FOR FIGURES 405-406) | **CHANGE:** None

Figure: 0360 Fine cracking and chipping in the kerb and gutter. | **CHANGE:** None

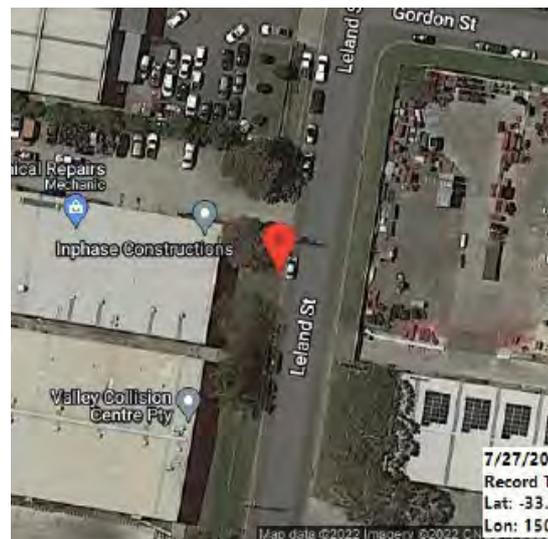
Figure: 0369 Fine cracking in the kerb and gutter. | **CHANGE:** None

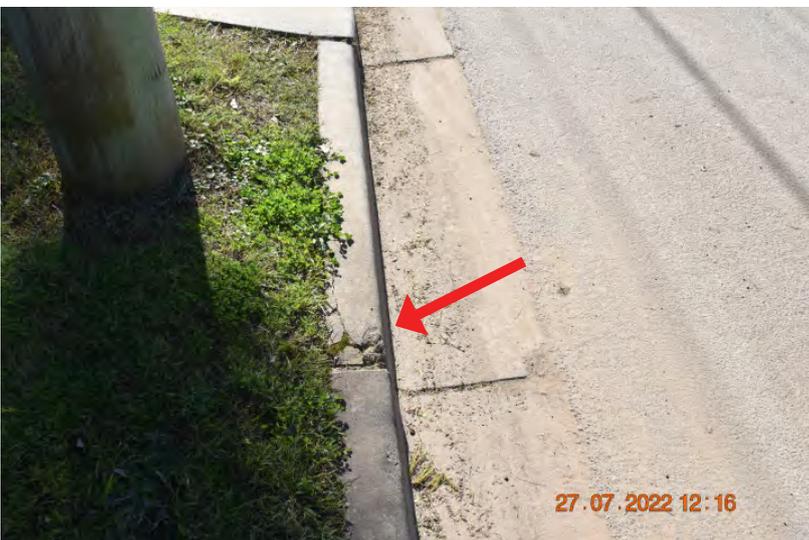
Figure: 0376 Chipping in the kerb. | **CHANGE:** None

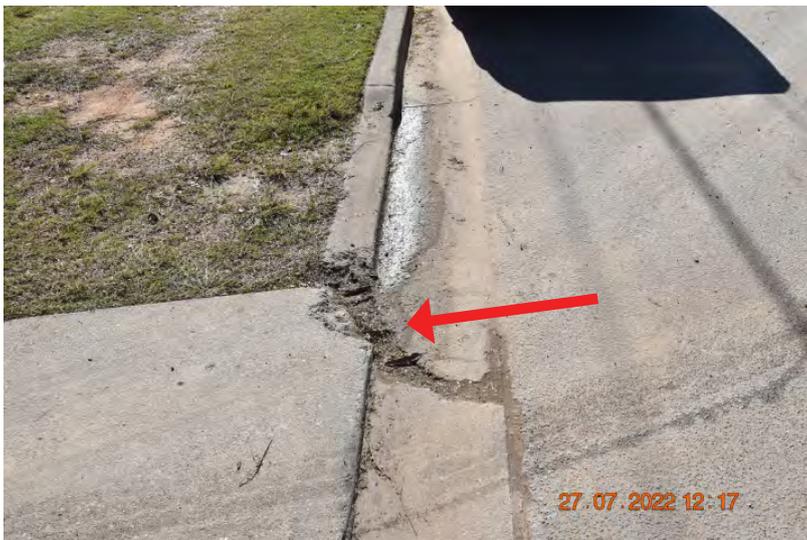
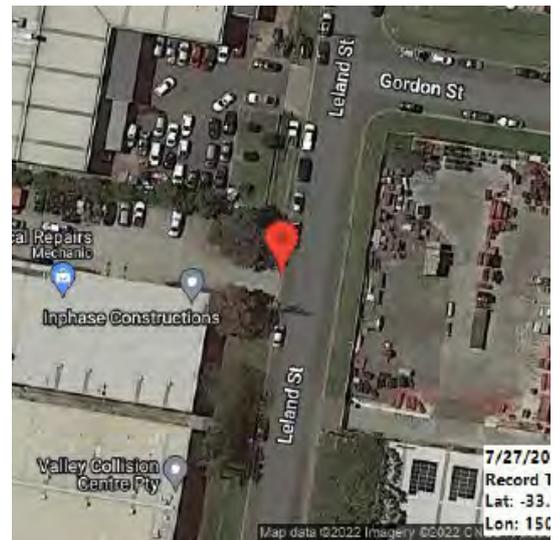
Figure: 0378 Chipping and substantial cracking in the kerb and gutter. | **CHANGE:** None

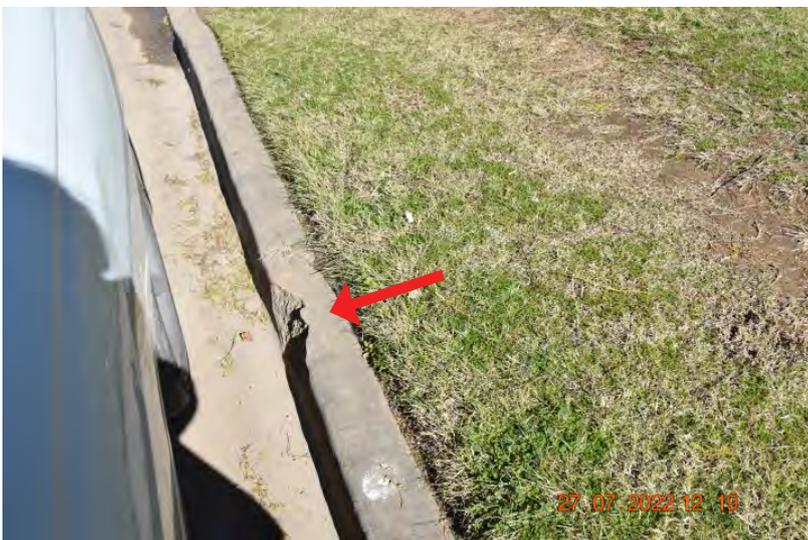
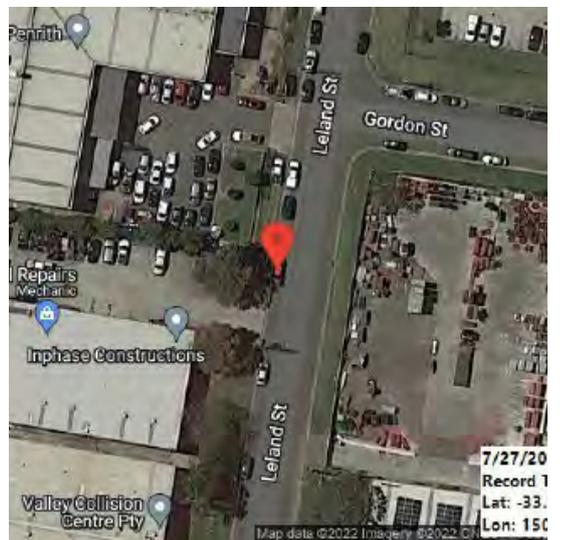
Figure: 0385 Chipping in the kerb. | **CHANGE:** None

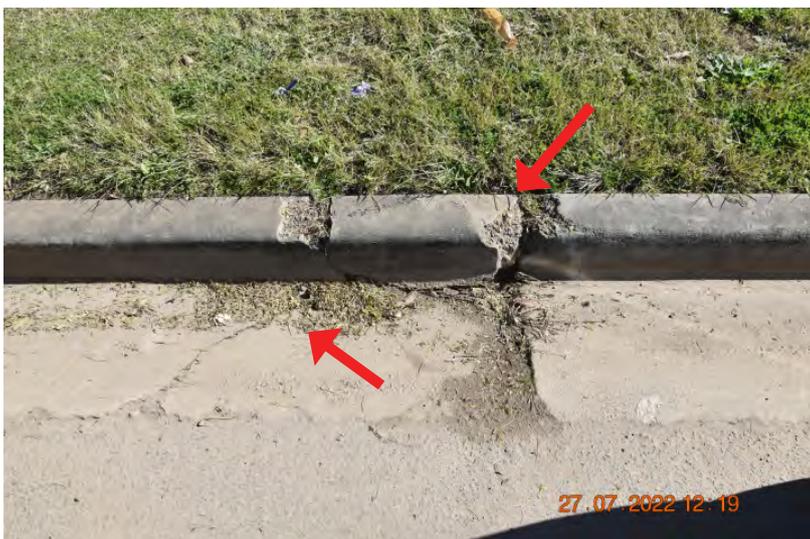
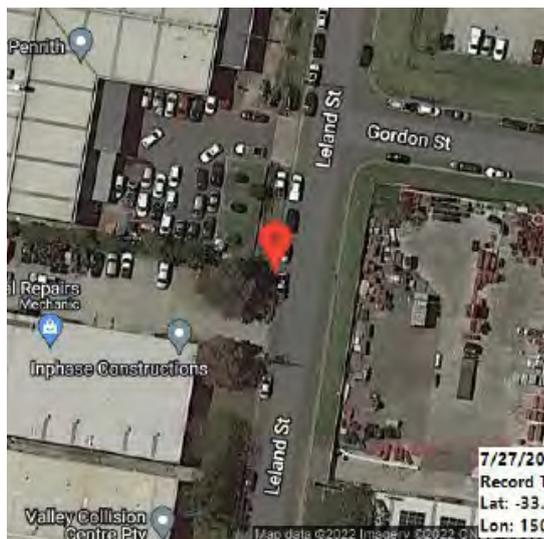
Figure: 0387 Substantial cracking and chipping in the kerb and gutter. | **CHANGE:** None

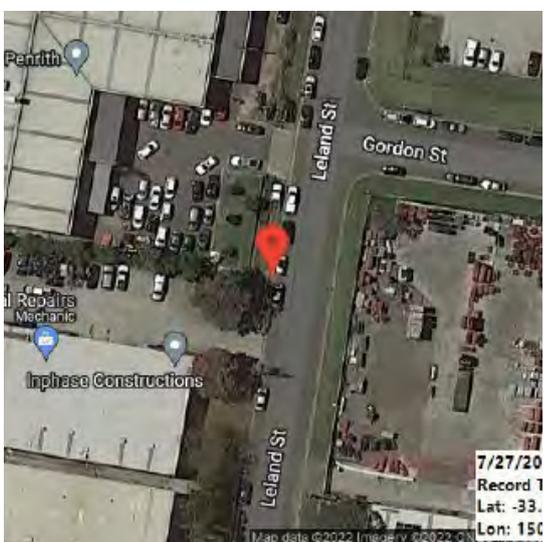
Figure: 0388 Fine cracking in the kerb. | **CHANGE:** None

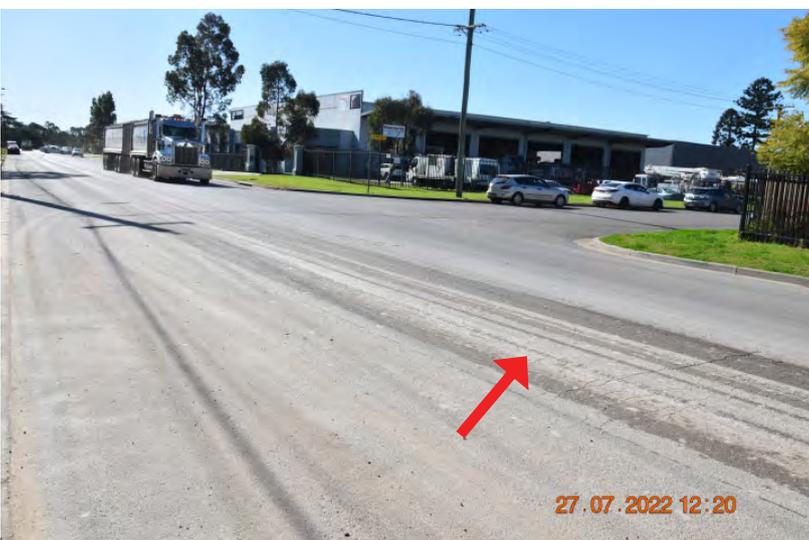
Figure: 0391 Fine cracking in the roadway. | **CHANGE:** None
