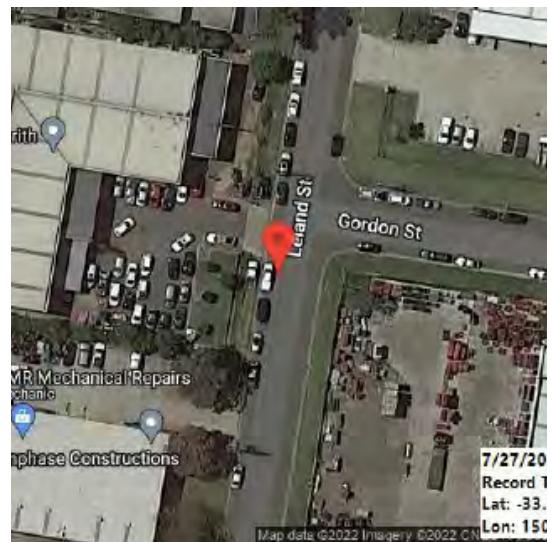
Figure: 0403 Slight cracking in the paving. | **CHANGE:** None

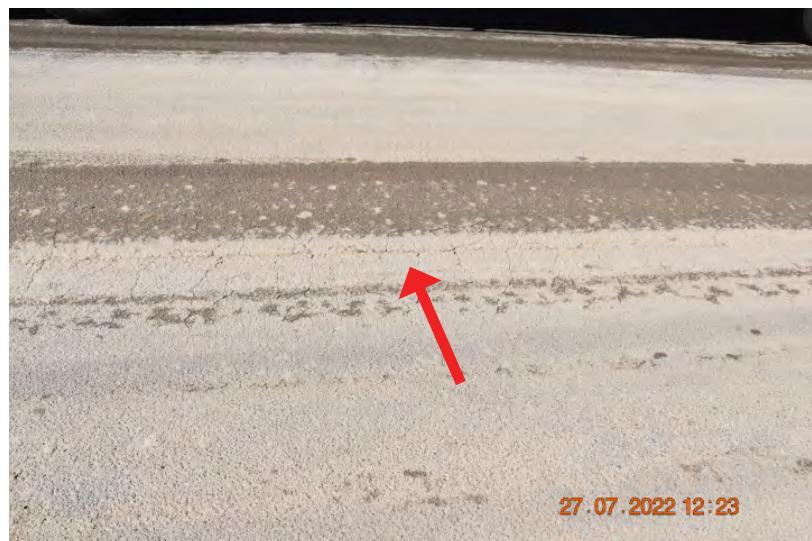
Figure: 0410 Slight separation in the roadway. (RPT FOR FIGURES 411-412) | CHANGE: None

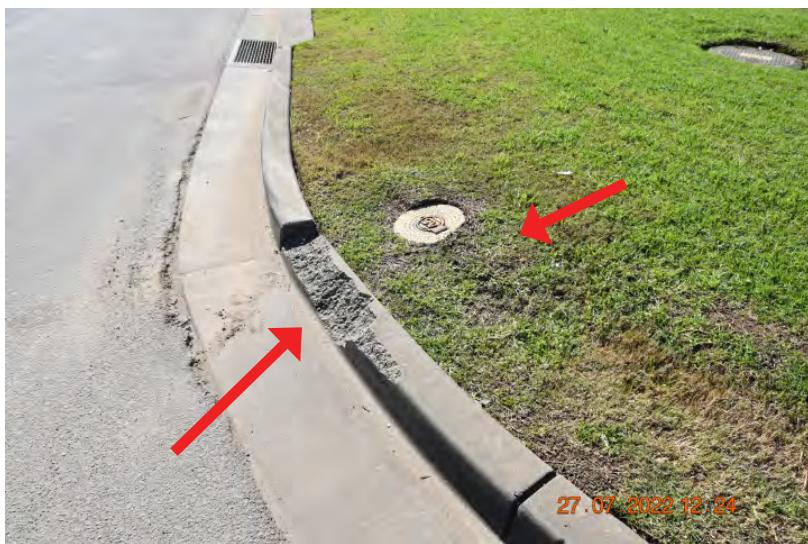
Figure: 0417 Chipping in the kerb. Also showing severe subsidence. | **CHANGE:** None

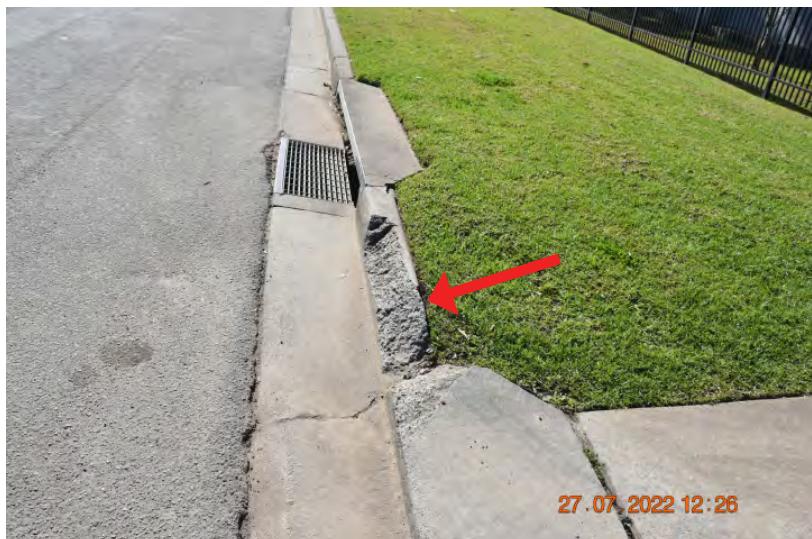
Figure: 0430 Chipping in the kerb. | **CHANGE:** None

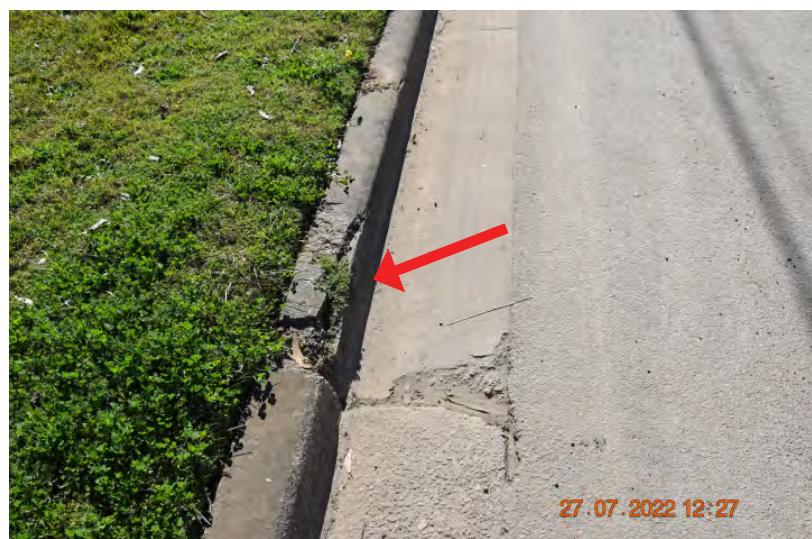
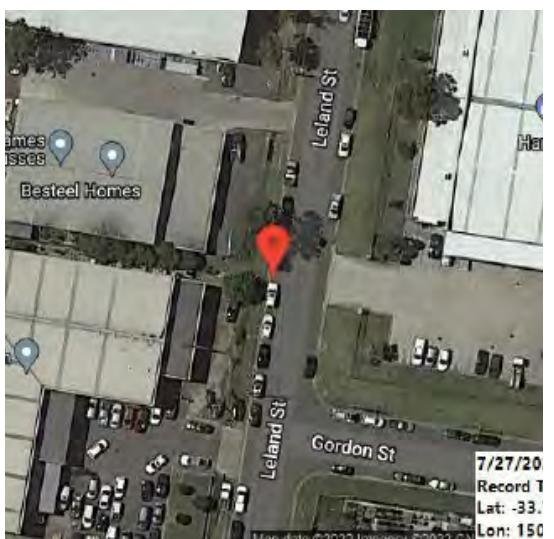
Figure: 0431 Chipping in the kerb and gutter. | **CHANGE:** None

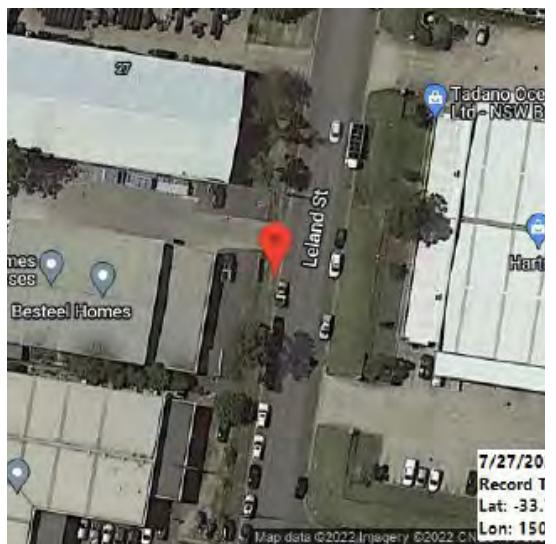
Figure: 0440 Chipping and slight cracking in the crossover. | **CHANGE:** None

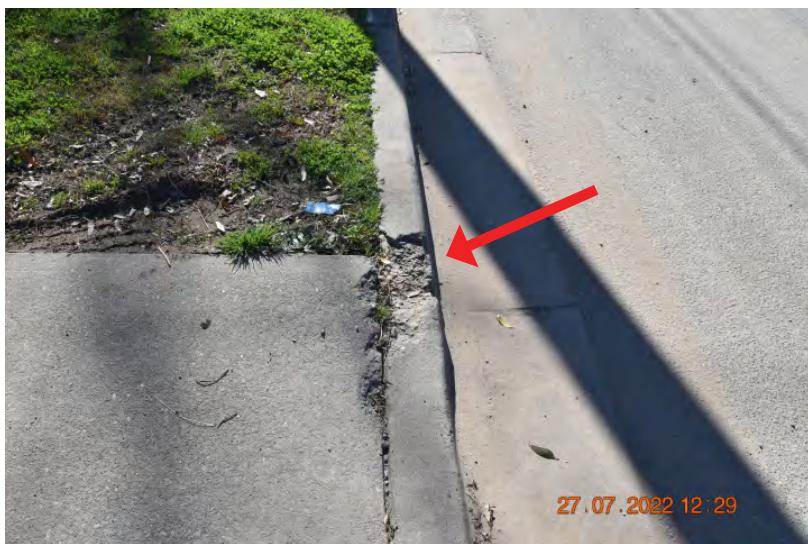
Figure: 0441 Chipping in the crossover. | **CHANGE:** None

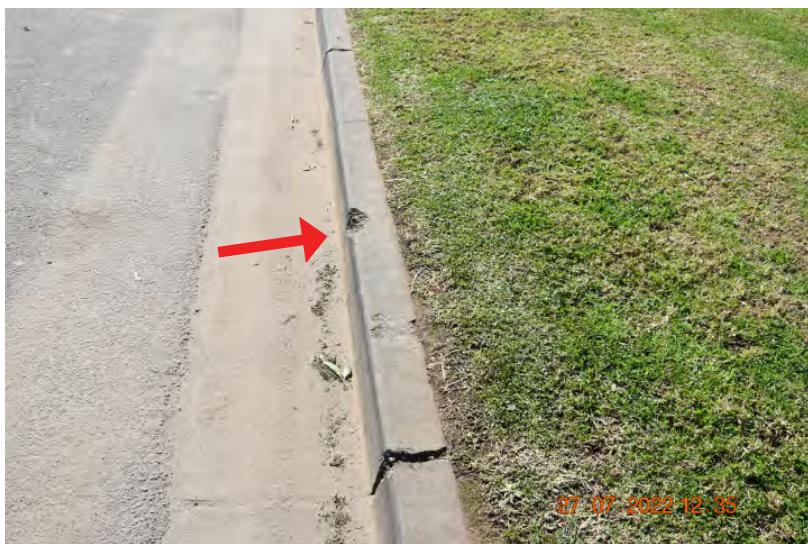
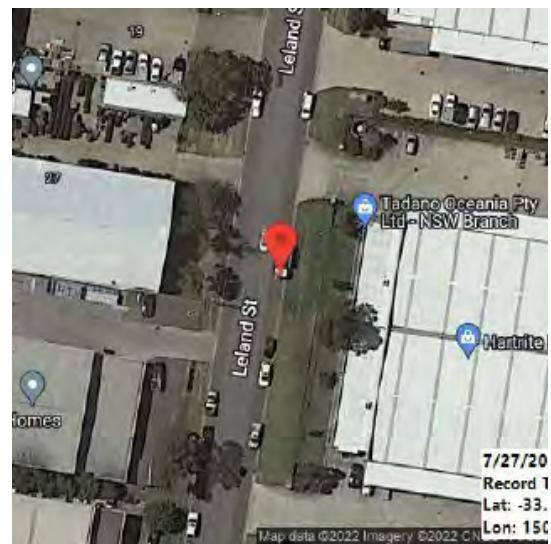
Figure: 0453 Chipping in the kerb and gutter. | CHANGE: None

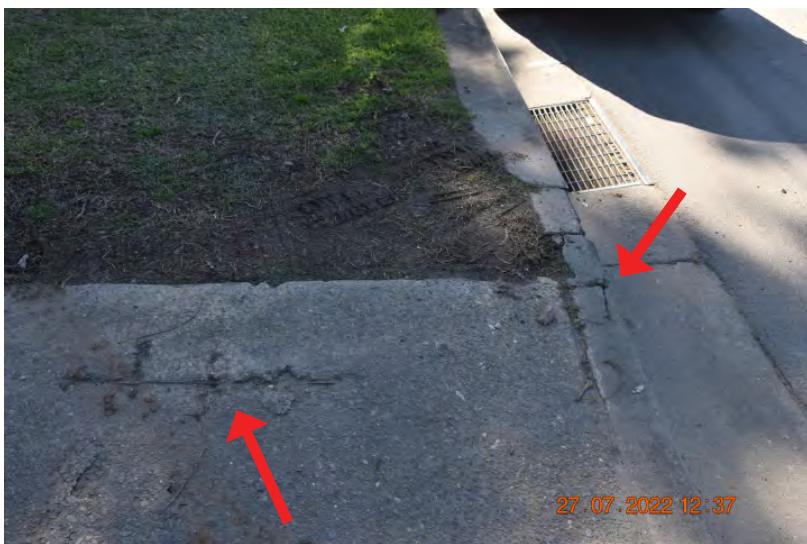
Figure: 0462 Scoring in the crossover. | **CHANGE:** None

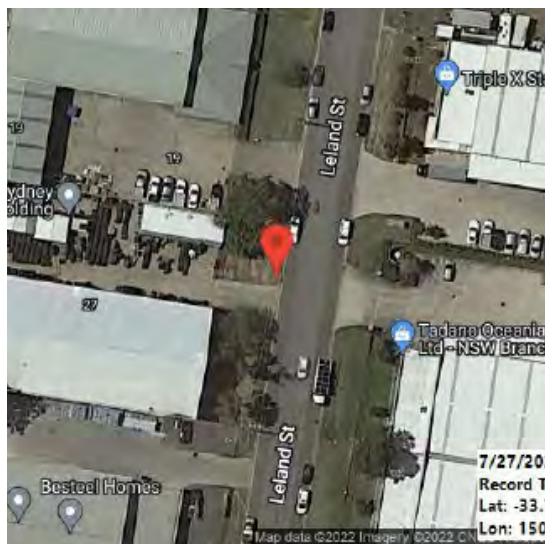
Figure: 0464 Fine cracking in the gutter. | **CHANGE:** None

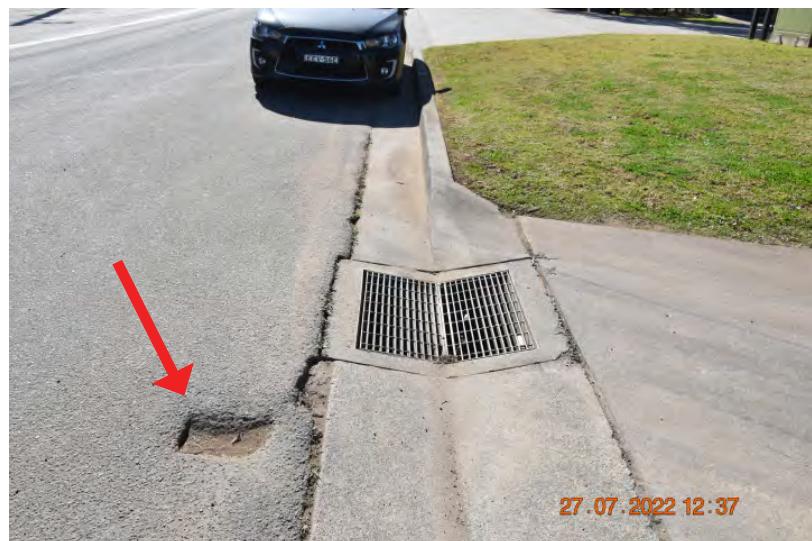
Figure: 0467 Scoring in the paving. | **CHANGE:** None

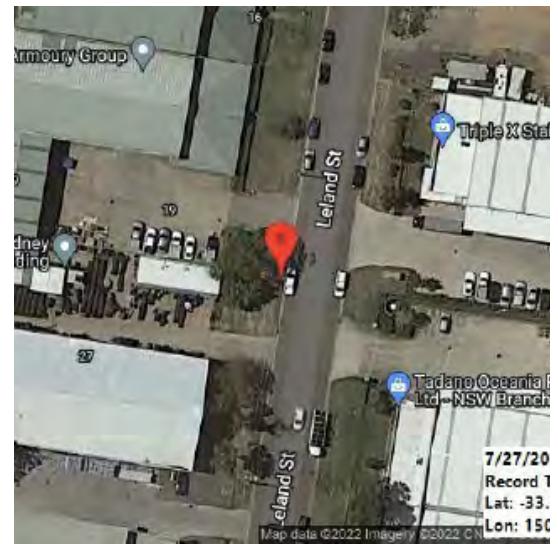
Figure: 0471 Slight cracking and chipping in the kerb and gutter. | **CHANGE:** None

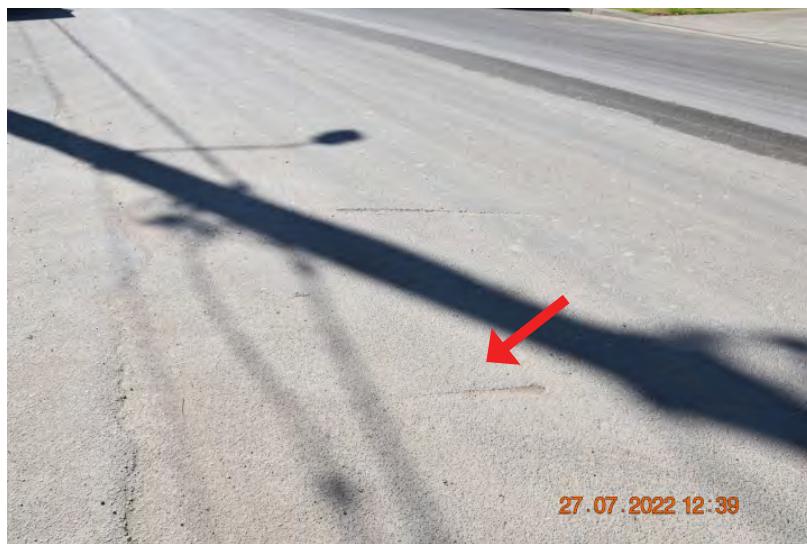
Figure: 0474 Scoring in the paving. | **CHANGE:** None

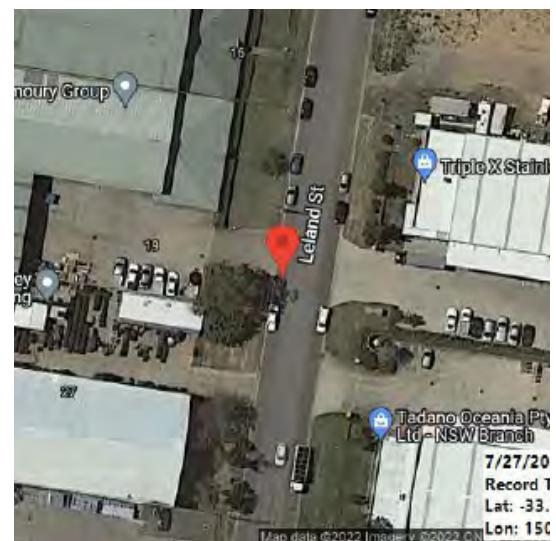
Figure: 0475 Slight cracking in the paving and the crossover. | **CHANGE:** None

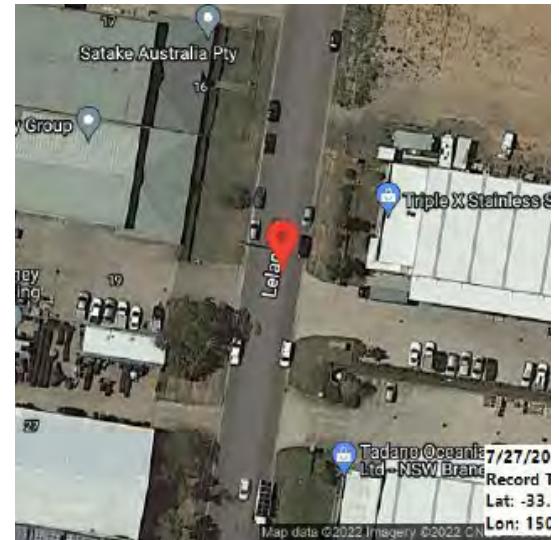
Figure: 0480 Slight cracking in the paving. | **CHANGE:** None

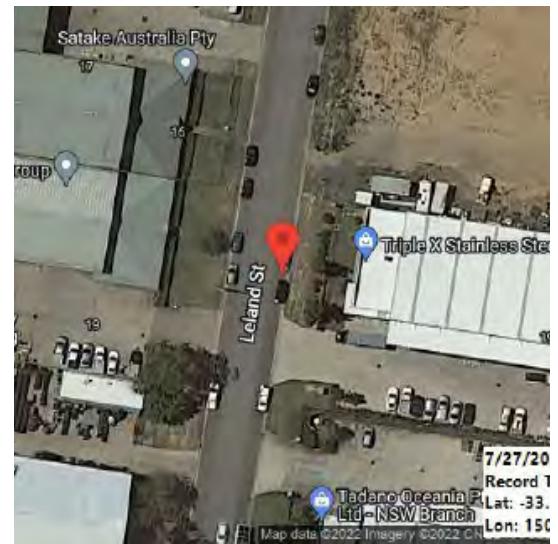
Figure: 0483 Slight cracking in the roadway. (RPT FOR FIGURES 484-485) | CHANGE: None

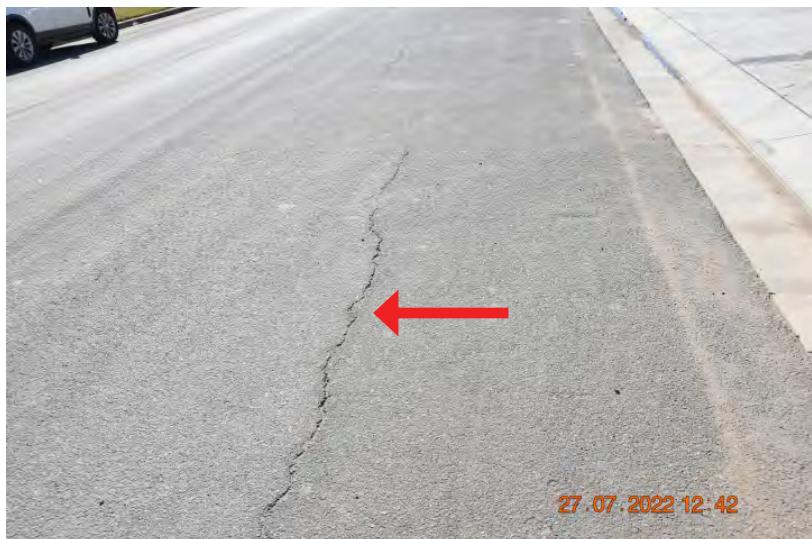
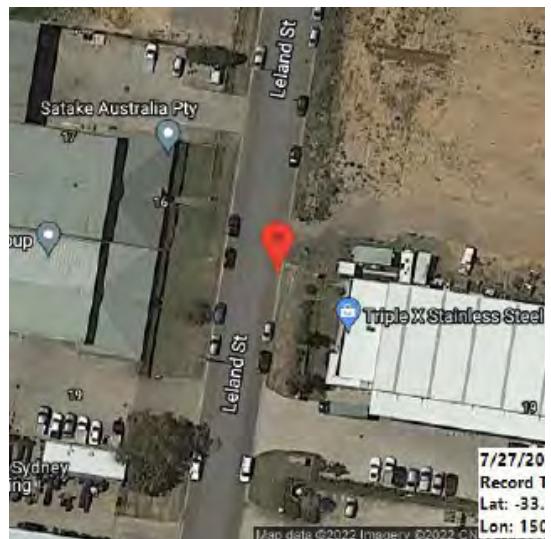
Figure: 0490 Slight cracking in the paving. | **CHANGE:** None

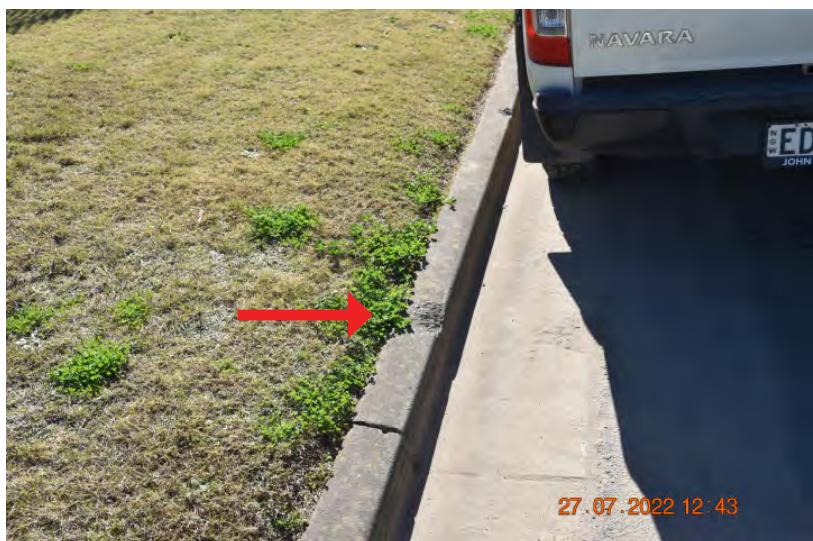
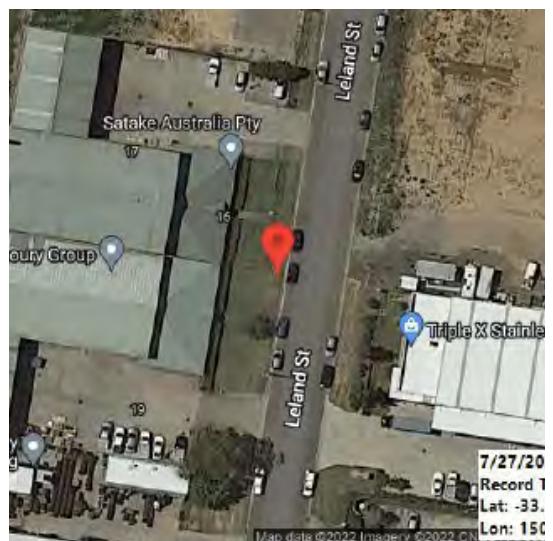
Figure: 0493 Chipping in the kerb. | CHANGE: None

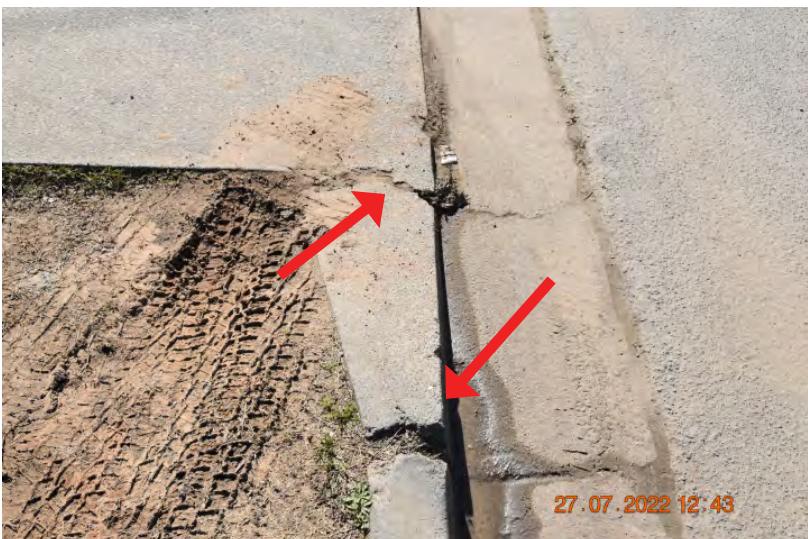
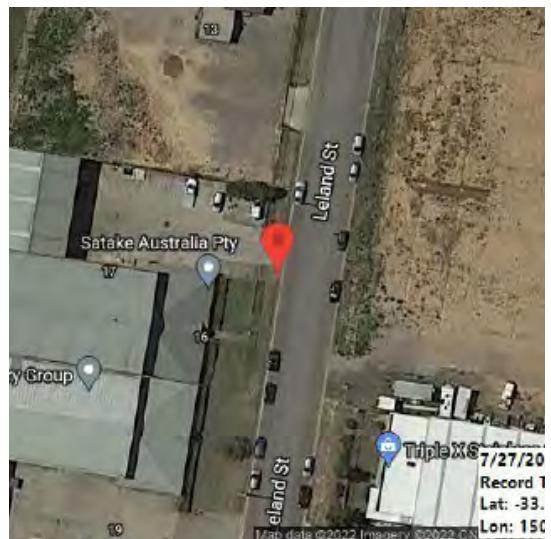
Figure: 0496 Slight cracking and chipping in the kerb and gutter. | **CHANGE:** None

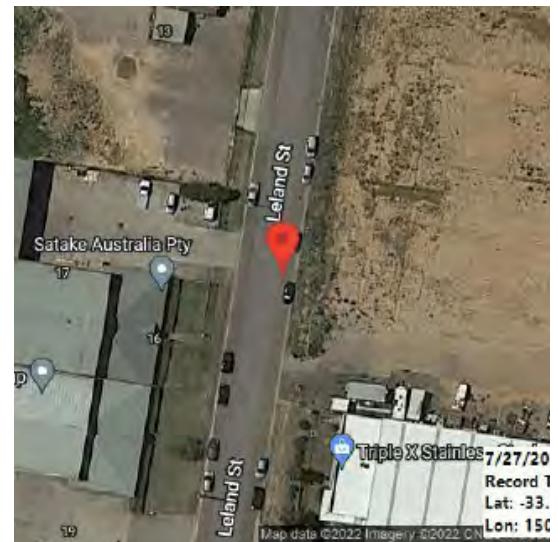
Figure: 0498 Slight cracking in the roadway. (RPT FOR FIGURES 499-500) | CHANGE: None

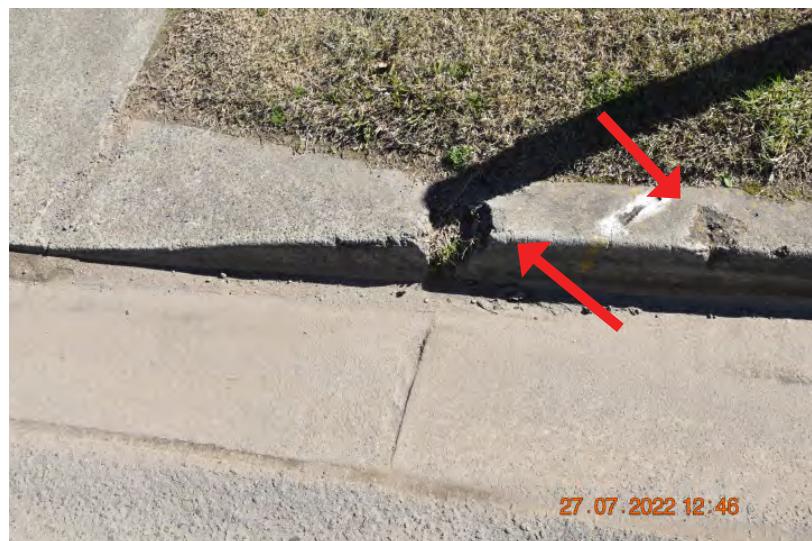
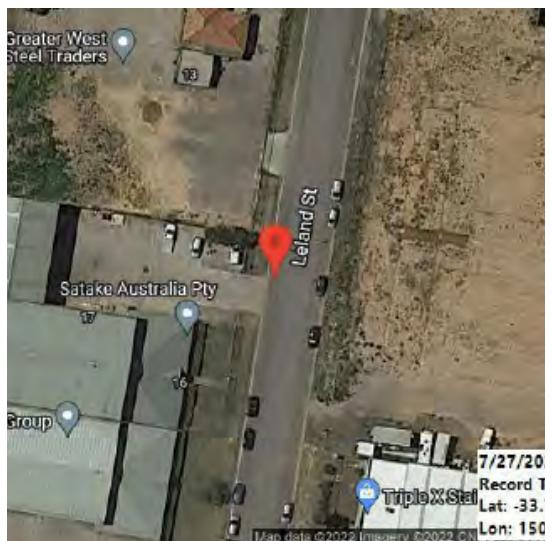
Figure: 0503 Chipping in the kerb. | **CHANGE:** None

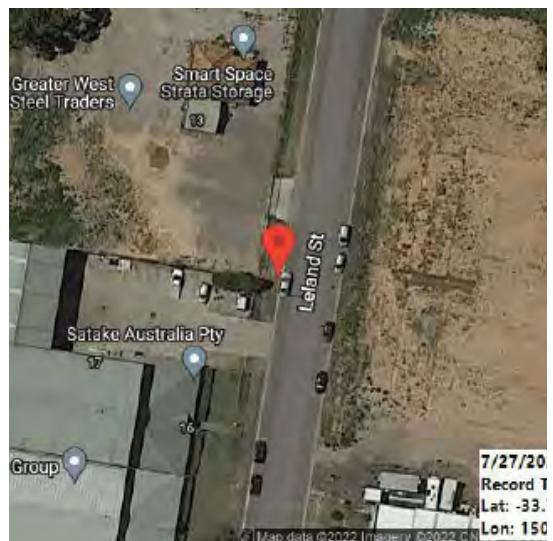
Figure: 0506 Chipping in the kerb. Also showing fine cracking in the gutter. | **CHANGE:** None

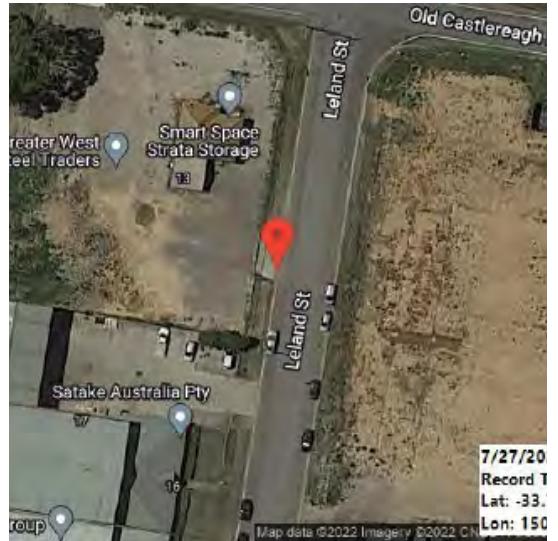
Figure: 0515 Fine cracking in the crossover, looking to the west. | **CHANGE:** None

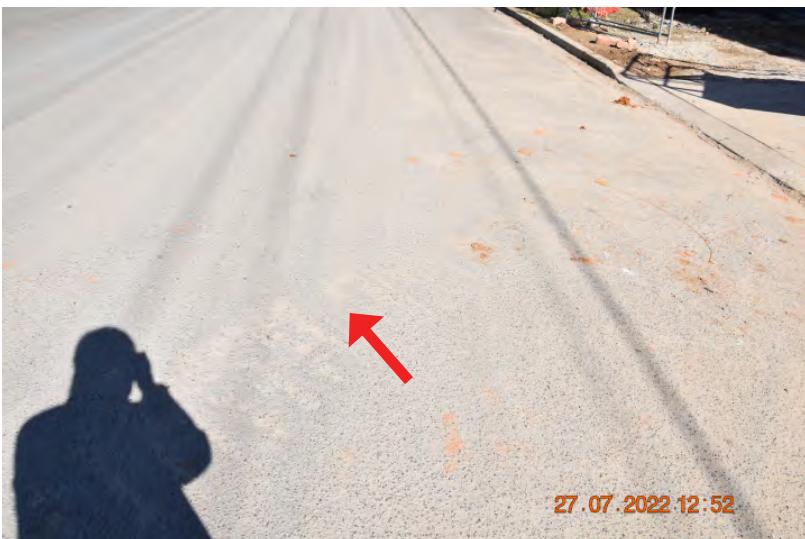
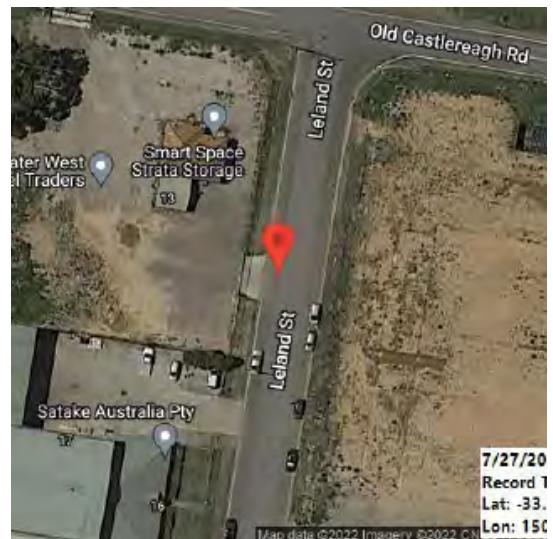
Figure: 0517 Scoring in the paving, looking to the south. | **CHANGE:** None

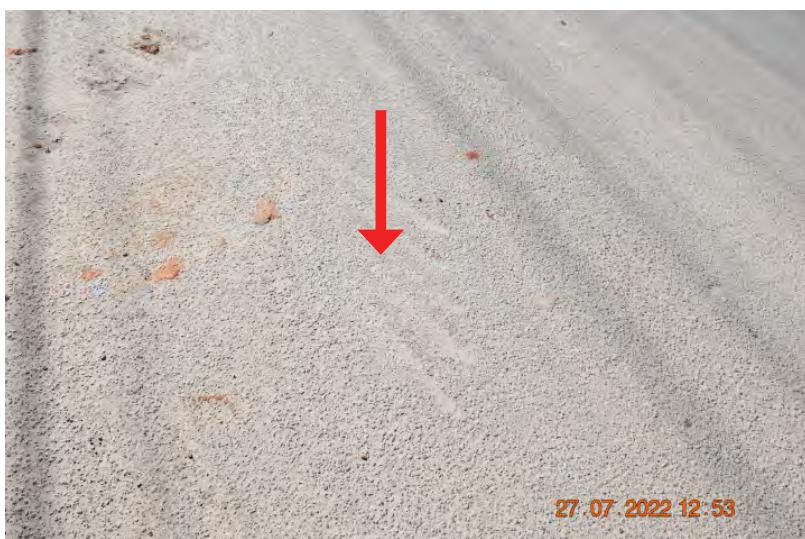
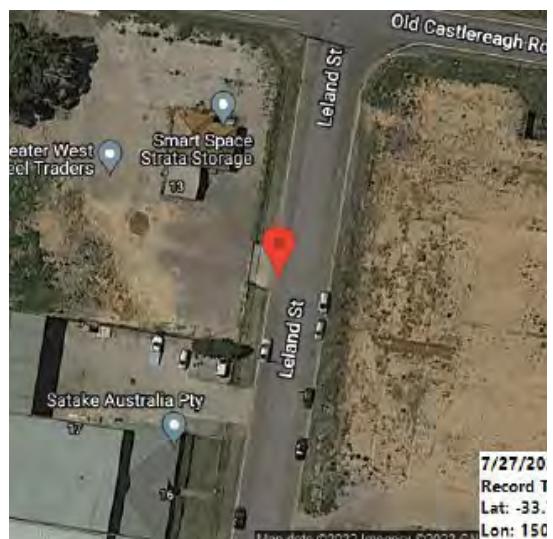
Figure: 0518 Scoring in the paving, looking to the north. | **CHANGE:** None

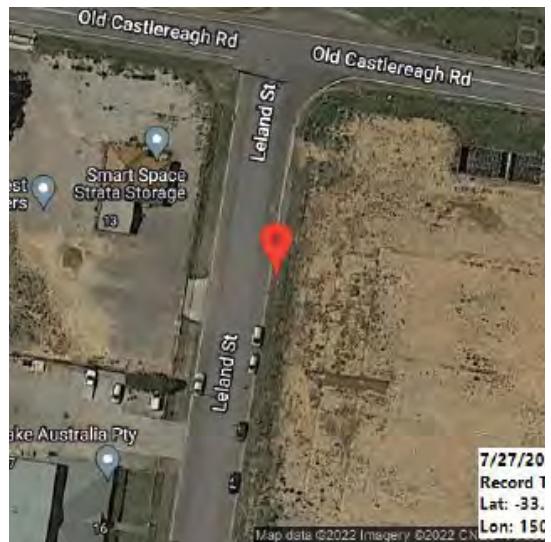
Figure: 0520 Chipping and fine cracking in the kerb and gutter. | **CHANGE:** None

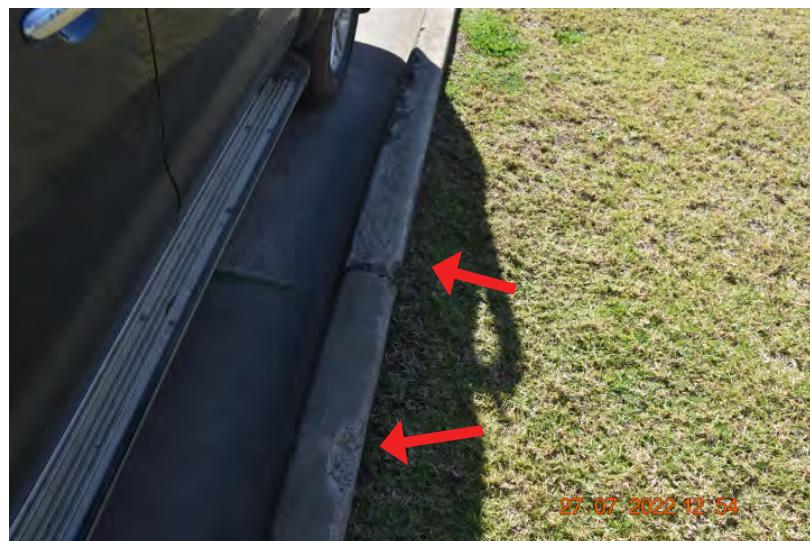
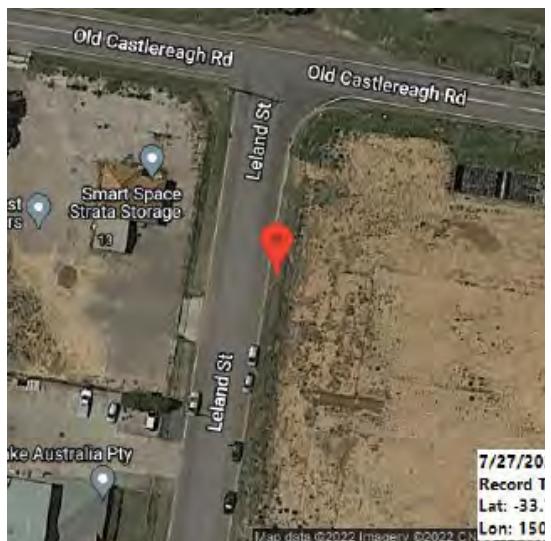
Figure: 0521 Chipping in the kerb. | **CHANGE:** None

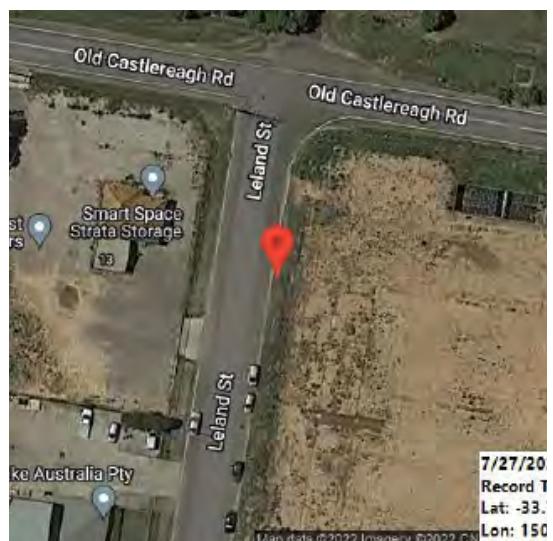
Figure: 0524 Slight cracking in the paving. | **CHANGE:** None

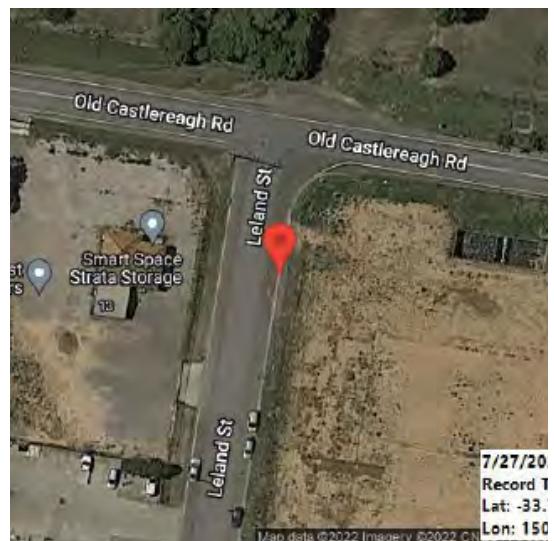
Figure: 0527 Slight cracking in the roadway. | **CHANGE:** None

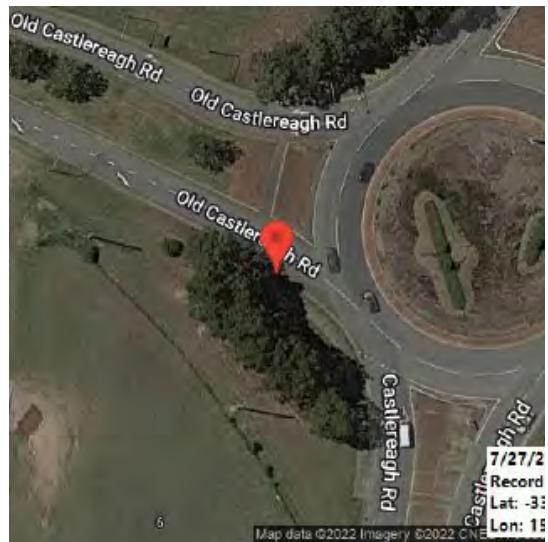
Figure: 0540 Slight cracking in the kerb and gutter. | **CHANGE:** None

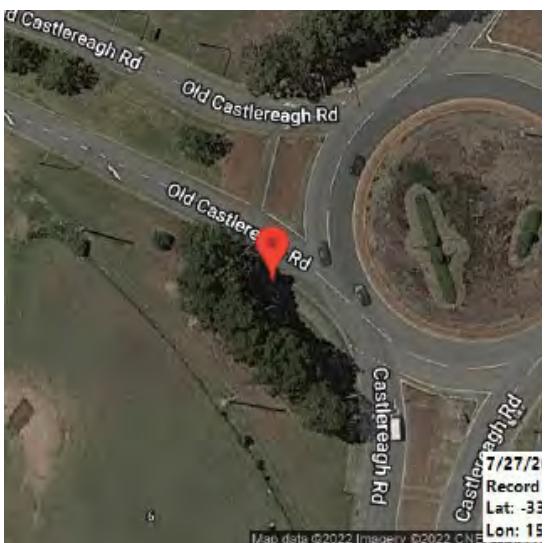
Figure: 0548 Slight cracking in the kerb and gutter. | **CHANGE:** None

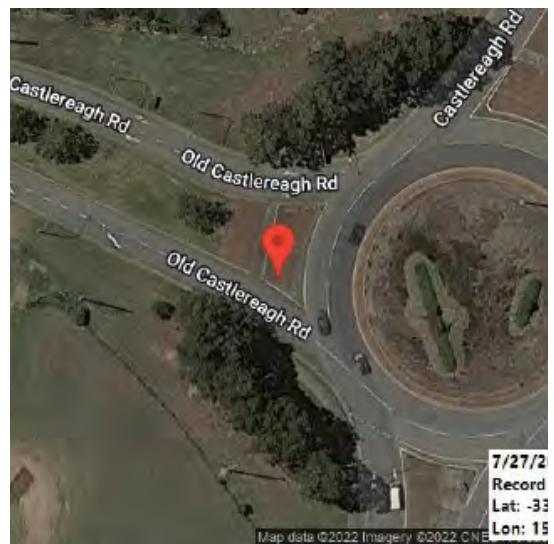
Figure: 0554 Slight cracking in the median strip. | **CHANGE:** None

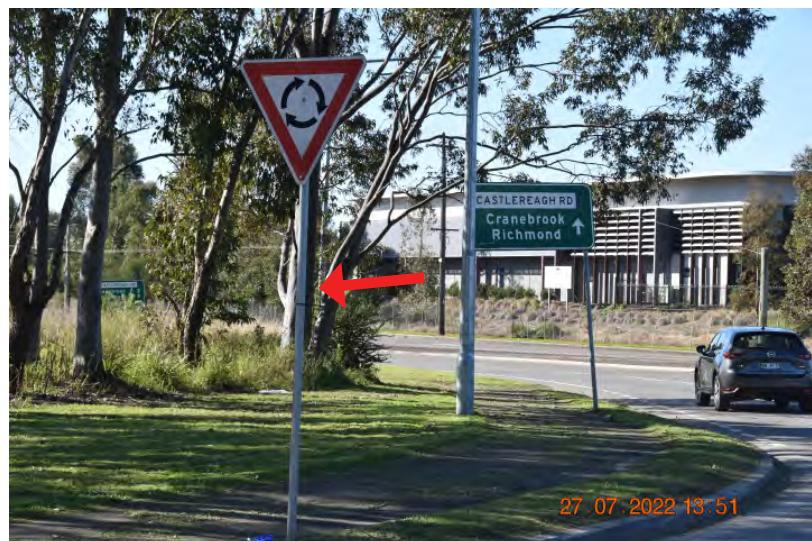
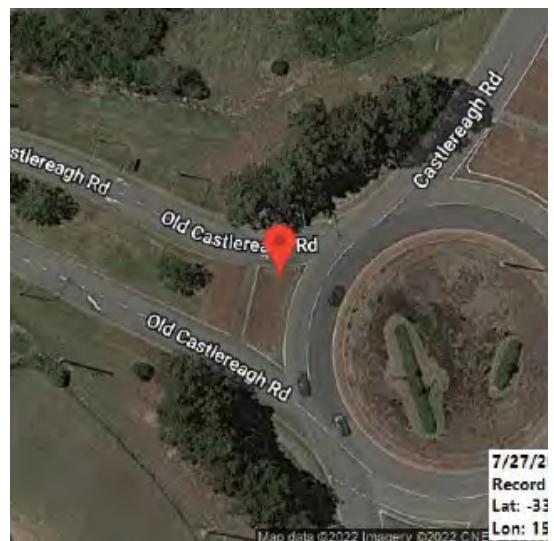
Figure: 0560 Leaning in the street sign. | CHANGE: None

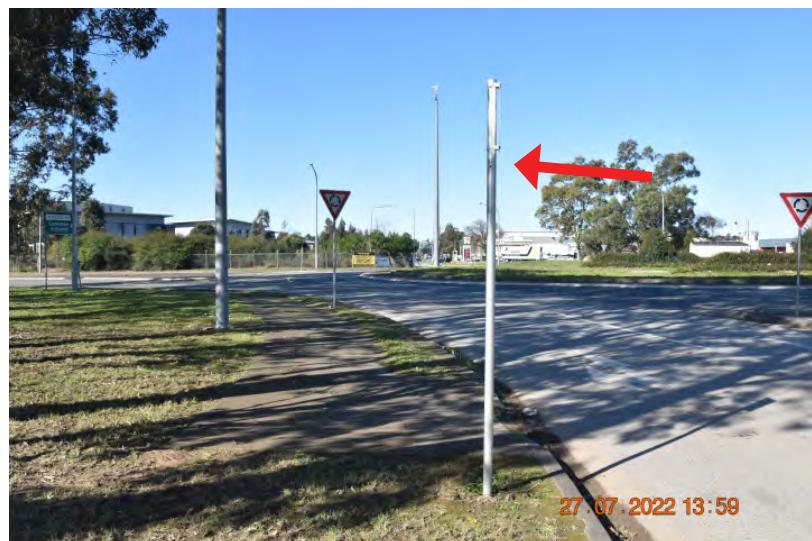
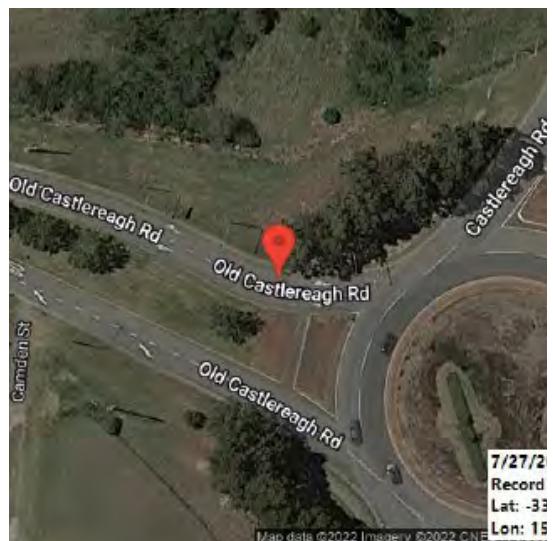
Figure: 0566 Leanin street sign. | **CHANGE:** None

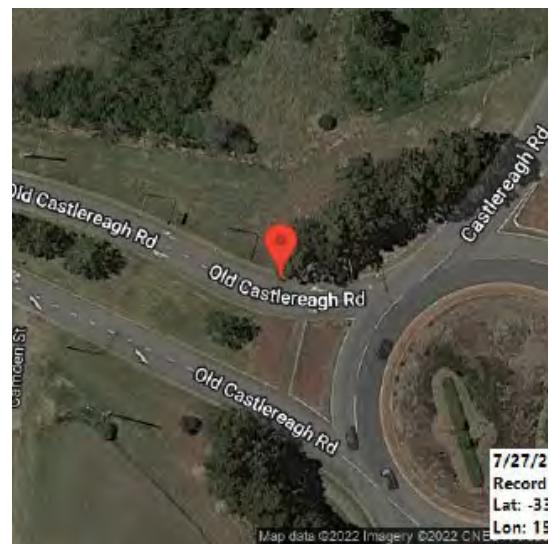
Figure: 0567 Slight cracking and chipping in the kerb and gutter. | **CHANGE:** None

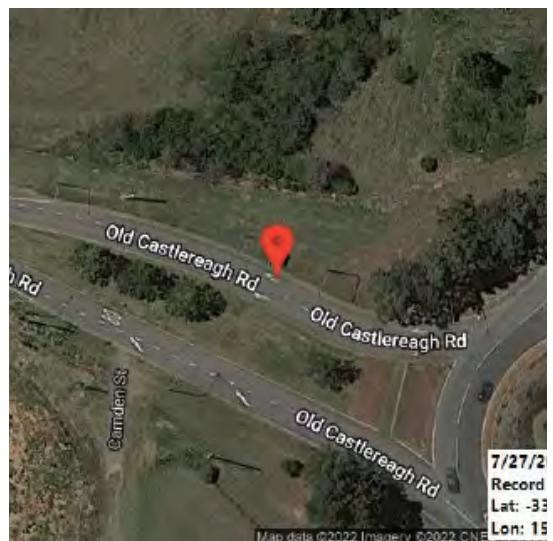
Figure: 0590 Slight cracking and chipping in the kerb and gutter. | **CHANGE:** None

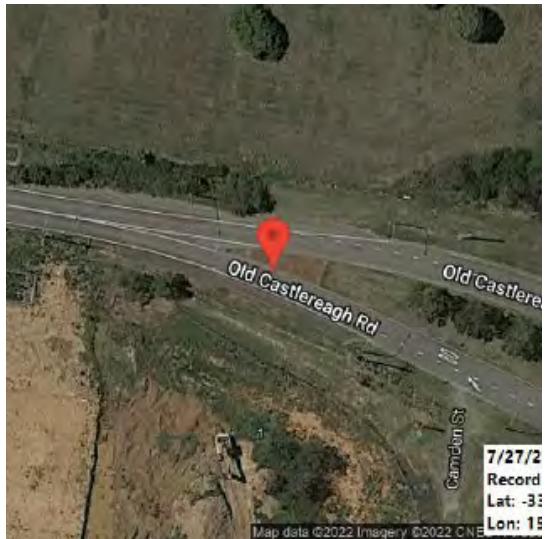
Figure: 0607 Fine cracking in the median strip. | CHANGE: None

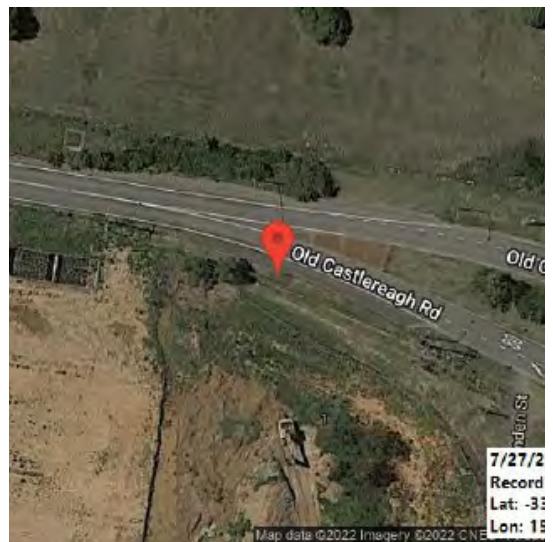
Figure: 0625 Slight cracking in the paving. | **CHANGE:** None

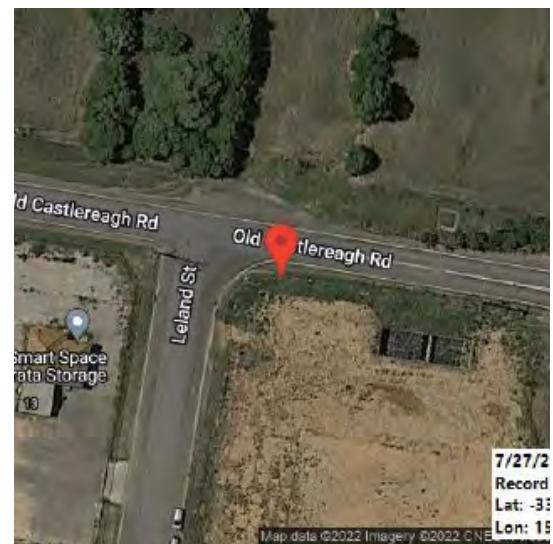
Figure: 0633 Slight cracking in the paving. | **CHANGE:** None

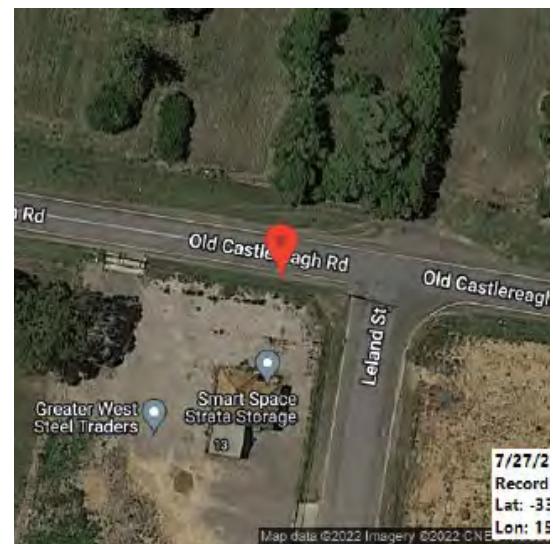
Figure: 0636 Slight cracking in the paving. | **CHANGE:** None

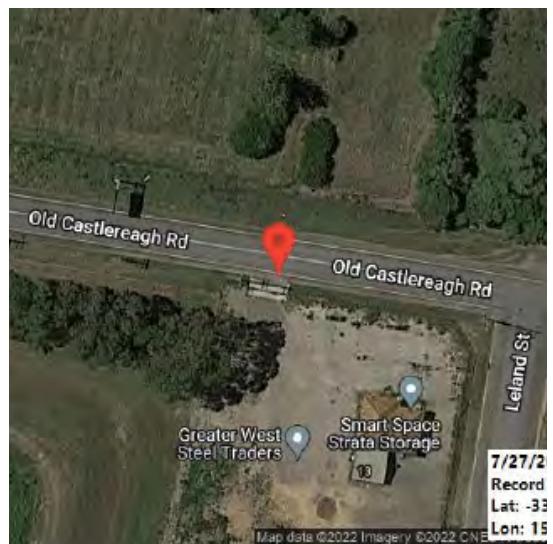
Figure: 0641 Slight cracking in the paving. (RPT FOR FIGURES 642-643) | **CHANGE:** None

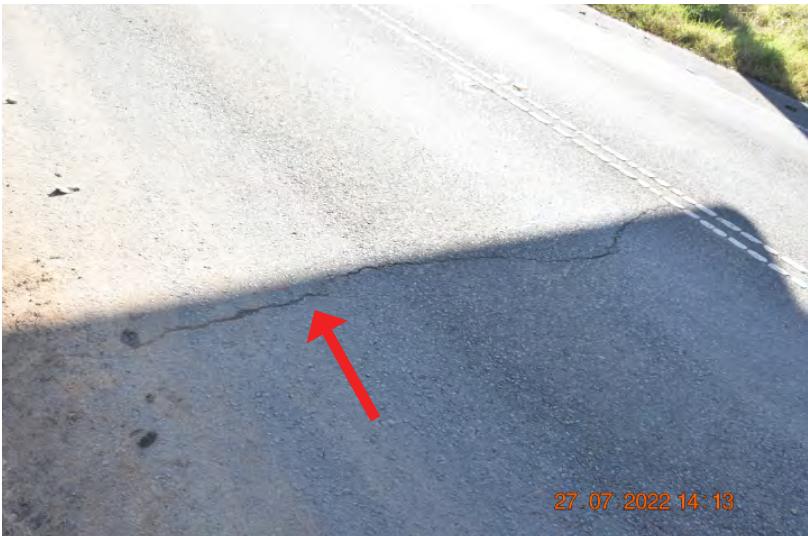
Figure: 0646 Slight cracking in the paving. | **CHANGE:** None

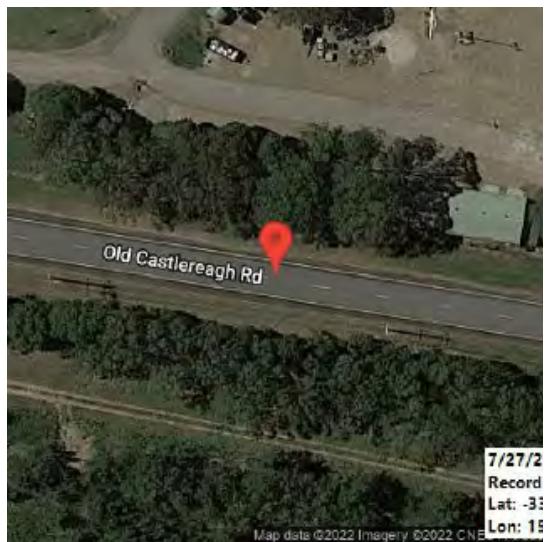
Figure: 0715 Fine cracking in the paving. | CHANGE: None

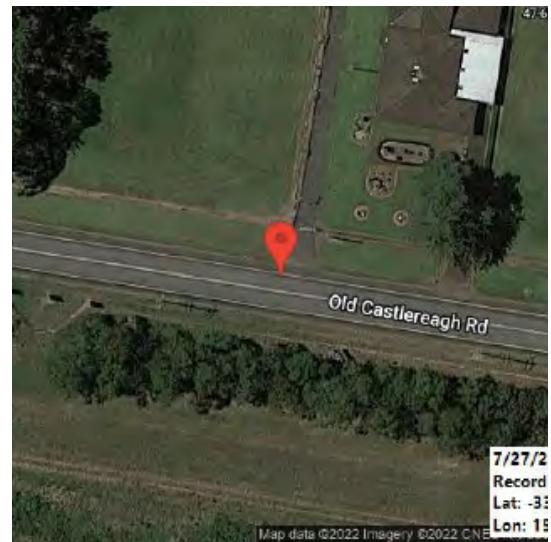
Figure: 0747 Fine cracking in the crossover. (RPT FOR FIGURES 748-749) | CHANGE: None
